**Cell 1 Regional Coastal Monitoring Programme
Update Report 10: 'Partial Measures' Survey 2018**

Durham Council

June 2018

(*) The present report is **Update Report 10** and provides an analysis of the 2018 Partial Measures survey for Durham Council's frontage.

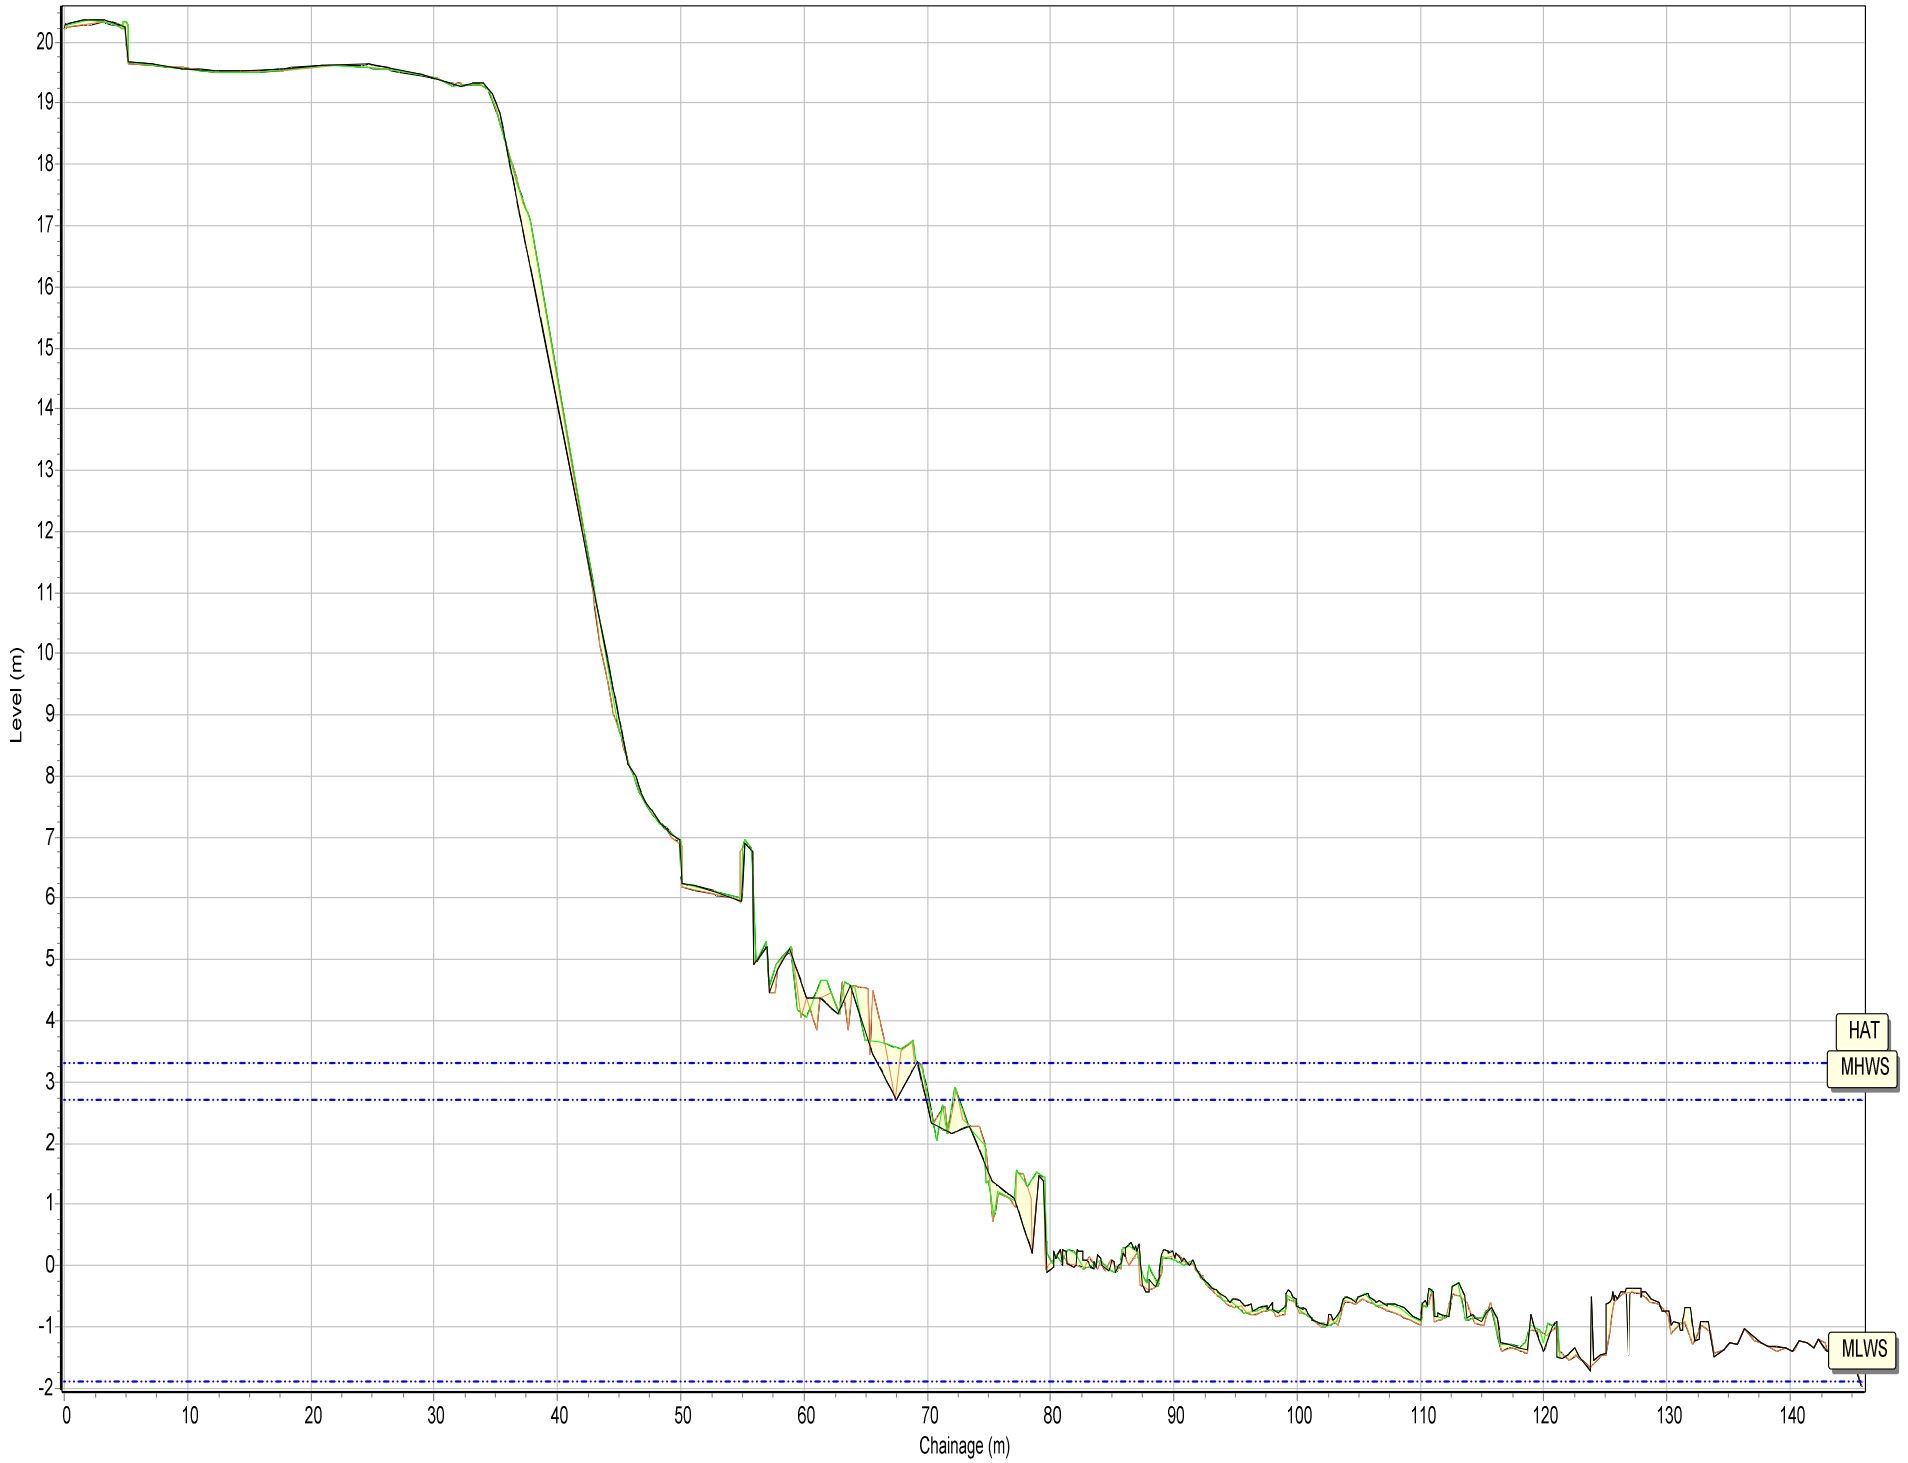
Beach Profiles: 1bEA1

Survey Date	Description of Changes Since Last Survey	Interpretation
30 th April 2018	<p>Beach Profiles:</p> <p>Featherbed Rocks is monitored by one beach profile line (EA1) during the Partial Measures survey (Appendix A). The previous survey was September 2017.</p> <p>Profile 1bEA1 has changed very little to 55m chainage, which covers the cliff and promenade. The uneven profile at the base of the sea wall between 55m and 80m is due to the rock armour. Beyond 80m there has been little change over the winter of 2017/18, the beach profiles reflect the rocky nature of the foreshore and that there is no beach over the shore platform.</p>	<p>The rocky nature of the foreshore means it is unlikely to undergo significant changes in morphology unless sediment is deposited. Previous monitoring indicates that a veneer beach tends to accumulate over the summer and is stripped off by winter storms, giving rise to small and localised changes in profile. The upper part of the profile, which covers the cliff promenade and rock armour remains unchanged, as does the lower part of the profile which covers the beach.</p> <p>Longer term trends:</p> <p>The level of the beach in April 2018 was comparable with the lowest beach levels recorded in March 2010, April 2013 and October 2013. The shore platform is exposed and as a result any apparent changes are likely to be due to differences in the survey point locations and the way that survey points are joined to show an interpolated surface.</p>

- The level of the beach at Featherbed Rocks in April 2018 was comparable with the lowest beach levels recorded in March 2010, April 2013 and October 2013. The shore platform is exposed on the lower beach
