**Cell 1 Regional Coastal Monitoring Programme  
Update Report 11: 'Partial Measures' Survey 2019**

(\*) The present report is **Update Report 11** and provides an analysis of the 2019 Partial Measures survey for Durham Council's frontage.

**Durham County Council Frontage**

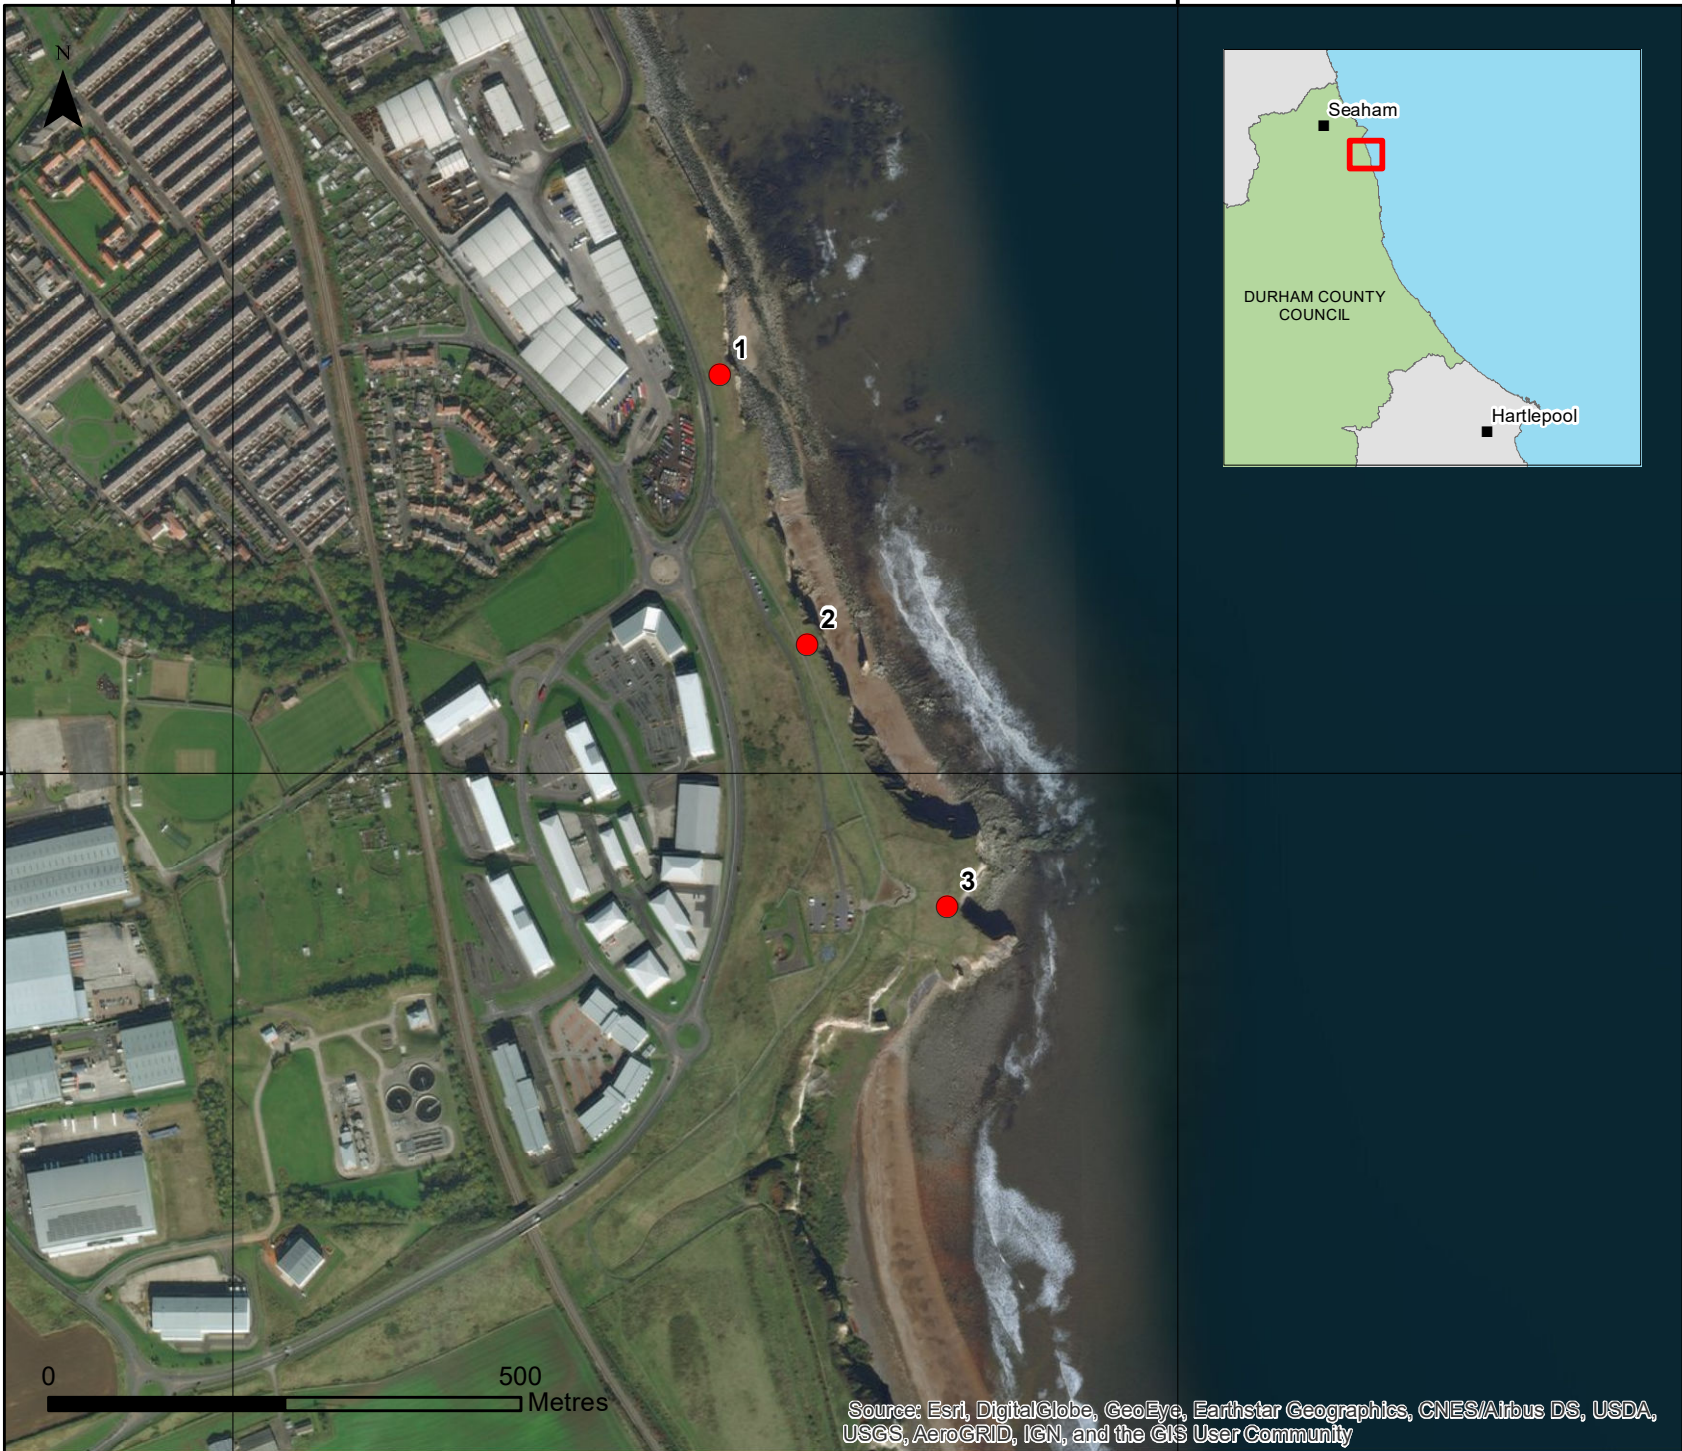
**Figure 3 - Map 1**

Three ground control points have been established at Dawdon (Figure B1). The maximum separation between any two points varies along the coast, reflecting the degree of risk from the erosion.

The cliff top surveys at Dawdon are undertaken bi-annually. Measurements are taken from a fixed ground control point along a fixed bearing to the edge of the cliff top.

Survey Date	Description of Changes Since Last Survey	Interpretation
18 <sup>th</sup> April 2019	<p><b>Cliff-top Survey:</b></p> <p>Three ground control points have been established along the cliff top at Dawdon (Figure B1). The separation between any two points is nominally 300m. These cliff top surveys are intended to inform on erosion rates of the undefended sea cliffs extending south of the rock armour revetment to the south of Seaham Harbour. The cliff top surveys at Dawdon are undertaken bi-annually.</p> <p>Measurements are taken from a fixed ground control point along a fixed bearing to the edge of the cliff top. Appendix B provides results from the April 2019 survey showing the position from the ground control point to the edge of the cliff top along the defined bearing and changes since the November 2008 baseline survey.</p> <p>The cliff monitoring data shows that there has been very little change over the winter of 2018/19, control points 2 and 3 have experienced no recession greater than the survey error of 0.1m. The cliff face at control point 1, located at Dawdon, has experienced an advancement of 0.18m over the winter of 2018/19. It is likely that this is caused by slumping of the upper cliff, however this cannot be confirmed without a detailed visual inspection.</p>	<p>There has been little change over the winter of 2018/19. Overall ground control point number 1 showed erosion of 1.02m, and ground control point 3 showed erosion of 1.22m since November 2008. Point 2 has shown little change.</p> <p><b>Longer term trends:</b></p> <p>There is more confidence in the long-term pattern of change, where the cumulative measured erosion is greater than the error inherent in the technique.</p> <p>Ground control points 1 and 3 have both shown an average recession rate of 0.1m/yr, since monitoring began in 2008.</p>

- At Seaham Cliffs, the survey data indicates that the average recession rate since monitoring began in 2008 is 0.09m/yr at Point 1 and 0.12m/yr at Point 3. Point 2 shows little change over the monitoring period.

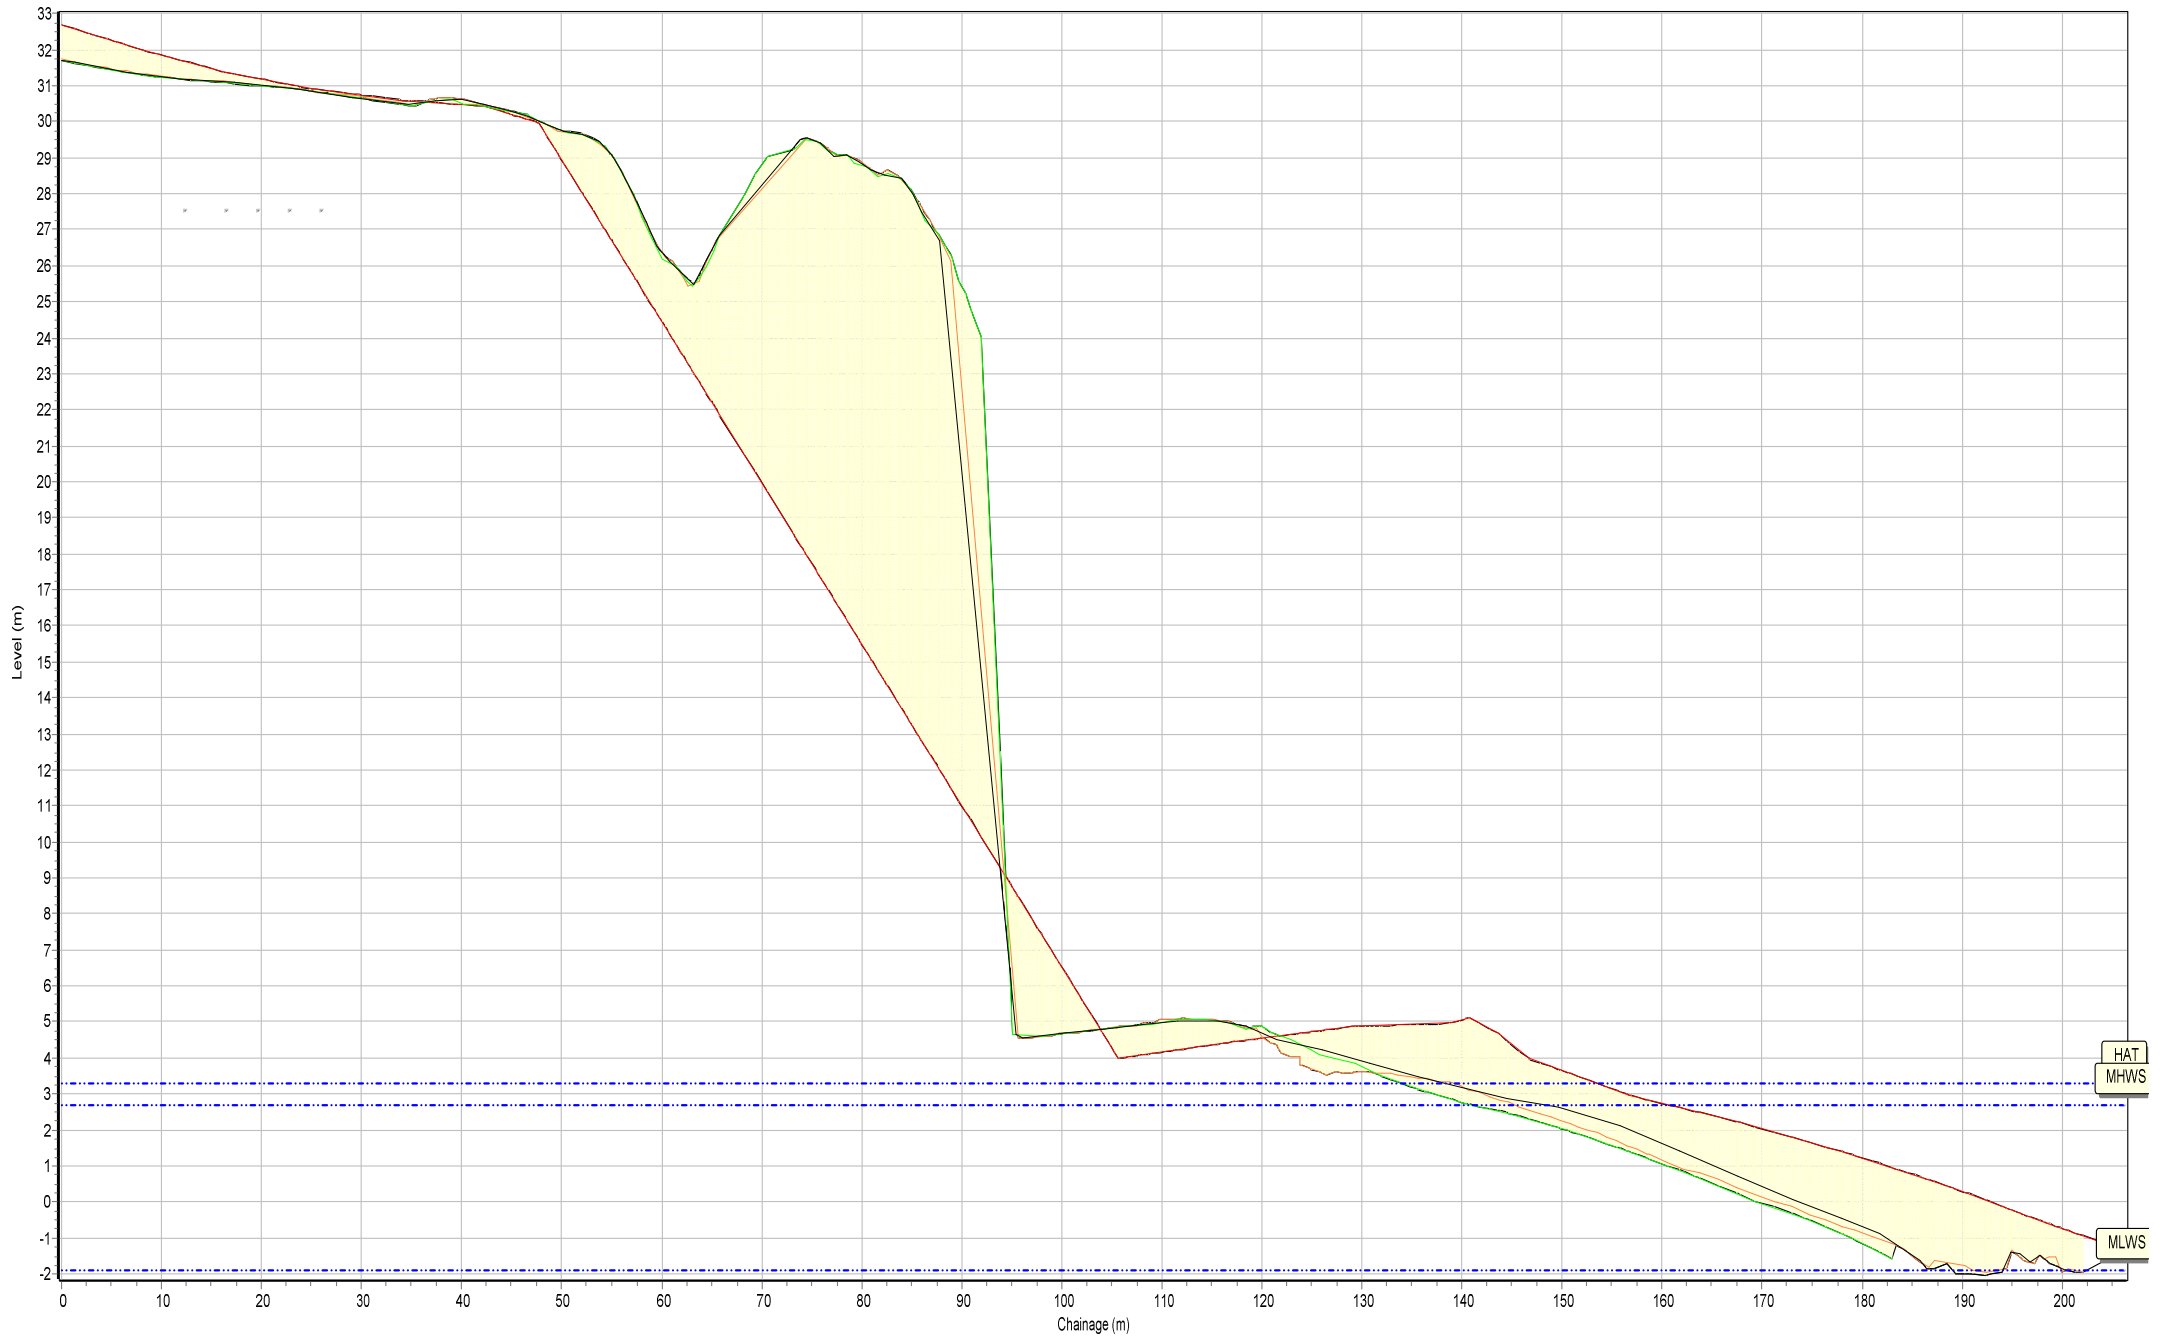
# Beach Profiles: 1bSH2

Survey Date	Description of Changes Since Last Survey	Interpretation
	<p>At <b>1bSH2</b> there has been very little change to the berm's crest at chainage 115m, up to <math>\pm 0.2</math>m. From chainage 120m to the exposed rock at 185m there has been accretion across the beach of up to 0.8m, but more typically 0.4m. The face of the beach crest at chainage 120m to 125m has flattened and the upper beach up to chainage 150m is at a shallow gradient. Seaward of chainage 150m the beach gradient increases. Overall the beach is at a medium level compared to the range recorded from previous surveys, except seaward of chainage 185m where the rocky foreshore is exposed.</p>

- At Blast Beach colliery spoil still prevents the sea from actively eroding the cliffs. However, there have been some changes in the beach profile over the winter of 2018/19, typically consisting of erosion and drawdown of the upper and mid beach. This is consistent with the periodic shift in the direction of sediment transport through the winter as noted in previous survey reports.

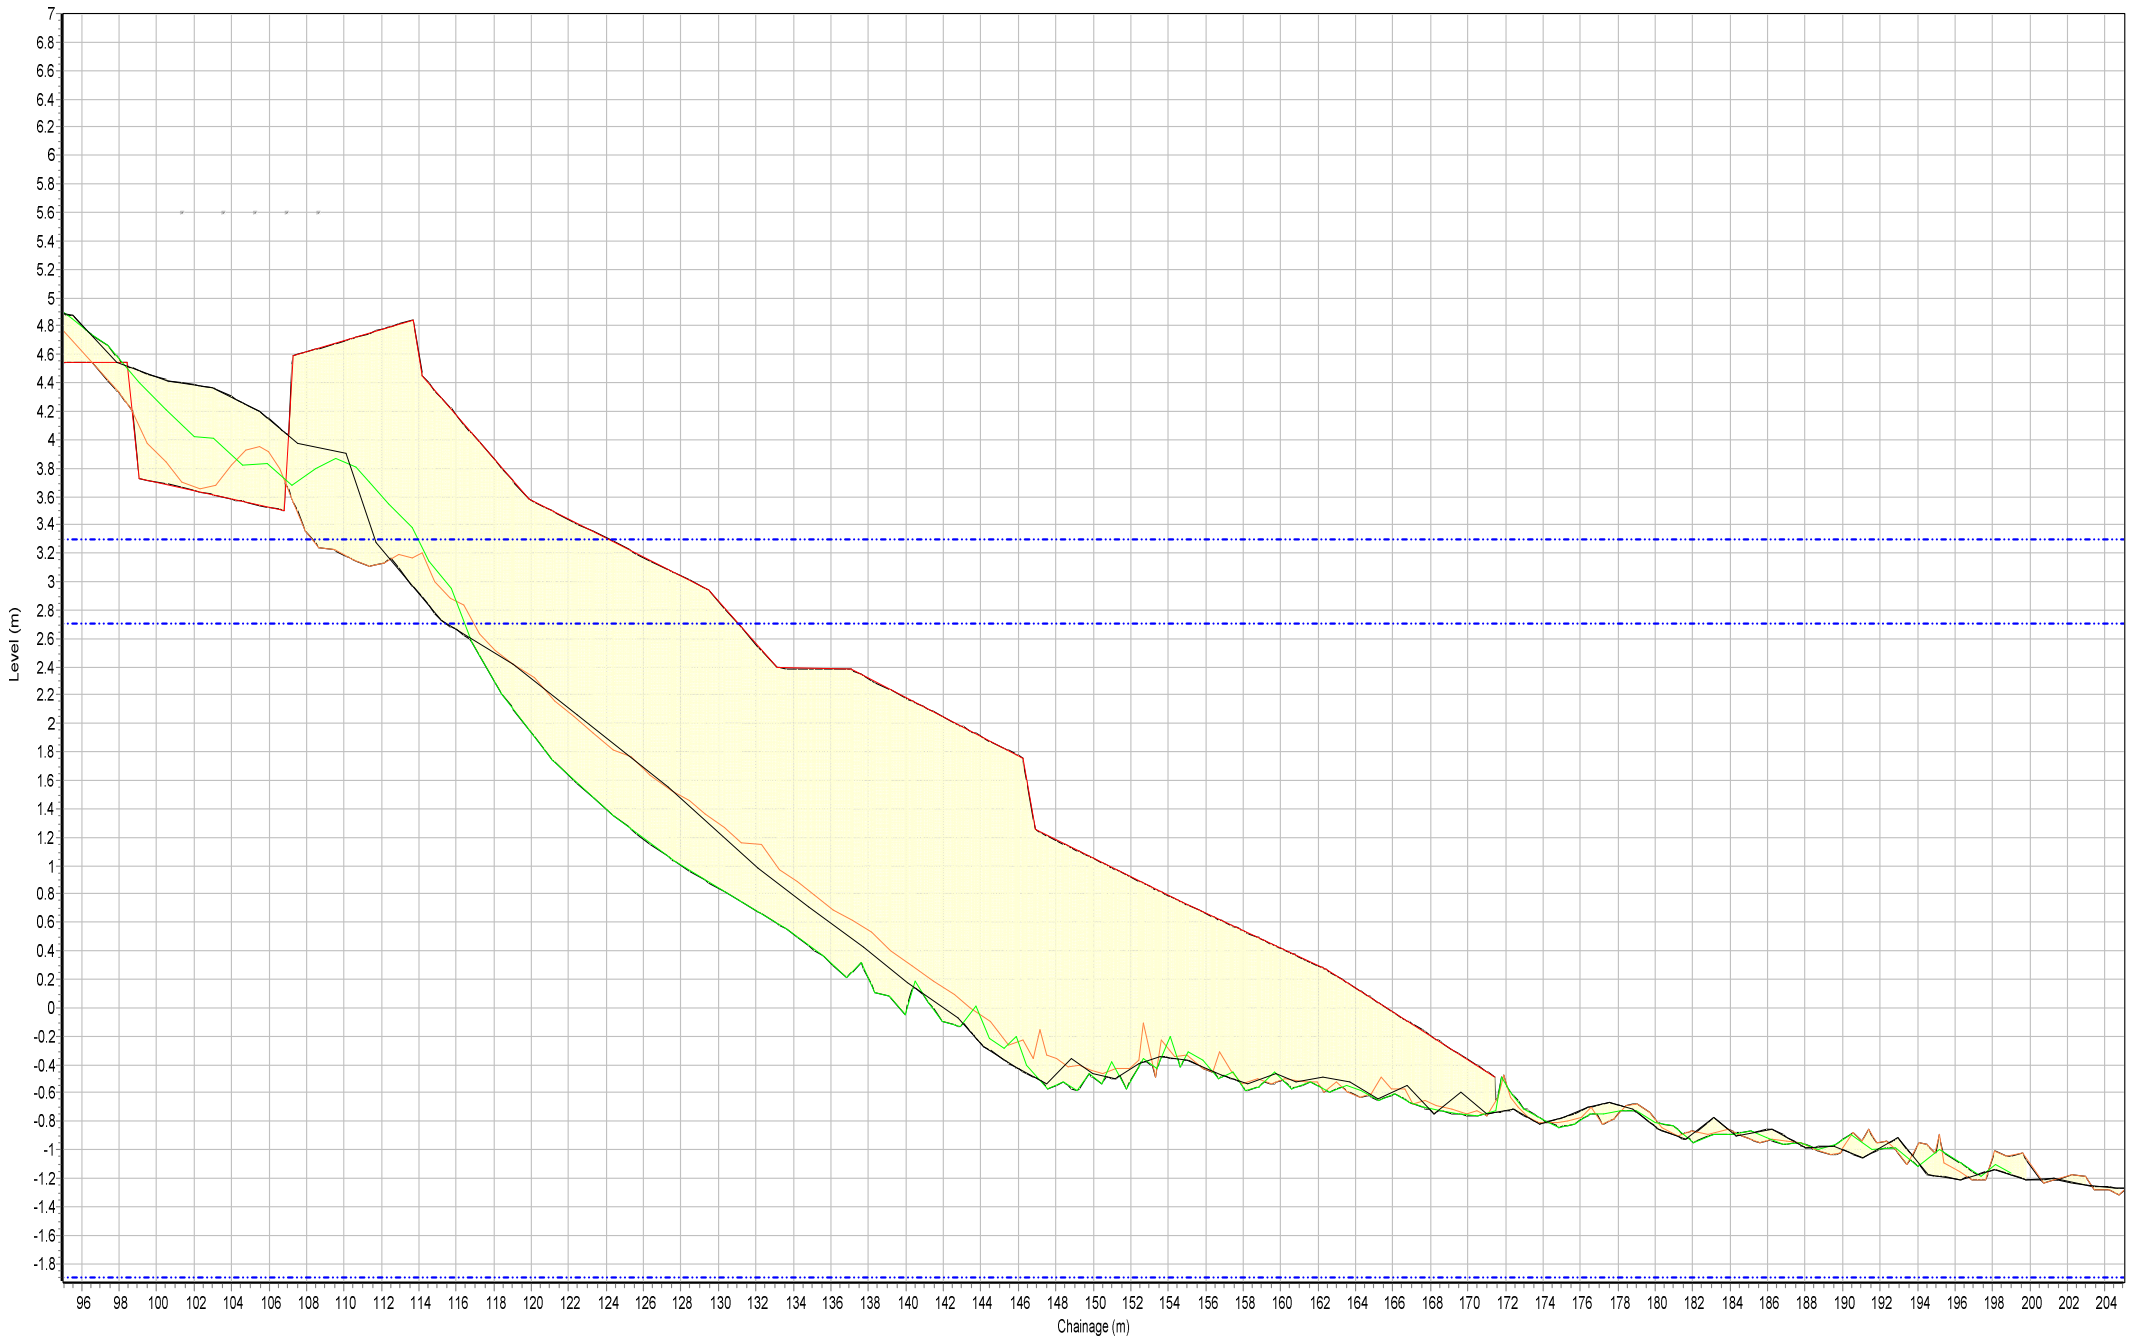
Beach Profiles: 1cEA2

Survey Date	Description of Changes Since Last Survey	Interpretation
18 <sup>th</sup> April 2019	<p><b>Beach Profiles:</b></p> <p>Hawthorne Hive is covered by one beach profile line <b>1cEA2</b> during the Partial Measures survey (Appendix A). The survey report notes “<i>unable to measure start of Section EA2 as the vegetation has choked out the section line and route over cliff faces</i>” and therefore all surveys following October 2012 start at 95m chainage.</p> <p>Until the partial measures survey in April 2013, a channel was present between 95m and 105m chainage, but it has infilled.</p> <p>The profile experienced drawdown in the mid beach during the December 2018 Full Measure survey, however in the Partial Measure 2019 survey accretion has dominated the profile. Between 115m chainage and 145m chainage beach level has increased by up to 0.5m compared to the December 2018 survey. The berm previously recorded at chainage 115m dropped in height by 1m, and a second, more pronounced, berm has formed at chainage 105m, increasing in level by 0.4m in the 2019 Partial Measures survey. From 145m chainage to the end of the survey at 260m chainage the boulders at the bottom of the beach remain exposed. Overall the beach is at a medium-low level compared to the range recorded from previous surveys.</p>	<p>The beach has recovered since the low levels in 2014, and December 2018. The profile is towards the middle of the range of previous profiles.</p> <p><b>Longer term trends:</b></p> <p>The profiles show the beach is undergoing progressive erosion.</p> <p>The infilling and incision of the channel seems to be an episodic process and is likely to reflect a combination of annual and seasonal variations in the flow of Hawthorn Burn and storm events which move sediment onshore to block the outflow of the burn.</p>

- At Hawthorn Hive the beach level was low in April and November 2014. The beach has now recovered slightly and is close to the middle of the previous range of results. However, it is likely that the long-term trend of progressive erosion will continue on this profile.
