## **Cell 1 Regional Coastal Monitoring Programme Update Report 12: 'Partial Measures' Survey 2020**

(\*) The present report is **Update Report 12** and provides an analysis of the 2020 Partial Measures survey for Durham County Council's frontage.

**Durham County Council Frontage**

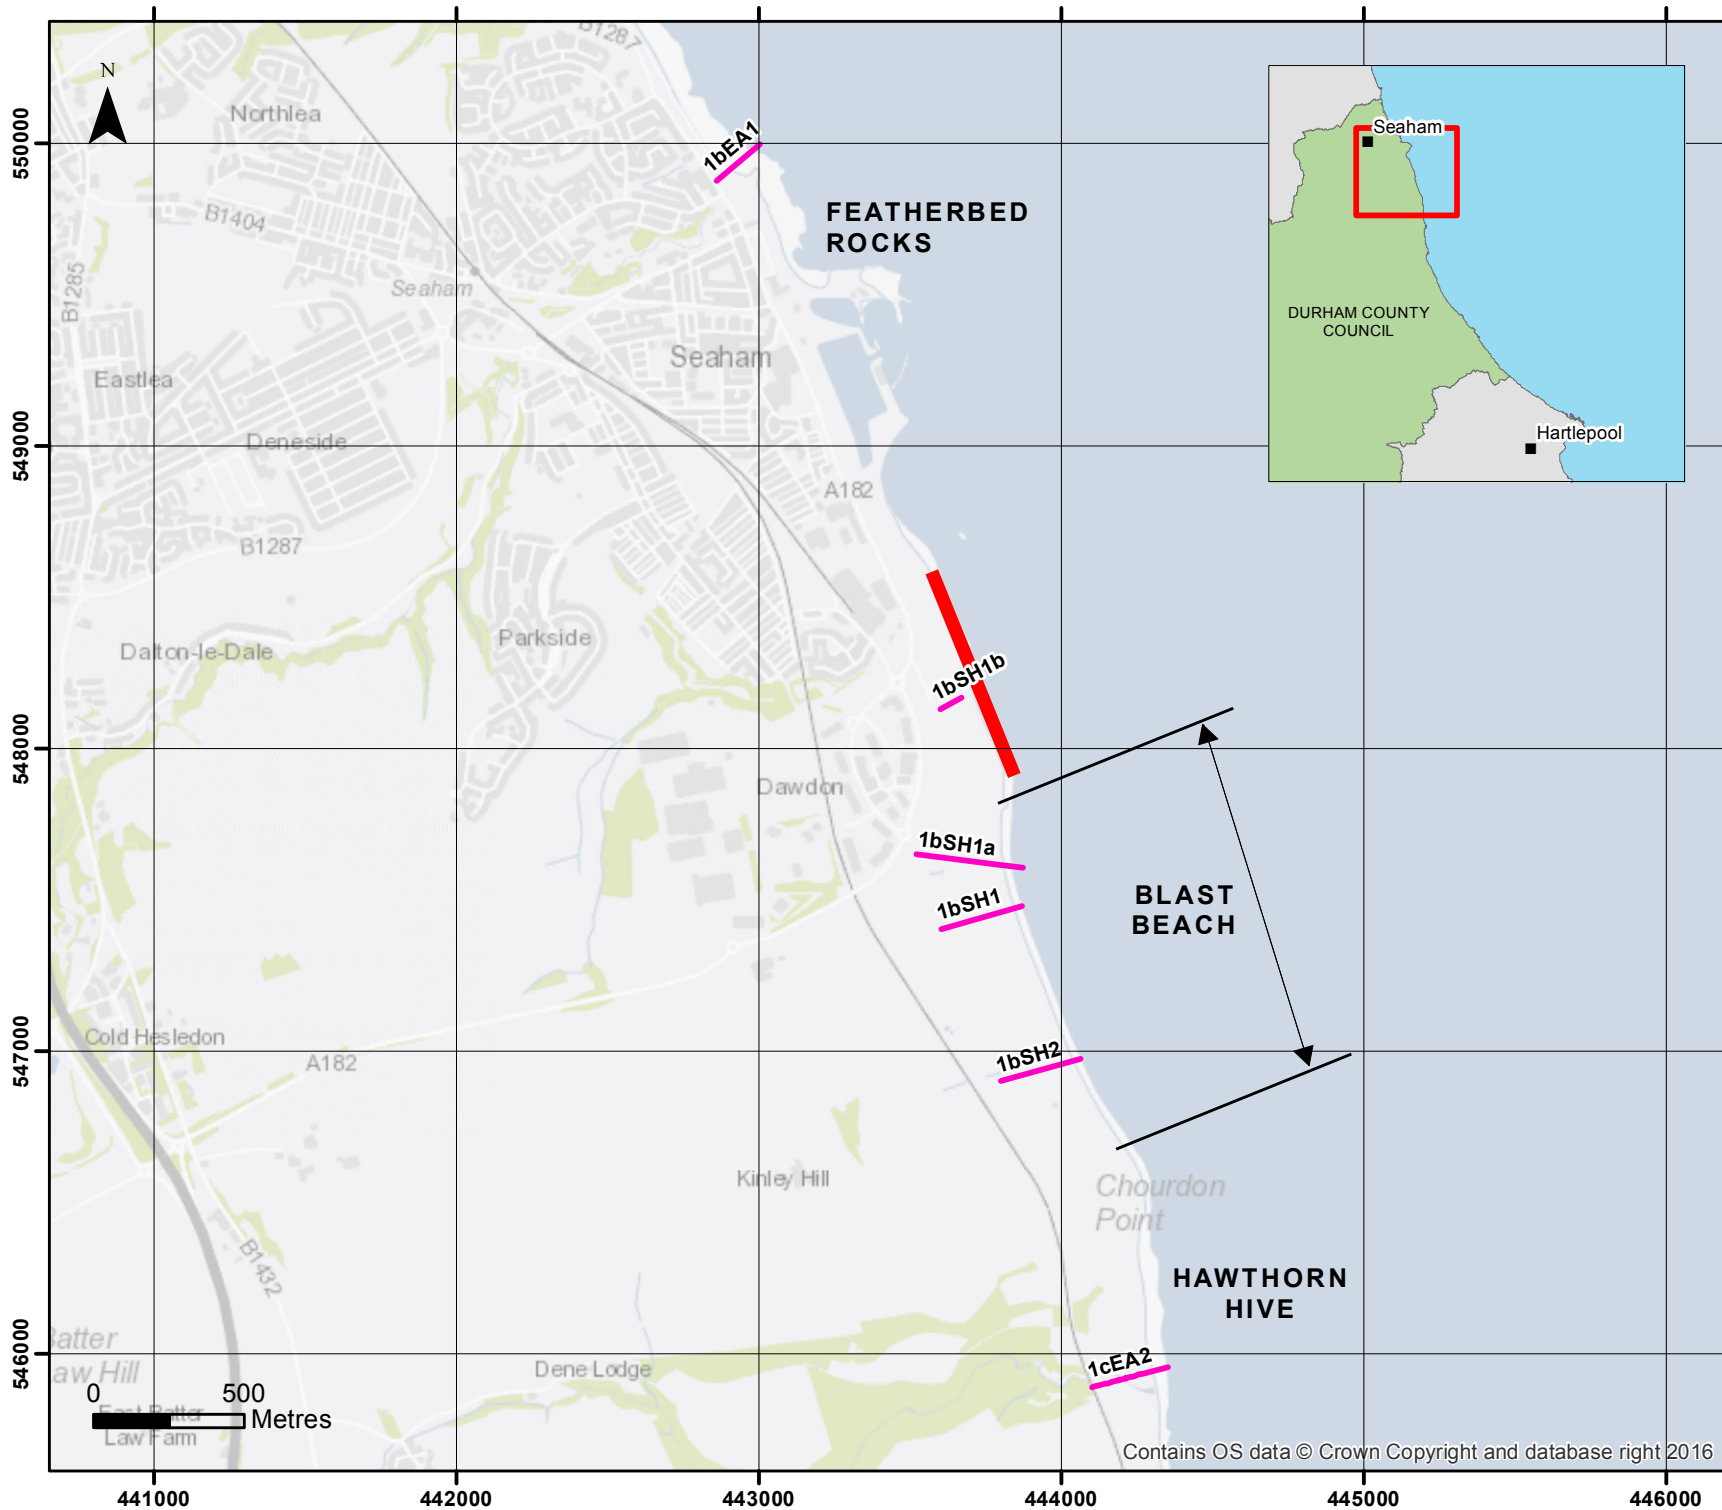
**Figure 2 - Map 1**

The location of these surveys is shown in Figure 2. The Partial Measures survey was undertaken along this frontage on 23<sup>rd</sup> May 2020. During the survey the weather was sunny and dry, with a force 7 wind from the south-west and a moderate sea state.

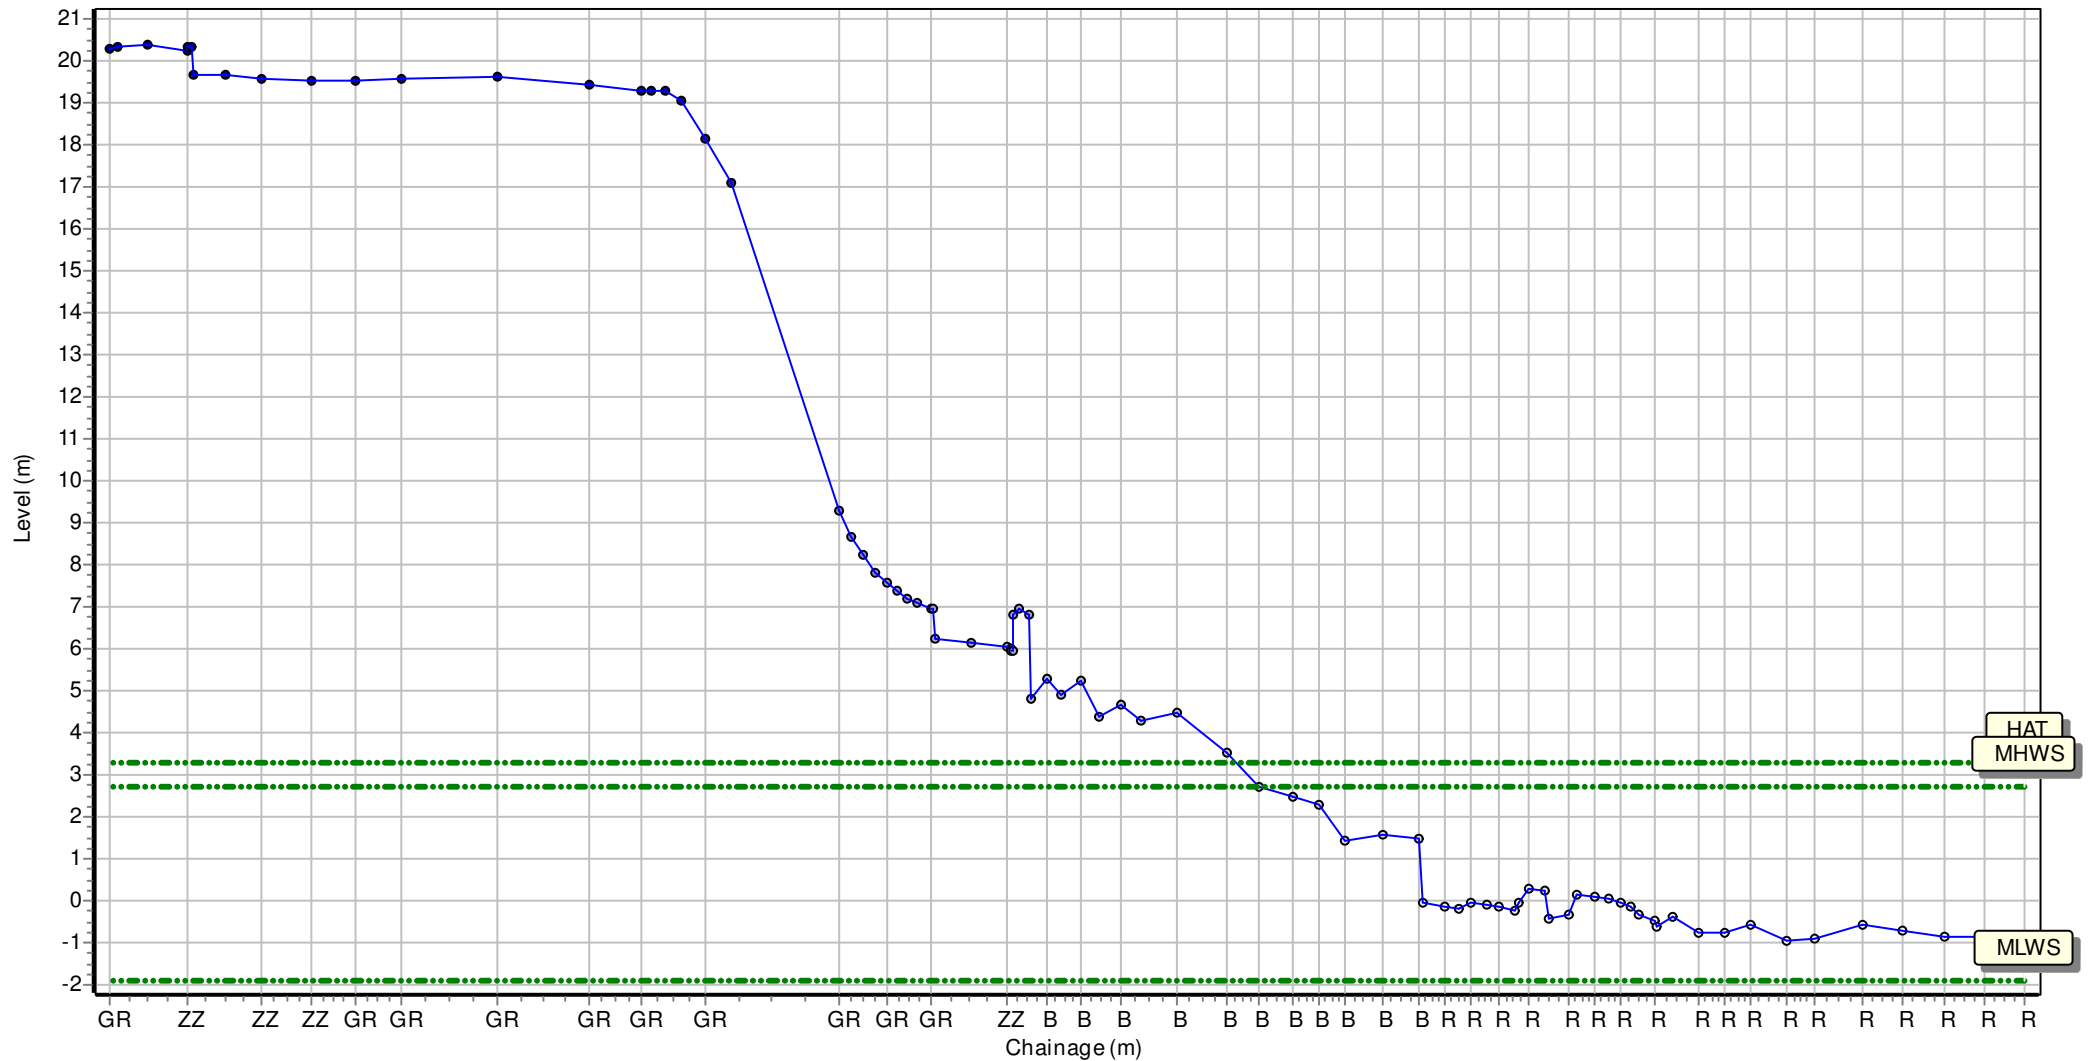
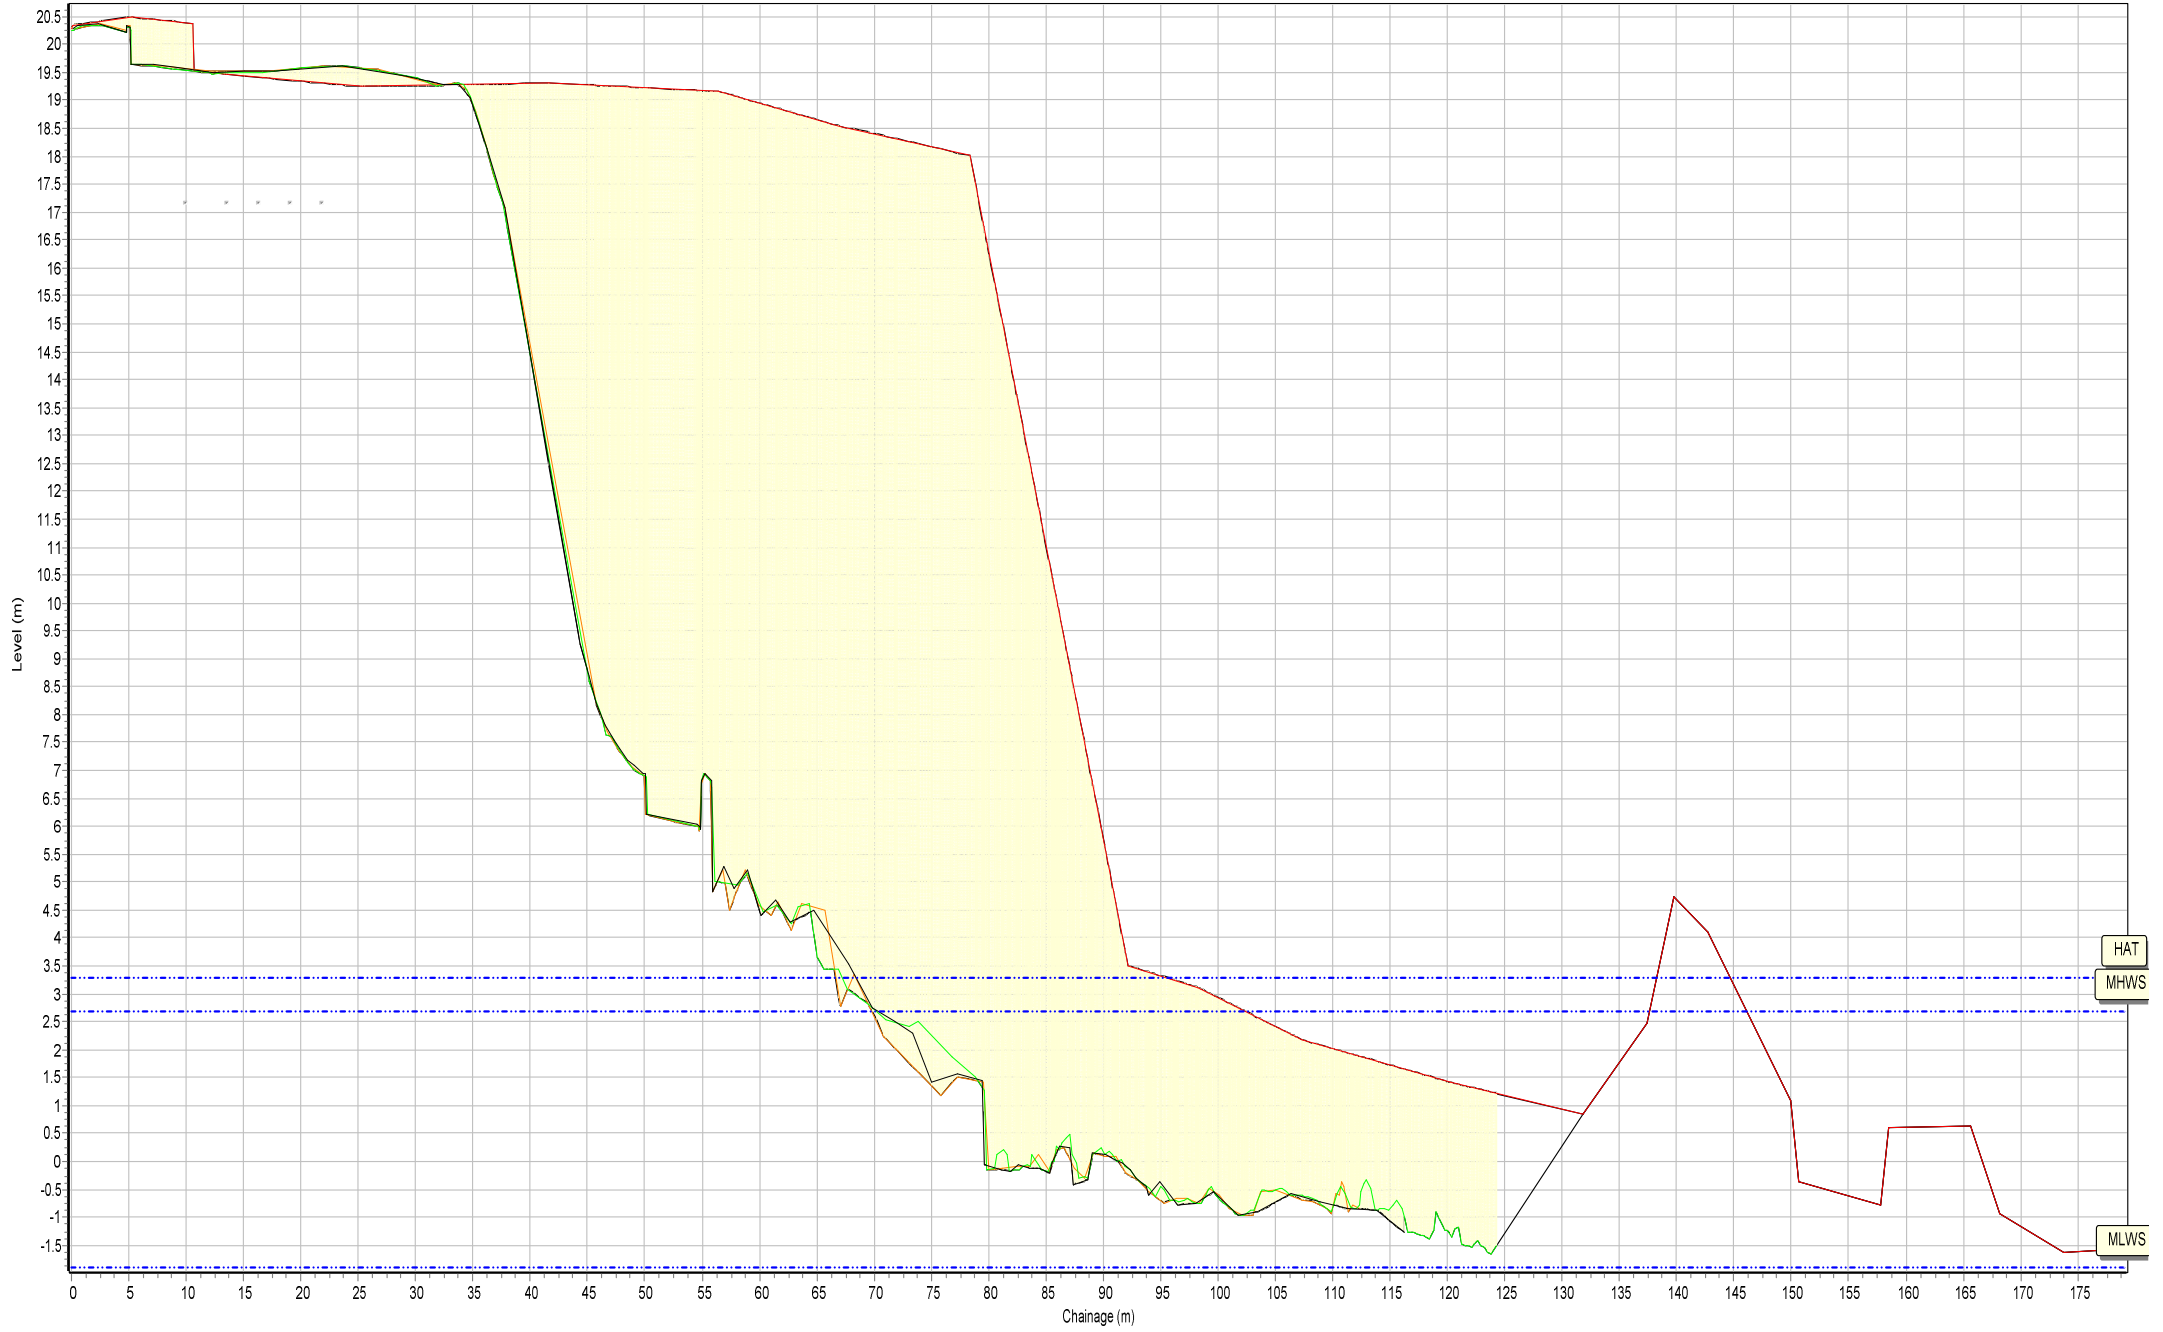
Location: 1bEA1

Survey Date	Description of Changes Since Last Survey	Interpretation
<p><b>23<sup>rd</sup> May 2020</b></p>	<p><b>Beach Profiles:</b></p> <p>Featherbed Rocks is monitored by one beach profile line (EA1) during the Partial Measures survey (Appendix A). The previous survey was October 2019.</p> <p>Profile 1bEA1 has changed very little to 55m chainage, which covers the cliff and promenade. The uneven profile at the base of the sea wall between 55m and 80m is due to the rock armour. There has been accretion between chainages 64-69m by up to 0.8m, and erosion between 71-79m by up to 0.8m. Beyond 80m there has been little change over the winter of 2019/20, the beach profiles reflect the rocky nature of the foreshore and that there is no beach over the shore platform.</p>	<p>The rocky nature of the foreshore means it is unlikely to undergo significant changes in morphology unless sediment is deposited. Previous monitoring indicates that a veneer beach tends to accumulate over the summer and is stripped off by winter storms, giving rise to small and localised changes in profile. The upper part of the profile, which covers the cliff promenade and rock armour remains unchanged, as does the lower part of the profile which covers the beach.</p> <p><b>Longer term trends:</b></p> <p>The level of the beach in May 2020 was comparable with the lowest beach levels recorded in March 2010, April 2013 and October 2013. The shore platform is exposed and as a result any apparent changes are likely to be due to differences in the survey point locations and the way that survey points are joined to show an interpolated surface.</p>

- The level of the beach at Featherbed Rocks in May 2020 was comparable to the lowest beach levels recorded in March 2010, April 2013 and October 2013. The shore platform is exposed on the lower beach.

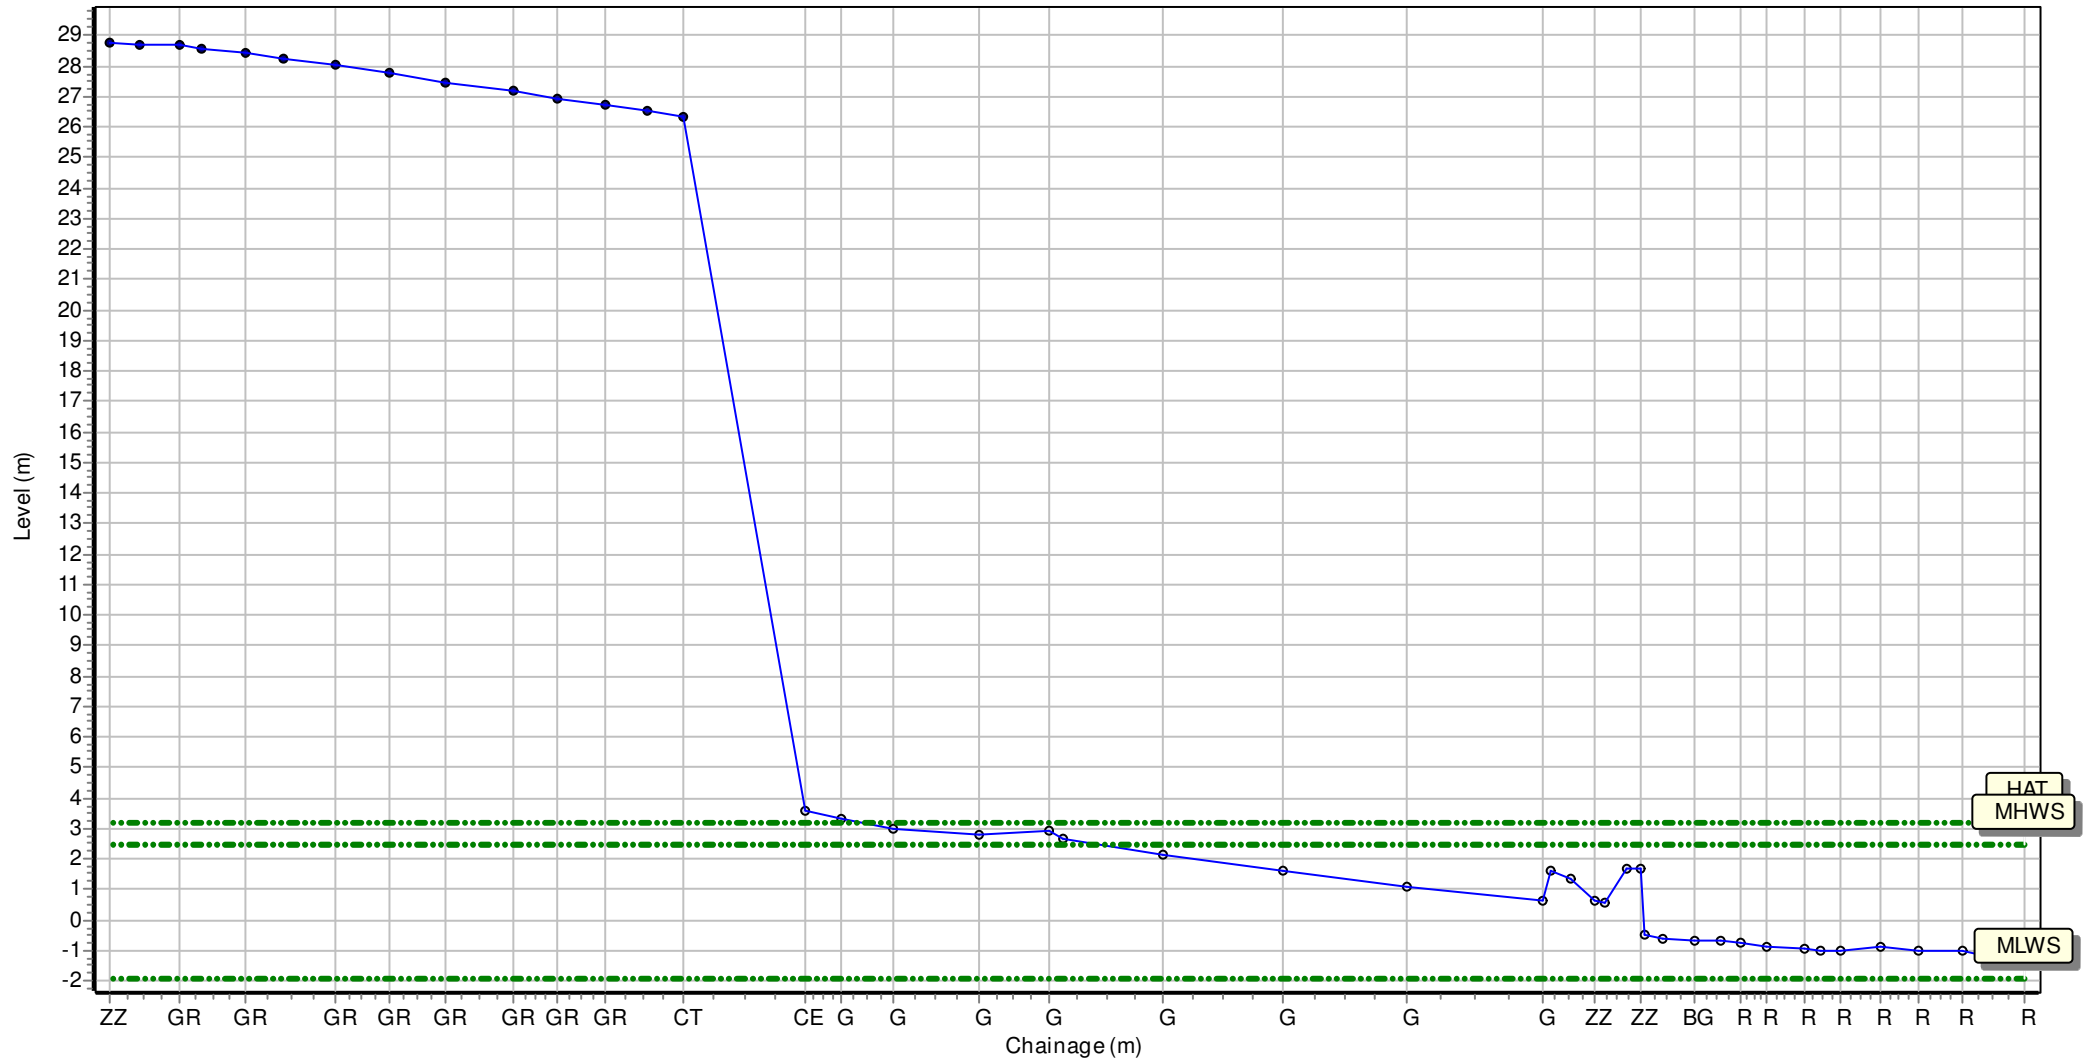
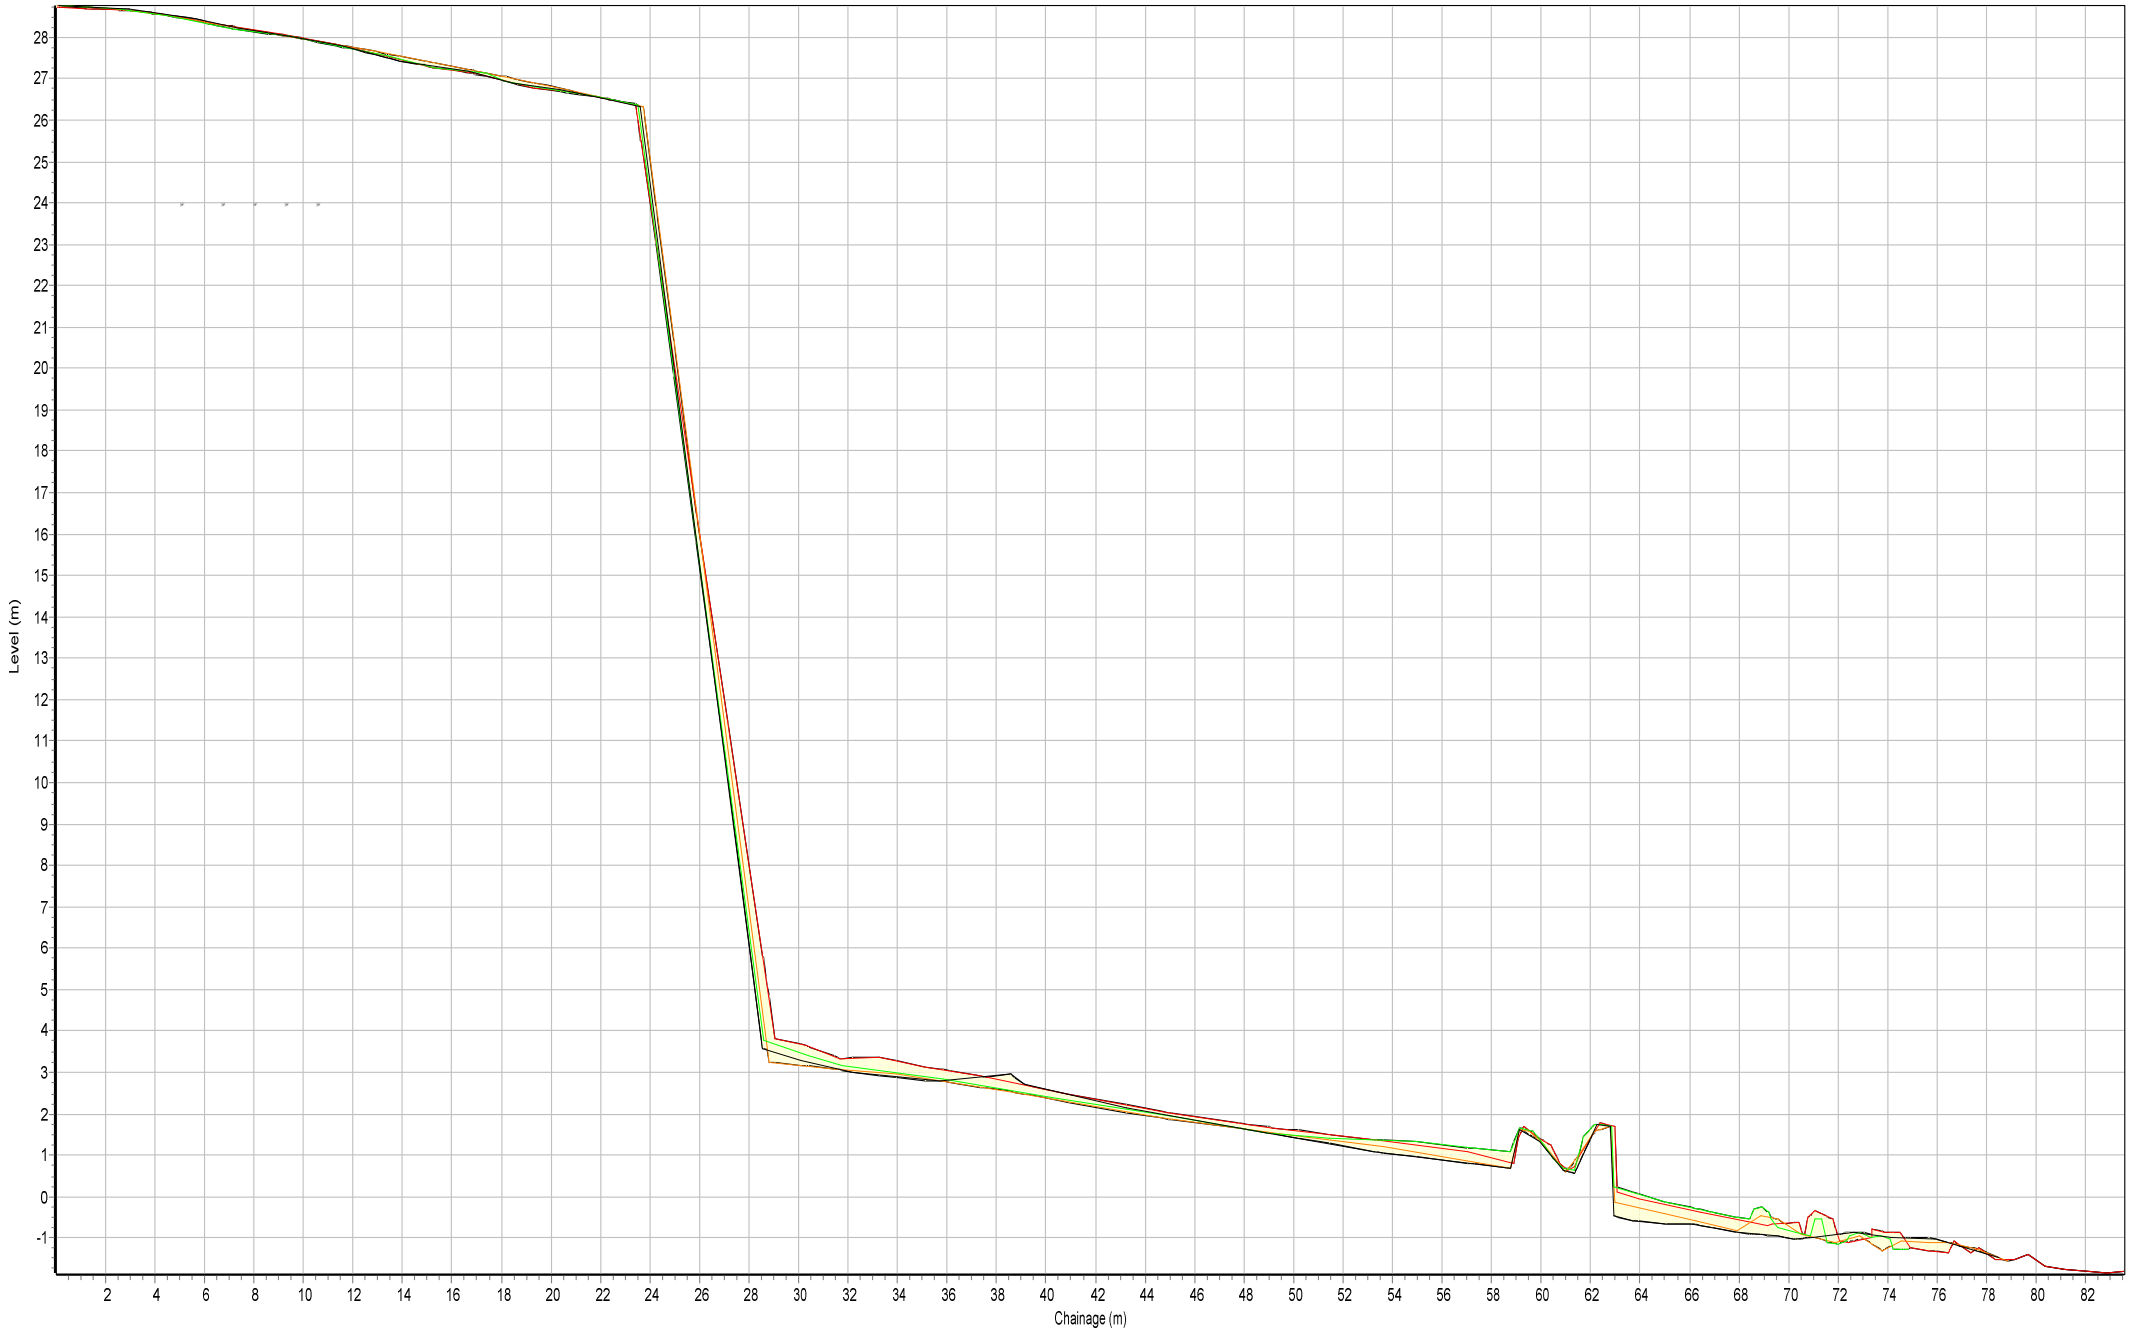
Location: 1bSH1B

Survey Date	Description of Changes Since Last Survey	Interpretation
23 <sup>rd</sup> May 2020	<p><b>Beach Profiles:</b></p> <p>Blast Beach is covered by four beach profile lines during the Partial Measures survey (Appendix A). Two of these commenced in November 2008, with 1bSH1a being added in October 2009, and 1bSH1b added in October 2015.</p> <p>Profile <b>1bSH1b</b> is adjacent to the sewage works south of Seaham. The 2020 survey recorded erosion from the cliff toe to chainage 36m by up to 0.2m. A small berm formed at chainage 39m with an accretion of 0.4m to chainage 45m, switching to erosion across the lower beach by up to 0.4m on the landward side of the concrete blocks and up to 0.8m on the seaward side. The beach toe has extended seaward by up to 4m. Overall the profile is at a medium level on the upper beach compared to the range recorded from previous surveys, whilst the lower beach is at a low level, particularly between chainages 63-71m which is at its lowest level recorded.</p> <p>The 2020 Partial Measures Survey Report notes that at <b>1bSH1a</b> dense vegetation restricts access to the cliff top and cliff base. There has been very little change to the spoil face at chainage 140m. Seaward of chainage 140m there has been accretion by up to 1.2m forming a small berm at chainage 147m. Seaward of chainage 160m there has been very little change in the beach profile. Overall the profile is at a low level compared to the range recorded from previous surveys.</p> <p>At <b>1bSH1</b> dense vegetation also restricts access to the cliff tops. There has been accretion of up to 0.1m from the base of the cliff across the upper beach to chainage 97m. The lower beach has experienced erosion of up to 0.4m chainage to the rocky foreshore at chainage 132m which is exposed until the end of the survey at 164m. The upper beach is at a high level compared to the range recorded from previous surveys whilst the middle and lower beach are at a low level.</p> <p>At <b>1bSH2</b> there has been accretion from the cliff toe to chainage 106m by up to 0.1m. The berm crest has experienced very little change. From chainage 120-155m there has been erosion of up to 0.2m across the middle beach, with very little change seaward of this until the end of the survey. Overall the beach is at a medium level compared to the range recorded from previous surveys.</p>	<p>Through the winter there has generally been accretion on the upper and middle beach and erosion on the lower beach. Rock platforms remain exposed across this section of frontage. The profiles remained a similar gradient to the spring and autumn profiles.</p> <p>All the profiles show the beach levels are generally in the range of previous profiles, however the section between chainage 63-71m at profile 1bSH1b is now at its lowest level recorded.</p> <p><b>Longer term trends:</b></p> <p>The beach at 1bSH2 shows an overall pattern of erosion from October 2008 to its lowest level at April 2014, showing recovery to the most recent survey in May 2020. However, SH1 and SH1a show much more fluctuation in beach level between 08/09 and May 2020.</p>

- At Blast Beach, colliery spoil still prevents the sea from actively eroding the cliffs. However, there have been some changes in the beach profile over the winter of 2019/20, typically consisting of accretion on the upper and middle beach and erosion on the lower beach.

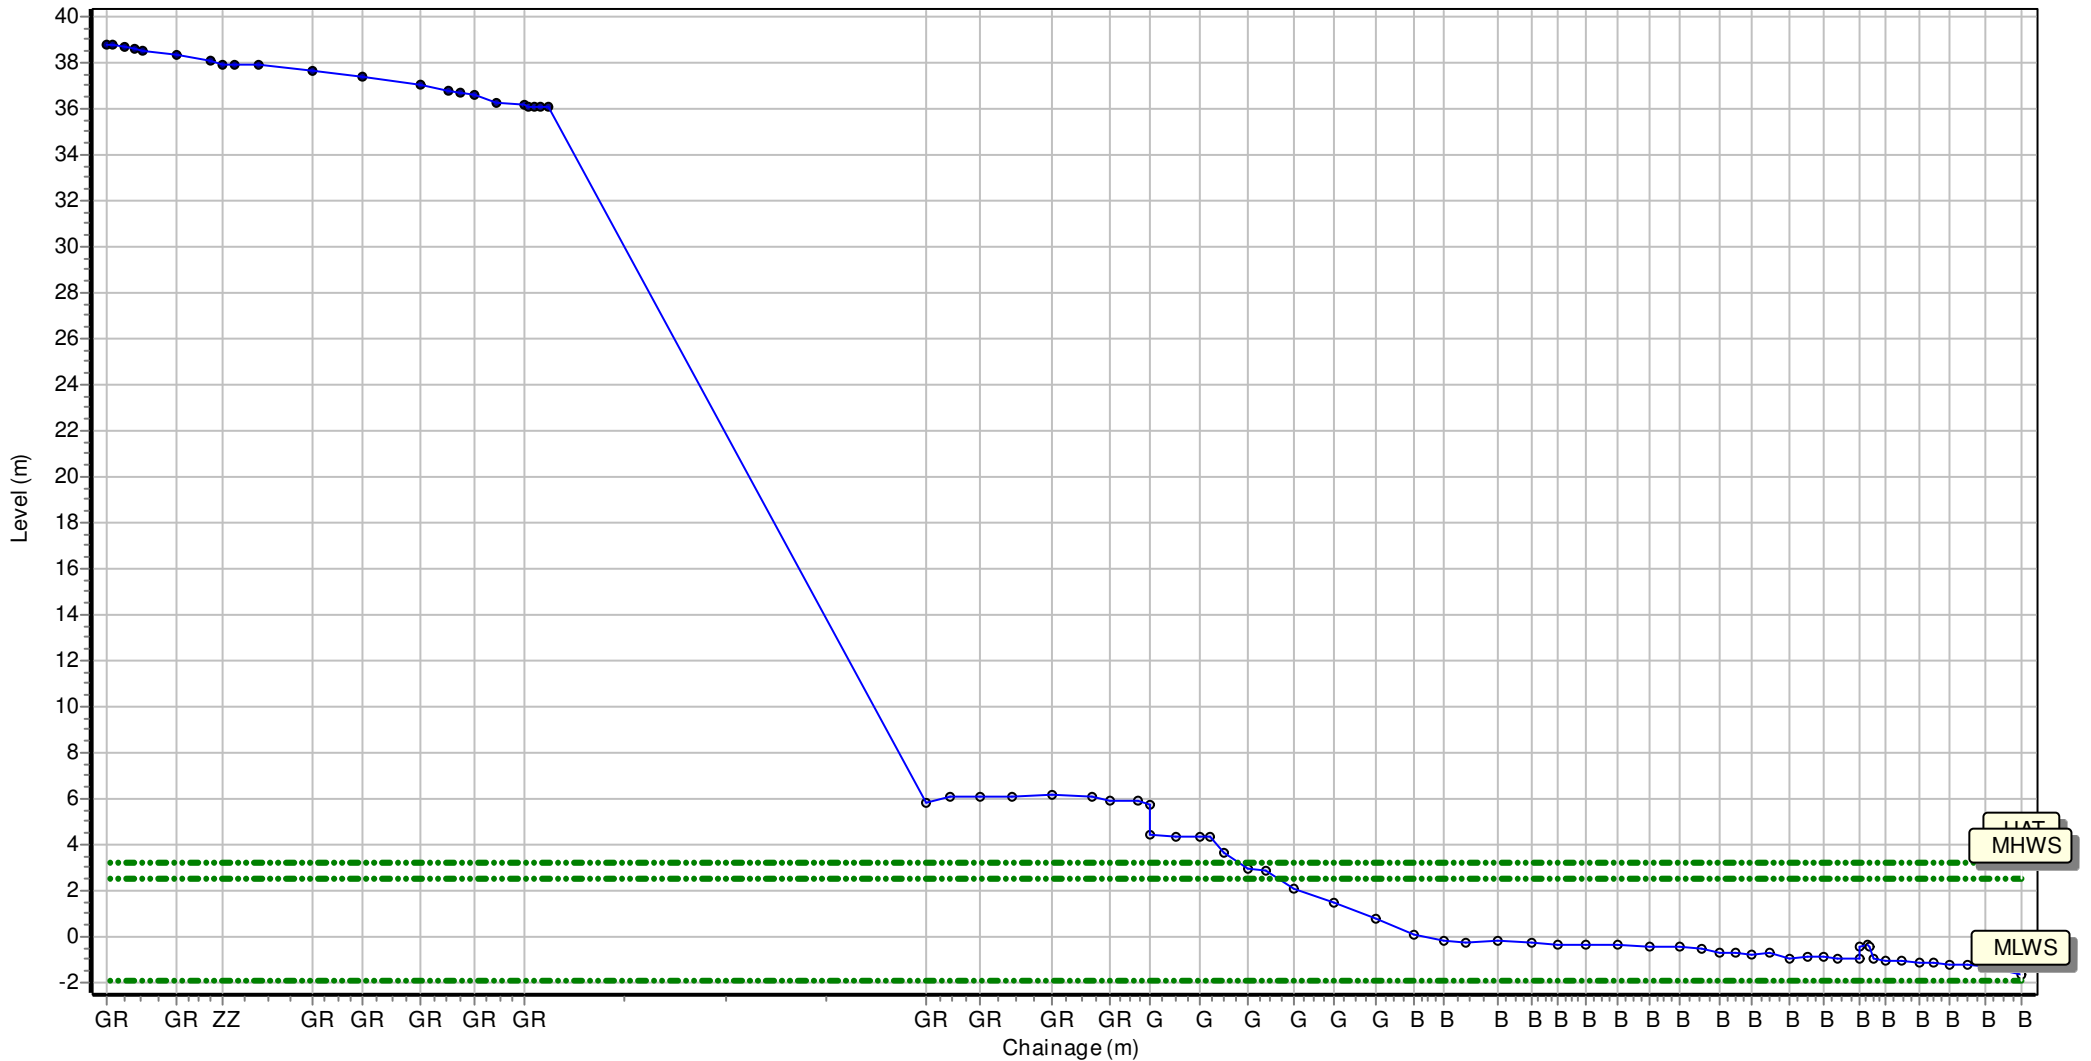
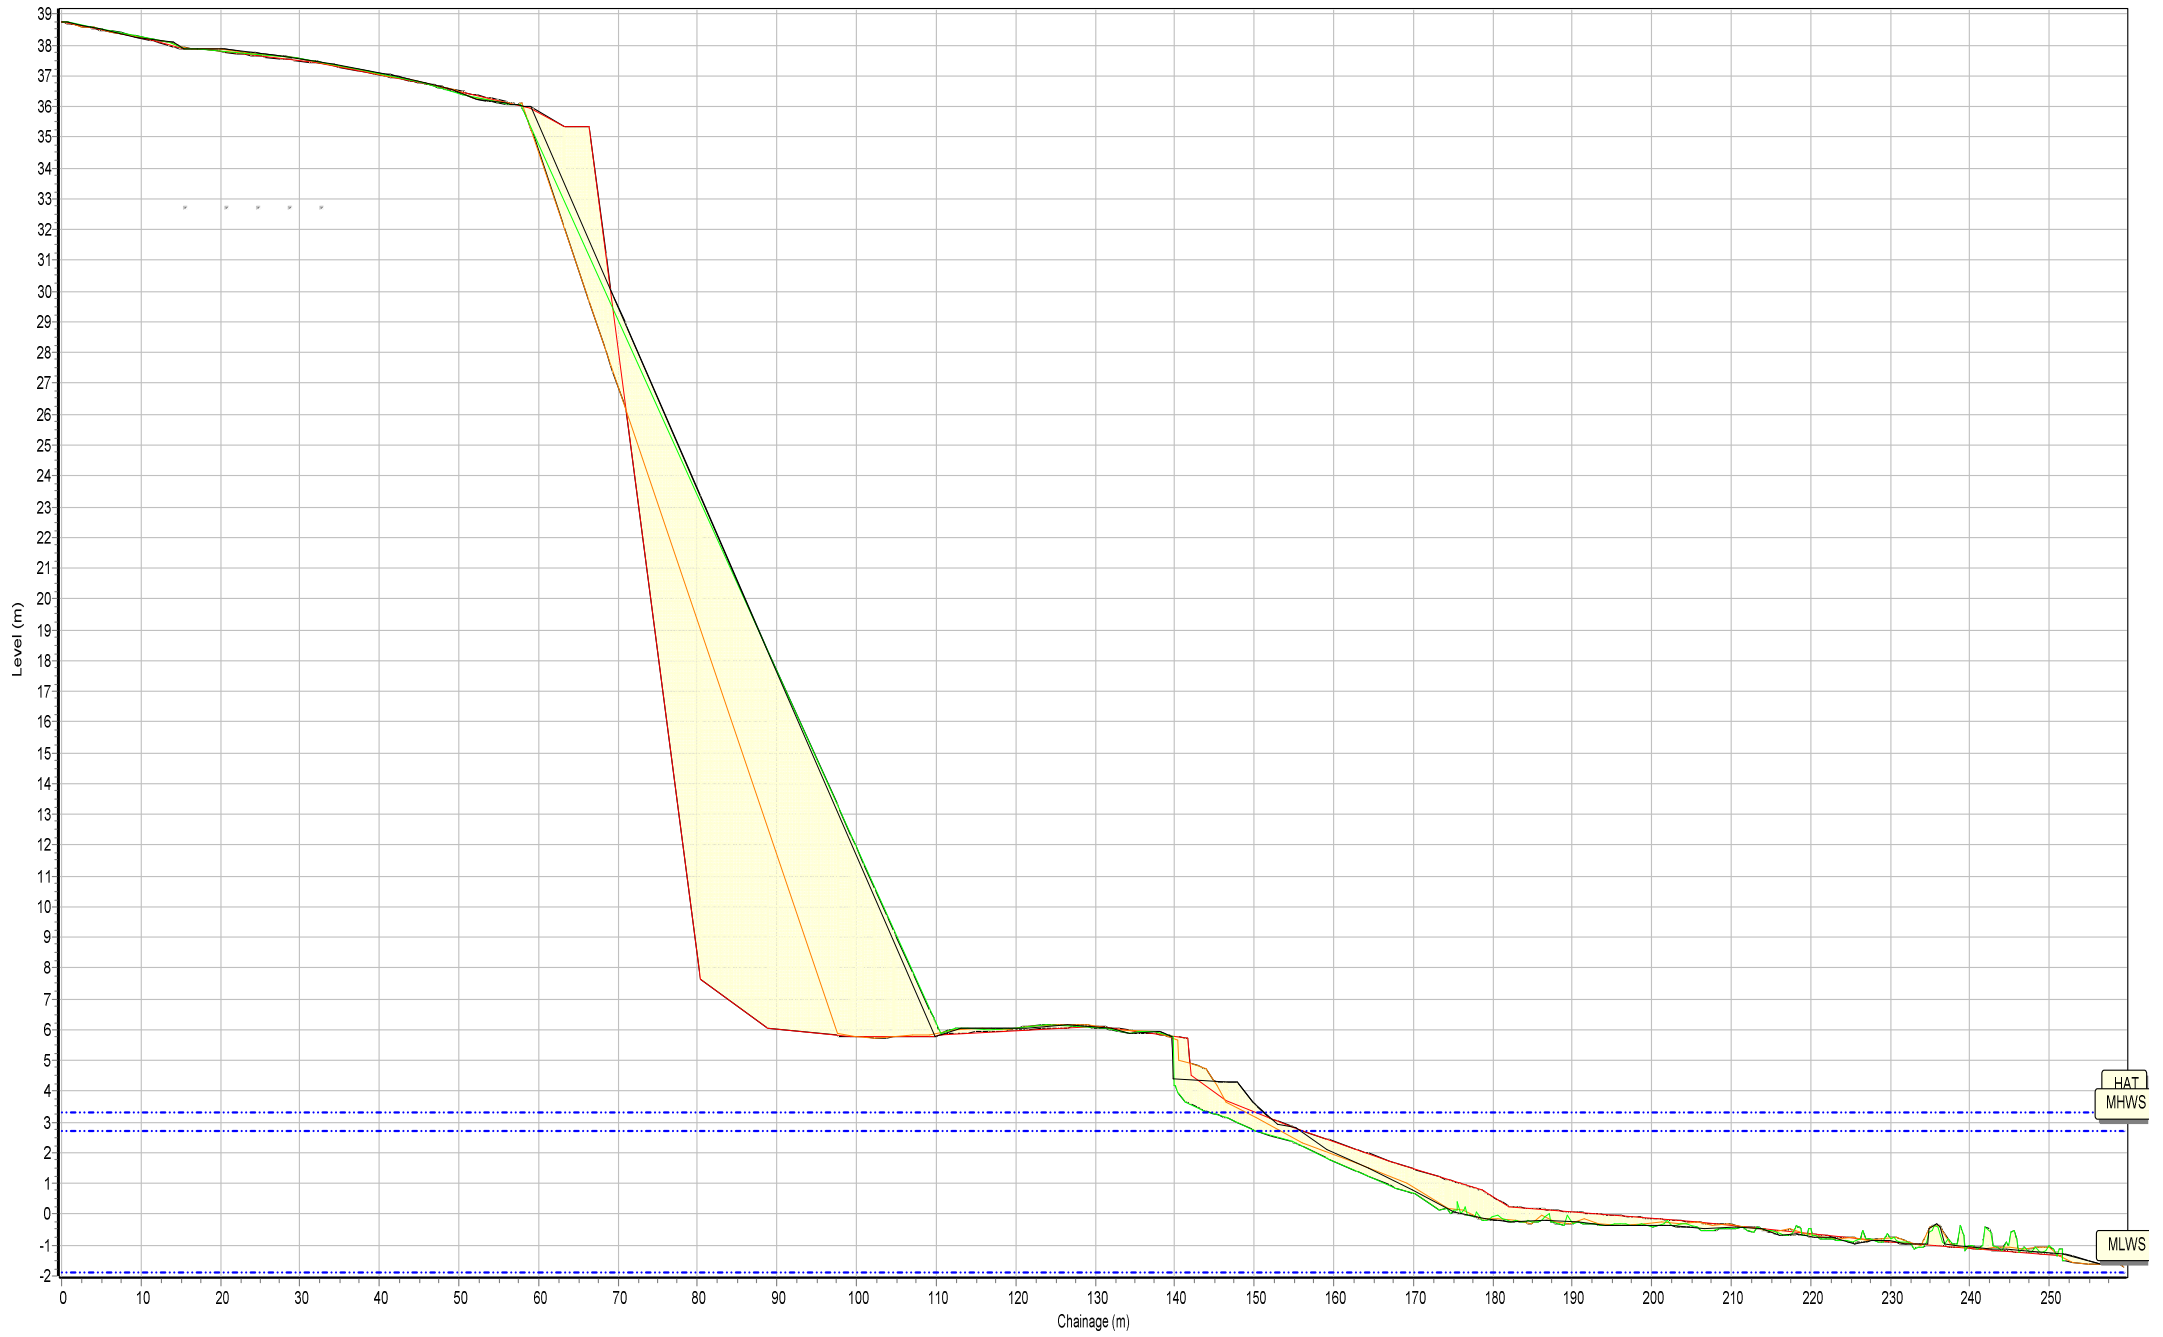
Location: 1bSH1A

- The surveyor noted difficulties accessing the cliff tops of sections SH1 and SH1A and the cliff base of SH1A due to dense vegetation.
- At Hawthorne Hive the surveyor was unable to measure the start of Section EA2 due to vegetation cover.
