## **Cell 1 Regional Coastal Monitoring Programme Update Report 12: 'Partial Measures' Survey 2020**

(\*) The present report is **Update Report 12** and provides an analysis of the 2020 Partial Measures survey for Durham County Council's frontage.

**Durham County Council Frontage**

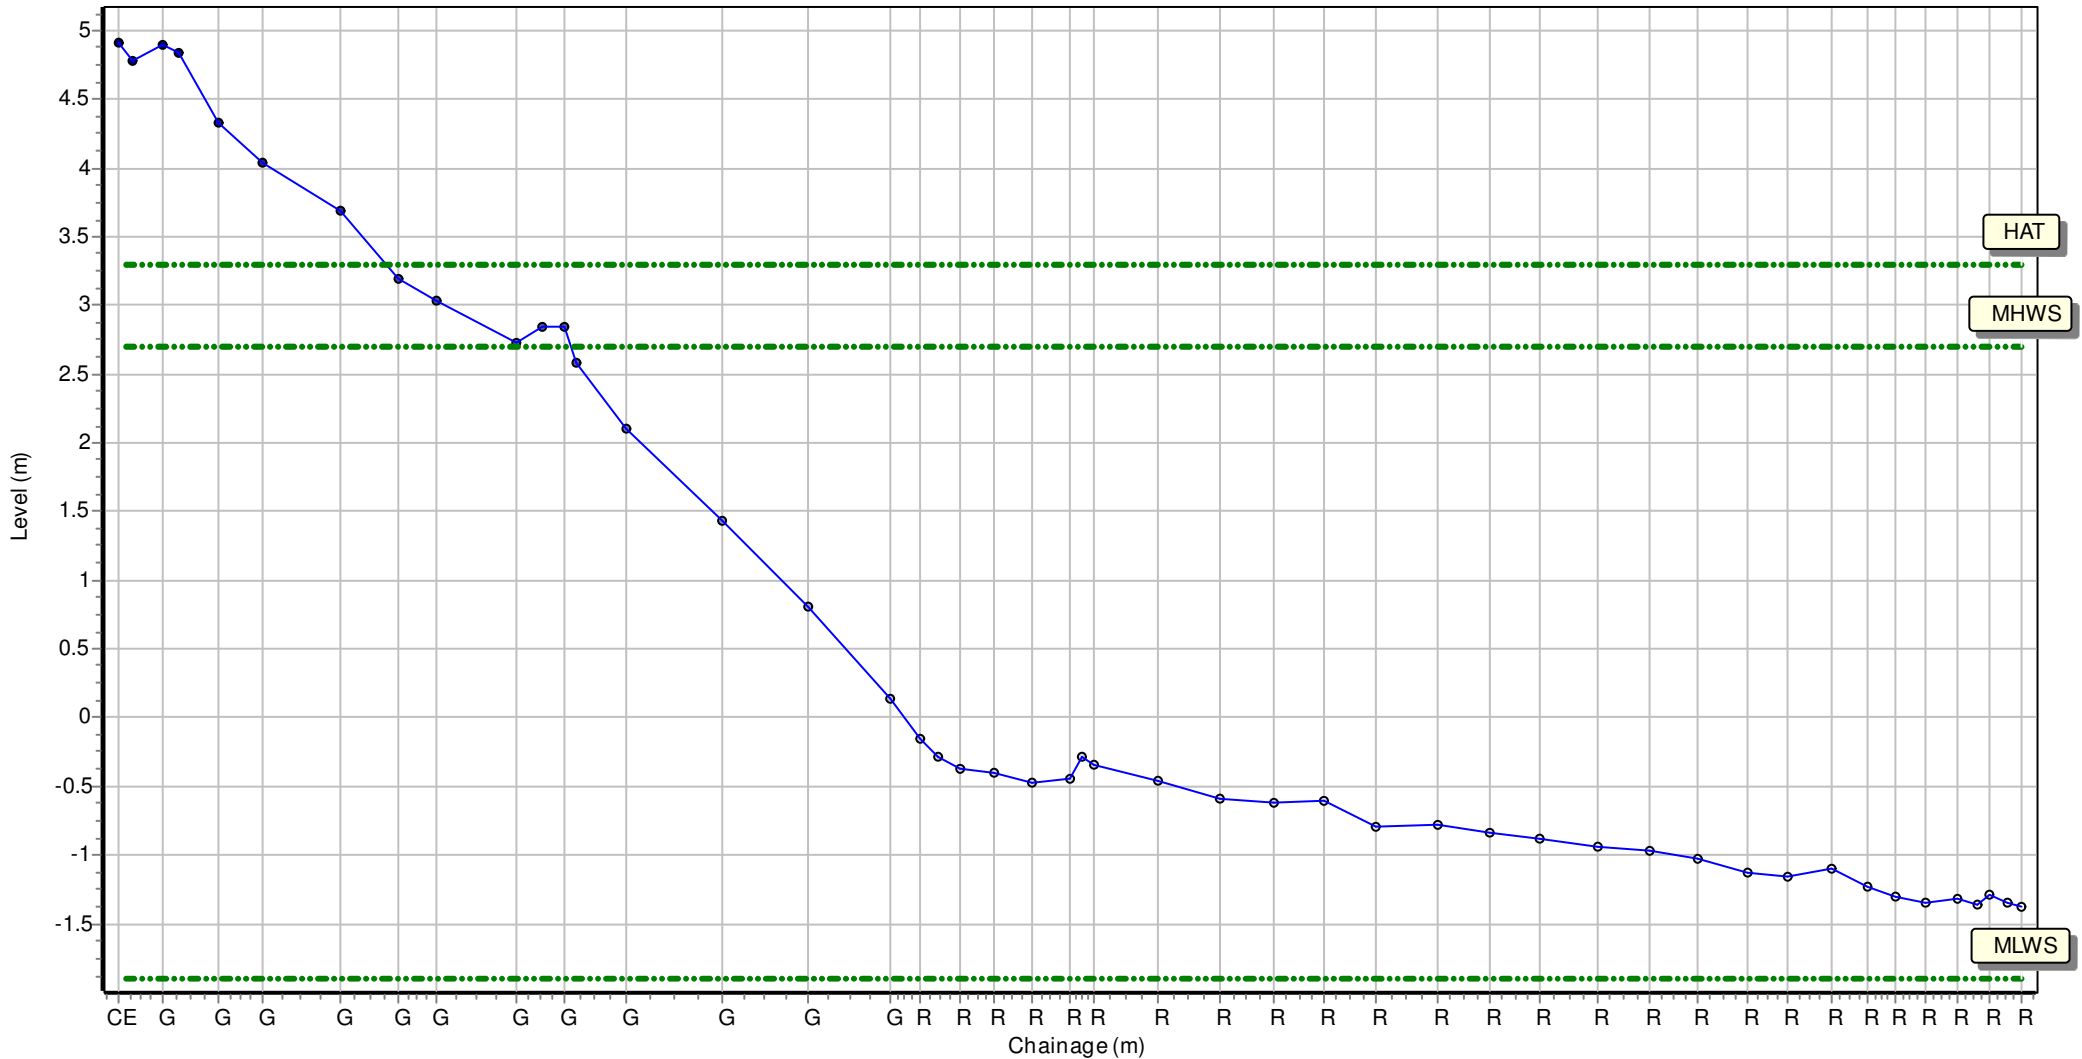
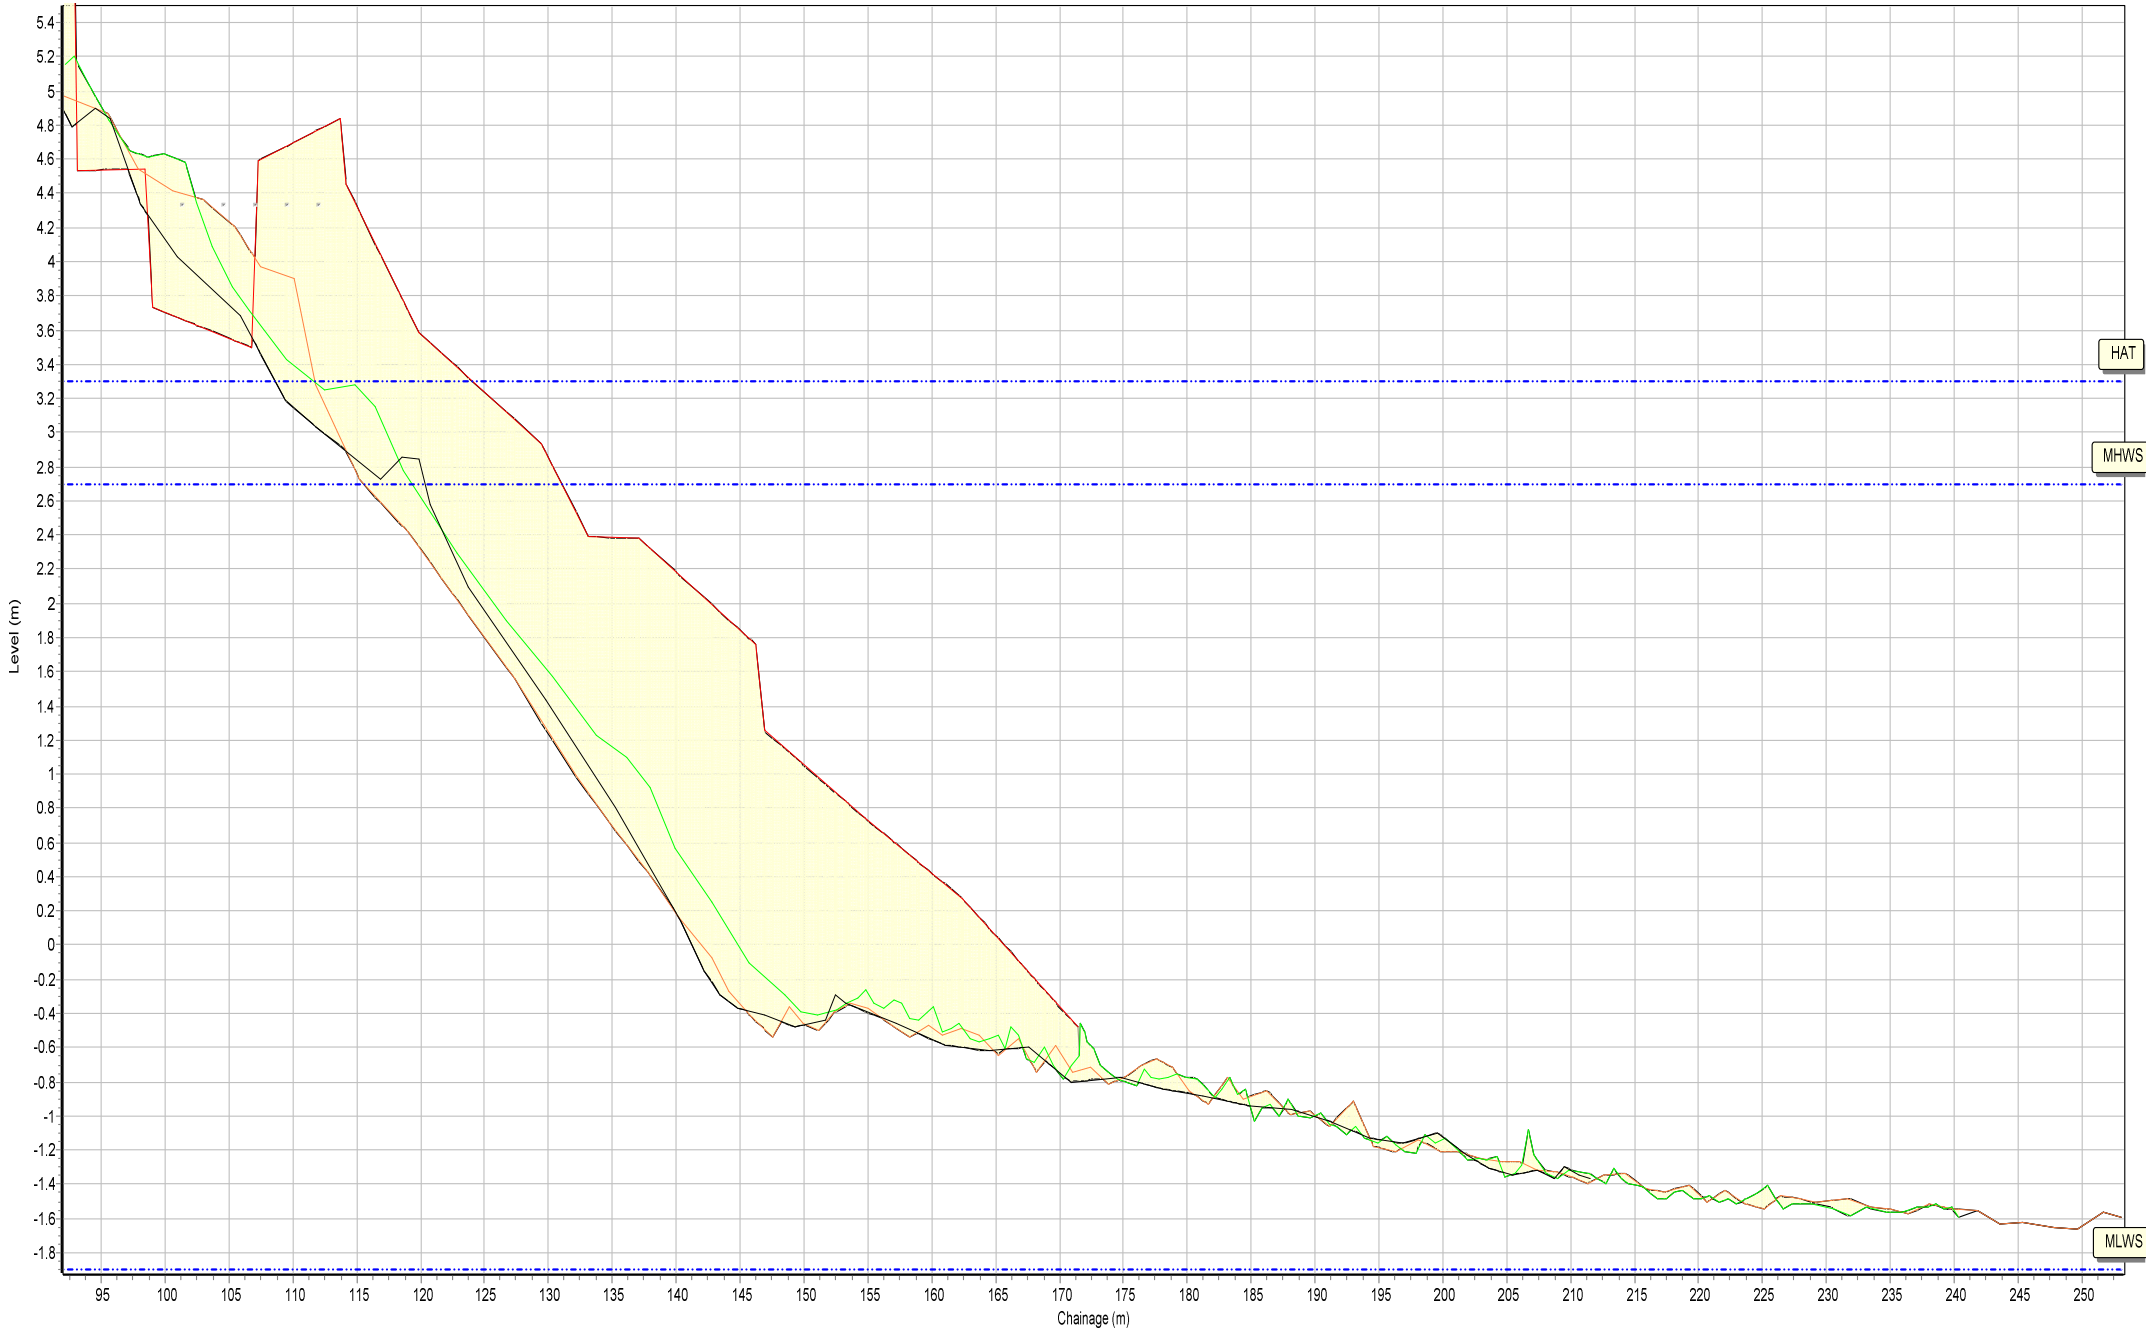
Location: 1cEA2

Survey Date	Description of Changes Since Last Survey	Interpretation
23 <sup>rd</sup> May 2020	<p><b>Beach Profiles:</b></p> <p>Hawthorne Hive is covered by one beach profile line <b>1cEA2</b> during the Partial Measures survey (Appendix A). The survey report notes “<i>unable to measure start of Section EA2 as the vegetation has choked out the section line and route over cliff faces</i>” and therefore all surveys following October 2012 start at 95m chainage.</p> <p>Until the partial measures survey in April 2013, a channel was present between 95m and 105m chainage, but it has infilled.</p> <p>The profile has generally eroded since the previous survey in October 2019. From the start of the survey to chainage 118m there has been erosion by up to 0.6m, switching to a small section of accretion by up to 0.2m. Seaward of chainage 121m there was erosion of up to 0.5m to chainage 152m. From 152m chainage to the end of the survey at 211m chainage the boulders from the previous survey appear to have moved in some places. Overall the beach is at a medium-low level compared to the range recorded from previous surveys.</p>	<p>The beach has recovered since the low levels in 2014, and December 2018. The profile is towards the middle of the range of previous profiles.</p> <p><b>Longer term trends:</b></p> <p>The profiles show the beach is undergoing progressive erosion.</p> <p>The infilling and incision of the channel seems to be an episodic process and is likely to reflect a combination of annual and seasonal variations in the flow of Hawthorn Burn and storm events which move sediment onshore to block the outflow of the burn.</p>

- The surveyor noted difficulties accessing the cliff tops of sections SH1 and SH1A and the cliff base of SH1A due to dense vegetation.
- At Hawthorne Hive the surveyor was unable to measure the start of Section EA2 due to vegetation cover.

- At Hawthorn Hive the beach level was low in April and November 2014. The beach has now recovered slightly and is close to the middle of the previous range of results. However, it is likely that the long-term trend of progressive erosion will continue on this profile.

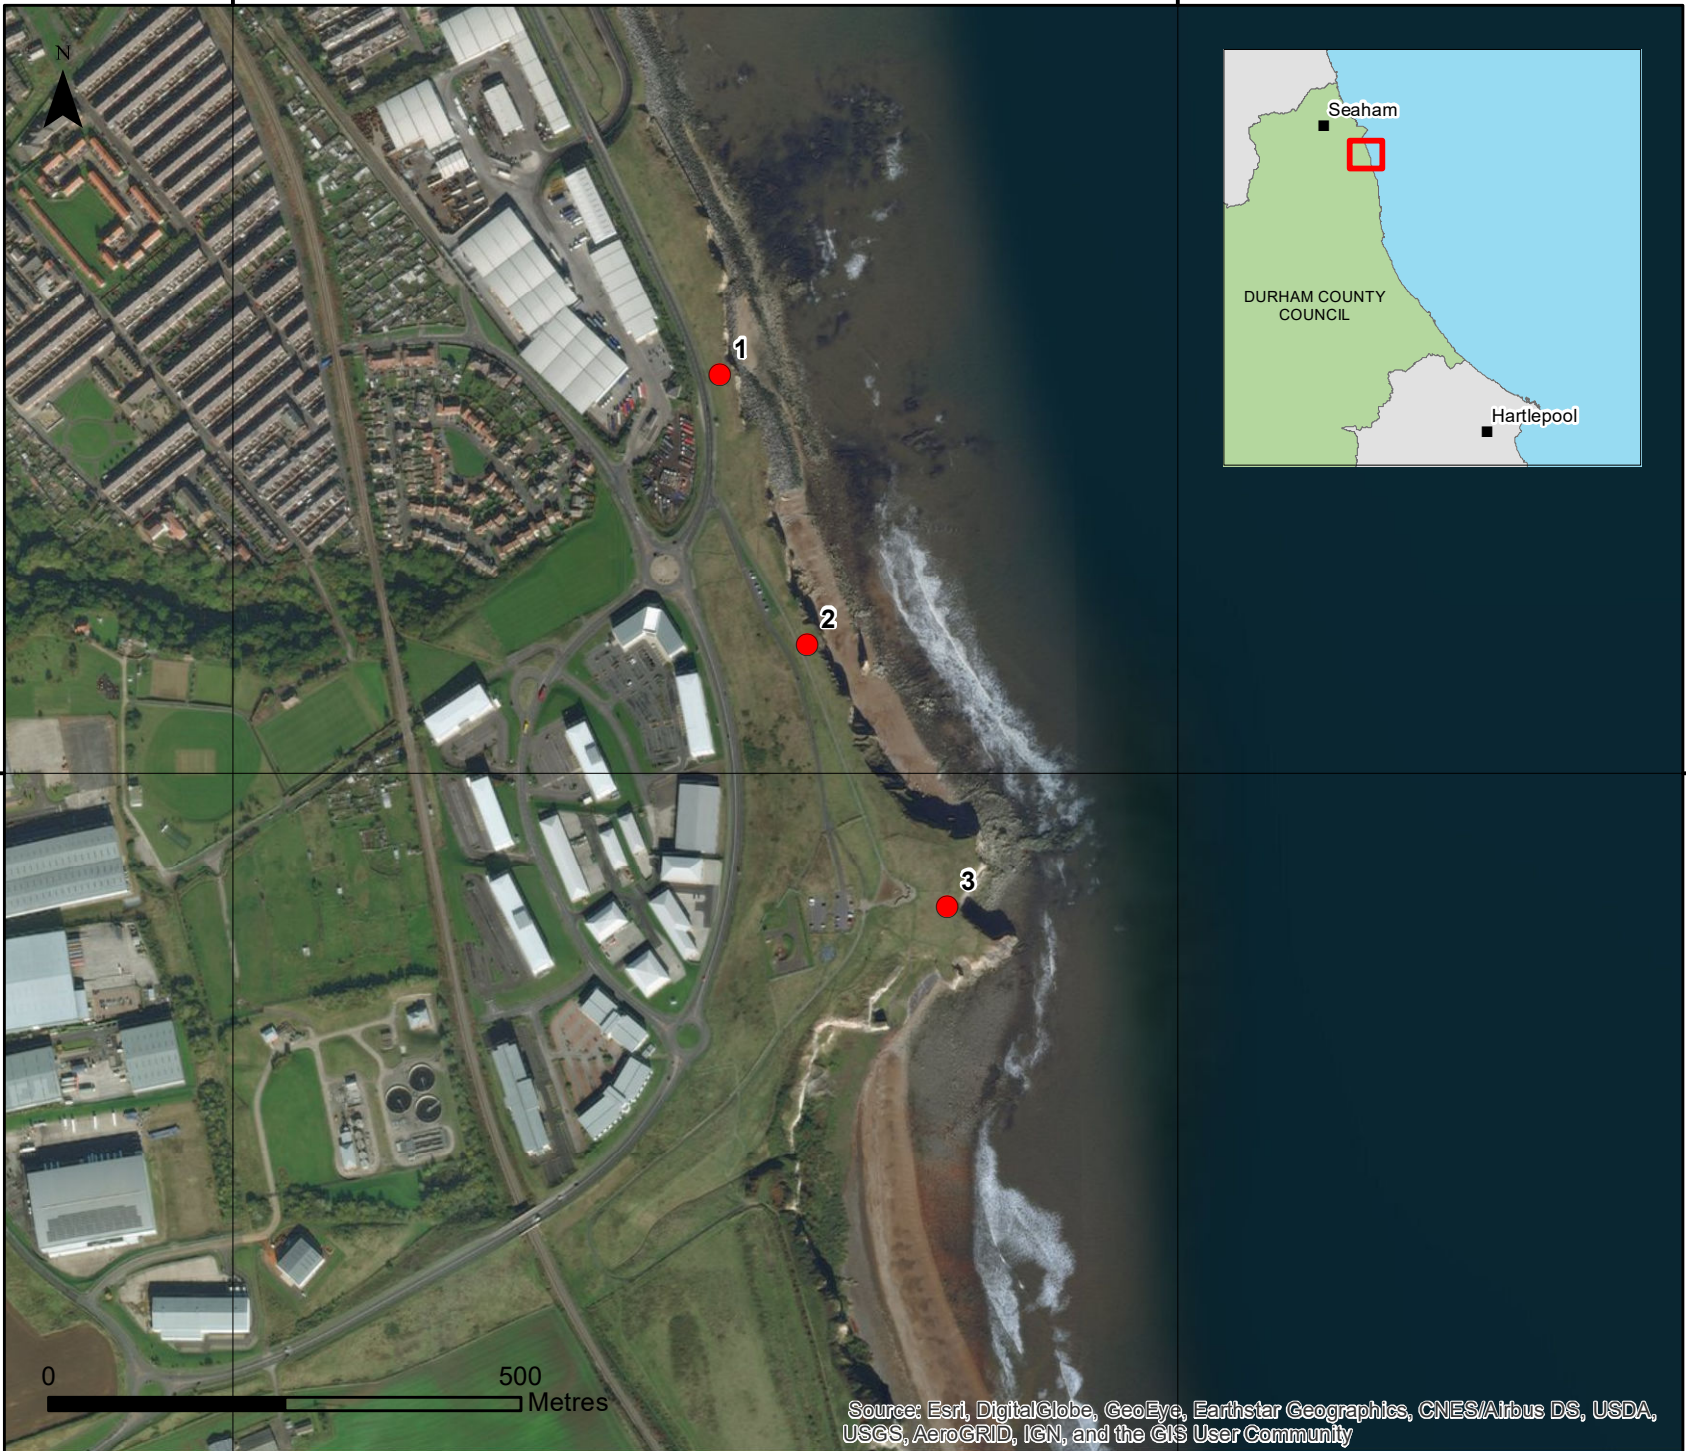
**Figure 3 - Map 1**

Survey Date	Description of Changes Since Last Survey	Interpretation
23 <sup>rd</sup> May 2020	<p><b>Cliff-top Survey:</b></p> <p>Three ground control points have been established along the cliff top at Dawdon (Figure 3). The separation between any two points is nominally 300m. These cliff top surveys are intended to inform on erosion rates of the undefended sea cliffs extending south of the rock armour revetment to the south of Seaham Harbour. The cliff top surveys at Dawdon are undertaken bi-annually.</p> <p>Measurements are taken from a fixed ground control point along a fixed bearing to the edge of the cliff top. Appendix B provides results from the May 2020 survey showing the position from the ground control point to the edge of the cliff top along the defined bearing and changes since the November 2008 baseline survey.</p> <p>The cliff monitoring data shows that there has been very little change over the winter of 2019/20, with no control points experiencing recession greater than the survey error of <math>\pm 0.2\text{m}</math>. The cliff face at control point 1, located at Dawdon, has experienced an advancement of 0.05m over the winter of 2019/20. It is likely that this is caused by slumping of the upper cliff, however this cannot be confirmed without a detailed visual inspection.</p>	<p>There has been little change over the winter of 2019/20. Overall ground control point number 1 showed erosion of 1.01m, and ground control point 3 showed erosion of 1.25m since November 2008. Point 2 has shown little change.</p> <p><b>Longer term trends:</b></p> <p>There is more confidence in the long-term pattern of change, where the cumulative measured erosion is greater than the error inherent in the technique.</p> <p>Ground control points 1 and 3 have both shown an average recession rate of 0.1m/yr, since monitoring began in 2008.</p>

- At Seaham Cliffs, the survey data indicates that the average recession rate since monitoring began in 2008 is 0.08m/yr at point 1 and 0.1m/yr at point 3. Point 2 shows little change over the monitoring period.

Three ground control points have been established at Dawdon (Figure 3). The maximum separation between any two points varies along the coast, reflecting the degree of risk from erosion.

The cliff top surveys at Dawdon are undertaken bi-annually. Measurements are taken from a fixed ground control point along a fixed bearing to the edge of the cliff top.

Ground Control Points				Distance to Cliff Top (m)			Total Erosion (m)		Erosion Rate (m/year)
Ref	Easting	Northing	Bearing	Baseline Survey	Previous Survey	Present Survey	Baseline to Present	Previous to Present	Baseline to Present
			(°)	Nov 2008	Oct 2019	May 2020	Nov 2008 – May 2020	Oct 2019- May 2020	Nov 2008 – May 2020
1	443515.4	548421.7	70	16.1	15.04	15.09	-1.01	0.05	-0.08
2	443607.8	548136.3	90	13.3	13.24	13.24	-0.06	0	0.00
3	443756.1	547858.5	95	14.8	13.55	13.55	-1.25	0	-0.10
