## **Cell 1 Regional Coastal Monitoring Programme Update Report 16: 'Partial Measures' Survey 2024**

**Durham County Council**

**May 2024**

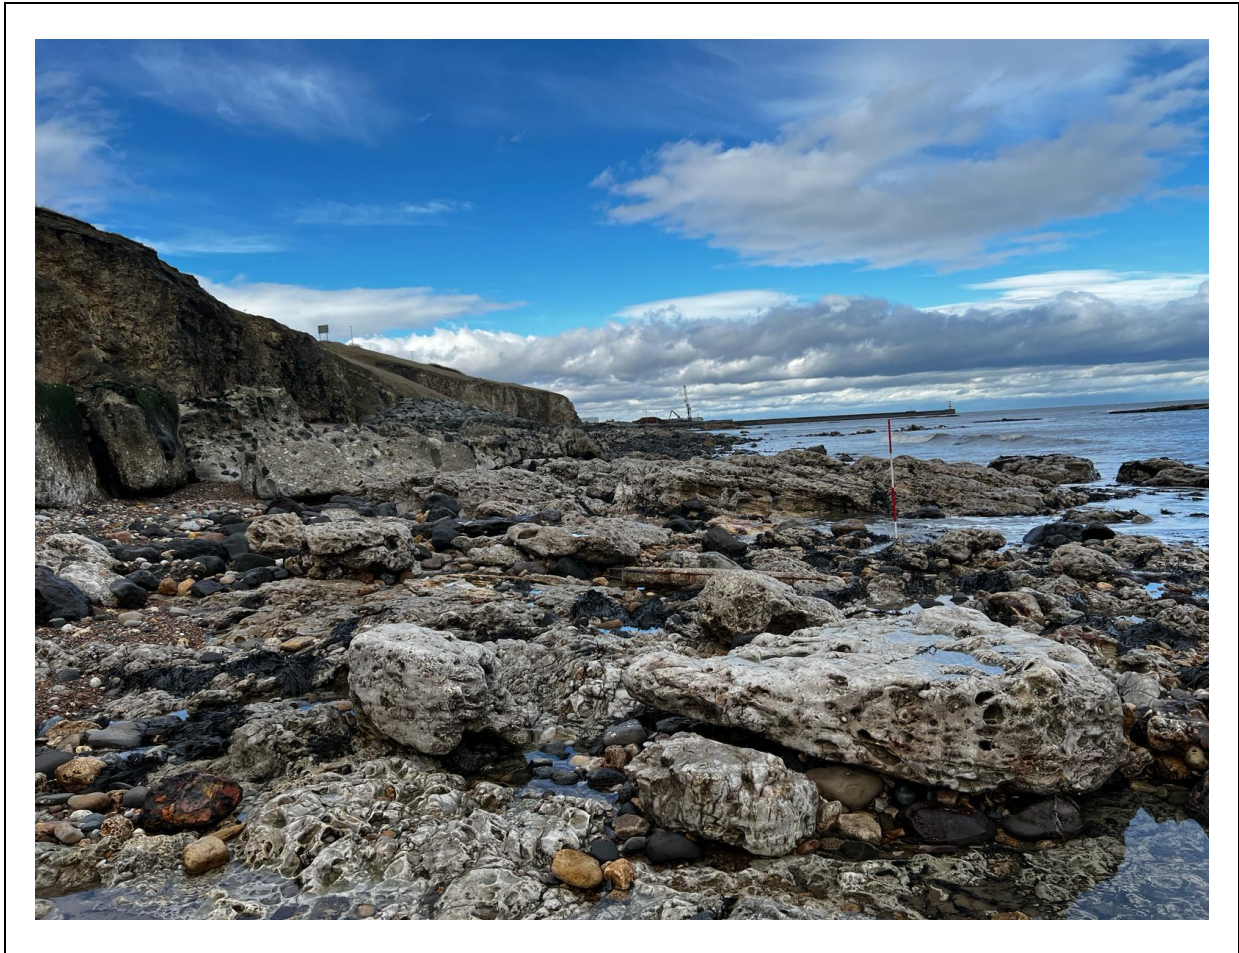
**Figure 1 Sediment Cells in England and Wales**

The Cell 1 Regional Coastal Monitoring Programme covers approximately 300km of the north east coastline, from the Scottish Border (just south of St. Abb's Head) to Flamborough Head in East Yorkshire. This coastline is often referred to as 'Coastal Sediment Cell 1' in England and Wales (Figure 1). Within this frontage the coastal landforms vary considerably, comprising low-lying tidal flats with fringing salt marshes, hard rock cliffs that are mantled with glacial sediment to varying thicknesses, softer rock cliffs and extensive landslide complexes.

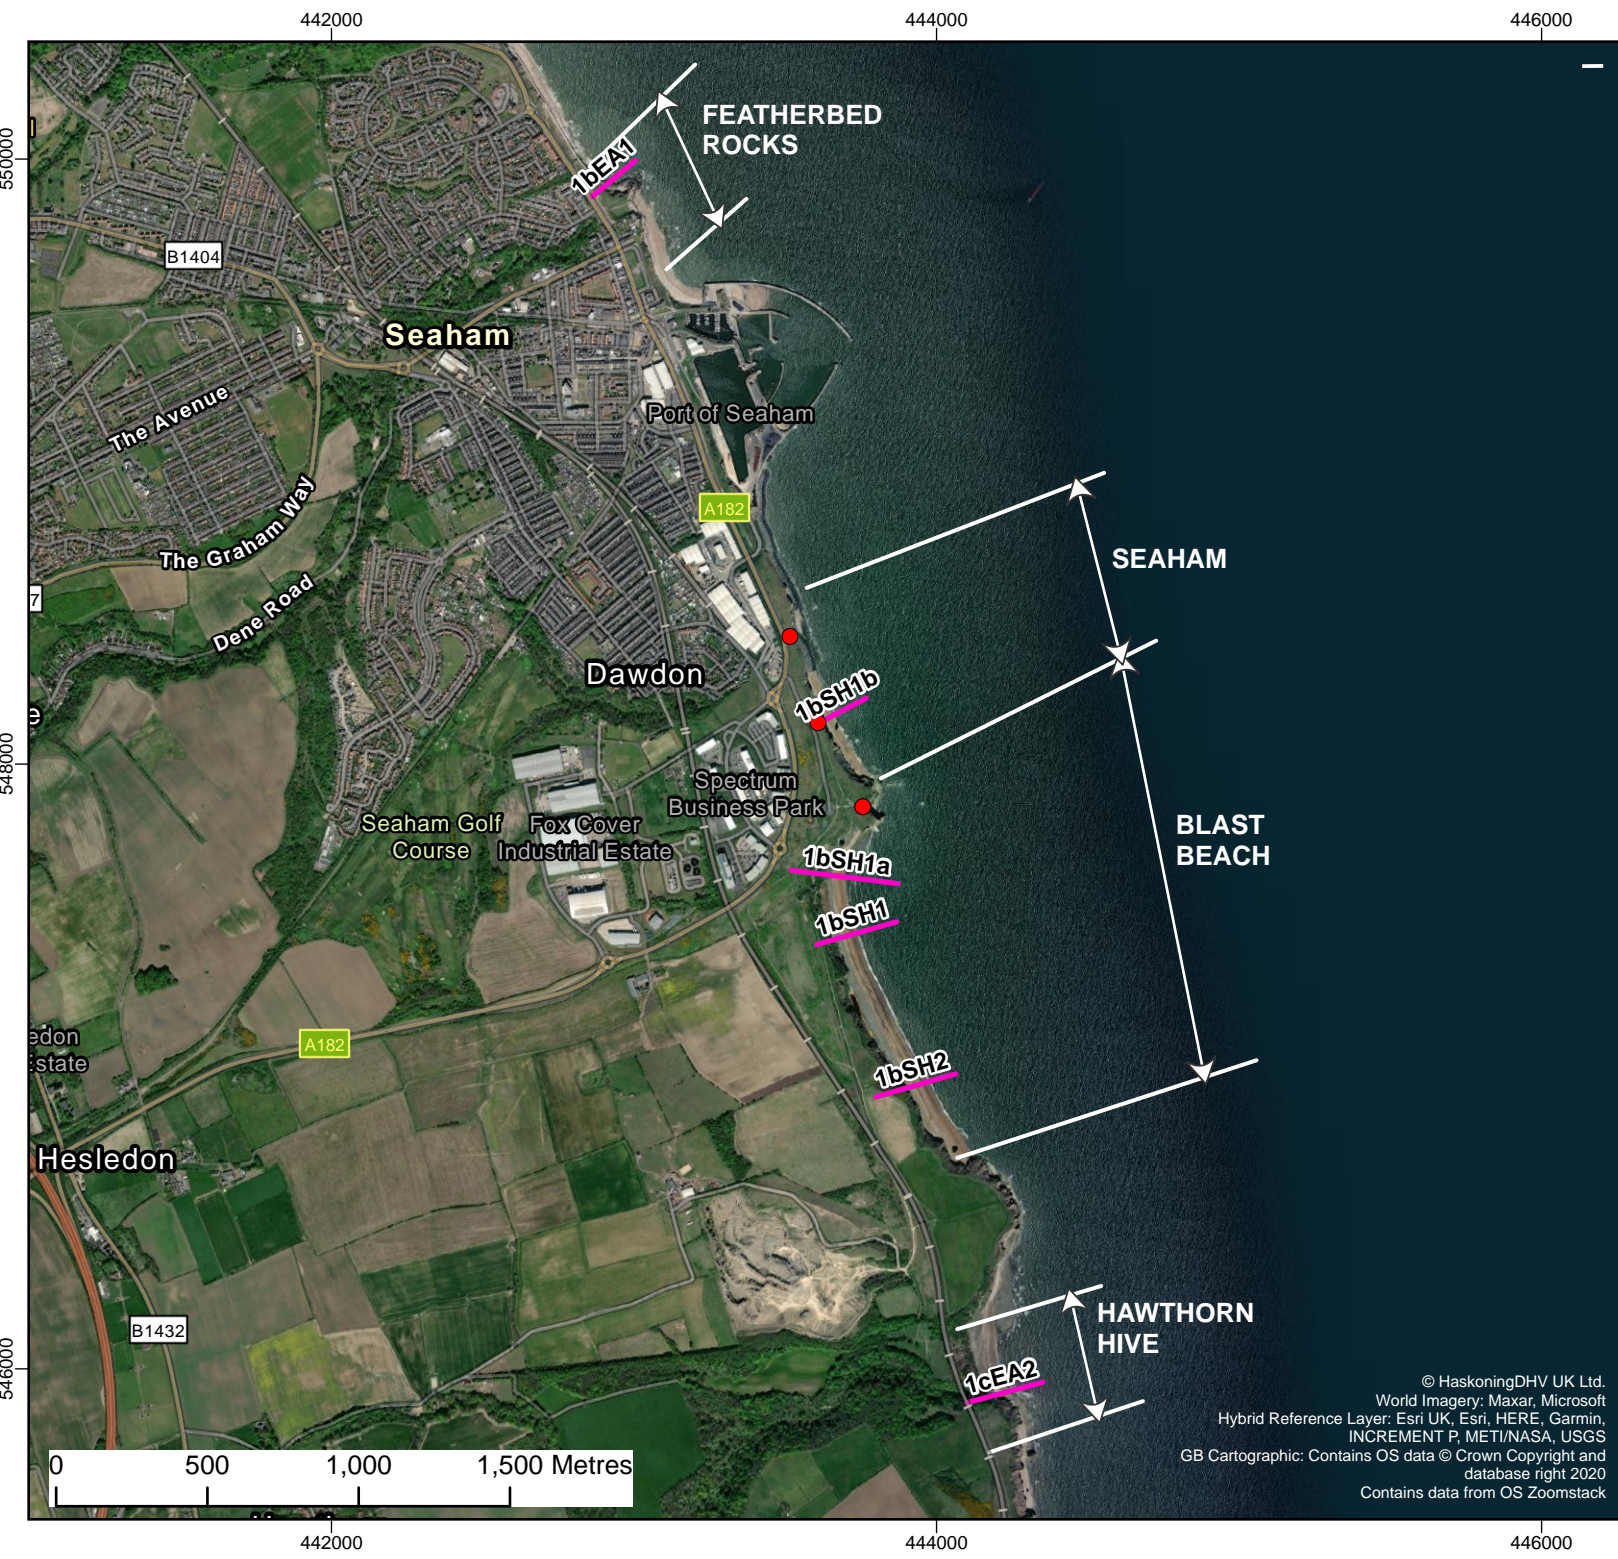
Title: **Figure 2 - Map 1**  
**FEATHERBED ROCKS TO HAWTHORN HIVE**  
**Durham County Council Frontage**

The location of these surveys is shown in Figure 2. The Partial Measures survey was undertaken along this frontage on 15<sup>th</sup> March 2024. During the survey the weather was dry and sunny. The wind was force 5 from the south east. The state was slight.

**Topographic Profile**

- Annual (Blue line)
- Bi-Annual (Pink line)

**Topographic Area**

- 6 monthly (Light Green)
- yearly (Orange)
- 5 yearly (Light Purple)

● Cliff Top Survey Points (refer to Figure 3 for details)

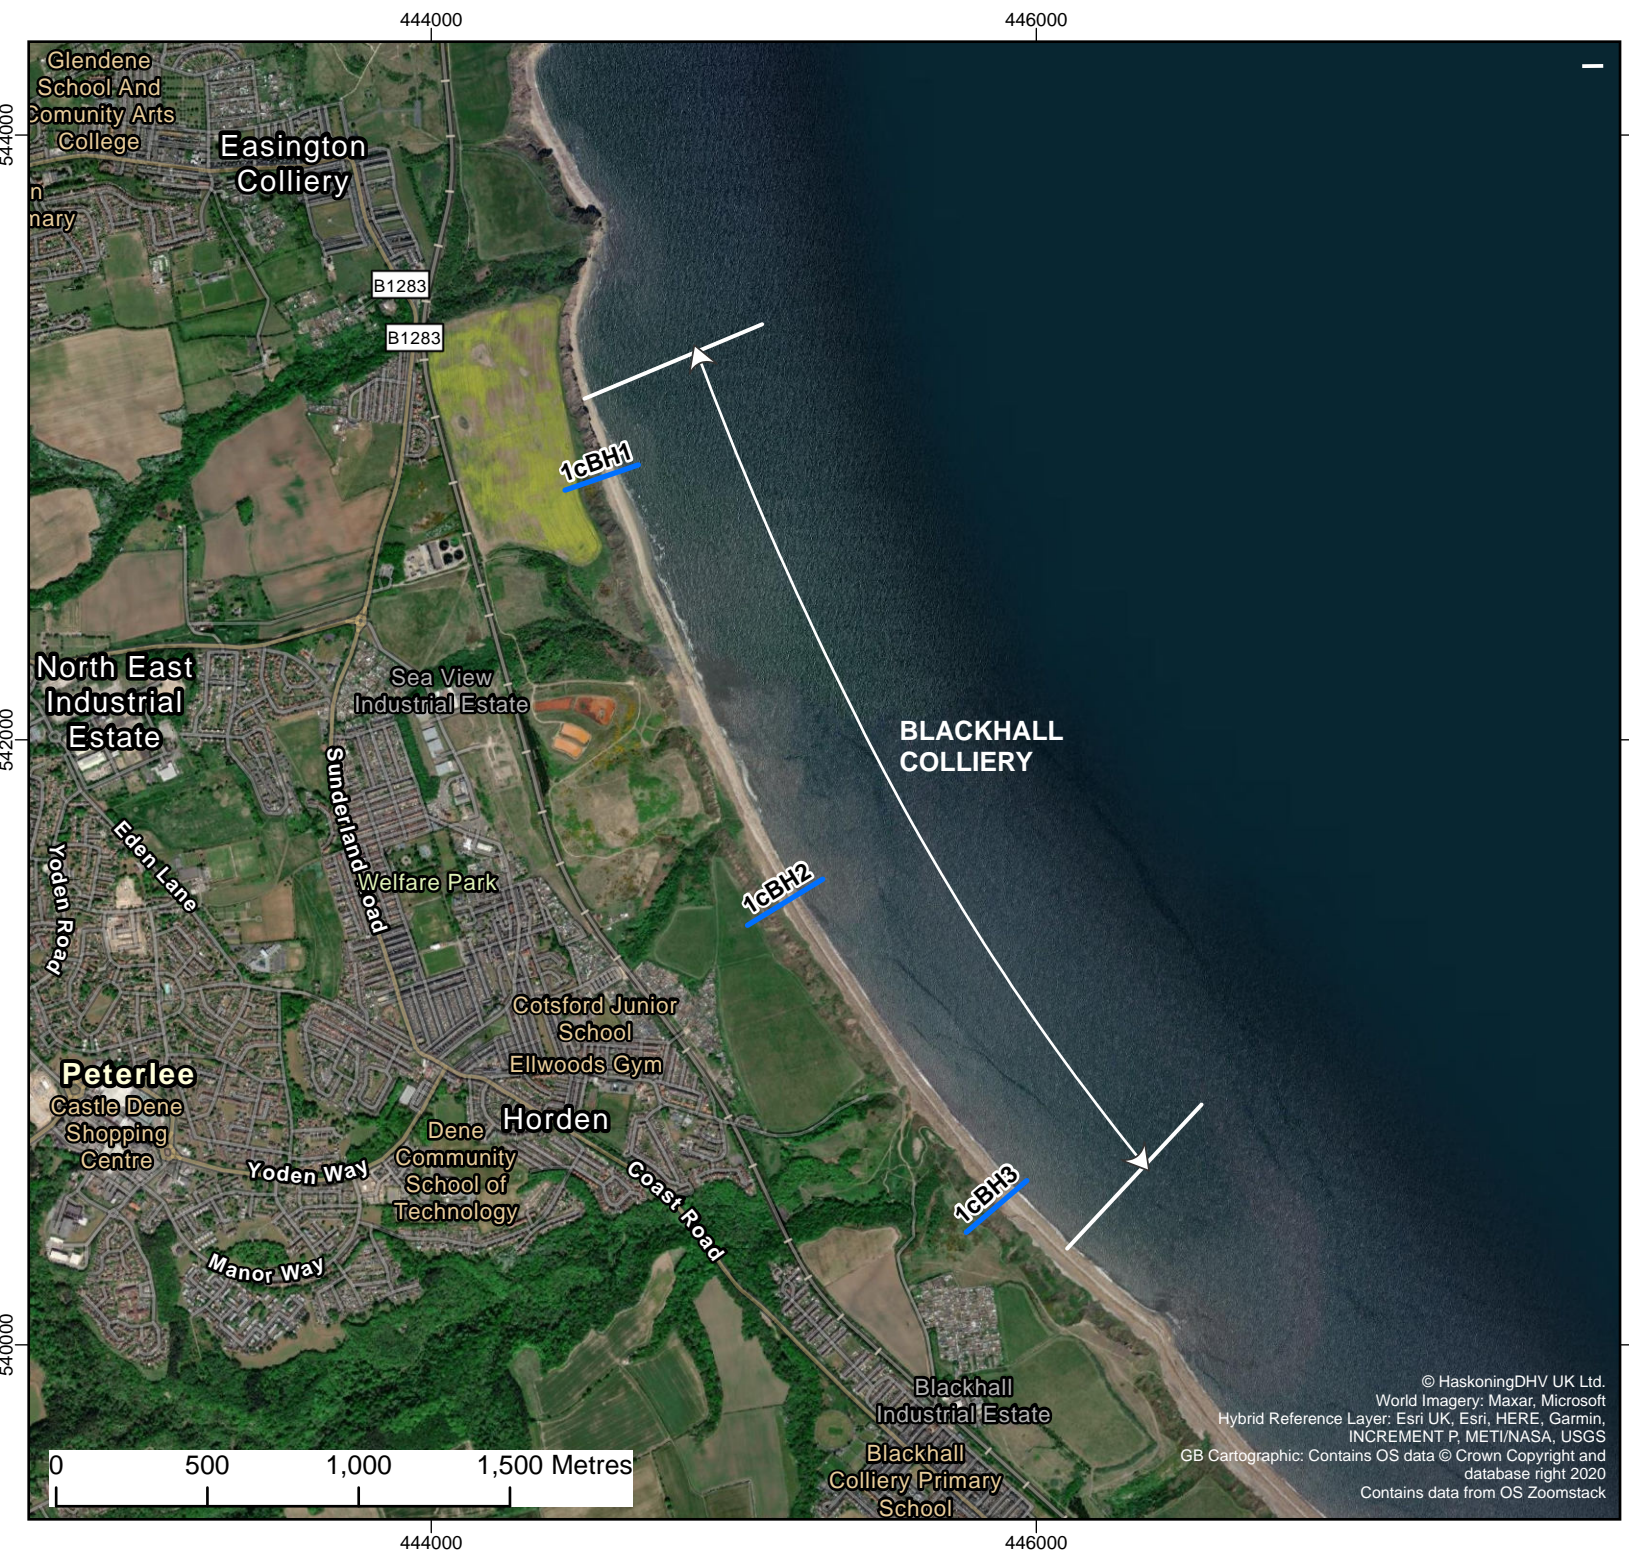
**Figure 2 - Map 2**

**SURVEY LOCATIONS**

**Topographic Profile**

- Annual (Blue line)
- Bi-Annual (Pink line)

**Topographic Area**

- 6 monthly (Light Green)
- yearly (Orange)
- 5 yearly (Light Purple)

- Cliff Top Survey Points (Red dot)

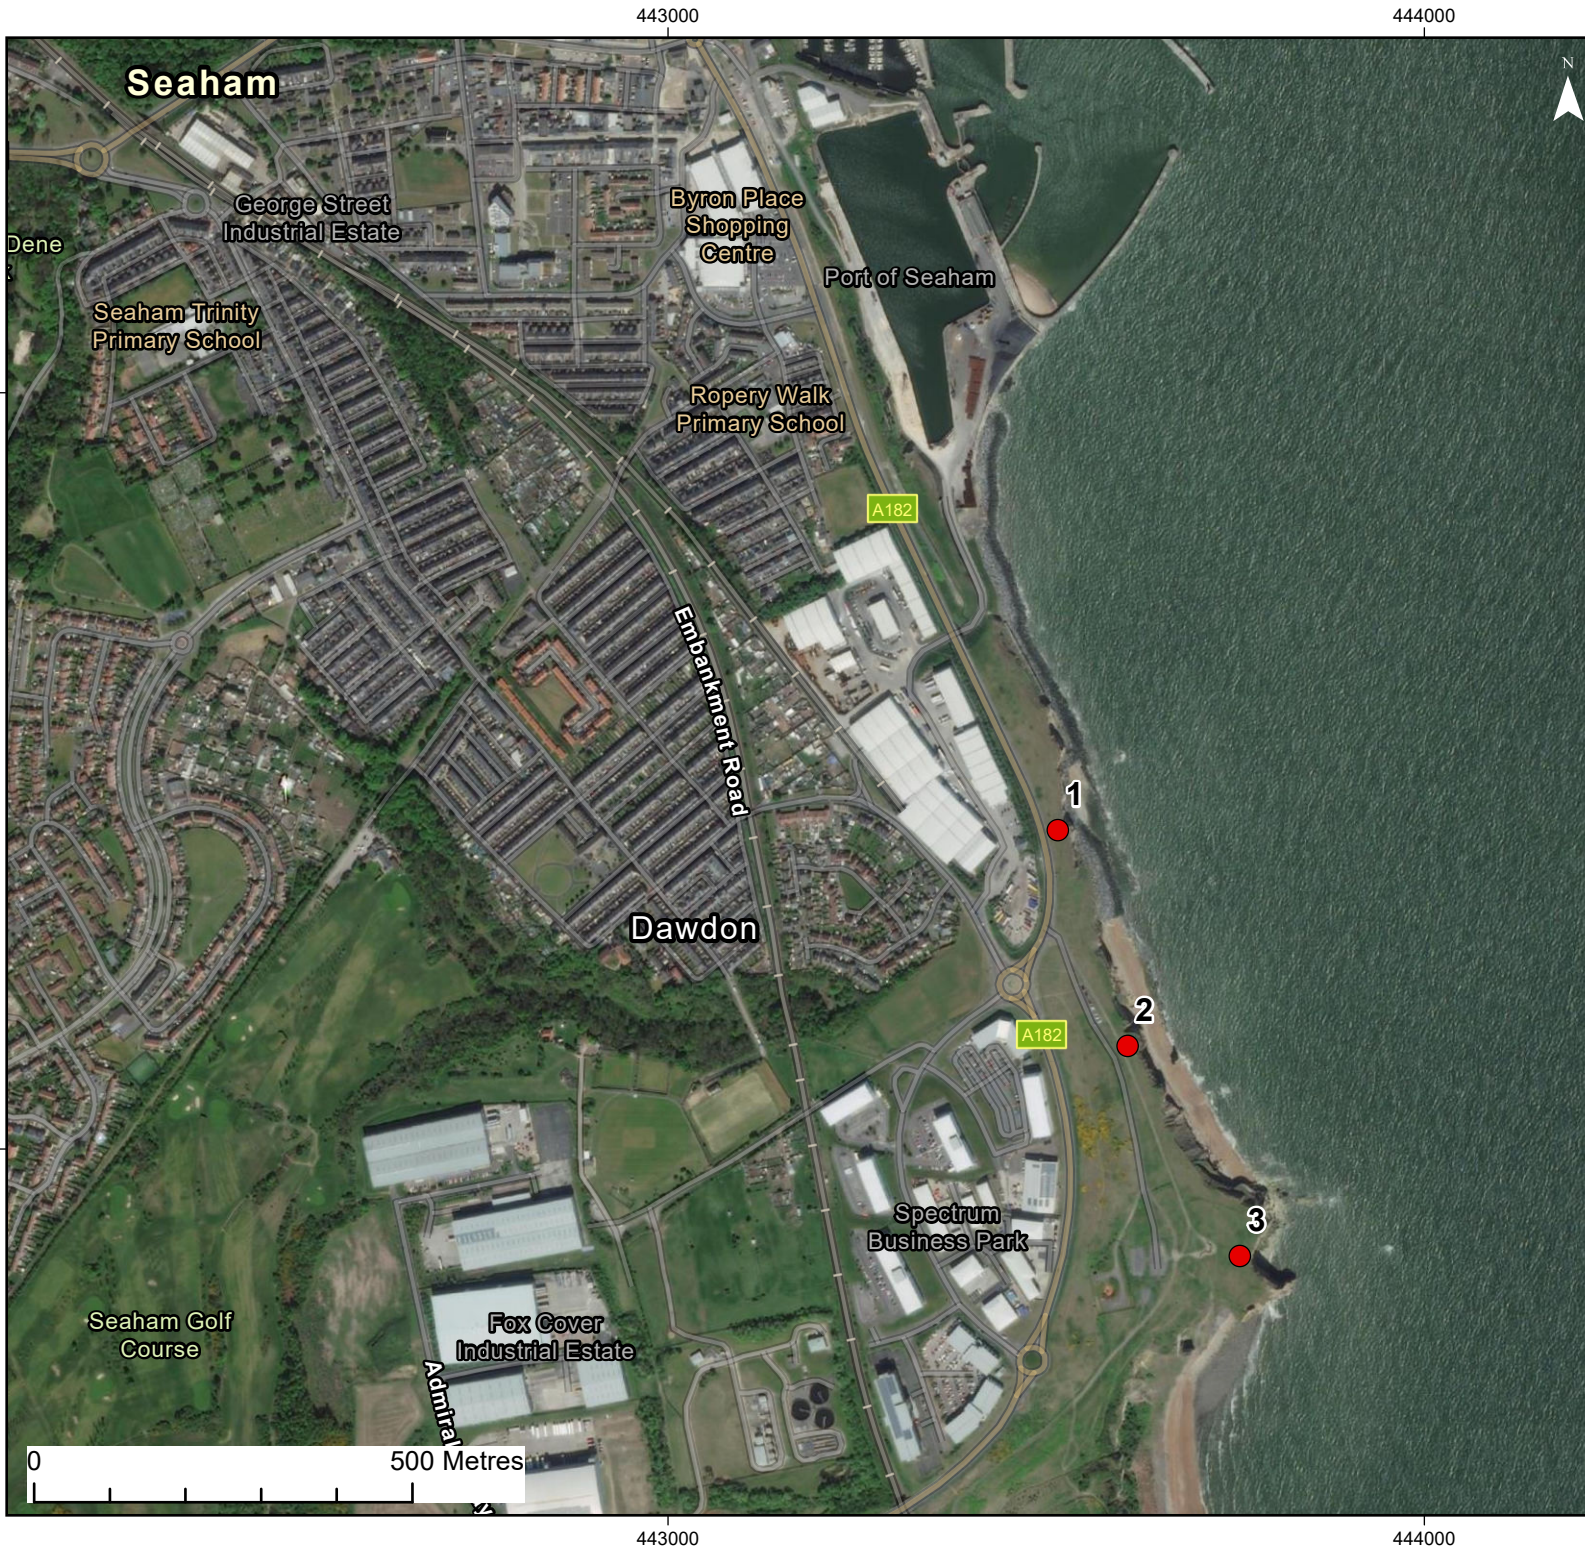
**Figure 3 - Map 1**

### SURVEY LOCATIONS

- Cliff Top Survey Points

Survey Date	Description of Changes Since Last Survey	Interpretation
15 <sup>th</sup> March 2024	<p><b>Cliff-top Survey:</b></p> <p>Three ground control points have been established along the cliff top at Dawdon (Figure B1). The separation between any two points is nominally 300m. These cliff top surveys are intended to inform on erosion rates of the undefended sea cliffs extending south of the rock armour revetment to the south of Seaham Harbour. The cliff top surveys at Dawdon are undertaken bi-annually.</p> <p>Measurements are taken from a fixed ground control point along a fixed bearing to the edge of the cliff top. Appendix B provides results from the March 2024 survey showing the position from the ground control point to the edge of the cliff top along the defined bearing and changes since the November 2008 baseline survey.</p> <p>The cliff monitoring data shows that the change across the three control points over winter 2023/24 is limited to <math>\pm 0.03\text{m}</math>, indicating a period of stability (Point 1 = 0.03m, Point 2 = 0.00m, Point 3 = -0.02m).</p>	<p>The cliffs at Dawdon have undergone a period of stability with change over winter 2023/24 limited to <math>\pm 0.03\text{m}</math>.</p> <p><b>Longer term trends:</b></p> <p>There is more confidence in the long-term pattern of change, where the cumulative measured erosion is greater than the error inherent in the technique.</p> <p>The period of recent stability has resulted in a reduction in the long term average recession rates. Since the baseline in 2008, Point 1 and 3 have comparable recession rate of 0.07m/year and 0.08m/year respectively whereas Point 2 having retreated only 0.32m in 14 years has a recession rate of 0.02m/year.</p>

Three ground control points have been established at Dawdon (Figure B1). The maximum separation between any two points varies along the coast, reflecting the degree of risk from erosion.

The cliff top surveys at Dawdon are undertaken bi-annually. Measurements are taken from a fixed ground control point along a fixed bearing to the edge of the cliff top.

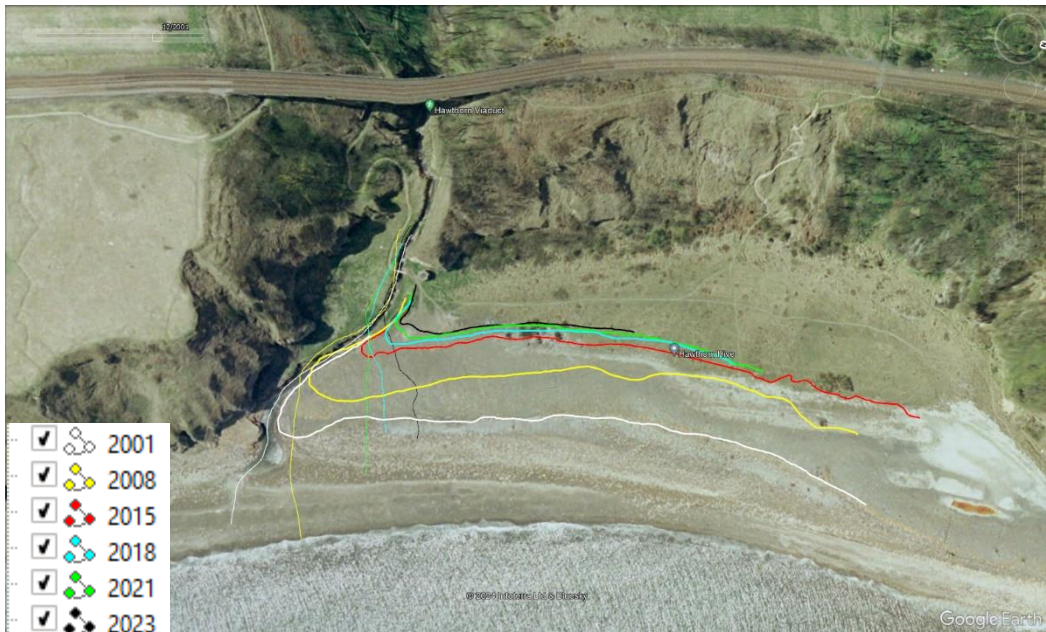
<p>Figure 4 - Hawthorne Burn alignment vs eroding colliery spoil platform.</p>	<p><b>Longer term trends:</b></p> <p>Figure 4 shows that over time, as the colliery spoil platform erodes, the Hawthorne Burn has been allowed to adopt a more natural, central alignment without being held in position by the spoil. This transition over time is also reflected in profile 1cEA2, where the channel has not been observed through profile since the partial measures survey in 2013, corresponding with the retreat of the spoil.</p> <p>Without the constraint of the colliery spoil, it is thought the channel will be more responsive to annual and seasonal variations in the flow of Hawthorn Burn and storm events which move sediment onshore to block the outflow of the burn which will result in a more varied alignment of the burn.</p>

- At Hawthorne Hive, the beach profile has been dominated by erosion since the previous survey in September 2023. This is typical a response to the direction, severity and number of storms that occurred through winter 2023/24, a pattern that has been observed along much of the north east coastline.

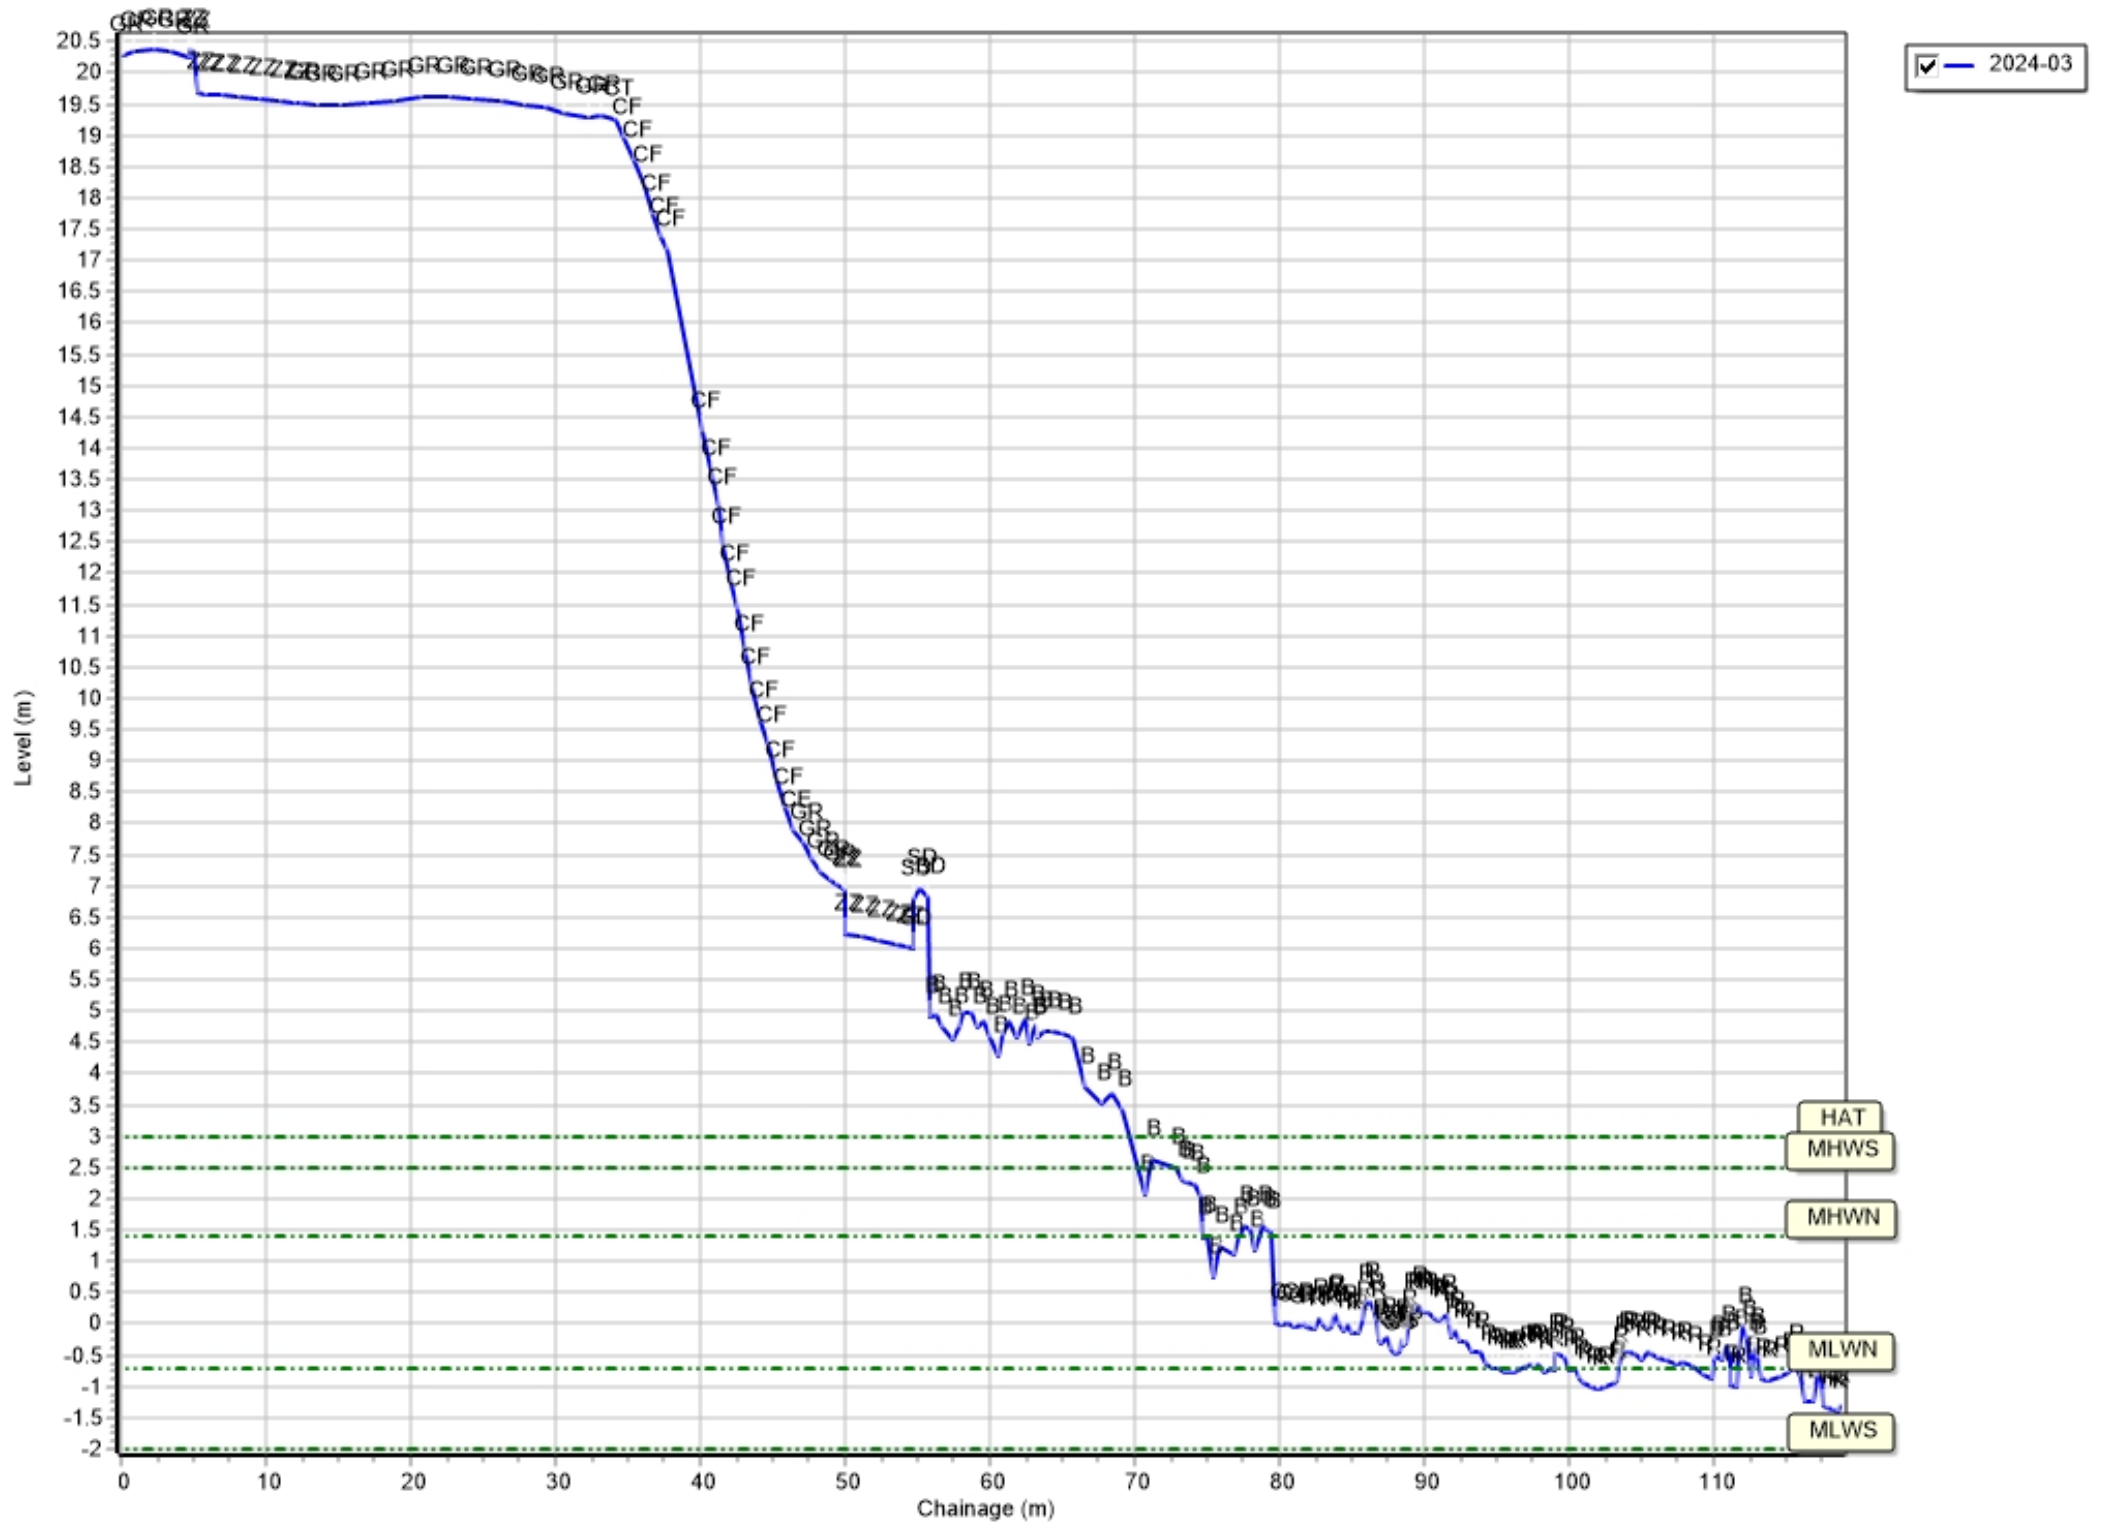
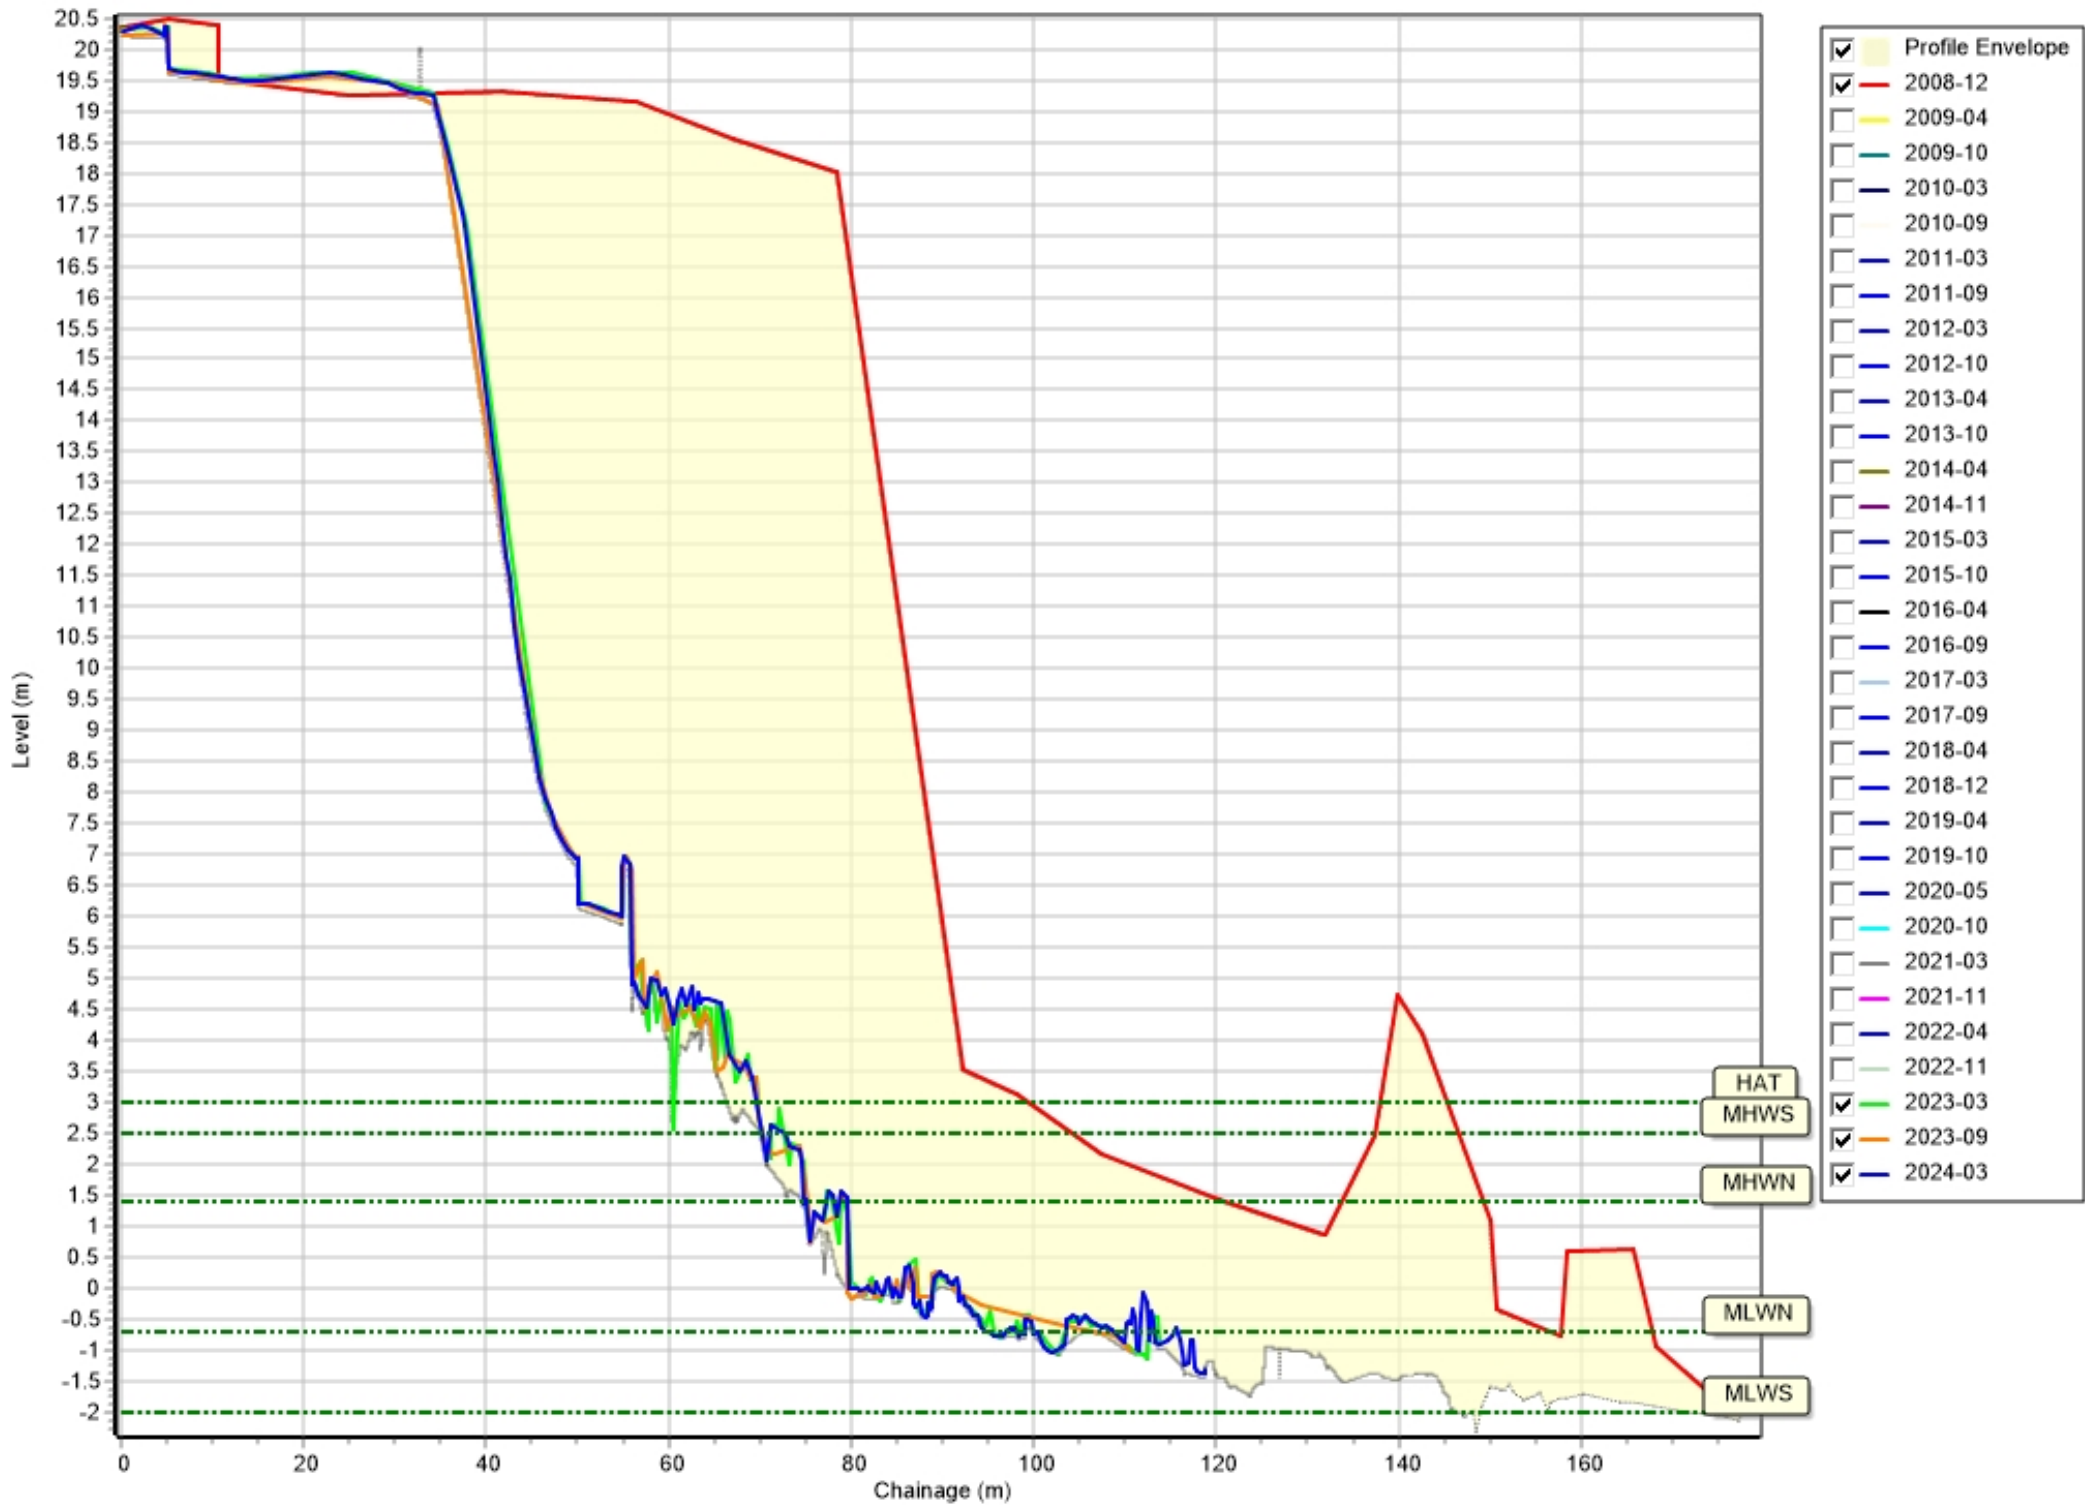
# Profiles: 1bEA1

Survey Date	Description of Changes Since Last Survey	Interpretation
<p>15<sup>th</sup> March 2024</p>	<p><b>Beach Profiles:</b></p> <p>Featherbed Rocks is monitored by one beach profile line (<b>1bEA1</b>) during the Partial Measures survey (Appendix A). It was last surveyed in September 2023.</p> <p>At Profile <b>1bEA1</b>, chainage 0m to 56m covers the cliff top, cliff face and promenade. This section of the profile historically has remained unchanged due to the protection offered by the rock armour. It is assumed the changes across the cliff face are due to difficulties surveying the steep topography. Chainage 56m to chainage 80m is covered by a rock revetment, it appears that there has been some local movement of rock since the previous survey with an increase in level observed between chainage 61m and 67m. Seawards of the revetment, the volume of sediment present has decreased further with a drop in level of up to 0.4m observed between chainage 91m and 104m. As a result, the rocky foreshore remains exposed over a greater length.</p>	<p>As is the long term trend, little change has been observed at Profile <b>1bEA1</b>. Local changes across the revetment suggest either the movement of armour stones locally or the revetment has been topped up since the previous survey.</p> <p>The further loss of material from the rocky foreshore, a response to the particularly stormy winter 2023/24, has exposed sections of the rocky foreshore not previously exposed since monitoring began.</p> <p><b>Longer term trends:</b></p> <p>The rocky nature of the foreshore means it is unlikely to undergo significant changes in morphology unless sediment is deposited. Previous monitoring indicates that a veneer beach tends to accumulate over the summer and is stripped off by winter storms, giving rise to small and localised changes in profile. Although the veneer beach has not been observed for a number of years. The upper part of the profile, which covers the cliff, promenade and rock armour remains unchanged, as does the lower part of the profile which covers the rocky foreshore.</p>

- At Featherbed Rocks, local changes across the revetment suggest either the movement of armour stones locally or that the revetment has been topped up since the previous survey. The further loss of material from the rocky foreshore, a response to the particularly stormy winter 2023/24, has exposed sections of the rocky foreshore not previously exposed since monitoring began.
