## **Cell 1 Regional Coastal Monitoring Programme Update Report 16: 'Partial Measures' Survey 2024**

**Durham County Council**

**May 2024**

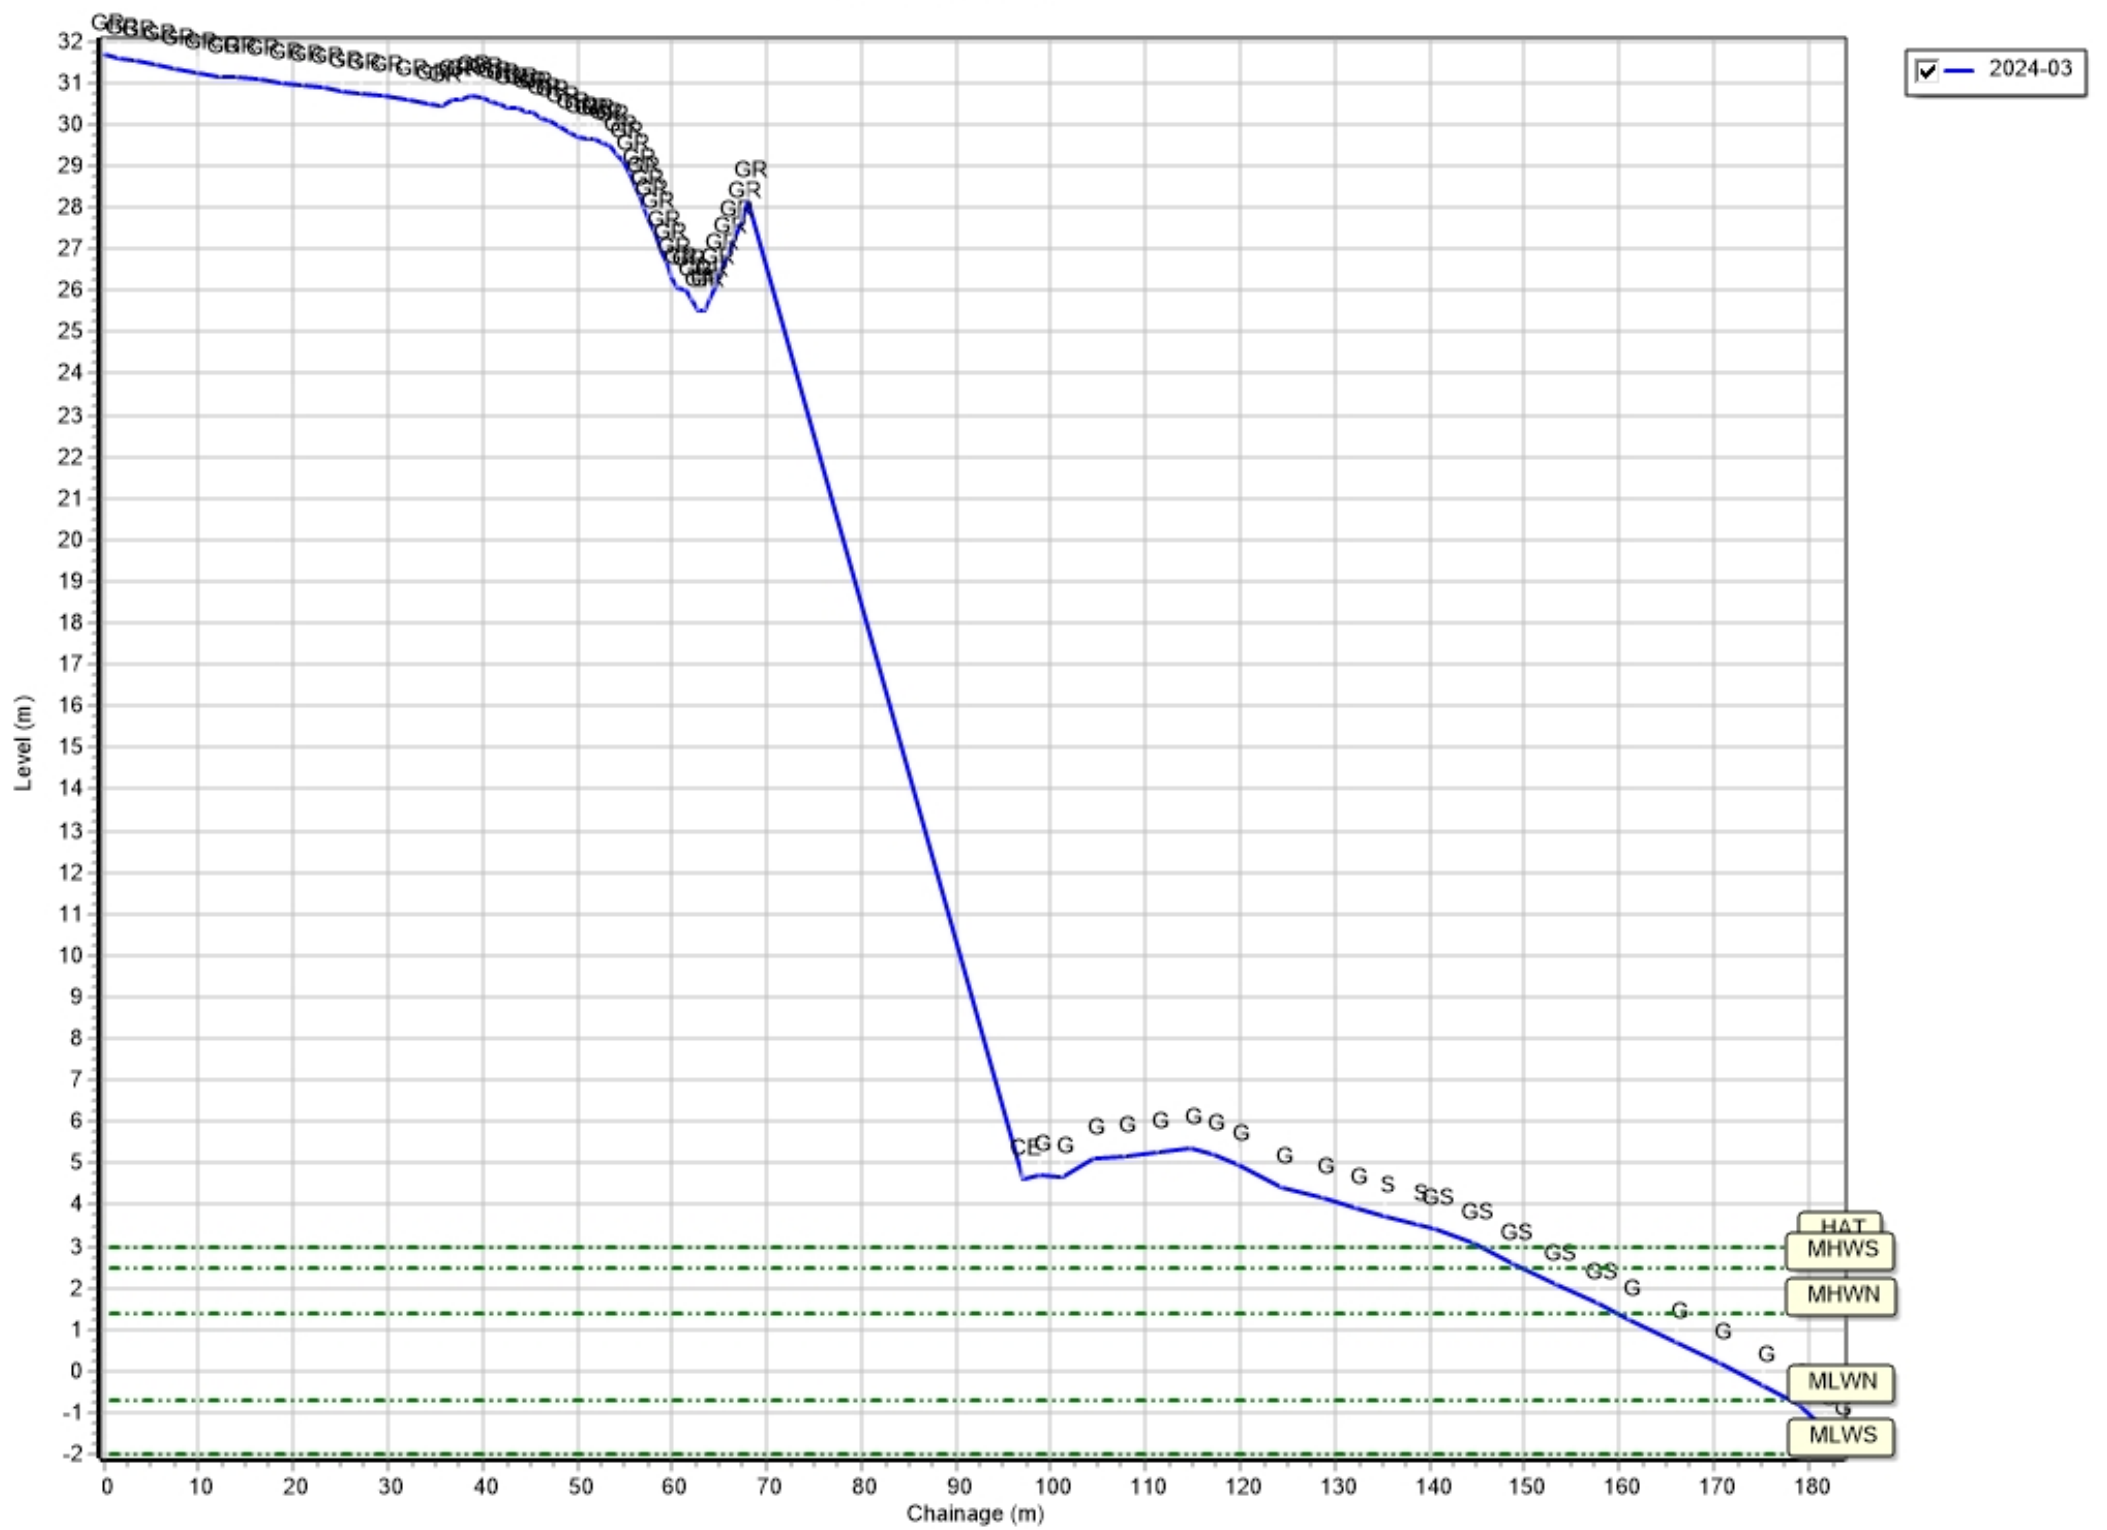
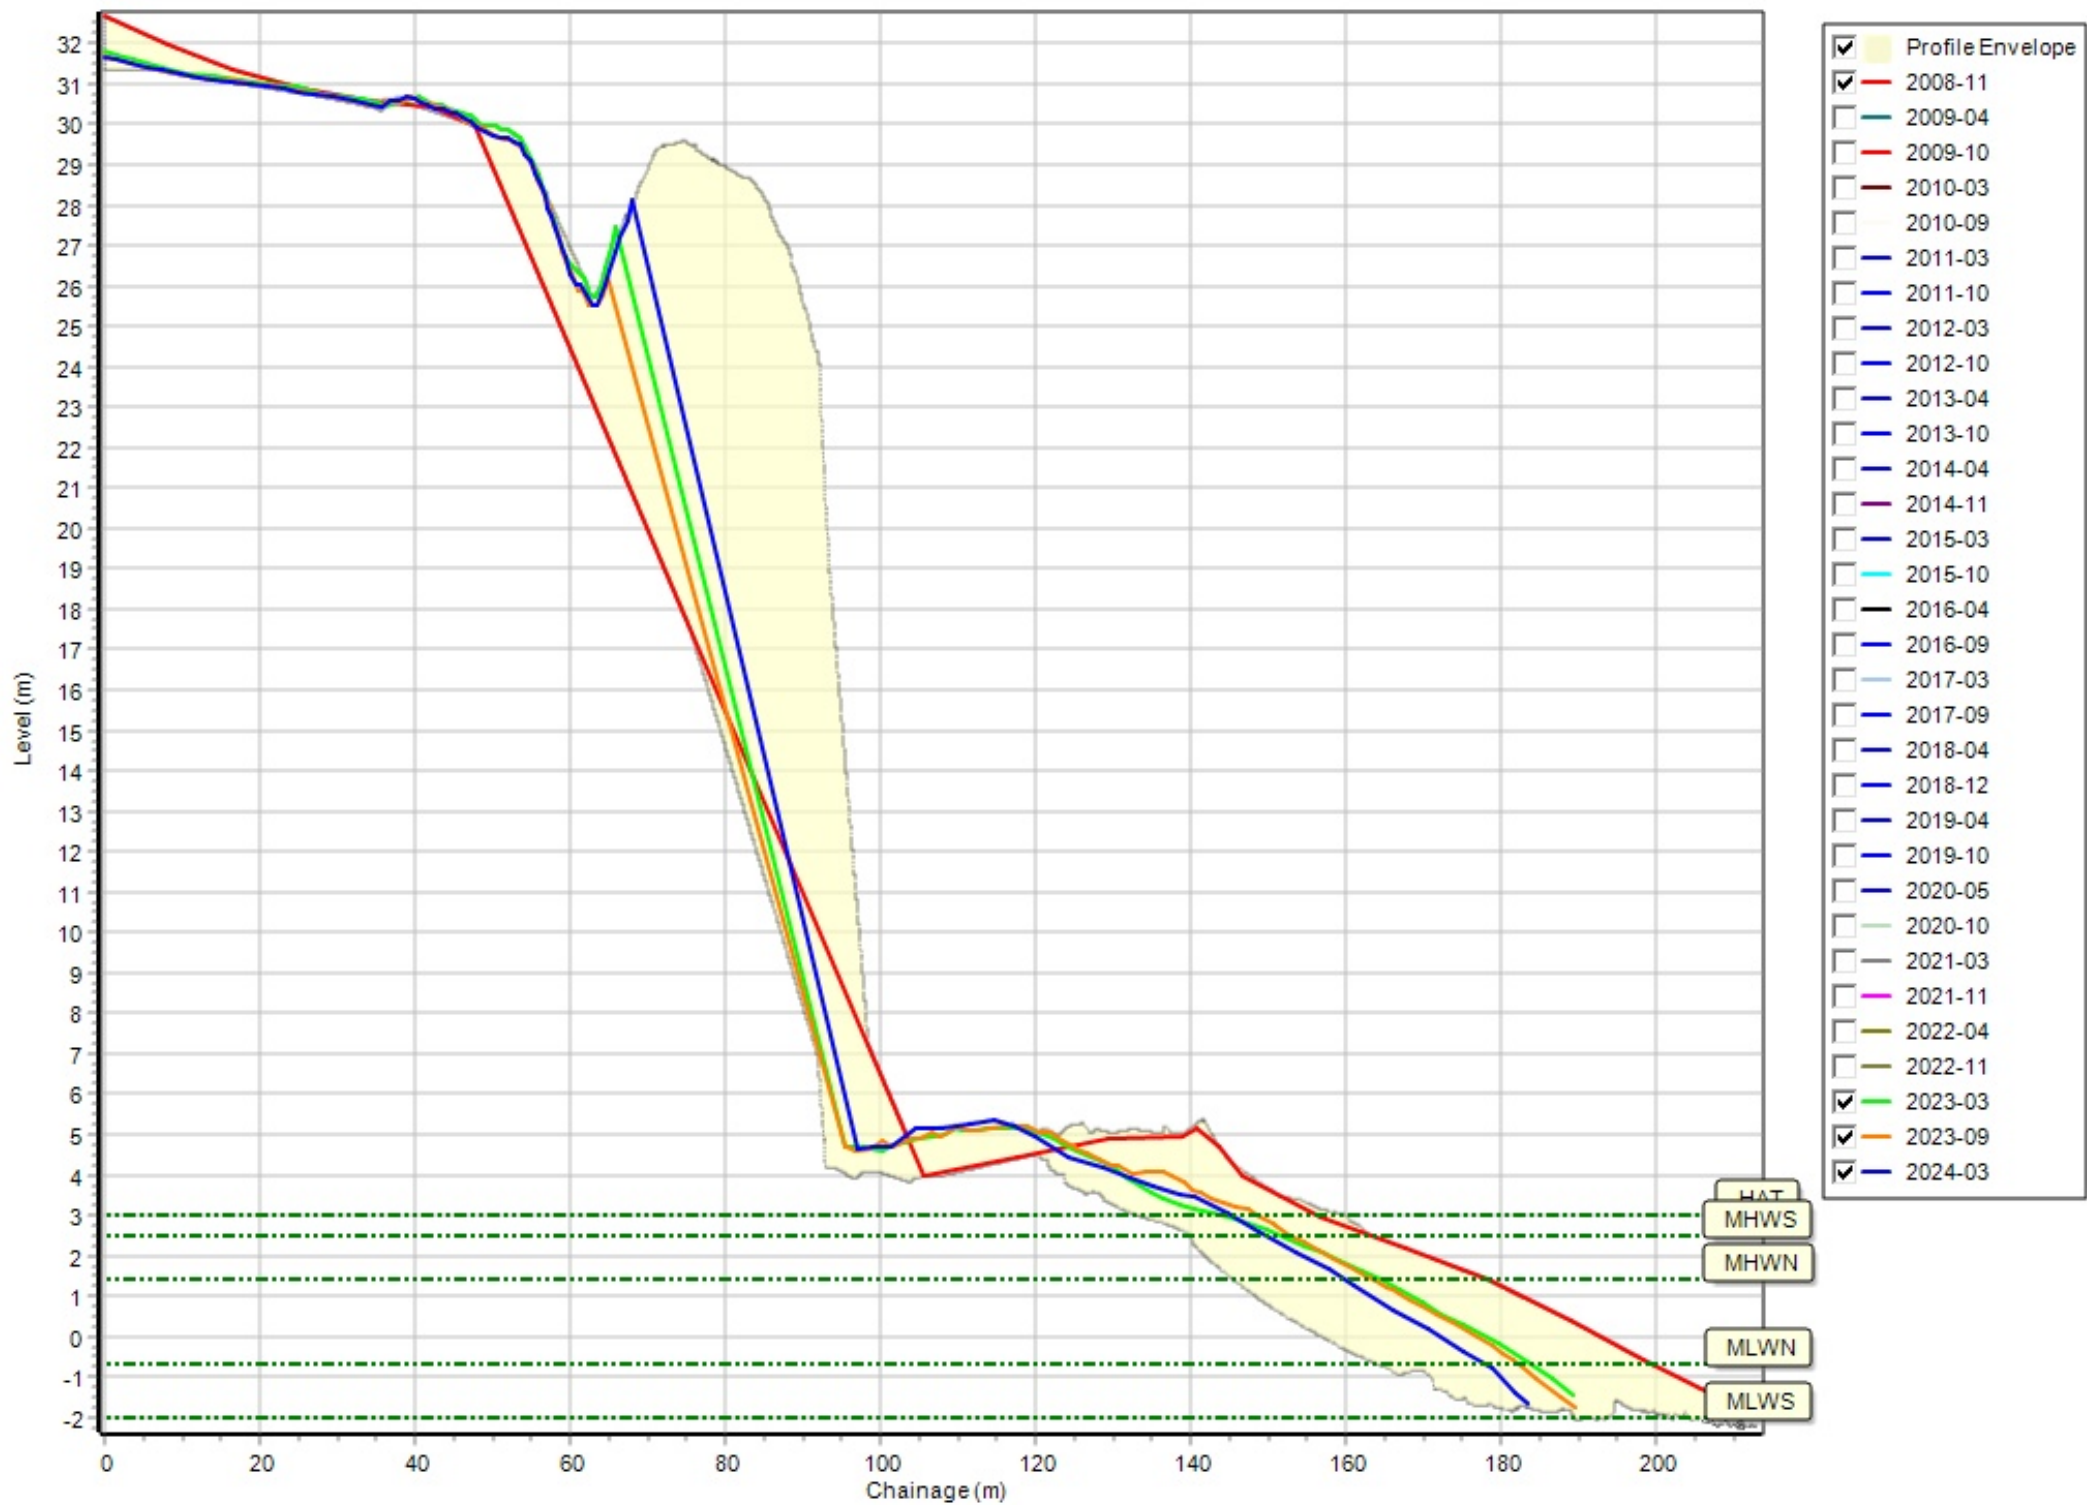
# Profiles: 1bSH2

Survey Date	Description of Changes Since Last Survey	Interpretation
	<p>At profile <b>1bSH2</b>, between chainage 97m and 117m, accretion of up to 0.2m in level has occurred on the residual colliery spoil platform. Seawards of chainage 117m, the beach has been dominated by erosion, increasing in magnitude down the profile (peaking at chainage 183m with a magnitude of -0.8m). When compared to the range of the previous surveys, the upper beach is at the highest level on record as a result of the accretion whereas the rest of the profile is generally at a medium level.</p>

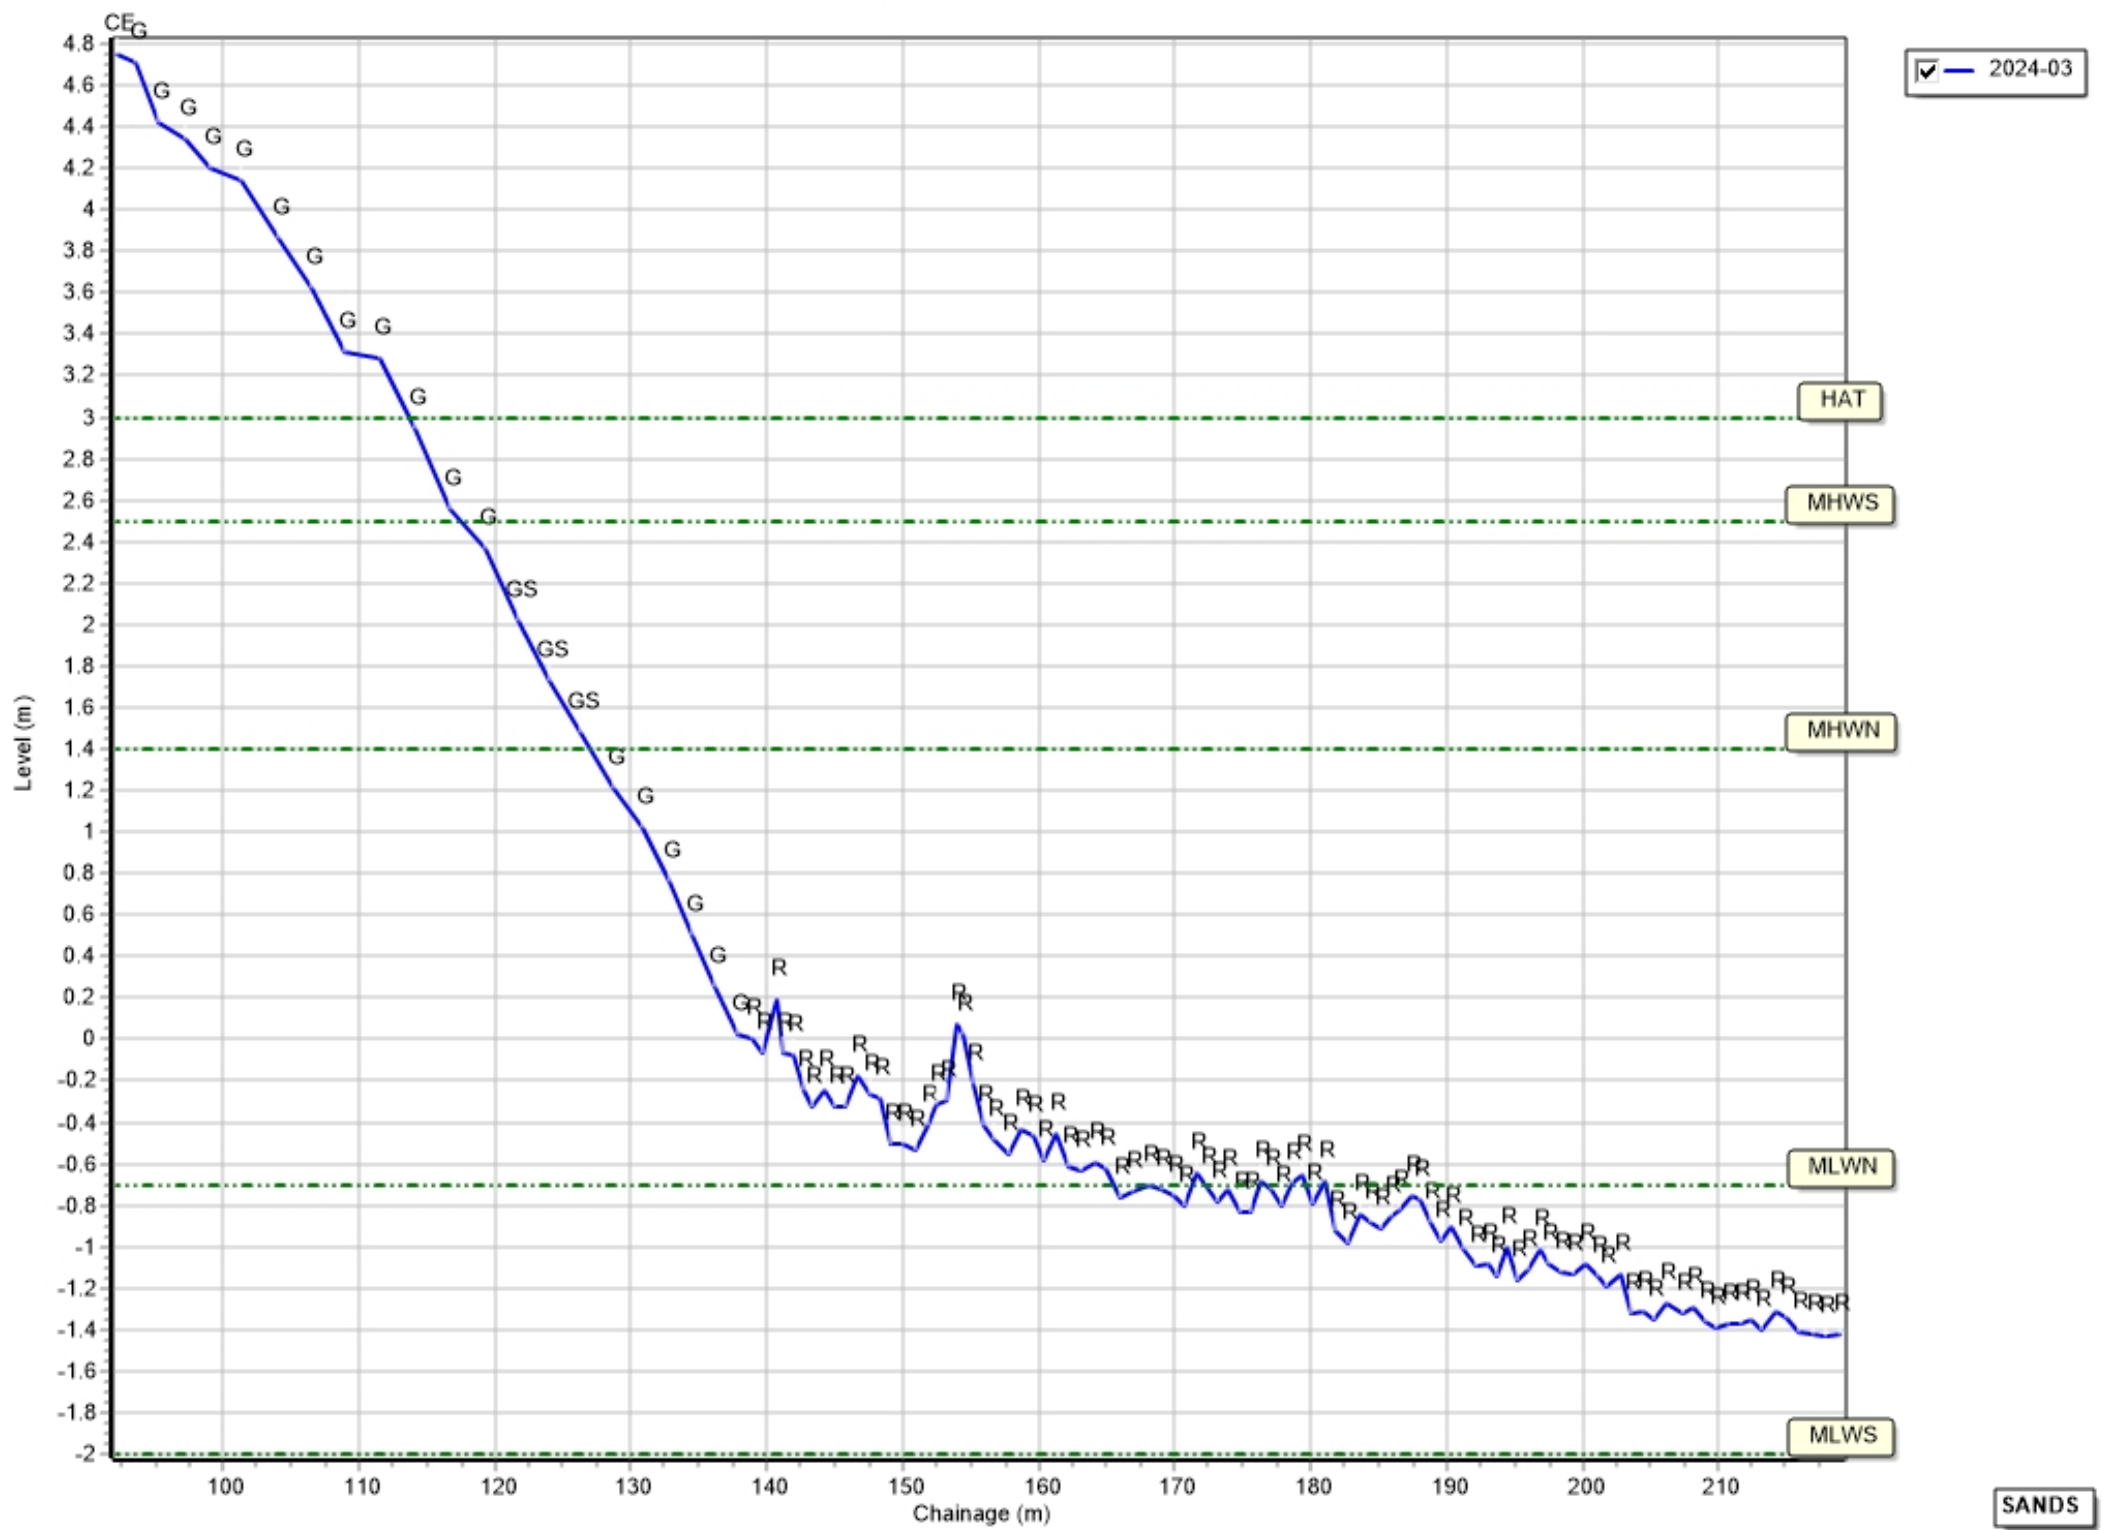
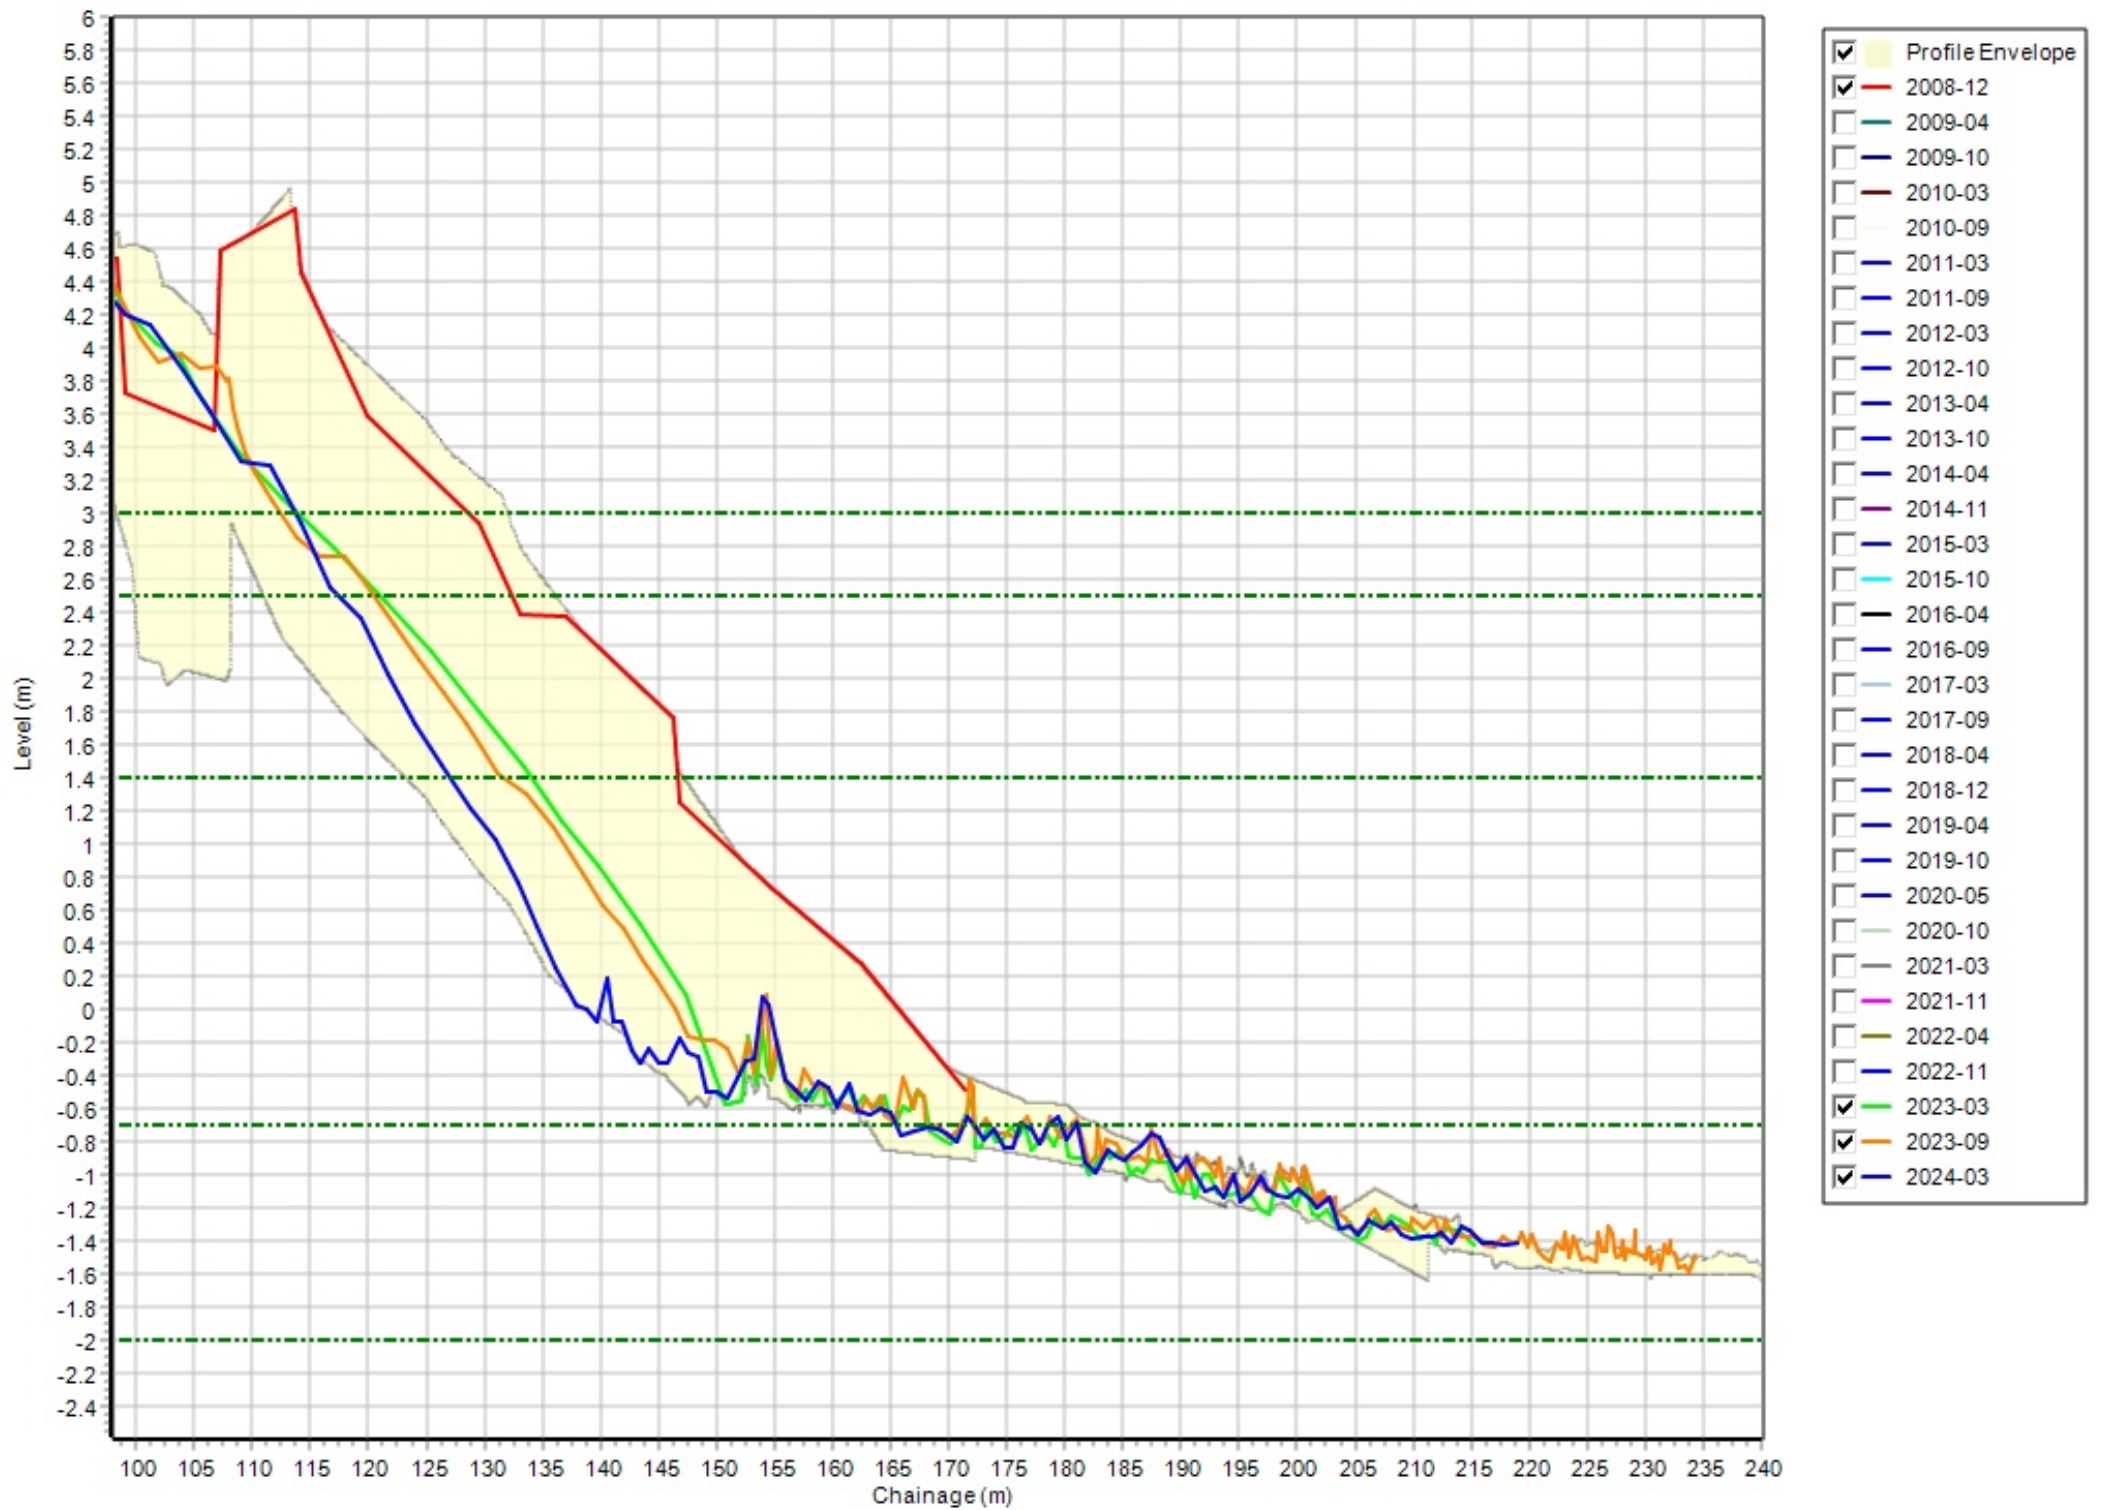
# Profiles: 1cEA2

Survey Date	Description of Changes Since Last Survey	Interpretation
<p><b>15<sup>th</sup> March 2024</b></p>	<p><b>Beach Profiles:</b></p> <p>Hawthorne Hive is covered by one beach profile line <b>1cEA2</b> during the Partial Measures survey (Appendix A). As of October 2012, the profile begins at chainage 92m due to dense vegetation restricting access to the cliff faces. Since the September 2023 survey the beach has generally been dominated by erosion, with the beach lowering by up to 0.8m in level between chainage 92m and 152m. This lowering has exposed a greater length of rocky foreshore which is now observed seawards of chainage 139m. Overall, the beach is at low level when compared to the range of the previous survey.</p>	<p>Since the previous survey in September 2023, beach levels at Hawthorne Hive have dropped. This pattern is observed across much of the North East coastline as a result of the intensity and direction of the storms through winter 2023/24.</p>

- At Hawthorne Hive, the beach profile has been dominated by erosion since the previous survey in September 2023. This is typical a response to the direction, severity and number of storms that occurred through winter 2023/24, a pattern that has been observed along much of the north east coastline.
