Cell 1 Regional Coastal Monitoring Programme Analytical Report 3: 'Full Measures' Survey 2010

Hartlepool Borough Council Final Report

January 2011

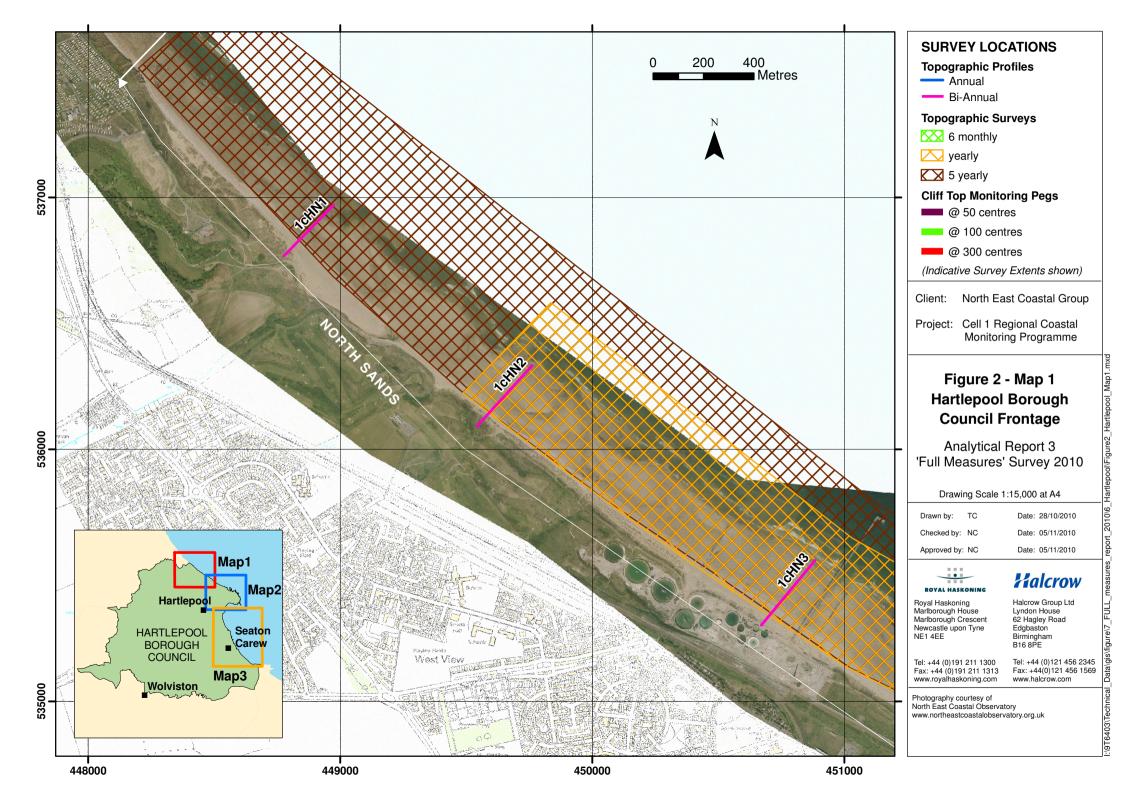
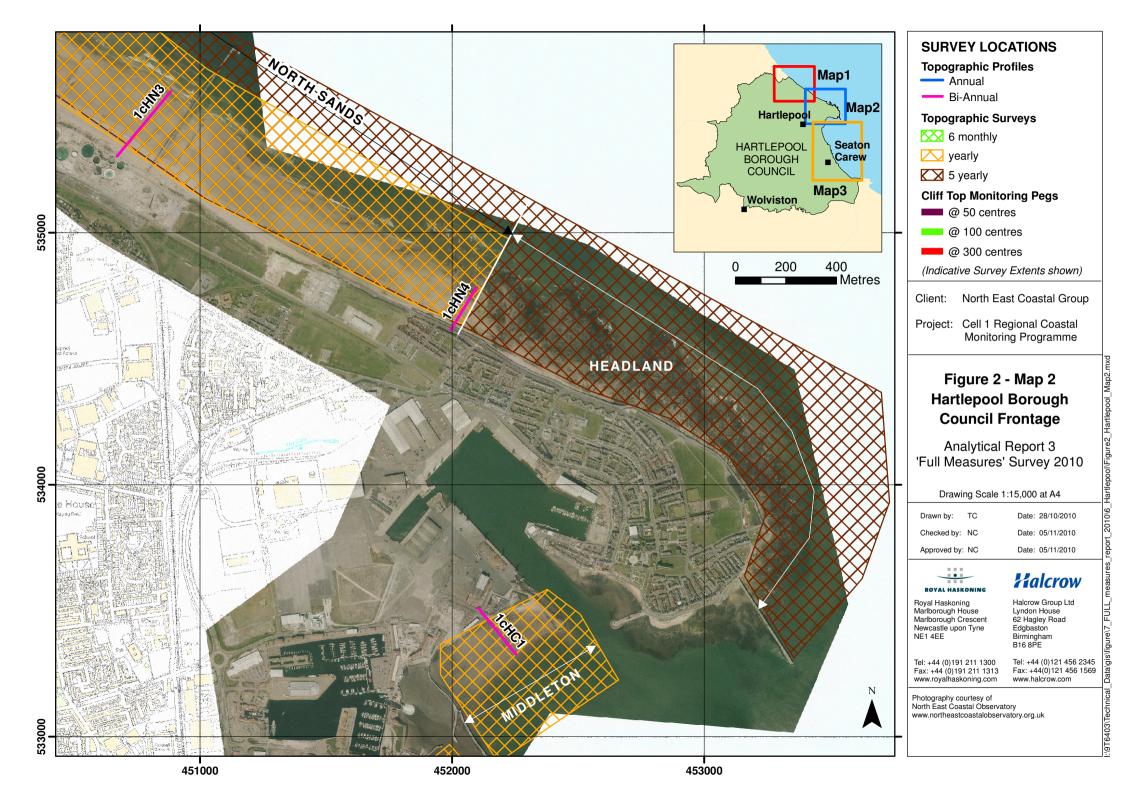
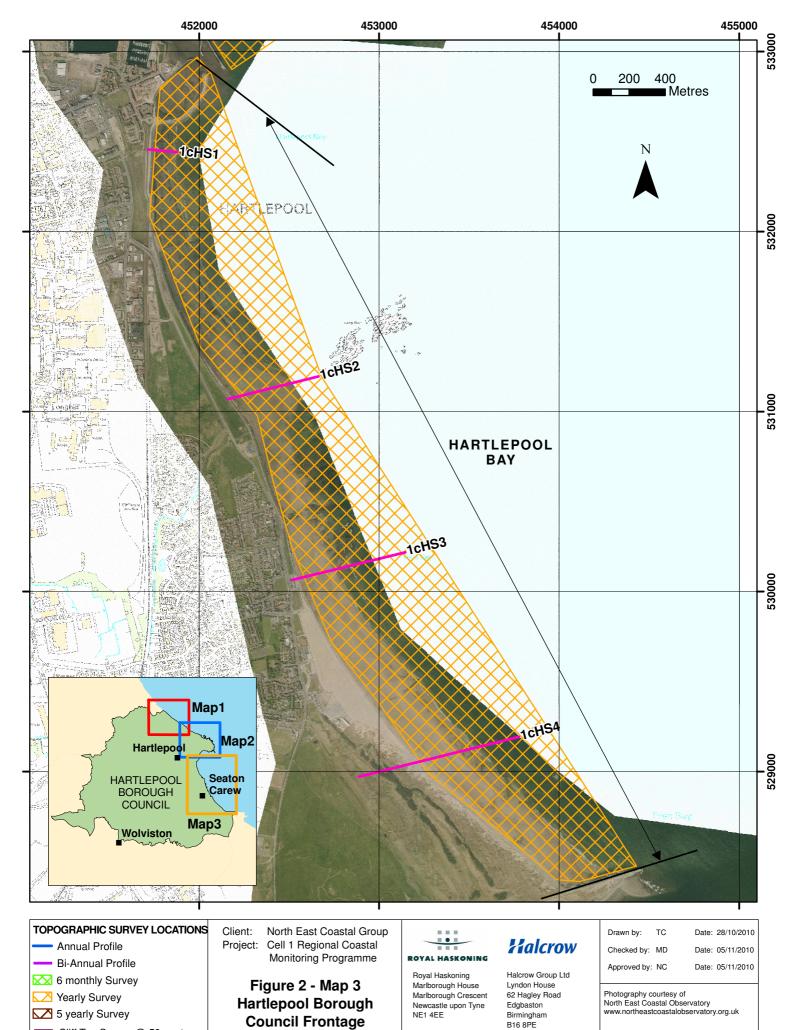
Figure 2 **Survey Locations**

The location of these surveys is shown in Figure 2. They have also previously been provided on a digital file which can be opened in Google Earth showing the locations of the surveys.

Cliff Top Survey @ 50 centres

Cliff Top Survey @ 100 centres

Cliff Top Survey @ 300 centres

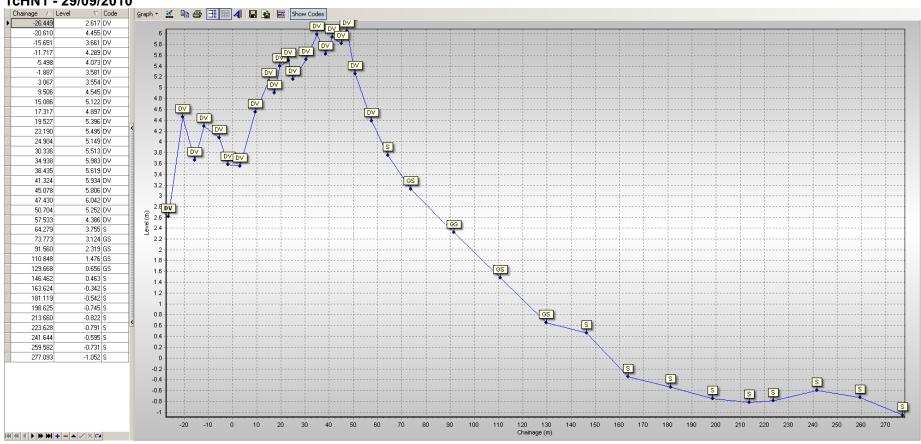
1cHN1 - 29/09/2010

Survey Date	Description of Changes Since Last Survey	Interpretation
09-2010	Beach Profiles: North Sands is covered by four beach profile lines during the Full Measures survey (Appendix A). HN1 is located within Durham County Council's jurisdiction, about 400m north of the outfall of Crimdon Beck, but has been reported here so changes can be interpreted in association with those observed elsewhere along North Sands at HN2, HN3 and HN4. The large berm previously reported in March 2010 at around MSL had been modified, with a general flattening at MSL and movement of most sediment seawards to notably increase levels along the lower profile. A small amount of landward recession, around 4m, occurred at the break of slope between the gravelly sand at the toe of the dunes and the flatter sandy profile, but this was well within the bounds of previously recorded change. There was no measureable change to the main seaward dune crest. The lowering which previously occurred at the toe of the dunes along HN2 between September 2009 and March 2010 showed recovery between March 2010 and September 2010, with upper foreshore levels increasing between the toe of the dunes and a chainage of around 170m, in places by up to 0.8m. Between chainages of around 170m and 250m there was a similar lowering in levels, but seaward of 250m the profile levels again increased, with a berm formed at the seaward extent of the transect. Profile HN3 commences by crossing the slag embankment that protects the former Britmag site. This showed no change in position since the March 2010 survey, but the fronting small dune ridge showed further growth due to sediment deposition since March 2010. Seaward of around MHWS, the entire profile maintained the same form as previously recorded, but suffered a general lowering of around 0.3m.	North Sands has typically been characterised by the redistribution of sediment since monitoring began in November 2008, with typical winter flattening and summer build up of the foreshore. This pattern is apparent in the March 2010 and September 2010 surveys, but complicated by some alongshore changes so that the frontage does not necessarily behave consistently along its length. HN1 has been typically characterised by changes associated with redistribution of sediment previously stored within a large previous berm (March 2010), with berm flattening and movement of sediment seawards to the lower foreshore. HN2 showed an upper foreshore increase in levels, mid beach lowering, and a small berm newly formed at the seaward end. HN3 continues to show stable slag banks, with the small dune at its toe continuing to accrete, with modest lowering of levels along the entire foreshore.

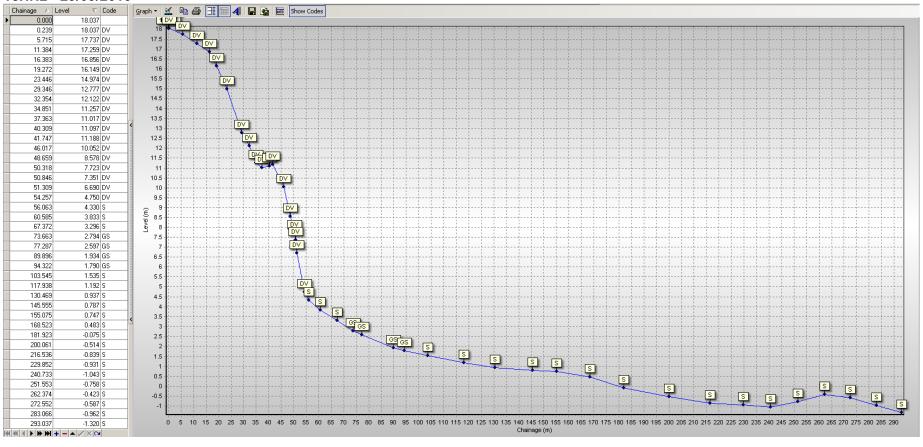
1cHN2 - 29/09/2010

- Whilst profile HN2 still appears to have an over-steepened 'cliff-edge' following the erosion damage during the winter of 2009/10, no slumping was observed between March 2010 and September 2010.

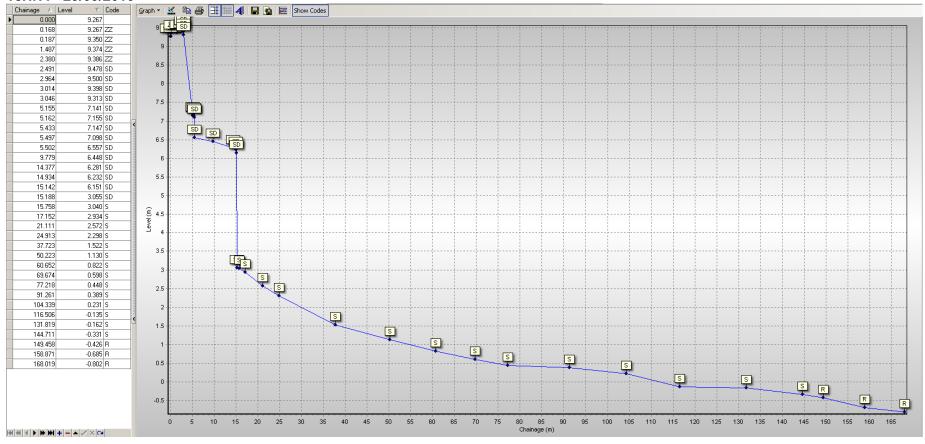
1cHN4 - 29/09/2010

Survey Date	Description of Changes Since Last Survey	Interpretation
09-2010	Along HN4, there was slight further lowering immediately at the toe of the sea wall, but general recovery of previously low foreshore levels seaward of here to a chainage of around 60m. The berm previously recorded in March 2010 at a chainage of around 105m had become flattened and the sediment deposited at the seaward end of the profile, including coverage of the rock outcrops with a sand veneer at the seaward limit of the transect.	HN4 showed an accreting upper foreshore, with redistribution of material from the previously recorded berm to form a sand veneer across the rock outcrops at the seaward end of the transect. Along profiles HN1 and HN2, the dunes remained stable and along HN3 the slag embankment remained stable. For HN2 this is particularly relevant because the Update Report 2 (May 2010) identified an oversteepened 'cliff-edge' to the dunes which could lead to future slumps. These have not, to date, occurred.

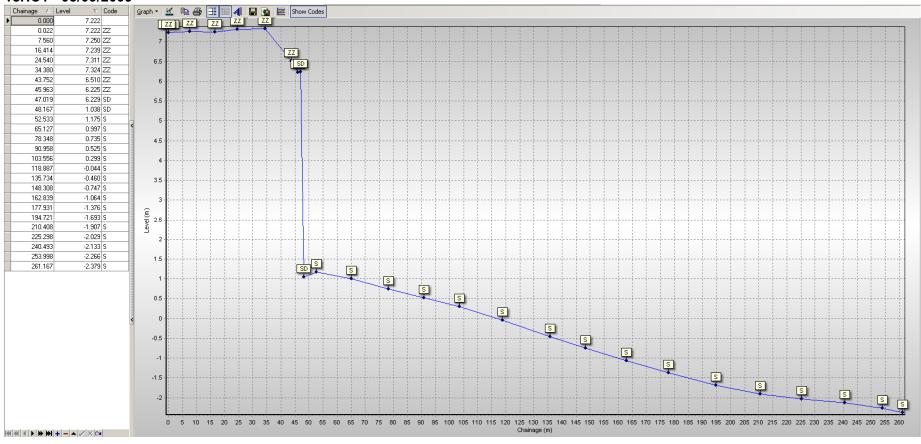
1cHC1 - 08/09/2009

Survey Date	Description of Changes Since Last Survey	Interpretation	
	Beach Profiles: Middleton is covered by one beach profile line during the Full Measures survey (Appendix A). Profile HC1 experienced significant lowering at the toe of the vertical wall between September 2009 and March 2010 and this process continued (but only directly at the toe of the wall) to September 2010, with levels at the toe now at a low level of 1.04mODN. In September 2009, the beach level at the toe was some 1.9m higher than at present. Seaward of the toe of the wall, however, the profile experienced accretion to a chainage of around 135m, with levels increasing by up to 0.3m in places.	Whilst the changes along most of the transect are within the bounds of previously recorded changed, the levels directly at the toe of the wall are particularly low, being 1.9m lower than those recorded in September 2009. This should be monitored for signs of recovery or further lowering, the latter potentially leading to wall undermining.

- Foreshore levels directly at the toe of the vertical wall in Middleton are now some 1.9m lower than those recorded in September 2009, although parts of the foreshore did increase in level by up to 0.3m through accretion.

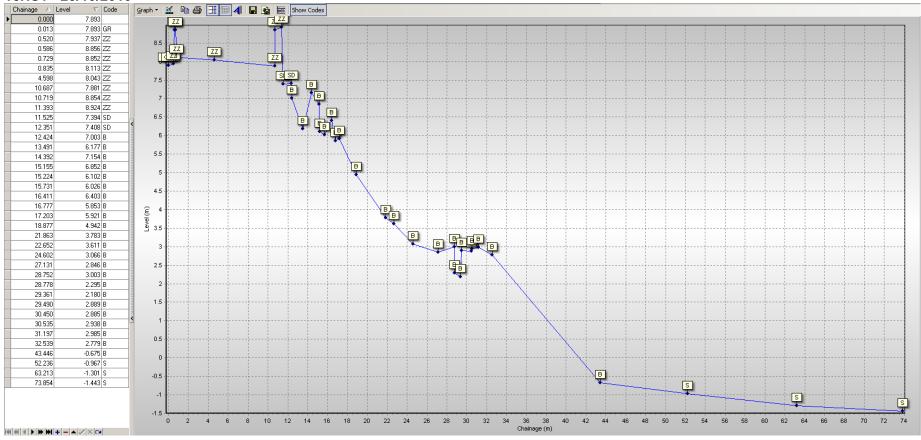
1cHS1 - 23/10/2010

Survey Date	Description of Changes Since Last Survey	Interpretation
10-2010	Beach Profiles: Hartlepool Bay is covered by four beach profile lines during the Full Measures survey (Appendix A). HS1 is located approximately 150m south of the root of the South Pier. The profile starts at the wall to the rear of the promenade and extends across the promenade, over the fronting concrete splash wall and down the sloping face of the rock armour revetment before reaching the beach. It then gently slopes down to low water. The profile experienced lowering by around 0.25m along its entire length, maintaining the same form. Similarly, profile HS2 experienced lowering along most of its length, maintaining the same form. Typically levels were around 0.1m lower than those recorded in March 2010. In contrast, profile HS3 experienced general accretion along its length. This was modest along the upper beach (to a chainage of around 125m) with generally slight depressions being infilled, but further seaward levels increased by up to 0.2m along the remainder of the transect. HS4 is located further south, around 1km north of the North Gare breakwater. It is in the area of undefended dunes at Seaton Sands. The profile covers approximately 350m of dunes before reaching beach level. There has been some very slight accretion on the seaward face of the dunes at around MHWS and above, with some modest foreshore lowering, by up to around 0.2m, around 50m either side of the MWL mark.	The foreshore lowering along the entire lengths of HS1 and HS2, as well as a short section of HS4, is very modest and well within the bounds of previously recorded behaviour. Interestingly, HS3 experienced general accretion, again on a modest scale, but this is the reverse of the trend observed further north (along HS1 and HS2) and further south (HS4).

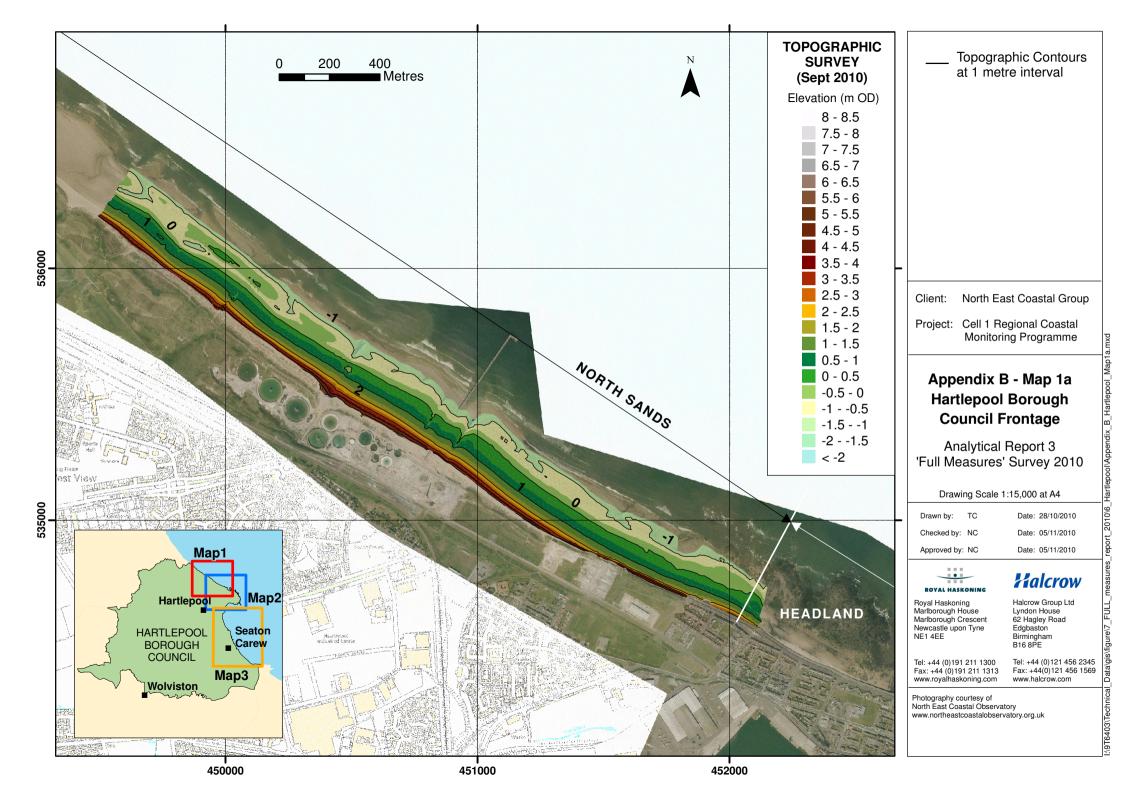
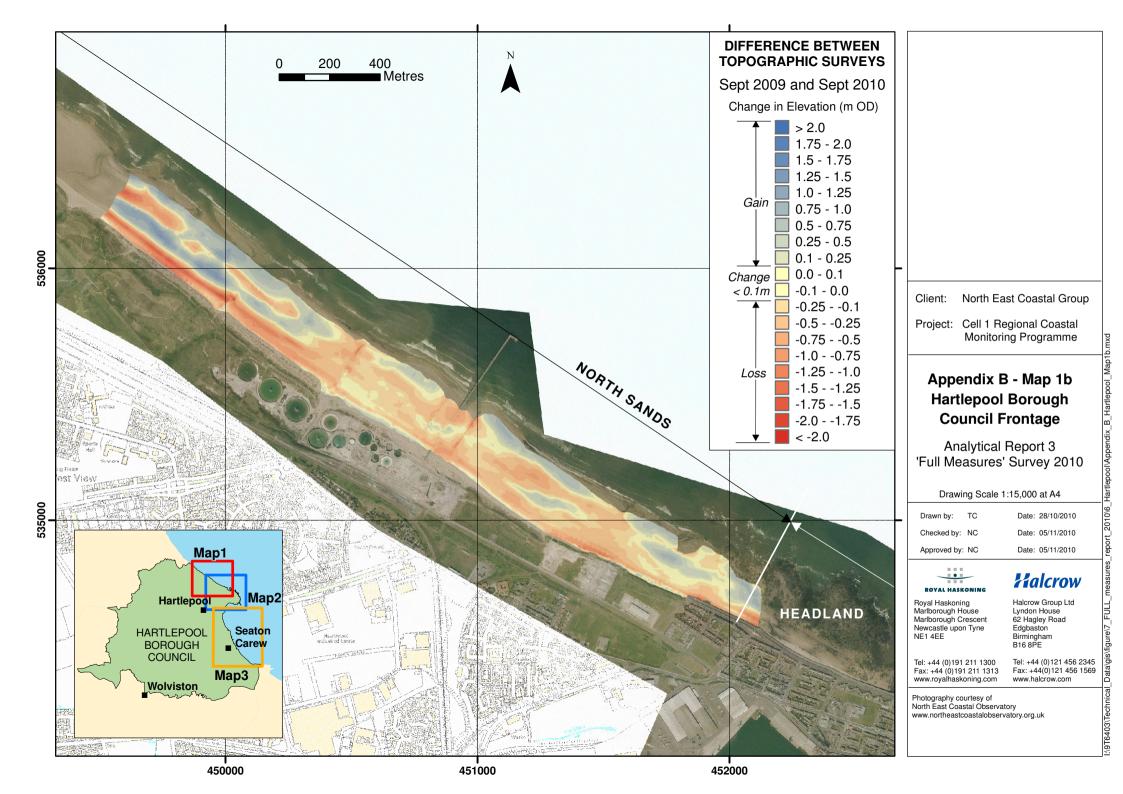
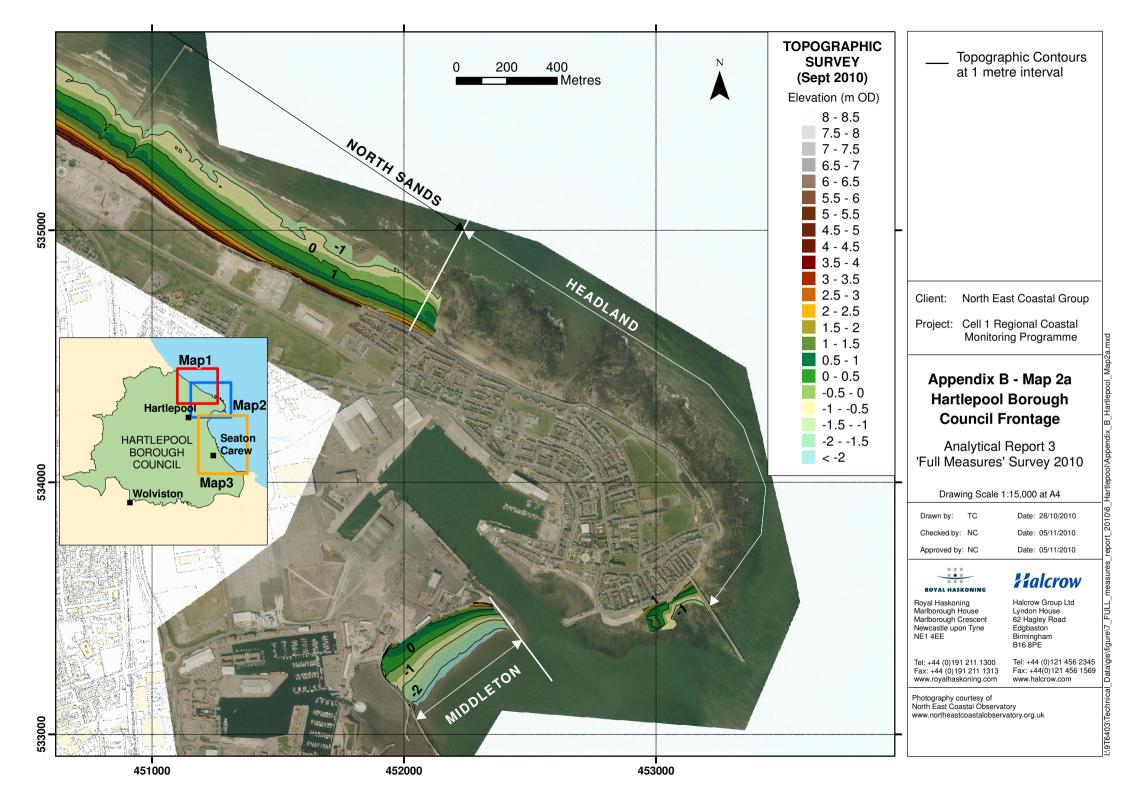
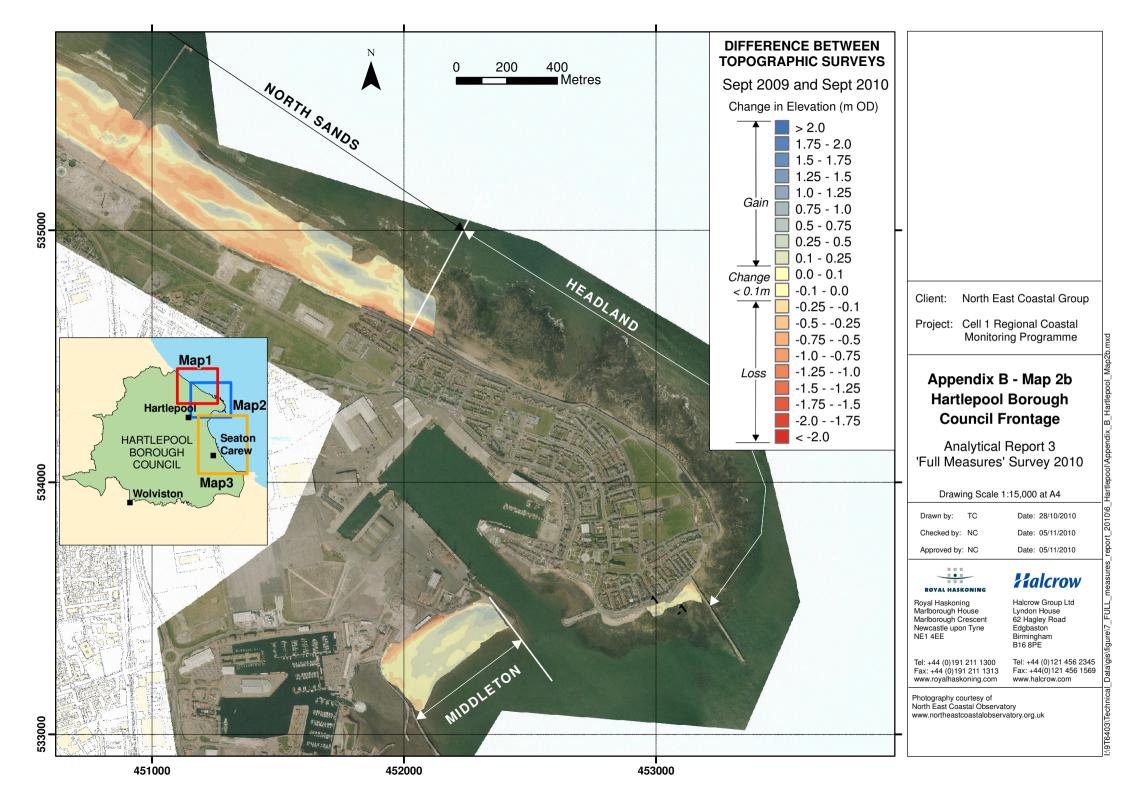
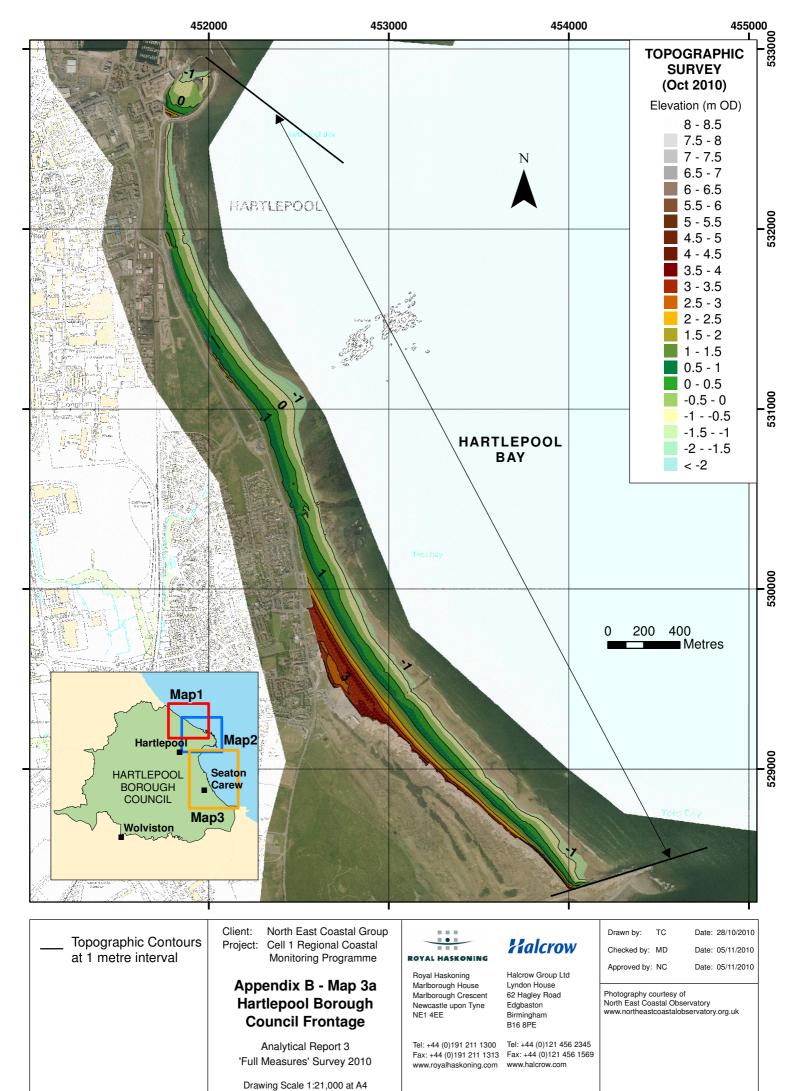
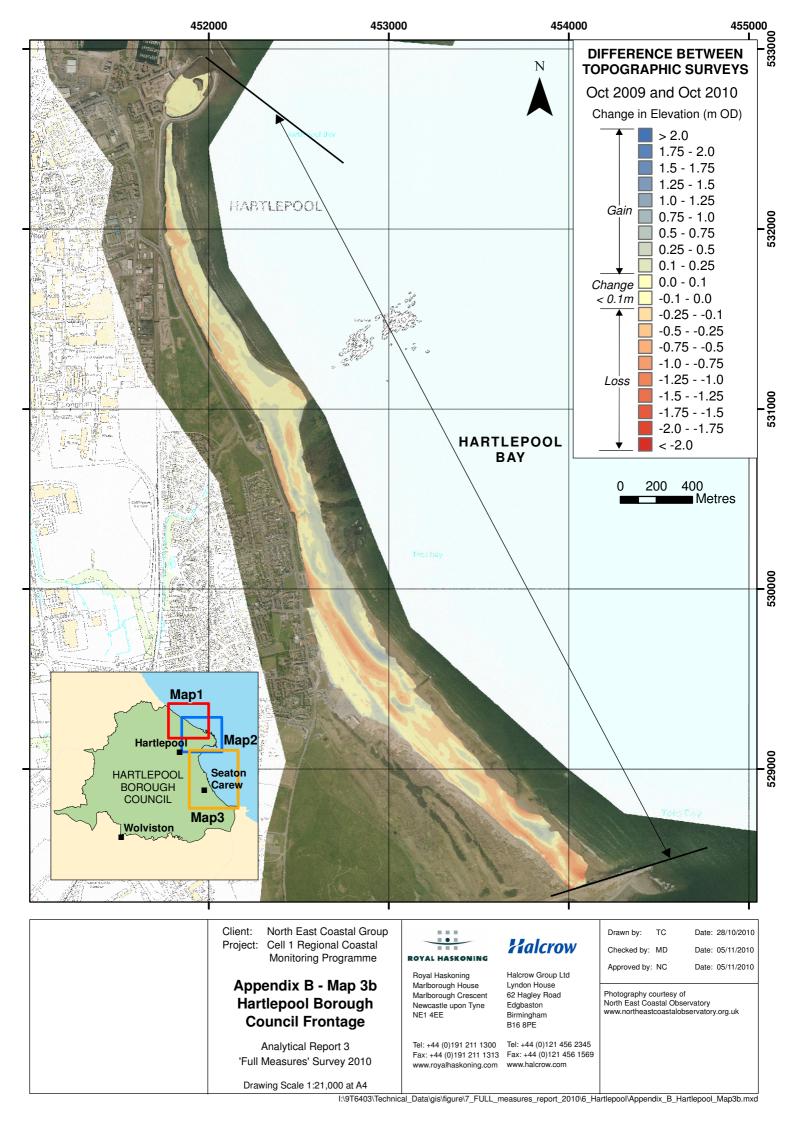
Appendix B Topographic Survey

09-2010	Topographic Survey: North Sands is covered by an annual topographic survey. [Note: Every five years, starting from the 2008 baseline survey, coverage is extended further north along North Sands and further south around Hartlepool Headland, but this was not scheduled for the present survey.] Data from the 2009 Full Measures survey have been used to create a DGM (Appendix B – Map 1a) using a Geographic Information System (GIS) computer software package. This shows that the mid and upper beach contours recorded in September 2010 were relatively consistent across the frontage, with the highest upper beach zones reducing slightly in width to the south where the sea wall begins. The lower beach was, however, much more typified by berms along discrete lengths. The GIS has also been used to calculate the differences between the current topographic survey and the earlier (November 2008) topographic survey, as shown in Appendix B – Map 1b, to identify areas of erosion and accretion. Since the previous topographic survey in September 2009, North Sands has suffered notable lowering of the upper beach along its entire length, with the central zone experiencing erosion across its whole inter-tidal width. The northern zone suffered the greatest lowering of the upper foreshore, but material was deposited further down the profile on the mid and lower beach causing modest accretion, although a mid beach berm previously recorded in September 2009 became flattened.	Whilst the 6-monthly beach profile transects show typical seasonal behaviour of North Sands, the annual topographic survey is intended to identify longer terms trends of net erosion or accretion. At present the surveys are too short to determine any significant longer term trends, but the changes between September 2009 and September 2010 are showing that the changes identified by the beach profiles are generally typical of the entire frontage, with berm formation/flattening and redistribution of sediment from upper to lower foreshore areas in many sections. The lowering across the entire foreshore width in the central section of the frontage does suggest that since September 2009 there may have been a net loss of sediment from the frontage, rather than purely redistribution, but future datasets will aid in this understanding.

09-2010	Topographic Survey: Middleton is covered by an annual topographic survey between Middleton Jetty and North Pier. Data from the 2009 Full Measures survey have been used to create a DGM (Appendix B – Map 2a) using a Geographic Information System (GIS) computer software package. This shows that the beach contours recorded in September 2010 were relatively consistent across the frontage, with a slight accumulation of material directly adjacent to the breakwater arm of Hartlepool harbour.	Whilst the 6-monthly beach profile survey shows typical seasonal behaviour of Middleton, the annual topographic survey is intended to identify longer terms trends of net erosion or accretion. Whilst there has been some redistribution of sediment between September 2009 and September 2010, this is of a fairly modest scale and does not indicate a net trend. Continued monitoring of this frontage will help build up a longer term understanding of such changes.

The GIS has also been used to calculate the differences between the current topographic survey and the earlier (November 2008) topographic survey, as shown in Appendix B – Map 2b, to identify areas of erosion and accretion. Since the previous topographic survey in September 2009, Middleton has experienced some lowering of the upper beach, especially along the section backed by the vertical wall in central and southern sections of the frontage. This has been confined to a relatively narrow band along the upper beach, with modest accretion typically experienced across the mid and lower foreshores.

Topographic Survey: Hartlepool Bay is covered by an annual topographic survey between the South Pier and the North Gare Breakwater. Data from the 2009 Full Measures survey have been used to create a DGM (Appendix B – Map 3a) using a Geographic Information System (GIS) computer software package.	The survey shows relatively uniform contours along the frontage, with higher beach levels towards the North Gare Breakwater and in the Seaton Carew dunes. The shoreline is 'pulled' seawards directly in the lee of Long Scar.

Survey Date	Description of Changes Since Last Survey	Interpretation	
	The GIS has also been used to calculate the differences between the current topographic survey and the earlier (September 2009) topographic survey, as shown in Appendix B – Map 3b, to identify areas of erosion and accretion. Generally, the foreshore experienced relatively modest changes, with some degree of upper foreshore lowering and lower foreshore accretion along many sections. The redistribution of sediment became more widespread towards the southern end of the frontage.	Changes observed along Hartlepool Bay are very modest and well within bounds of previously observed behaviour.
