# **Cell 1 Regional Coastal Monitoring Programme Analytical Report 9: 'Full Measures' Survey 2016**

Hartlepool Borough Council

March 2017

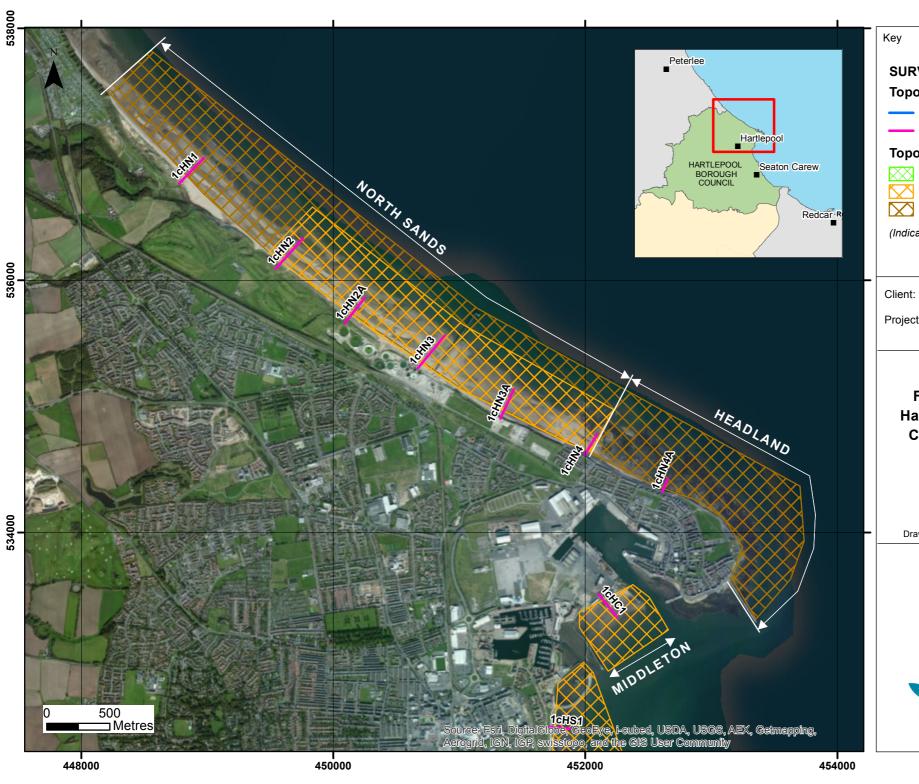
# Figure 2 - Map 1 Hartlepool Borough Council Frontage

The location of these surveys is shown in Figure 2. The 2016 Full Measures survey was undertaken along this frontage on various dates between 24<sup>th</sup> August and 6th September. During this time, the weather was generally dry and sunny with force 2 to 4 breezes from the south-west. The sea state at all sites was either calm or moderate. The survey reports from Academy Geomatics document details of the weather conditions over this survey period.

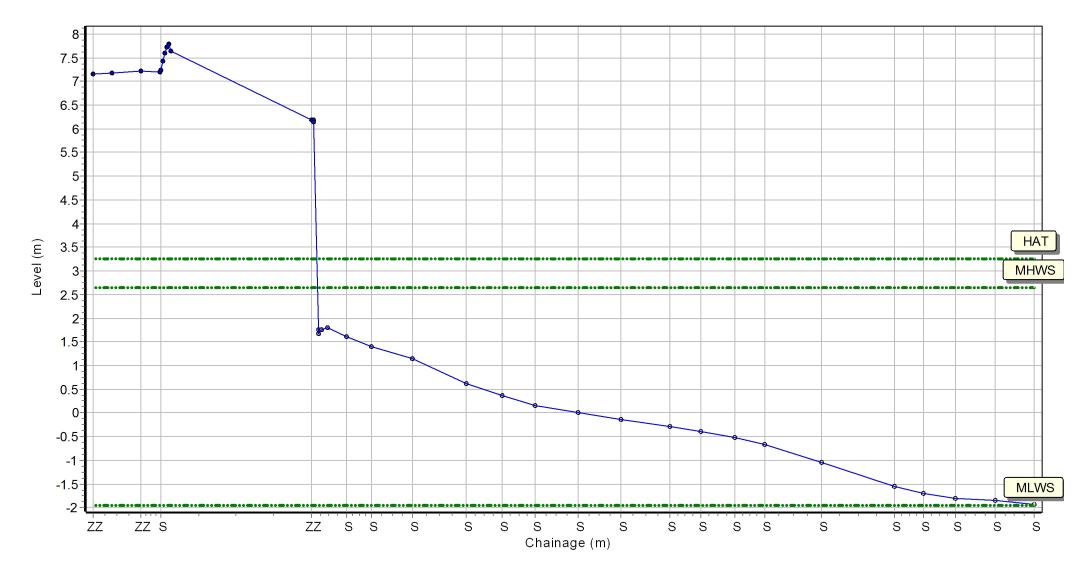
Location: 1cHC1

Survey Date	Description of Changes Since Last Survey	Interpretation
	Beach Profiles:  Middleton is covered by one beach profile line during the Full Measures survey (Appendix A). The beach at Profile 1cHC1 between the seawall at 50m chainage and 150m chainage shows accretion of up to 0.2m. Seawards of 150m there has been erosion of 0.3m. Overall the beach is at a medium level compared to the range from previous surveys.	The beach profile showed a gain in the upper beach and a loss in the lower beach and steepening overall. The difference plot for Middleton shows a zone of erosion across the mid beach. In front of the headland the difference plots show a patchy distribution of change due to the thin but mobile cover of sand here.
	Topographic Survey:	Longer term trends:
24 <sup>th</sup> August 2016	The frontage is covered by an annual topographic survey between Middleton Jetty and North Pier. Data from the 2016 Full Measures survey have been used to create a DGM (Appendix B – Map 1) using GIS software. Beach contours indicate a steeper beach in the east than the west, with the contours locally affected by pipelines and groynes. In the Autumn 2013 survey, differences between the eastern and western ends of the beach were less marked. Earlier years show a similar topography to 2014 and 2015.	The beach is in the mid-range of the previously recorded levels but is relatively steep. The fact that the profile was recorded in the end of August means that the beginning of the autumn storms would not have had an effect of lowering this beach.

At Middleton there was no access to the upper section of profile 1cHC1.

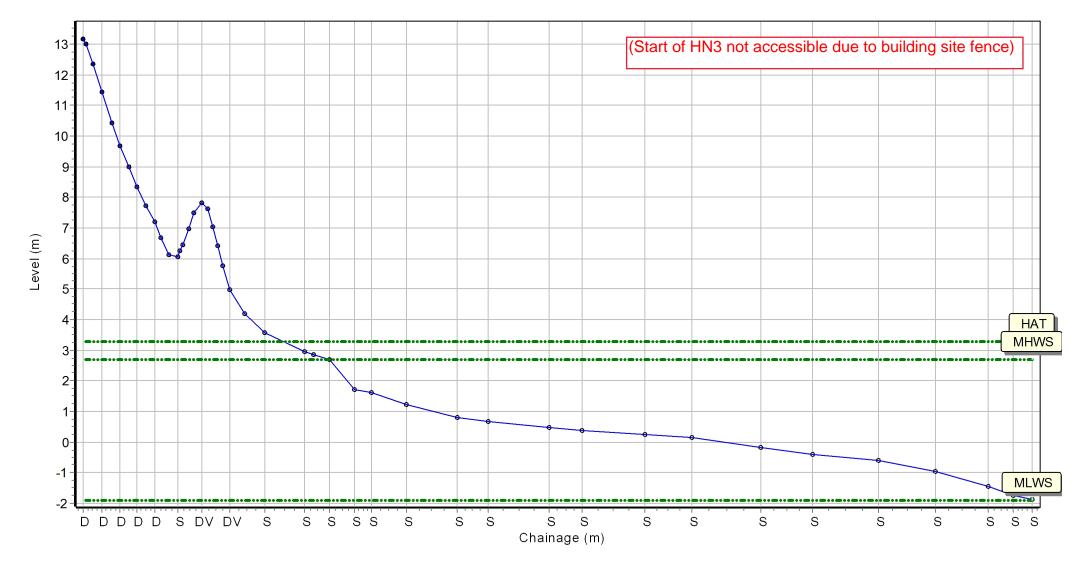
Location: 1cHN3

At Hartlepool North the start of section 1cHN3 was behind a site fence. A new revetment was also being built at the eastern end of the site to create a new sea defence.

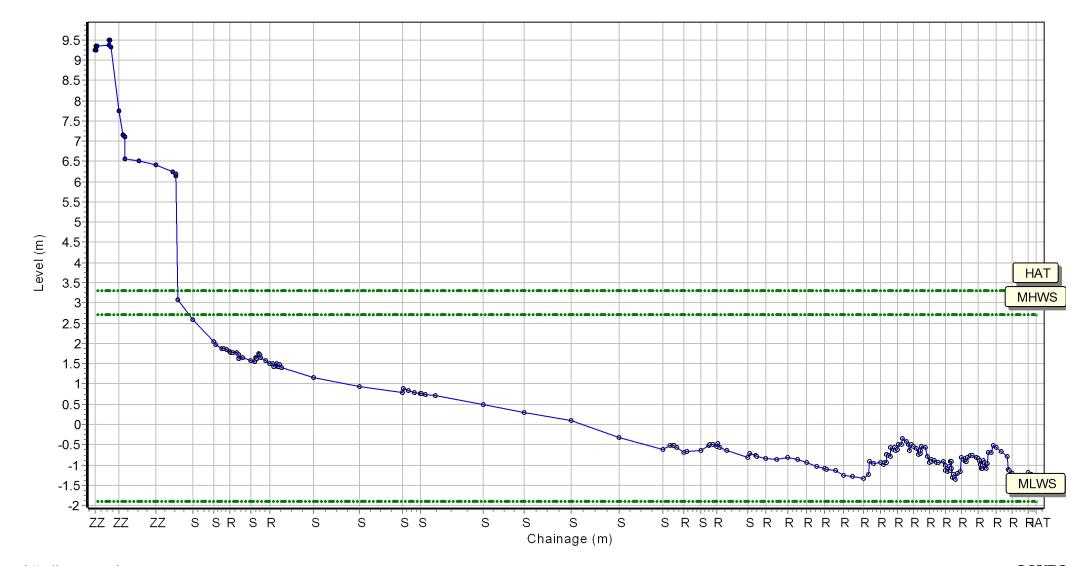
Location: 1cHN4

At Profile <b>1cHN4</b> there has been an accumulation of up to 0.8m high at the toe of the rock protrusion at chainage 15m. The sand mound between chainage 40m and 65m recorded since April 2015 has been removed with erosion of up to 0.3m. Between chainage 65m and 105m there has been an accumulation of sand across the previously exposed rock platform of up to 0.4m. From 105m to the end of the survey the rocks on the bottom of the beach are exposed, which is usual for this profile. Overall the profile is towards the low end of the range recorded from previous surveys.	
	At Profile <b>1cHN4a</b> there has been a large accumulation of sand of up to 0.7m across the upper beach between chainage 10m and 45m covering the previously exposed rock platform. Seawards of 45m chainage the rock platform is exposed and shows little change to previous surveys, with the exception of a small accumulation of sand between 55m and 70m chainage Overall the profile is at a medium-low level compared to the previous recorded surveys.

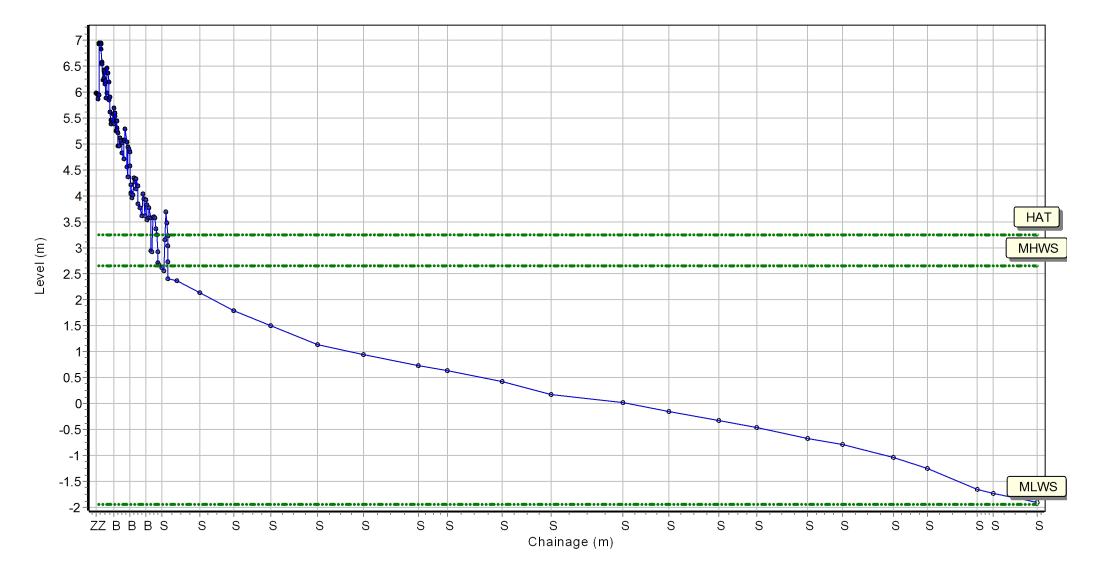
Location: 1cHS2

5 <sup>th</sup> – 6 <sup>th</sup> September 2016	There has been accretion of up to 0.5m along all but the most seaward end of Profile <b>1cHS2</b> , burying the berms which had developed in the April 2016 survey. Seaward of chainage 250m the beach has lowered by up to 0.4m. The overall effect has been to steepen the beach. The September 2016 profile is the highest recorded through the upper and middle beach and there has been progressive accretion.	stability over 2016. The accretion of the northern three profiles continues. On the southern profile, HS4, the beach had steepened which could be a precursor to erosion. The foredune continues to develop although footfall may be damaging it and leading to erosion.
	At profile <b>1cHS3</b> there has been accretion of up to 0.4m on the upper beach between chainage 30m and 75m. Between chainage 75m and 110m there has been some slight lowering to the beach of less than 0.2m. Between 110m and 200m a berm has formed up to 0.4m high. Whilst the lower foreshore seaward of 200m has eroded by up to 0.5m, steepening the toe of the beach dramatically, similar to the beach toe in the March 2014 survey. Up to chainage 190m the beach profile is one of the highest recorded.

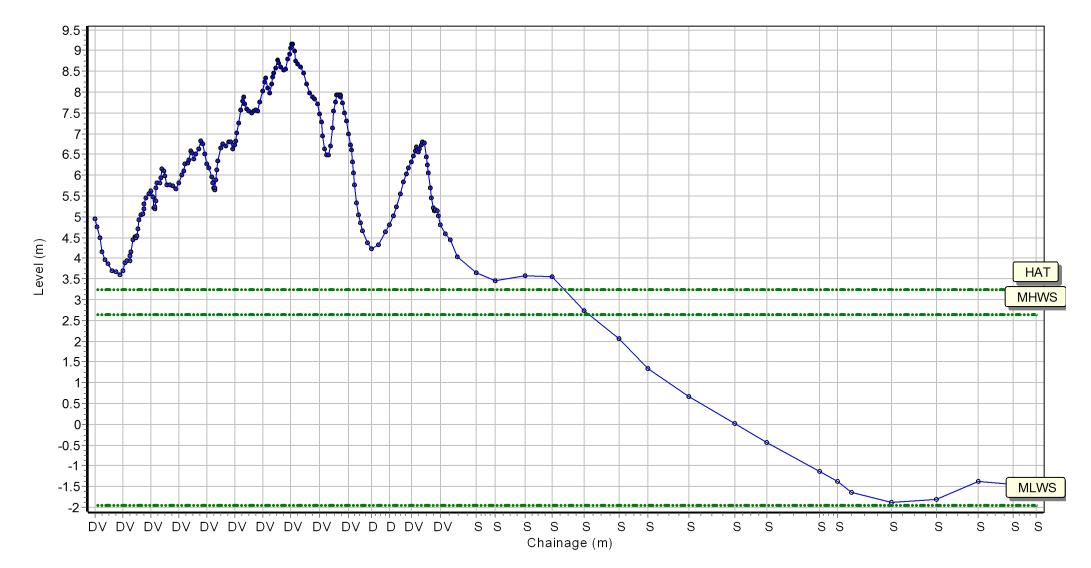
Location: 1cHS4

The profile <b>1cHS4</b> is located further south, around 1km north of the North Gare breakwater in an area of undefended dunes at Seaton Sands. The profile covers approximately 325m of dunes before the beach. The dune section is stable, with a foredune continuing to accrete at around 320m chainage with 0.3m of growth since April 2016. The deepening of the depression between the main dune and the foredune has halted since April 2016, showing 0.1m of accretion. The berm developed in the April

Survey Date	Description of Changes Since Last Survey	Interpretation
	2016 survey at chainage 370m has grown by 0.3m, with the rest of the upper beach increasing by up to 0.6m down to chainage 470m. From chainage 470m the beach level has dropped significantly by up to 1m forming a depression 90m across. The profile is mid-high in the range of previous surveys across the upper beach, but from chainage 470m it is the lowest on record.	
	Topographic Survey:	
	Hartlepool Bay is covered by an annual topographic survey between the South Pier and the North Gare Breakwater. Data from the 2016 Full Measures survey have been used to create a DGM (Appendix B – Map 2) using a GIS software package. The plot shows the two smaller bays within the larger Hartlepool Bay frontage. These smaller bays are separated by a slight promontory at Carr House Sands between Hartlepool and Seaton Carew. The beach contours are generally shore parallel, except where linear features (e.g. outfalls) and rock outcrops are present, such as in the northern part of Seaton Sands. Elevations at the rear of the beach are lowest in the north of the survey area near South Pier and higher further south.
