**Cell 1 Regional Coastal Monitoring Programme
Analytical Report 11: 'Full Measures' Survey 2018**

(*) The present report is **Analytical Report 11** and provides an analysis of the 2018 Full Measures survey for Hartlepool Borough Council's frontage.

Hartlepool Borough Council's frontage extends from Crimdon Beck in the north, to the North Gare Breakwater in the south. For the purposes of this report, it has been sub-divided into four areas, namely:

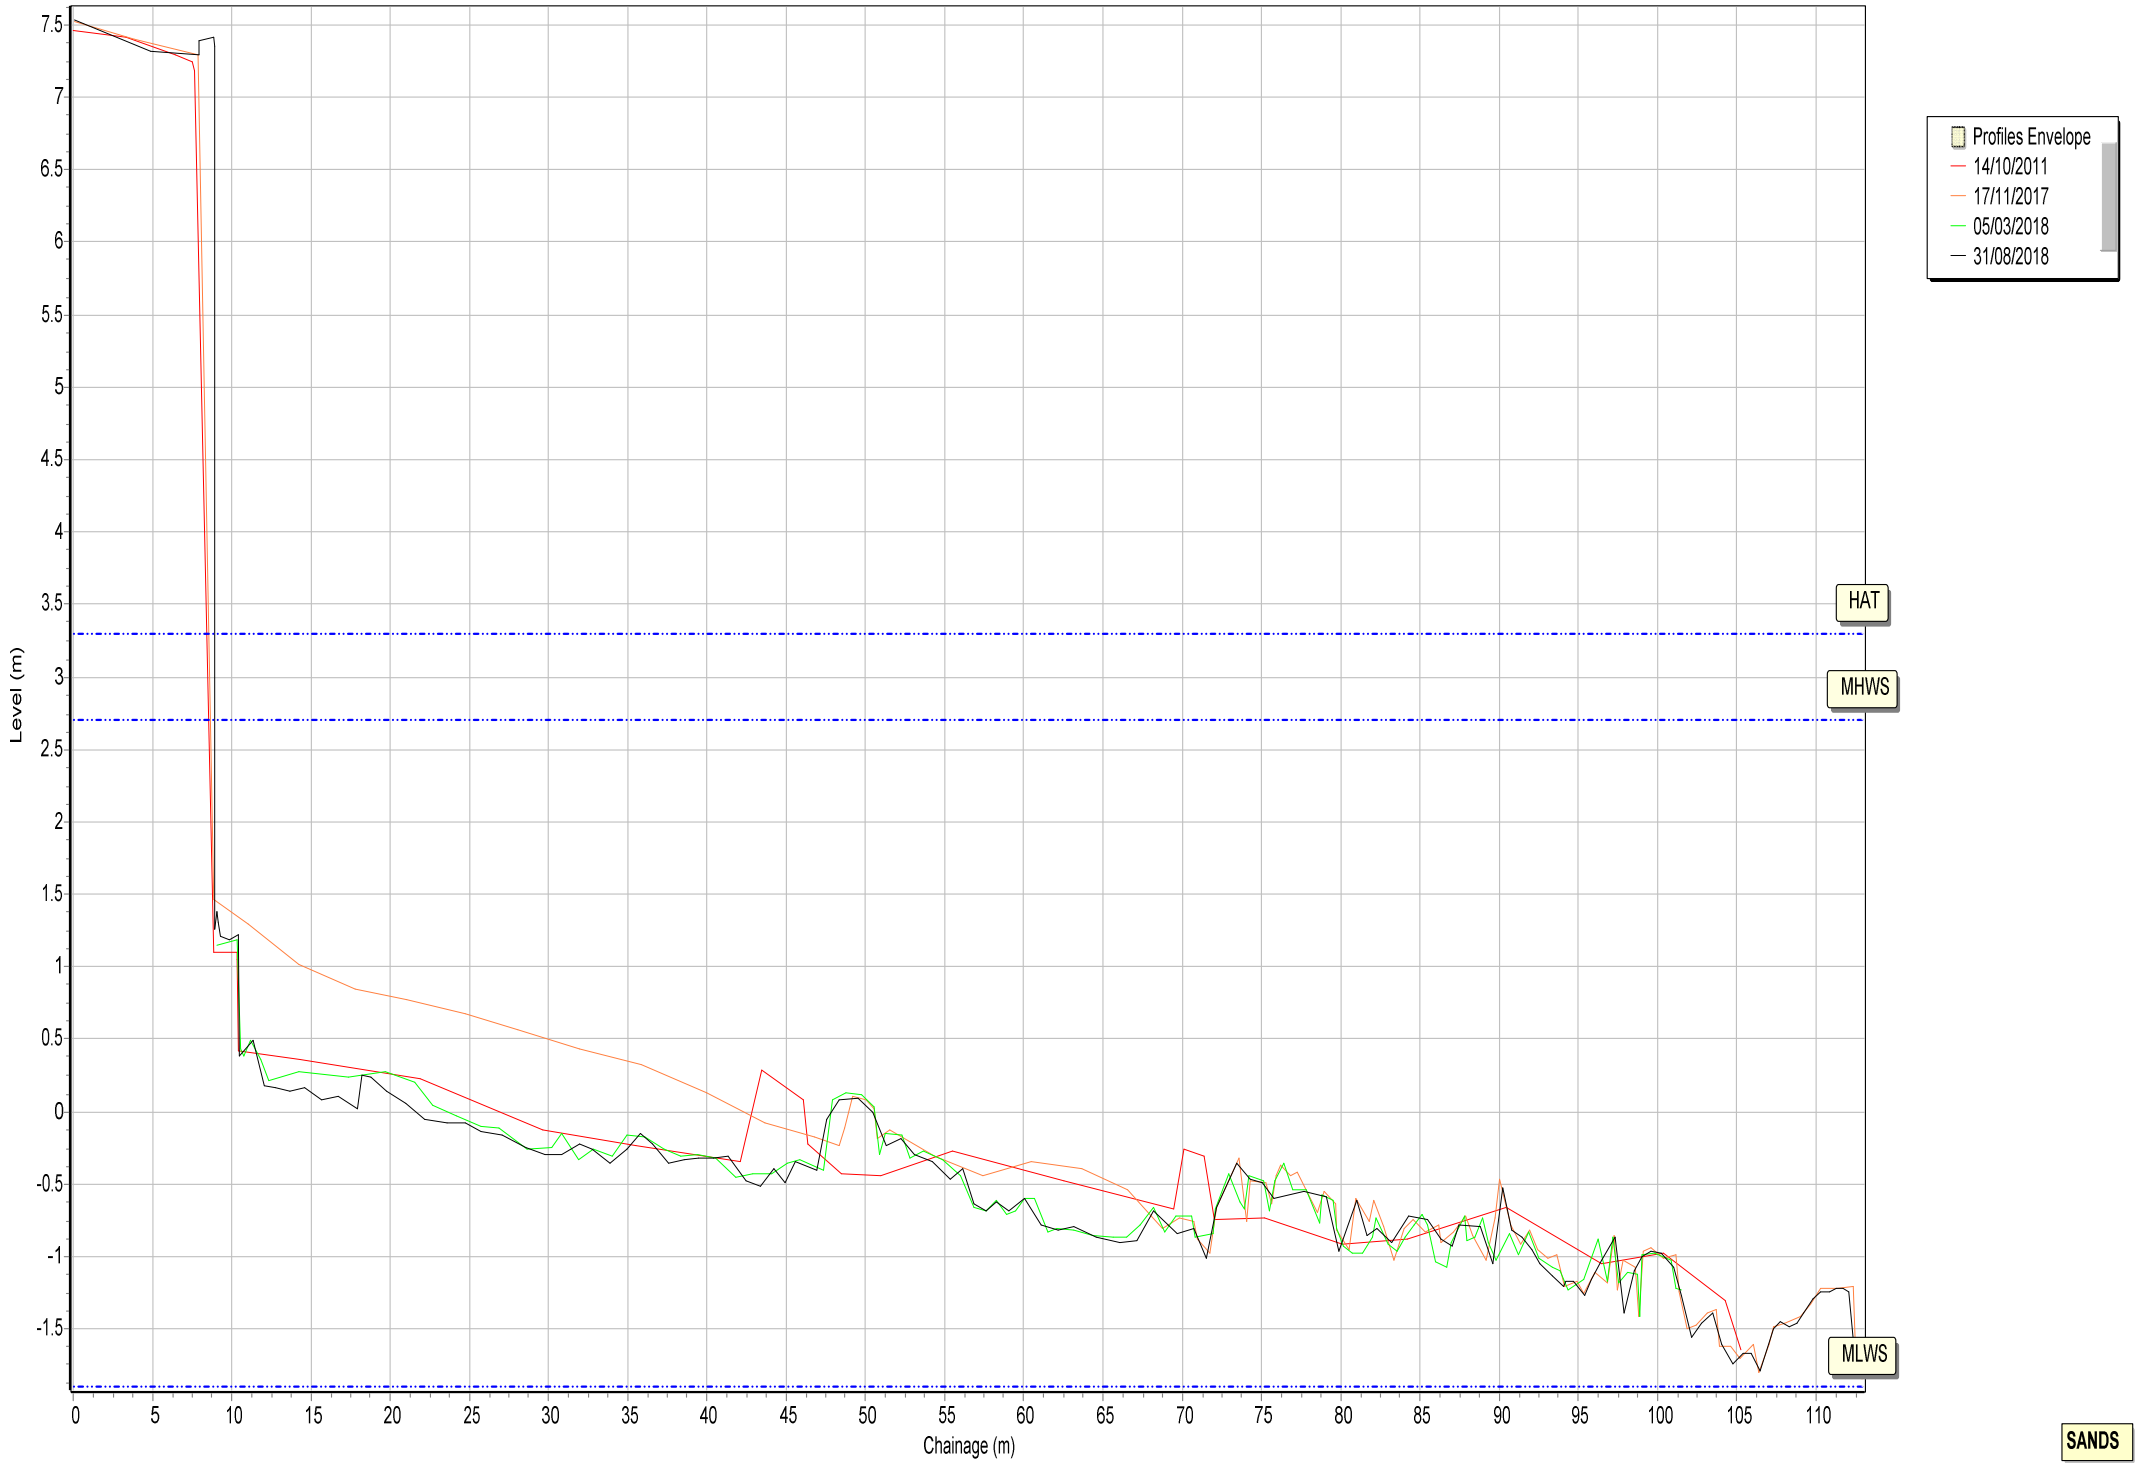
Beach Profiles: 1cHN4A

At Hartlepool North, work was still ongoing between profiles 1aHN4 and 1aHN4A. Section 1HN4A has been completed, with the establishment of a new capstone, resulting in a seaward movement of the sea wall by approximately 1.2m.
