# Cell 1 Regional Coastal Monitoring Programme Analytical Report 12: 'Full Measures' Survey 2019

Hartlepool Borough Council

October 2019

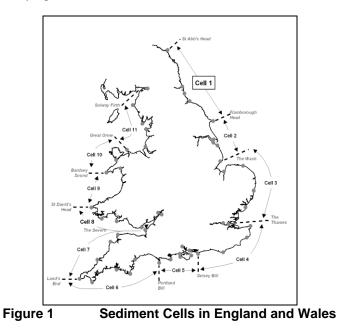
The Cell 1 Regional Coastal Monitoring Programme covers approximately 300km of the north east coastline, from the Scottish Border (just south of St. Abb's Head) to Flamborough Head in East Yorkshire. This coastline is often referred to as 'Coastal Sediment Cell 1' in England and Wales (Figure 1). Within this frontage the coastal landforms vary considerably, comprising low-lying tidal flats with fringing salt marshes, hard rock cliffs that are mantled with glacial sediment to varying thicknesses, softer rock cliffs and extensive landslide complexes.

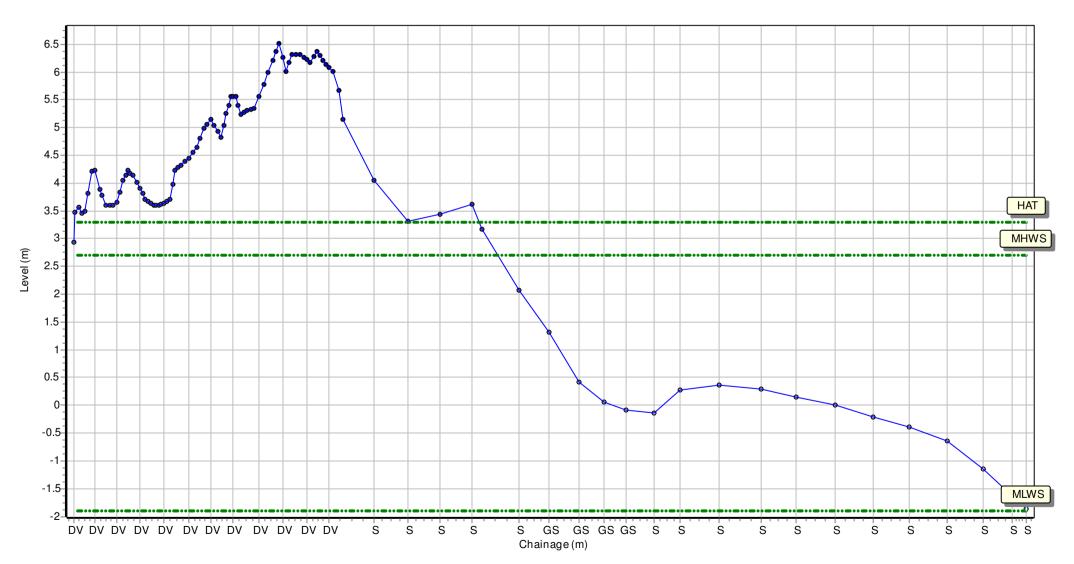
#### Location: 1cHN1

Easting: 448779.624 Northing: 536767.42 Profile Bearing: 44 ° from North

Survey Date	Description of Changes Since Last Survey	Interpretation
16 <sup>th</sup> -17 <sup>th</sup> Sep 2019	<ul> <li>Beach Profiles:</li> <li>North Sands is covered by four beach profile lines during the Full Measures survey (Appendix A). They were last surveyed in February 2019.</li> <li>Profile 1cHN1 is located within Durham County Council's area of responsibility, about 400m north of the outfall of Crimdon Beck, but is reported here so changes can be interpreted in association with those observed elsewhere along North Sands at HN2, HN3 and HN4.</li> <li>The beginning of profile 1cHN1 between 0m and 70m change covers dunes and has small sections of accretion of up to 0.1m, whilst the seaward face of the dunes has prograded by up to 2.0m. A berm has formed at chainage 94m, with an accretion of up to 1.1m. The middle beach has eroded by 0.8m between chainages 119m and 162m. The berm present during the last survey has moved landward by 50m, whilst the beach toe has moved landward by 20m. The profile is generally at a high level across the dunes and upper beach compared to previous surveys, particularly the upper beach berm which is at its highest level recorded. The middle and lower beach is at a medium level compared to previous surveys.</li> <li>At Profile 1cHN2, the profile has not changed on the section with dunes. There has been accretion from the toe of the dunes to chainage 97m of up to 0.7m, forming a small berm at chainage 71m. Between</li> </ul>	The dunes at North Sands have remained stable since the previous survey, whilst beach levels have predominantly accreted on the upper beach and lower beach, and eroded across the middle beach, except towards the east of the survey area where there is relatively no change across the rock platform. Beach levels are at a medium to low level overall, however the upper beach berm at Profile 1cHN1 is at its highest level recorded. Longer term trends: The 2019 full measures survey is generally in line with the longer term trends which suggest accretion in the west and stability in the middle and east of the survey area.

<ul> <li>chainage 97m and 135m, there has been erosion of 0.35m. Seaward of 135m chainage, there has been an accretion of up to 1.0m, extending the toe of the beach seaward by 80m. Overall the profile is at a medium level compared with previously recorded surveys.</li> <li>Profile <b>1cHN2A</b> was established in October 2011 and runs through the dunes close to North Sands. The foredune which had started to re-accrete in the September 2015 has continued to accrete marginally. The toe of the dunes has accreted by up to 0.6m, forming a small berm at chainage 86m.There is small section of erosion between chainages 86m and 123m by 0.4m. Seaward of chainage 123m there has been an accretion of up to 0.5m, with an extension of the beach toe by up to 33m. Overall, the profile shows low levels compared with previously recorded surveys.</li> </ul>

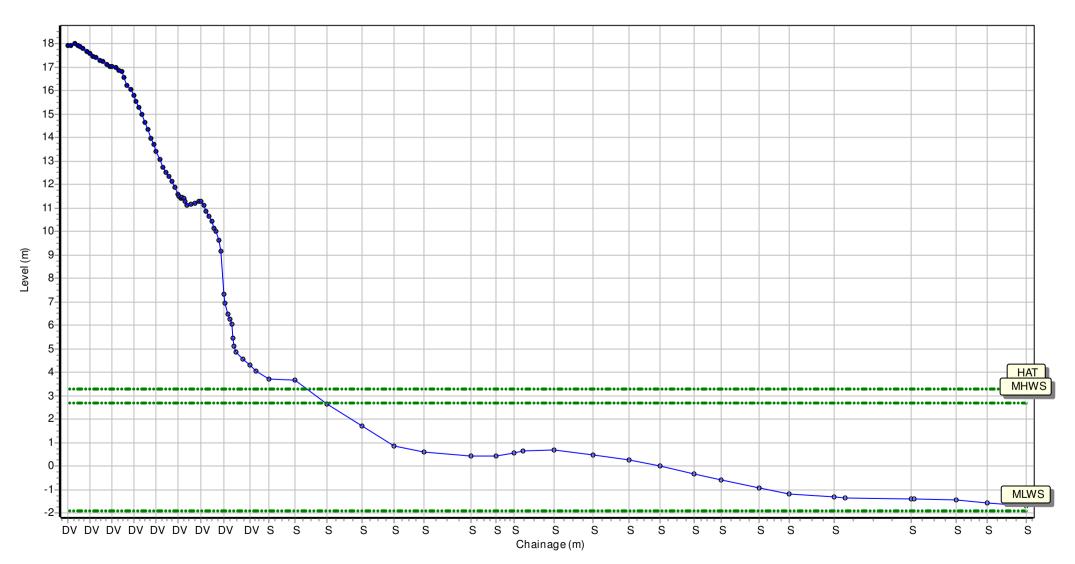
#### Location: 1cHN2

Easting: 449547.217 Northing: 536095.458 Profile Bearing: 42 ° from North

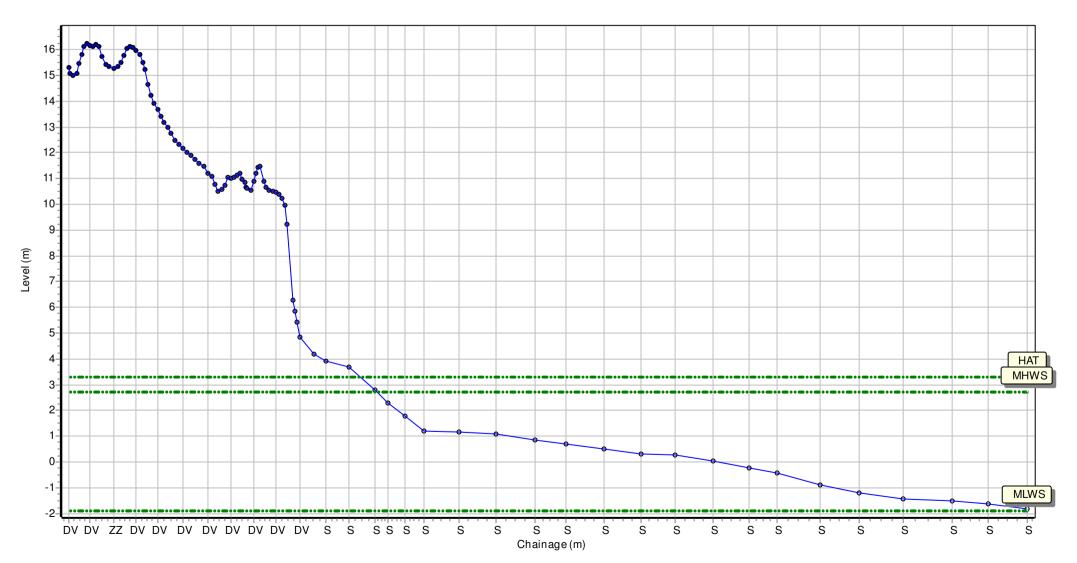
#### Location: 1cHN2A

Easting: 450088.047 Northing: 535658.212 Profile Bearing: 39 ° from North

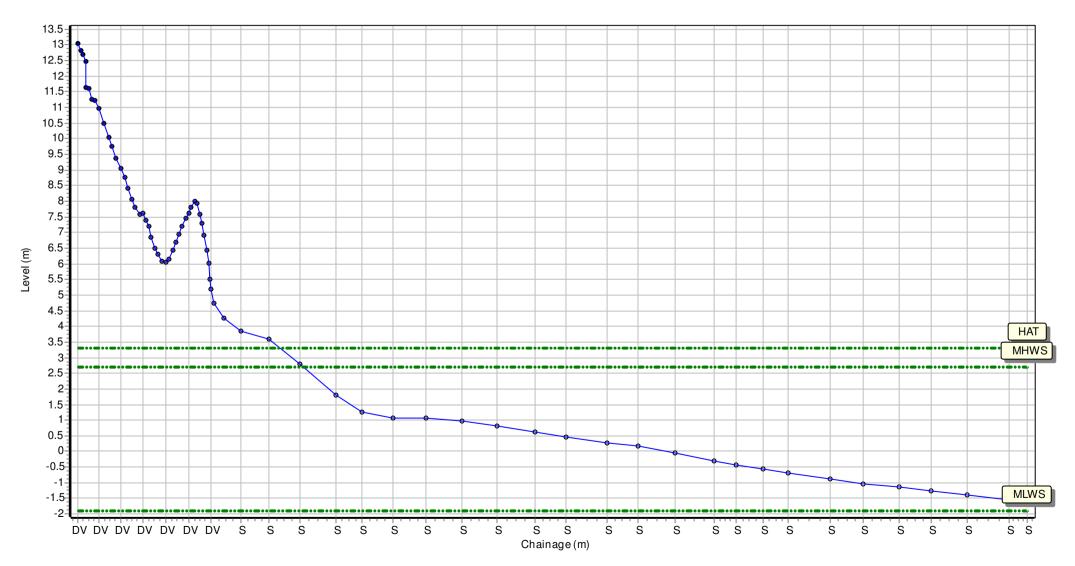
#### Location: 1cHN3

Easting: 450674.424 Northing: 535305.141 Profile Bearing: 30 ° from North

Survey Date	Description of Changes Since Last Survey	Interpretation
	At Profile <b>1cHN3</b> there has been little change of the dunes. The toe of the dunes has accreted to chainage 83m by up to 1.0m, forming a small berm at 56m. The majority of the beach profile shows an accretion of up to 0.5m between 83m chainage and 219m. Seaward of chainage 219m there has been a minor amount of erosion of 0.1m. The dunes are at a high level, whilst the rest of the beach profile is at a low level compared to the range recorded from previous surveys.	
	At Profile <b>1cHN3a</b> there has been relative stability down to the dune face at 20m chainage, with minor sections of change limited to $\pm 0.1$ m. The drop in beach level at the toe of the dunes recorded in the March 2018 survey has continued to show signs of recovery, with levels accreting by 0.6m. There has been little change across the middle beach, limited to $\pm 0.15$ m. Seaward of 122m, there has been accretion of 0.8m. Overall the level is in the mid-to-low range of the previous profiles.

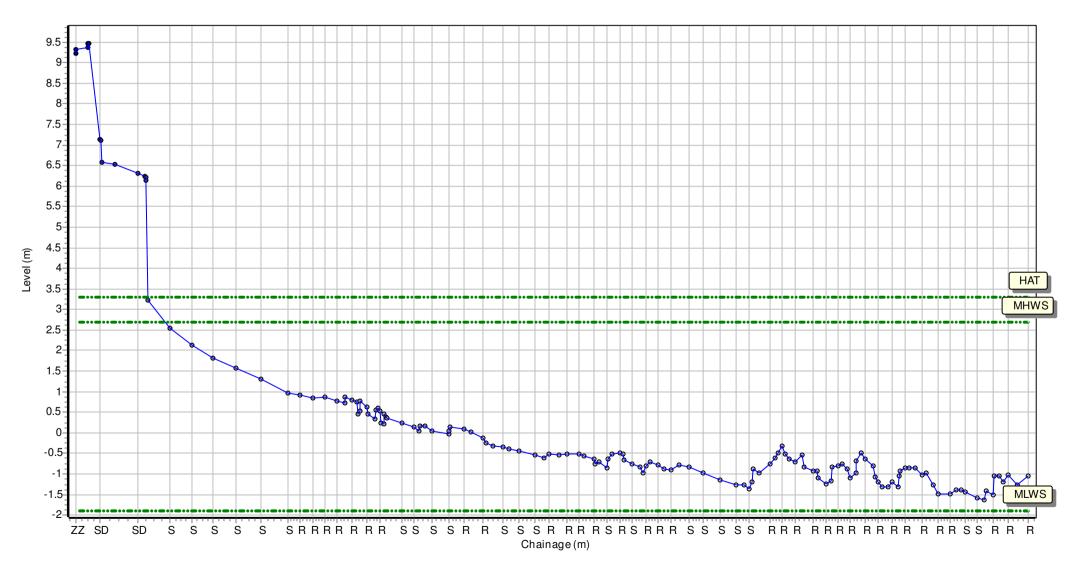
## Location: 1cHN4

Easting: 451997.114 Northing: 534616.627 Profile Bearing: 25 ° from North

At Profile <b>1cHN4</b> there has been little change from the toe of the rock protrusion to chainage 38m. Sediment covering the rock platform from the previous survey has been removed and is now exposed from chainage 38m seawards. There has been relatively no change across the exposed rock platform. Overall the profile is towards the low end of the range recorded from previous surveys.	
	At Profile <b>1cHN4a</b> , there has been little change across the beach profile compared to previous surveys, with minor sections of erosion / accretion limited to $\pm 0.1$ m. Overall the profile is at a medium-low level compared to the previous recorded surveys.	
	<b>Topographic Survey:</b> North Sands is covered by an annual topographic survey. Data from the 2019 Full Measures survey have been used to create a DGM (Appendix B – Map 1) using a GIS package. The majority of the frontage is characterised by shore-parallel contours, except in the vicinity of outfalls, groynes and the pier where contours change direction.	The difference plot at North Sands shows alternating sections of erosion and accretion, with more modest erosion rates west of the pier compared to the east. The plot reflects the seasonal movement of sediment across the beach as sand bars. This is in contrast to the Autumn 2018 survey which was dominated by

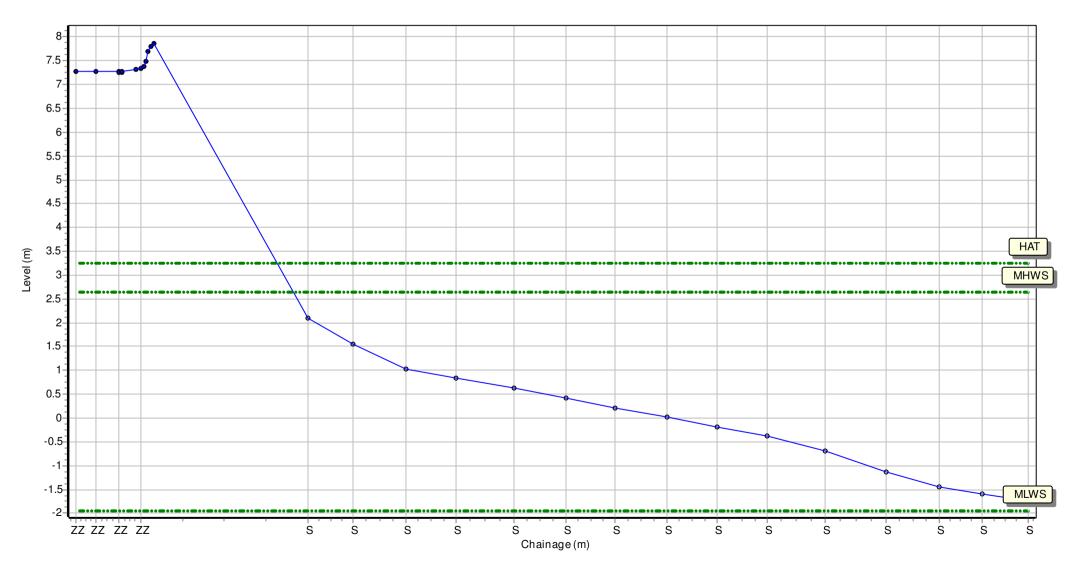
Location: 1cHC1				
Date:	18/09/2019	Inspector: AG	Low Tide:	Low Tide Time:
Wind		Sea State:	Visibility:	Rain:

Easting: 452108.075 Northing: 533506.119 Profile Bearing: 150 ° from North

Survey Date	Description of Changes Since Last Survey	Interpretation
18 <sup>th</sup> September 2019	<b>Beach Profiles:</b> Middleton is covered by one beach profile line during the Full Measures 2019 survey (Appendix A). The survey report notes that there was no access to the upper section of the profile. The beach at Profile <b>1cHC1</b> between the toe of the seawall at chainage 48m and 67m shows accretion of up to 0.35m. Between chainage 67m and 151m, there has been accretion of up to 0.15m. Seawards of 151m there has been erosion of the beach toe of 0.35m. Overall the beach is at a medium level across the upper and lower beach compared to the range from previous surveys. The middle beach is at a high level compared to the range from previous surveys.	The beach profile showed a gain in the upper and middle beach and a loss in the lower beach. <b>Longer term trends</b> : The upper and lower beach is in the medium range of the previously recorded levels, whilst the middle beach is at a high level.

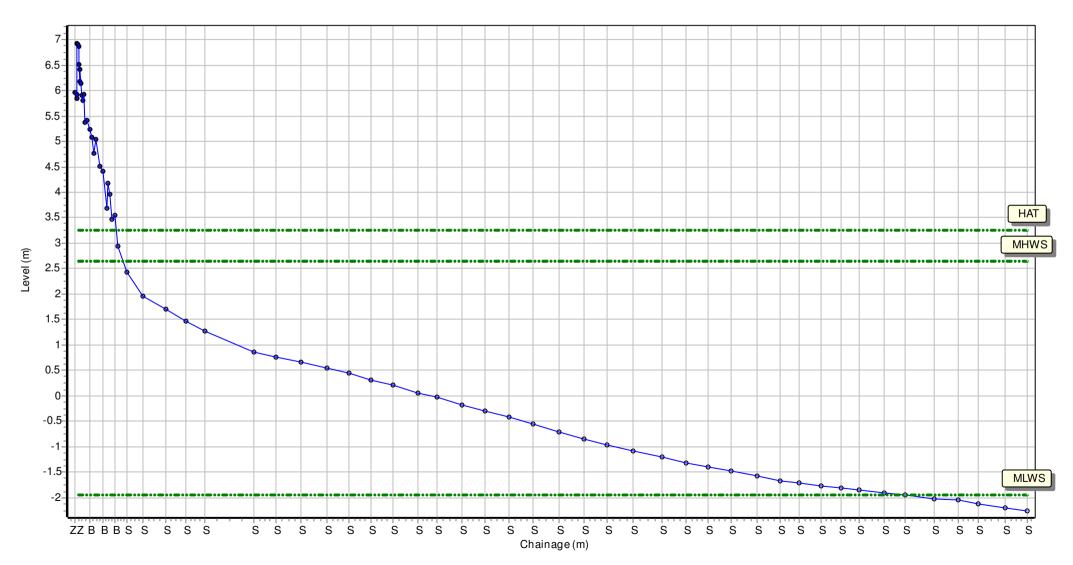
# Location:1cHS2Date:03/09/2019Inspector: AGLow Tide:Low Tide Time:WindSea State:Visibility:Rain:

Easting: 452160.59 Northing: 531071.39 Profile Bearing: 77 ° from North

There has been accretion of up to 0.5m at the toe of the rock revetment at Profile <b>1cHS2</b> . There has been accretion across the upper beach of up to 0.3m. The middle beach shows negligible change limited to $\pm 0.1m$ . The lower beach shows an accretion of 0.2m, creating a flatter compared to February 2019. The profile is at a high level compared to previously recorded surveys.	
	At profile <b>1cHS3</b> there has been accretion of up to 0.4m on the upper beach between chainage 30m and 90m, forming a small berm at chainage 60m. The lower beach berm has moved landward by 60m. The lower beach has accreted by 0.5m and the toe of the beach has extended seaward by 56m. The upper beach is at a medium level, whilst the middle and lower beach is at a high level compared to previous surveys.	
	The profile <b>1cHS4</b> is located further south, around 1km north of the North Gare breakwater in an area of undefended dunes at Seaton Sands. The profile covers approximately 325m of dunes before the beach. The dune section is stable, with a foredune continuing to accrete at around 320m chainage with 0.2m of growth since March 2018. The berm present in the February 2019 survey at chainage 386m has accreted by 0.2m and migrated landward by 2m. The rest of the beach has accreted by up to 1.3m

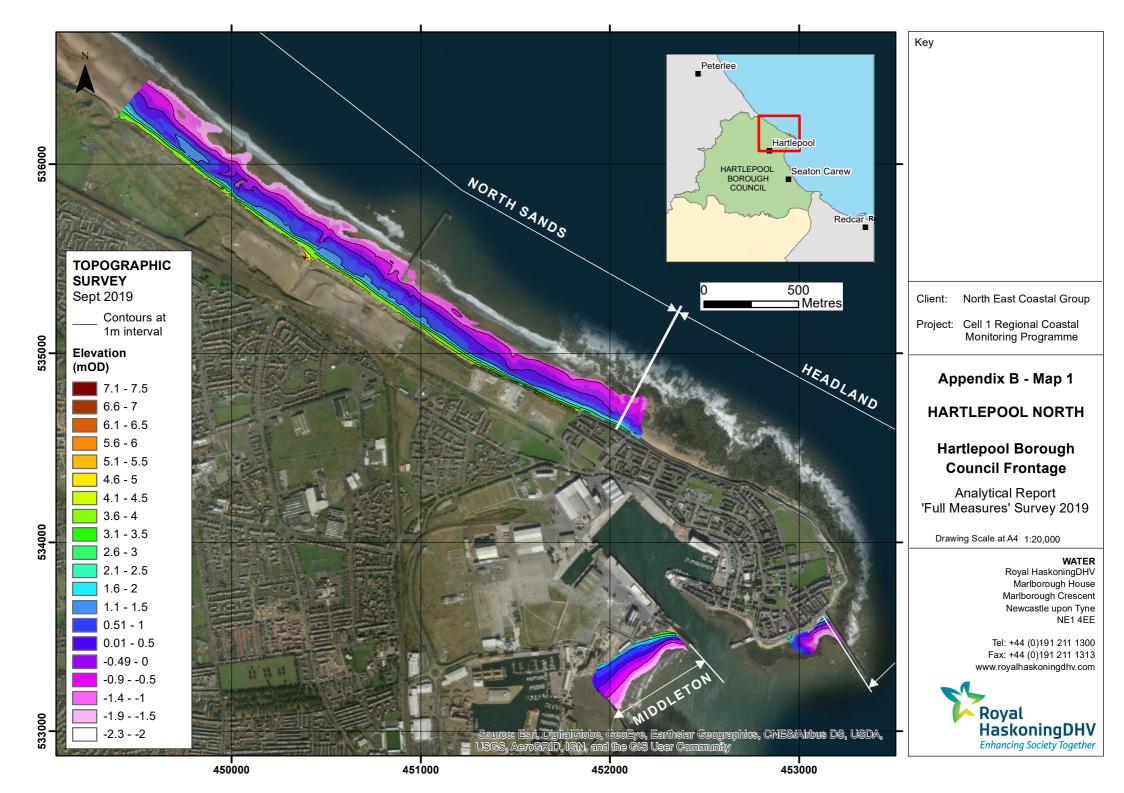
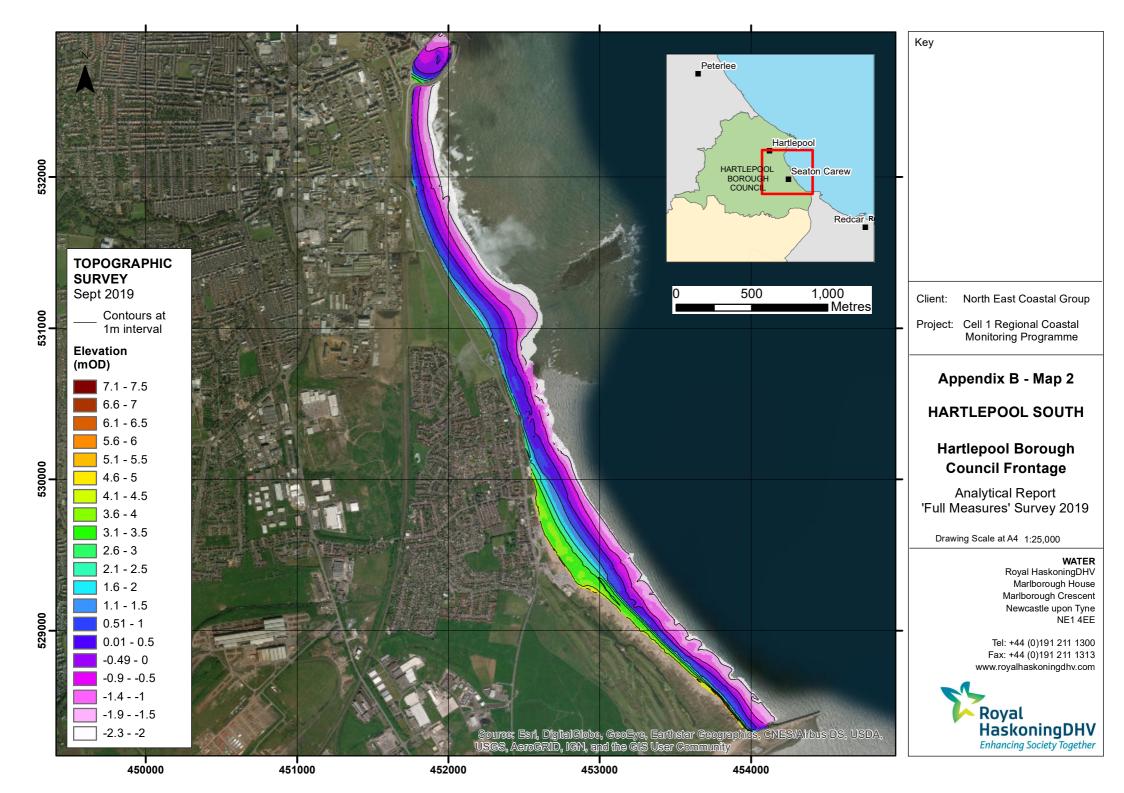
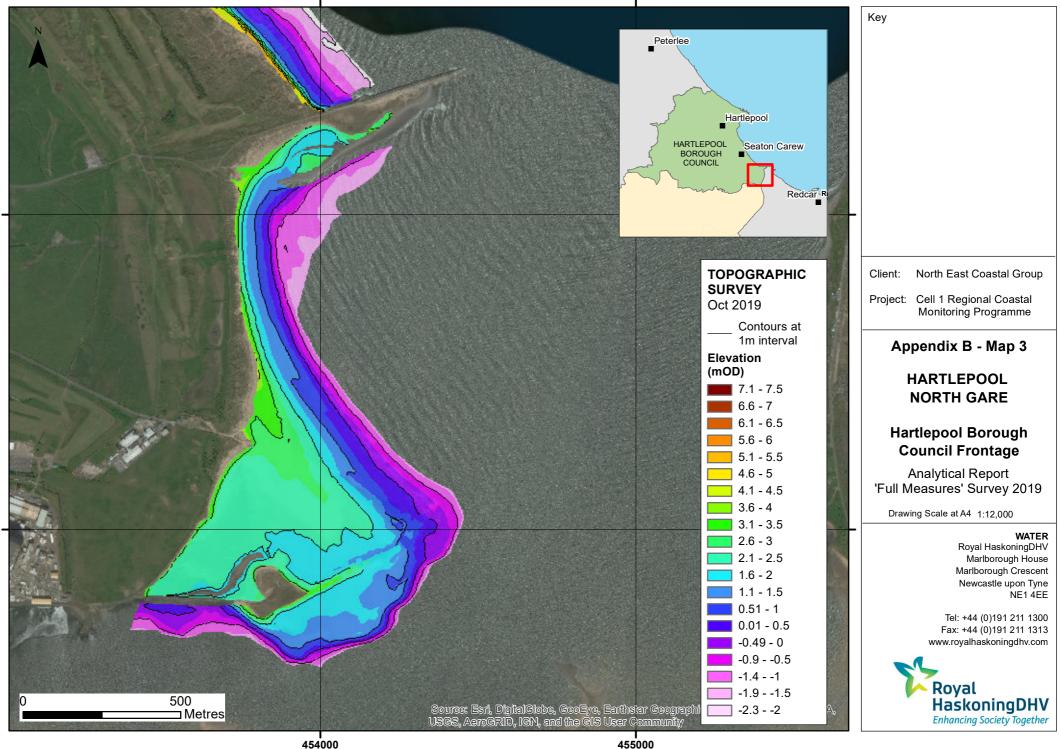
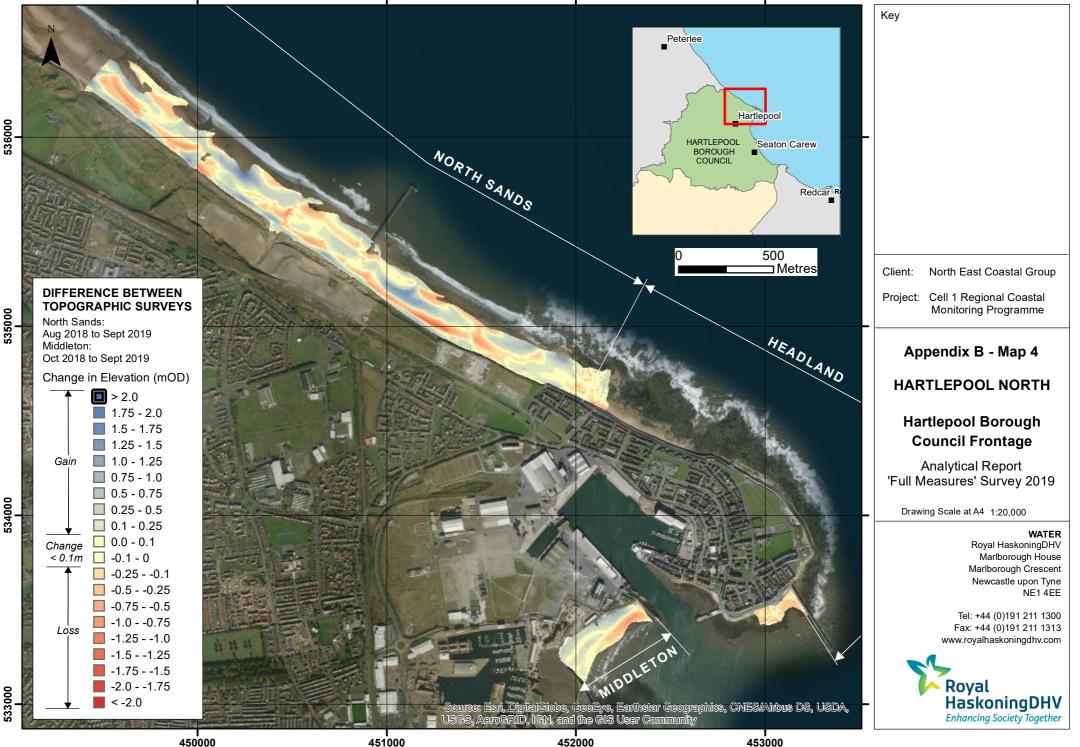
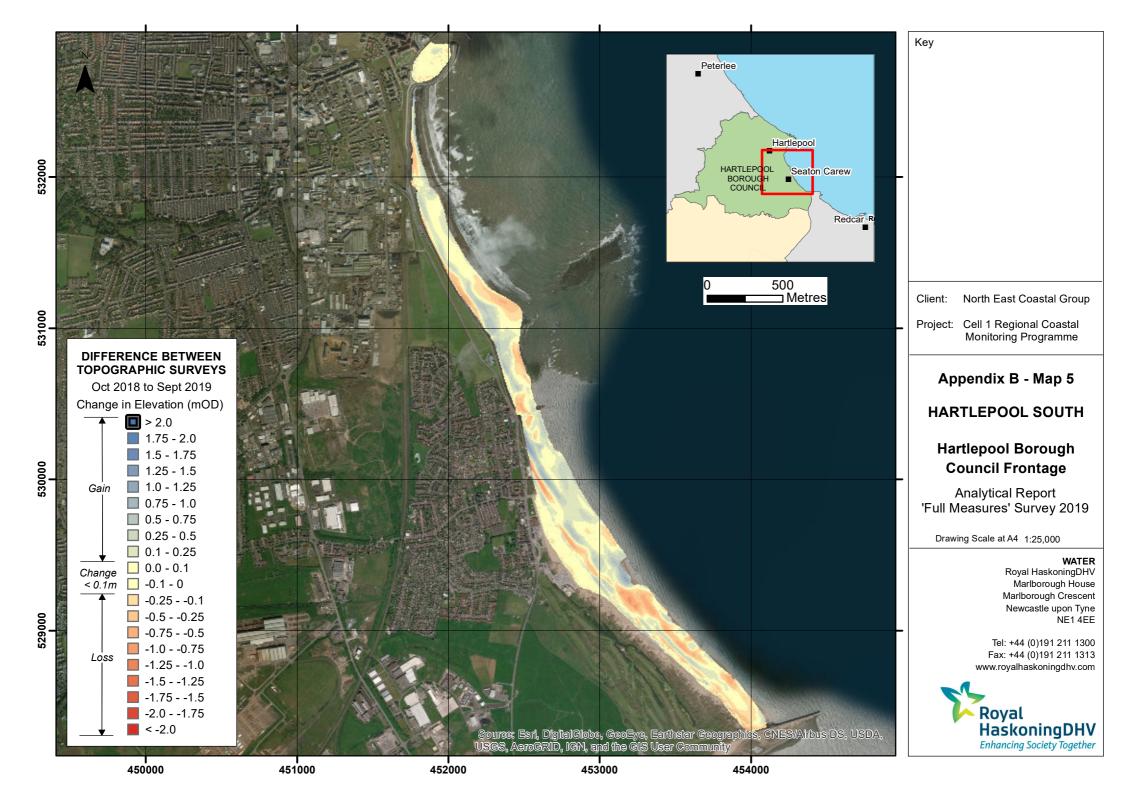
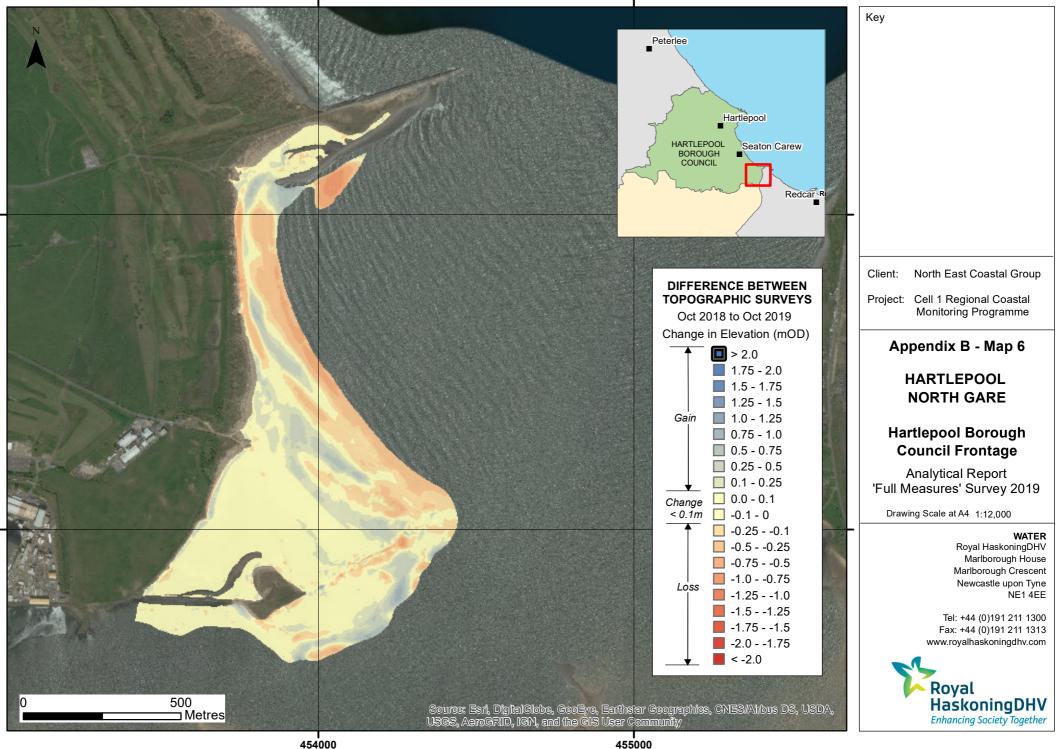
**Topographic Survey**

The GIS has also been used to calculate the differences between the Autumn 2018 and Autumn 2019 topographic surveys, as shown in Appendix B – Map 5, to identify areas of erosion and accretion. The changes recorded over 2019 show the north of the bay has generally undergone very little change, whilst the central area has wide bands of accretion on the middle and lower beach, with a narrow band of erosion on the upper to middle beach. The southern area shows a dominance of erosion. The changes observed are modest in the north and centre of the bay at less than $\pm 0.75m$ and are slightly higher in magnitude towards the south of the bay, reaching $\pm 1.0m$ . The plot generally shows shore-parallel changes, reflecting the seasonal movement of sediment across the beach in the form of sand bars.
