Cell 1 Regional Coastal Monitoring Programme Analytical Report 13: 'Full Measures' Survey 2020

Hartlepool Borough Council
February 2021

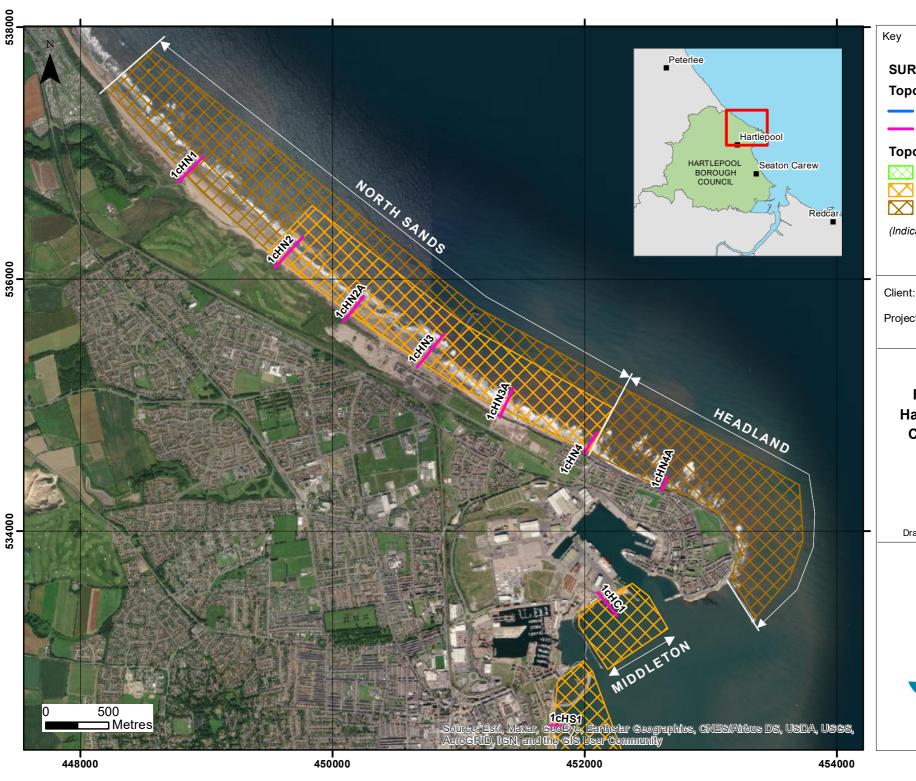
Figure 2 - Map 1 Hartlepool Borough Council Frontage

SURVEY LOCATIONS Topographic Profiles

(Indicative Survey Extents shown)

The location of these surveys is shown in Figure 2. The 2020 Full Measures survey was undertaken along this frontage on various dates between 17th September and 19th October 2020. During this time, the weather was generally dry and sunny with force 2 to 6 breezes from variable directions. The sea state at all sites was either calm or moderate. The survey reports from Academy Geomatics document details of the weather conditions over this survey period.

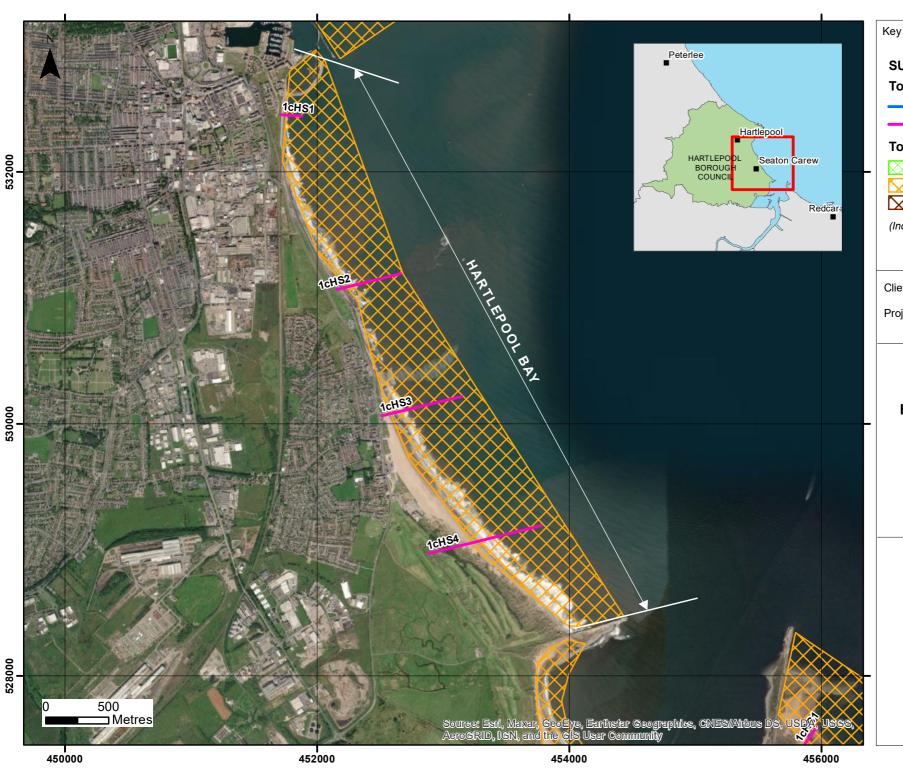
Figure 2 - Map 2 Hartlepool Borough Council Frontage

SURVEY LOCATIONS Topographic Profiles

(Indicative Survey Extents shown)

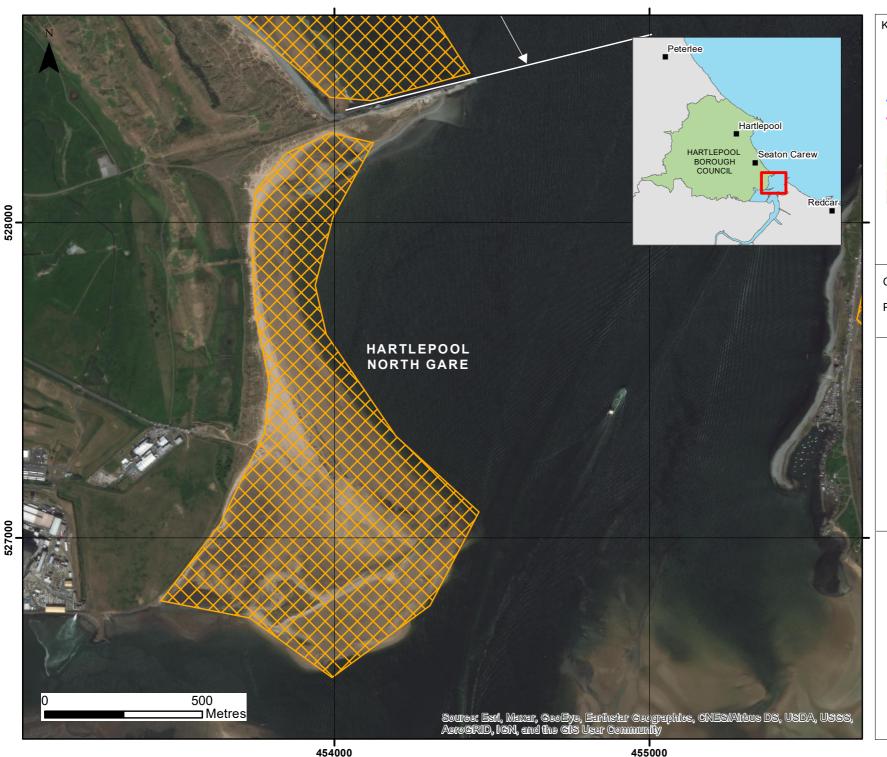
Figure 2 - Map 3 **Hartlepool Borough Council Frontage**

SURVEY LOCATIONS Topographic Profiles

(Indicative Survey Extents shown)

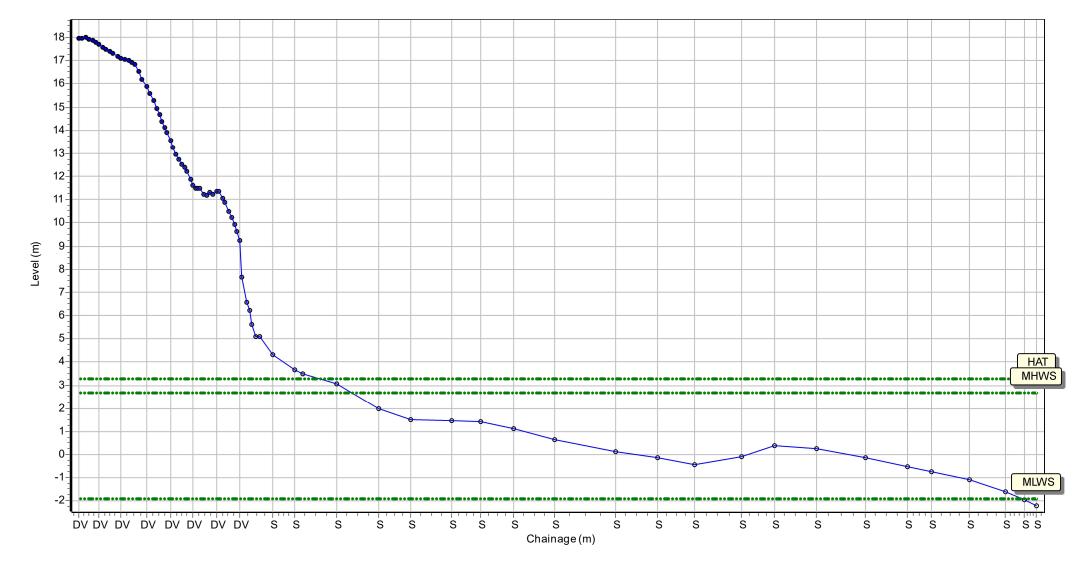
Location: 1cHN2

At profile 1cHN2 , the dunes show very little change, with sections of erosion and accretion limited to ±0.1m. The toe of the dunes has accreted by up to 0.6m in level. The upper and middle beach to chainage 189m has experienced variable erosion and accretion, limited to ±0.4m. Seaward of 189m chainage, a berm has formed with the accretion of up to 1.0m of sediment at chainage 210m extending the toe of the beach seaward by 15m. Overall, the upper and middle beach profile is at a medium level compared with previously recorded surveys, whilst the lower beach is at a high level being the highest

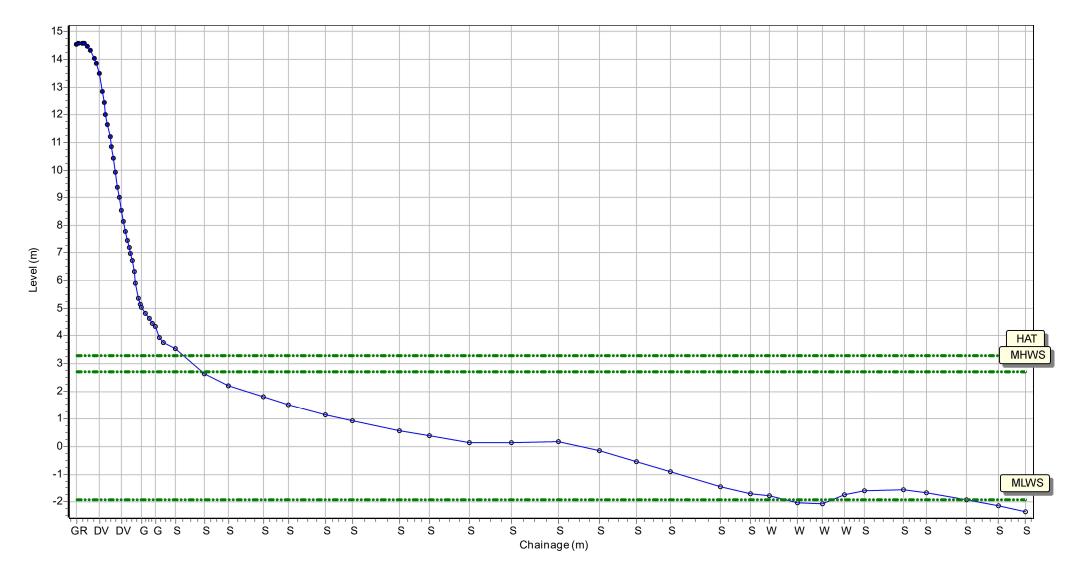
Location: 1cHN3A

At profile 1cHN3a there has been relative stability down to the dune face at 20m chainage, with minor sections of change limited to less than ±0.1m. The dune toe has eroded by 0.1m. There has been accretion across the majority of the upper and middle beach by up to 0.4m to chainage 180m. A shallow lower beach berm seaward of 180m has dropped in level by up to 0.9m. Overall the level is in the mid-to-low range of the previous profiles.	
	At profile 1cHN4 there has been an accretion of sediment across the majority of the beach by up to 0.4m on the upper and lower beach and 0.2m on the middle beach. The rock platform is exposed from chainage 141m seawards, extending to chainage 217m. There has been relatively no change across the exposed rock platform. Overall, the profile is towards the low end of the range recorded from previous surveys.	
	At profile 1cHN4a , there has been an accumulation of up to 0.6m of sediment on the upper beach between chainages 10-31m, covering up previously exposed rocks. Seaward of this point, there has been little change across the beach profile compared to previous surveys, with minor changes in positions of rocks. Overall, the profile is at a medium level on the upper beach, and a low level on the

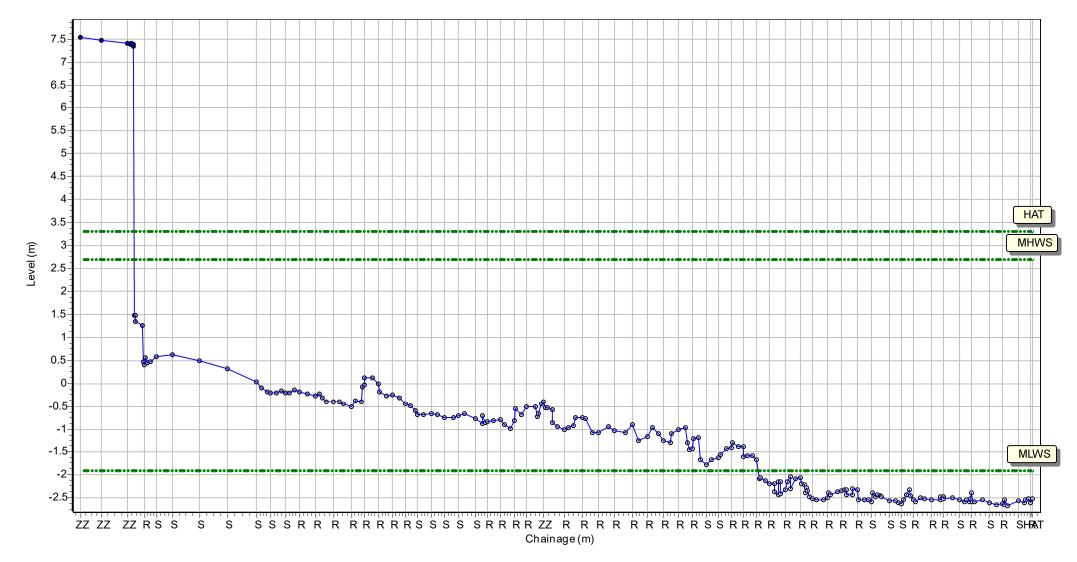
Location: 1cHC1

Summary: 2020 Full Measures Topo Survey

Easting: 452610.565 Northing: 534321.038 Profile Bearing: 23 ° from North

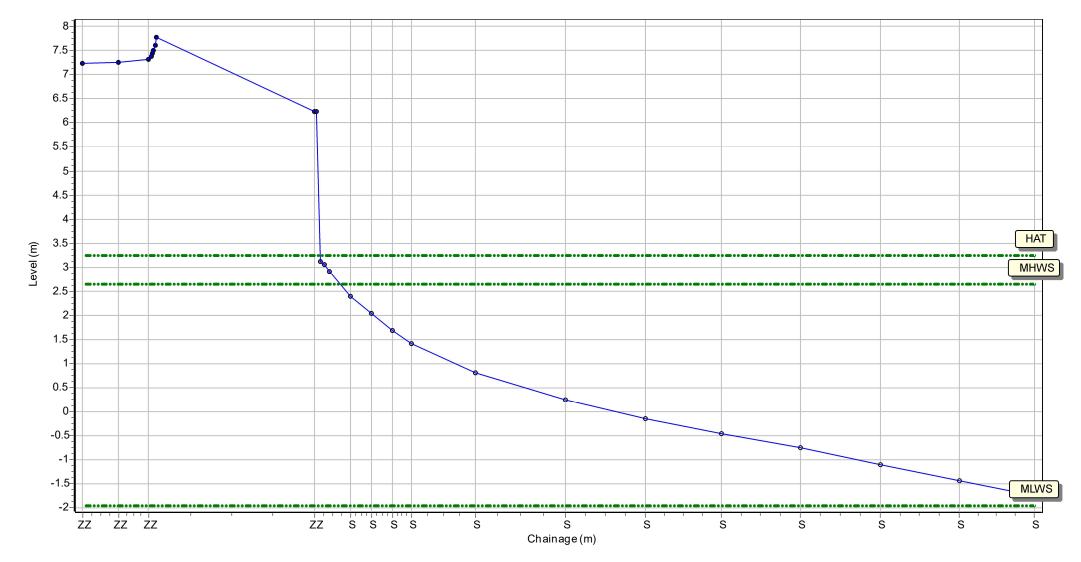
Survey Date	Description of Changes Since Last Survey	Interpretation
19-20 th Sept 2020	Beach Profiles: Middleton is covered by one beach profile line during the Full Measures 2020 survey (Appendix A). The survey report notes that there was no access to the upper section of the profile. The beach at profile 1cHC1 between the toe of the seawall at chainage 48m and 58m shows accretion by up to 0.6m. Between chainage 58m and the lower foreshore at chainage 150m, there has been erosion by up to 0.2m. Seawards of 150m there has been an increase in level by 0.1m and an extension seaward of approximately 34m. Overall the beach is at a high level at the toe of the seawall (reaching its highest level recorded between the seawall and chainage 53m) and at a medium level across the middle and lower beach compared to the range from previous surveys.	The beach profile showed an accumulation of material at the toe of the sea wall and on the lower foreshore, however the majority of the rest of the beach profile eroded. Longer term trends: The beach is generally in the middle of the previously recorded levels, however the beach level at the toe of the seawall is at its highest position recorded.

At Middleton, there was no access to the upper section of profile 1cHC1.

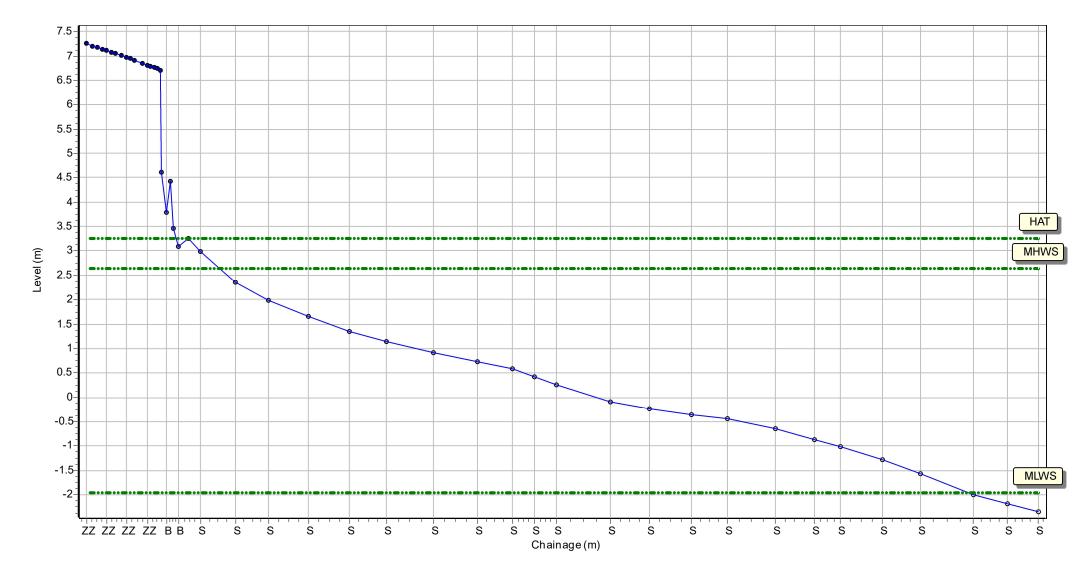
Location: 1cHS3

At profile 1cHS3 there has been erosion between the toe of the rock armour and chainage 65m by up to 0.6m. The beach profile between chainages 65-135m have undergone negligible change since the previous survey, with erosion / accretion limited to ±0.1m. The middle beach between chainages 135-220m has eroded by up to 0.2m, before switching to accretion on the lower beach by up to 0.2m. The beach profile is at a medium-high level compared to the range recorded from previous surveys. The profile 1cHS4 is located further south, around 1km north of the North Gare breakwater in an area of undefended dunes at Seaton Sands. The profile covers approximately 325m of dunes before the beach. The dune section has varying sections of erosion and accretion limited to ±0.3m but has generally remained stable since the previous survey. The foredune at 320m chainage has continued to accrete

Survey Date	Description of Changes Since Last Survey	Interpretation
	with 0.15m of growth since May 2020, and an overall accretion of 3.0m since March 2009. The seaward face of the foredune has accreted by up to 0.3m at chainage 327m. A small section of erosion has occurred at the toe of the dunes by up to 0.2m to chainage 400m, switching to a small section of accretion by up to 0.2m to chainage 455m. On the middle to lower beach between chainages 455-541m, the beach profile has dropped by up to 0.6m, before switching to accretion on the lower foreshore by up to 0.4m, forming a small berm. The foredune and lower foreshore are at a high level, particularly the foredune which is at its highest level recorded. The rest of the beach has dropped to a medium-low level compared to the range recorded from previous surveys.	
	Topographic Survey:	
	Hartlepool Bay is covered by an annual topographic survey between the South Pier and the North Gare Breakwater. Data from the 2020 Full Measures survey have been used to create a DGM (Appendix B – Map 2) using a GIS software package. The plot shows the two smaller bays within the larger Hartlepool Bay frontage. These smaller bays are separated by a slight promontory at Carr House Sands between Hartlepool and Seaton Carew. The beach contours are generally shore parallel, except where linear features (e.g. outfalls) and rock outcrops are present, such as in the northern part of Seaton Sands. Elevations at the rear of the beach are lowest in the north of the survey area near South Pier and higher further south.

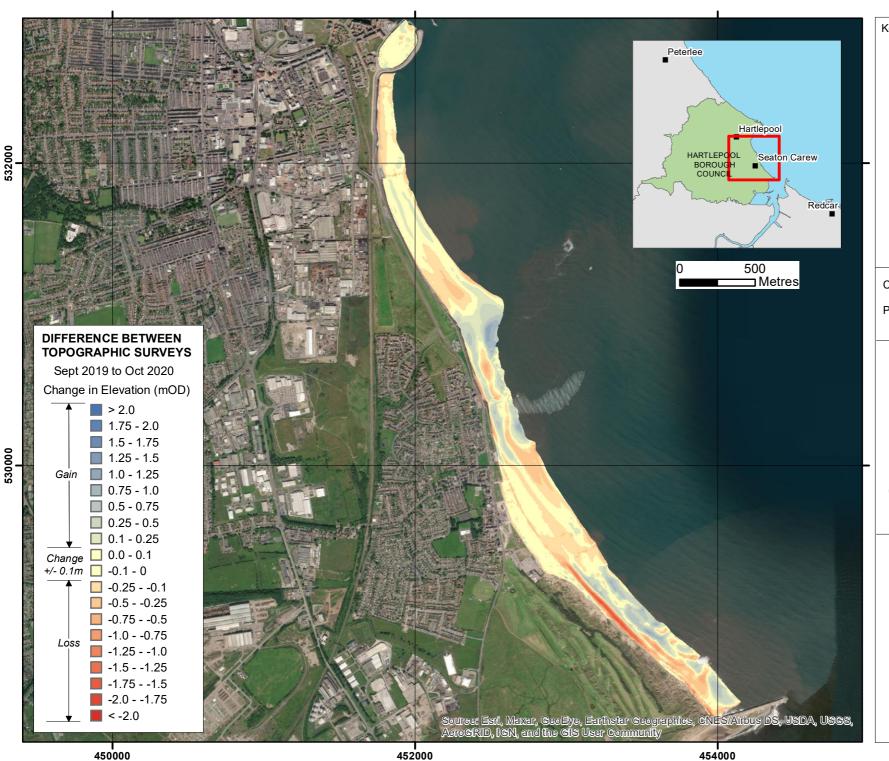
Appendix B - Map 5

The GIS has also been used to calculate the differences between the Autumn 2019 and Autumn 2020 topographic surveys, as shown in Appendix B – Map 5, to identify areas of erosion and accretion. The changes recorded over 2020 show the north of the bay has generally undergone little change, with low magnitude of erosion (<0.5m) dominating slightly on the upper-middle beach towards the centre of the bay, and on the upper beach in the north of the bay. The central area has a wide zone of accretion of up to 1.0-1.25m which tapers out towards the south – with bands of erosion present on the middle beach and at the dune toe. The central area of the southern half of the survey extent shows alternating bands of limited change (±0.1m) and low-magnitude erosion (<0.25-0.5m). The southern area of the survey extent shows a dominance of erosion on the upper beach, with accretion on the middle and lower beach. Change is of higher magnitude in the south of the survey area (±1.75). Overall, the plot generally shows shore-parallel changes, reflecting the seasonal movement of sediment across the beach in the form of sand bars.

- Profiles in the north of Hartlepool Bay generally show erosion across the upper-lower beach, with accretion in level across the lower foreshore. The southern profiles show alternating bands of erosion and accretion, reflecting the seasonal movement of sediment across the beach as sand bars. The foredune at profile 1cHS4 has continued to accrete, reaching its highest level since records began in 2009. This pattern is also supported by the topographic survey difference plot.
