# Cell 1 Regional Coastal Monitoring Programme Analytical Report 15: 'Full Measures' Survey 2022

Hartlepool Borough Council January 2023

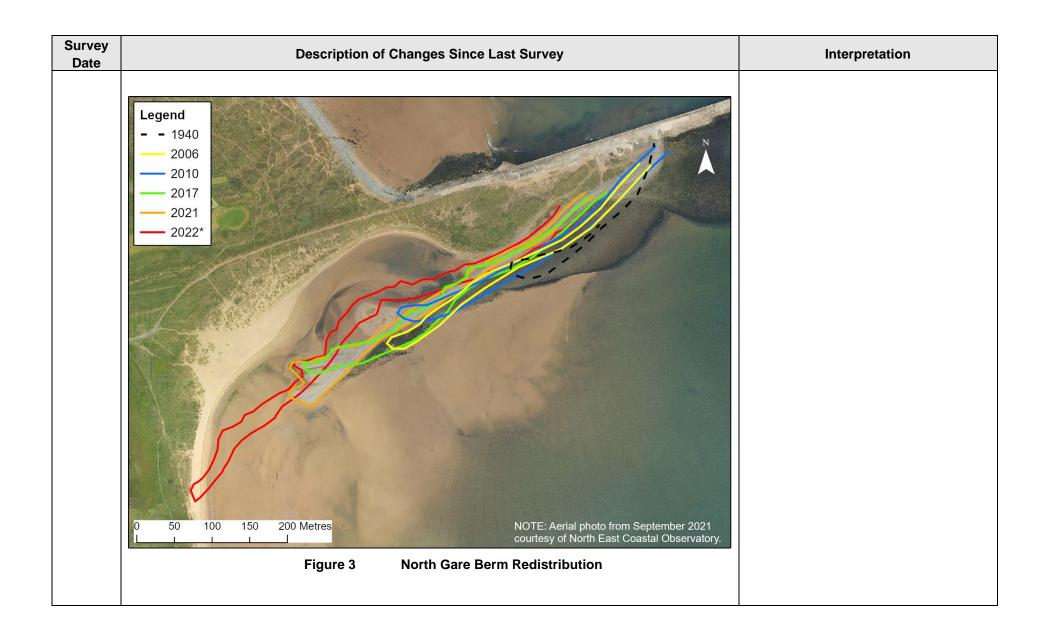
The GIS has also been used to calculate the differences between the September 2021 and October 2022 topographic surveys, as shown in Appendix B – Map 8, to identify areas of net erosion and accretion.	
13 <sup>th</sup> – 14 <sup>th</sup> October 2022	The plot shows that on the south aspect of the North Gare breakwater there has been a progressive redistribution of cobble berm from the tip of the North Gare towards the root. This has reached the point in 2022 where the corner of beach, in the lee of the breakwater, is now cut off from the rest of the bay. The difference plot shows that behind the now extended berm, there has been an increase in sediment levels of up to 1.25m. It is thought that if the berm remains that sediment will continue to build behind it and eventually dunes will begin to develop. An area of intense erosion can be seen where the cobble berm now connects to the beach and may be associated with scour around the end of the hard structure. Figure 3 below highlights the redistribution of this berm over time.

- At North Gare, the most significant change since the previous survey in September 2021 is the
  redistribution of the cobble berm form the tip of North Gare to the root, cutting off a section of
  beach. Accretion can be observed behind the berm which is likely to continue if the beach remains
  cut off. Elsewhere change has again occurred in shoreline parallel bands of change, generally
  moving from the lower beach to the upper beach. There is no cause for concern at any of these
  areas.

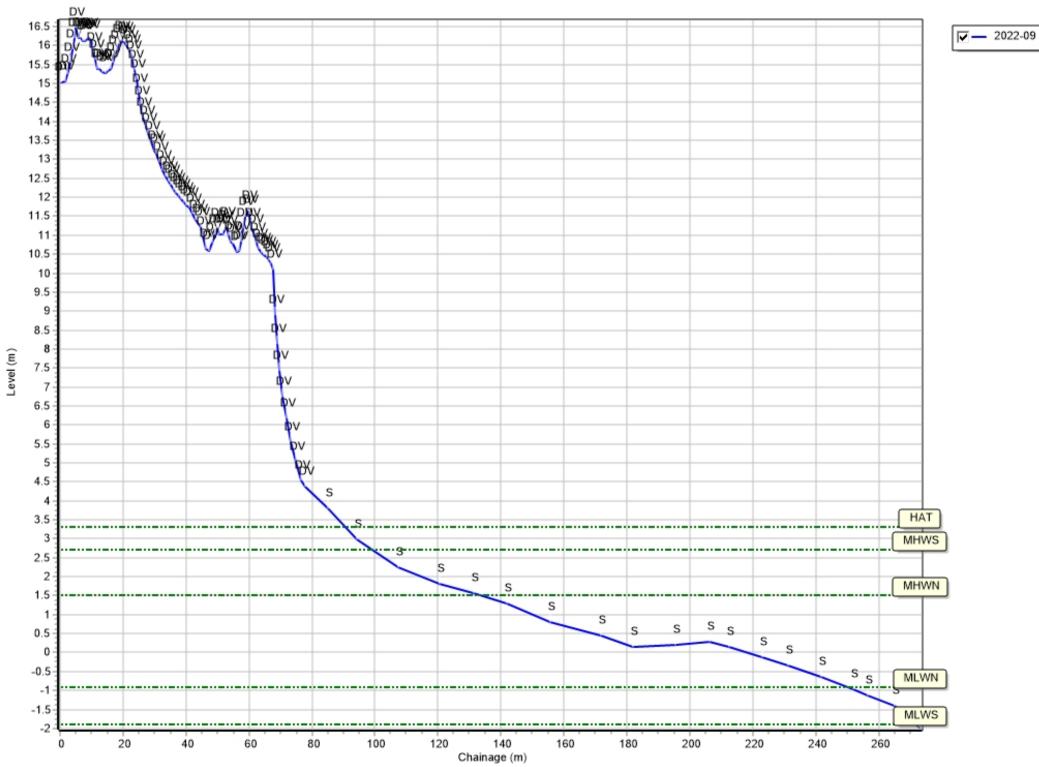
### Profiles: 1cHN2A

Profile <b>1cHN2A</b> was established in October 2011 and runs through the dunes close to North Sands. The dunes, between chainage 0m and 76m have remained stable, experiencing minor accretion and erosion limited to ±0.1m. At the toe of the foredune, beach levels have accreted by 0.4m in level to chainage 92m. Accretion is also observed between chainage 110m and 178m of a magnitude up to 0.2m. The berm observed previously at chainage 175m has shifted seawards to chainage 182m. The seaward face of the berm has slackened resulting in an increase in level of 0.7m at chainage 250m. The profile remains within the range of the previous surveys. At profile <b>1cHN3</b> , the dunes up to chainage 42m have remained stable. The crest of the foredune has

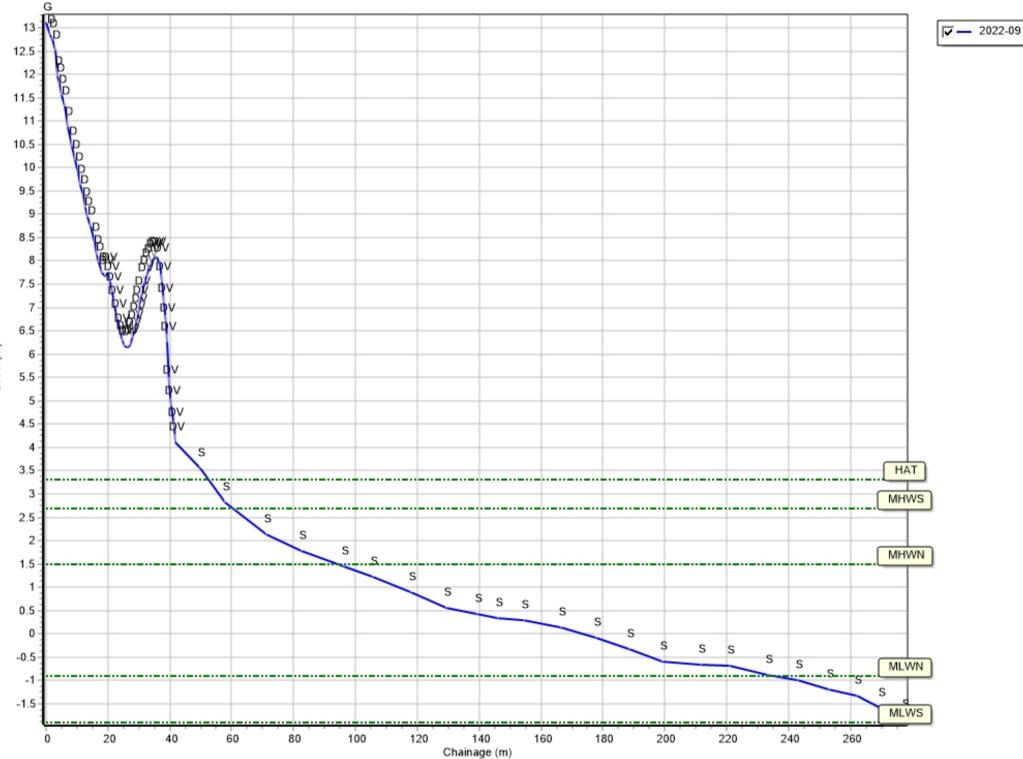
### Profiles: 1cHN3

Survey Date	Description of Changes Since Last Survey	Interpretation
	accreted by 0.1m in level. The upper beach between chainage 42m and 117m has accreted by 0.1m in level. Seaward of chainage 117m, the beach has eroded by 0.1m in level. The profile is at a medium level compared to the range from previous surveys.	
	At profile <b>1cHN3A</b> the dune face has remained unchanged, with the toe of the dune experiencing a minor accretion of 0.2m in level between chainages 23m and 32m. Seaward of the dune, the beach profile highlights alternating lengths of erosion and accretion, on the whole limited to $\pm 0.2m$ . The most significant change is between chainage 160m and 229m, which has recorded an accretion of up to 0.7m in level. When compared to the range of previous surveys, the October 2021 survey is at a medium level except the significant accretion on the lower beach which is at the highest level.

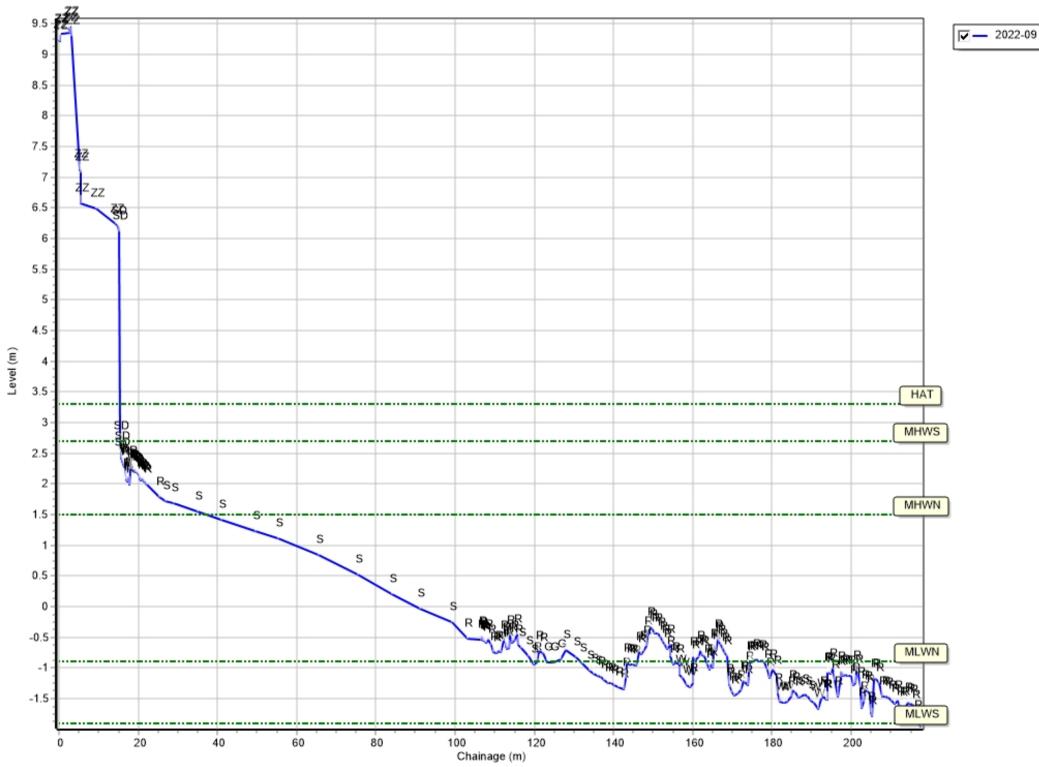
Profiles: 1cHN4

At profile <b>1cHN4</b> , between the toe of the defence (chainage 16m) and chainage 43m, the beach has dropped by up to 1.0m in level, exposing the rocky foreshore over a 5m length adjacent to the seawall. Between chainage 43m and 80m the beach has remained stable with minor accretion (<0.1m) occurring. On the lower beach, between chainage 80m and 104m, accretion by 0.4m in level has concealed a portion of the previously exposed rocky foreshore. Seaward of chainage 104m the rocky foreshore remains exposed.	
	At profile <b>1cHN4a</b> the defended part of the profile to 10m chainage has not changed since October 2011. The rocky shore platform remains exposed seaward of chainage 74m. However, wide-scale accretion (up to 0.5m in level) across the upper beach has concealed the foreshore in this location. Overall, the profile is at a high level compared to the previous recorded surveys, particular on the upper beach where it is the highest level on record.

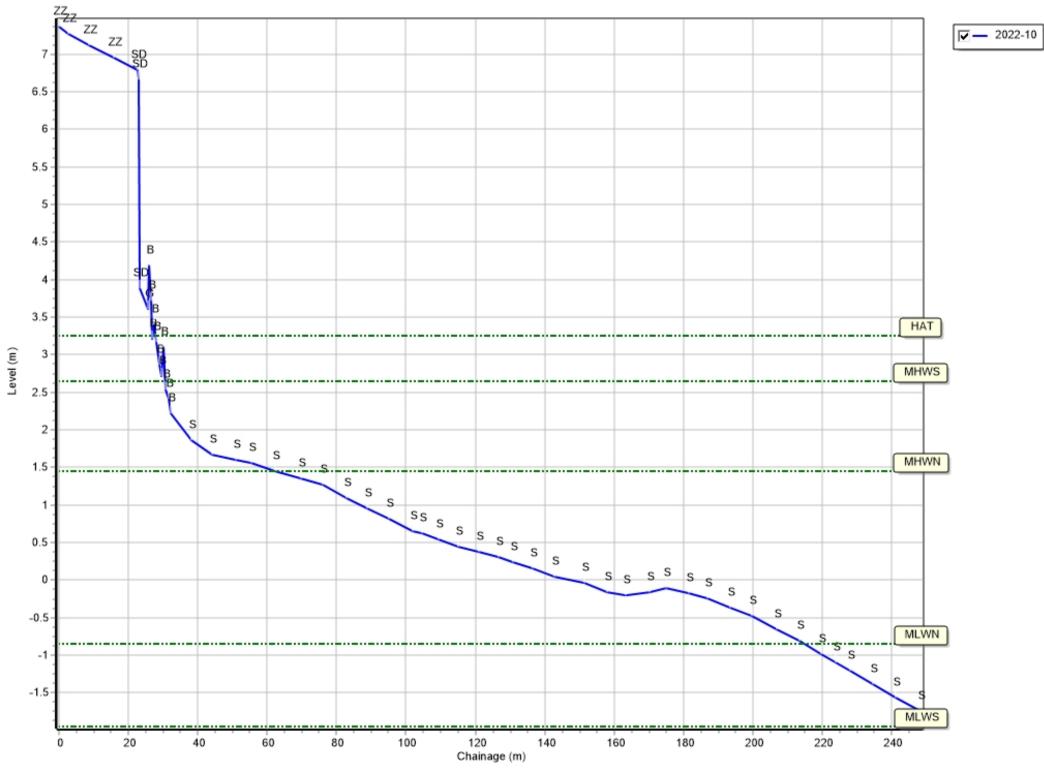
### Profiles: 1cHS3

Profile <b>1cHS3</b> shows no changes over the defended part of the profile up to 30m chainage. At the toe of the revetment, beach levels have locally dropped by 0.3m, tapering to no change by chainage 60m. On the middle section of beach, between chainages 60m and 160m, the levels have remained stable with any change limited $\pm 0.1m$ . On the lower beach, a berm has formed with accretion of up to 0.45m in level observed up until the end of the profile at chainage 248m.	
	The profile <b>1cHS4</b> is located further south, around 1km north of the North Gare breakwater in an area of undefended dunes at Seaton Sands. The survey report notes that dense thorn bushes restricted the start of the section. The profile covers approximately 325m of dunes before the beach. The dune section has generally remained stable since the previous survey with the majority of change limited to ±0.1m. The crest of the foredune has shifted seaward by 1.5m but does not appear to have changed in elevation. Seawards of the dunes, the beach has also remained largely stable and displays a uniform

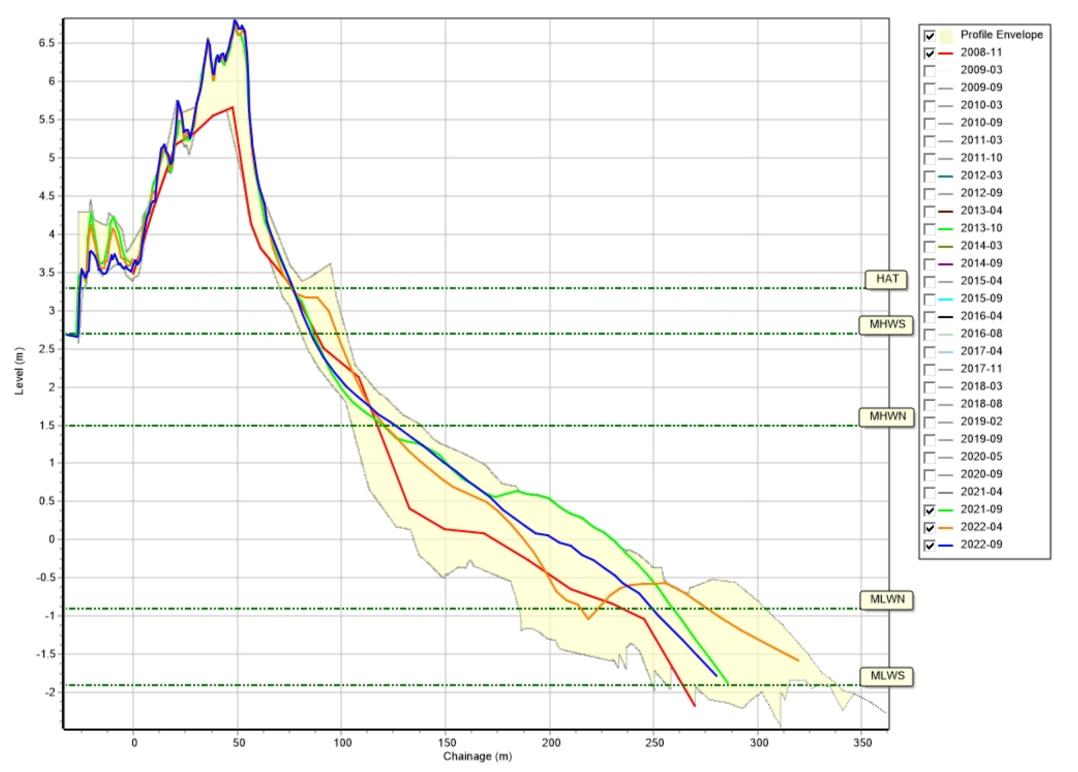
Profiles: 1cHS4

Survey Date	Description of Changes Since Last Survey	Interpretation
	gradient. Minor accretion is observed between chainage 390m and 425m at a magnitude of 0.1m. A berm previously observed at chainage 442m is no longer present and therefore beach levels have dropped locally in this location by 0.3m. Overall the beach is at medium level when compared to the range of the previous surveys.	
	Topographic Survey:	
	Hartlepool Bay is covered by an annual topographic survey between the South Pier and the North Gare Breakwater. Data from the 2022 Full Measures survey have been used to create a DGM (Appendix B – Map 2 & Map 3) using a GIS software package.	
	The plot shows the two smaller bays within the larger Hartlepool Bay frontage. These smaller bays are separated by a slight promontory at Carr House Sands between Hartlepool and Seaton Carew. The beach contours are generally shore parallel, except where linear features (e.g., outfalls) and rock outcrops are present, such as in the northern part of Seaton Sands. Elevations at the rear of the beach are lowest in the north of the survey area near South Pier and higher further south at North Gare resulting much steeper upper beach,

At Hartlepool Bay, dense thorn bushes restricted the start of profile 1cHS4 and heavy onshore winds restricted the depth of survey achievable at the southern end.
