**Cell 1 Regional Coastal Monitoring Programme
Update Report 6: 'Partial Measures' Survey 2014**

Update Report 6
 Partial Measures Survey
 Spring 2014

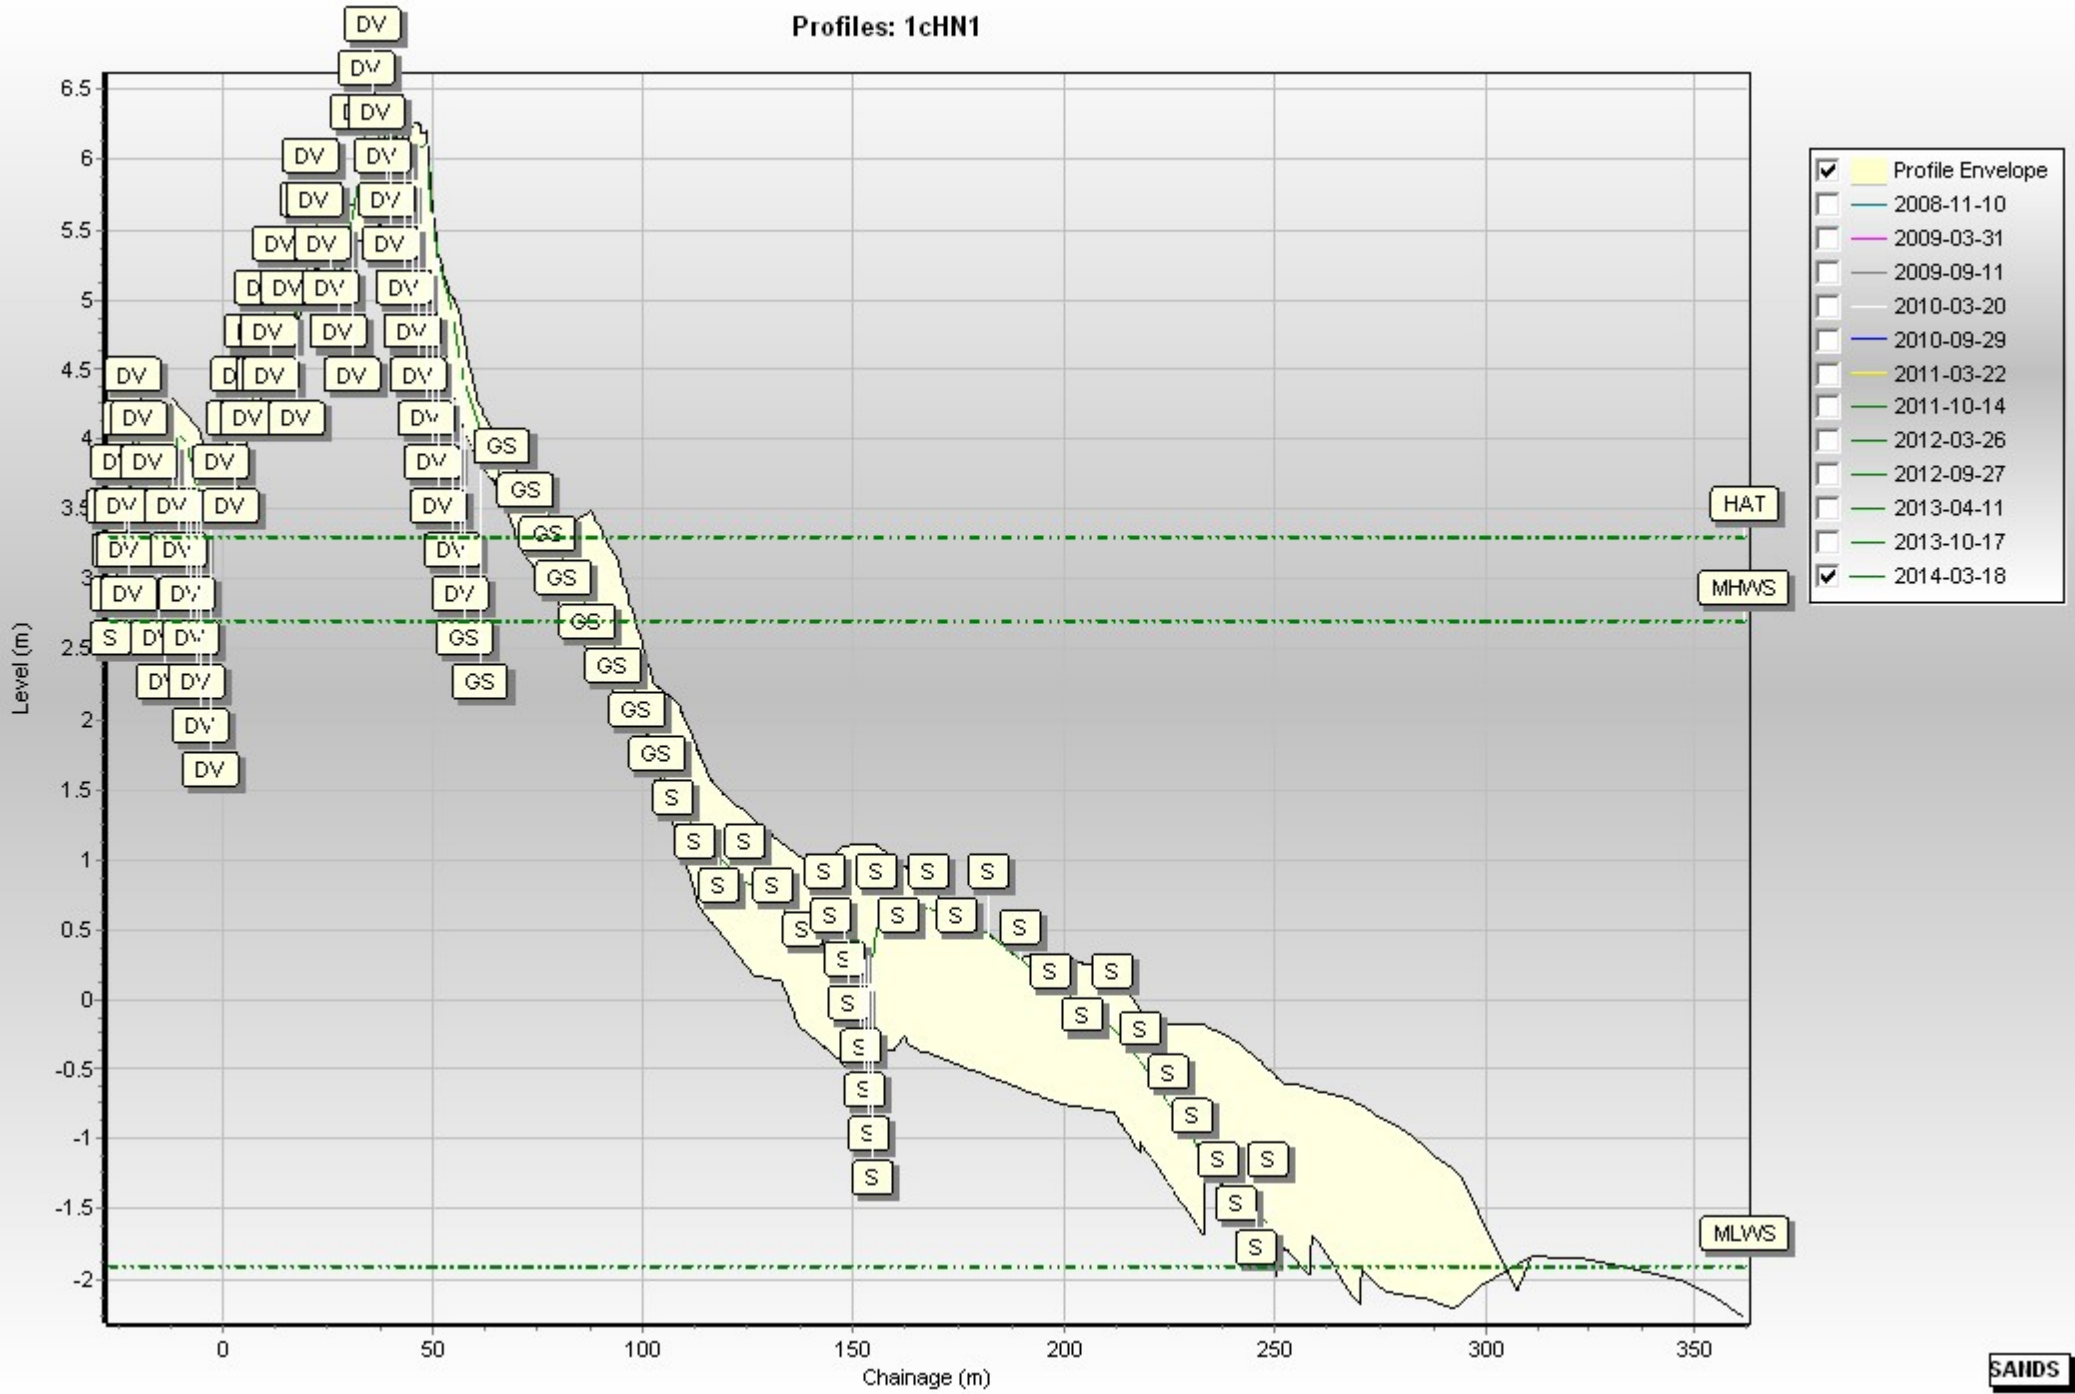
Profiles: 1cHN1

Survey Date	Description of Changes Since Last Survey	Interpretation
<p>18th March 2014</p>	<p>Beach Profiles:</p> <p>North Sands is covered by four beach profile lines during the Partial Measures survey (Appendix A) that were last surveyed in September 2012.</p> <p>Profile 1cHN1 is located within Durham County Council's jurisdiction, about 400m north of the outfall of Crimdon Beck, but has been reported here so changes can be interpreted in association with those observed elsewhere along North Sands at 1cHN2, 1cHN3 and 1cHN4. The March 2014 profile for 1cHN1 is very similar to the October 2014 survey until 51m chainage. Between 51m and 71m chainage the level of the profile has dropped by around 0.7m. From 71m to 100m chainage the beach has accreted since the last survey. Between 100m and 155m chainage the beach level is up to 0.4m lower than the previous survey and between 155m and 195m chainage the beach has accreted by around 0.4m. At the base of the profile from 195m chainage to MLWS the beach level is around 0.5m lower than in October 2013.</p> <p>Profile 1cHN2 shows stability from 0m to 50m chainage. Between 50m and 100m chainage the dune front has retreated by 1.3m and the upper beach has lowered by 1.1m since October 2013. The profile is similar between 100 and 118m chainage, below which the trough has developed, lowering the beach by around 0.2m as far as 127m chainage. From 127m to 166m chainage the beach has accreted and between 166m and 190m chainage the profile is similar to October 2013. However, between 190m and MLWS the beach has accreted significantly by around 1.2m, creating a gentler profile slope. Except at the dune front, that has eroded more than seen in the past, the profile is within the range of previous surveys. .</p> <p>Profile 1cHN2a was established in October 2011 and runs through the dunes close to North Sands. The part of the survey over the dunes to 70m chainage has remained stable since October 2011. Between 70 and 90m chainage the dune front has eroded by around 8m and the upper beach is 1m lower than in October 2014. The beach has accreted between 110m and 180m chainage by around 0.5m and experienced slight erosion (ca. 0.3m) between 180m and 205m chainage. The foreshore at</p>	<p>In the north-westerly, undefended parts of the bay the March 2014 survey shows a pattern of significant dune erosion and upper beach lowering. This is accompanied by deposition nearer low water to create a shallower slope than in the October 2013 profiles. The defended sections of coastline in the southeast of the bay are generally also at their lowest. The exception is profile 1cHN4 where a substantial amount of sand has accreted against the sea wall.</p> <p>This effect is probably a result of the significant storm surge that occurred in December 2013.</p> <p>Longer term trends:</p> <p>The pattern of dune erosion and back shore lowering is unprecedented in the monitoring record. Future data will show how long recovery takes. Exposure of the shore platform in the defended section to the south of the bay continues.</p>

- At North Sands the furthest northwest profiles (in the undefended part of the bay) show dune face erosion and upper beach lowering, which probably occurred during the storm surge of December 2013. The dune toe is at its furthest landward extent since monitoring began and future reports should review how the beach reacts to this change. Substantial amounts of the rocky shore platform in the lower part of the intertidal zone continue to be exposed in the more southern, defended sections of the bay.

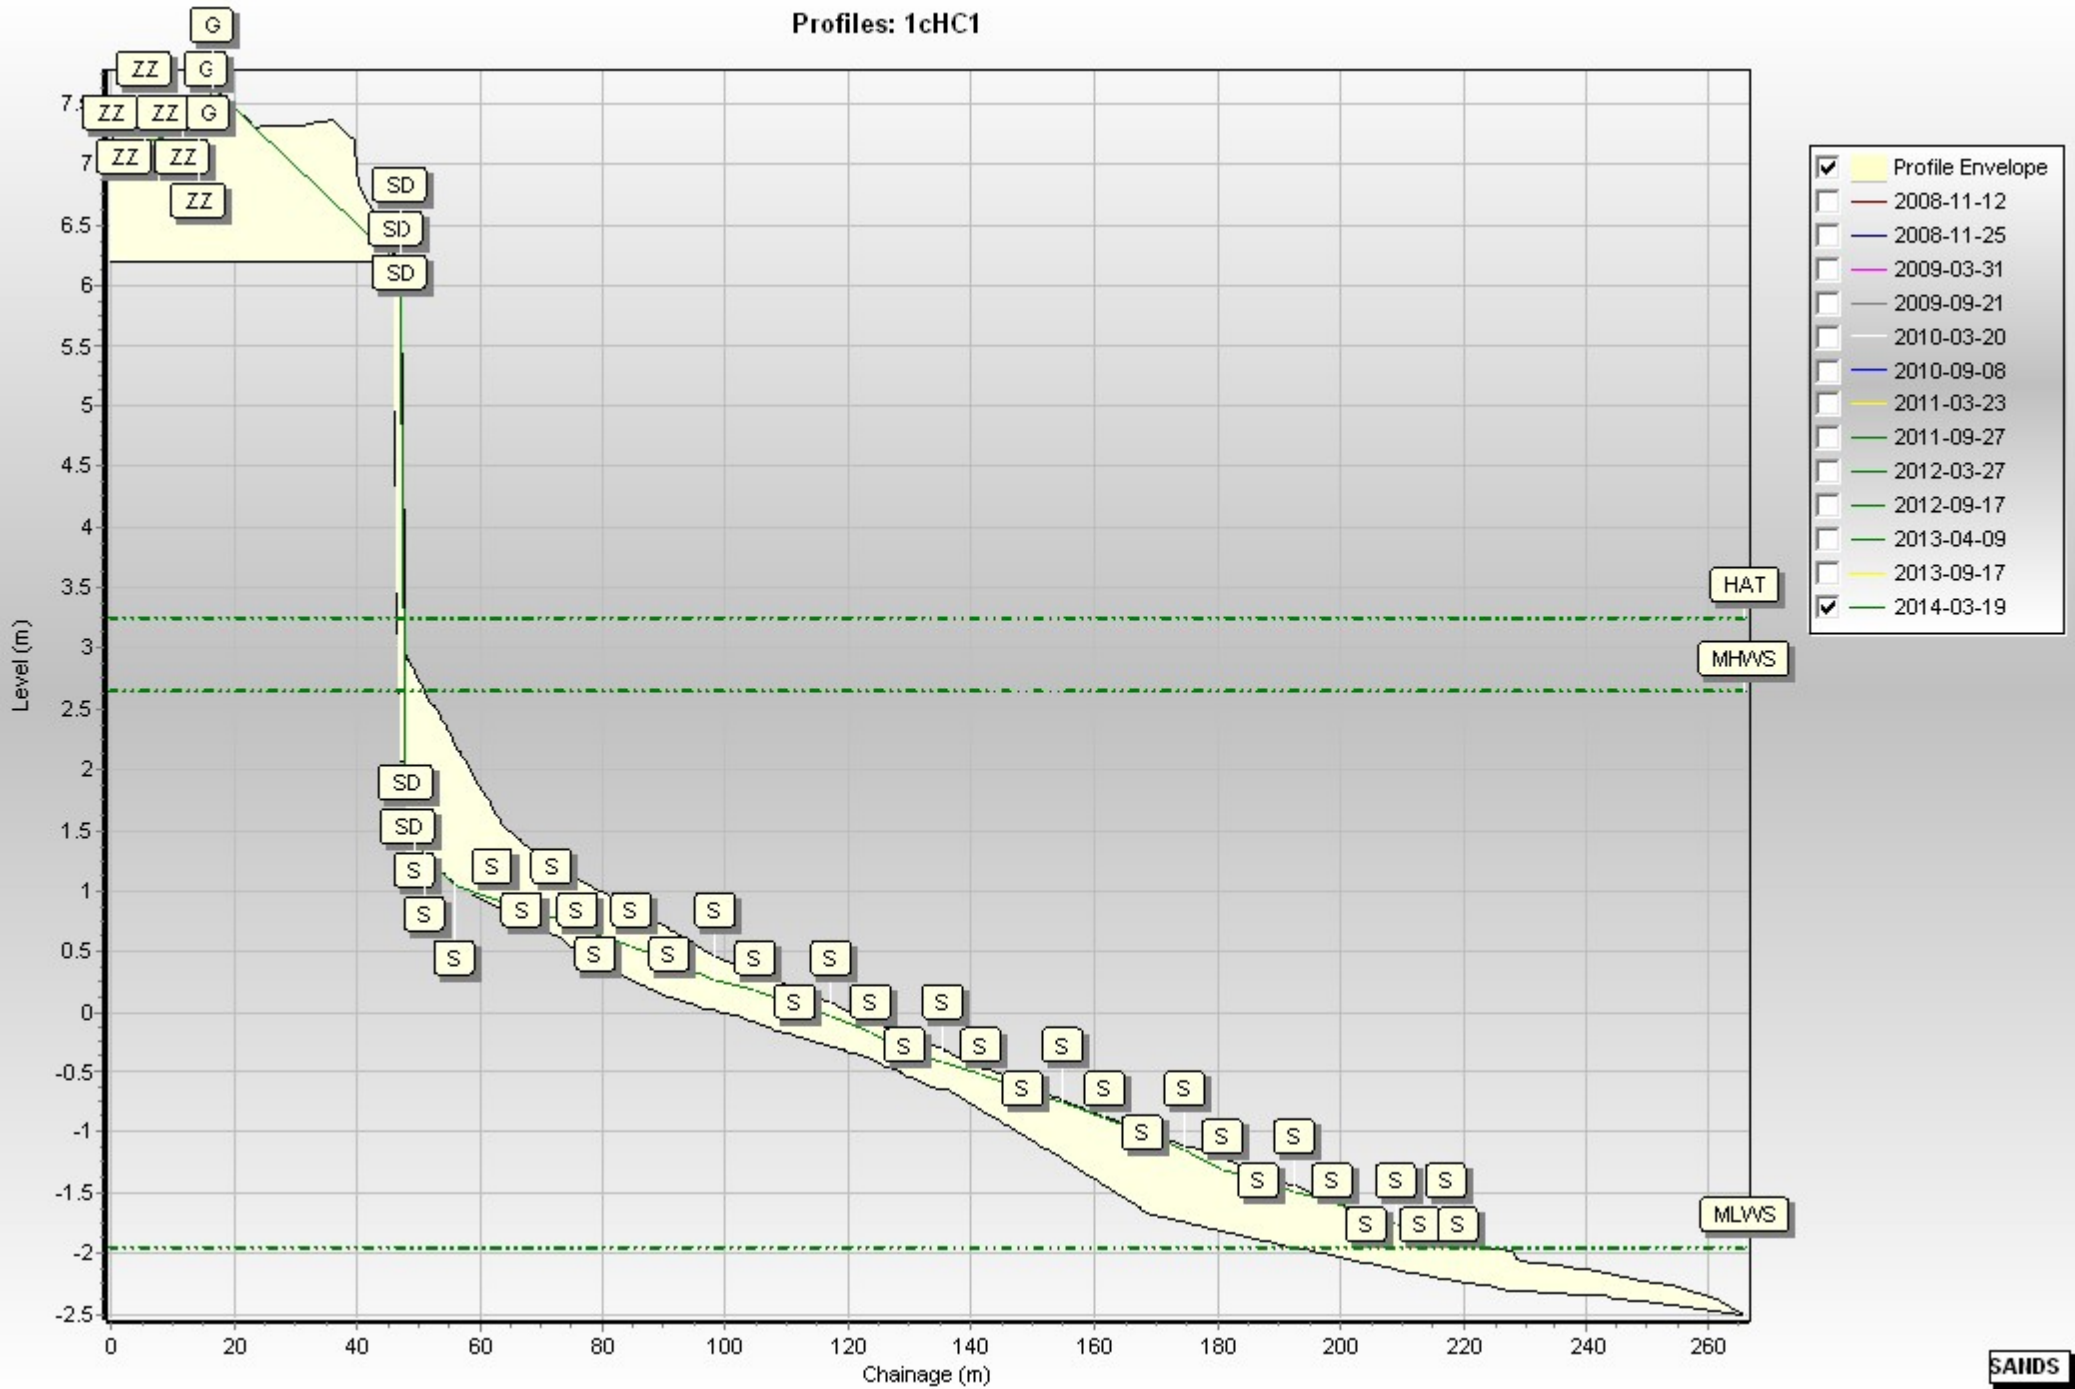
Profiles: 1cHC1

Survey Date	Description of Changes Since Last Survey	Interpretation
<p>19th March 2013</p>	<p>Beach Profiles:</p> <p>Middleton is covered by one beach profile line during the Partial Measures survey (Appendix A). The profile was last surveyed in September 2013.</p> <p>Profile 1cHC1 has eroded by around 0.8m at the toe of the sea wall since September 2013 and the extent of the erosion continues as far as 66m chainage. From 66m chainage 160m chainage the beach has accreted slightly (up to 0.4m). Between chainage 160m and the end of the survey at ca. 230m chainage, the beach profile is very similar to that recorded in September 2013.</p>	<p>The beach was at a low level compared to the previous surveys, as can be expected following winter storms and the storm surge.</p> <p>Longer term trends: The beach level at this location tends to fluctuate through the year, with the most variable area being adjacent to the sea wall where wave energy is reflected. There a pattern of seasonal variation, with lower levels typically recorded in the spring, following the period of winter storms. Recovery tends to occur by the autumn.</p>

- At Middleton the beach has eroded in its upper part adjacent to the sea wall and accreted further downslope. This level of seasonal variability is normal and there is no cause for concern

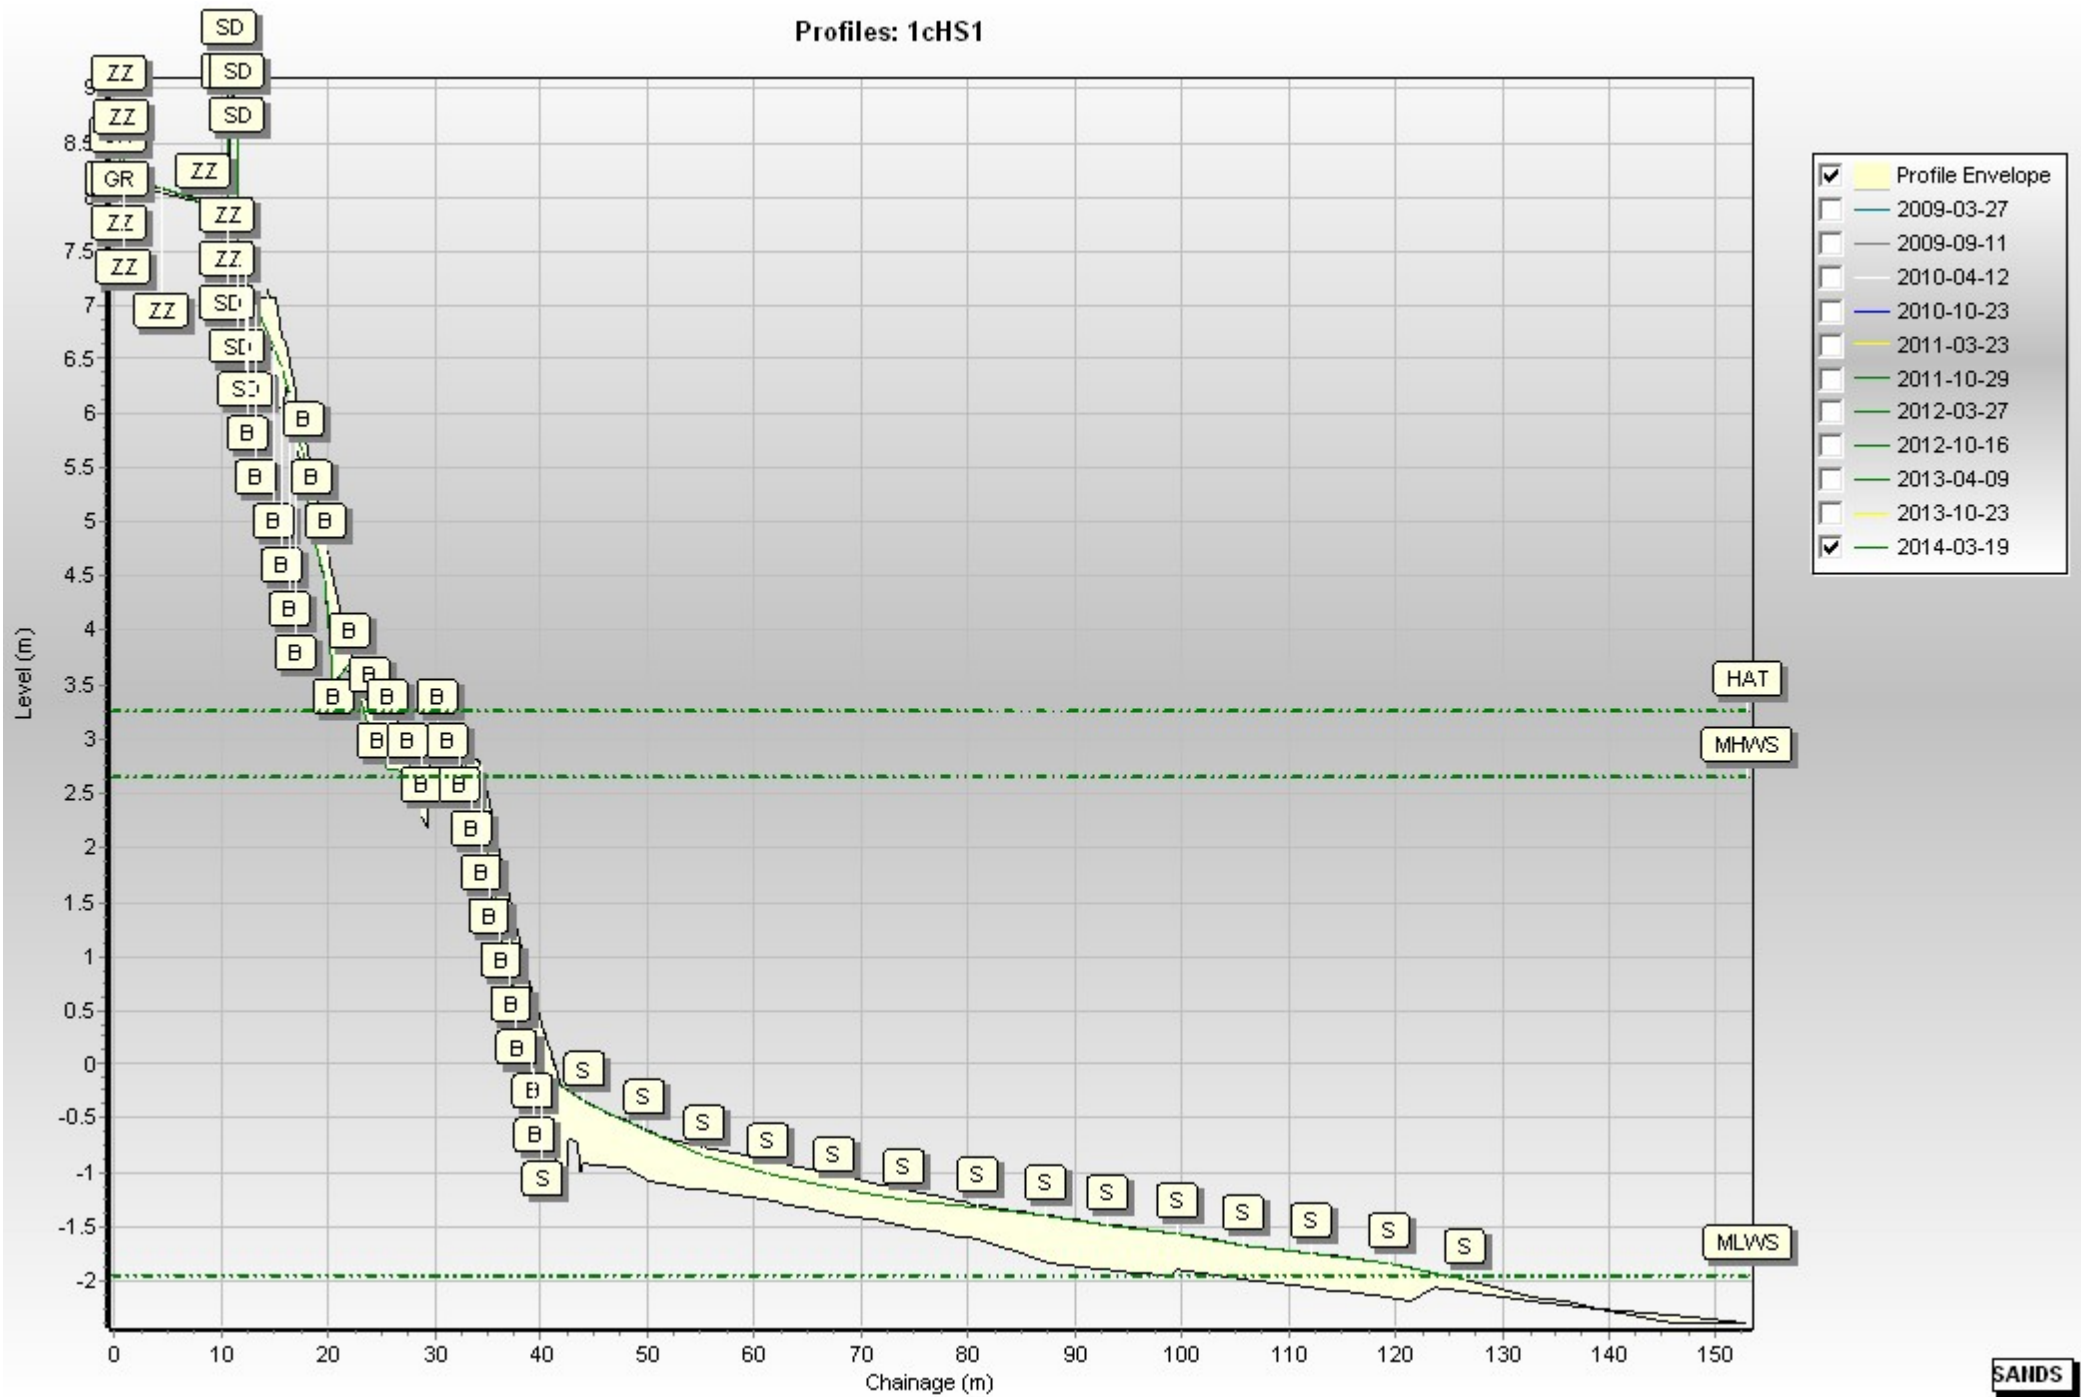
Profiles: 1cHS1

Survey Date	Description of Changes Since Last Survey	Interpretation
<p>19th March 2014</p>	<p>Beach Profiles:</p> <p>Hartlepool Bay is covered by four beach profile lines during the Partial Measures survey (Appendix A). The profiles were last surveyed in September 2013.</p> <p>Profile 1cHS1 is located c. 150m south of the root of the South Pier. The profile starts at the wall to the rear of the promenade and extends over the fronting concrete splash wall and down the sloping face of the rock armour revetment before reaching the beach. Very little change has occurred until 70m chainage since September 2013. From 70m chainage to the end of the survey at 125m the lower intertidal zone has accreted by around 0.6m.</p> <p>Profile 1cHS2 shows limited differences between the September 2013 and March 2014 surveys. The most significant is accretion of 0.4m of sand at the upper beach between the base of the rock armour at 30m chainage and 150m chainage. Limited lowering of the profile has occurred between 200m and 310m chainage. Deposition appears to have occurred between chainage 310m and 340m chainage. The overall effect of these changes is to create a consistently sloping profile with fewer variations in slope angle than in the immediately preceding surveys.</p> <p>At profile 1cHS3 there were no changes between the start of the survey and 30m chainage between March 2014 and September 2013. Between 30m and 110m chainage, the level of the beach has reduced by around 0.4m but accreted between 110m and 175m chainage by a similar amount. The lower intertidal zone has accreted by around 0.4m between 200m and 240m chainage except at the very end of the profile between 240 and 250m chainage where the profile has steepened.</p> <p>Profile 1cHS4 is located 1km north of the North Gare Breakwater, within the area of undefended dunes at Seaton Carew. The dune front has retreated by around 1m and the area between two dune ridges at c. 270m chainage and c. 320m chainage has lowered by around 0.5m. A limited amount of accretion has occurred between MHWS and 420m and there has been more substantial erosion of sand (up to 0.7m lowering of the beach profile) between 420m and 456m chainage to create the steepest profile in the mid-upper intertidal zone since monitoring began in 2009. Between 456m chainage and MLWS a substantial berm at least 1m high has appeared, pushing MLWS beyond 580m chainage and reversing the pattern of erosion of the lower intertidal zone seen since 2012.</p>	<p>The March 2014 data show that deposition or bar formation in the lower intertidal zone has occurred in all profiles, with the bar formation being most pronounced in the southerly profiles. The more southerly profiles (1cHS3 and 1cHS4) show erosion of the upper beach and dune front. This is likely due to differences in exposure to the storm surge and other winter storms.</p> <p>Longer term trends: With the exception of 1cHS4, beach levels within Hartlepool Bay in March 2014 were amongst the highest recorded in comparison to previous surveys. 1cHS4 continues to show the steep, irregular beach profile it has had since April 2013, but may flatten if surging summer waves push some of the accumulated sediment in the substantial sand bar further up the beach.</p>

- Hartlepool Bay has been subject to further steepening of the beach at its southern extent, with some erosion of the dune toe and lowering of the base of a hollow inland of the foredune. However, a substantial bar has accreted which may weld to the shore over the summer to create a more gently sloping beach. All profiles show a degree of deposition in the lower intertidal zone and with the exception of the most southerly profile (1cHS4) are relatively high in comparison to previous surveys.
