**Cell 1 Regional Coastal Monitoring Programme  
Update Report 7: 'Partial Measures' Survey 2015**

(\*) The present report is **Update Report 7** and provides an analysis of the 2015 Partial Measures survey for Hartlepool Council's frontage.

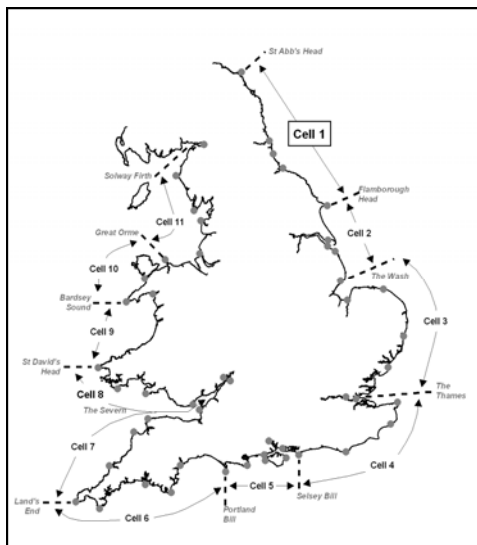
**Figure 1 Sediment Cells in England and Wales**

The Cell 1 Regional Coastal Monitoring Programme covers approximately 300km of the north east coastline, from the Scottish Border (just south of St. Abb's Head) to Flamborough Head in East Yorkshire. This coastline is often referred to as 'Coastal Sediment Cell 1' in England and Wales (Figure 1).

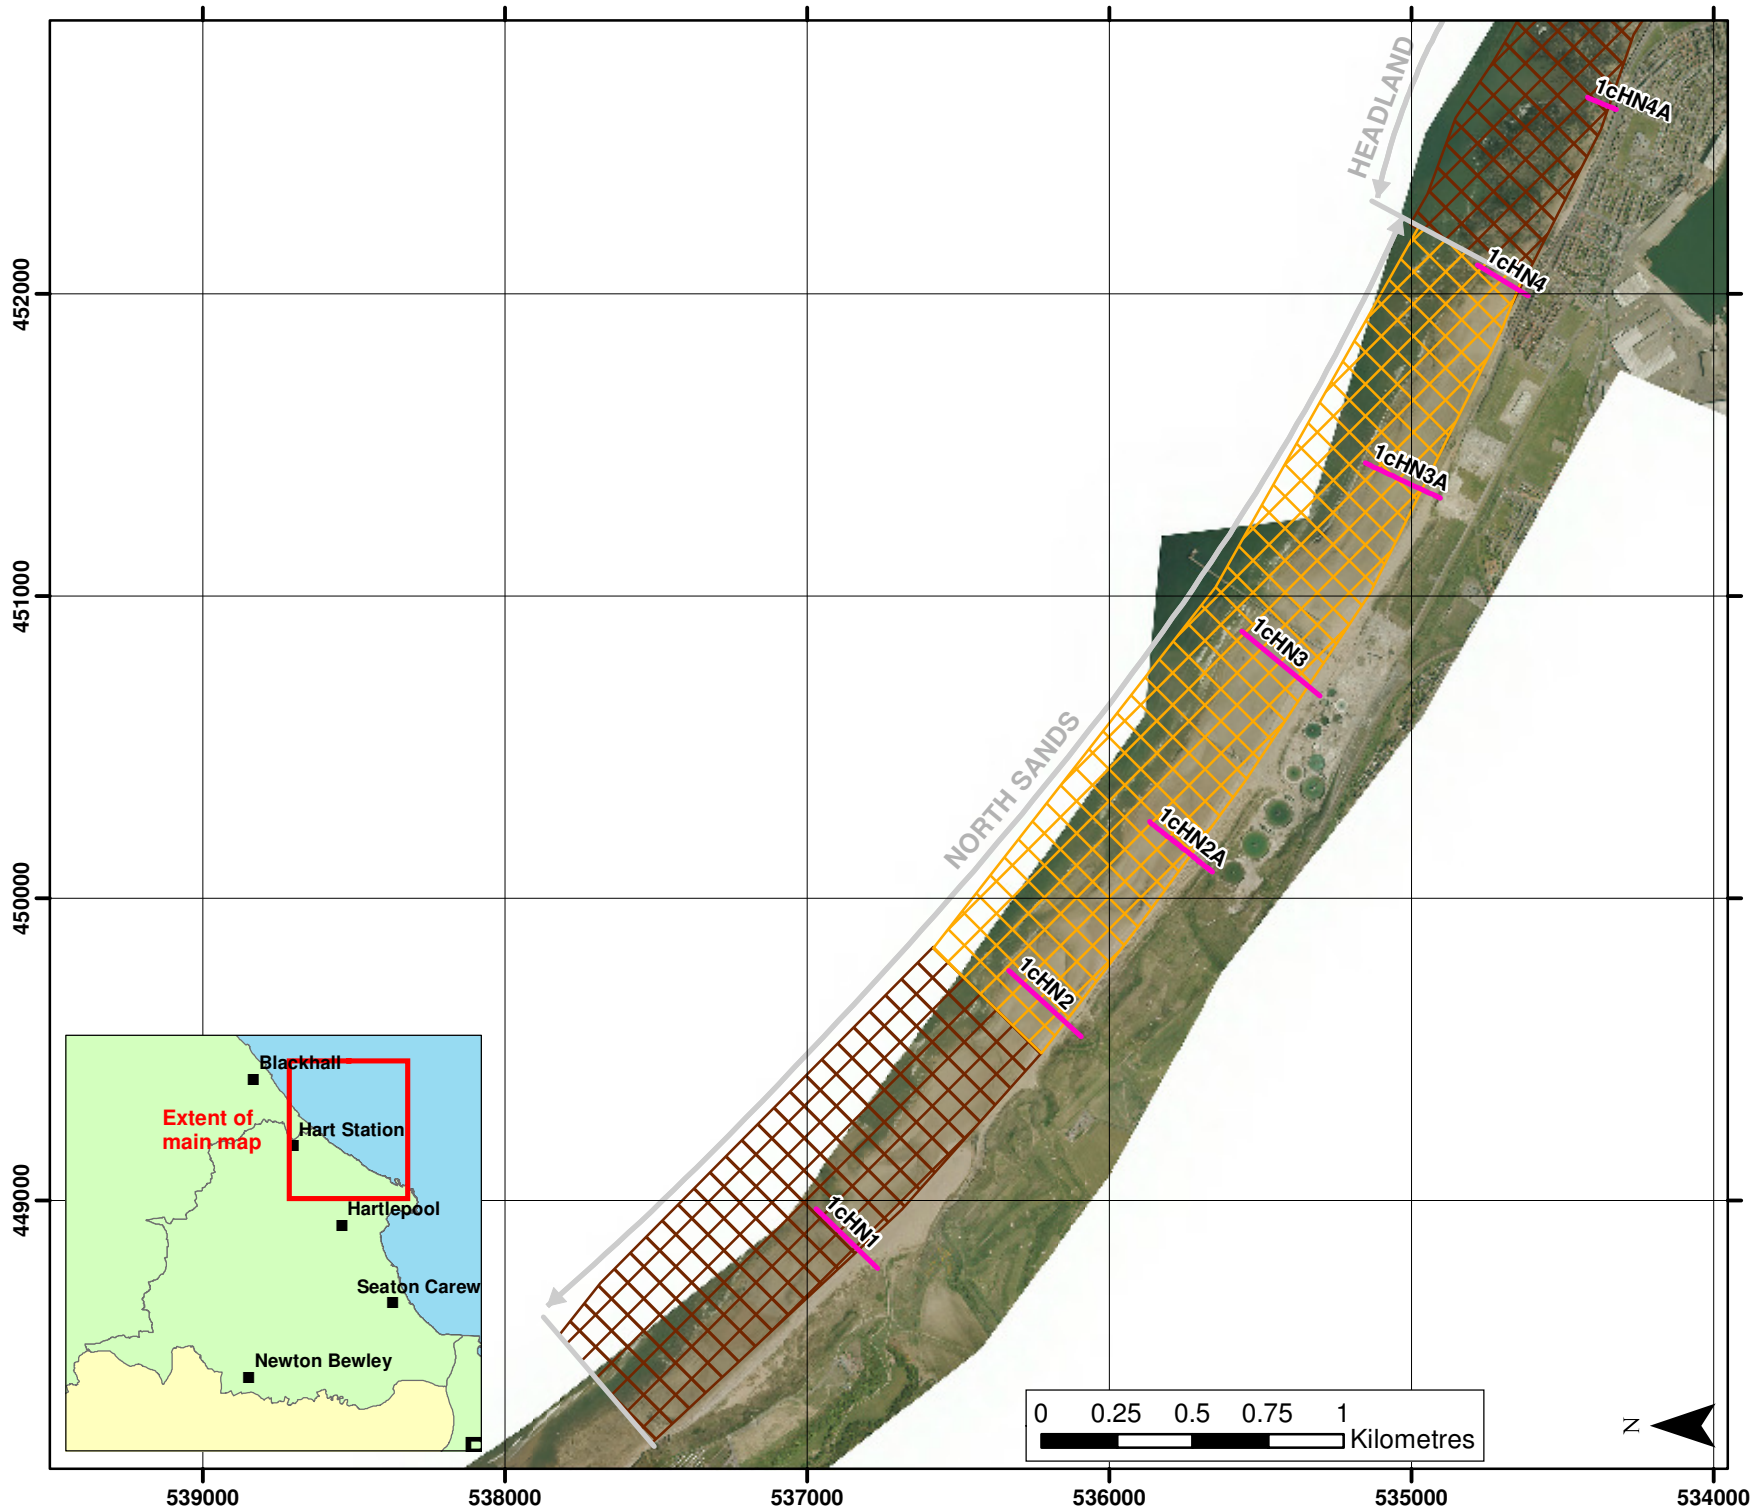
**Figure 2 - Map 1**  
**Survey Locations**  
**North Sands**  
**Hartlepool Borough Council**

The location of these surveys is shown in Figure 2. The Partial Measures survey was undertaken along this frontage between 18<sup>th</sup> and 19<sup>th</sup> April 2015. During this time weather conditions were dry and sunny. The wind was force 1 from the east or south east. The sea state was calm.

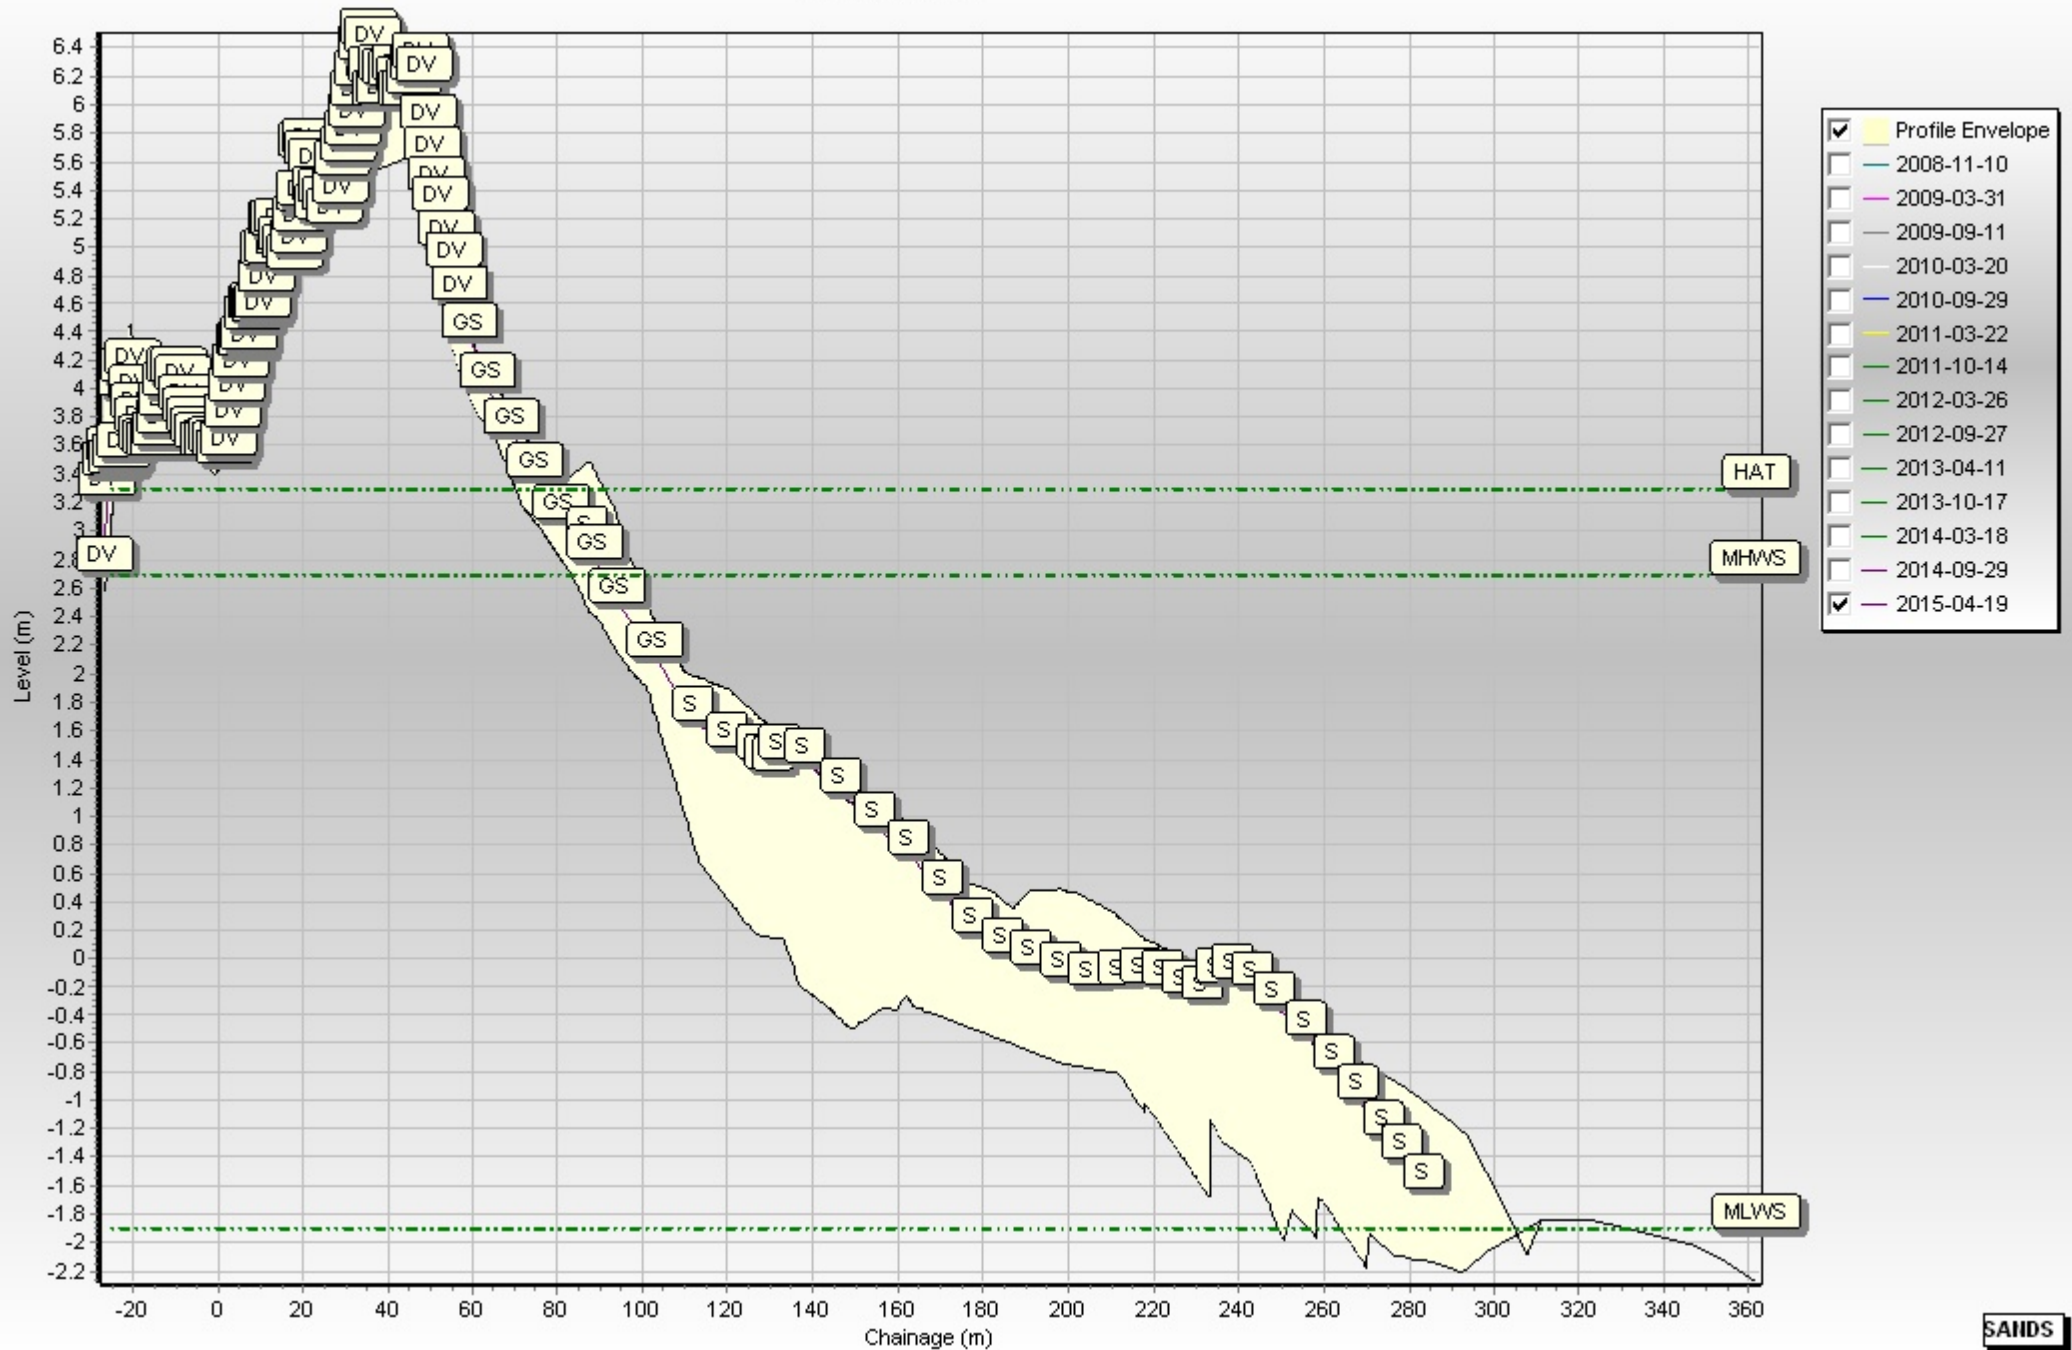
### Profiles: 1cHN1

Survey Date	Description of Changes Since Last Survey	Interpretation
19 <sup>th</sup> April 2015	<p><b>Beach Profiles:</b></p> <p>North Sands is covered by four beach profile lines during the Partial Measures survey (Appendix A) that were last surveyed in September 2012.</p> <p><b>Profile 1cHN1</b> is located within Durham County Council's jurisdiction, c. 400m north of the outfall of Crimdon Beck. It is reported here so changes can be interpreted in association with those observed elsewhere along North Sands. The beginning of the profile between 0m and 70m chainage covers dunes and has not changed. Between 70 and 135m chainage the beach has dropped by up to 0.4m since September 2014. From 135m to 170m chainage the beach level has increased by 0.2m. Between 170m and 215m chainage the beach level has reduced by 0.6m and a ridge has lost. From 215m to 280m chainage the beach level has increased of 0.6m. Together this pattern suggests migration of ridges and runnels towards MLW over the winter of 2014/15.</p> <p>Profile <b>1cHN2</b> covers dune between chainage 0 and 60m. It is stable from 0m to 60m chainage with no change to the dune front since April 2014. In the April 2014, October 2014 and the April 2015 profiles there are two ridges on the beach. The landward ridge is steep sided with an angular top between September 2014 and April 2015 the crest of the ridge had moved seaward and dropped, building out the level of the mid beach. The seaward ridge is often more curved in profile and has moved down the beach to below the MLWS level. The beach has steepened overall since September 2014, leading to an increase of beach level of up to 1.6m on the upper beach and a drop of up to 1.2m the level on the lower beach.</p> <p><b>Profile 1cHN2a</b> was established in October 2011 and runs through the dunes close to North Sands. The areas of dunes to 75m chainage has remained stable since October 2011. At 75m the dune face is stable following the large loss between October 2013 and March 2014. Overall the beach has flattened since September 2014. Between 75m and 160m chainage the level of the beach has increased by 0.5m. Between 160m and 200m chainage a mound has been created in the mid beach due to an increase in beach level of around 0.75m. From 200m chainage to the end of the profile at around 300m</p>	<p>HN1 had two ridges with a runnel in between in both the September 2014 and April 2015 profiles. The beach features had moved seaward over the winter of 2014/15, which suggests typical winter beach draw down.</p> <p>The toe of the dune in profiles HN2, 2a and 3a had been subject to large loss between October 2013 and March 2014, but since March 2014 the dune front has remained stable.</p> <p>The beach at profiles HN3 and HN3a are flat and close to the middle of the range of previous profiles. In contrast, HN4 and HN4a profiles are low with rock exposed for much of the seaward half of both profiles.</p> <p><b>Longer term trends:</b></p> <p>Following dune erosion over the winter of 2013/14 the upper beach has remained stable. There has been erosion at the toe of the defence at HN4. The fluctuation in the veneer beach continues so that parts of the shore platform in the south of the bay have become exposed.</p>

- At North Sands the beach had two ridges in September 2014 which appear to have been drawn down over the winter of 2014/15, showing seasonal variation in the beach. Since March 2014 the front of the dune in profiles HN2, 2a and 3a has remained stable. The toe of the dune in these locations had been subject to large loss between October 2013 and March 2014. In the middle of this section (profiles HN3 and HN3a) the beach is flat and close to the middle of the range of previous profiles. In the South (profiles HN4 and HN4a) the beach level is low with rock exposed for much of the seaward half of both profiles.

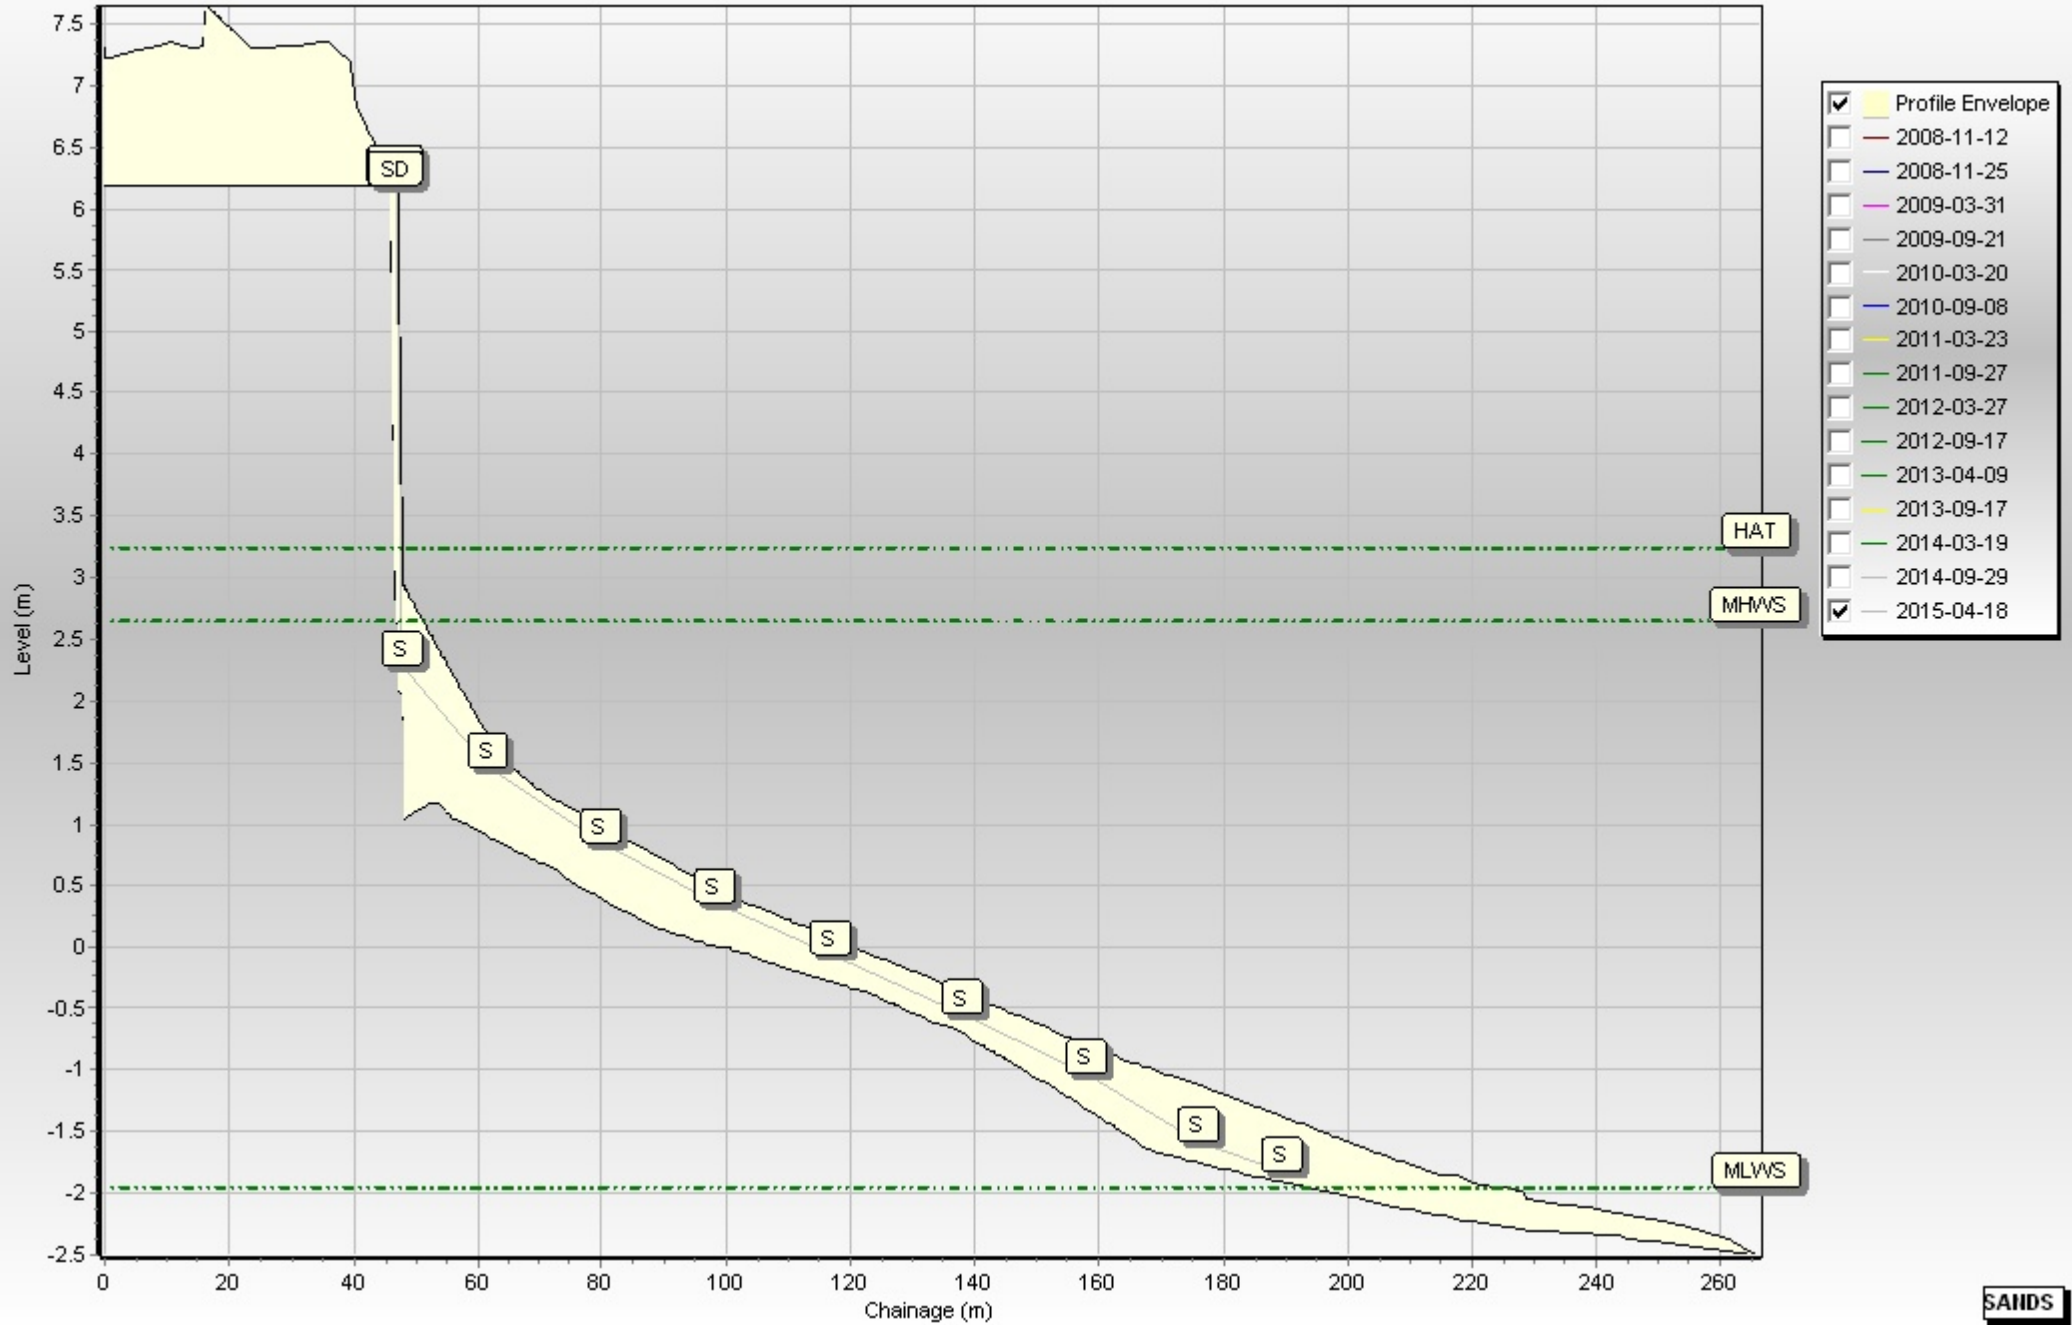
Profiles: 1cHC1

Survey Date	Description of Changes Since Last Survey	Interpretation
18 <sup>th</sup> April 2015	<p><b>Beach Profiles:</b></p> <p>Middleton is covered by one beach profile line during the Partial Measures survey (Appendix A). The profile was last surveyed in September 2014.</p> <p><b>Profile 1cHC1</b> shows little change in beach level, although it has slightly steepened overall. The top of the beach between 50m and 80m chainage accreted by 0.5m since September 2014. Between 80m and 120m chainage there has been little change in beach level. From 120m to 170m change the beach has eroded by 0.25m. From 170m chainage to the extent of the survey at 190m there is little difference in the beach level.</p>	<p>The upper part of the beach was high compared to historical levels, but the seaward part of the beach is among the lowest recorded. As a result the beach is very steep, this is likely to be due to a winter dominated by waves with a strong swash component.</p> <p><b>Longer term trends:</b> The beach level at this location tends to fluctuate through the year, with the most variable area being adjacent to the sea wall where wave energy is reflected. There a pattern of seasonal variation, with lower levels typically recorded in the spring, following the period of winter storms. Recovery tends to occur by the autumn.</p>

- At Middleton the beach is very steep. The upper part of the beach was reasonably high, but the seaward part of the beach is among the lowest recorded. The cause could be a winter dominated by waves with a strong swash component.

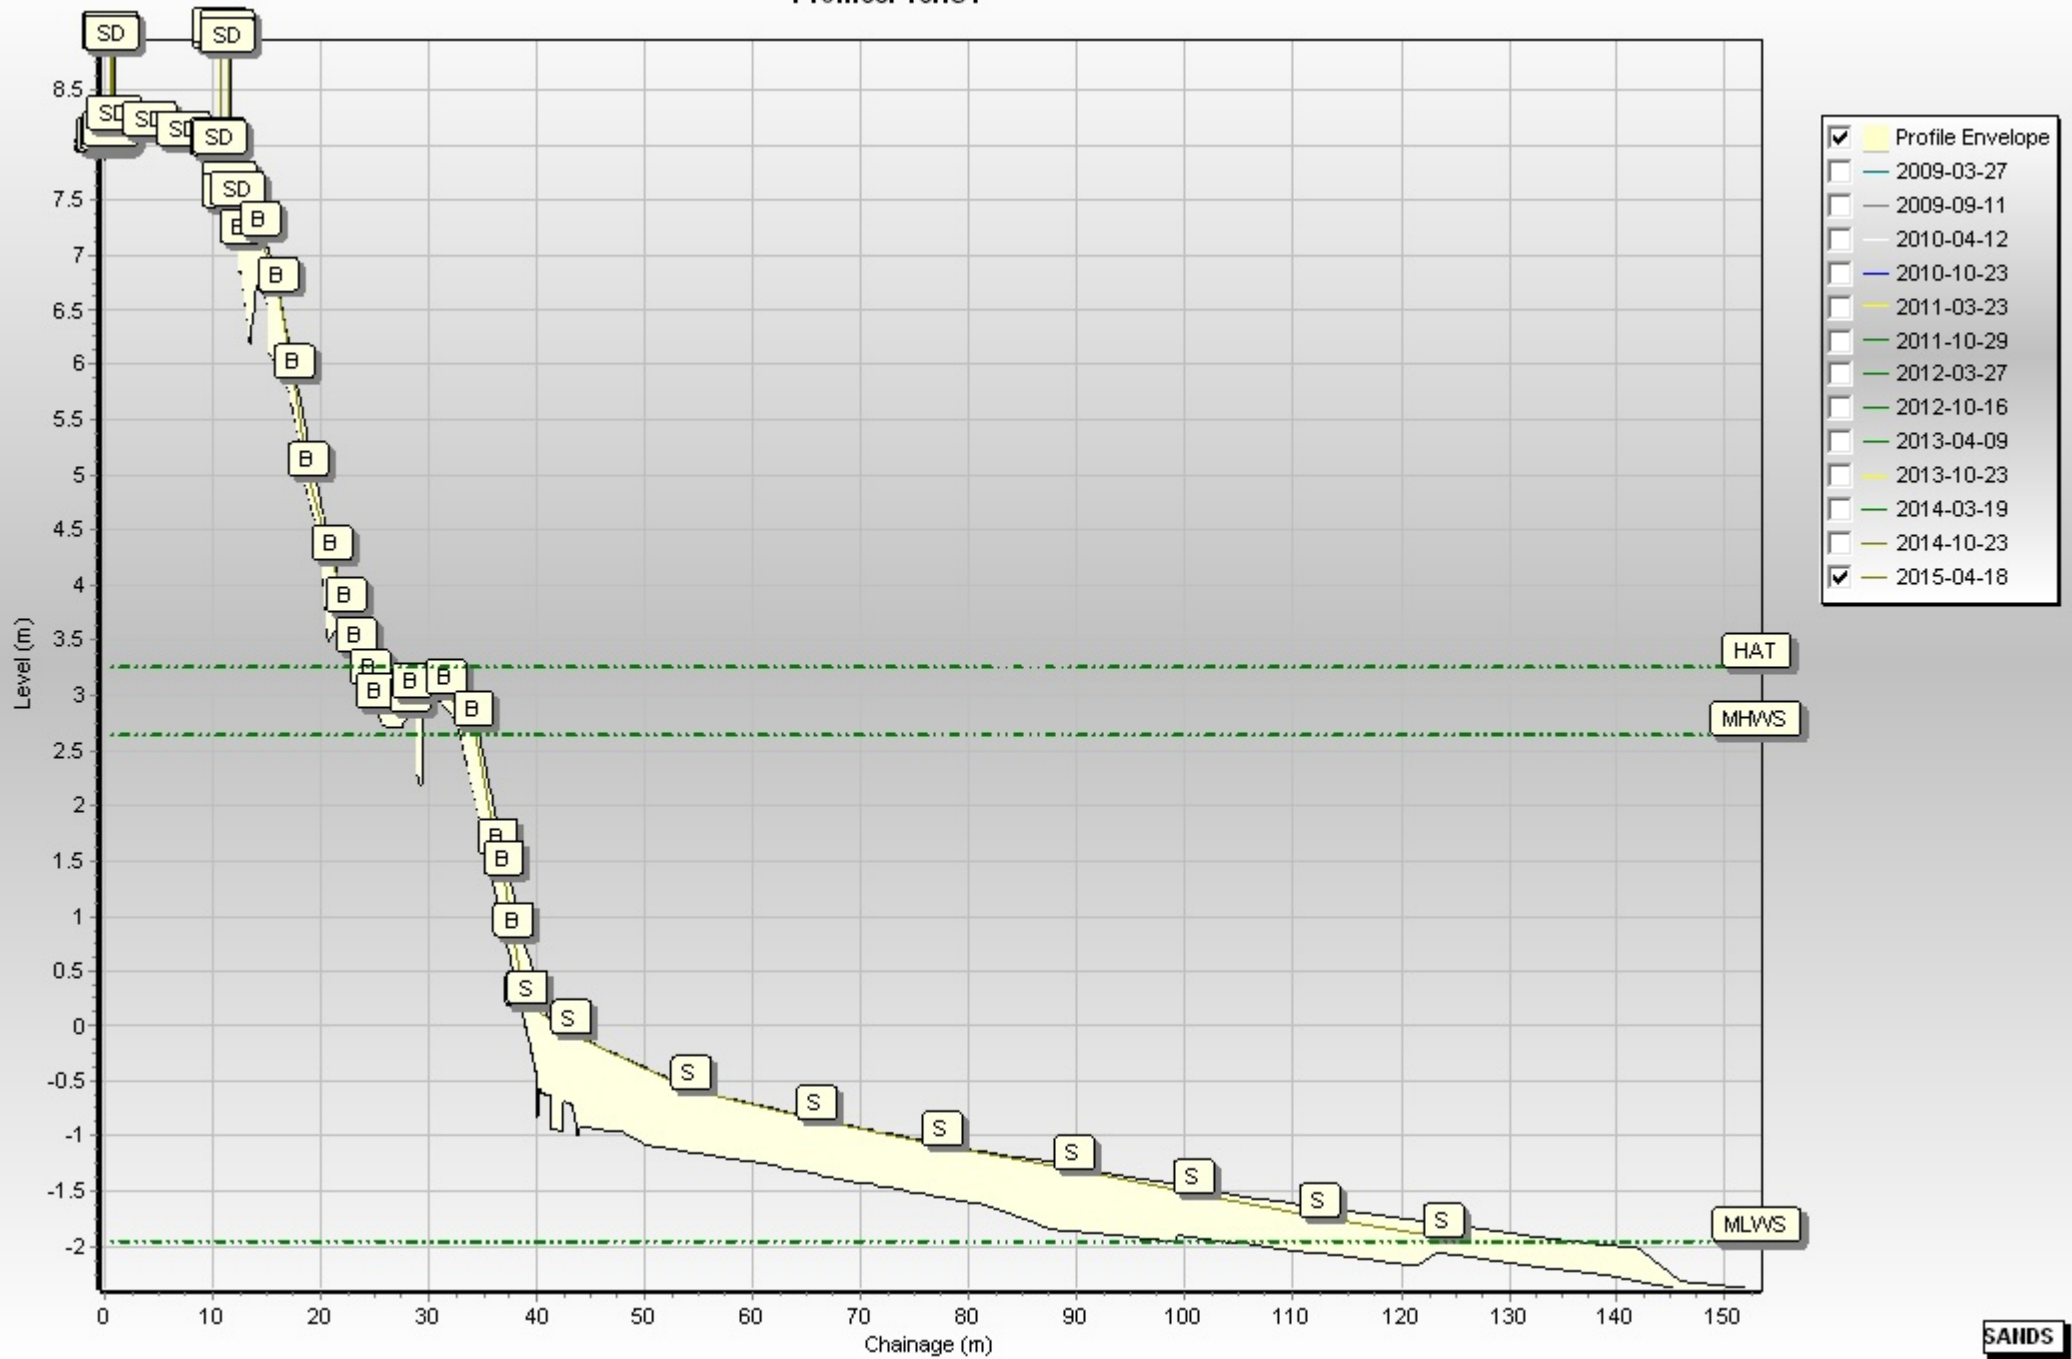
Profiles: 1cHS1

Survey Date	Description of Changes Since Last Survey	Interpretation
18 <sup>th</sup> April 2015	<p><b>Beach Profiles:</b></p> <p>Hartlepool Bay is covered by four beach profile lines during the Partial Measures survey (Appendix A).</p> <p><b>Profile 1cHS1</b> is located c. 150m south of the root of the South Pier. The profile starts at the wall to the rear of the promenade and extends over the fronting concrete splash wall and down the sloping face of the rock armour revetment before reaching the beach. Very little change has occurred until 40m chainage, which is the toe of the sea wall, since September 2014. Beyond 40m, the March 2015 profile is the highest on record. At 40m chainage the beach level is near the highest recorded and since October 2014 the beach level has also increased by up to 0.5m between 40m and 80m chainage to exceed past levels. Beyond 80m chainage to the end of the profile at 120m chainage the profile has changed very little.</p> <p><b>Profile 1cHS2</b> shows limited differences between the September 2014 and April 2015 surveys. The profile overall has steepened and is near the highest recorded. The beach between 20 and 200m chainage has remained stable. Beyond 200m chainage the beach dropped by 0.2m since October 2015.</p> <p><b>Profile 1cHS3</b> shows no changes between the start of the survey and 30m chainage between October 2014 and April 2015. From 30m to 60m chainage the beach level has increased by 0.2m since October. Between 60m and 160m chainage there has been minimal change of less than 0.2m. From 160m to the end of the survey at 260m chainage the beach level has increased by 0.4m over the winter of 2014/15. The beach profile is high compared to the previous profiles.</p> <p><b>Profile 1cHS4</b> is located 1km north of the North Gare Breakwater, within the area of undefended dunes at Seaton Carew. The part of the profile dominated by dunes, to 290m chainage has remained stable. The depression between the main body of dunes and the foredune at 300m chainage is deepening. The photographs suggesting lowering may result from footpath erosion. The crest of the foredune at 320m chainage has increased in height by 0.1m since October 2014 and 0.3m since March 2014. There is no change in the beach between 320 and 360m chainage. At 360m chainage there was a ridge of beach material above the HAT level in the March and October profiles, by April 2015 the ridge had been lost (a drop of 0.2m). From MHWS at about 390m to the end of the profile at MLWS at 580m chainage the beach has altered very little with limited accretion up to 0.2m since October 2014.</p>	<p>In April 2015 profiles HS1 and HS2 were at or near their highest level and were very steep. HS3 is also high but the gradient is similar to previous profiles. HS4 is very steep so the upper beach is among the highest of the profiles and the lower part of the beach has dropped. There profiles were very smooth with few bars or runnels.</p> <p>The dunes at 1cHS4 are in good condition. The foredune continues to accrete but erosion associated with a walkway is causing localised lowering that may affect stability of the wider dune system in the long term.</p> <p><b>Longer term trends:</b> Beach levels within Hartlepool Bay in April 2015 were amongst the highest recorded in comparison to previous surveys. The beach levels have been progressively increasing across the bay. The steepening of the beach is likely to be due to the swash dominated conditions during the winter of 2014/15.</p>

- Hartlepool Bay has been subject to further accretion and steepening of the beach. All of the profiles are flat, with no bars or ridges. The dunes at the southern end of the bay are stable but people walking over them may affect their stability long term.
