**Cell 1 Regional Coastal Monitoring Programme
Update Report 11: 'Partial Measures' Survey 2019**

(*) The present report is **Update Report 11** and provides an analysis of the 2019 Partial Measures survey for Hartlepool Council's frontage.

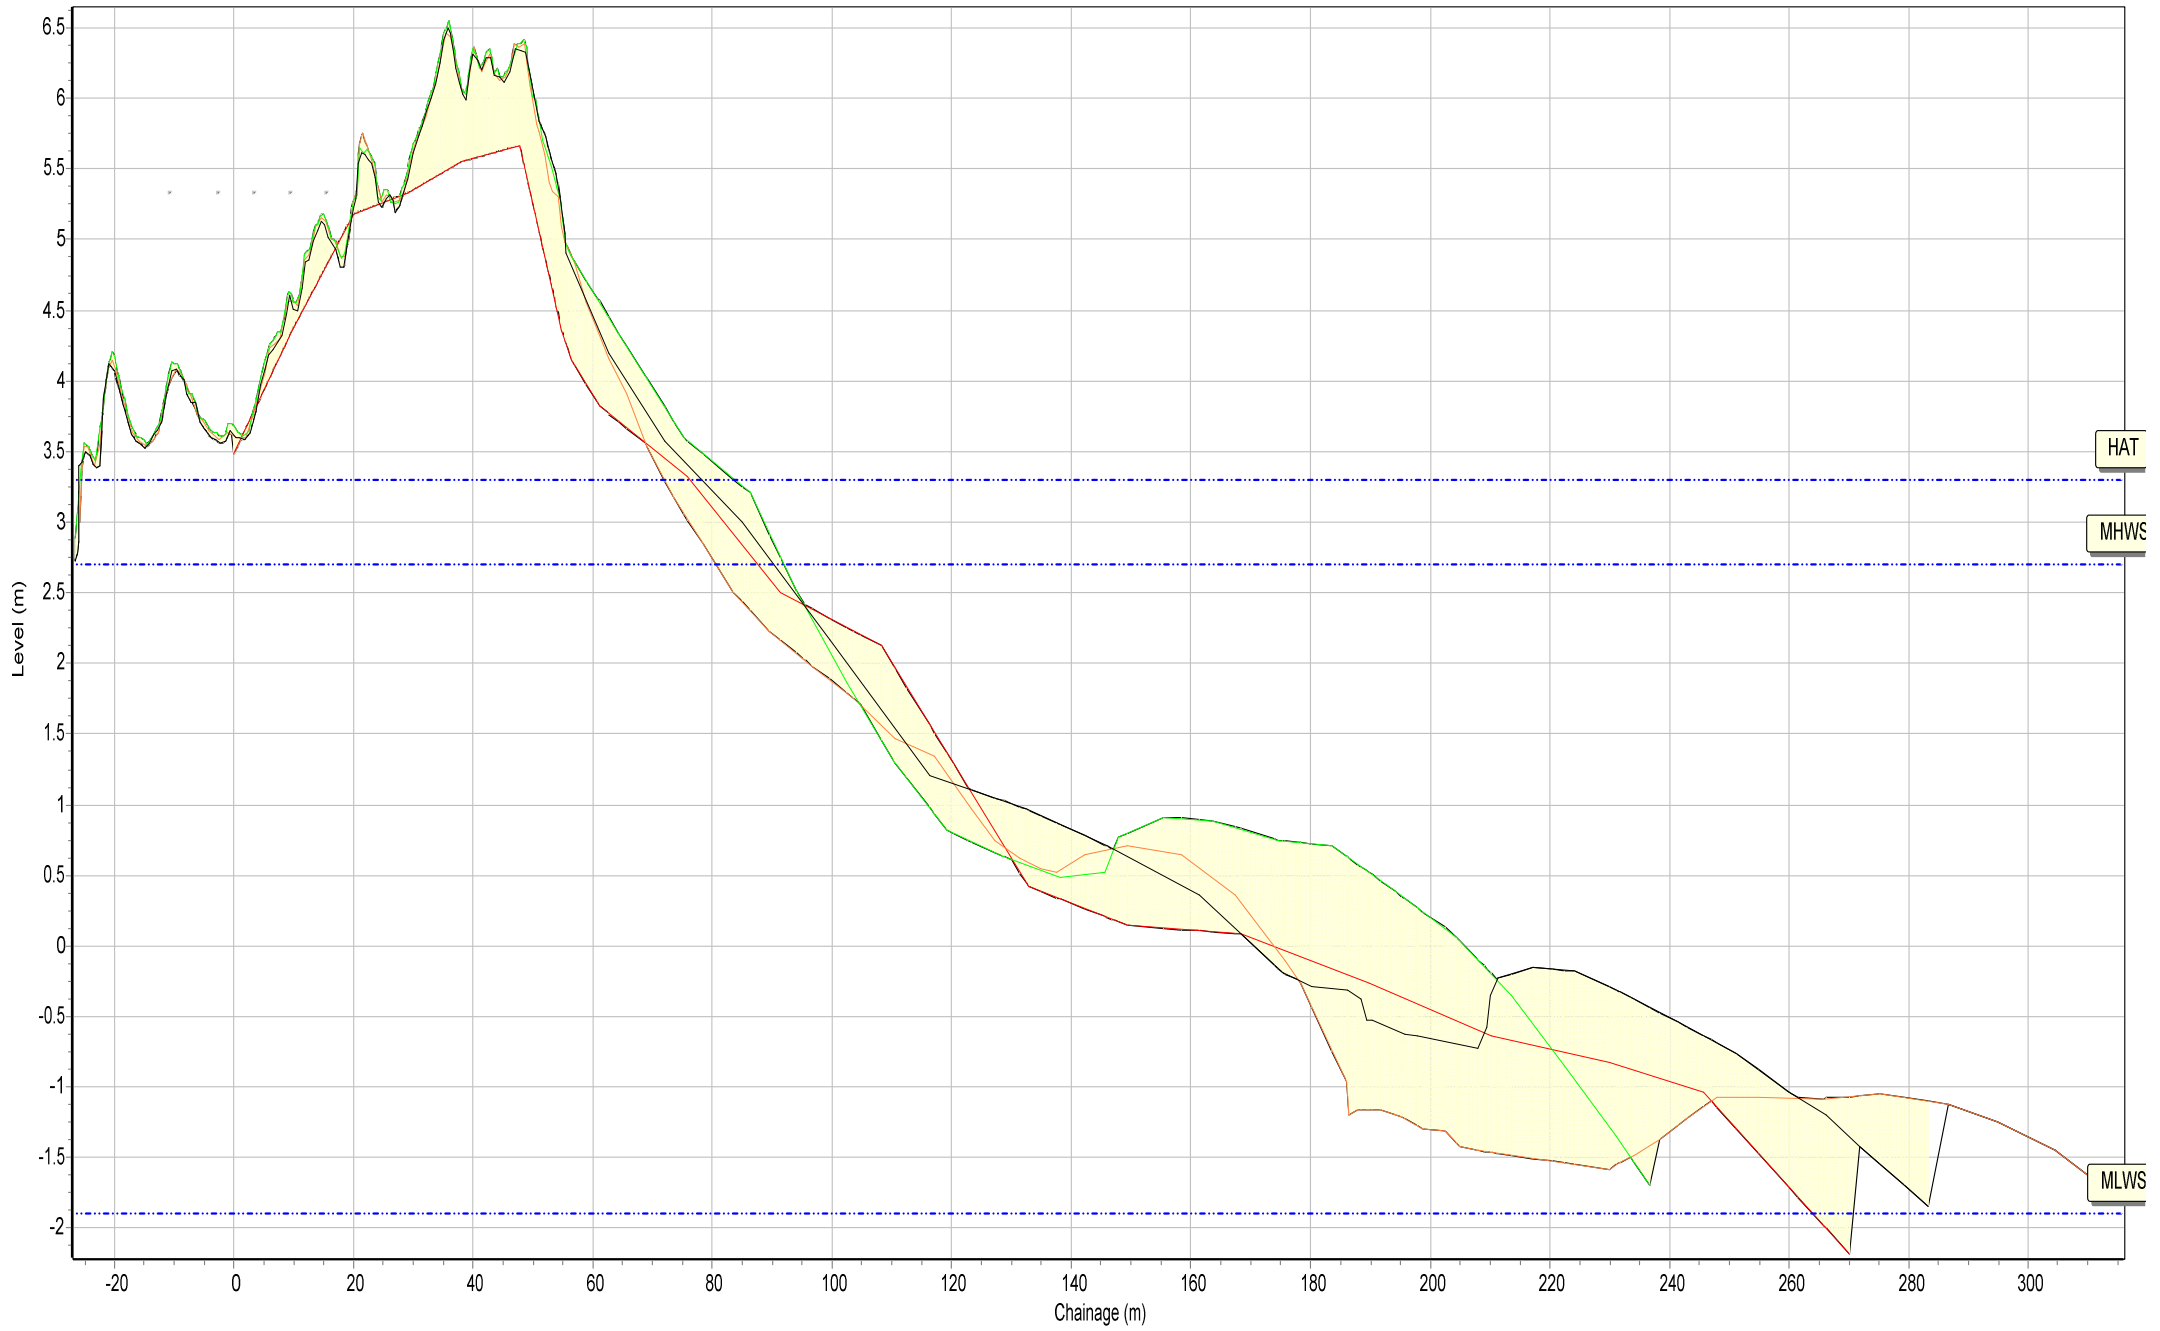
Beach Profiles: 1cHN1

Survey Date	Description of Changes Since Last Survey	Interpretation
<p>21st February 2019</p>	<p>Beach Profiles:</p> <p>North Sands is covered by six beach profile lines during the Partial Measures survey (Appendix A) that were last surveyed in August 2018.</p> <p>Profile 1cHN1 is located within Durham County Council's jurisdiction, c. 400m north of the outfall of Crimdon Beck. It is reported here so changes can be interpreted in association with those observed elsewhere along North Sands.</p> <p>The beginning of the profile between 0m and 65m chainage covers dunes and has not changed since the previous survey. There have been varying amounts of erosion and accretion across the rest of the profile. A small degree of accretion has occurred on the upper beach. However, the largest area of accretion (up to 1.3m) has occurred between chainage 210m and 260m, where a sizeable high berm has formed. The area of greatest erosion occurs seaward from chainage 260m to the end of the survey at 280m. Berms in the mid reach of the profile (chainage 140m to 185m) which were reported in the previous partial measure survey report have flattened. Overall the profile is at a medium level compared to the range recorded from previous surveys, although it is at a higher level in the vicinity of the mid beach berm.</p> <p>Profile 1cHN2 covers the dune between chainage 0 and 50m. From chainage 55m to 210m the beach level has increased by up to 1.3m since March 2018. The lower beach seawards of chainage 200m has eroded by up to 1.0m. The profile now lies at the lowest limit of the profile envelope seaward of this point. MLWS now lies at chainage 210m, its most landward position on record. There has been a small volume of accretion on the upper beach towards the toe of the dunes. The accretion which occurred over the summer of 2018 between chainage 120m to 180m has decreased slightly with the crest of this mid-beach berm moving seawards and decreasing in level. The beach profile is at its lowest recorded level in the lower beach compared to the range recorded from previous surveys, low-medium in the middle beach, and medium in the upper beach.</p>	<p>The profiles are at or near the lowest elevation, particularly in the upper beach, with platforms exposed. This pattern is typical of winter conditions.</p> <p>Longer term trends:</p> <p>Following dune erosion over the winter of 2013/14 the areas with dunes have remained stable. At HN1 and 2 the beach levels are low-medium compared with previous years. At HN2a the beach is in the middle of the range of profiles showing likely seasonal fluctuation.</p> <p>At profiles HN3a, 4 and 4a the beach is low compared with previous profiles for at least some of the profile. The fluctuation in the veneer beach continues so that parts of the shore platform in the south of the bay have become exposed.</p>

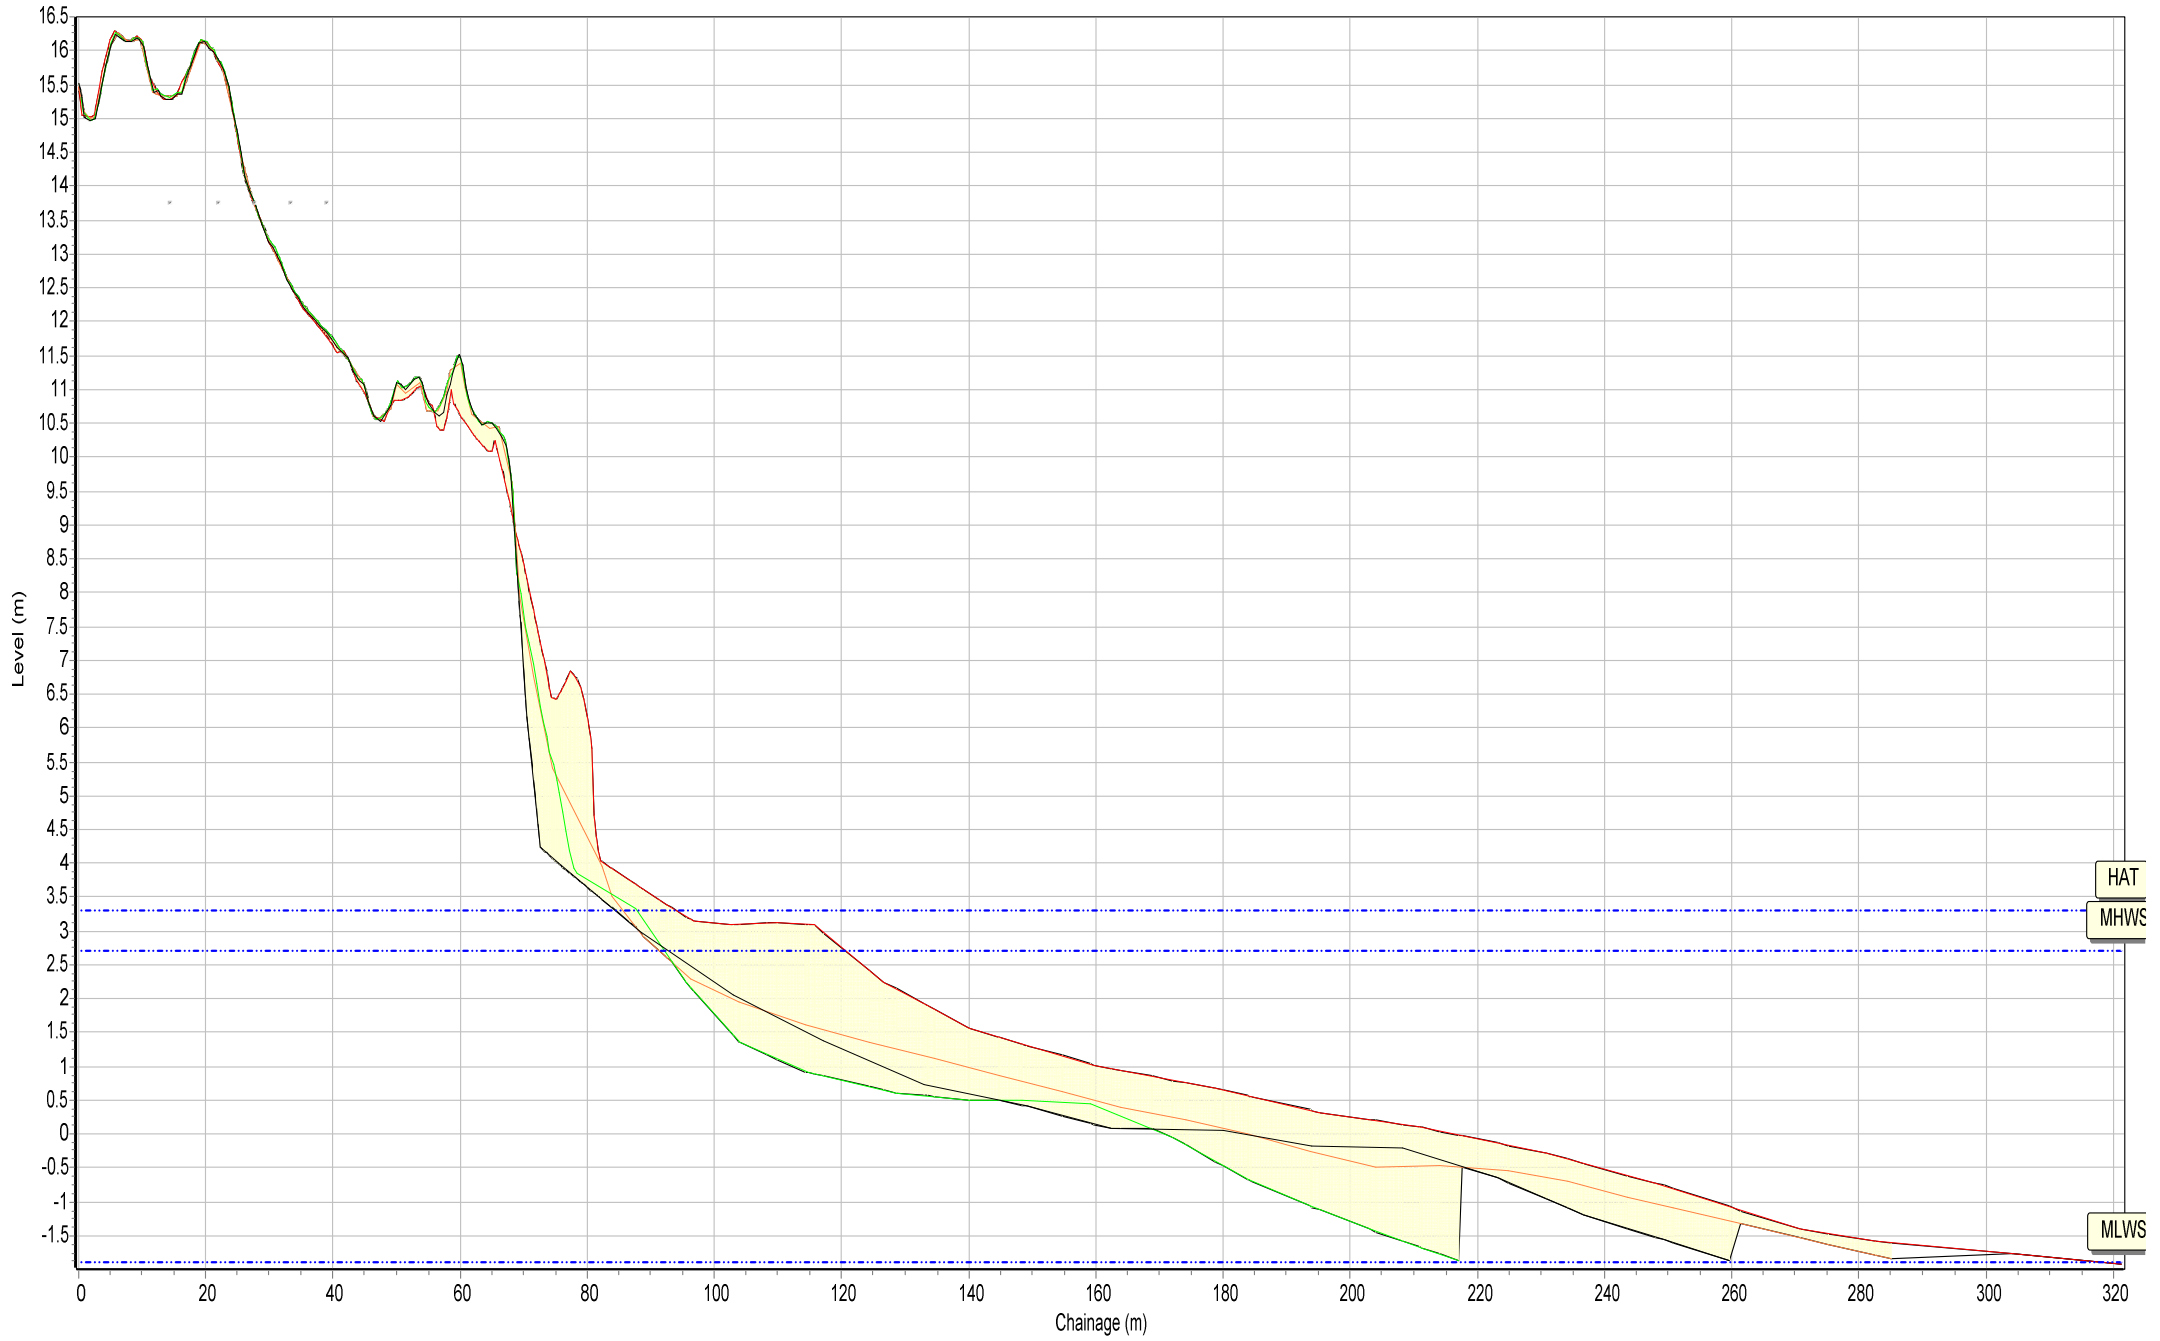
Beach Profiles: 1cHN2A

Survey Date	Description of Changes Since Last Survey	Interpretation
	<p>Profile 1cHN2A was established in October 2011 and runs through the dunes close to North Sands. The area of dunes between 0m and 70m chainage has remained reasonably stable. Between 70m and 80m the toe of the foredunes has retreated by approximately six metres over the winter of 2018. This dune face is now at its most landward position following 12m of erosion since 2011. The beach profile shows accretion of up to 0.3m on the upper beach between chainage 100m and 140m, and up to 1.0m on the lower beach between chainage 180m and 220m. Seaward of chainage 220m the beach profile has shown accretion of up to 0.40m. Since 2011 erosion at the toe of the beach has moved MLWS landwards by around 60m. Overall the beach is at a low-medium level compared to the range recorded from previous surveys, having shown some recovery in the lower and mid reaches, despite further losses to the upper beach and dune face.</p> <p>At Profile 1cHN3 there has been little change to the dunes. The upper beach between chainage 40m and 70m has experienced some accretion of up to 0.3m. Between chainage 70m and 200m the beach has eroded slightly by up to 0.45m. The toe of the beach seawards of 200m shows some accretion of 0.7m. The profile is at its lowest recorded level between chainage 70m and 130m, similarly from chainage 155m to 200m. The remainder of the profile is at a low level compared to the range recorded from previous surveys.</p> <p>At Profile 1cHN3A the dune front at 20m chainage has remained stable. There has been erosion of up to 0.4m at the toe of the dunes, from chainage 25m to 45m. The general trend across the profile is of erosion of up to 1.5m. The exception is between chainage 95m and 130m where there has been accretion of up to 0.4m. Due to losses from the lower beach, MLWS falls at chainage 185m, rather than around chainage 250m. The beach is at its lowest recorded level between chainage 60m and 80m, and seawards of chainage 140m. The mid beach also remains at a low level compared to the range recorded from previous surveys, despite some accretion over the winter period.</p> <p>Profile 1cHN4 shows no change in the defended part of the profile. Between chainage 15m and 50m the sandy upper beach returned over the summer of 2018 and has only sustained some minor losses throughout the winter of up to 0.3m. The general trend across the upper and mid beach (between 50m and 110m chainage) is that the bed rock remains covered by around 0.3m of sand, however there appears to be the occasional rocky outcrop which remains exposed. From chainage 110m to the end of the survey at 200m chainage the rocks at the bottom of the beach are exposed, which is common for this profile. Overall the profile is at a low level compared to the range recorded from the previous</p>

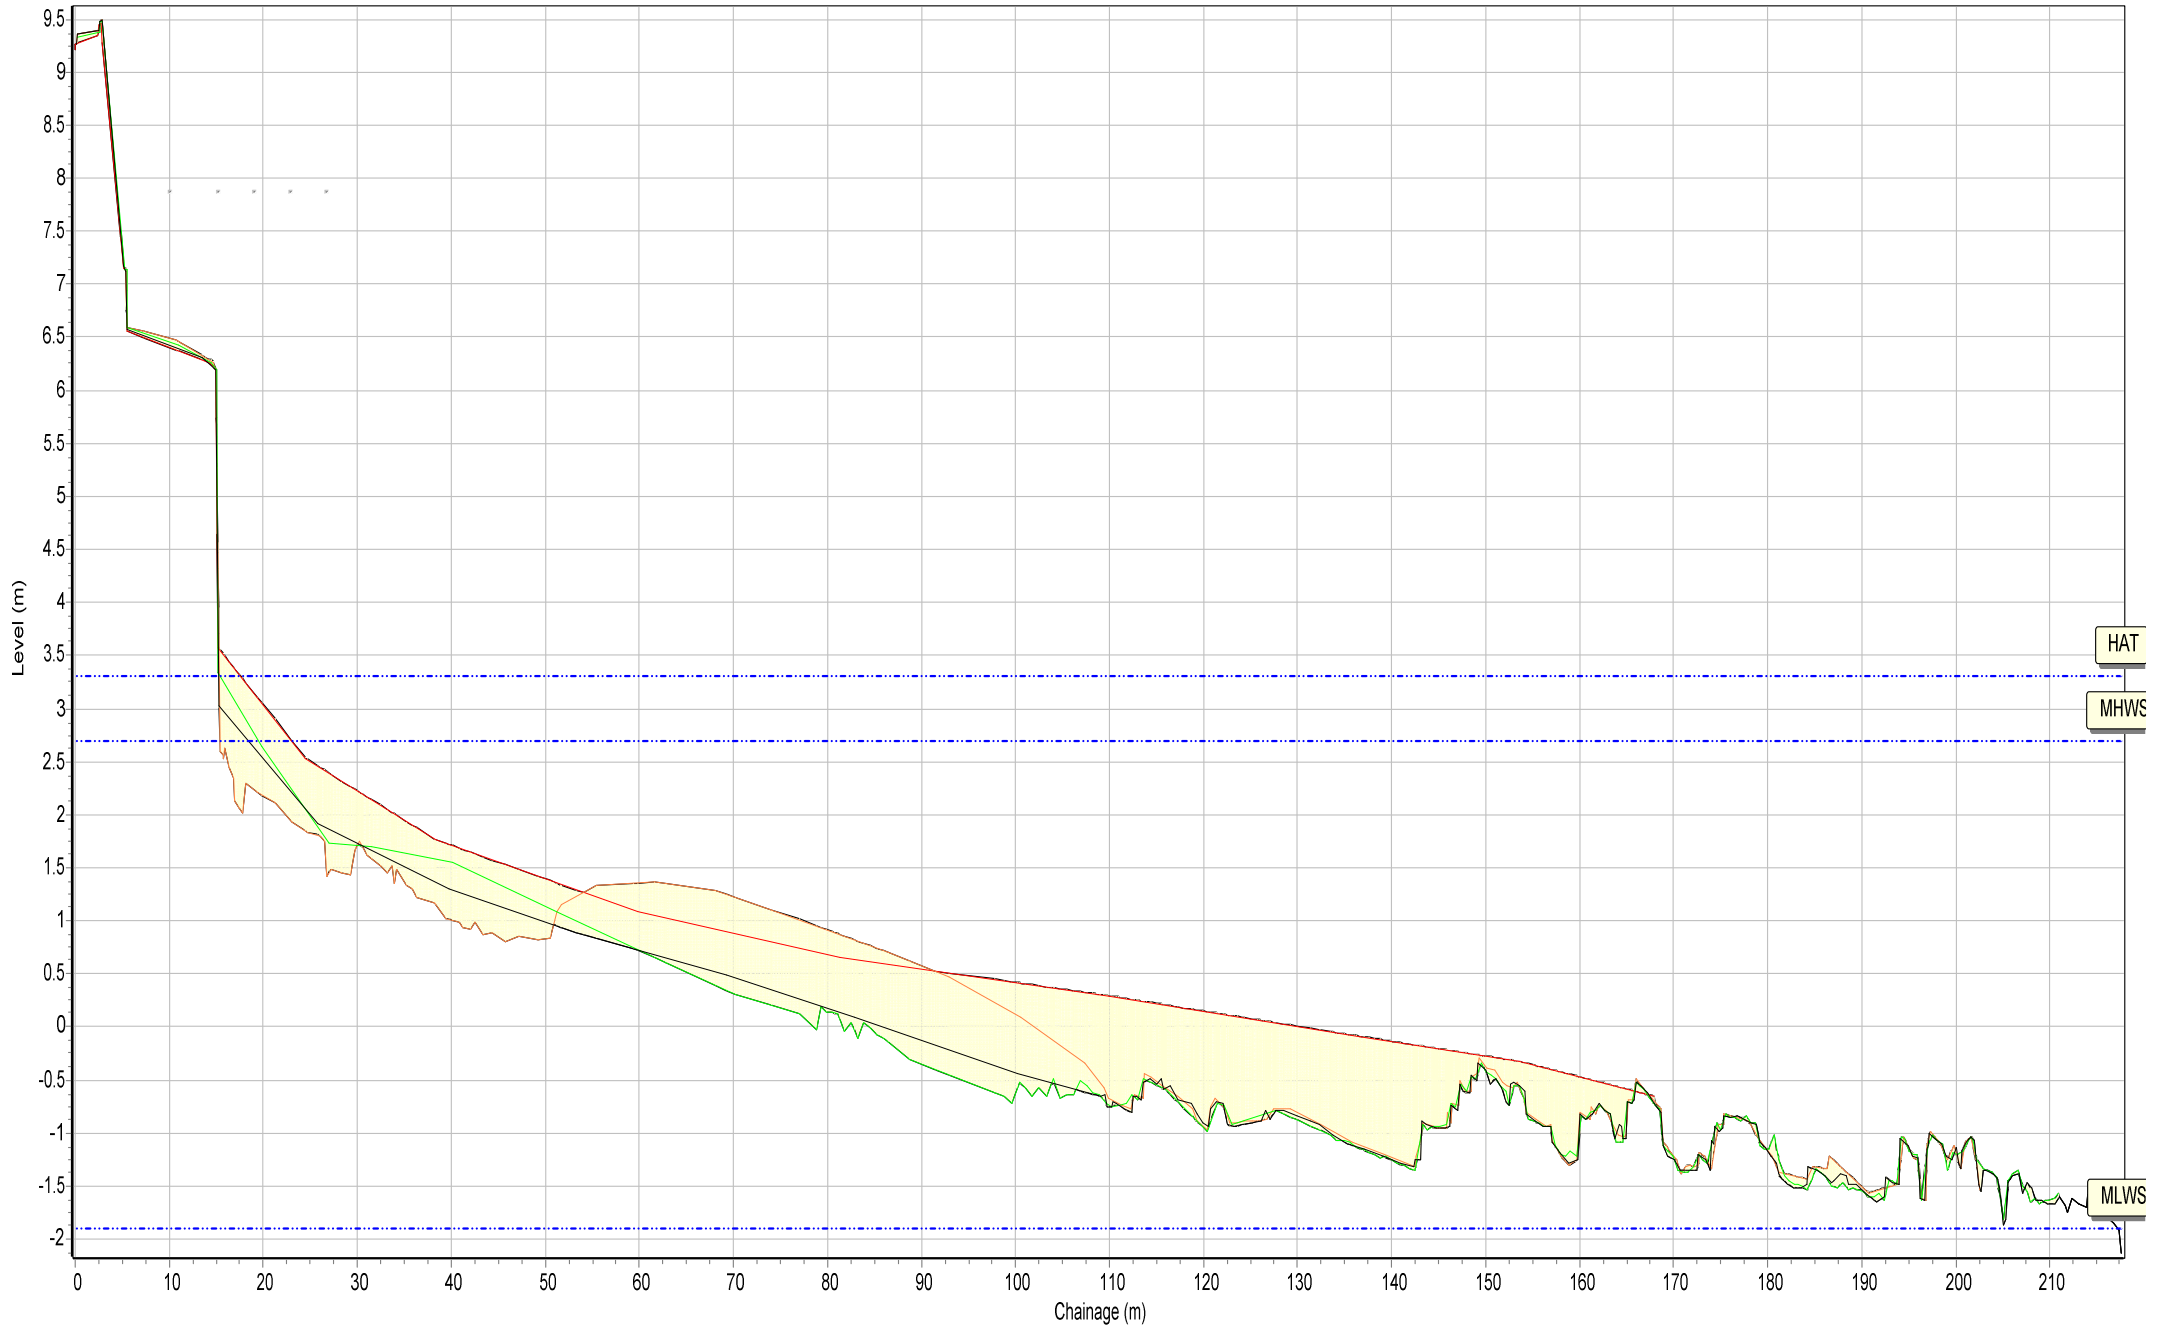
Beach Profiles: 1cHN4

- At Hartlepool North construction work which has in recent surveys restricted access to the upper reaches of profiles 1cHN4 and 1cHN4A is now complete meaning these profiles were surveyed in full. The construction works comprised of a seawall encasement and new capstone resulting in a seaward movement of the seawall by approximately 1.2m.
- At Hartlepool Central a damaged fence along the crest of the brickwork seawall means that access was restricted to the upper reaches of profile 1cHC1
- The rest of the survey was completed without incident.

- At North Sands the dunes are stable, and the beaches are healthy, although the sand depletes as you move east towards the headland, with HN4 showing an exposure of the wave cut platform. The profiles are at or near the lowest elevation, particularly in the upper beach, with platforms exposed. This pattern is typical of winter conditions.

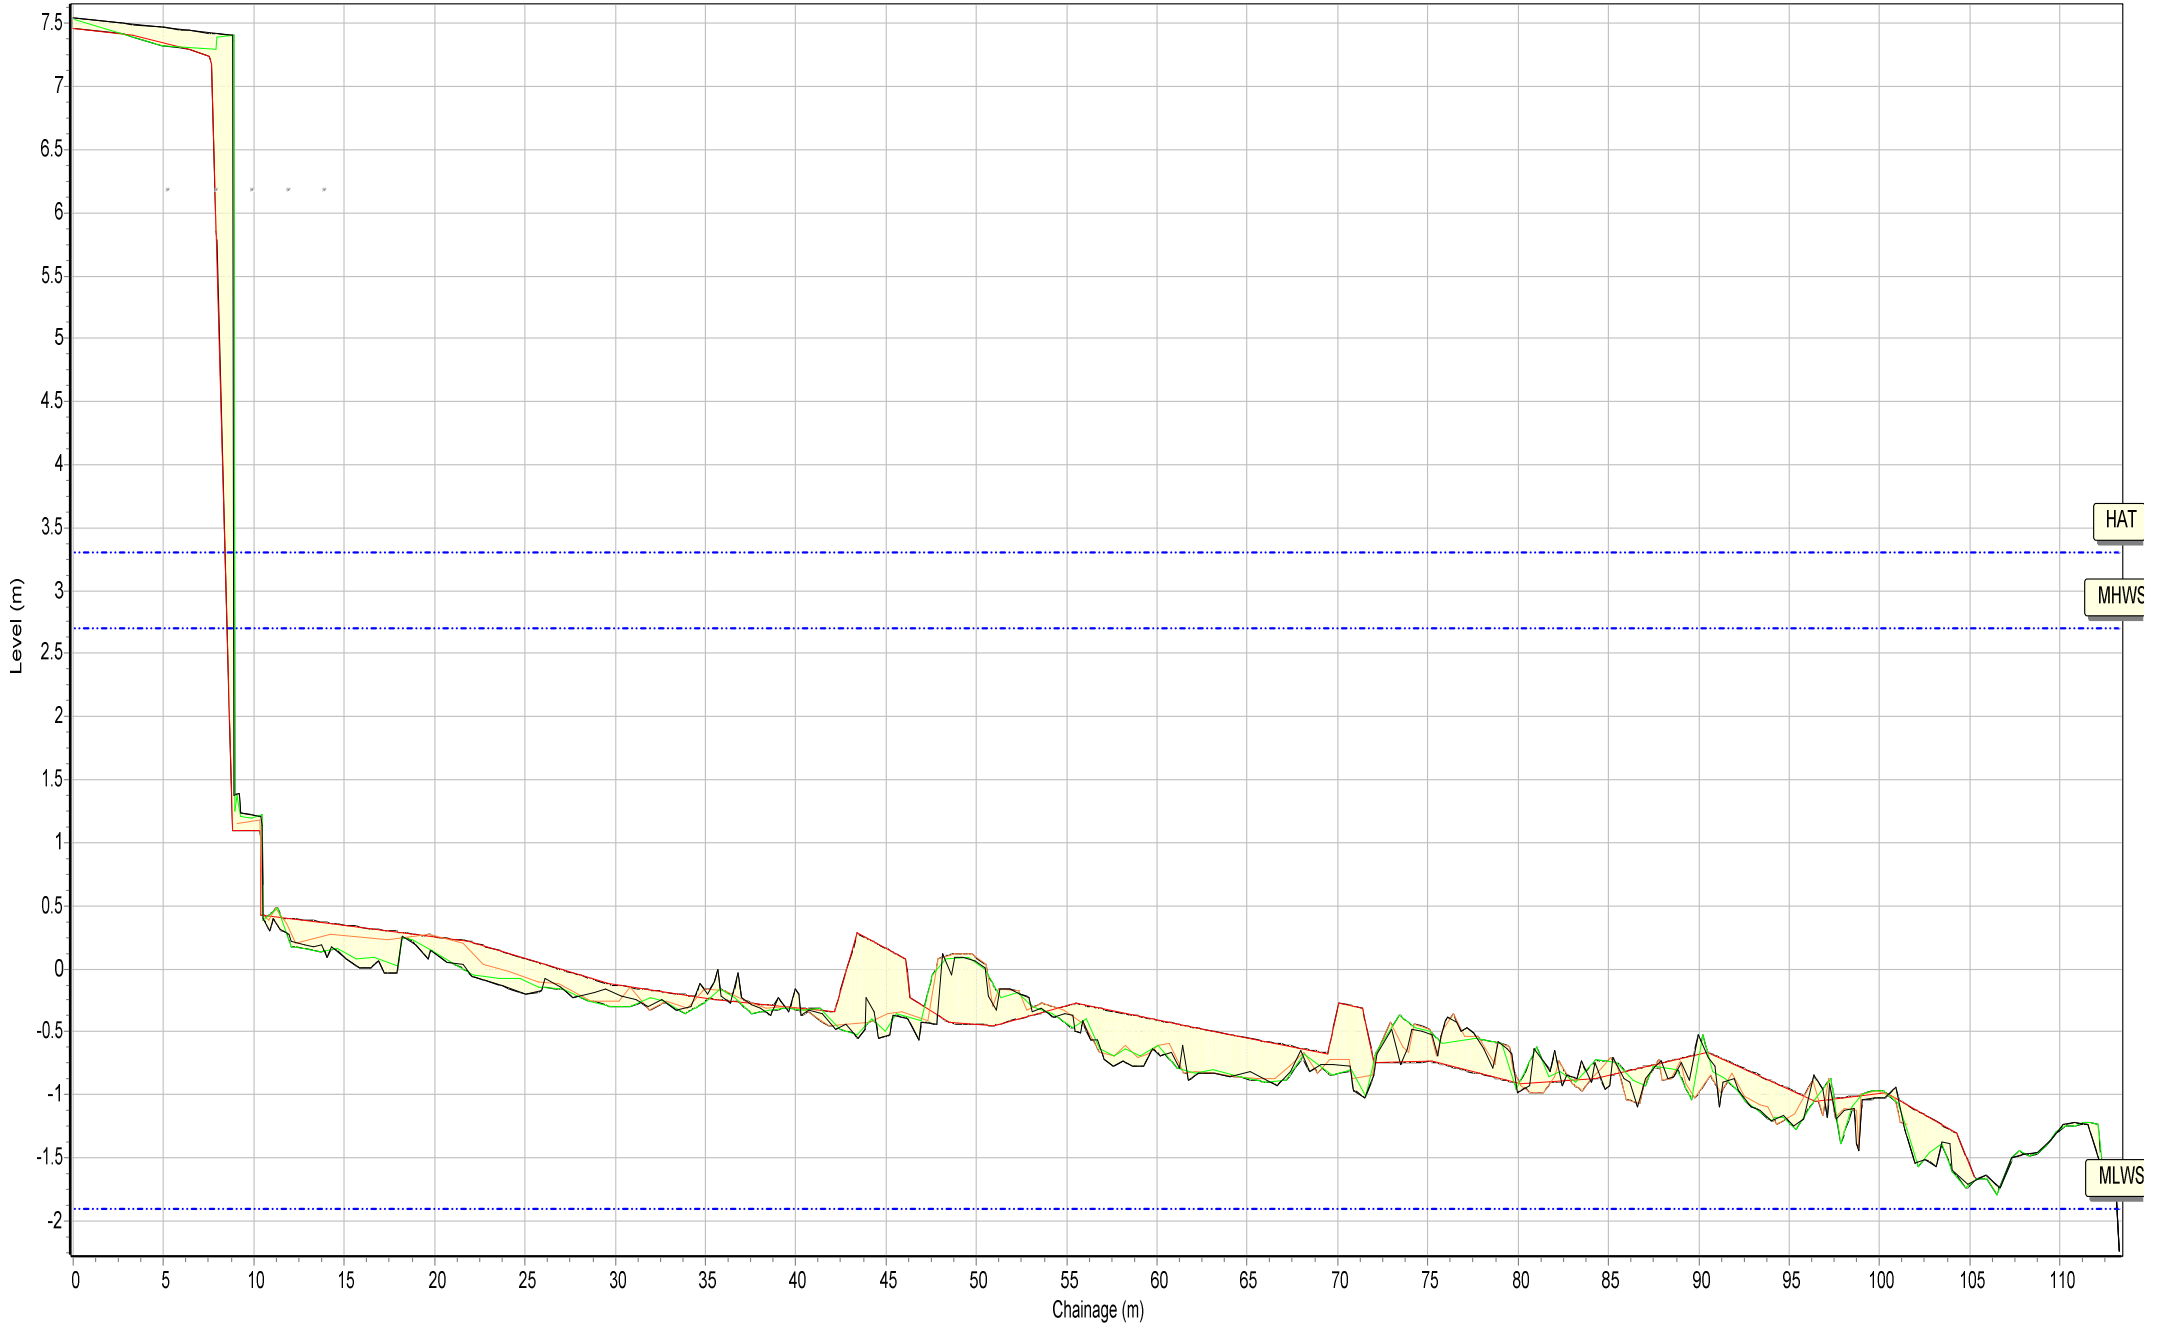
Beach Profiles: 1cHN4A

Survey Date	Description of Changes Since Last Survey	Interpretation
	<p>surveys,</p> <p>Profile 1cHN4A was established in October 2011. The defended part of the profile to 10m chainage has not changed since October 2011. The rocky shore platform has been exposed over the remainder of the profile, following a drop in beach level of up to 1.0m throughout the winter of 2017. There are occasional minor variations from the previous survey however these are likely to be due to the survey techniques as they generally are less than +/- 0.1m. As a result, from chainage 10m seawards, the rock platform remains exposed as it was in the previous survey. The profile is therefore at a low level compared to the range recorded in previous surveys as no beach is present at all, with the rock platform exposed over the full profile.</p>

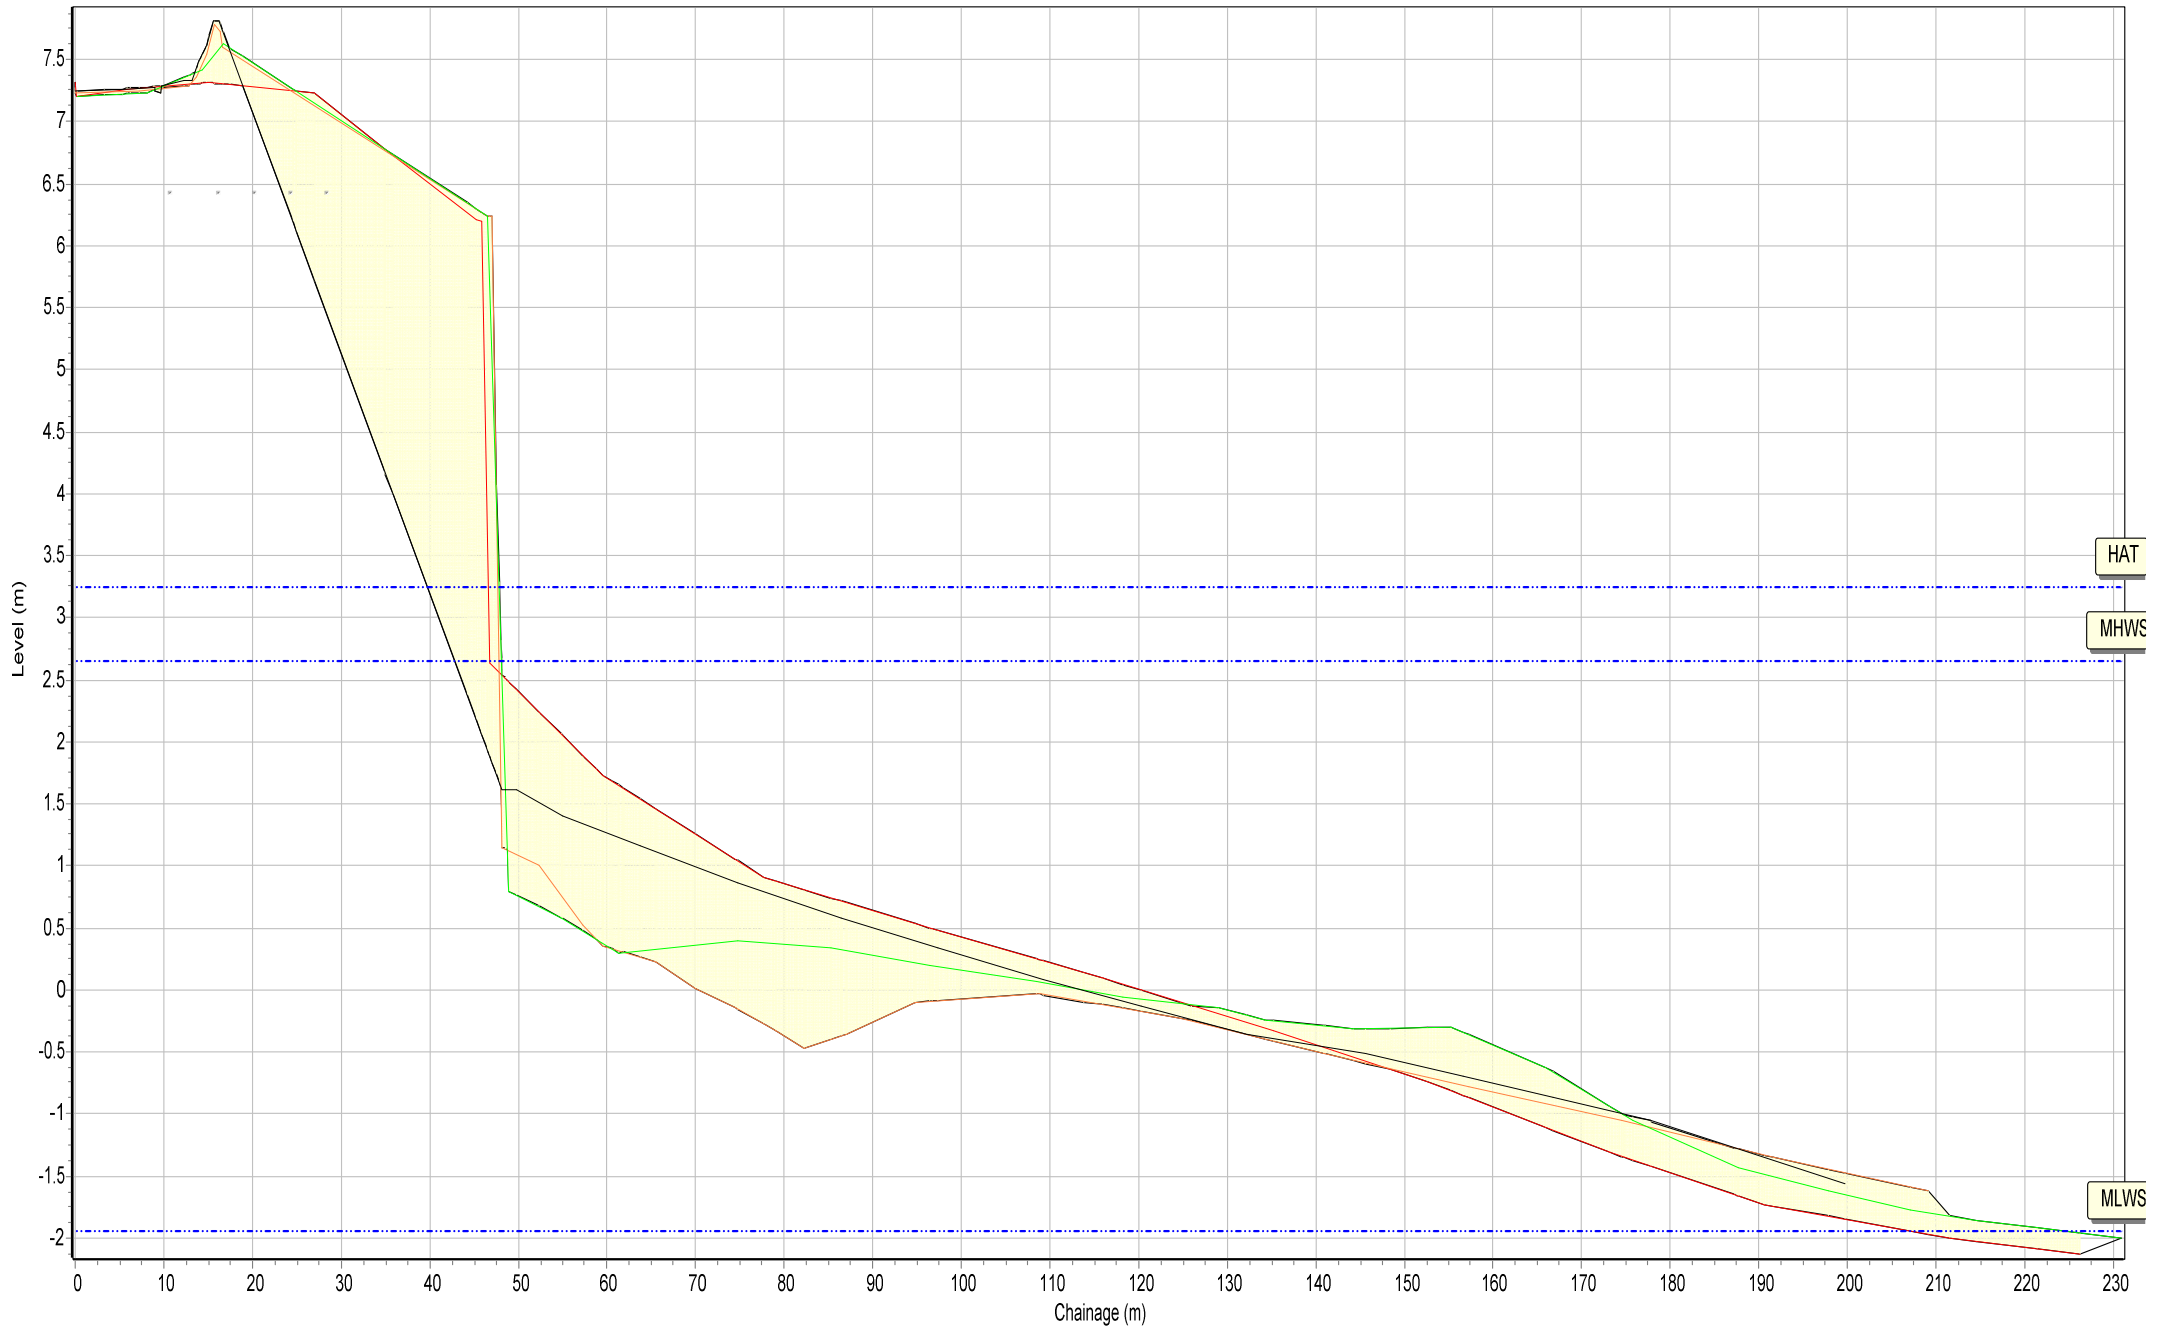
Beach Profiles: 1cHC1

Survey Date	Description of Changes Since Last Survey	Interpretation
<p>22nd February 2019</p>	<p>Beach Profiles:</p> <p>Middleton is covered by one beach profile line during the Partial Measures survey (Appendix A). The profile was last surveyed in September 2017.</p> <p>At Profile 1cHC1 there is an apparent retreat of the defence line in the upper profile, however this is an anomaly caused by lack of access to crest of the seawall due to a broken fence. From photographs taken during the survey the seawall face appears stable despite some open joints and evidence of differential settlement. At the toe of the seawall there has been an accretion beach material of around 1m. The profile has flattened since the last survey in October 2018. With accretion in the upper reaches and some depletion in the mid reaches. A berm present in the October 2018 survey has flattened over the winter of 2018. The profile is at the highest recorded level briefly from chainage 175m to 190m. Generally, the beach profile appears to be at a high-medium level compared to the range of previously recorded results.</p>	<p>The beach profile appears healthy and the accretion of material against the seawall has seen beach levels recover following the losses recorded in the October 2018 survey.</p> <p>Longer term trends: The beach level at this location tends to fluctuate through the year, with the most variable area being adjacent to the sea wall where wave energy is reflected. There is a pattern of seasonal variation, with lower levels typically recorded in the spring, following the period of winter storms. Recovery tends to occur by the autumn.</p>

- At Middleton the upper beach level has increased, and the lower beach level has depleted slightly. Shallow berms which were present in the previous survey have flattened and the beach profile now lies within the mid-range of previously recorded results.

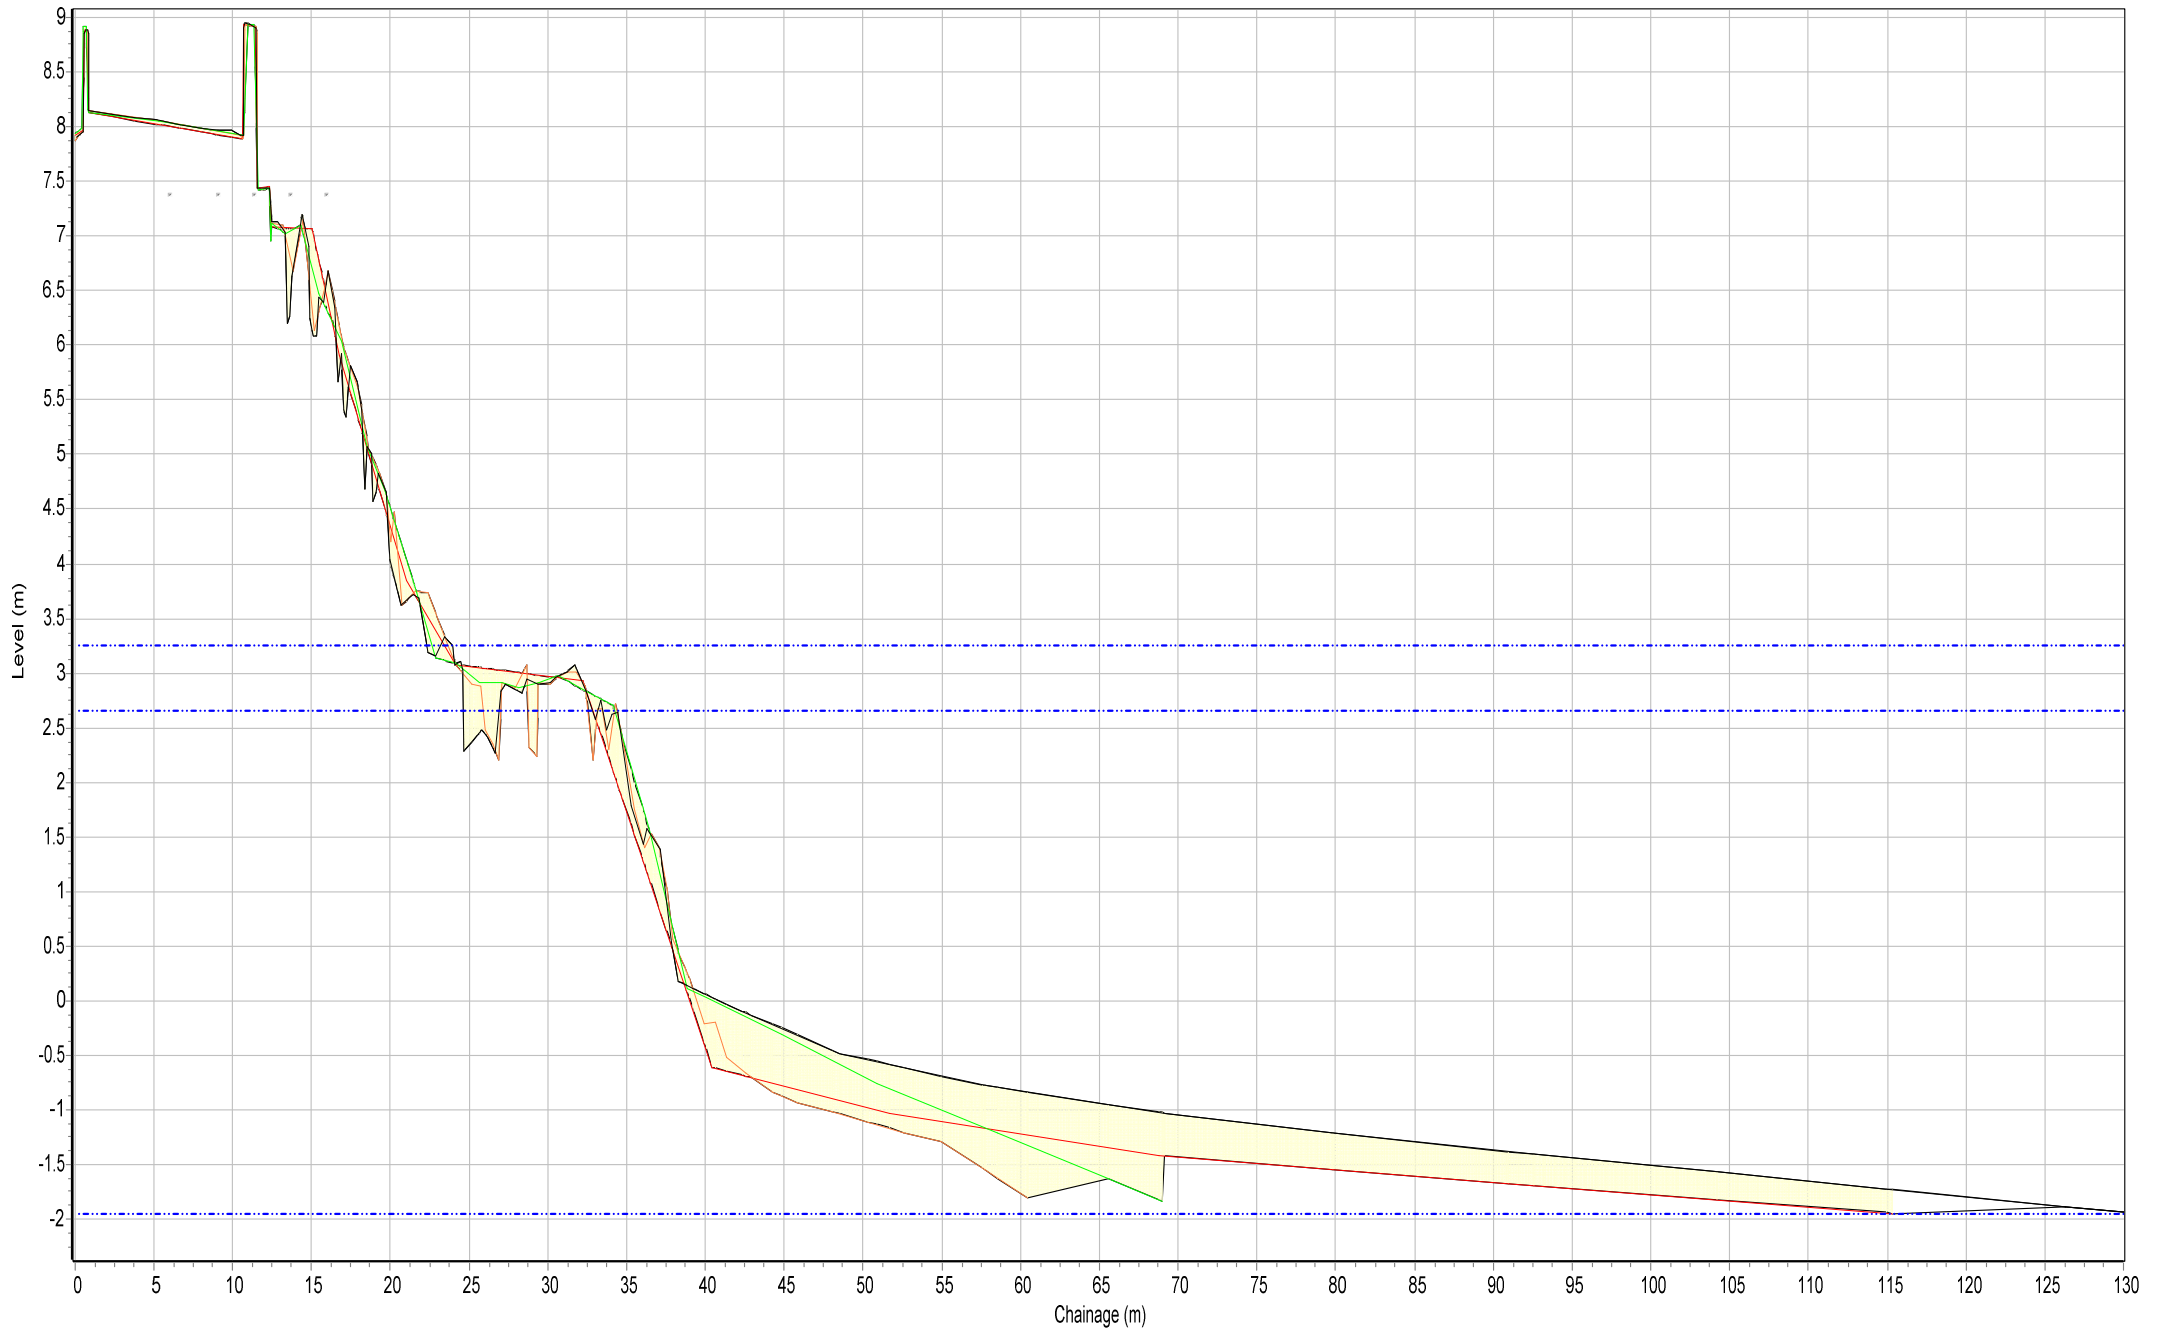
Beach Profiles: 1cHS1

Survey Date	Description of Changes Since Last Survey	Interpretation
21 st February 2019	<p>Beach Profiles:</p> <p>Hartlepool Bay is covered by four beach profile lines during the Partial Measures survey (Appendix A).</p> <p>Profile 1cHS1 is located c. 150m south of the root of the South Pier. The profile starts at the wall to the rear of the promenade and extends over the fronting concrete splash wall and down the sloping face of the rock armour revetment before reaching the beach. Very little change has occurred until 40m chainage, which is the toe of the sea defences, since September 2014. There has been accretion of up to 1.0m across the beach profile. The toe of the beach has moved seaward by around 60m. Overall the beach is at a high-medium level compared to the range recorded from previous surveys.</p> <p>At Profile 1cHS2 there has been a loss of material against the base of the coastal defence meaning that more of the rock armour is exposed than in the previous survey (October 2018). In the upper-mid reaches of the profile there has been up to 0.40m of accretion, whilst the mid and lower reaches of the profile have experienced a drop in level of up to 0.3m. Seawards of chainage 330m the profile is at its lowest recorded level. Overall the profile is at a medium level compared to the range recorded from previous surveys, with the extremity of the lower beach being exceptionally low.</p> <p>Profile 1cHS3 shows no changes over the defended part of the profile up to 30m chainage. There has been a drop in levels of up to 0.6m across the upper reaches of the beach profile. However, a shallow depression which had formed over the summer of 2018, between chainage 65m and 110m, has been infilled leading to an evenly graded upper and mid beach which is at a medium level compared to the range of previous surveys. A shallow berm on the lower-mid section has moved seaward by approximately 40m, with the crest now lying between chainage 180m and 210m and forms the highest recorded level in this location, Seaward of this berm the profile decreases in level towards MLWS which lies 10m landward of the previous survey. Overall the profile is at a medium level compared to the range recorded from previous surveys.</p> <p>Profile 1cHS4 is located 1km north of the North Gare Breakwater, within the area of undefended dunes at Seaton Carew. The part of the profile dominated by dunes, to 290m chainage, has remained stable. The depression between the main body of dunes and the foredune at 300m chainage has been deepening since 2013, however recent surveys indicate the rate at which this is occurring is slowing.</p>	<p>Overall the profiles show that the beach remains at a relatively medium level in most places.</p> <p>The dunes are in good condition. The foredune continues to accrete but erosion associated with a walkway is causing localised lowering in HS4 that may affect stability of the wider dune system in the long term.</p> <p>Longer term trends: Beach levels within Hartlepool Bay in February 2019 were at a medium level in comparison to previous surveys. The beach levels have been progressively increasing across the bay.</p>
