**Cell 1 Regional Coastal Monitoring Programme
Update Report 11: 'Partial Measures' Survey 2019**

(*) The present report is **Update Report 11** and provides an analysis of the 2019 Partial Measures survey for Hartlepool Council's frontage.

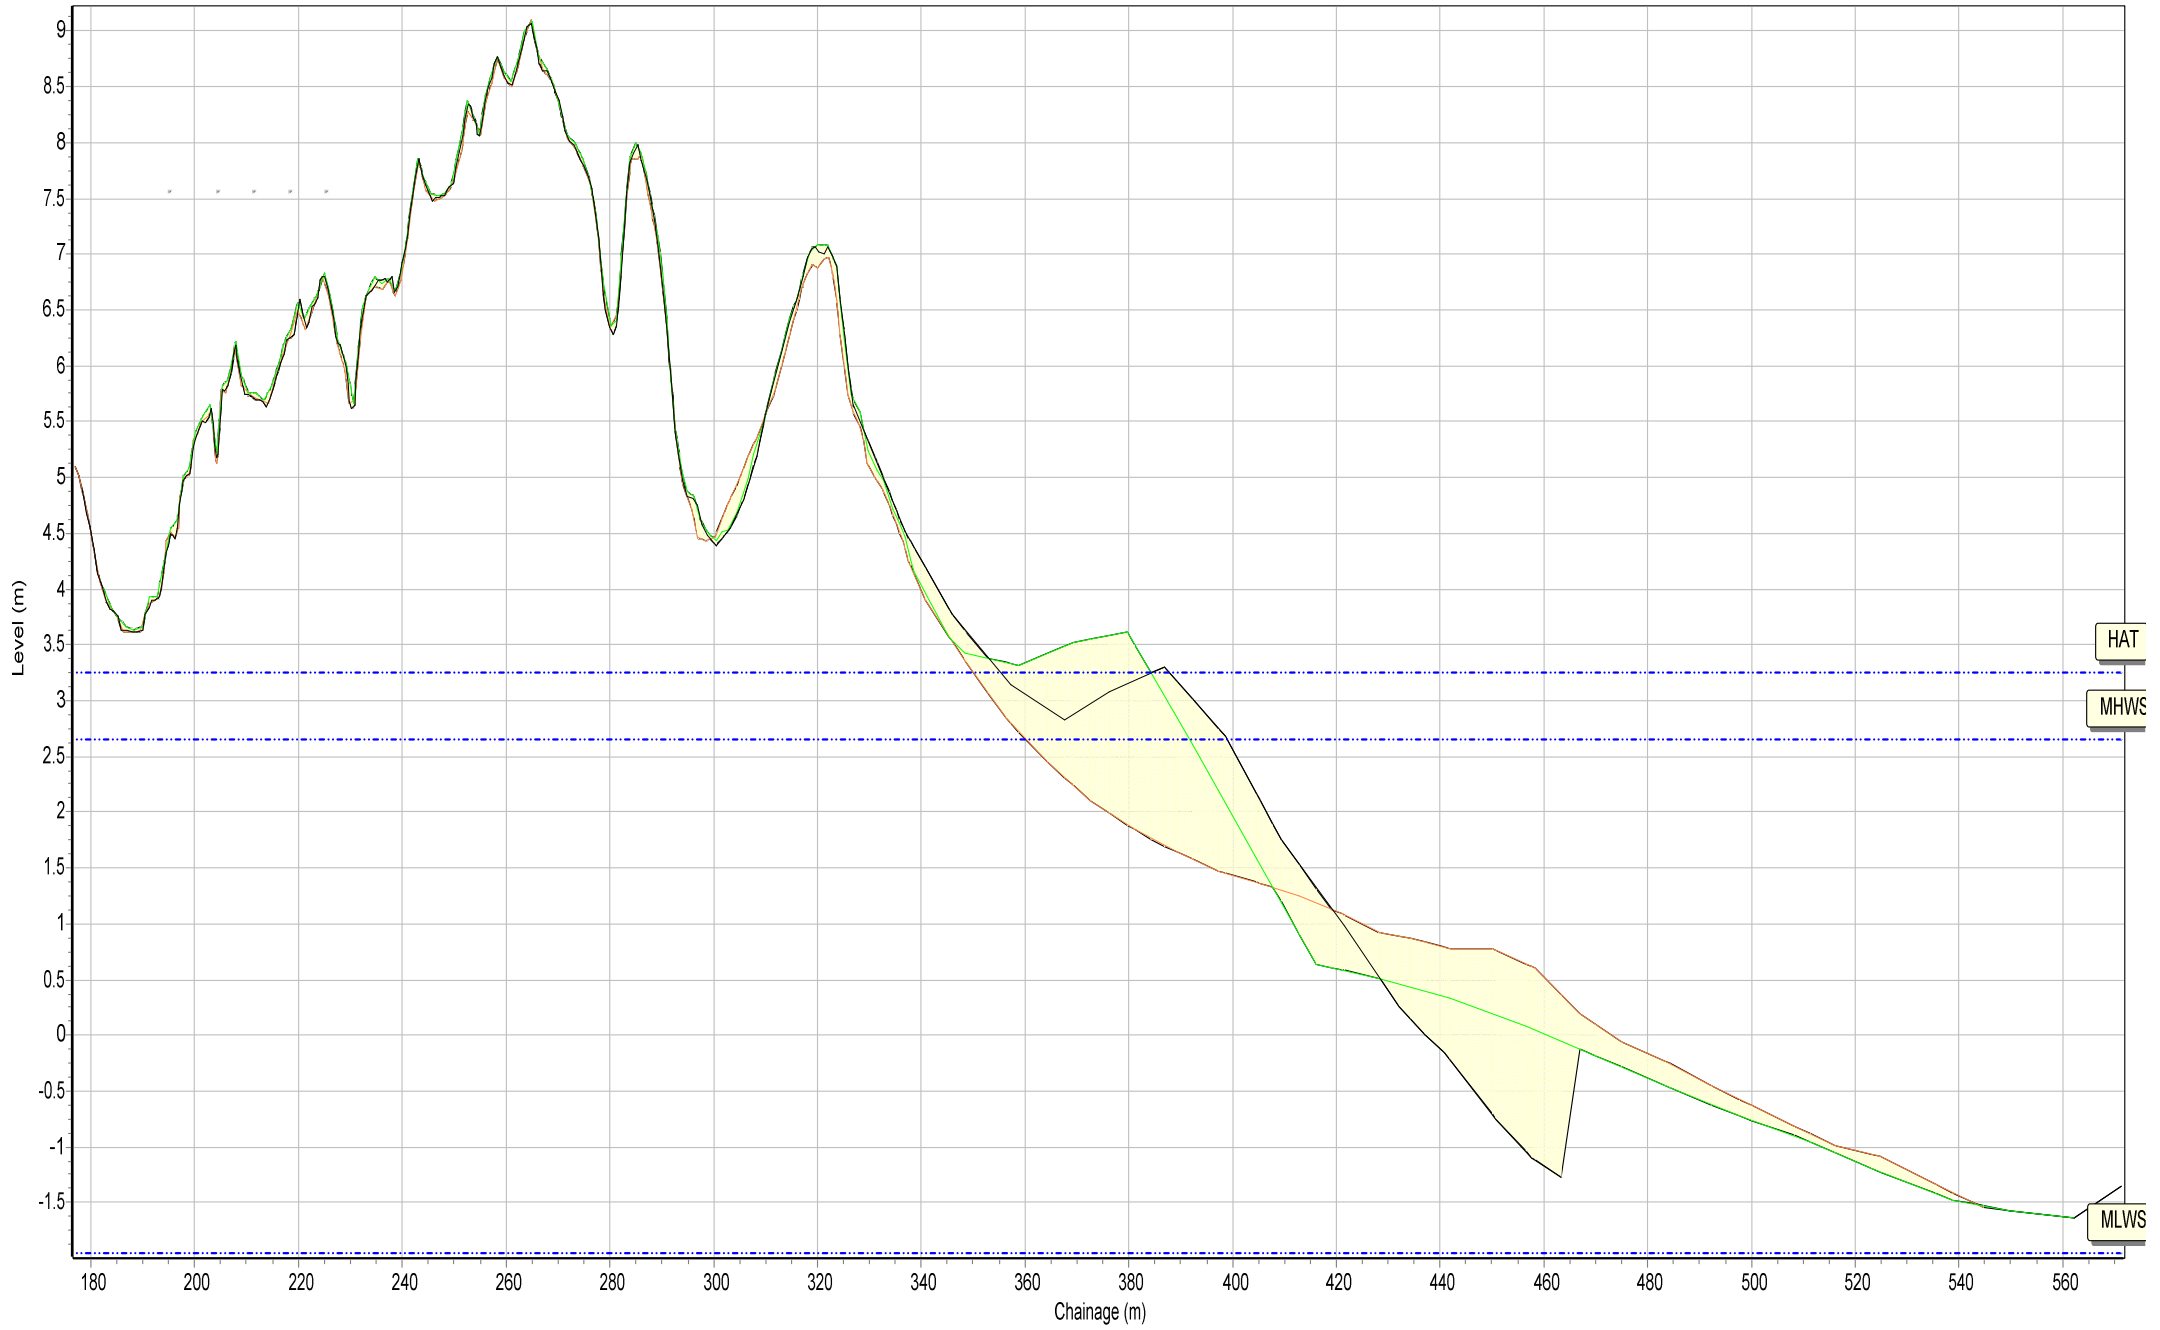
Beach Profiles: 1cHS4

Survey Date	Description of Changes Since Last Survey	Interpretation
	<p>The photographs suggesting lowering may result from footpath erosion. The crest of the foredune at 320m chainage has shown some depletion over the winter of 2018, despite a general trend of accretion since 2011. Between chainage 340m and 415m the beach level has dropped by up to 0.6m, with the berm feature previously recorded at chainage 365m since April 2016 moving seaward to chainage 385m. Between chainage 385m and 430m there has been accretion of up to 0.5m as the face of the lower berm has moved seaward. Seawards of chainage 430m there has been erosion of up to 1.2m. The overall effect of the changes is a steeper lower beach profile than that recorded in previous surveys. The February 2019 survey recorded a total profile length of approximately 460m which is 100m shorter than the October 2018 survey. Overall the profile is at a medium level compared to the range recorded by the previous surveys, with the exception of the toe of the beach which now lies at its most landward position.</p>

- Hartlepool Bay has generally been dominated by erosion over the winter of 2018, however the profiles remain at medium levels compared to the range recorded from previous surveys. The area of greatest concern remains in the south of the bay, at 1cHS4, where the dunes are stable but unrestricted public access may affect their stability long term.
