**Cell 1 Regional Coastal Monitoring Programme
Update Report 12: 'Partial Measures' Survey 2020**

(*) The present report is **Update Report 12** and provides an analysis of the 2020 Partial Measures survey for Hartlepool Council's frontage.

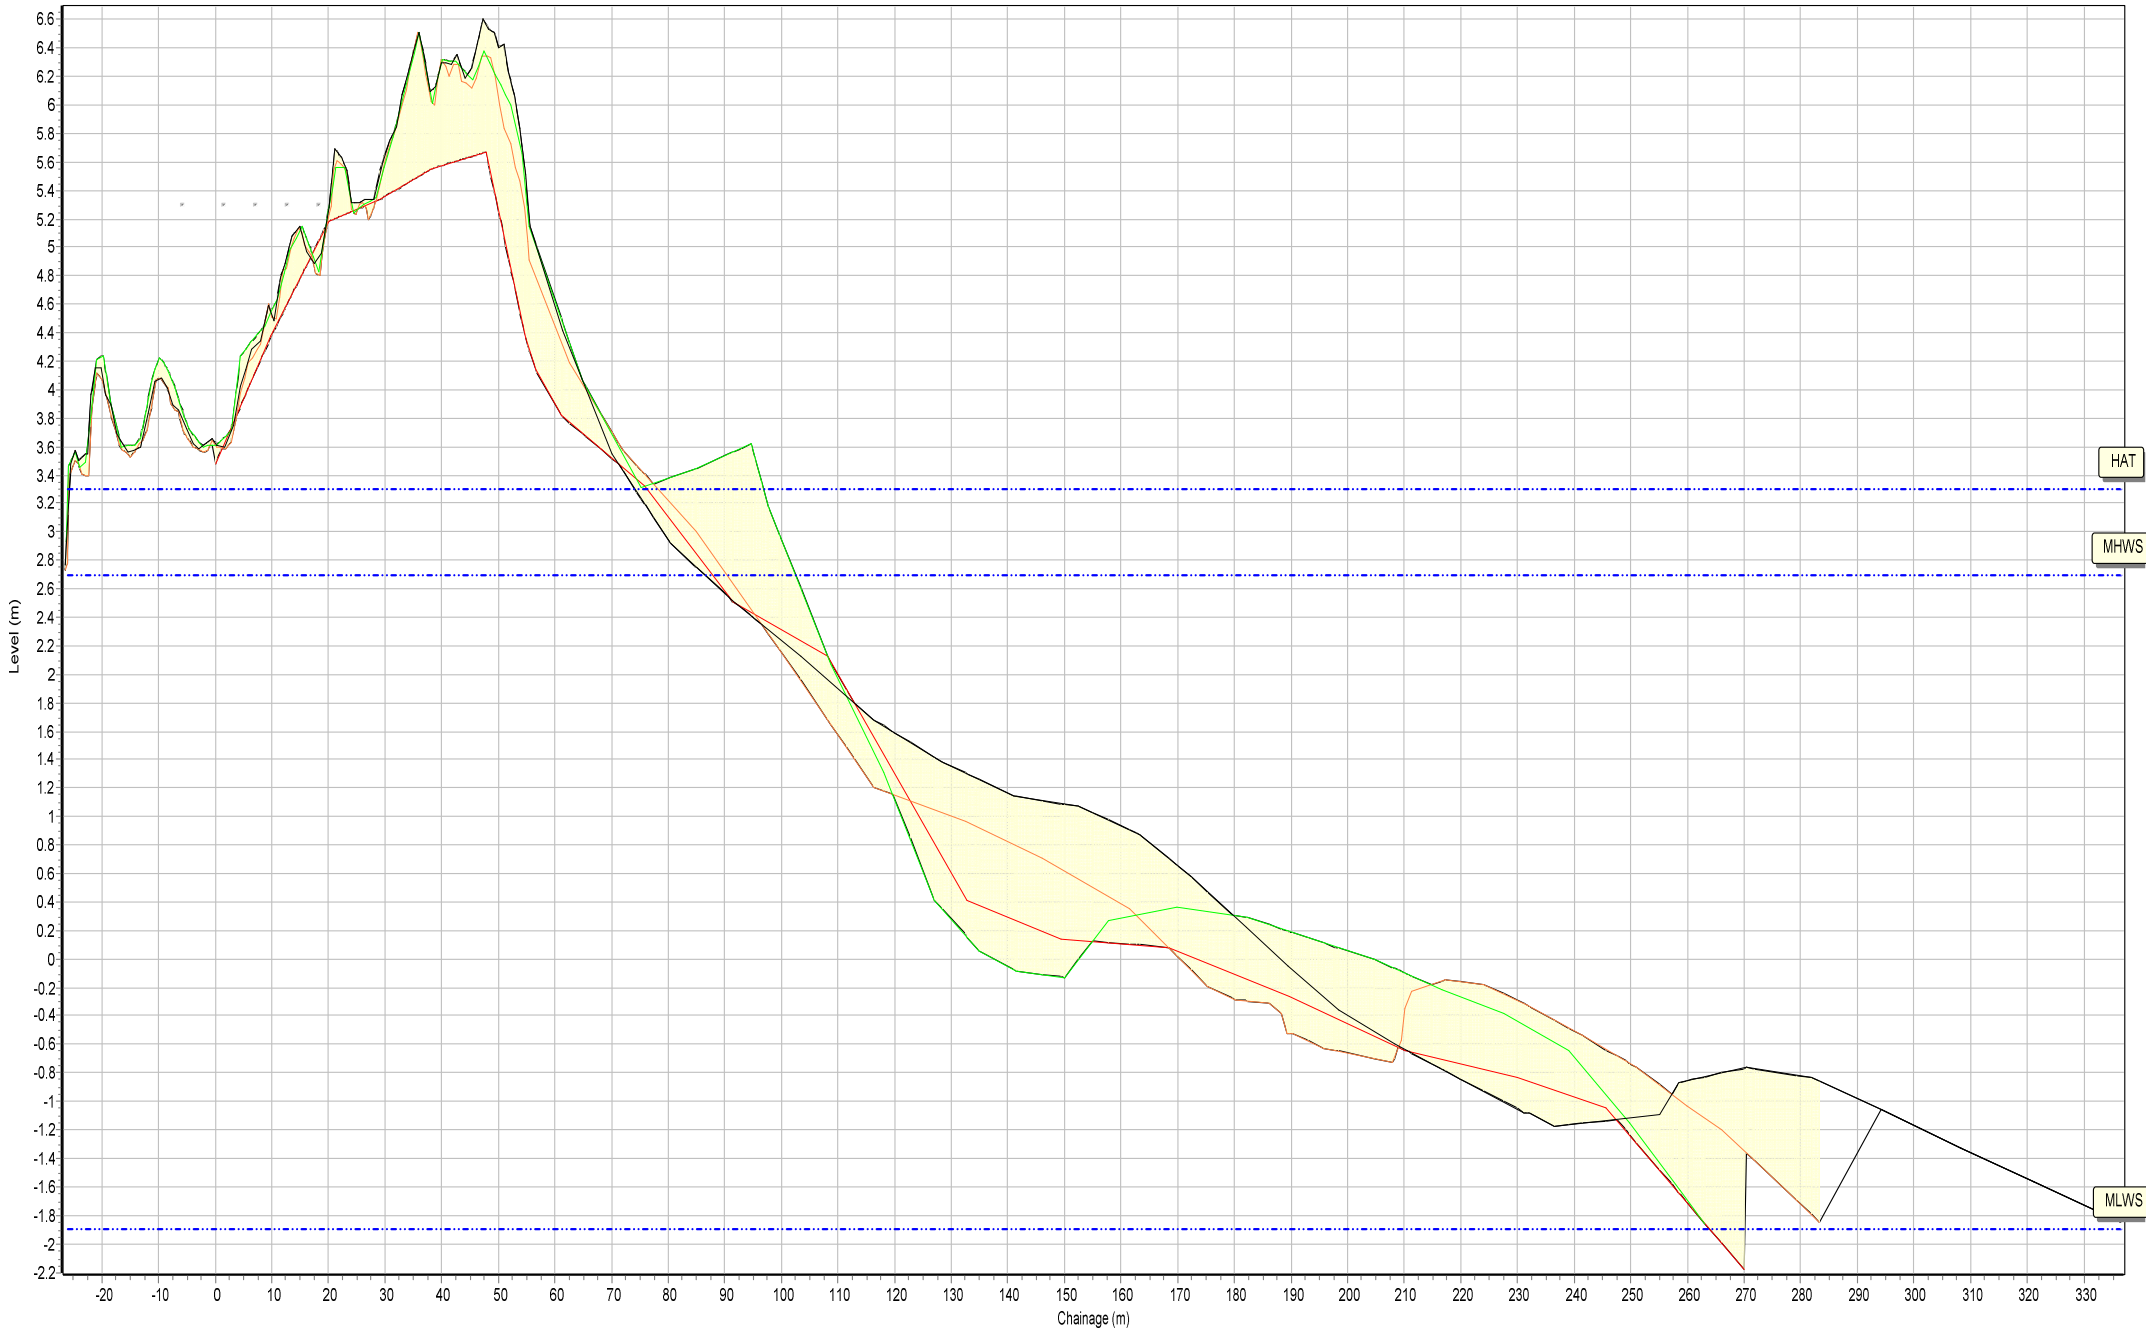
Beach Profiles: 1cHN1

Survey Date	Description of Changes Since Last Survey	Interpretation
21 st May 2020	<p>Beach Profiles:</p> <p>North Sands is covered by six beach profile lines during the Partial Measures survey (Appendix A) that were last surveyed in September 2019.</p> <p>Profile 1cHN1 is located within Durham County Council's jurisdiction, c. 400m north of the outfall of Crimdon Beck. It is reported here so changes can be interpreted in association with those observed elsewhere along North Sands.</p> <p>The beginning of the profile between 0m and 45m chainage covers dunes and has not changed since the previous survey. The front dune at chainage 50m has accreted by up to 0.2m since the previous survey, with very little change to the dune face to chainage 66m. Between chainage 66m and 111m the upper beach has a smoothed profile, with erosion of an upper beach berm by up to 1.0m and infilling of a hollow at chainage 145m by up to 1.2m. Similarly on the middle to low beach, a berm has been eroded by up to 0.6m and a berm has formed at chainage 280m with an accretion of up to 1.0m. The beach toe has extended by 72m. Overall the profile is at a medium level compared to the range recorded from previous surveys, although it is at a higher level in the vicinity of the lower beach berm, particularly between chainages 275-335m which is at its highest level recorded.</p> <p>Profile 1cHN2 covers the dune between chainage 0m and 52m. From chainage 52m to 82m the beach level has lowered by up to 0.5m. Between chainage 82m and 141m a hollow has infilled by up to 0.6m, switching to erosion by up to 0.3m to chainage 201m. On the mid to lower beach the beach level has increased between chainages 201-250m by up to 0.2m, once again switching to erosion at the beach toe by up to 0.3m. The beach toe has moved landward by approximately 30m. Overall, the beach profile is at a medium level compared to the range recorded from previous surveys, and the beach toe is at one of the most landward positions recorded.</p> <p>Profile 1cHN2A was established in October 2011 and runs through the dunes close to North Sands. The area of dunes between 0m and 70m chainage has remained reasonably stable. Between 70m and</p>	<p>The profiles are generally at a medium-low level, with several profiles experiencing drawdown of sediment from the upper beach to the middle and lower beach profile. This pattern is typical of winter conditions.</p> <p>Longer term trends:</p> <p>Following dune erosion over the winter of 2013/14 the areas with dunes have remained stable. At HN1, 2, 2A and 3A the beach levels are medium compared with previous years.</p> <p>At profiles HN3, 4 and 4A the beach is low compared with previous profiles for at least some of the profile. The fluctuation in the veneer beach continues so that parts of the shore platform in the south of the bay have become exposed.</p>
