North East  
Coastal  
Observatory

## **Cell 1 Regional Coastal Monitoring Programme Update Report 14: 'Partial Measures' Survey 2022**

**June 2022**

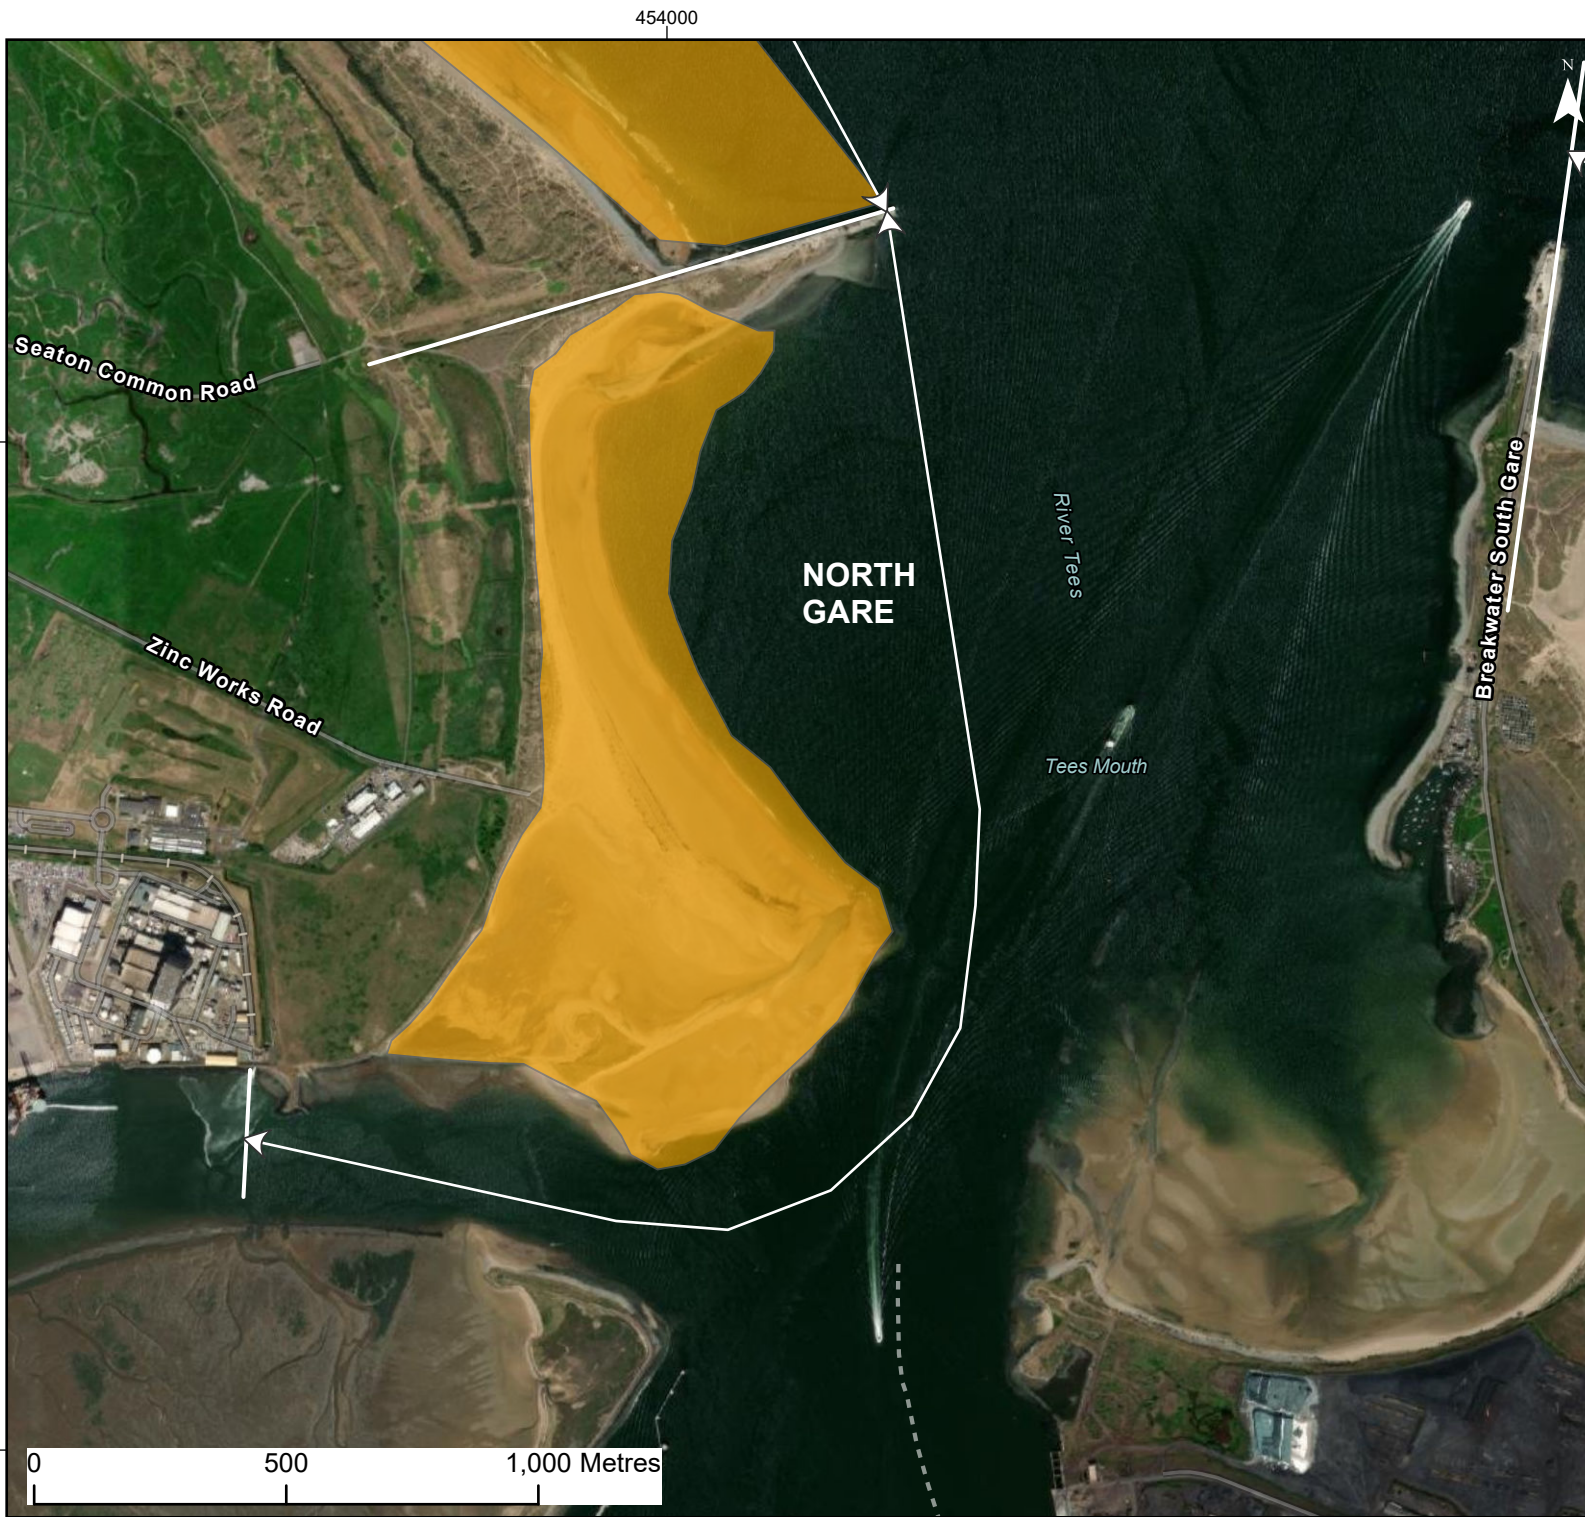
Title: **Figure 2 - Map 3**  
**NORTH GARE**  
**Hartlepool Borough Council Frontage**

**SURVEY LOCATIONS**

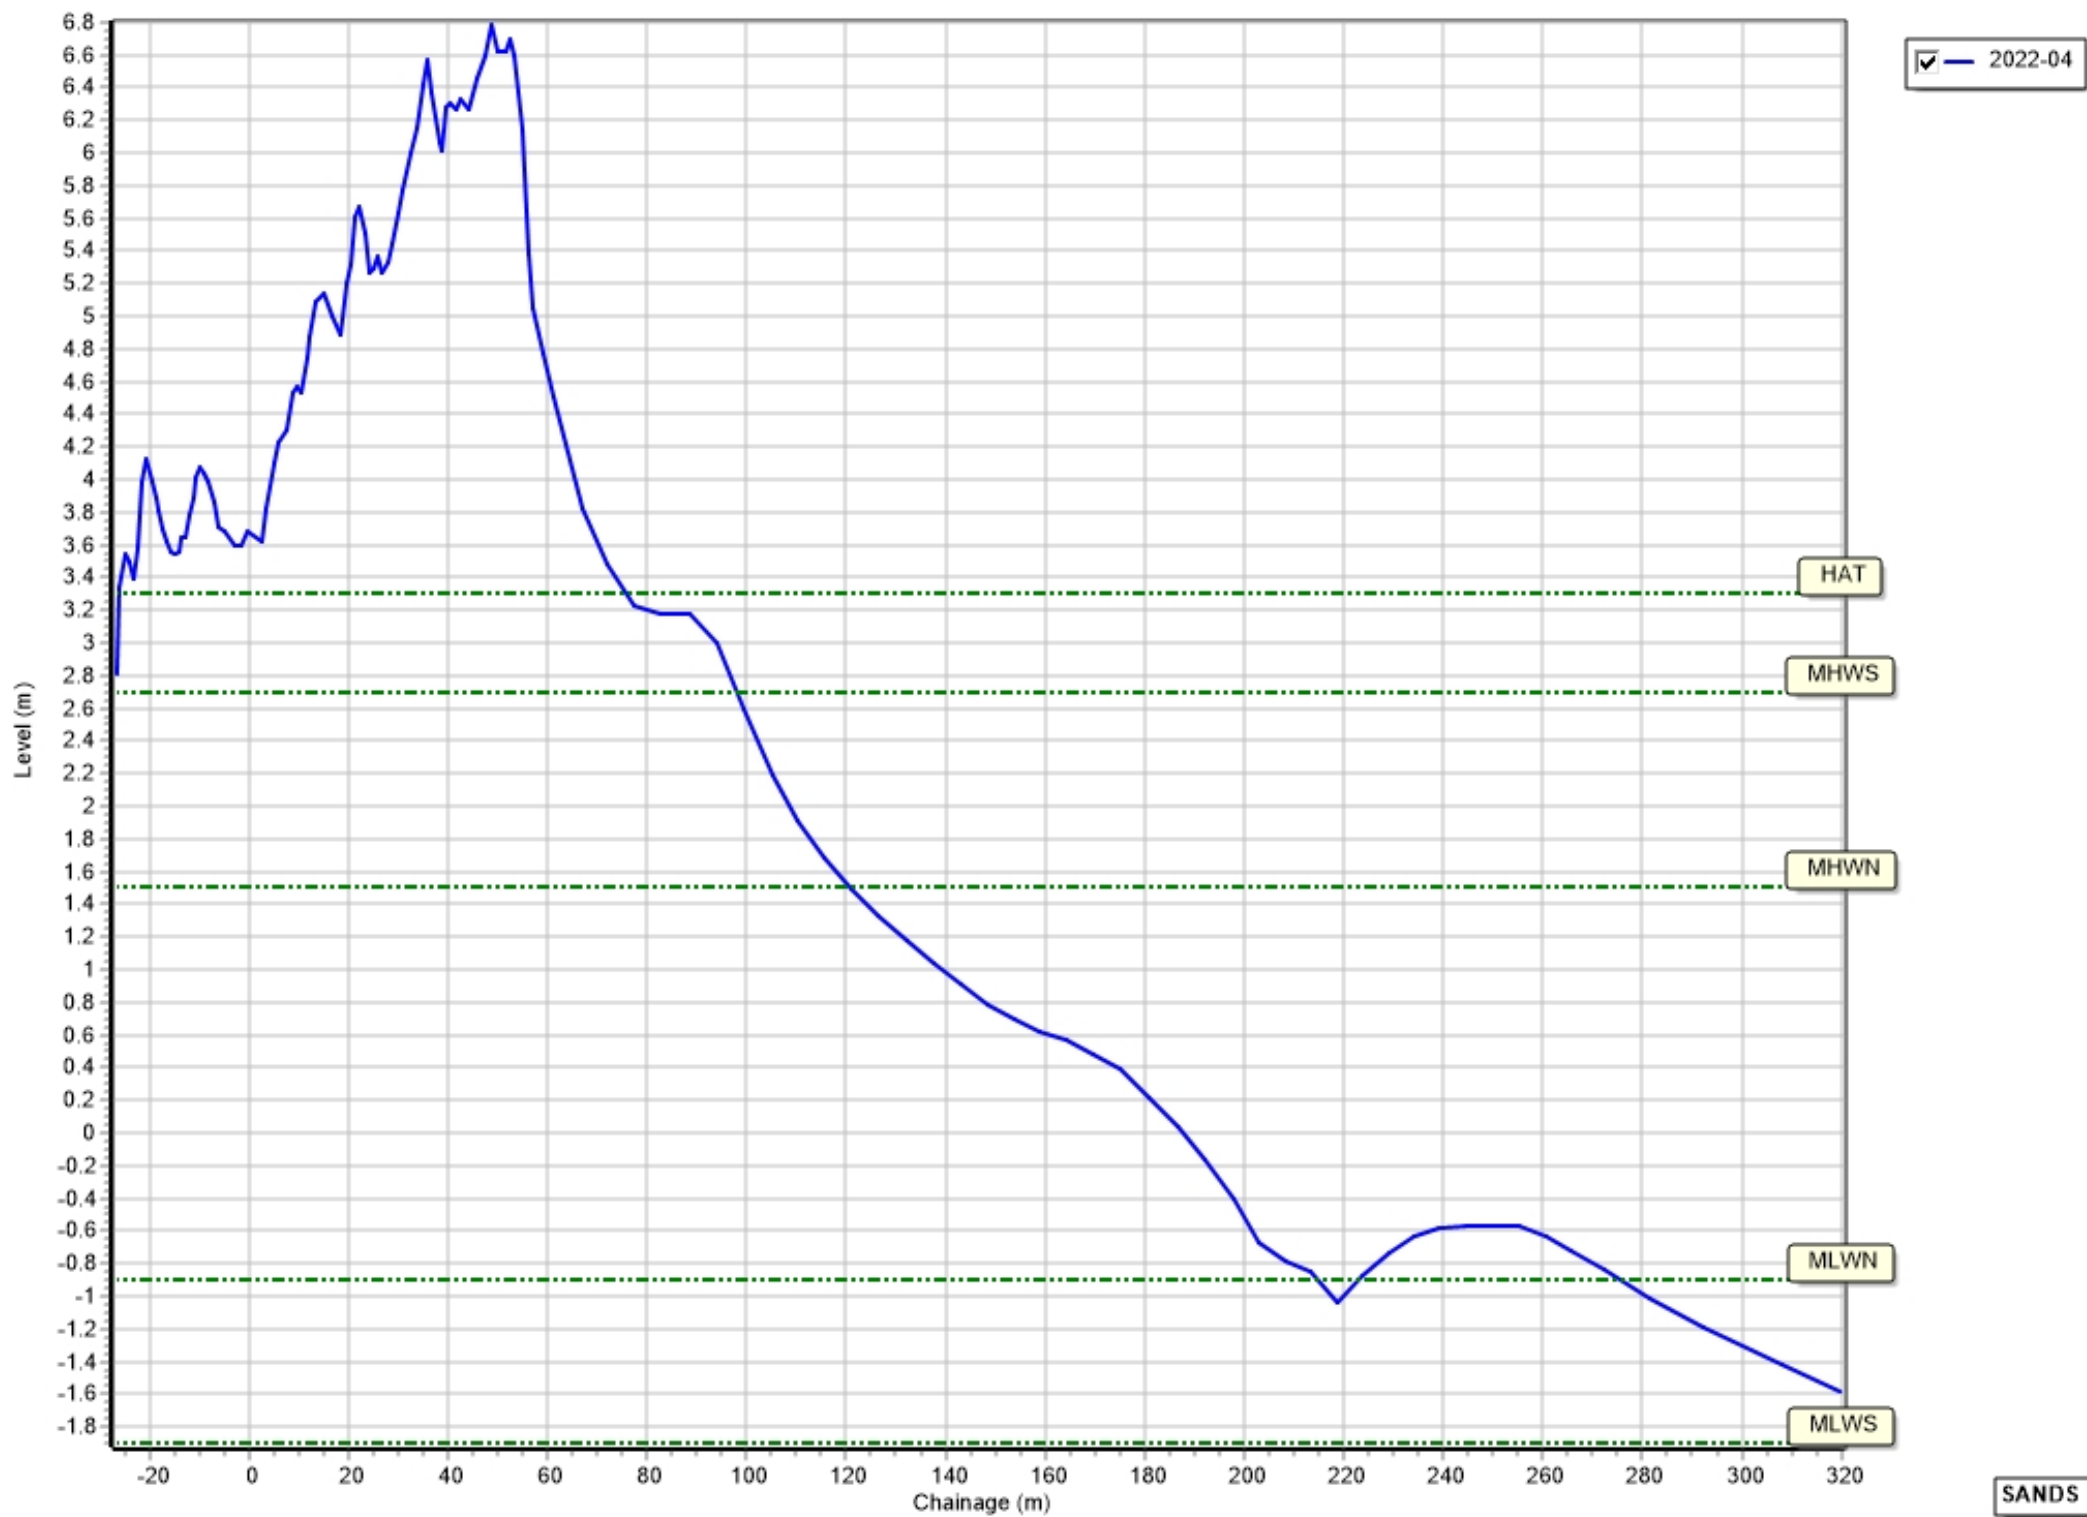
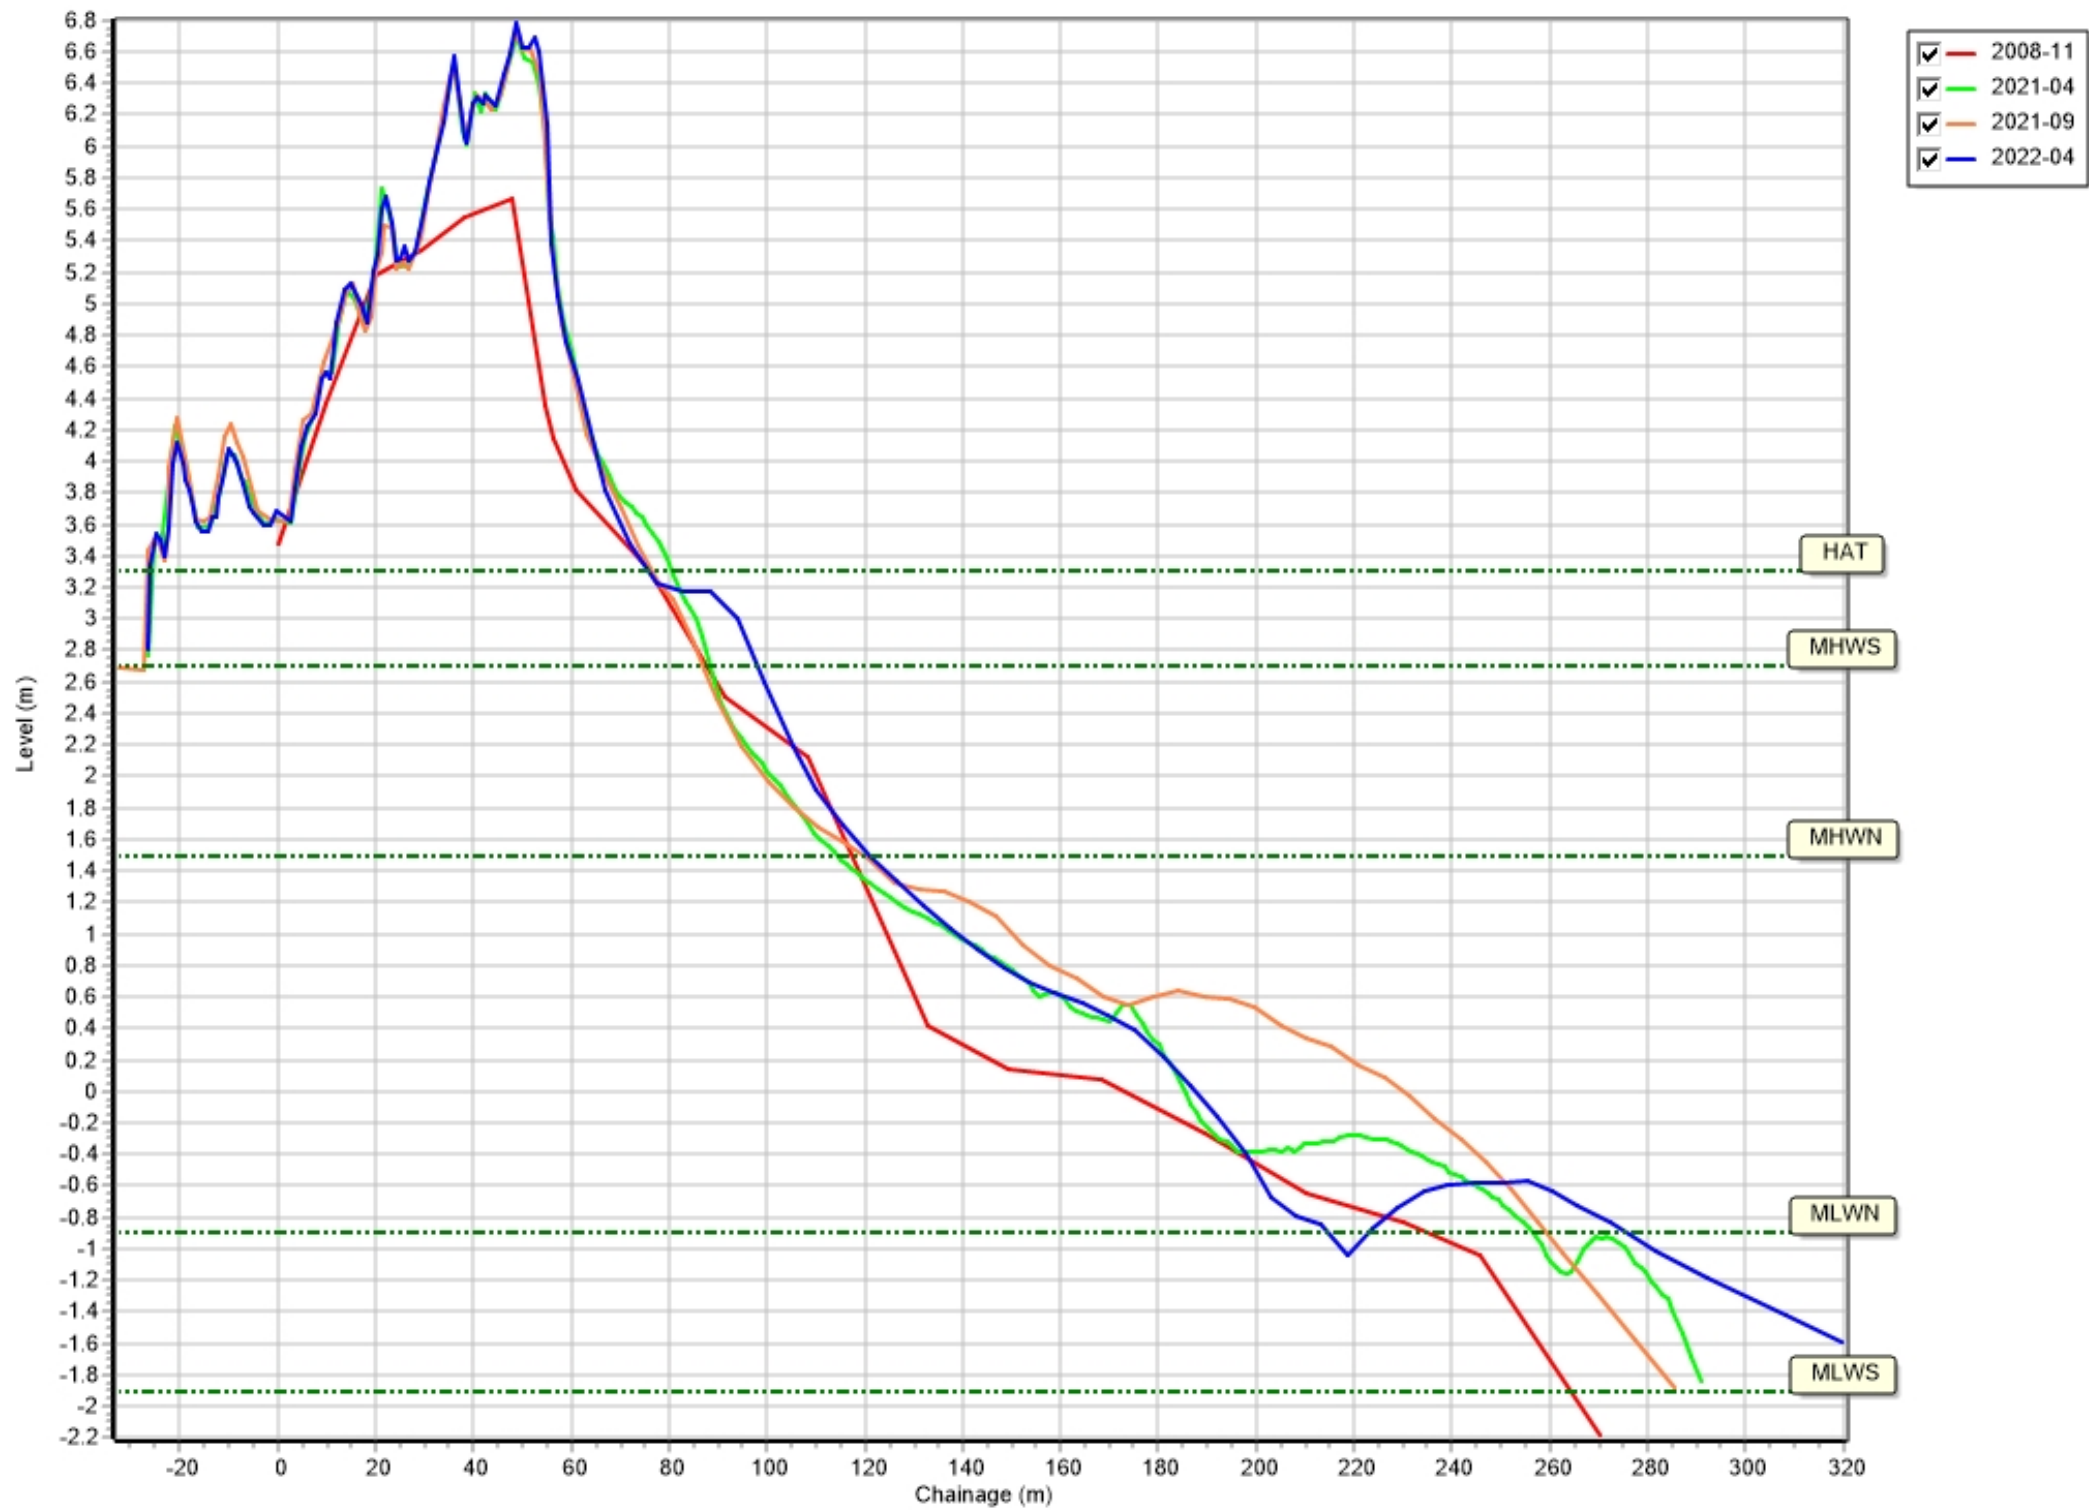
Profiles: 1cHN1

Survey Date	Description of Changes Since Last Survey	Interpretation
28 <sup>th</sup> April 2022	<p><b>Beach Profiles:</b></p> <p>North Sands is covered by seven beach profile lines during the Partial Measures survey (Appendix A) that were last surveyed in September 2021.</p> <p>Profile <b>1cHN1</b> is located within Durham County Council's jurisdiction, c. 400m north of the outfall of Crimdon Beck. It is reported here so changes can be interpreted in association with those observed elsewhere along North Sands. The beginning of profile <b>1cHN1</b>, between chainages 0m and 70m, covers dunes and has remained largely stable. The crest of the rear dunes at chainages -20m and -10m have both nominally dropped in level by 0.15m whereas the crest of the foredune has shown low level accretion. Between chainages 80m and 120m the upper beach has accreted by 0.6m in level, before switching to lowering of 0.2m in level, resulting the in the general steeping of the profile. Between chainages 180m and 240m, a channel has incised through the lower beach resulting in, at its worse, a drop in level of 1.3m. Although unconfirmed, it is thought the channel is Crimdon Dene Beck that has been diverted due to shifting sands. Overall, the profile is at a medium level compared to the range recorded in previous surveys.</p> <p>At profile <b>1cHN2</b>, the dunes, between chainage 0 and 52m, show very little change. Seaward of the dunes, the beach profile has generally smoothed since the previous survey resulting in alternating lengths of accretion and erosion. Between chainages 55m to 85m, and 137m to 189m the beach has lowered by up to 0.5m. Whereas between chainages 85m to 137m the beach has accreted by 0.8m. There has also been accretion on the lower beach extending the profile seaward. Overall, the beach profile is at a medium level compared to the range recorded from previous surveys.</p> <p>Profile <b>1cHN2A</b> was established in October 2011 and runs through the dunes close to North Sands. The area of dunes between 0m and 68m chainage has remained reasonably stable, limited to <math>\pm 0.1</math>m change. Seawards of the dunes, the beach shows a general pattern of erosion of the upper beach and accretion of the lower beach suggesting a general winter draw down. Between chainages 70m and 110m the beach has eroded by to 0.7m in level. Between chainages 180m and 242m the beach has</p>	<p>The northern and central profiles have experienced varying degrees of drawdown of sediment from the upper beach to the middle and lower beach. This pattern is typical of winter conditions.</p> <p>The two southern profiles have shown sediment recovery on the upper beach although the rocky shore is still exposed along the majority of the middle and lower beach</p> <p>All profiles are at a medium level when compared to the envelope of past recorded changes.</p> <p><b>Longer term trends:</b></p> <p>Following measureable dune erosion over the winter of 2013/14 the areas with dunes have remained stable, with several dune sections currently at their highest recorded levels.</p> <p>The fluctuation in the veneer beach continues so that parts of the shore platform in the south of the bay have become exposed.</p>

- At North Sands, the northern and central profiles have experienced varying degrees of drawdown of sediment from the upper beach to the middle and lower beach. This pattern is typical of winter conditions. The two southern profiles have shown sediment recovery on the upper beach although the rocky shore is still exposed along the majority of the middle and lower beach. All profiles are at a medium level when compared to the range of previous surveys.

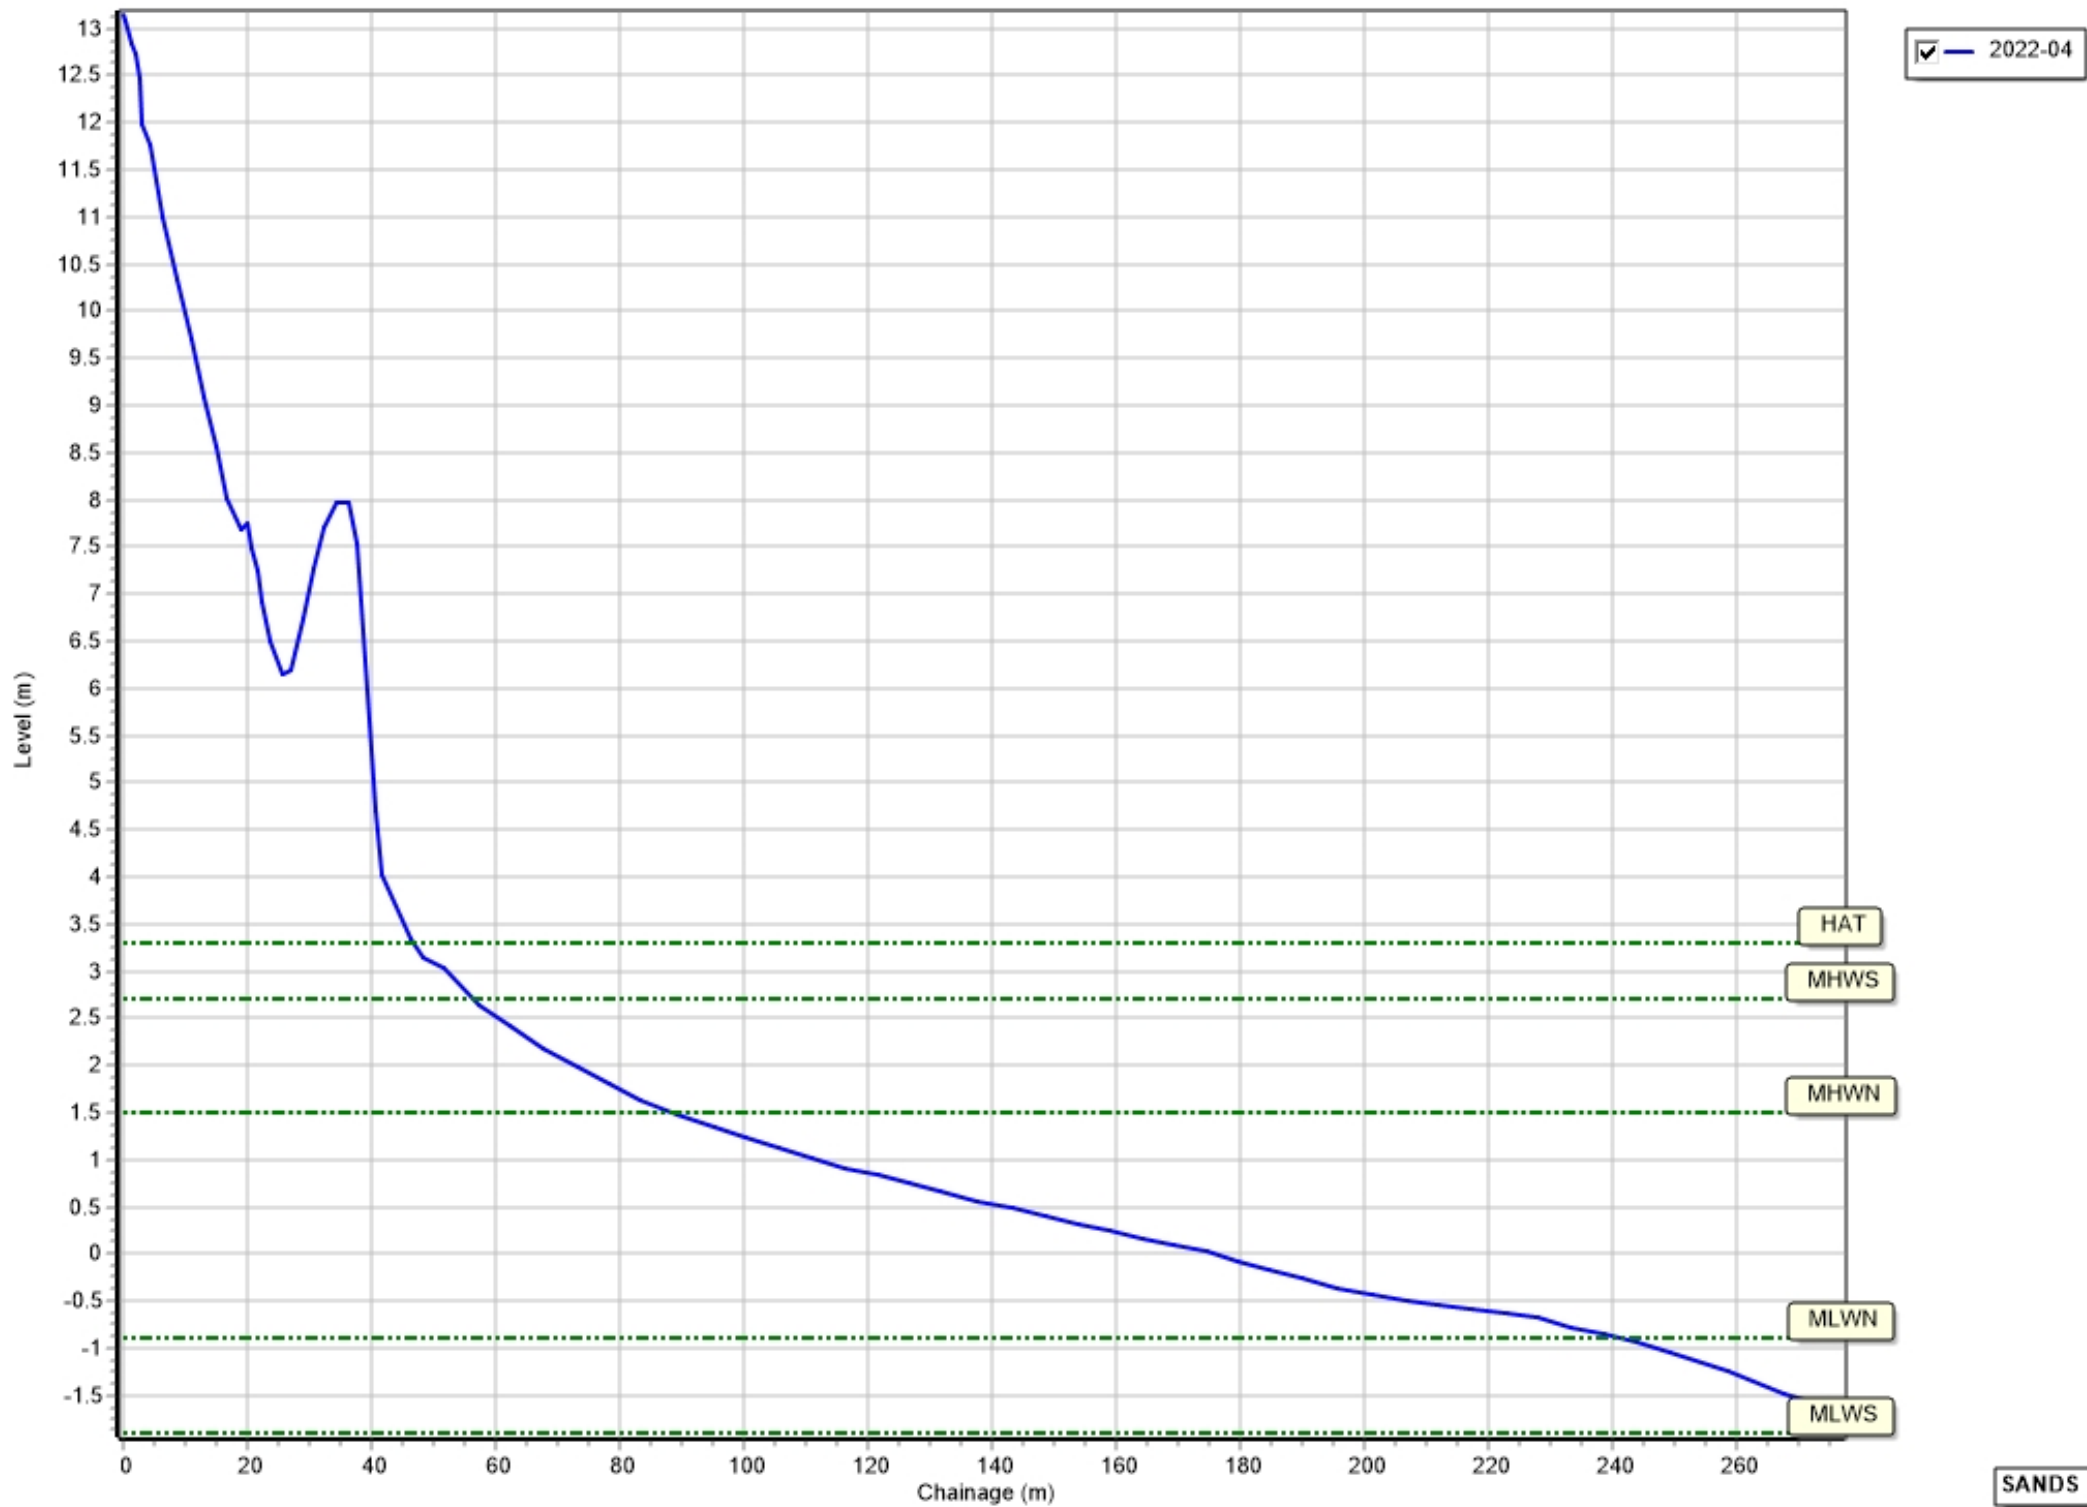
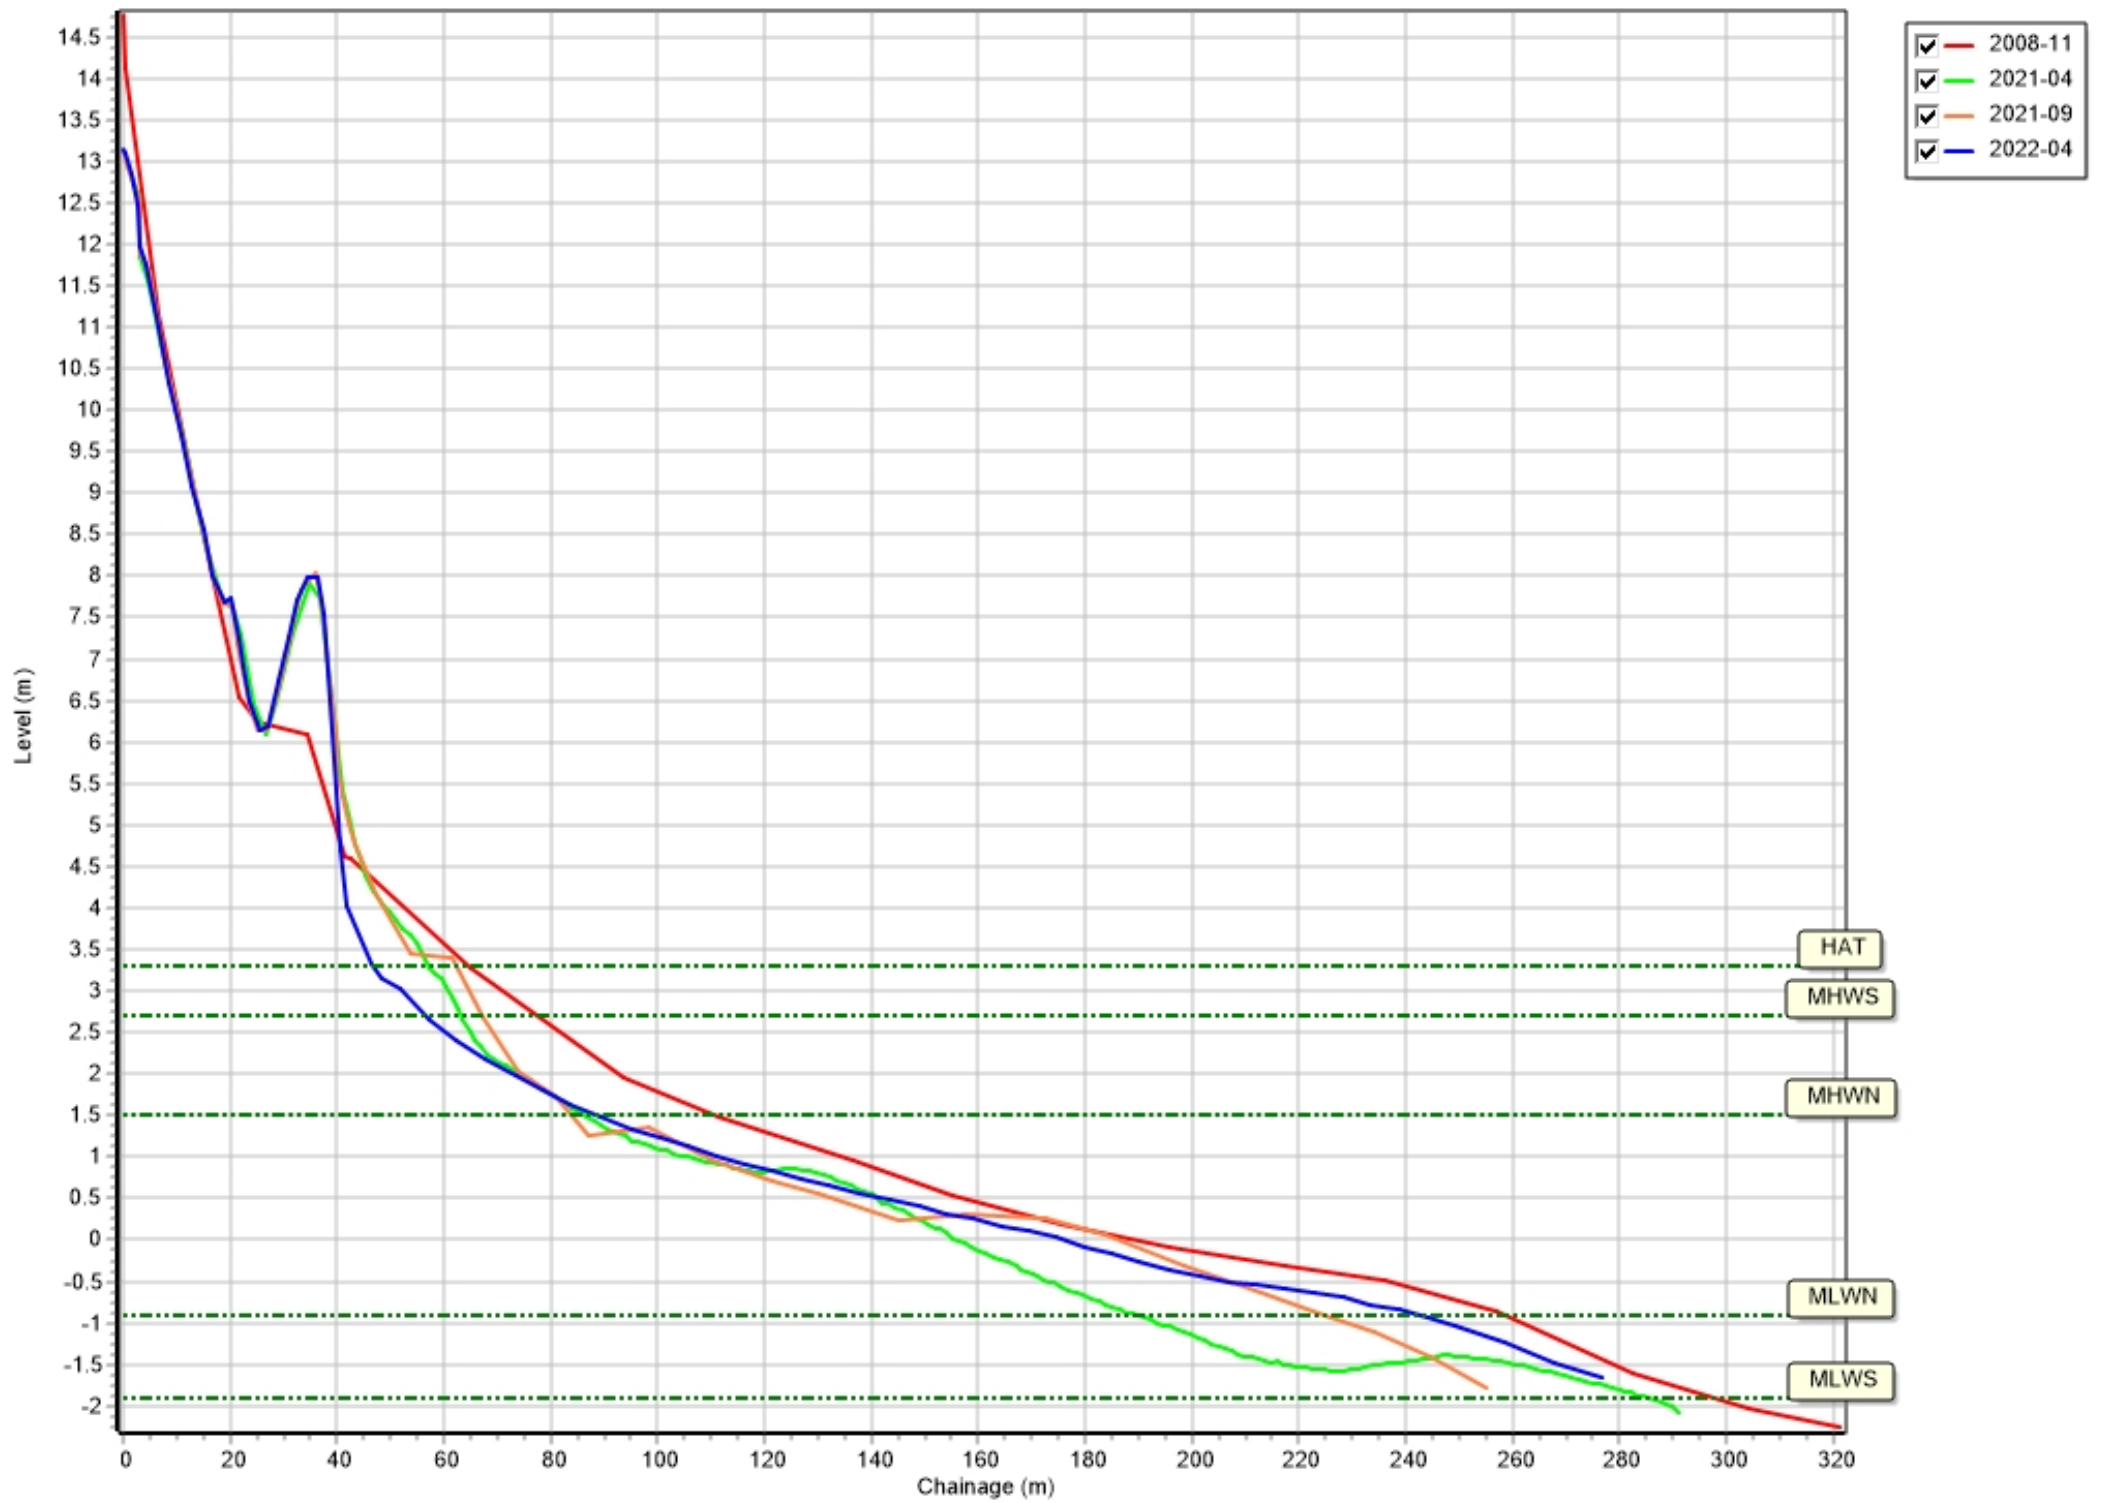
Profiles: 1cHN3

Survey Date	Description of Changes Since Last Survey	Interpretation
	<p>accreted by 0.95m forming a berm on the lower beach. Overall, the beach profile is at a medium level compared to the range recorded from previous surveys.</p> <p>Profile <b>1cHN3</b> has generally smoothed across the majority of the beach since the November 2021 survey, resulting alternating lengths of low level accretion and erosion, largely limited to <math>\pm 0.2</math>m. The most significant changes occur at the very upper beach (Chainage 40m to 80m) and very lower beach (Seawards of Chainage 210m), where the upper beach has eroded by up to 0.8m in level and the lower beach has accreted by up to 0.55m in level, suggesting a possible Winter draw down. The dunes have remained stable. Overall, the beach profile is at a medium level compared to the range recorded from previous surveys. However, the upper beach / toe of the dune is at the lowest level on record.</p> <p>At profile <b>1cHN3A</b> the dunes and beach has remained largely stable since the November 2021 survey. The dune front at 20m chainage is unchanged. The upper beach to chainages 130m has experienced consistent low level accretion in the order of +0.2m. Between chainages 130m and 210m the beach has undergone no change. Seawards of chainage 210m the beach has again experienced a low level of accretion in the order of +0.2m. Overall, the profile is at a medium level compared to the range recorded from previous surveying moving to a high level towards the lower beach.</p> <p>Profile <b>1cHN4</b> shows no change in the defended part of the profile. At the toe of the seawall (chainage 15m) the beach level has accreted by 1.0m, gradually reducing to no change by chainage 40m. Accretion of 0.3m in level is also observed between chainages 50m to 85m. Seawards of chainage 85m the rocky foreshore remains exposed and shows no change. Overall, the profile is at a medium level compared to the range from previous surveys.</p> <p>Profile <b>1cHN4A</b> was established in October 2011. The defended part of the profile to 10m chainage has not changed since October 2011. The rocky shore platform remains exposed seaward of chainage 40m. However, accretion of the upper beach (0.35m) has concealed the rocky foreshore in this location. This accretion means that between chainages 13m and 27m the profile is at its highest level when compared to the range of previous surveys. Seaward of chainage 40m the profile is at a low level.</p>
