North East  
Coastal  
Observatory

## **Cell 1 Regional Coastal Monitoring Programme Update Report 14: 'Partial Measures' Survey 2022**

**June 2022**

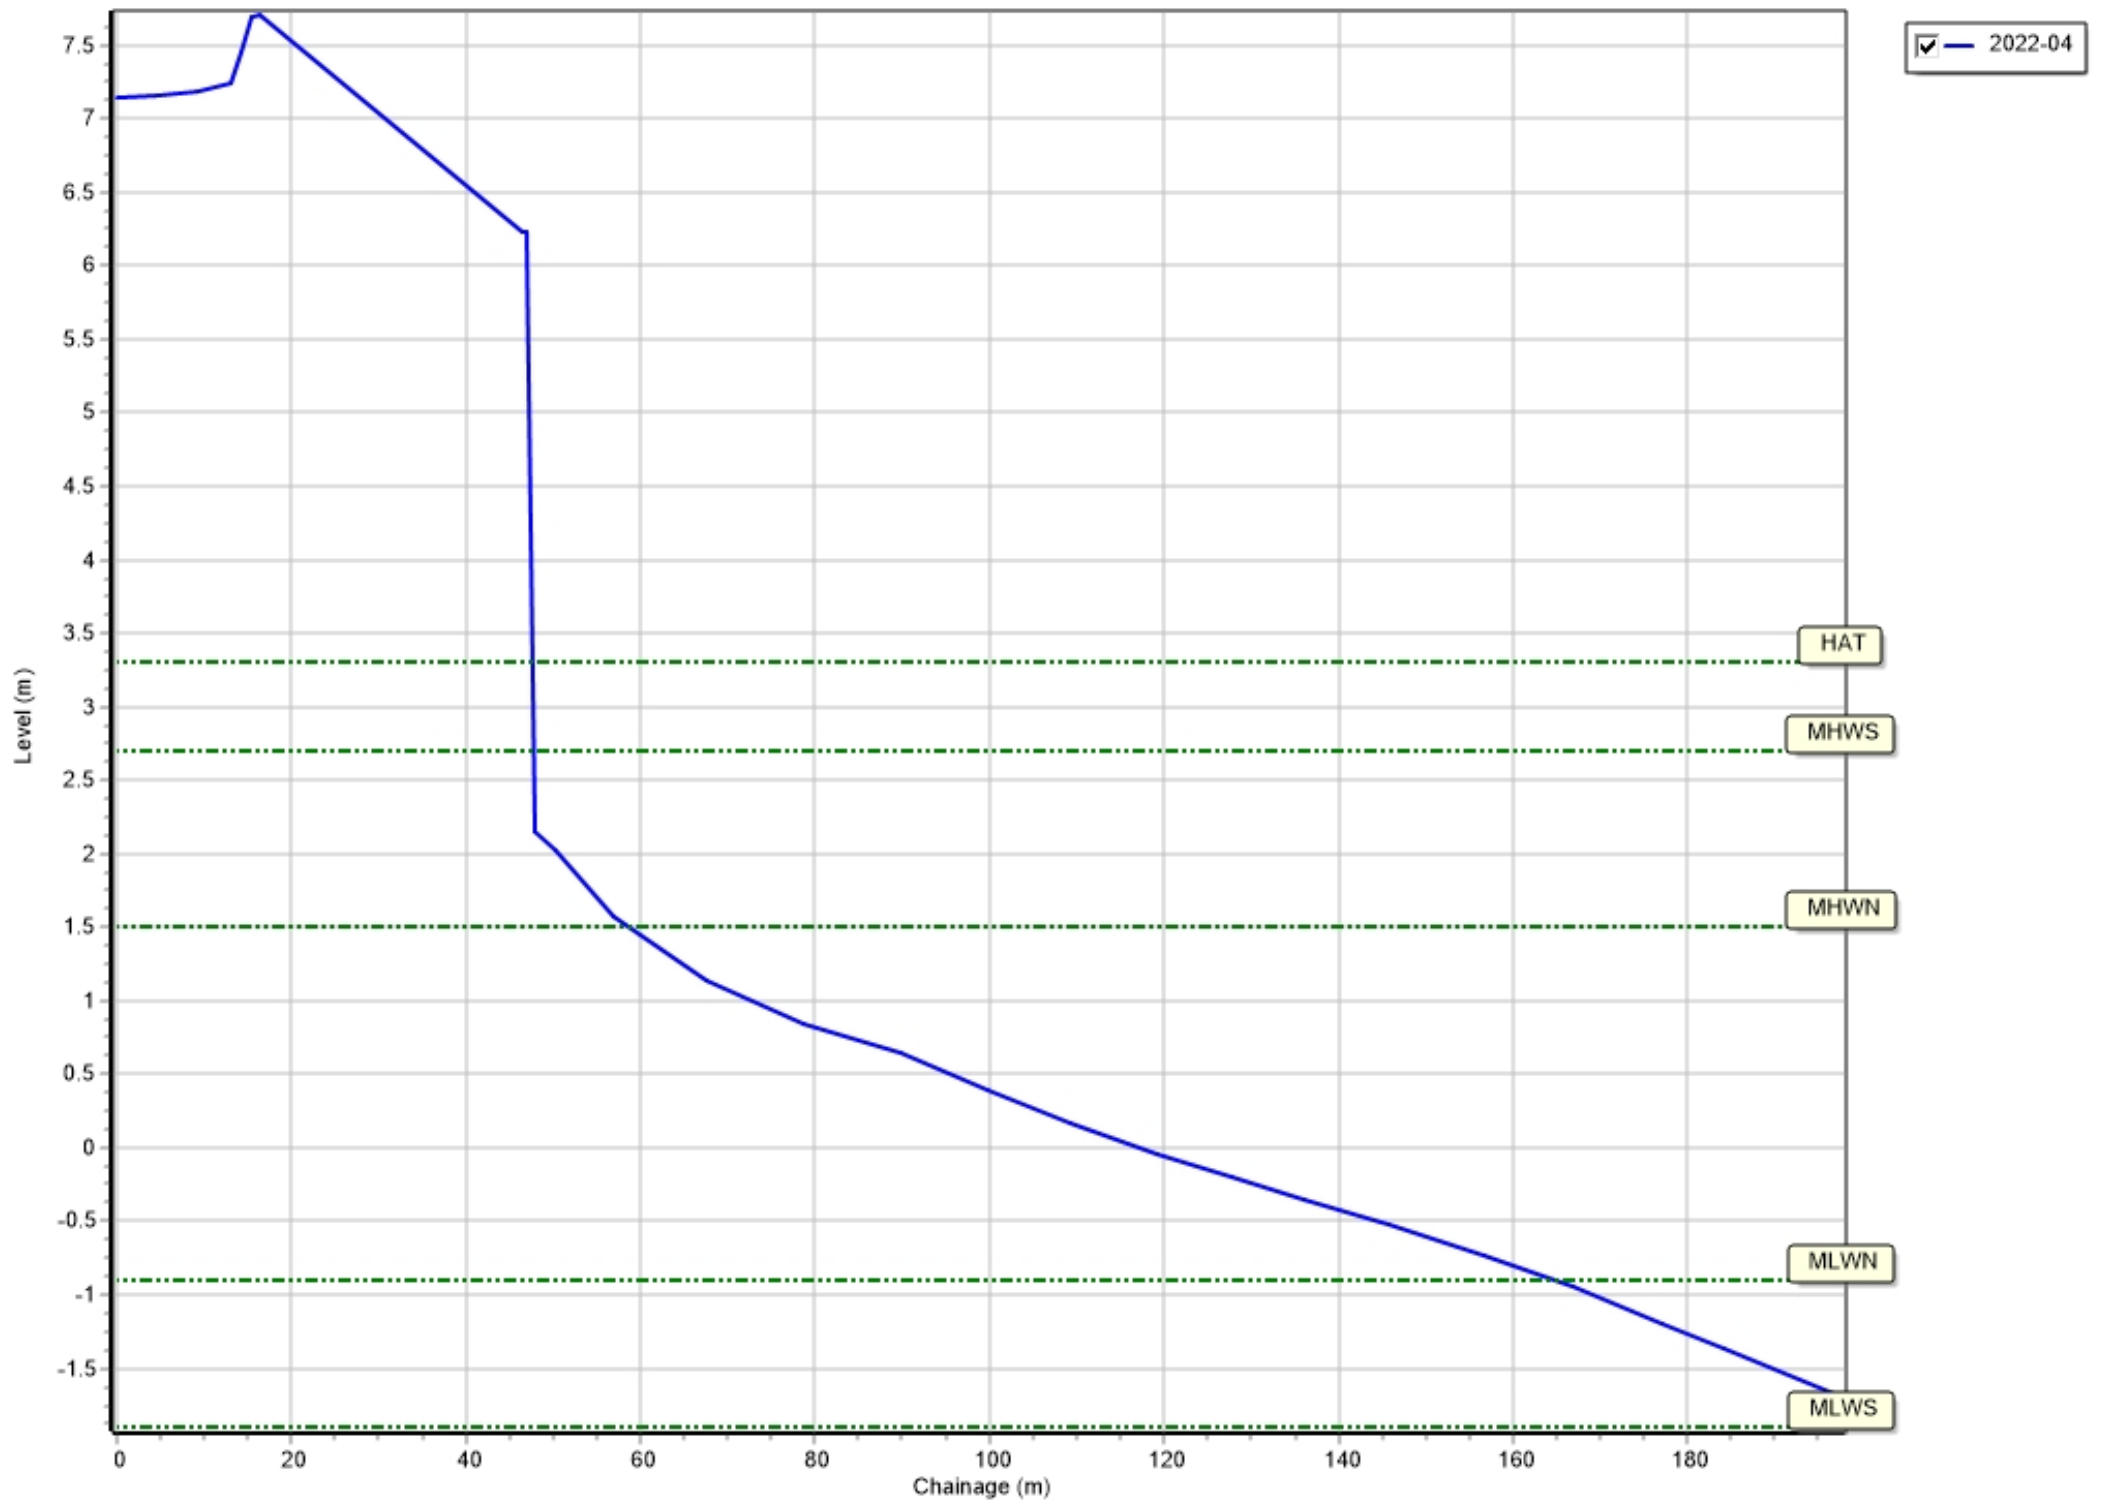
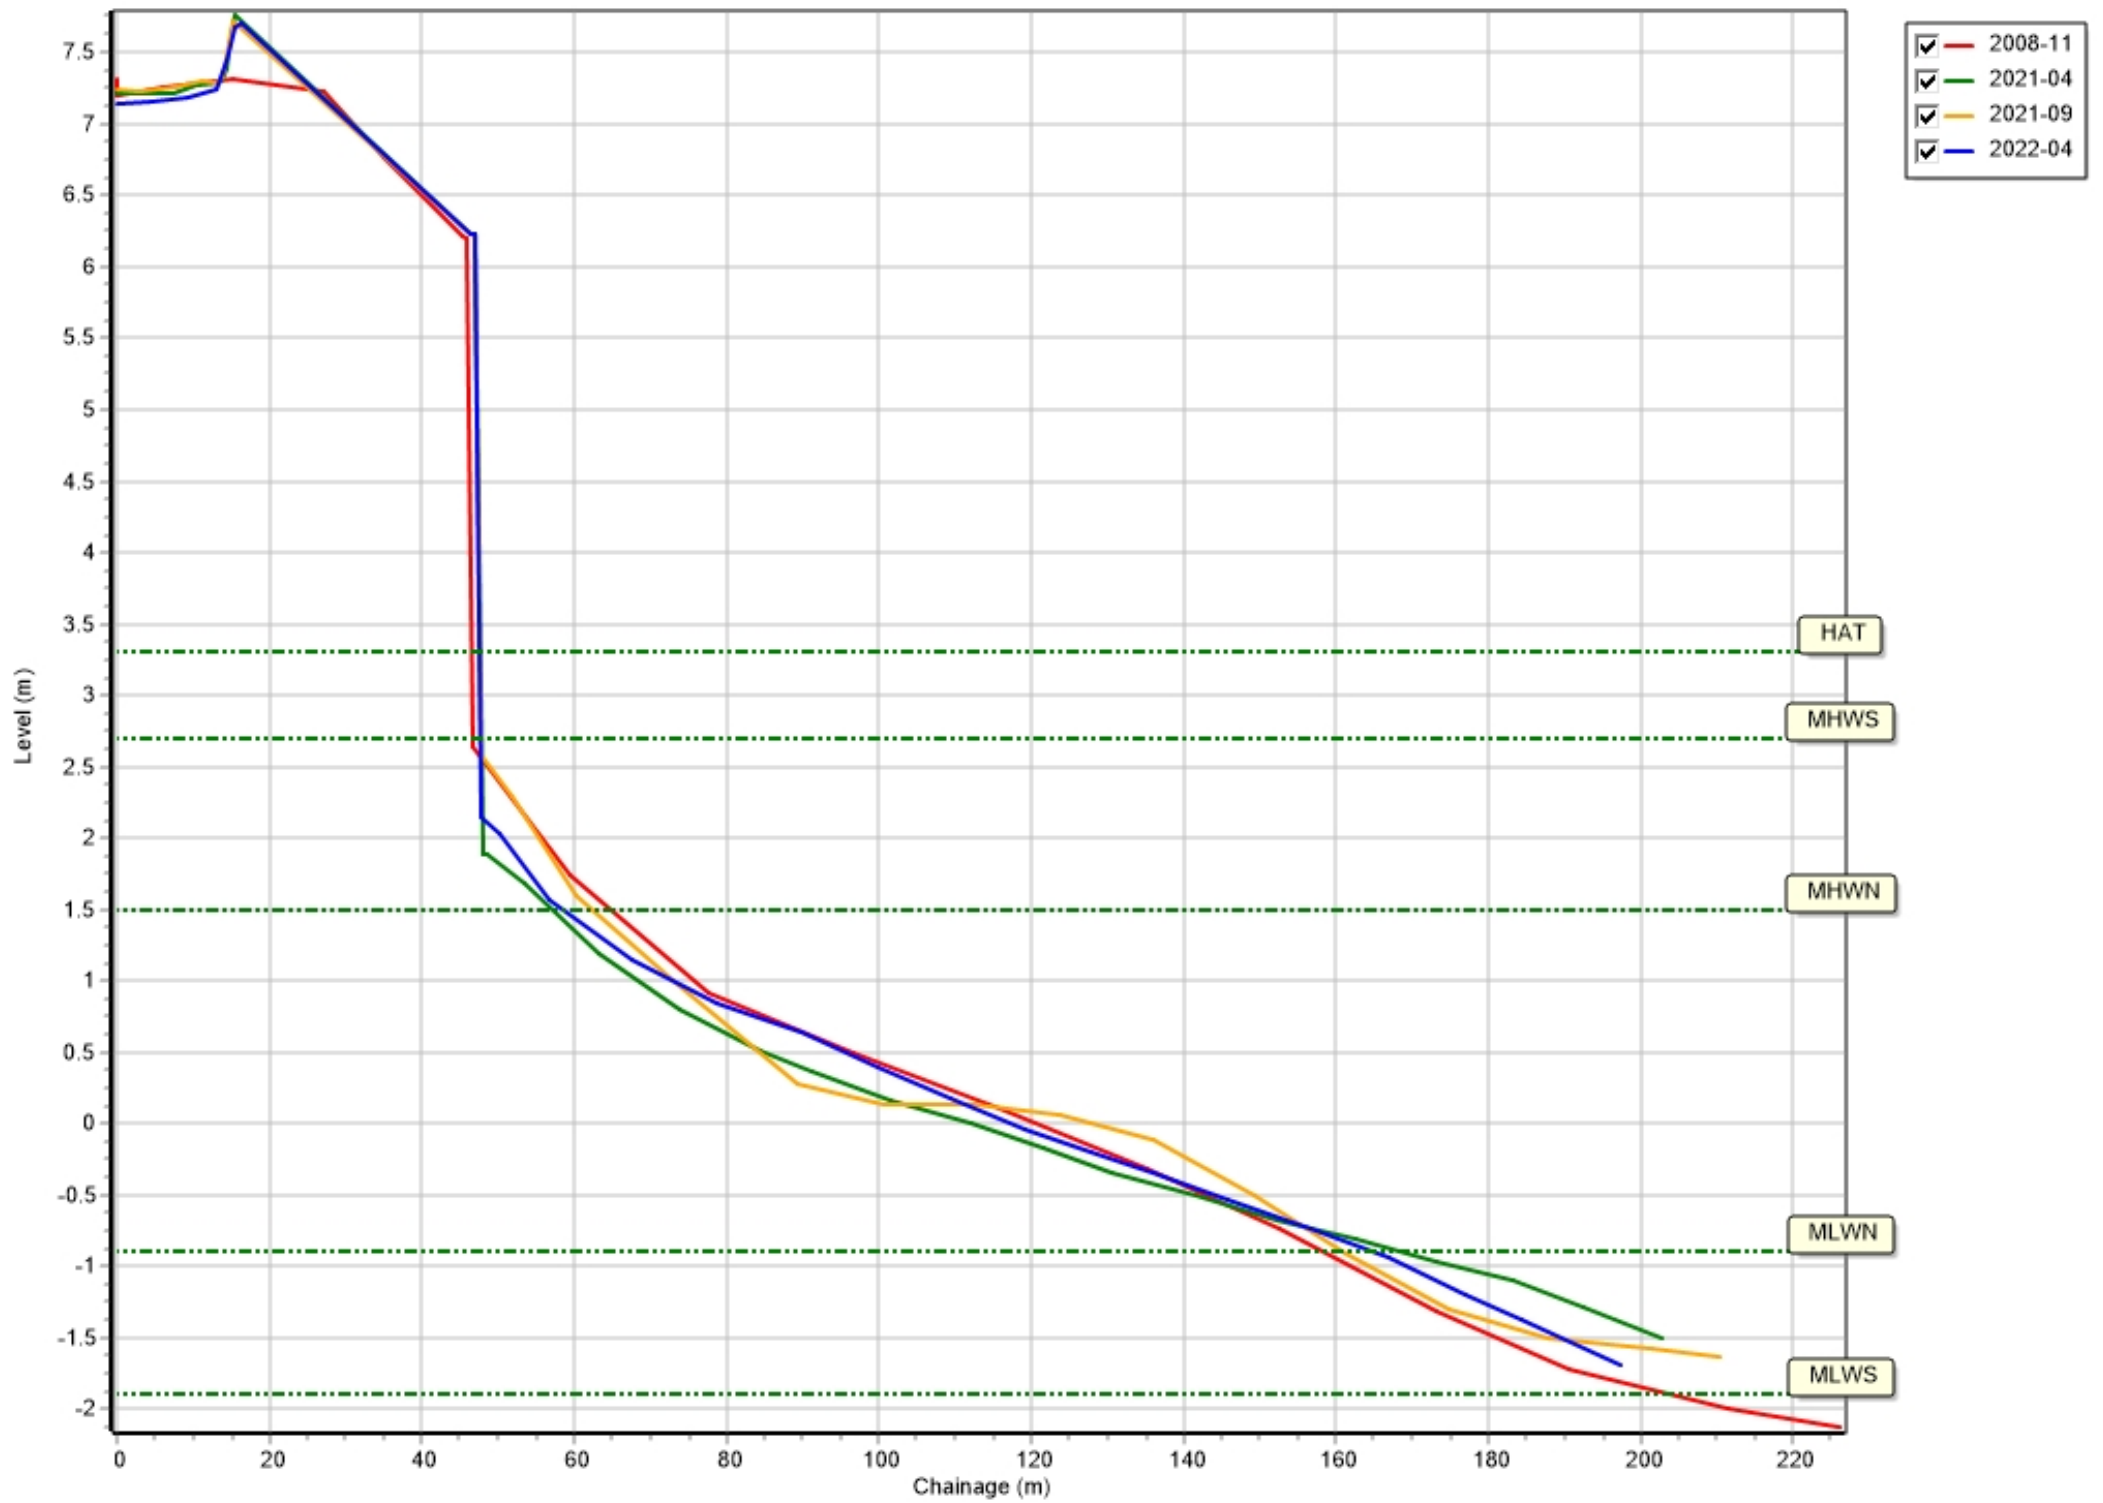
Profiles: 1cHC1

Survey Date	Description of Changes Since Last Survey	Interpretation
29 <sup>th</sup> April 2022	<p><b>Beach Profiles:</b></p> <p>Middleton is covered by one beach profile line, <b>1cHC1</b>, during the Partial Measures survey (Appendix A). The profile was last surveyed in November 2021. The survey report again notes 'no access to upper section on HC1 within the factory area'. The beach profile has generally smoothed since the previous survey resulting in alternating lengths of accretion and erosion. At the toe of the seawall (chainage 48m) the beach has lowered by 0.4m before switching to accretion between chainage 80m to 100m, then back to lowering between 110m to 150m and then back accretion between 160m to 190m. The magnitude of change is limited to 0.35m. Overall, the beach profile remains at a high level compared to the range recorded from previous surveys.</p>	<p>The beach profile at the toe of the seawall has lowered marginally since the previous survey, however the profile is healthy following the record low levels surveyed in March 2018.</p> <p><b>Longer term trends:</b> The beach level at this location tends to fluctuate through the year, with the most variable area being adjacent to the sea wall where wave energy is reflected. There is a pattern of seasonal variation, with lower levels typically recorded in the spring, following the period of winter storms. Recovery tends to occur by the autumn.</p>

- At Hartlepool Central a damaged fence along the crest of the brickwork seawall means that access was restricted to the upper reaches of profile 1cHC1.

- At Middleton, the beach profile at the toe of the seawall has lowered marginally since the previous survey, however the profile appears healthy following the record low levels surveyed in March 2018.

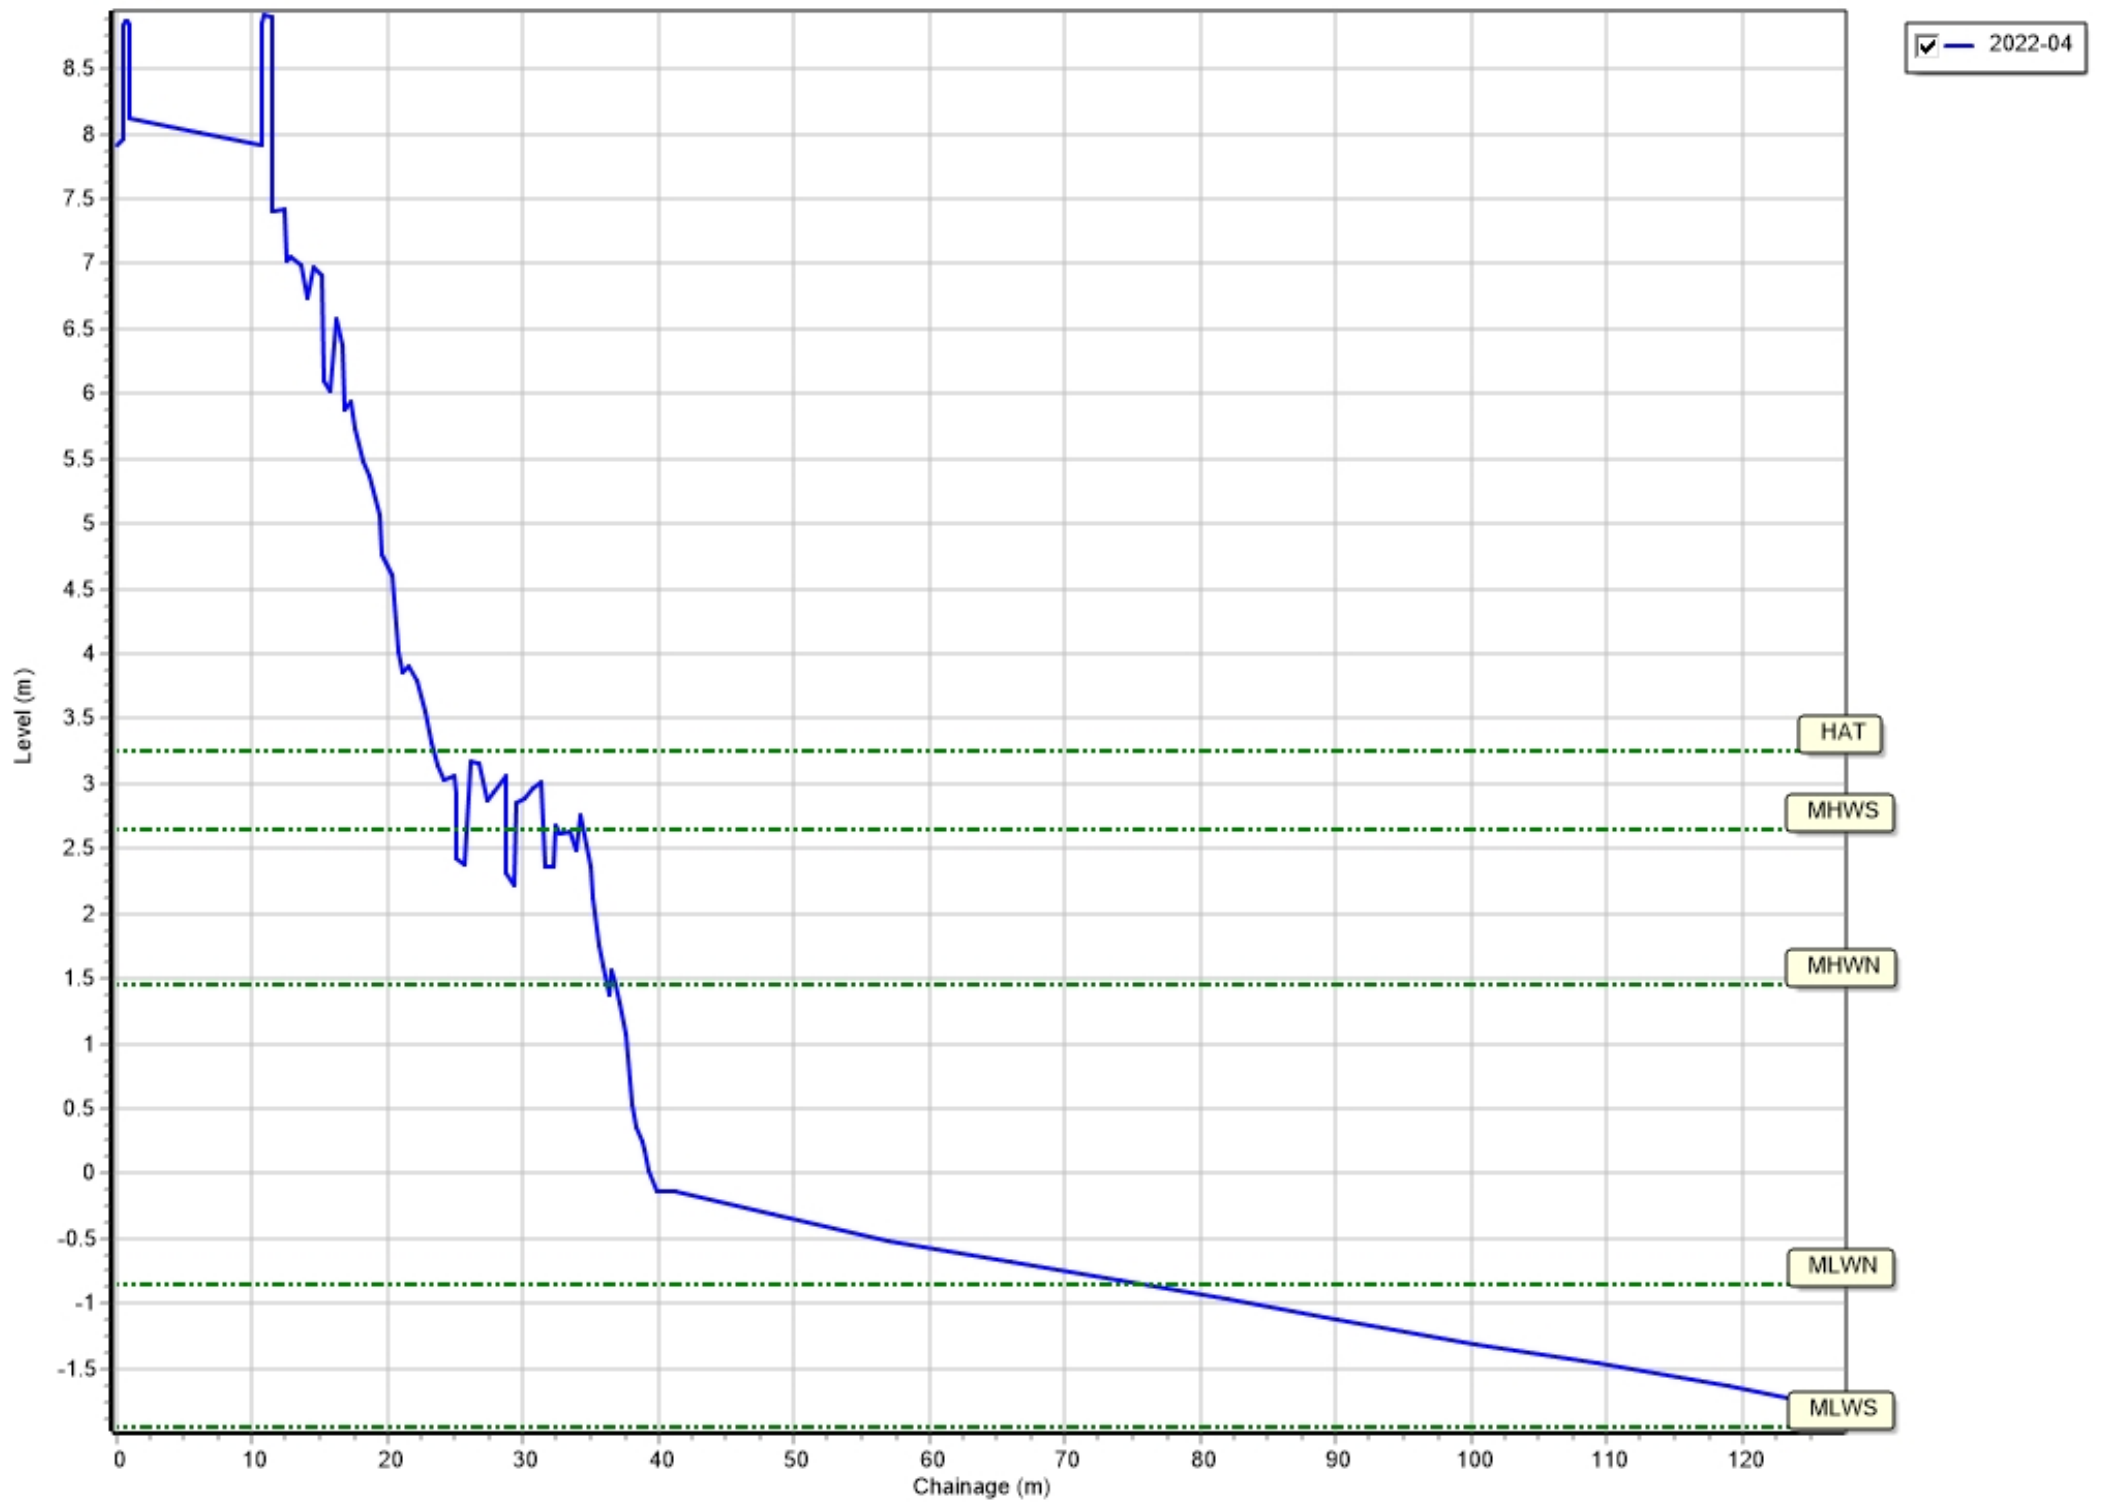
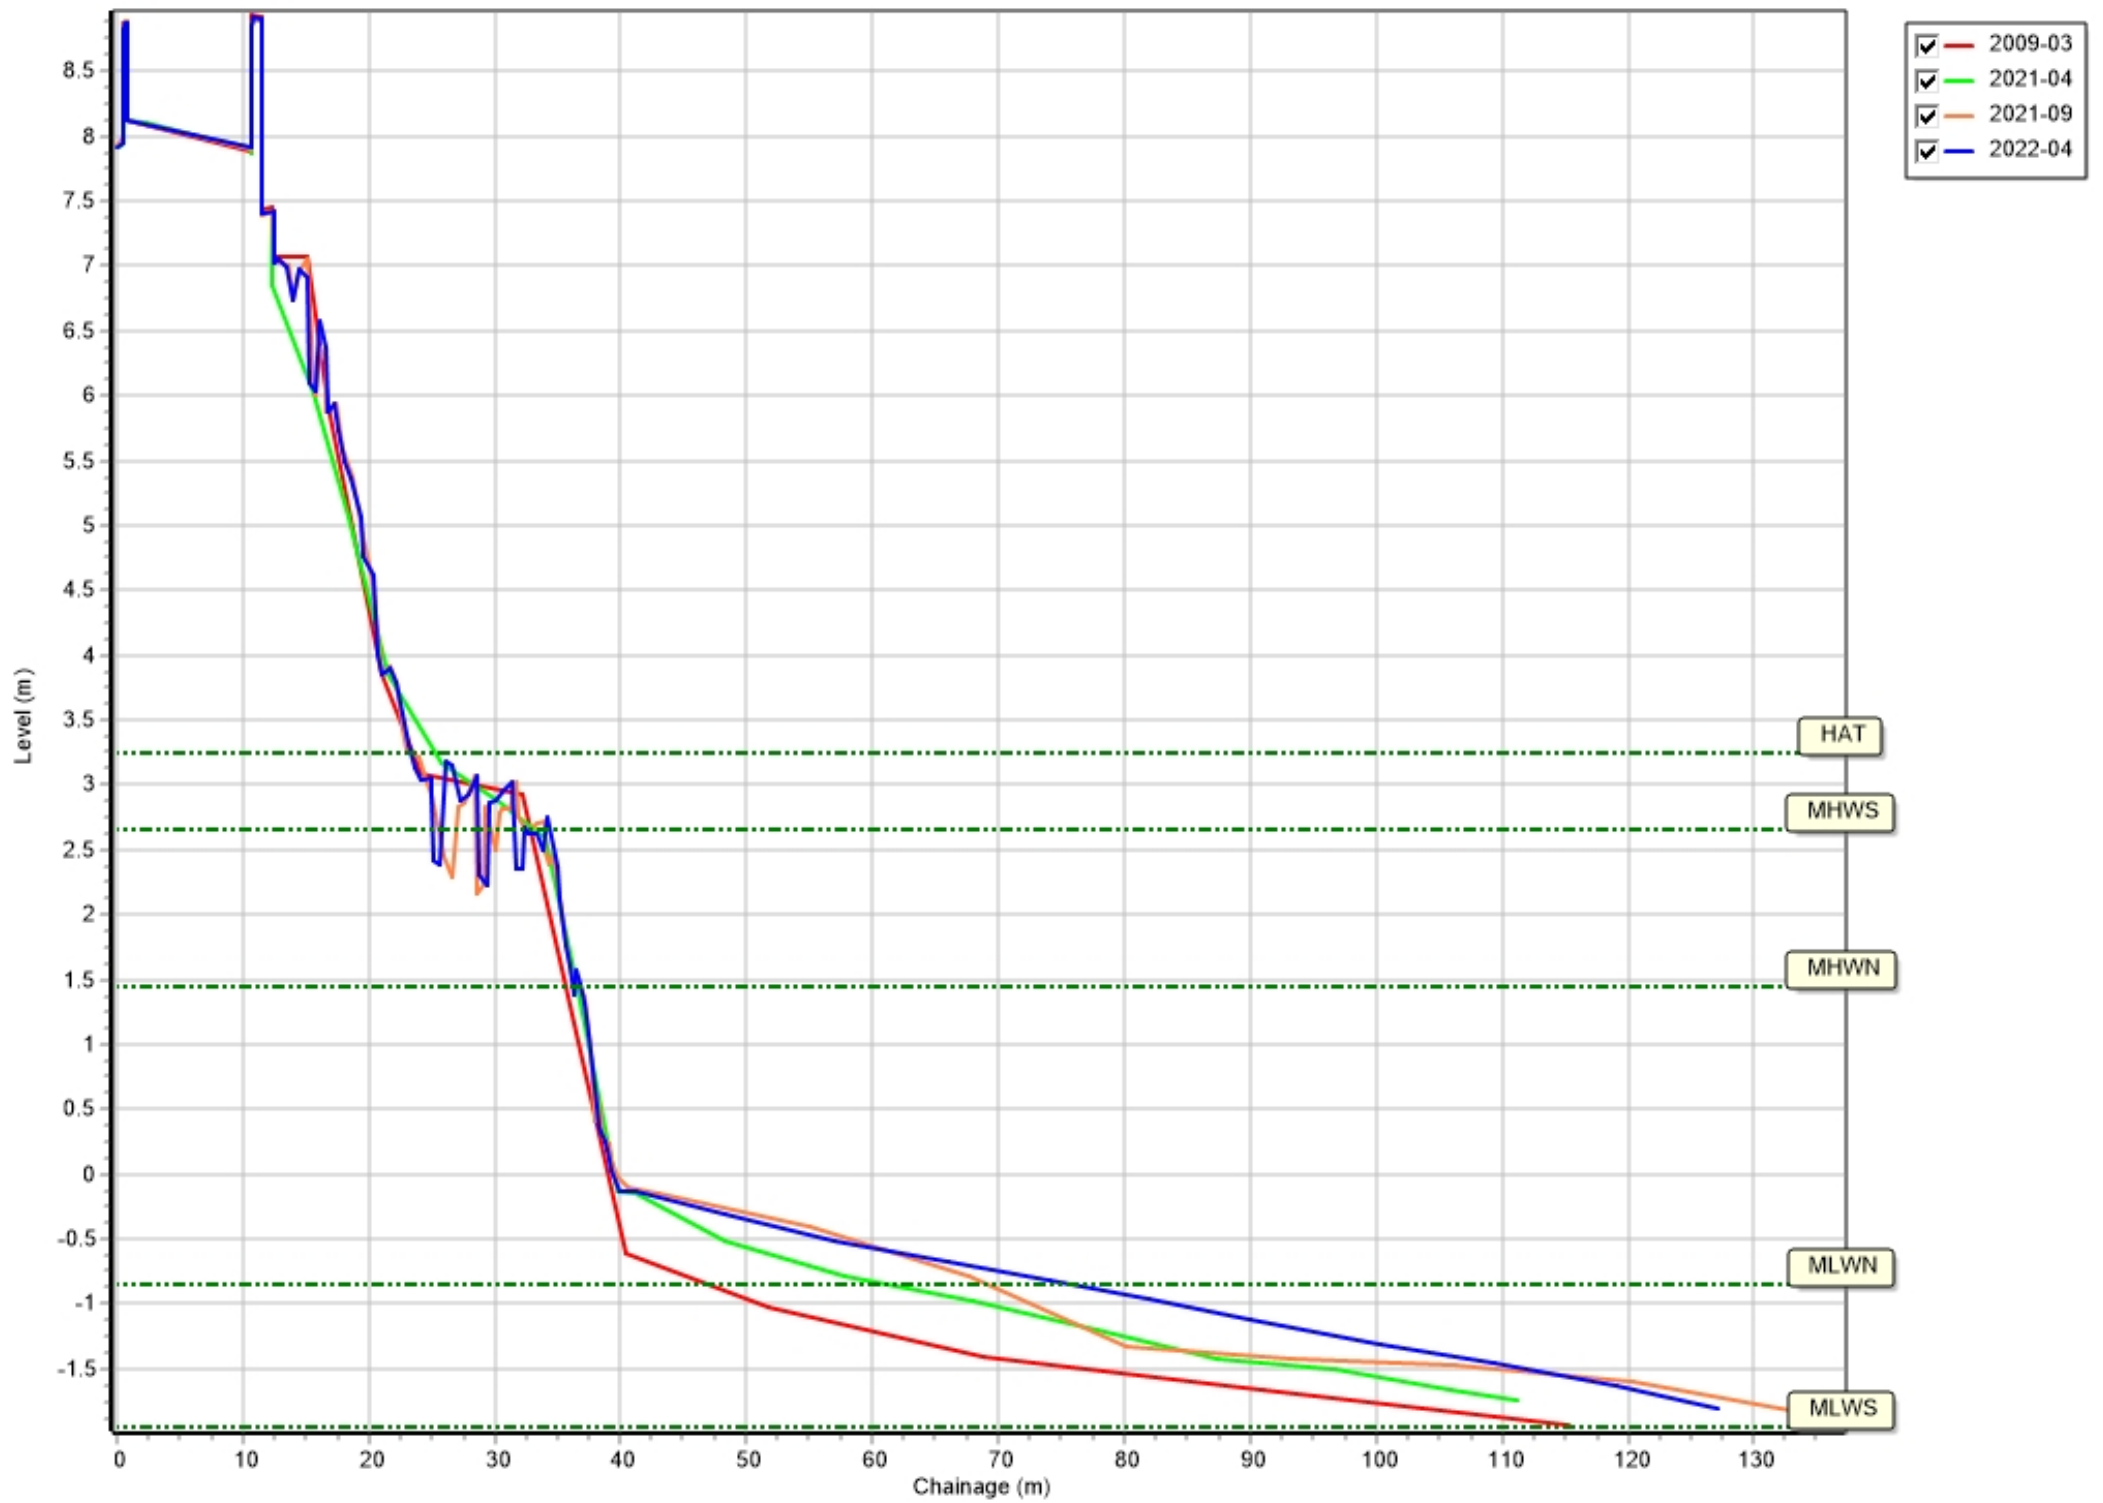
Profiles: 1cHS1

Survey Date	Description of Changes Since Last Survey	Interpretation
29 <sup>th</sup> April 2022	<p><b>Beach Profiles:</b></p> <p>Hartlepool Bay is covered by four beach profile lines during the Partial Measures survey (Appendix A). Profile <b>1cHS1</b> is located approximately 150m south of the root of the South Pier. The profile starts at the wall to the rear of the promenade and extends across the promenade, over the fronting concrete splash wall and down the sloping face of the rock armour revetment before reaching the beach. No significant change has occurred until 40m chainage, which is the toe of the sea defences. The upper beach level against the rock armour has also remained constant since the previous survey up to chainage 60m. Between 60m and 110m the beach profile has accreted by up to 0.35m resulting in a smoother beach profile. Overall, the profile is at a very high level compared to the range recorded from previous surveys.</p> <p>At profile <b>1cHS2</b>, there has been a general pattern of erosion on the upper and middle beach and accretion on the lower beach, causing the undulating beach profile observed in November 2021 to smoothen. The erosion on the upper beach is observed between chainage 25m (the toe of the sea defence) and chainage 95m, and again between 115m to 196m. The magnitude of erosion is limited to 0.3m. The accretion of the lower beach is observed between 196m and 304m. Overall, the profile is at a medium level compared to the range recorded from previous surveys.</p> <p>Profile <b>1cHS3</b> shows no changes over the defended part of the profile up to 30m chainage. The beach profile seaward of chainage 30m has been dominated by erosion and has lowered consistently by up to 0.6m to chainage 198m. As a result, the profile is a low to very low level when compared to the range recorded from previous surveys.</p> <p>Profile <b>1cHS4</b> is located 1km north of the North Gare Breakwater, within the area of undefended dunes at Seaton Carew. The part of the profile dominated by dunes to 340m chainage has remained stable. The depression between the main body of dunes and the foredune at 300m chainage has been deepening since 2013, with a further deepening of 0.1m since November 2021. The depression is at its lowest level compared to the range recorded by previous surveys. On the upper beach, between 344m and 423m, the beach levels have dropped significantly reducing in level by up to 1.3m. This material appears to have been drawn down as a beach platform at chainage 424m to 500m has been covered. The lower beach has remained stable. The upper beach is at a low level when compared to previous</p>	<p>Beach levels across Hartlepool Bay have generally lowered over the winter of 2021/22. The southern and central profiles show that lowering has dominated the upper and middle beach with some minor accretion on the lower beach. This pattern is typical of winter conditions causing drawdown of material. The profile to the north shows accretion has occurred in this location, with beach levels remaining very high.</p> <p>Where present, the dunes remain in good condition, with the survey photos suggesting foredune growth in some areas.</p> <p><b>Longer term trends:</b> Since the start of the surveys, beach levels appear to have been progressively increasing towards the north of the bay.</p>

- At Hartlepool Bay, beach levels have generally lowered over the winter of 2021/22. The southern and central profiles show that lowering has dominated the upper and middle beach with some minor accretion on the lower beach. This pattern is typical of winter conditions causing drawdown of material. The profile to the north shows further accretion has occurred in this location. Where present, the dunes across remain in good condition, with the survey photos suggesting foredune growth in some areas.
