**Cell 1 Regional Coastal Monitoring Programme  
Analytical Report 5: 'Full Measures' Survey 2012**

**Redcar and Cleveland  
Borough Council  
Final Report**

**March 2013**

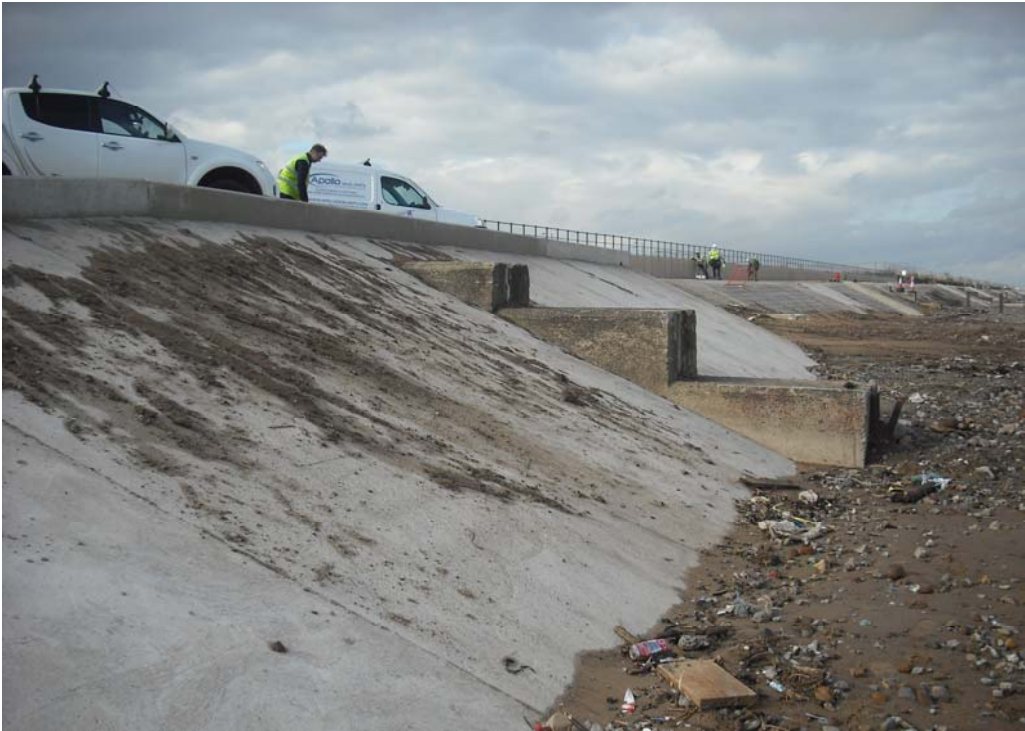
<p>The new defence at Profile RC6.</p>	<p>A new defence has been built, which affects the landward section of profiles RC5 and RC6. Profile RC5 had accreted while RC6 remained stable. RC7 was stable for most of the profile but eroded at the lower end. Two mounds of material accreted on the beach at RC5. At RC 6 and RC7 the beach gradient remained the same between spring and autumn.</p> <p>The topographic change plots support the pattern of localised accretion and stability shown in the beach profiles. There was accretion overall although the north-east facing part of the frontage had a patchy distribution of accretion and erosion.</p> <p><b>Longer term trends:</b> The construction of a new defence means that this 2012 Full Measures Report will act as a new baseline for the behaviour of the beach in front of the defence. The overall observed pattern is of stability with some accretion in parts of the bay (such as on the rocks offshore of Redcar).</p> <p><b>Autumn 2008 to Autumn 2012 trends</b></p> <p>The plot of long term elevation net difference between Winter 2008 and Autumn 2012 shows that the changes observed are of a similar magnitude to those observed over the six month survey periods. This suggests that net long term change is limited and that the pattern of change indicated reflects seasonal</p>

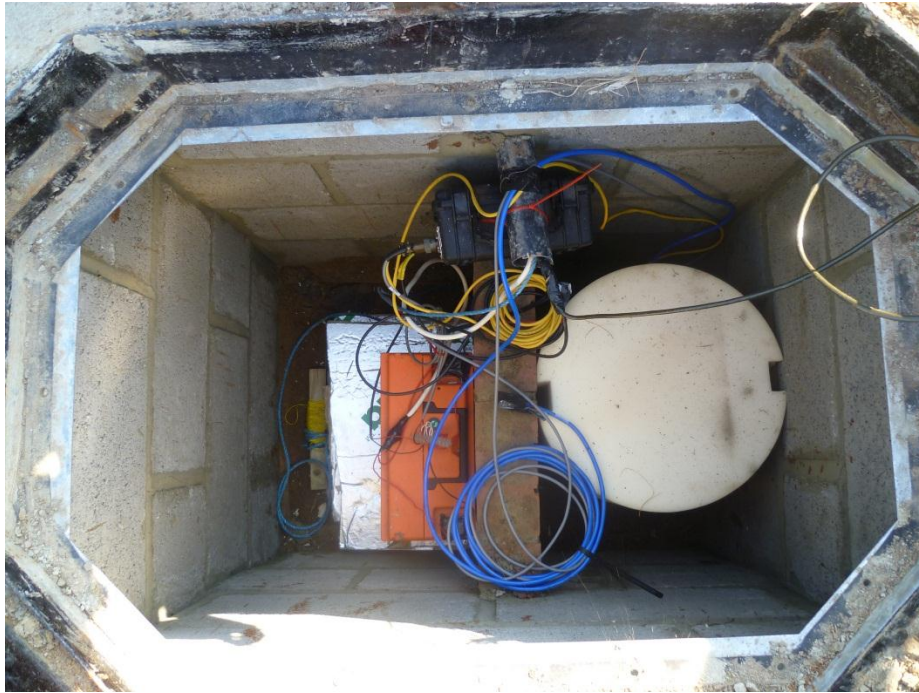
Figure 1 View into the seismic well, showing the Guralp seismometer encased within a foam box to minimize the effects of air circulation on the instrument. The data logger and model is contained with the black Pelicase. 12 v power and communications are provided via a buried conduit to the lamp-post adjacent to the site, which is seen entering the well at the top of this photo.

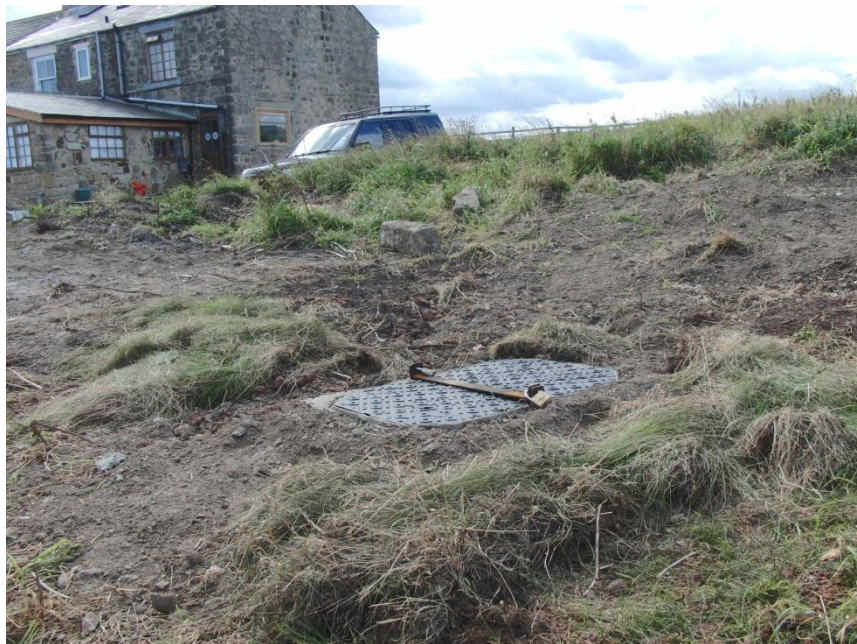
Figure 2 View of the sealed seismometer installation, flush with the ground, and set back from the edge of the cliff by 5 m.

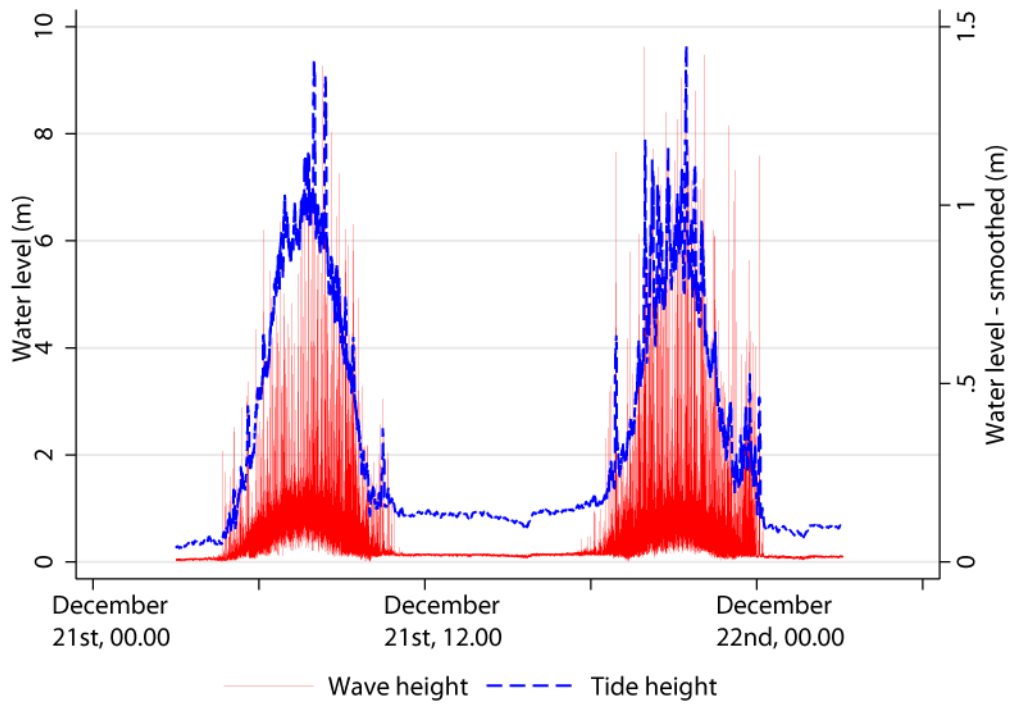
Figure 4 Water level obtained from laser radar, over a single day (21st December 2012)

The laser has a cabled connection to a PC housed in the seismic well on the cliff top, where software logs the data internally, and streams the data via a GPRS modem to Durham. The data is then archived and processed to 15-minute intervals, and merged into the rest of the monitoring data. An example of the data is provided in Figure 4, which shows the raw data stream (red - left axis) and a 1000 sample smoothed derivative (blue – right axis). The raw data minus the smoothed data gives wave heights, whereas purely the smoothed data gives mean sea surface water level.

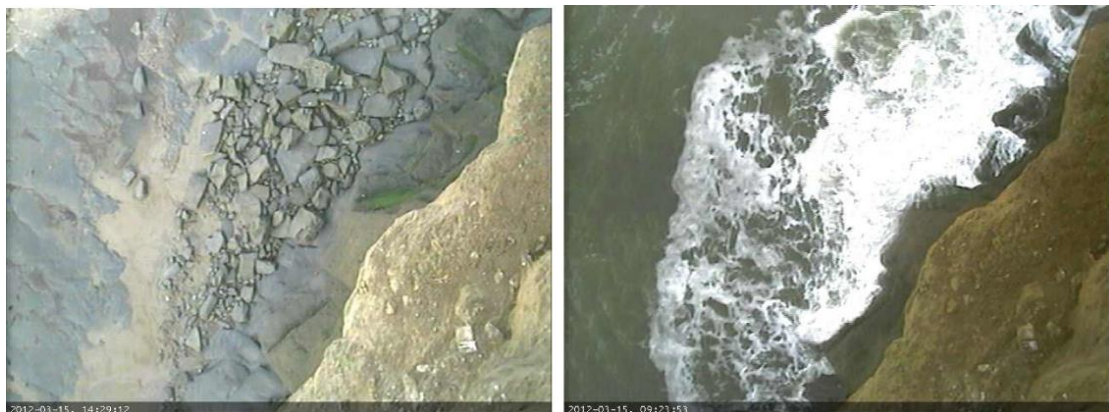
Figure 5 View from the web-cam during low tide (left) and high tide (right)

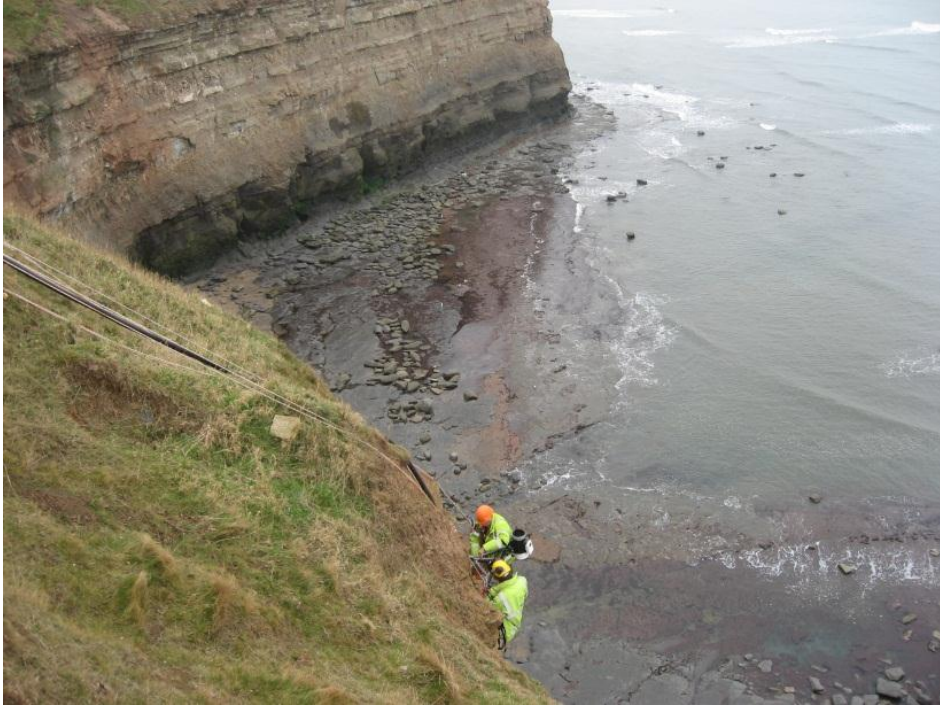
Figure 6 Installation of the cliff face instrumentation, including weather station, laser radar and camera.

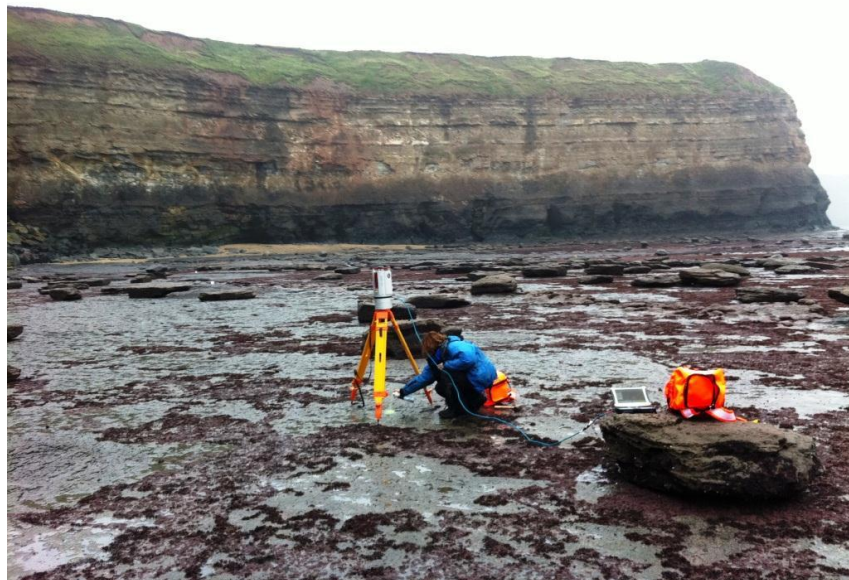
Figure 8 Reigl VZ-1000 at QP1 on the foreshore below Cowbar Nab.

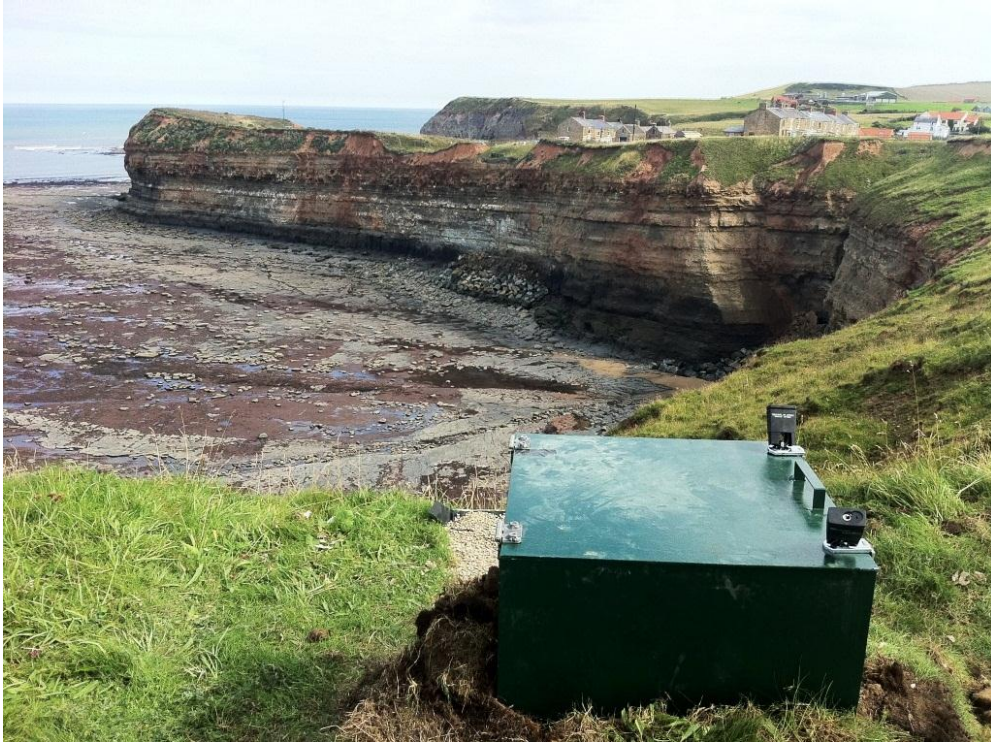
Figure 11 Foreground: Permanent laser scanner installation, showing the view of Cowbar from the scanner housing in the background.

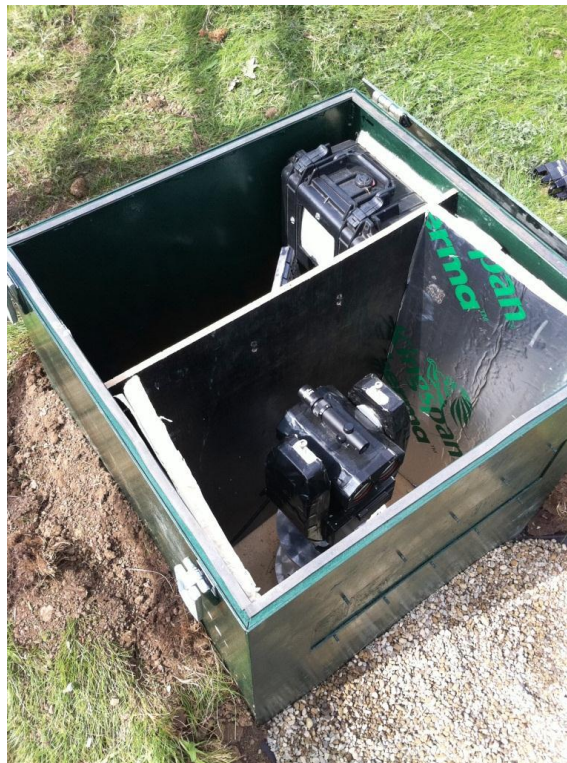
Figure 12 View inside the permanent scanner installation, showing the scanner nearest to the window mechanism, and the controls PC at the rear of the box

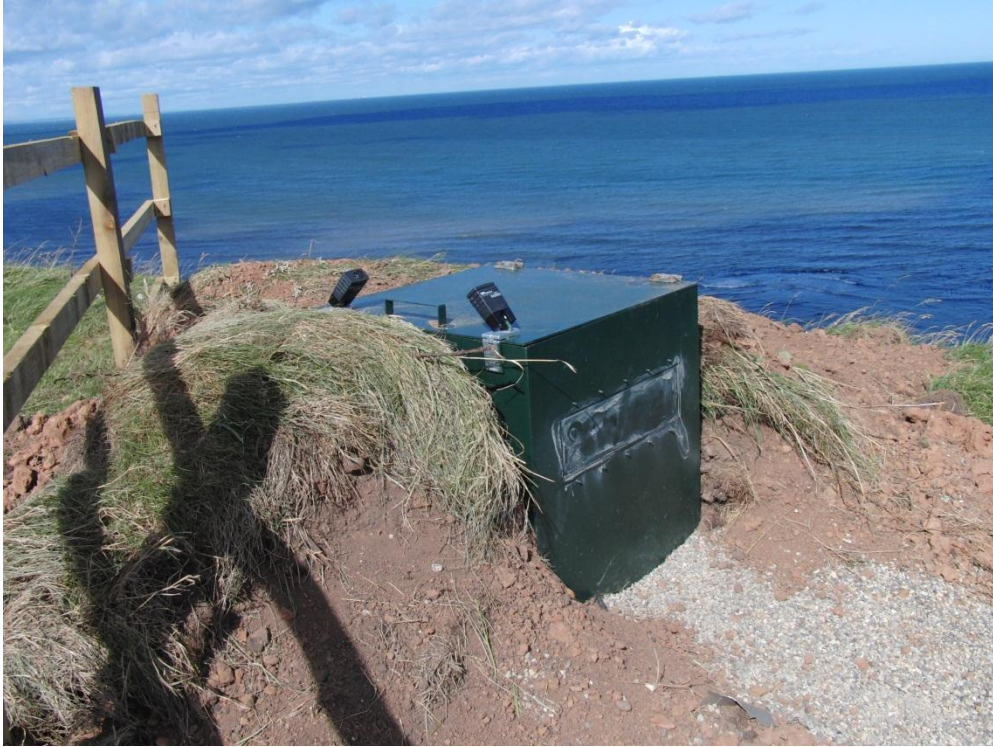
Figure 13 View of the automatic window (closed) on the scanner housing.

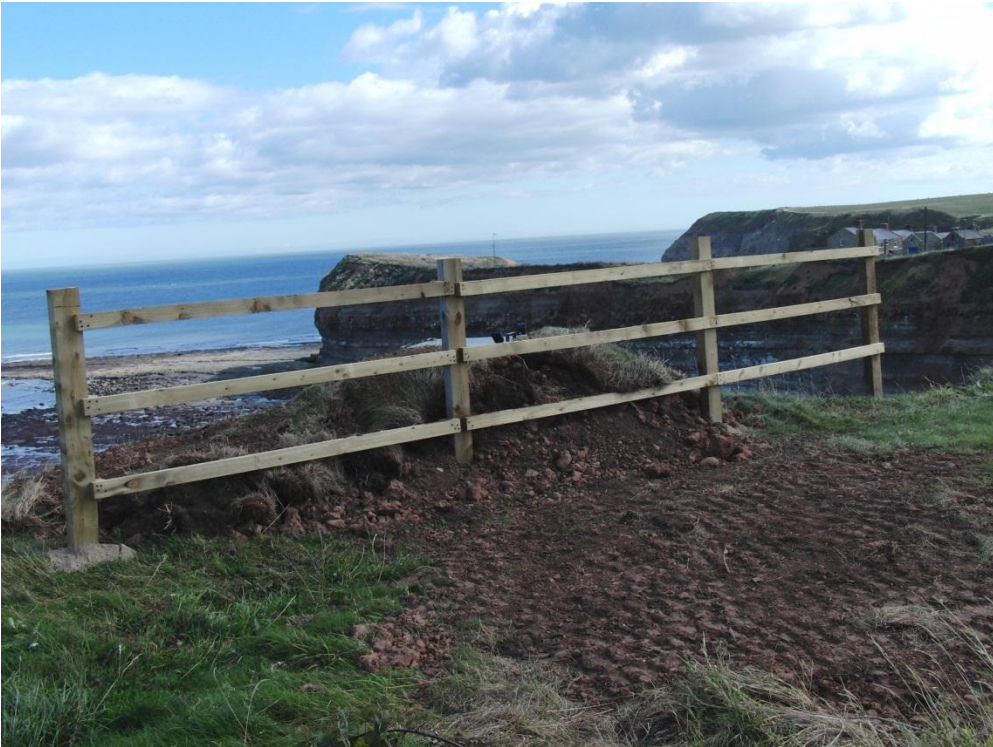
Figure 14 Fencing erected around the scanner housing
