**Cell 1 Regional Coastal Monitoring Programme  
Analytical Report 13: 'Full Measures' Survey 2020**

**Redcar and Cleveland  
Borough Council**

**February 2021**

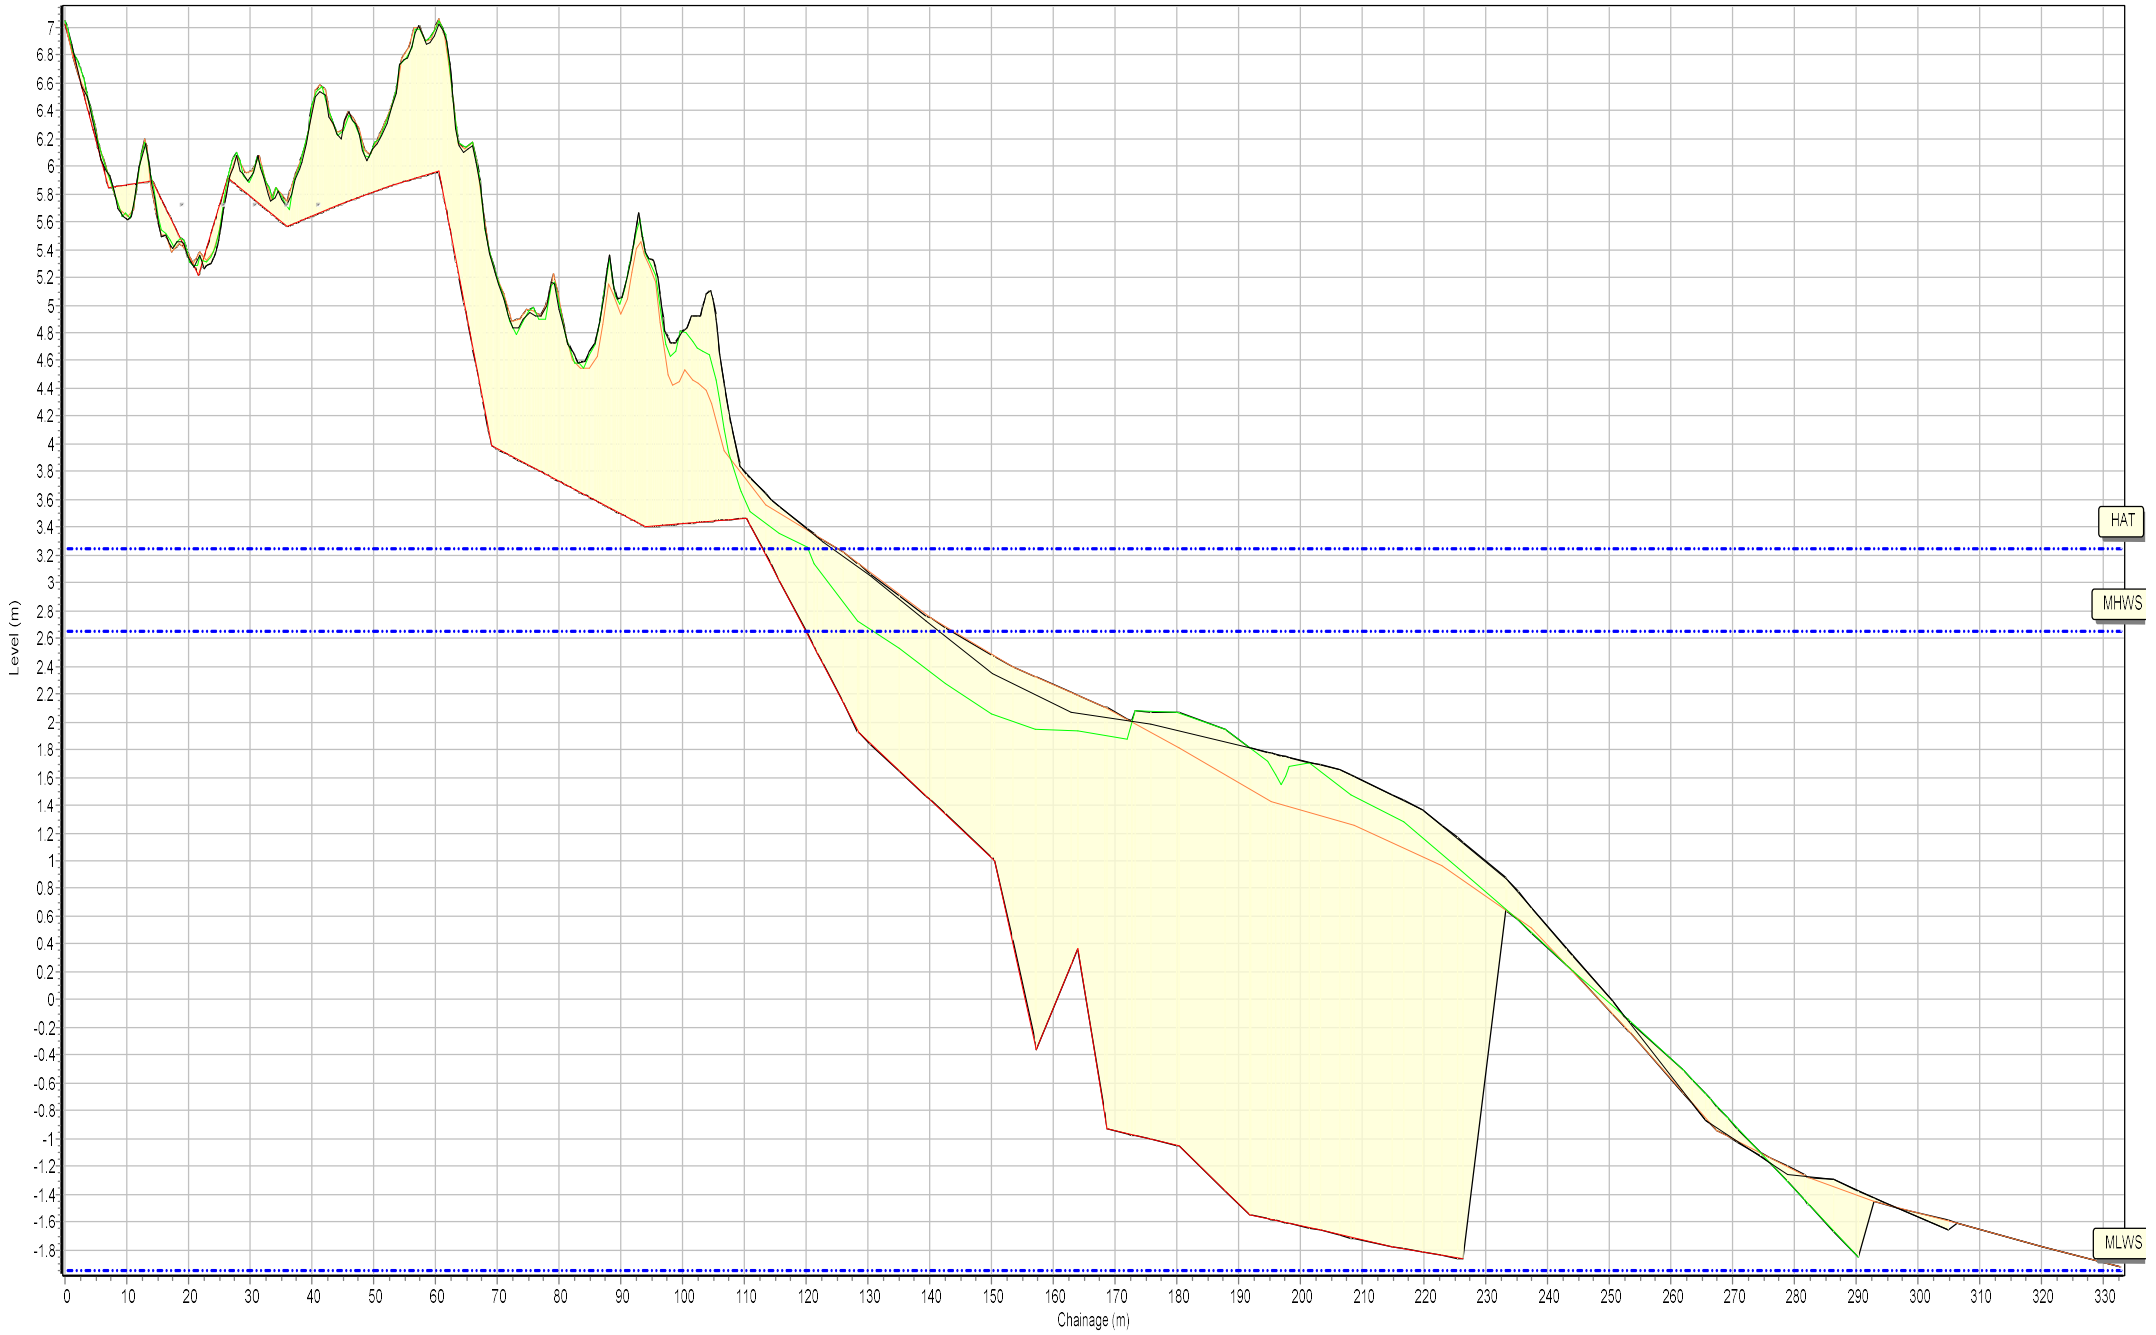
Beach Profiles: 1cRC1

Profiles Envelope 17/11/2008 31/10/2019 29/05/2020 04/11/2020

Survey Date	Description of Changes Since Last Survey	Interpretation
4 <sup>th</sup> November 2020	<p><b>Beach Profiles:</b></p> <p>Coatham Sands is covered by four beach profile lines during the Full Measures survey (RC1 to RC4; Appendix A).</p> <p>Profile <b>1cRC1</b> is located approximately 300m south of the South Gare breakwater, in the lee of the German Charlies slag banks. The upper profile is dominated by dune ridges, which have remained stable since the 2009 surveys. The foredune has undergone accretion of 0.3m at its crest. There has been accretion from the toe of the dunes at chainage 107m to chainage 171m of up to 0.4m. This has caused a smoothing of the beach profile in its upper and mid reaches. From chainage 171m to chainage 187m a narrow mid-beach berm has been eroded leading to a drop in the beach level here of 0.2m. Seawards from this point up to chainage 252m a low level of accretion has increased the lower-mid beach level by up to 0.2m. From this point to chainage 276m the trend is reversed, and erosion has led to a reduction in the level by up to 0.2m. Whereas the toe of the profile, between chainage 276m and the end of the survey at chainage 298m has experienced accretion of up to 0.5m in level. This has led to a seaward extension of the toe by 15m. Overall these changes have smoothed the profile when compared with the previous Partial Measures survey. The beach level remains high compared to the range recorded from previous surveys. The profile is at its highest recorded level in three locations; on the foredunes from chainage 78m to 107m, at the toe of the foredune from chainage 107m to 114m and on the mid-beach from chainage 192m to 234m.</p> <p>At Profile <b>1cRC2</b>, the dunes continue to remain stable. Over the summer of 2020, the foredunes have experienced up to 0.4m of accretion in level, most notably at the crest of the foremost dune. The seaward face of the foredune has also experience significant accretion of up to 0.4m in level. At the toe of the foredune from chainage 98m to chainage 135m there has been accretion leading to an increase in level of 0.2m. Across the remainder of the beach the profile has remained largely unchanged. Two small upper beach berms which were recorded in the Spring 2020 survey have been eroded and the profile now has a consistent, shallow gradient across its entirety. A small degree of erosion on the mid-beach has seen levels, between chainage 220m and 260m, drop by 0.1m. At the seaward end of the</p>	<p>Overall, the dunes have remained stable at Coatham Sands since the previous partial measures survey. Whilst the beach profiles show that accretion has been the dominant process over the intervening period, covering the summer of 2020, there has been some low levels of erosion in the two southernmost profiles (1cRC3 and 1cRC4).</p> <p>The topographic survey difference plots show a similar trend, with accretion being the dominant process, particularly over the central swathe of the survey extent. There are however two areas of erosion, the southernmost area has been identified in beach profile 1cRC4. The northernmost area of erosion is located slightly to the south east of the location of 1cRC1 and as such was not identified in the beach profile surveys. Generally, erosion has been constrained to the lower beach, however in the south of the survey extent there has been some erosion on the upper beach.</p> <p><b>Longer term trends:</b> The beach profile surveys indicate that the magnitude of change over summer 2020 has been low and is in line with the range of previously recorded results.</p> <p>The topographic survey difference plot has identified an area of erosion in the north west of the survey area, however this is generally contained on the lower</p>

Survey Date	Description of Changes Since Last Survey	Interpretation
	<p>profile, from chainage 340m to the end of the survey at chainage 385m there has been accretion, increasing the level of the beach by up to 0.4m at the toe of the profile. The profile is at a high level when compared with the range recorded in previous surveys. Most notably on the foredune where the profile is at its highest recorded level between chainage 77m and chainage 105m.</p> <p>Profile <b>1cRRC3</b> shows stable dunes with some accretion leading to an increase in level of up to 0.3m at the crest of the foredune. There has been a small degree of erosion on the seaward face of the foredune, although this has only resulted in a small reduction in level limited to between 0.1m and 0.2m from chainage 47m and chainage 55m. From the toe of the dune at chainage 55m across the upper and mid – beach to chainage 225m the profile has experienced accretion raising the beach level by 0.3m. Between chainage 225m and 255m there has been a small degree of erosion leading to a reduction in level of 0.2m. Seawards from this point to chainage 307m a lower beach berm has formed increasing the level of the profile by 0.3m between chainage 255m and 308m. At the seaward toe of the profile, from chainage 308m to the end of the survey at chainage 340m, erosion has led to a reduction in level of 0.3m. Overall, the profile is at a medium to high level when compared with the range recorded from previous surveys. The only exception to this is at the crest of the foredune, between chainage 31m and chainage 40m, where the profile is at its highest recorded level.</p> <p>Profile <b>1cRRC4</b> is the beginning of the defended section at Redcar. There has been accretion against the seawall from chainage 11m to 16m increasing the beach level by 0.4m directly along the face of the seawall. On the upper beach, from chainage 16m to chainage 40m erosion has caused the beach levels to drop by 0.2m. This material has been drawn down and formed a shallow berm between chainage 40m and chainage 70m. The remainder of the profile from chainage 70m until the end of the survey at chainage 340m has experienced consistent erosion, decreasing beach levels by between 0.1m and 0.2m. Overall the profile is at a high level on the upper beach, a medium level on the mid-beach and a low level on the lower beach, when compared with the range recorded from previous surveys. The profile is at its highest recorded level between chainage 47m and 57m and its lowest level between chainage 225m and 328m.</p>	<p>and mid-beach. The changes recorded in Autumn 2020 are in line with those recorded in previous surveys.</p>

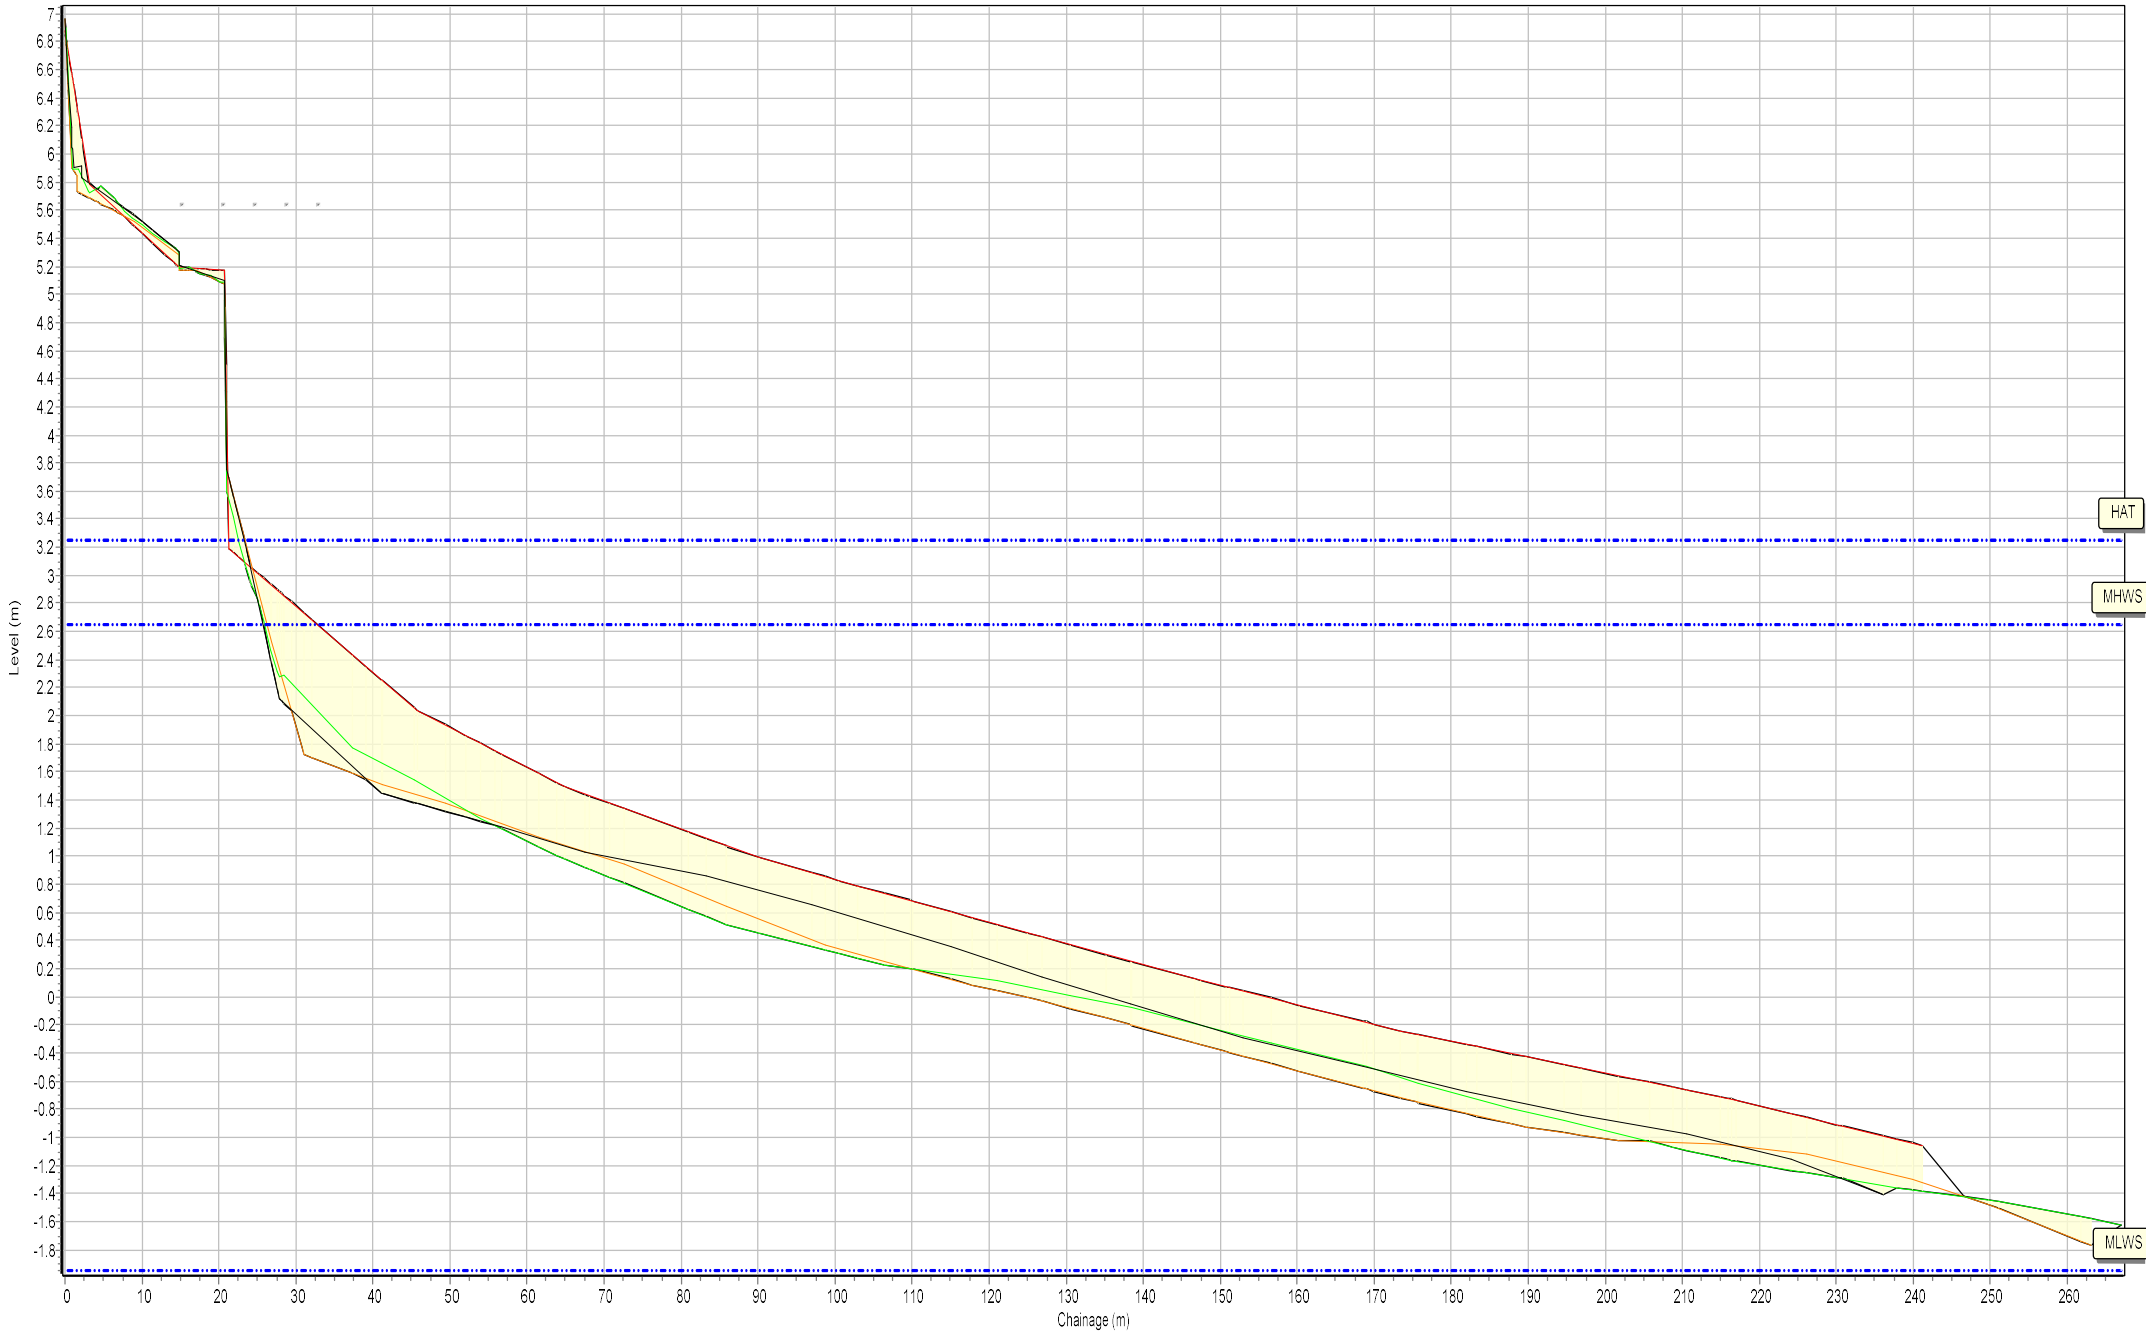
Beach Profiles: 1cRC9

Profiles Envelope 17/11/2008 31/10/2019 29/05/2020 04/11/2020

Survey Date	Description of Changes Since Last Survey	Interpretation
<p>4<sup>th</sup> November 2020</p>	<p><b>Beach Profiles:</b></p> <p>Saltburn Sands is covered by one beach profile during the Full Measures survey (RC9; Appendix A).</p> <p>At profile <b>1cRC9</b>, there has been accretion of 0.2m of material at the toe of the seawall from chainage 21m to 26m. Whilst from chainage 26m to 55m beach levels have decreased by 0.4m Seaward of this point, from chainage 55m to chainage 145m beach levels have increased by 0.3m. Between chainage 140m and 180m there has been no discernible change. At the seaward end of the profile from chainage 180m until the end of the survey at chainage 235m there has been a slight increase in level of 0.1m. Overall, the beach is at a medium level compared to the range recorded from previous surveys.</p>	<p>The beach showed a general trend of stability with some slight increases in level at profile 1cRC9.</p> <p>The difference plot between the last partial measures survey in Spring 2020 and the present full measures survey in Autumn 2020 shows low levels of accretion across much of the beach. There is also some limited erosion much across the upper beach, fronting the promenade and sea wall and around the mouth of Skelton Beck. The difference plot between the last full measures survey in Autumn 2019 and the present full measures survey in Autumn 2020 shows slightly more variability trend to the west of Skelton Beck although the majority of change remains low in magnitude.</p>

- The beach at Saltburn Sands has remained relatively stable over the summer of 2020 with some accretion evident at profile 1cRC9. However, the trend of winter erosion and summer recovery appears to be leading to a net loss from the beach as summer recovery is not compensating fully for the winter drawdown.
