Cell 1 Regional Coastal Monitoring Programme Analytical Report 14: 'Full Measures' Survey 2021

Redcar and Cleveland Borough Council

December 2021

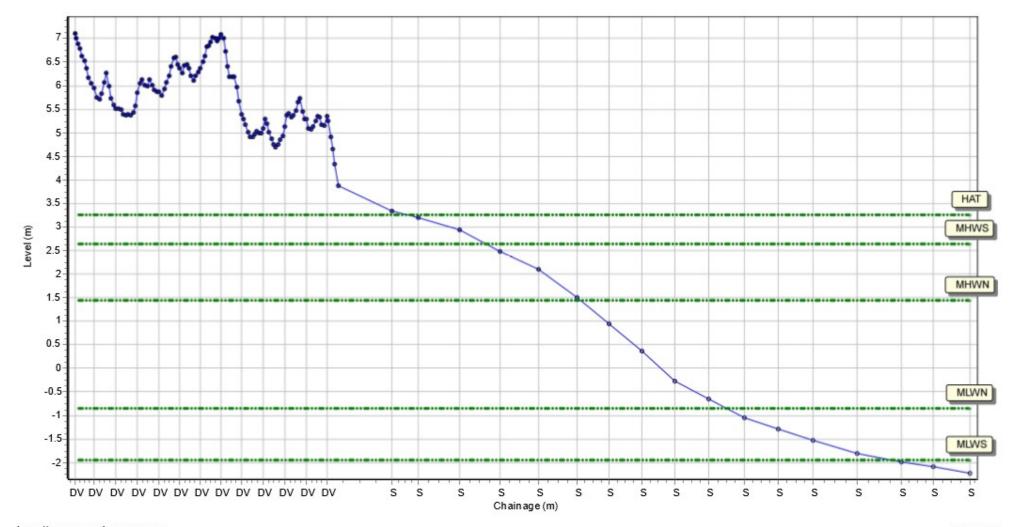
Location: 1cRC1

Easting: 455811.436 Northing: 527373.402 Profile Bearing: 34 ° from North

Survey Date	Description of Changes Since Last Survey	Interpretation
	Beach Profiles:	Overall, the dunes have remained stable at Coatham
	Coatham Sands is covered by four beach profile lines during the Full Measures survey (RC1 to RC4; Appendix A).	Sands since the previous partial measures survey. The beach profiles vary along the bay. To the North, the profile (1cRC1) has experienced a high magnitude
	Profile 1cRC1 is located approximately 300m south of the South Gare breakwater, in the lee of the German Charlies slag banks. The upper profile is dominated by dune ridges, which have remained stable since the 2009 surveys. The foredune has undergone accretion in level of 0.2m at its crest. The beach profile itself is split into two areas of distinct change. From chainage 107m, at the toe of the dune, to chainage 221m, the beach has accreted by up to 0.95m in level. At chainage 221m, the change switches to erosion which continues to chainage 302m. The magnitude of erosion is up to 1.1m reduction in level The upper beach level is at its highest level when compared to the range recorded from	of change. The central profiles show a general trend of low level accretion and the most southern profile (1cRC4) shows a general trend of erosion, particularly at the lower beach The topographic survey difference plots show a similar trend along most of the bay with the most intense

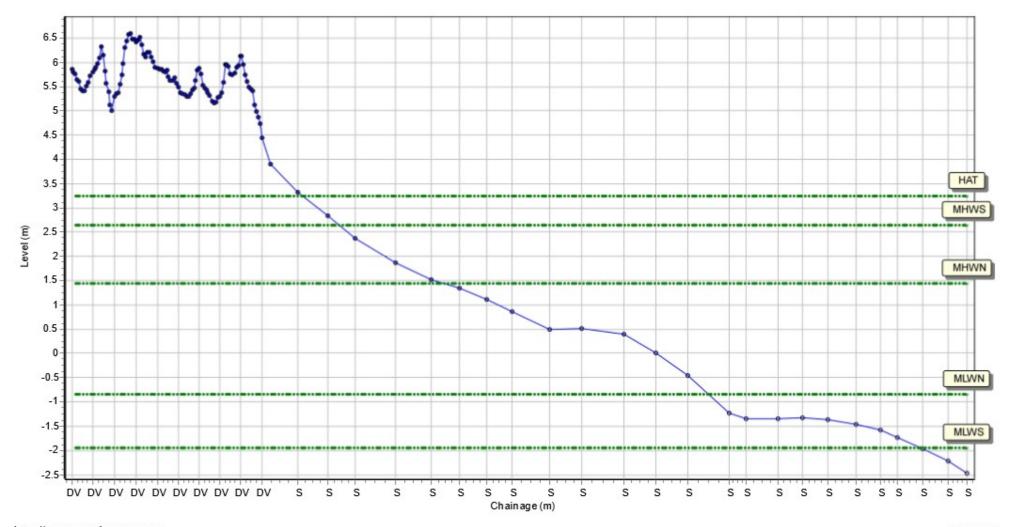
Location: 1cRC2

Easting: 456633.253 Northing: 526599.577 Profile Bearing: 34 ° from North

October	previous surveys, whereas the lower beach level is at a medium level. At Profile 1cRC2, the dunes continue to remain stable, with changes in level limited to ±0.1m The face	change occurring to the North. The topographic survey paints a slightly different picture along the central area, where erosion is the dominant process broken
2021	and toe of foredune has accreted since the last survey, resulting in the dune advancing seaward ~1m. The upper beach, between chainages 130m and 230m has also accreted by up to 0.25m in level. At chainage 260m, there has been accretion of 0.5m in level, resulting in flattening of a berm observed in the previous survey. There has also been accretion of the lower beach On average, the profile is at a high level when compared with the range recorded in previous surveys, most notably on the dunes and upper beach.	up with low level accretion. It is clear the central profiles (1cRC2 and 1cRC3) are located in these minority areas of accretion which would be misleading if analysing the profiles alone. To the south, the magnitude of erosion is much less, correlating with what was observed in profile 1cRC4.

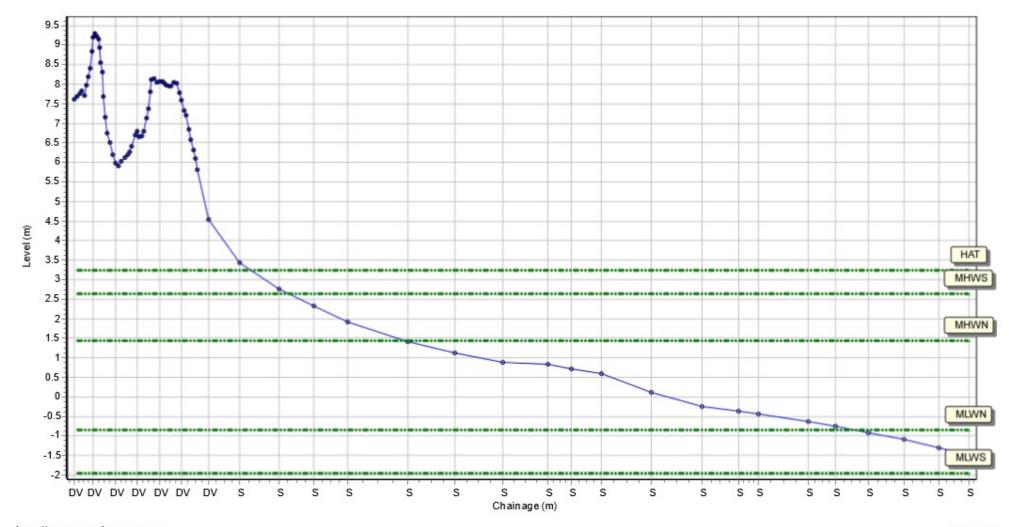
Location: 1cRC3

Easting: 457706.365 Northing: 525898.597 Profile Bearing: 28 ° from North

Profile 1cRC3 shows stable dunes with some accretion leading to an increase in level of up to 0.2m in level at the crest of the foredune. From the toe of the dune at chainage 55m across the upper and mid – beach to chainage 167m the profile has experienced accretion, raising the beach level by 0.2.m. At chainage 167m the accretion increases to 0.45m until chainage 228m forming a shallow berm. The lower beach has also experience accretion. Overall, the profile is at a high level when compared with the range recorded from previous surveys. In particular the section between chainages 192m and 212m is at the highest level on record.	Longer term trends: With the exception of 2018, there appears to have been a general trend of net accretion observed in the Autumn analysis over the years. The topographic survey plot for 2021 indicates a slight deviation from this trend with net erosion. However, the magnitude of change has been low and is in line with the range of previously recorded results.

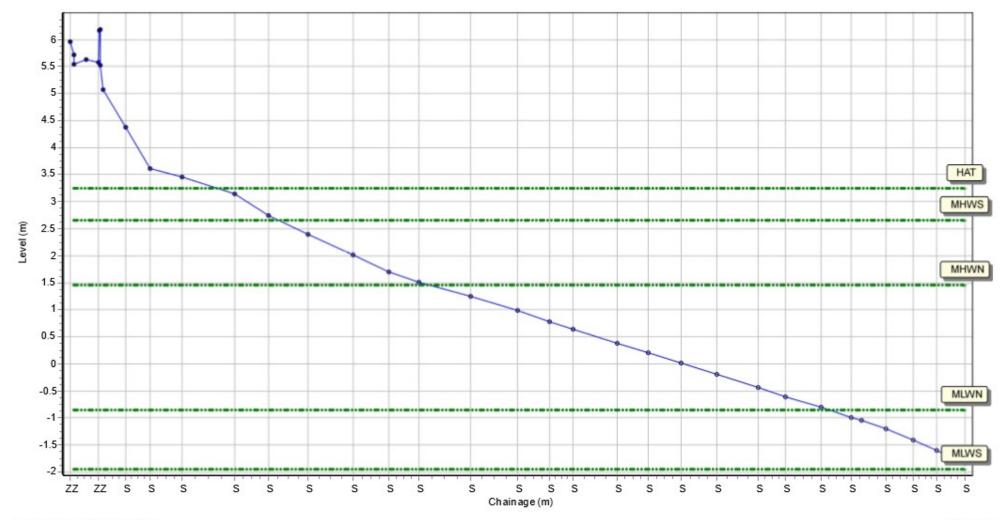
Location: 1cRC4

Easting: 459337.597 Northing: 525336.99 Profile Bearing: 13 ° from North

Survey Date	Description of Changes Since Last Survey	Interpretation
	Profile 1cRC4 is the beginning of the defended section at Redcar. There has been accretion against the seawall from chainage 12m to 28m increasing the beach level by 0.5m An upper beach berm has migrated landward by approximately 15m. Between chainages 90m and 250m, the beach has largely remained stable with erosion/accretion in level limited to ±0.1m. From chainage 250m onwards, the lower beach has eroded, steepening the beach profile. On average, the profile is at a low level compared to the previous surveys	
	Topographic Survey:	
	Coatham Sands is covered by an annual topographic survey extending from the South Gare Breakwater, although the survey is contiguous with the 6-monthly Redcar Sands survey. Data have been used to create a DGM (Appendix B – Map 1) using GIS. This shows that the beach contours recorded in Autumn 2021 remain shore parallel along the frontage, with a gentle beach slope. The beach is narrower and steeper to the north west of the subtle promontory around 1km SE of the breakwater and of shallower gradient further south-east.

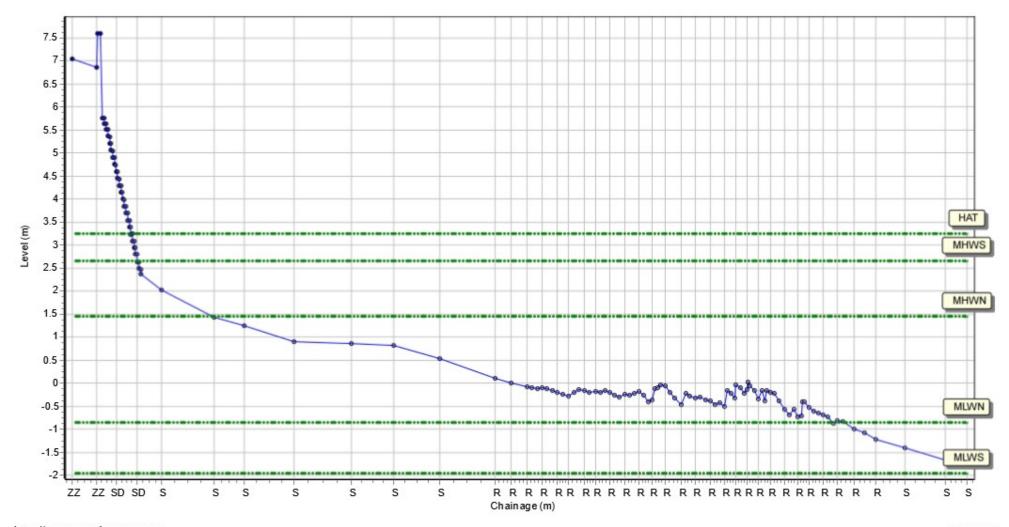
Location: 1cRC5

Easting: 460845.21 Northing: 525146.997 Profile Bearing: 26 ° from North

Survey Date	Description of Changes Since Last Survey	Interpretation
October 2021	Redcar Sands is covered by three beach profile lines during the Full Measures survey (RC5 to RC7; Appendix A), with RC7 being approximately on the boundary with the Marske Sands area. At profile 1cRC5, there has been steepening of the upper beach at the toe of the defence, with an accretion of 0.65m in level evident at the toe. From chainages 32m to 83, the profile has largely remained stable with local accretion evident. Then, between chainages 83m and 146m chainage, the beach has eroded by 0.45m in level exposing more of the rocky foreshore. The lower beach from chainage 180m onwards has eroded by 0.15m in level, resulting in the end of the profile retreating landwards 8m. When compared with the range recorded from previous surveys, the profile is at a medium level. At profile 1cRC6, the beach profile has remained largely stable. The upper beach profile is unchanged from the seawall to chainage 100m. From chainage 100m to chainage 200m, the beach levels have increased by 0.1m in level. The lower beach has steepened resulting the end of the profile shifting approximately 30m landwards. When compared with the range recorded from previous surveys, the October 2021 profile is generally at a medium level with the exception of the upper beach which is at a low level. Profile 1cRC7 has experienced very little change on the dune frontage, chainage 0 to 67m, since the previous survey. At the toe of the dunes and upper beach, between chainage 67m and 135m there is a small increase in level of 0.1m. Between chainages 135m and 190m, a beach hollow has been filled in, creating an uninterrupted smooth middle beach. Overall, the beach is at a medium level compared with the range recorded from previous surveys.	All three of the profiles show erosion of the lower beach in 2021. The upper and middle beach are largely dominated by low level accretion. The topographic change plot between Mar 2021 and October 2021 broadly reflects this pattern with the upper beach largely dominated by accretion. The most intense change is observed adjacent to Redcar Rocks The pattern of change between Autumn 2020 and Autumn 2021 shows slightly more variability with the area dominated by erosion. Longer term trends: The beach levels are generally at a medium to high level compared to previous years, suggesting recovery since the storms and surge of winter 2013/14. A slight exception to this is Profile 1cRC5 which is at its lowest on the middle beach where the rocky foreshore is exposed. The new hard defences at Redcar have affected the patterns of accretion on the upper beach due to the introduction of a less reflective seawall.

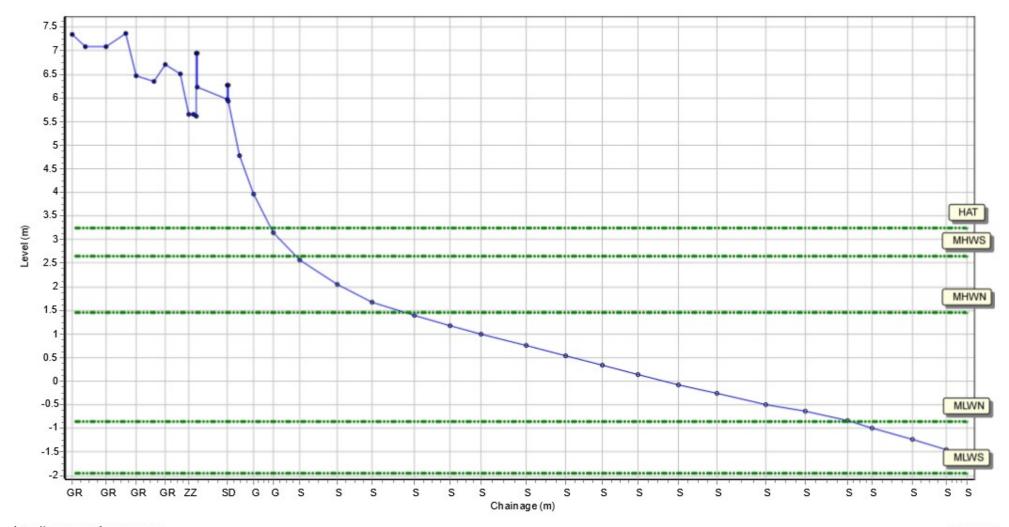
Location: 1cRC6

Easting: 461776.835 Northing: 524269.592 Profile Bearing: 39 ° from North

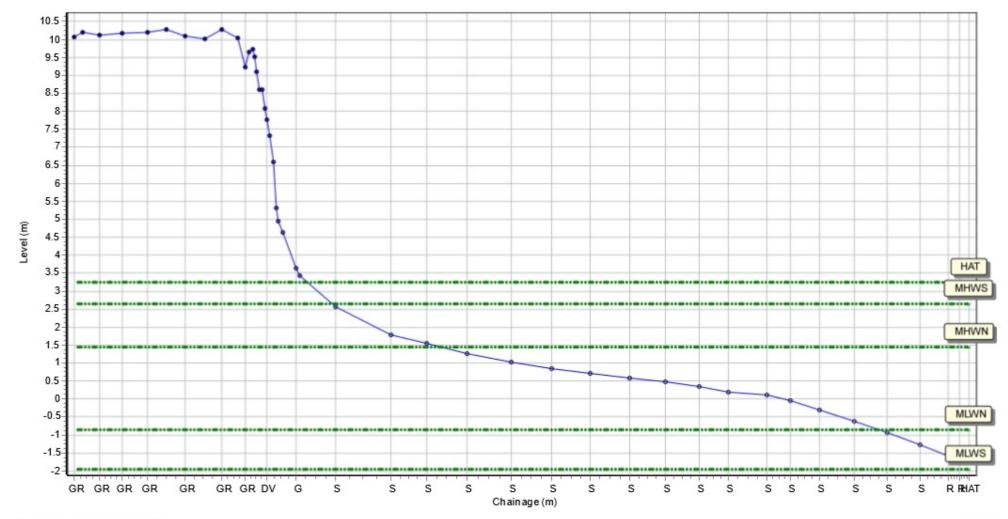
Location: 1cRC7

Easting: 462568.453 Northing: 523568.436 Profile Bearing: 37 ° from North

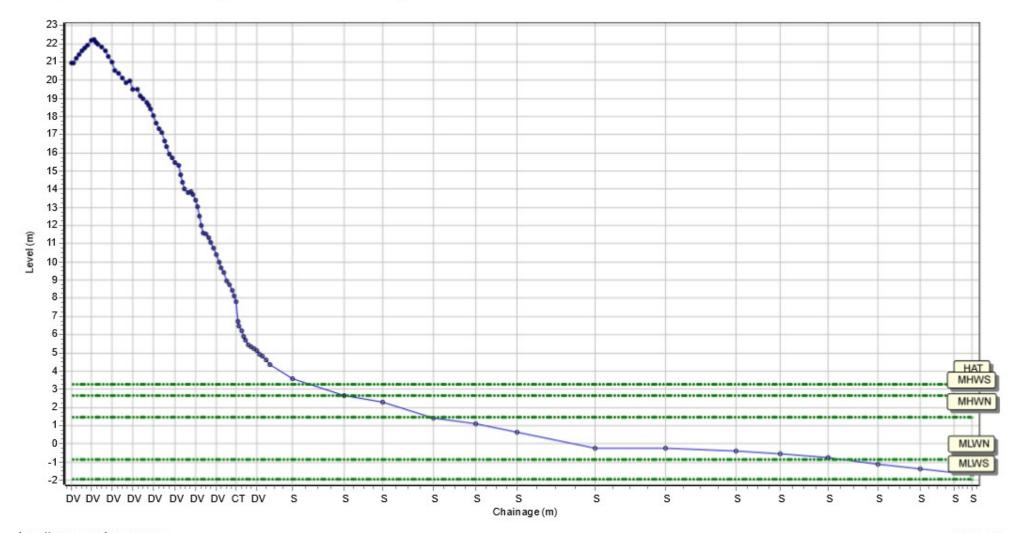
Location: 1cRC8

Easting: 464245.579 Northing: 522578.097 Profile Bearing: 28 ° from North

Survey Date	Description of Changes Since Last Survey	Interpretation
October 2021	Beach Profiles: Marske Sands is covered by two beach profile lines during the Full Measures survey (RC7 to RC8; Appendix A), with RC7 being approximately on the boundary with the Redcar Sands area. Profile 1cRC7 is located along The Stray and has been discussed in Section 2.2. At profile 1cRC8, there is no significant change to the face of the cliff. The beach has accreted consistently over the length of the profile since the last survey, maintaining a flat shelf in the mid-beach. On the upper beach, between chainages 55m and 120m, the change is limited to 0.2m in level, increasing to 0.45m in level along the middle section (chainages 165m to 220m). The beach profile is at a medium level compared with the range of previously recorded surveys.	Both profiles at Marske Sands have experienced accretion associated with migrating berms. Profile 1cRC7 at The Stray has also experienced a low level of erosion at the lower beach but despite this is at a high level when compared with the range recorded in previous surveys. At Profile 1cRC8 accretion has dominated and shore parallel berms have developed across the beach. The difference plot for Autumn 2020 to Autumn 2021 shows a band of erosion on the mid-beach with accretion generally dominating the upper beach and

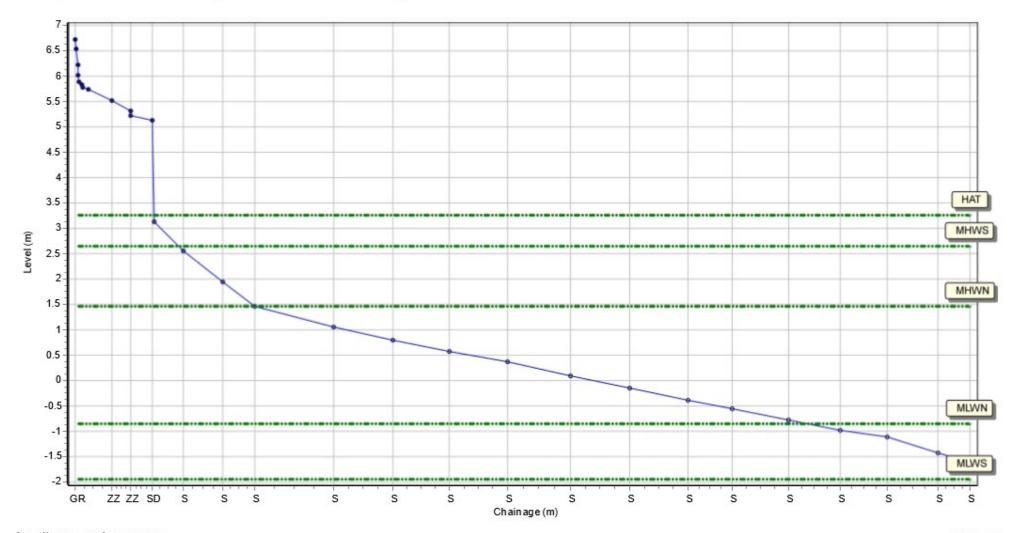
Location: 1cRC9

Easting: 466477.532 Northing: 521748.87 Profile Bearing: 22 ° from North

Survey Date	Description of Changes Since Last Survey	Interpretation
October 2021	Beach Profiles: Saltburn Sands is covered by one beach profile during the Full Measures survey (RC9; Appendix A). At profile 1cRC9, there has no change across the defended section of the profile (chainage 0m to 21m). At the toe of the seawall the beach profile has slackened, resulting in a local drop of material of 0.5m at the seawall itself but with net gain of material across the 25m of beach. From Chainage 48m to 240m there has been a consistent accretion in level of 0.4m across the whole profile. Overall, the beach is at a medium level compared to the range recorded from previous surveys.	The beach showed a general trend of accretion at profile 1cRC9. This is also echoed in the difference plot between the last partial measures survey in Spring 2021 and the present full measures survey in Autumn 2021 which shows a wide scale accretion across the majority of the bay. The difference plot between the last full measures survey in Autumn 2020 and the present full
