Cell 1 Regional Coastal Monitoring Programme Analytical Report 16: 'Full Measures' Survey 2023

**Redcar and Cleveland
Borough Council
January 2024**

* The present report is **Analytical Report 16** and provides an analysis of the 2023 Full Measures survey for Redcar and Cleveland Borough Council's frontage.

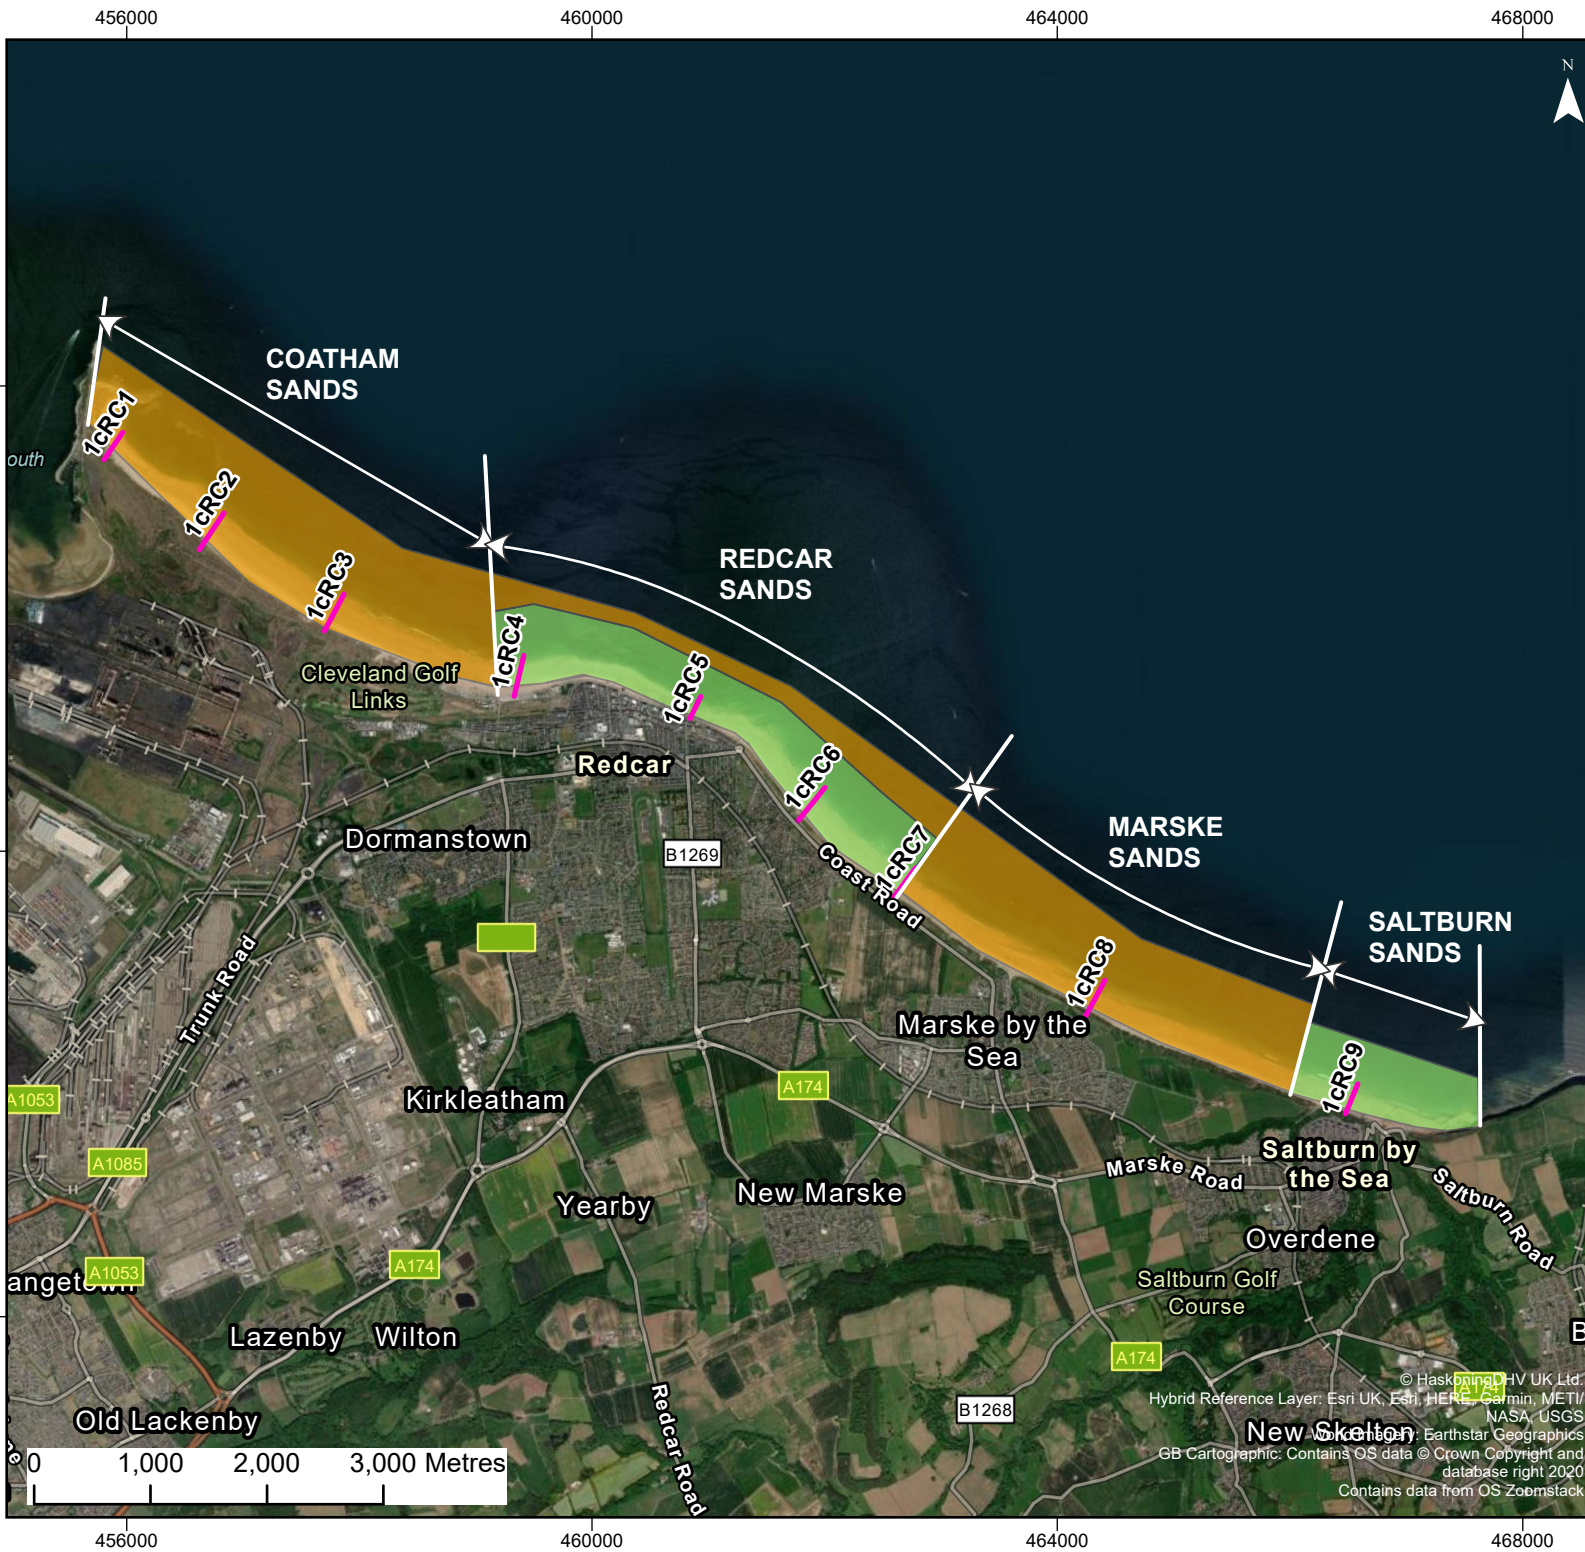
Title: **Figure 2 - Map 1**
COATHAM SANDS TO SALT BURN SANDS
Redcar and Cleveland Borough Council Frontage

SURVEY LOCATIONS

Topographic Profile

- Annual (Blue line)
- Bi-Annual (Pink line)

Topographic Area

- 6 monthly (Light Green)
- yearly (Yellow)
- 5 yearly (Light Purple)

- Cliff Top Survey Points (Red dot)

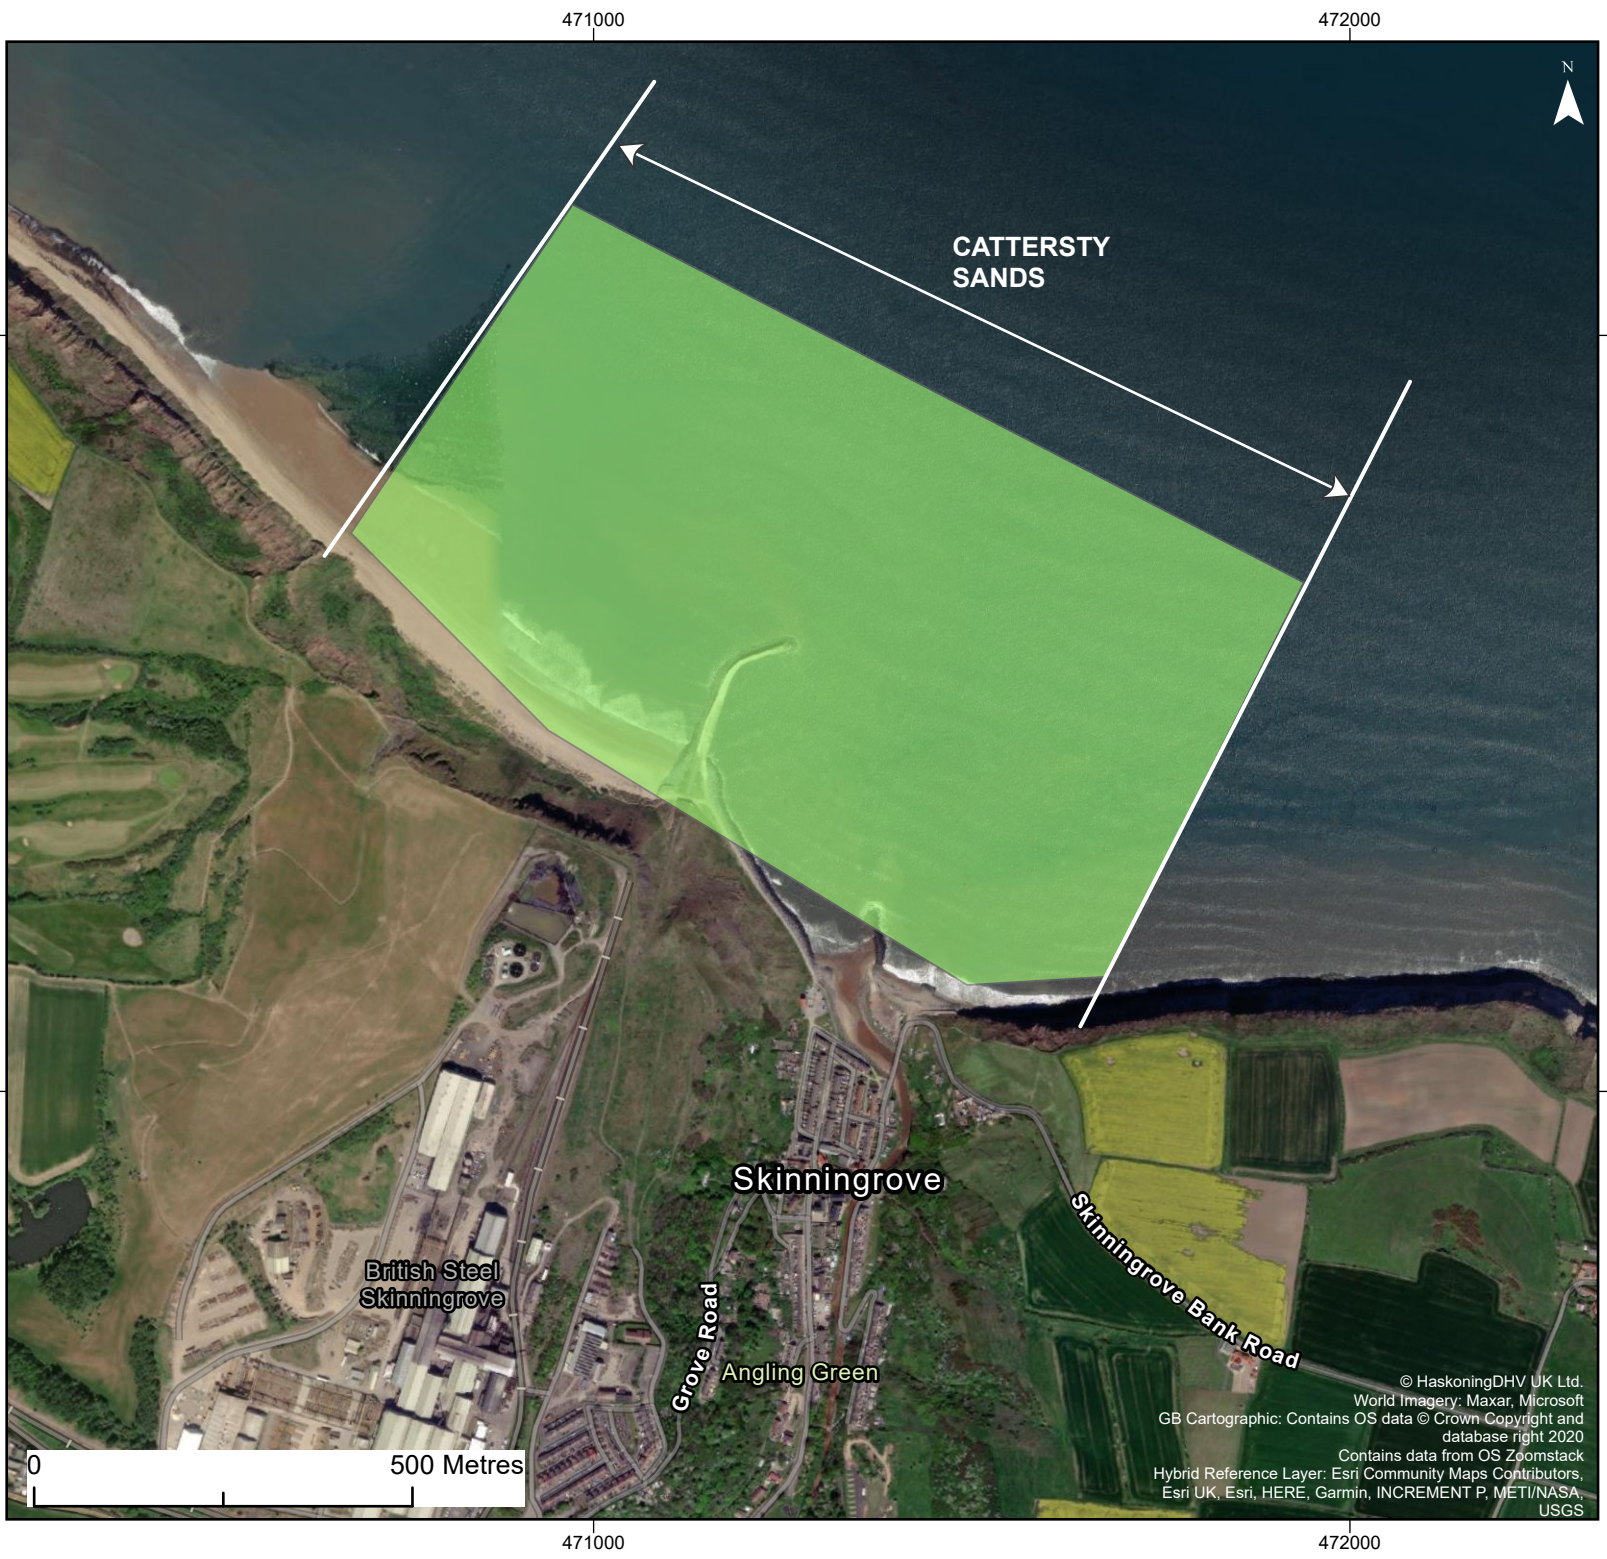
Figure 2 - Map 2

SURVEY LOCATIONS

Topographic Profile

- Annual (Blue line)
- Bi-Annual (Pink line)

Topographic Area

- 6 monthly (Light Green)
- yearly (Orange)
- 5 yearly (Purple)

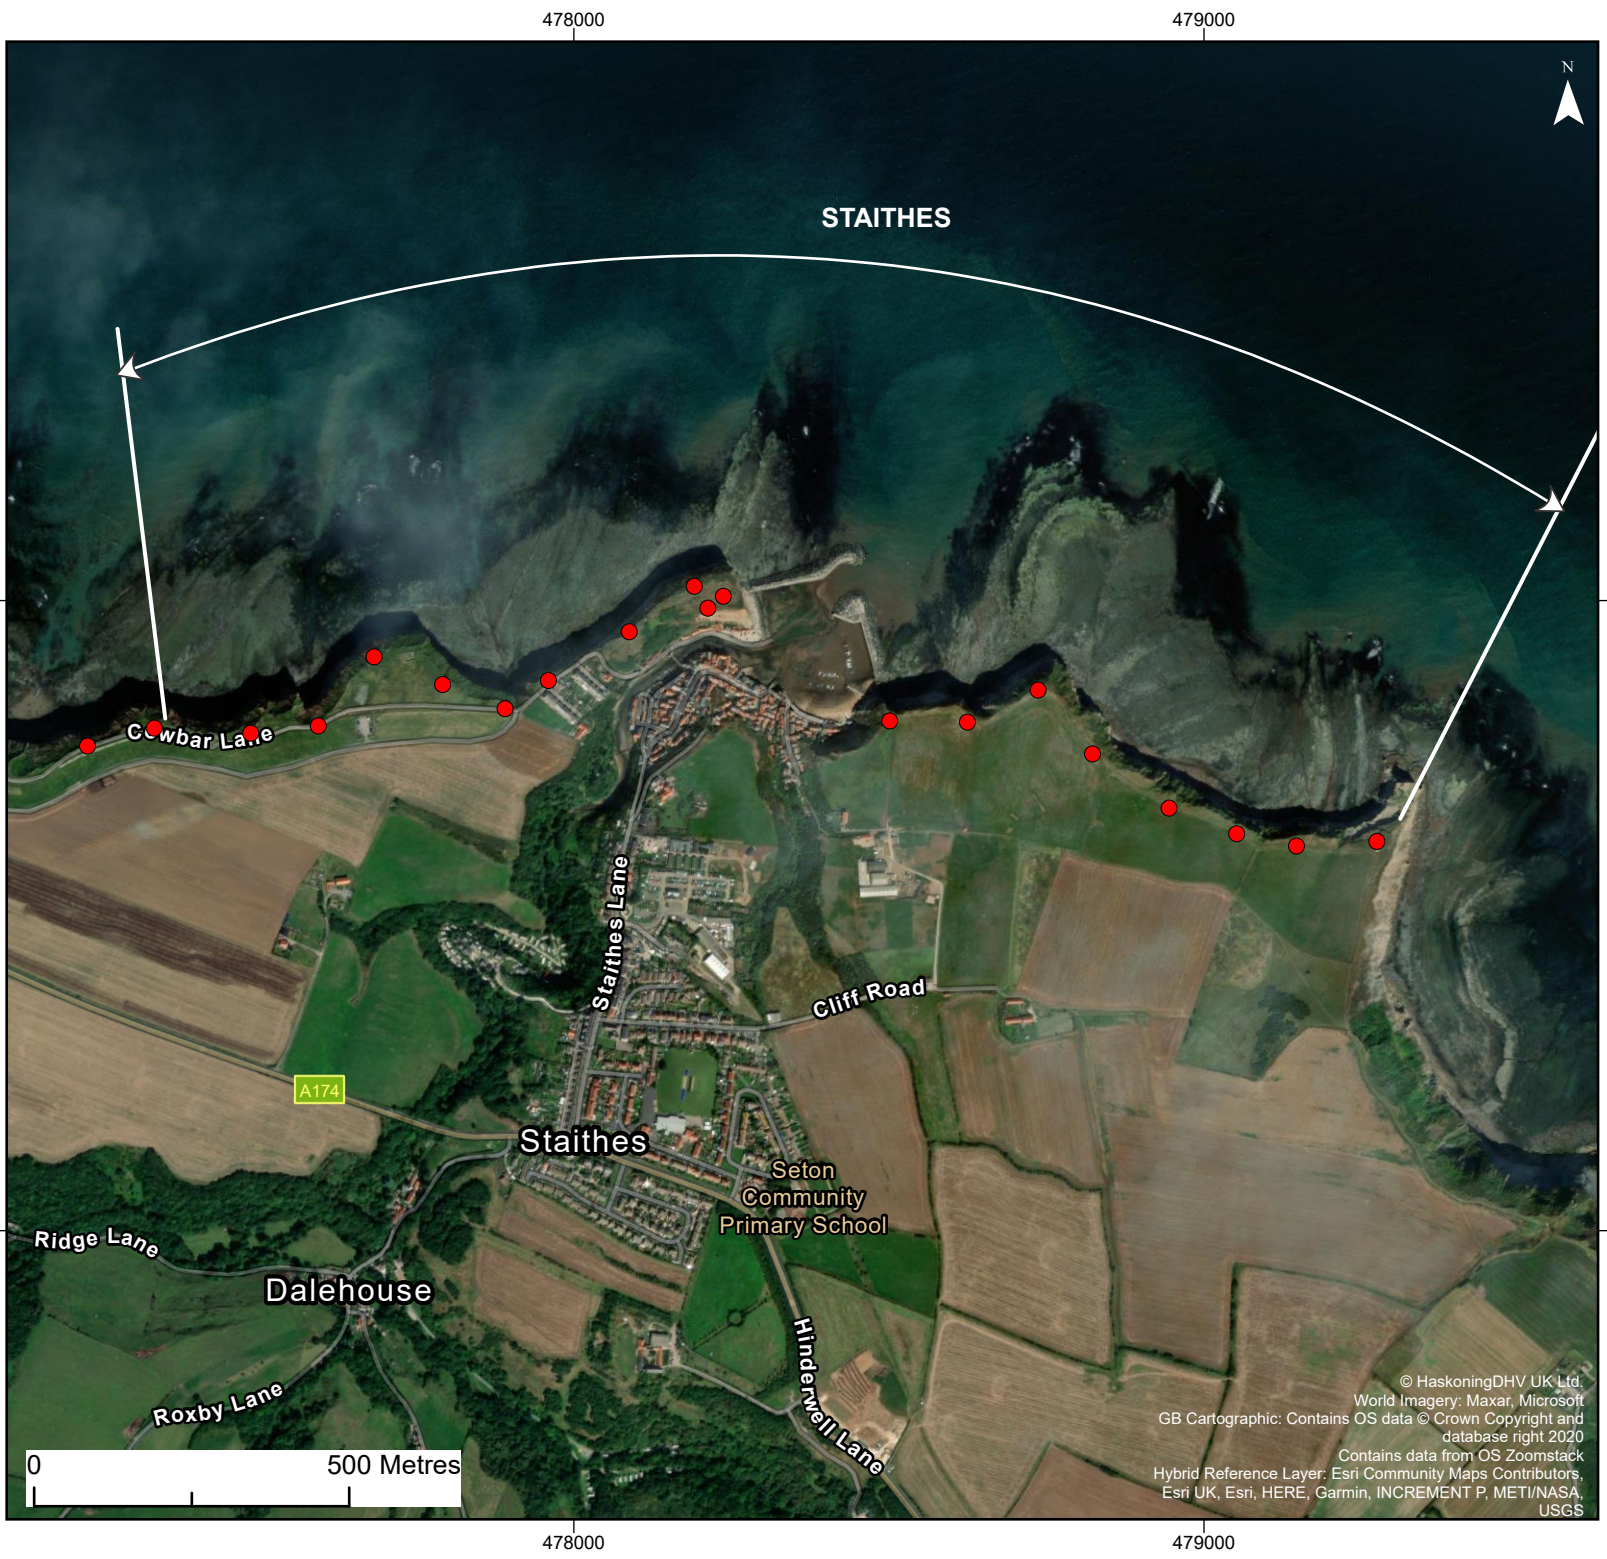
Figure 2 - Map 3

SURVEY LOCATIONS

Topographic Profile

- Annual
- Bi-Annual

Topographic Area

- 6 monthly
- yearly
- 5 yearly

- Cliff Top Survey Points (refer to Figure 3 for details)

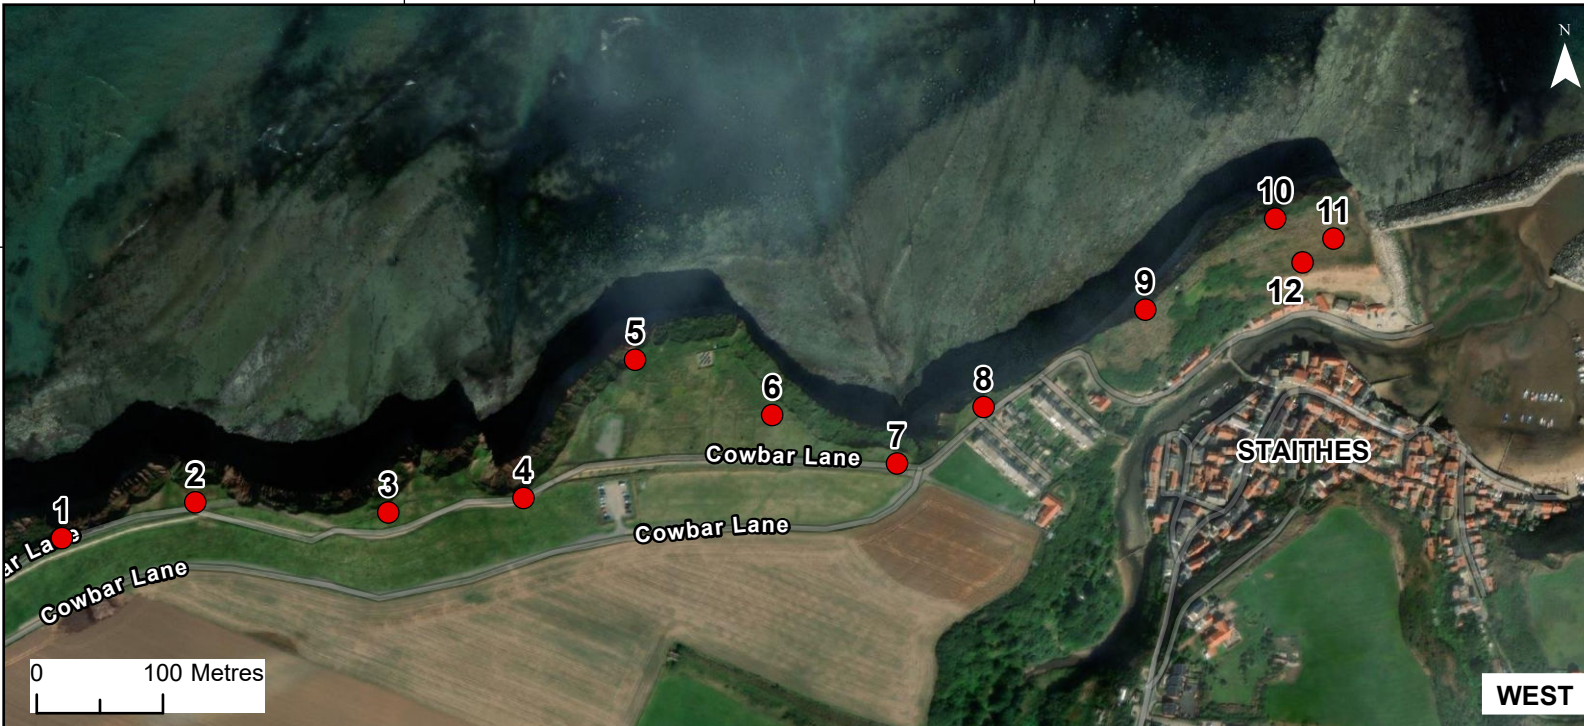
Title:
Figure 3 - Map 1
STAITHES
Redcar and Cleveland Borough Council Frontage

SURVEY LOCATIONS

- Cliff Top Survey Points

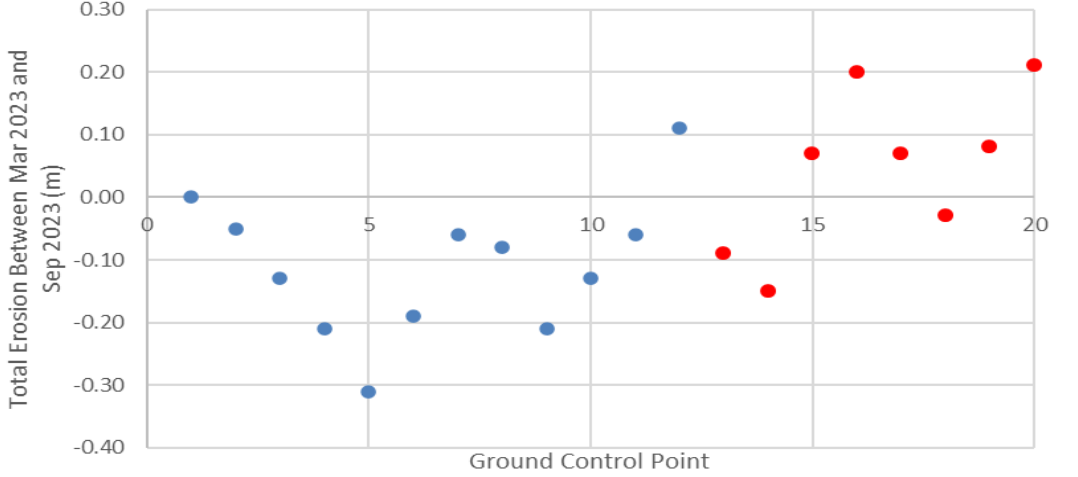
Survey Date	Description of Changes Since Last Survey	Interpretation
<p style="text-align: center;">21st September 2023</p>	<p>Cliff-top Survey:</p> <p>Twenty ground control points have been established at Cowbar and Staithes for biannual cliff top monitoring. Points 13 to 20 are located on the cliffs to the south of Staithes Beck and therefore sit in the North Yorkshire Council area. Points 1 to 7 are north of the beck and therefore are within the Redcar and Cleveland unitary authority area. The separation between any two points is around 100m. Data collection involves a distance offset measurement from the ground control point to the cliff edge along a fixed bearing.</p> <p>Between March 2023 and September 2023, only 3 of the 20 ground control points experienced a retreat greater than +0.1m. These were Points 12, 16 and 20 experiencing 0.11m, 0.2m and 0.21m respectively, indicating a period of relative stability. The data also shows that between the survey dates 13 of the 20 points have advanced seawards, of which 7 were outside the assumed margin of error of the survey technique (± 0.1). It is unlikely this is true change and more likely a reflection in varying vegetation levels between surveys creating difficulty in identifying the cliff top.</p> <p>Intriguingly, the plot below highlights that the vast majority of these ‘advancements’ have occurred on the cliffs to north of Staithes Beck (blue dots), whilst the limited erosion has occurred south of Staithes (Red dots). This is not easily explained and could be a number of factors including varying vegetation levels or different surveying teams.</p>	<p>Only 3 of the 20 control points have experienced retreat greater than the margin of error (± 0.1m) indicating a period of stability.</p> <p>Longer term trends: Table C1 shows that survey Location 1 has shown the greatest total erosion with a loss of 7.60m between the November 2008 baseline and September 2023, resulting in a long-term average recession rate of 0.51m/yr.</p> <p>Location 4 has also showed progressive erosion with an average recession rate of 0.15m/year. Both stations are located adjacent the old Cowbar Lane which in places has now collapsed entirely.</p> <p>Location 13 has also experienced ongoing erosion of with an average recession rate of 0.21m/year.</p> <p>Despite these long-term recessions zero of these three points have retreated since the previous survey.</p>

<p>Plot 1</p> <p>Calculation of longer-term erosion rates based on the recorded change between 2008 and 2023 indicates that 17 of the 20 posts on the frontage recorded a change rate within a range of ± 0.1 m/year. Points 1, 4, and 13 show average erosion rate of above 0.1 m/yr., experiencing 0.51 m, 0.15 m and 0.21 m respectively.</p>

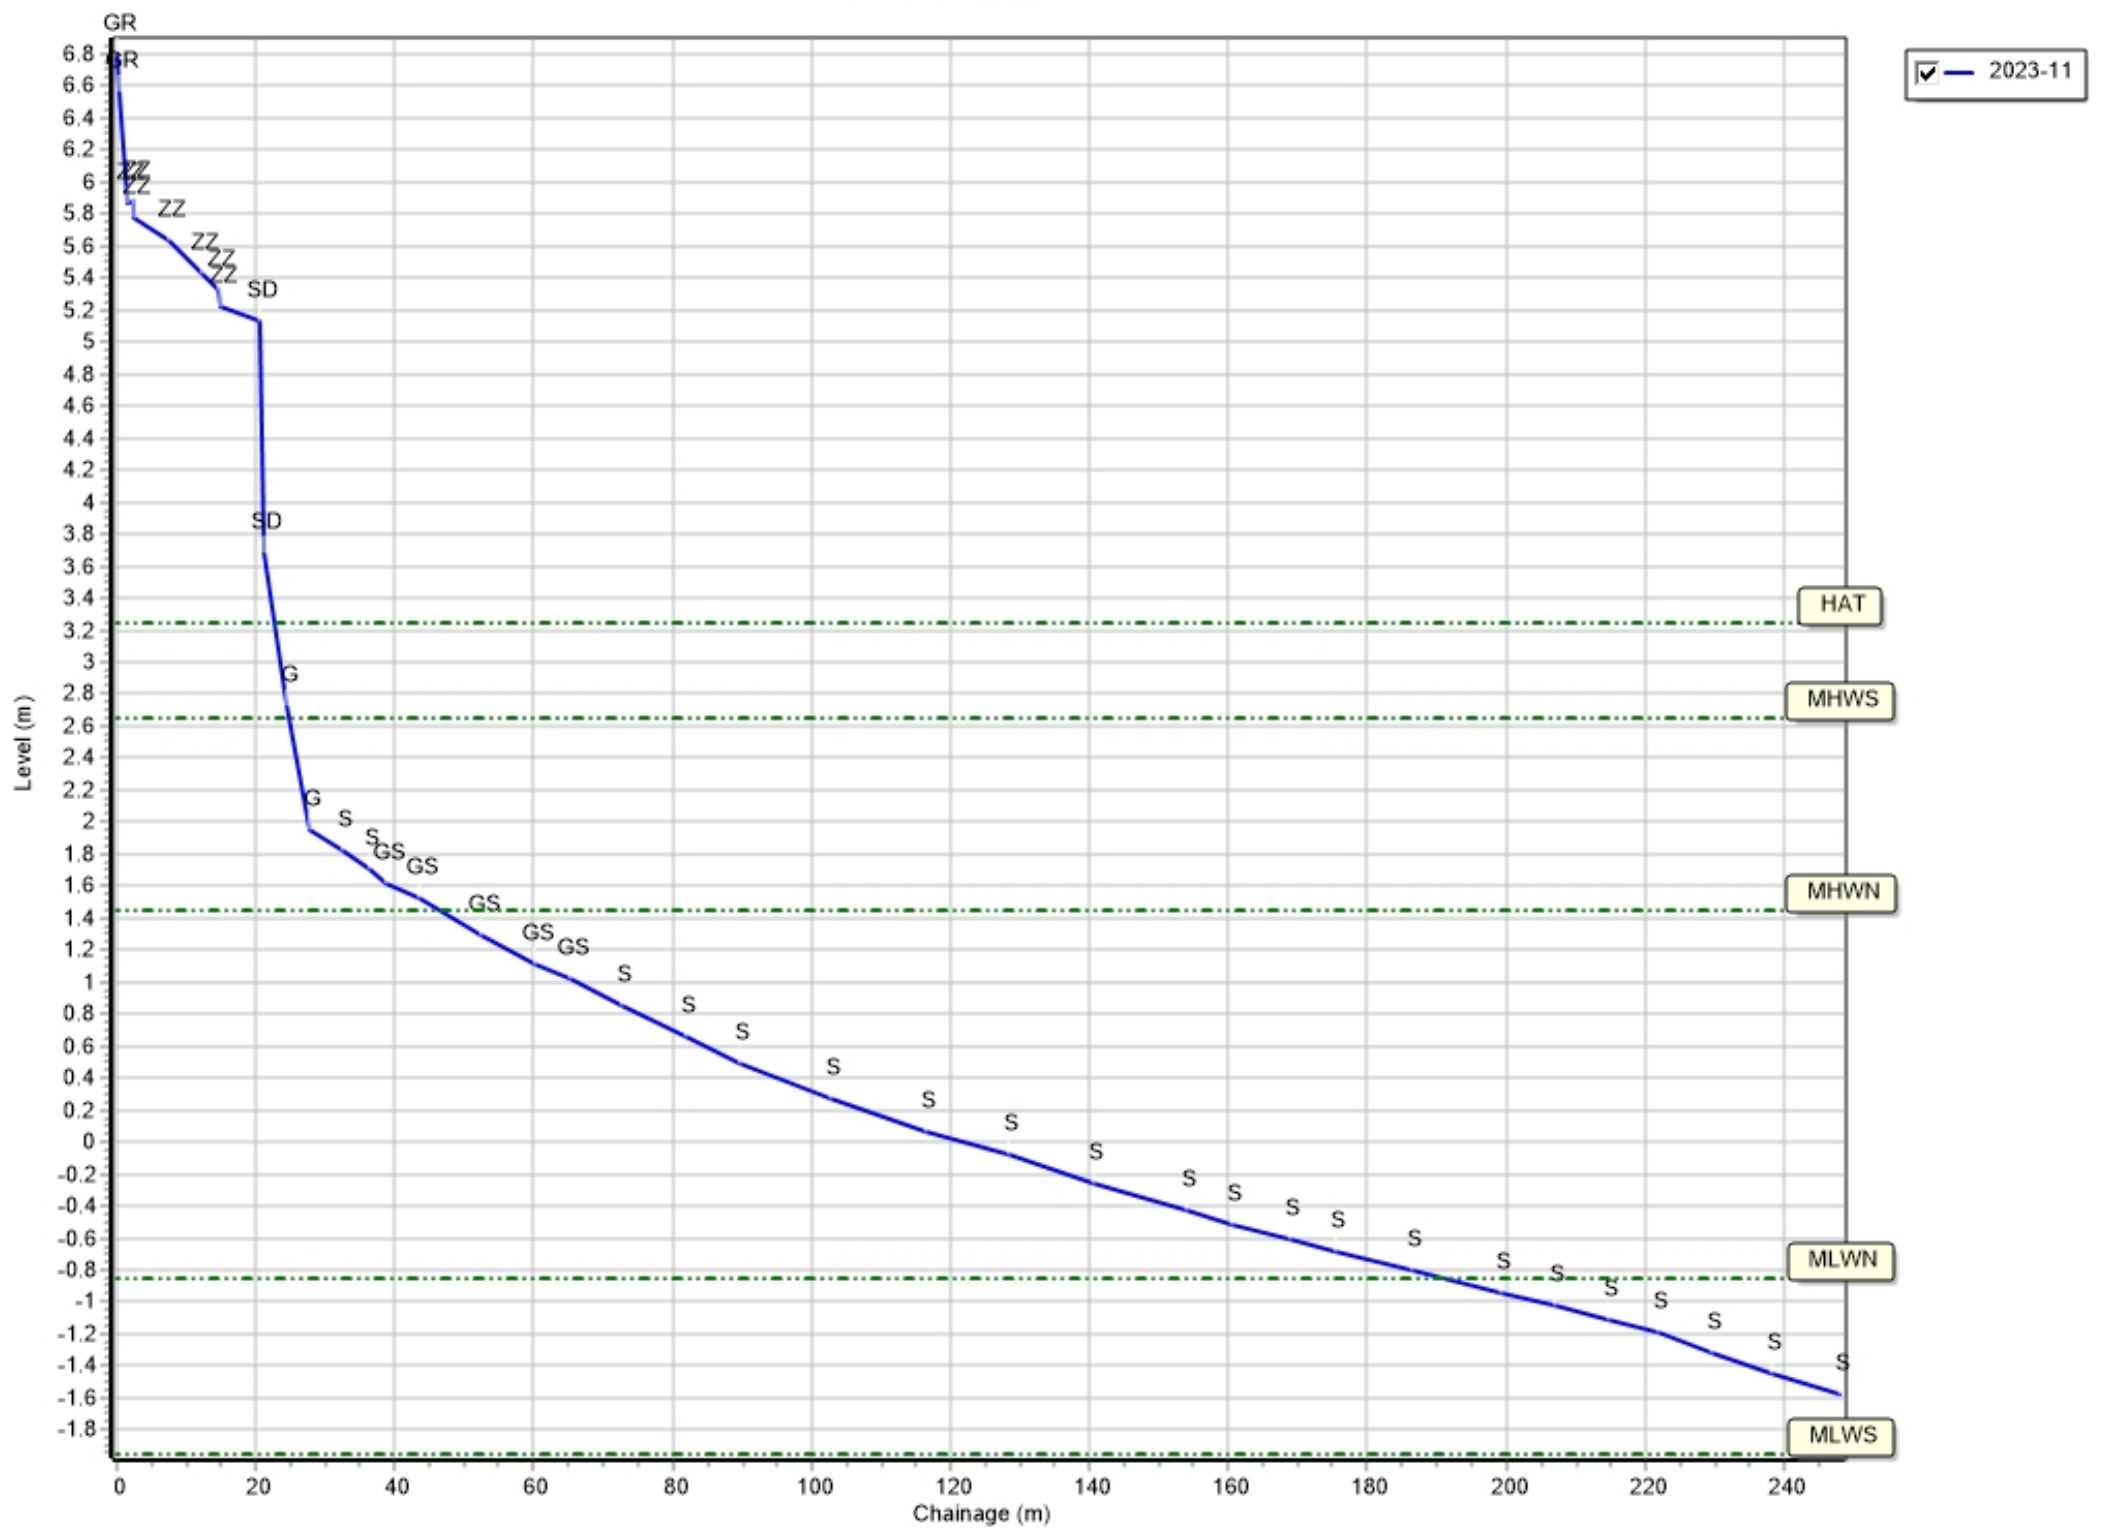
Profiles: 1cRC9

- It is understood the local accretion at the toe of the sea wall observed in profile 1cRC9 is creating a ramping effect for approaching waves exacerbating flooding issues. It is understood that the council is looking to commission a beach management plan to for the area to help address this.

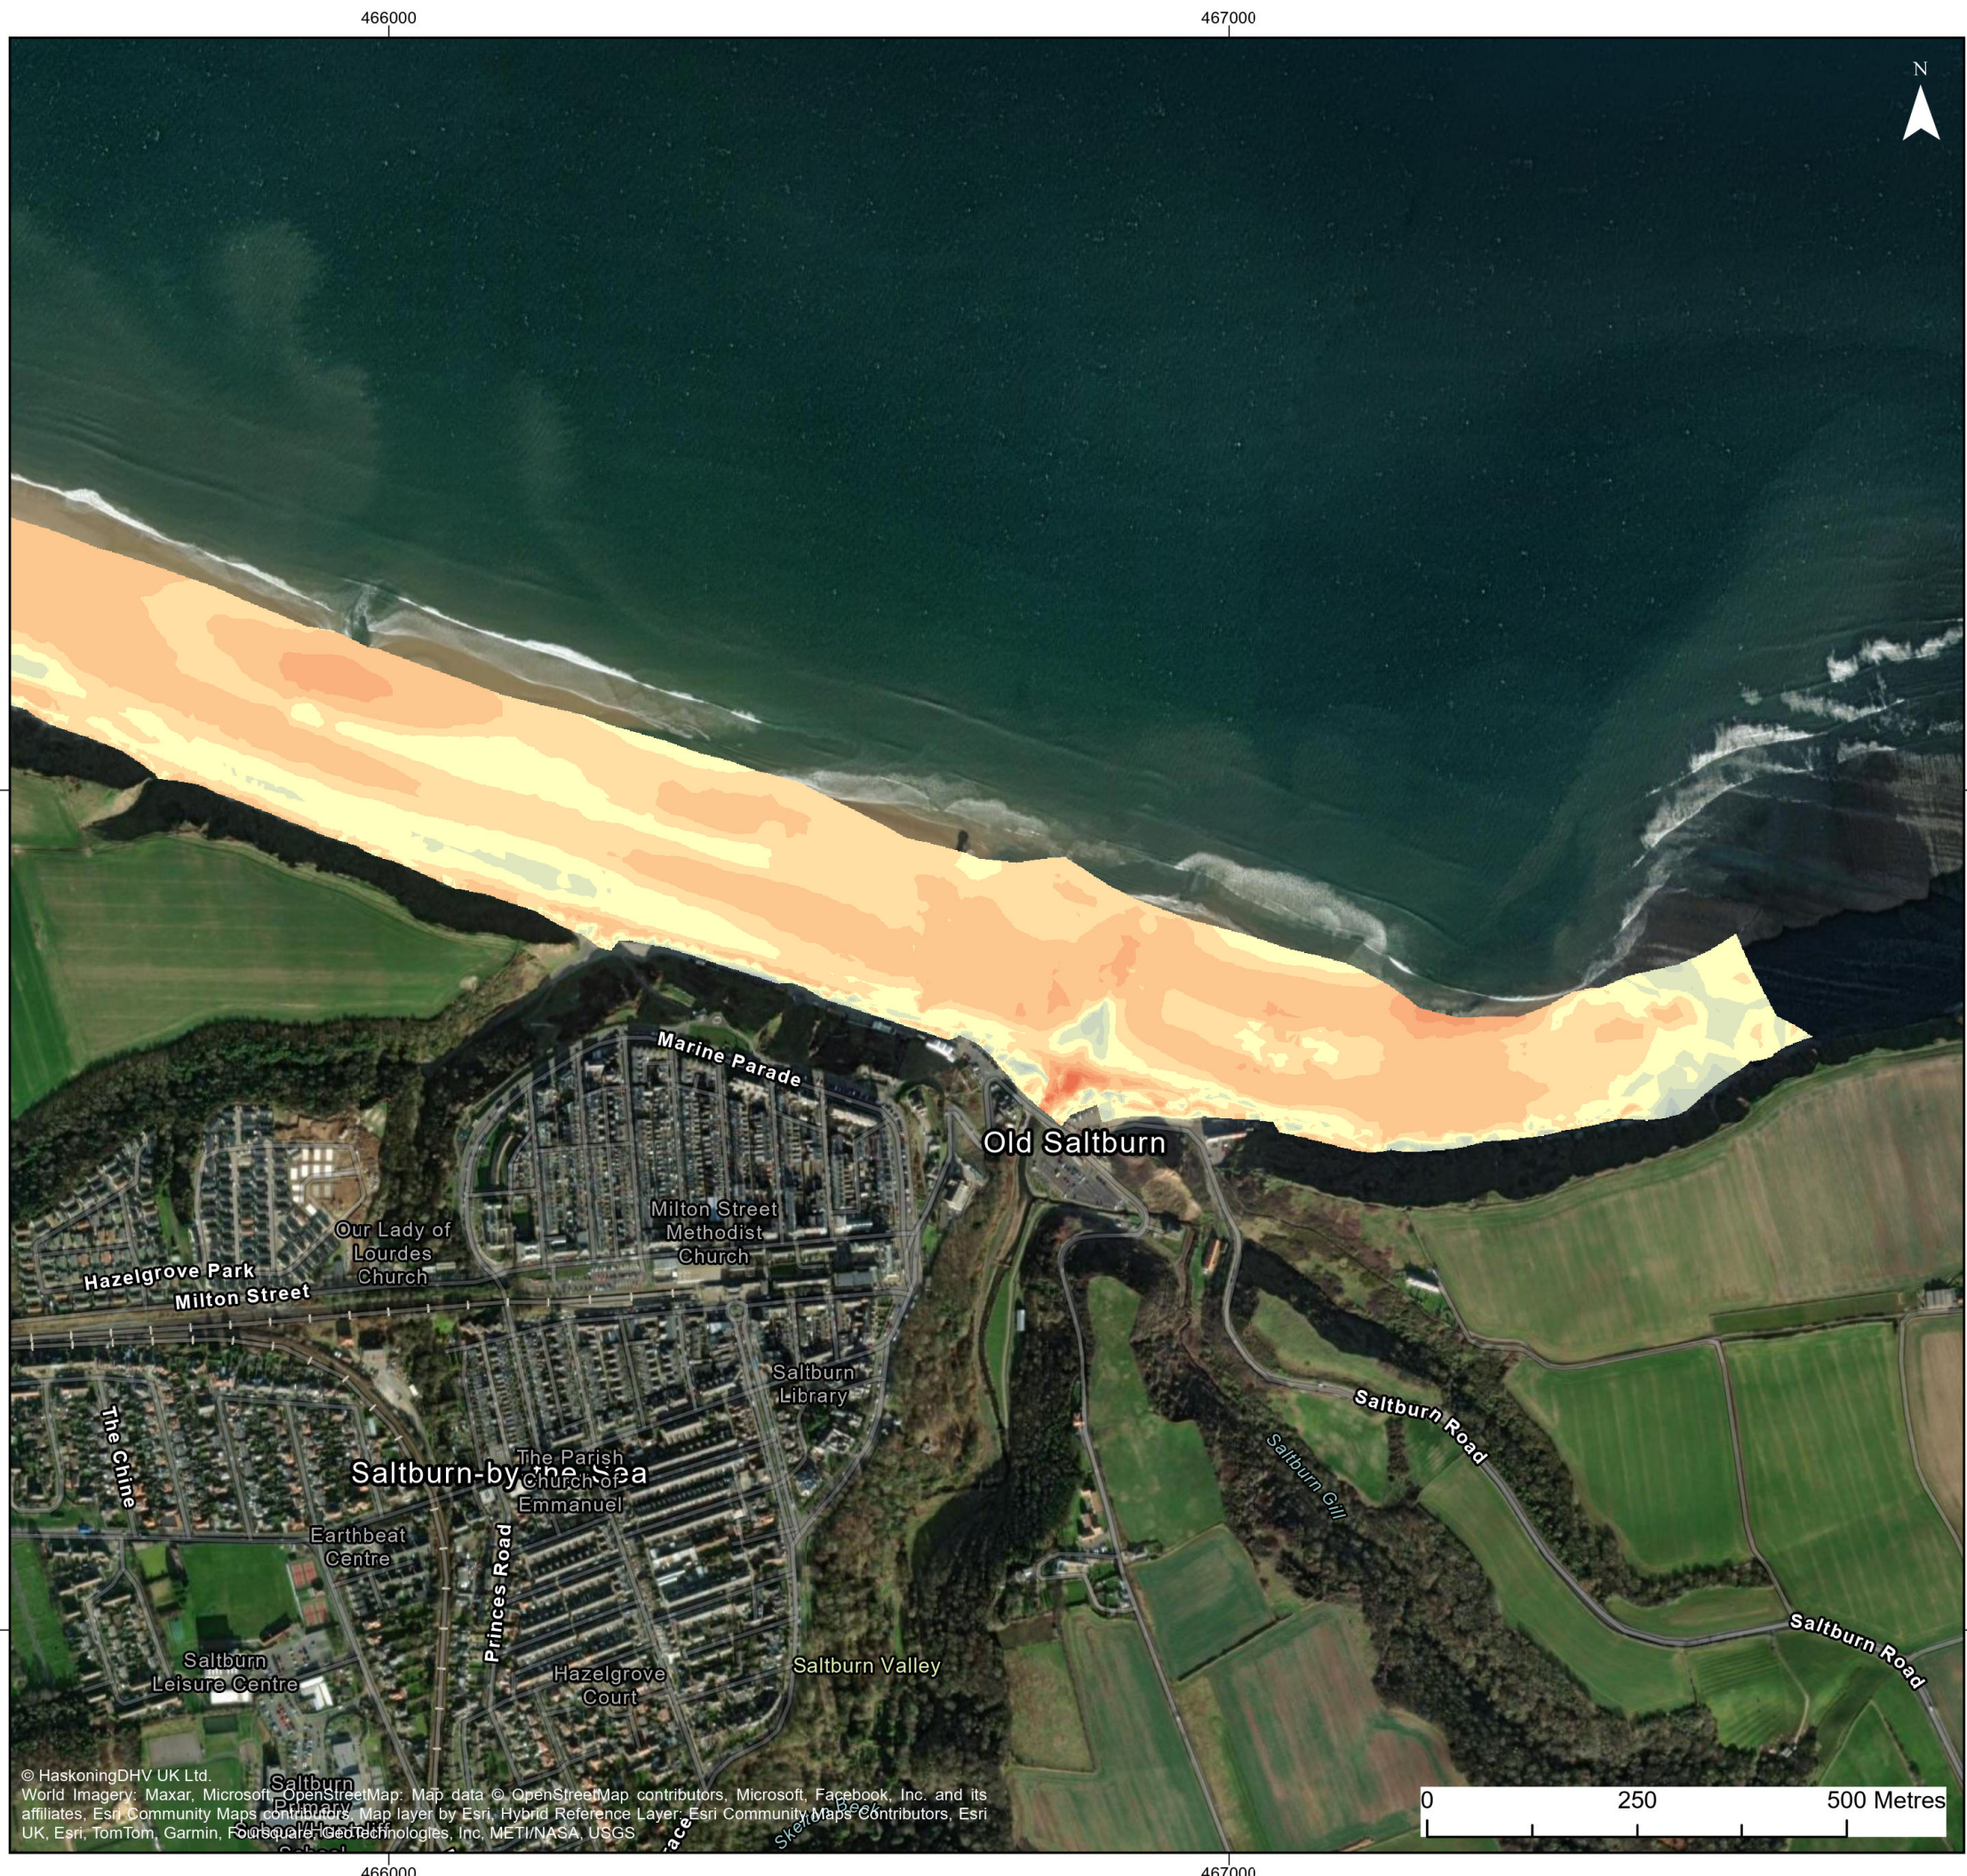
Difference between topographic surveys
(Oct 2022 to Nov 2023)

Change in Elevation (mOD)

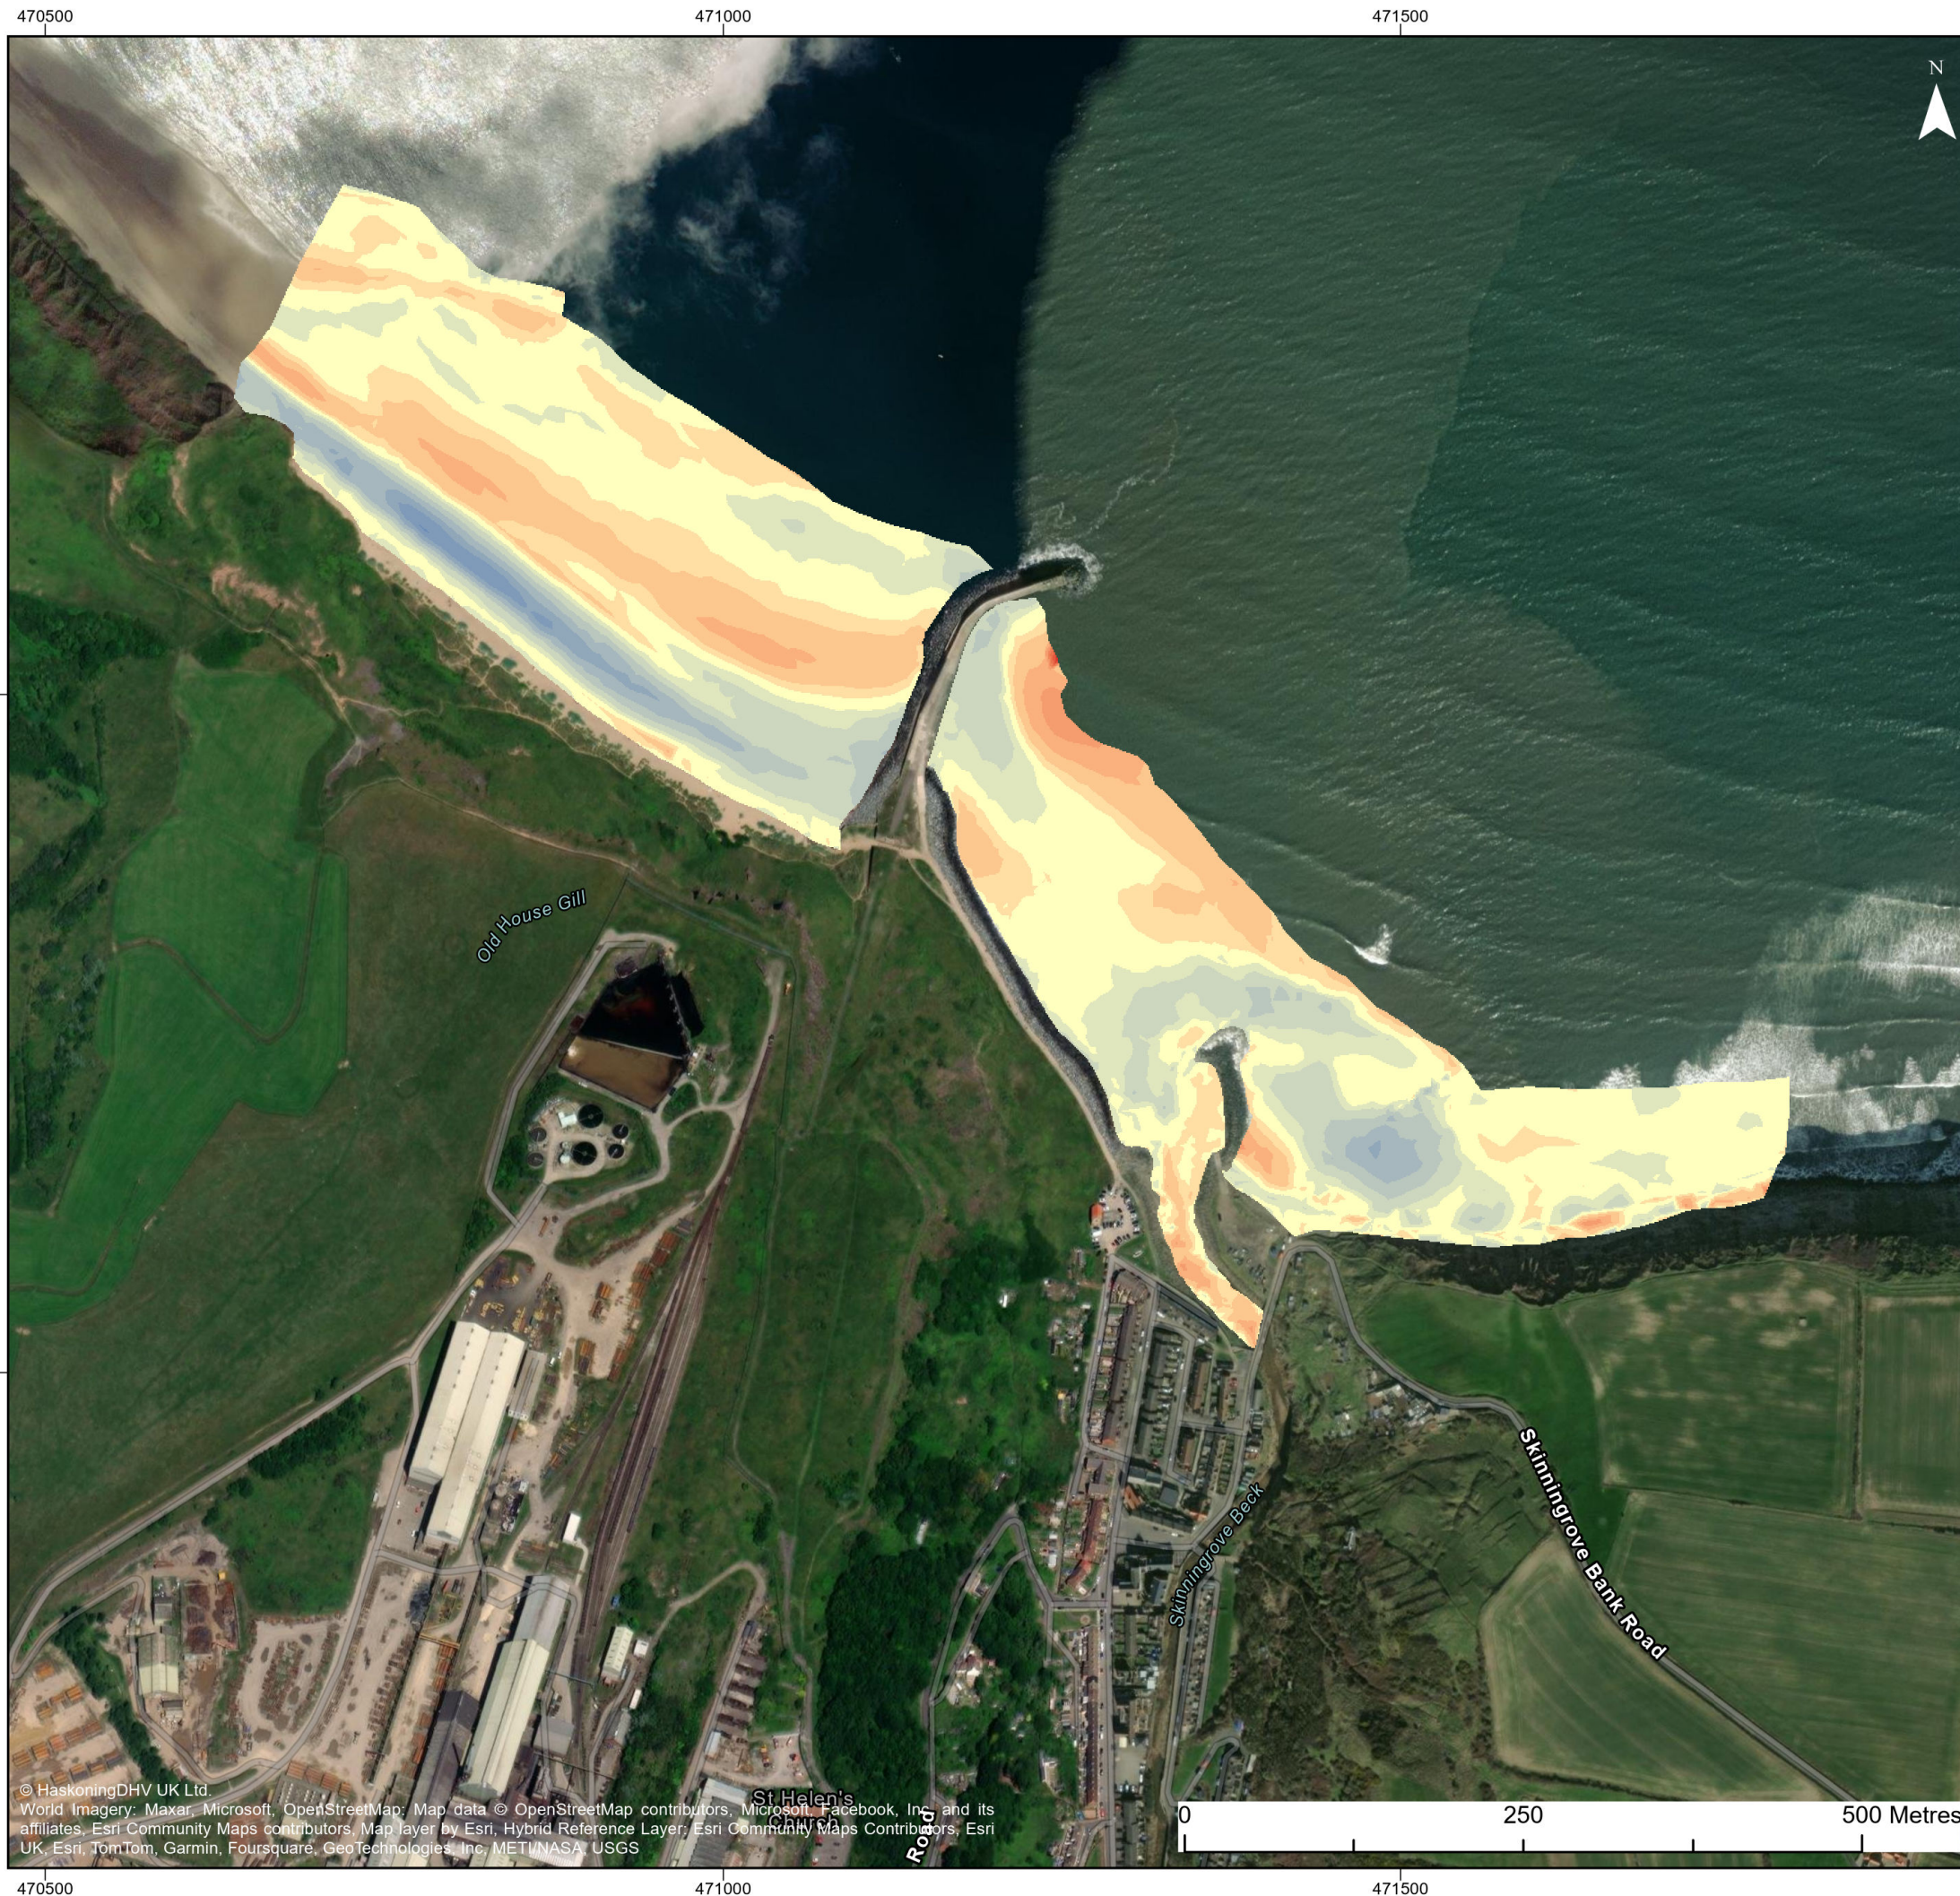
Difference between topographic surveys
 (Apr 2023 to Sept 2023)
