Cell 1 Regional Coastal Monitoring Programme Analytical Report 16: 'Full Measures' Survey 2023

**Redcar and Cleveland
Borough Council
January 2024**

* The present report is **Analytical Report 16** and provides an analysis of the 2023 Full Measures survey for Redcar and Cleveland Borough Council's frontage.

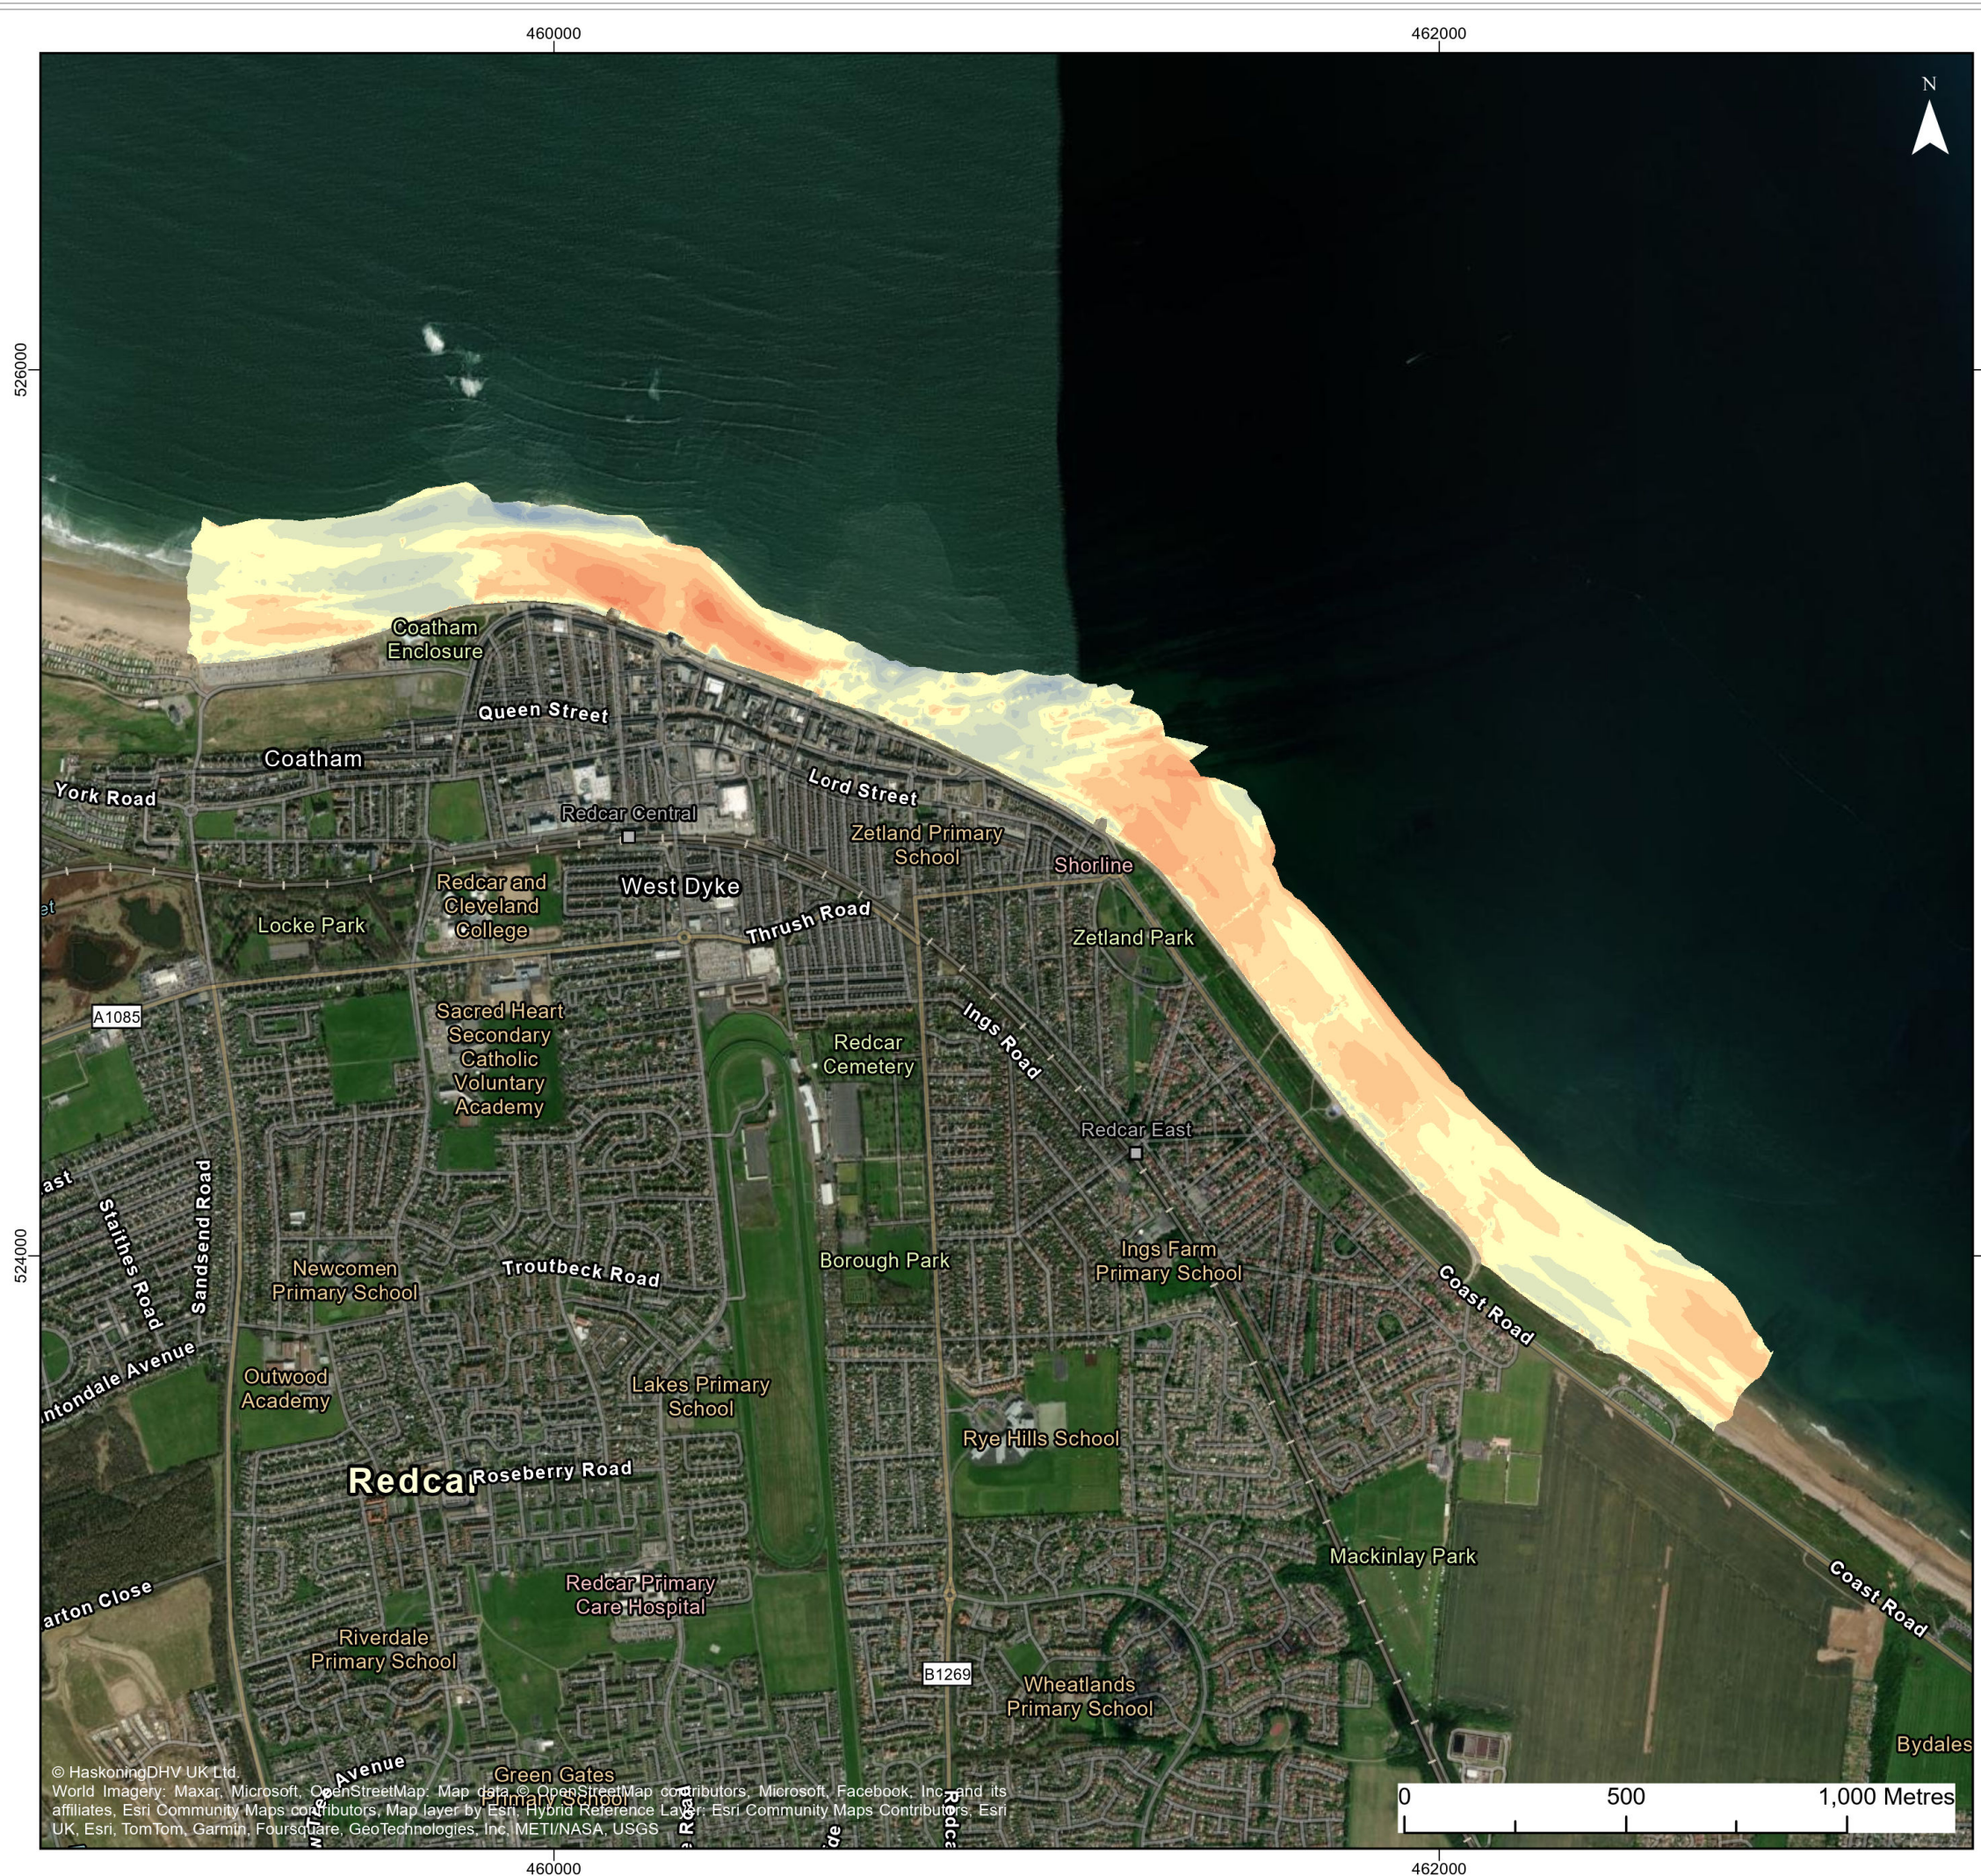
Difference between topographic surveys
(Apr 2023 to Sept 2023)

Change in Elevation (mOD)
