**Cell 1 Regional Coastal Monitoring Programme
Update Report 1: 'Partial Measures' Survey 2009**

**Redcar & Cleveland
Borough Council
Final Report**

June 2009

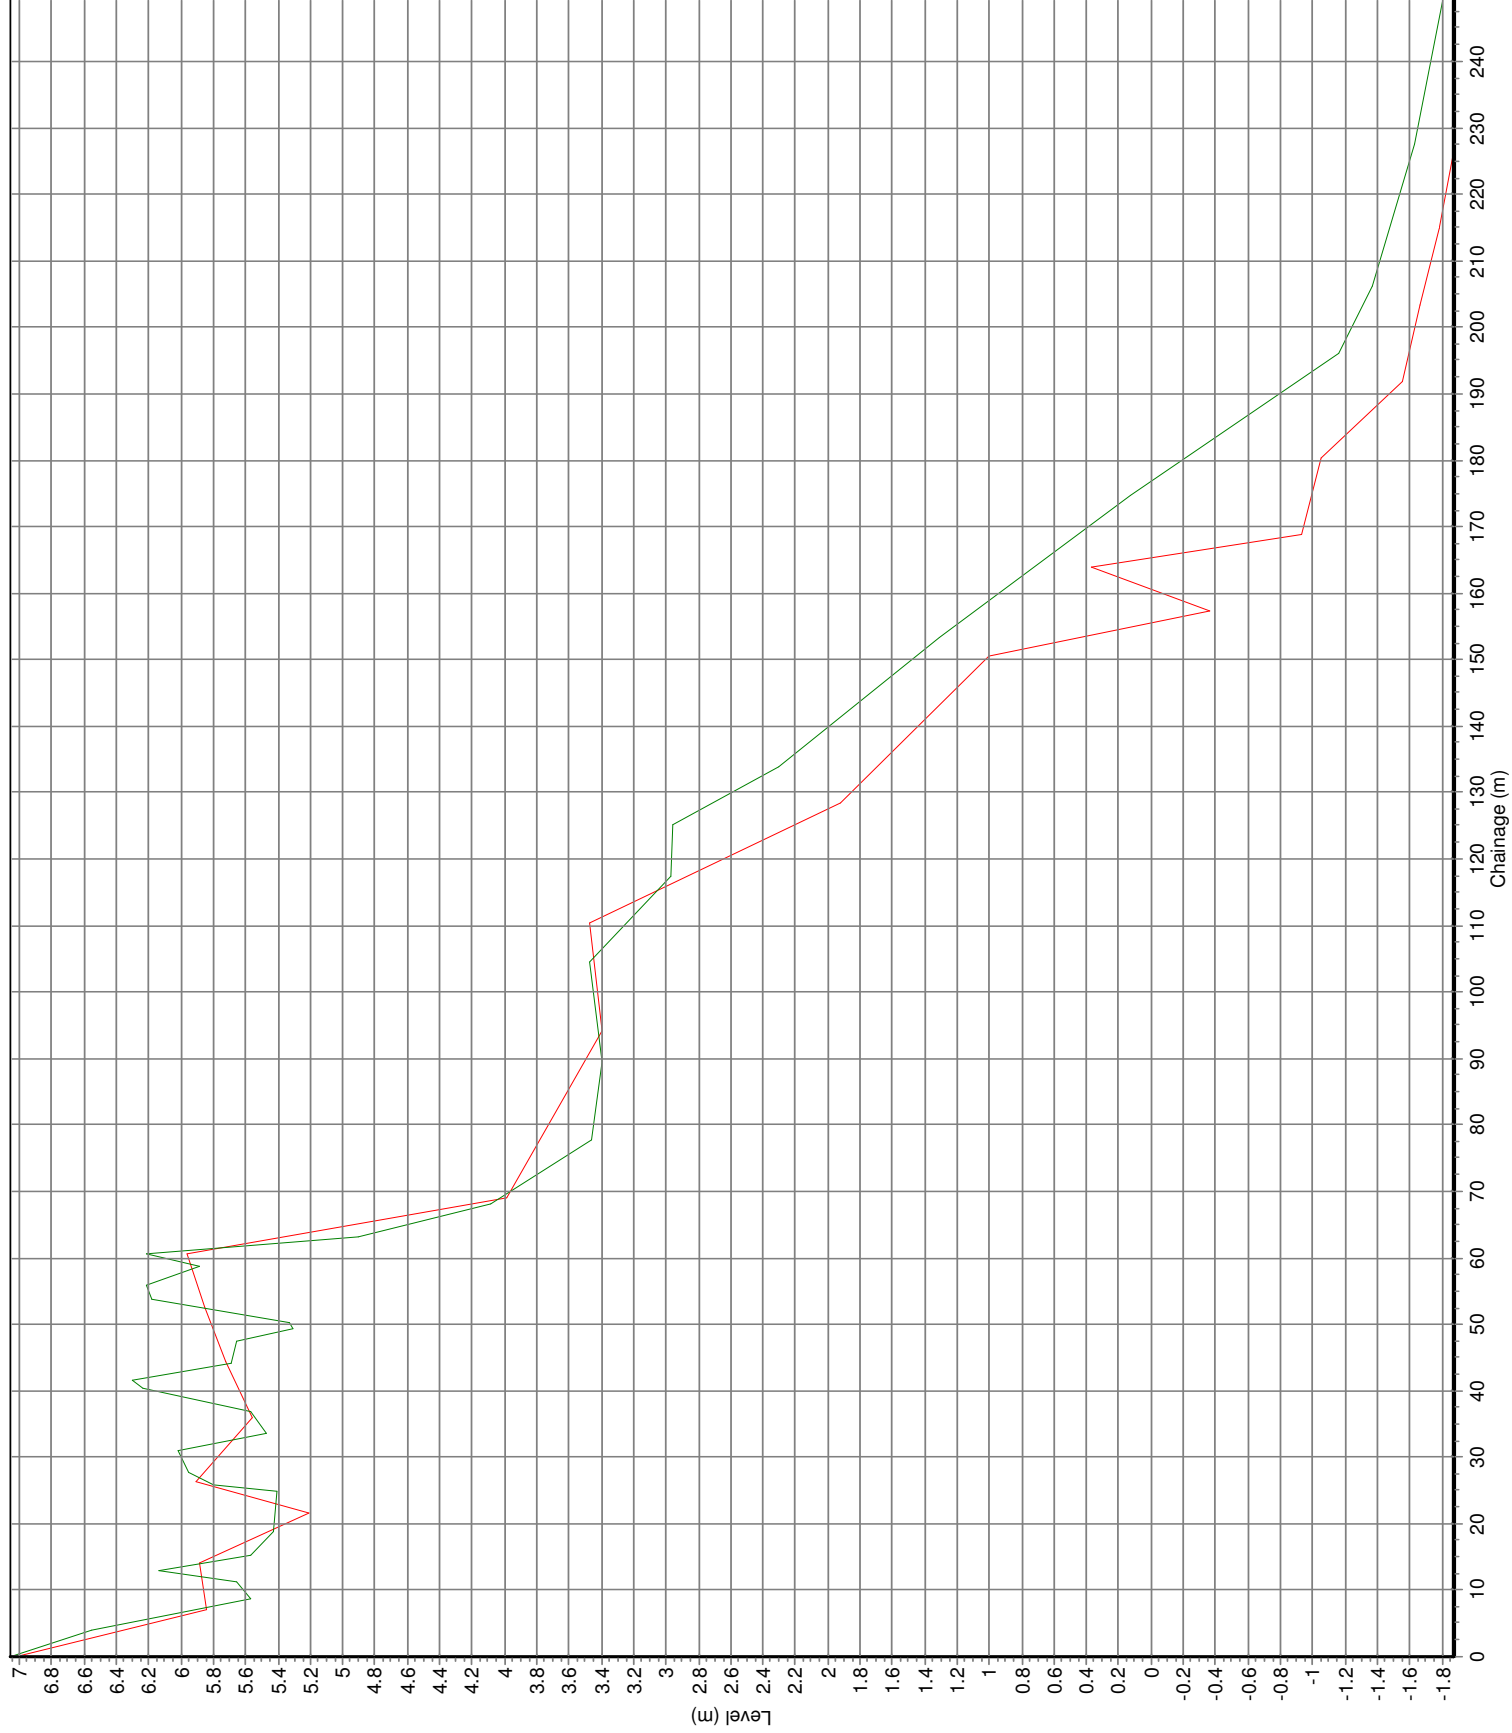
Beach Profiles: 1cRC1

Survey Date	Description of Changes Since Last Survey	Interpretation
03-2009	<p>Beach Profiles:</p> <p>Coatham Sands is covered by four beach profiles (RC1 to RC4; Appendix A).</p> <p>The March 2009 survey along RC1 picks out good definition of the dune crest, with a number of ridges clearly noted. The seaward face and toe of the dunes experienced a small amount of lowering and the berm previously identified at a chainage of around 110m was slightly flattened, but lower down the beach profile sediment accumulation occurred. This typically resulted in increased beach levels by around 0.5, but at a chainage of 170m, the beach levels were some 1.35m higher.</p> <p>The main change along RC2 occurred seaward of a chainage of 220m, where beach lowering occurred. This started with quite modest differences, but increased to a difference of the order of 0.7m at a chainage of 290m. Lowering also occurred along the upper beach, between about MHWN and HAT, although the magnitude of this was much less, being of the order of 0.1m at most.</p> <p>Along RC3 the wide berm identified on the previous survey had become flattened, resulting in a lowering of levels around the former crest of the berm, but a general increase in levels, by around 0.3m, along the rest of the profile (both to landward and to seaward). A slight berm formed around MHWS on the upper section of beach. There was also some slight accretion at the toe and face of the seaward dune ridge.</p> <p>Very little change occurred along RC4 although between chainages of 105 and 250m on the mid beach some modest accretion occurred. Typically this was of the order of 0.1m, but locally increased to 0.2m.</p>	<p>At the northern end of Coatham Sands, the accretion experienced along profile RC1 is typical of the accretion expected at this location, which is sheltered to an extent by the presence of the German Charlies slag banks.</p> <p>Further south the frontage is outwith the zone of protection of these features and there appears to have been some loss from RC2 and gain along RC3, perhaps indicating a longshore redistribution of sediment.</p> <p>At the southern end of Coatham Sands, the profile was relatively stable, indicating the sheltering effect provided against waves from some sectors by Coatham Rocks.</p>

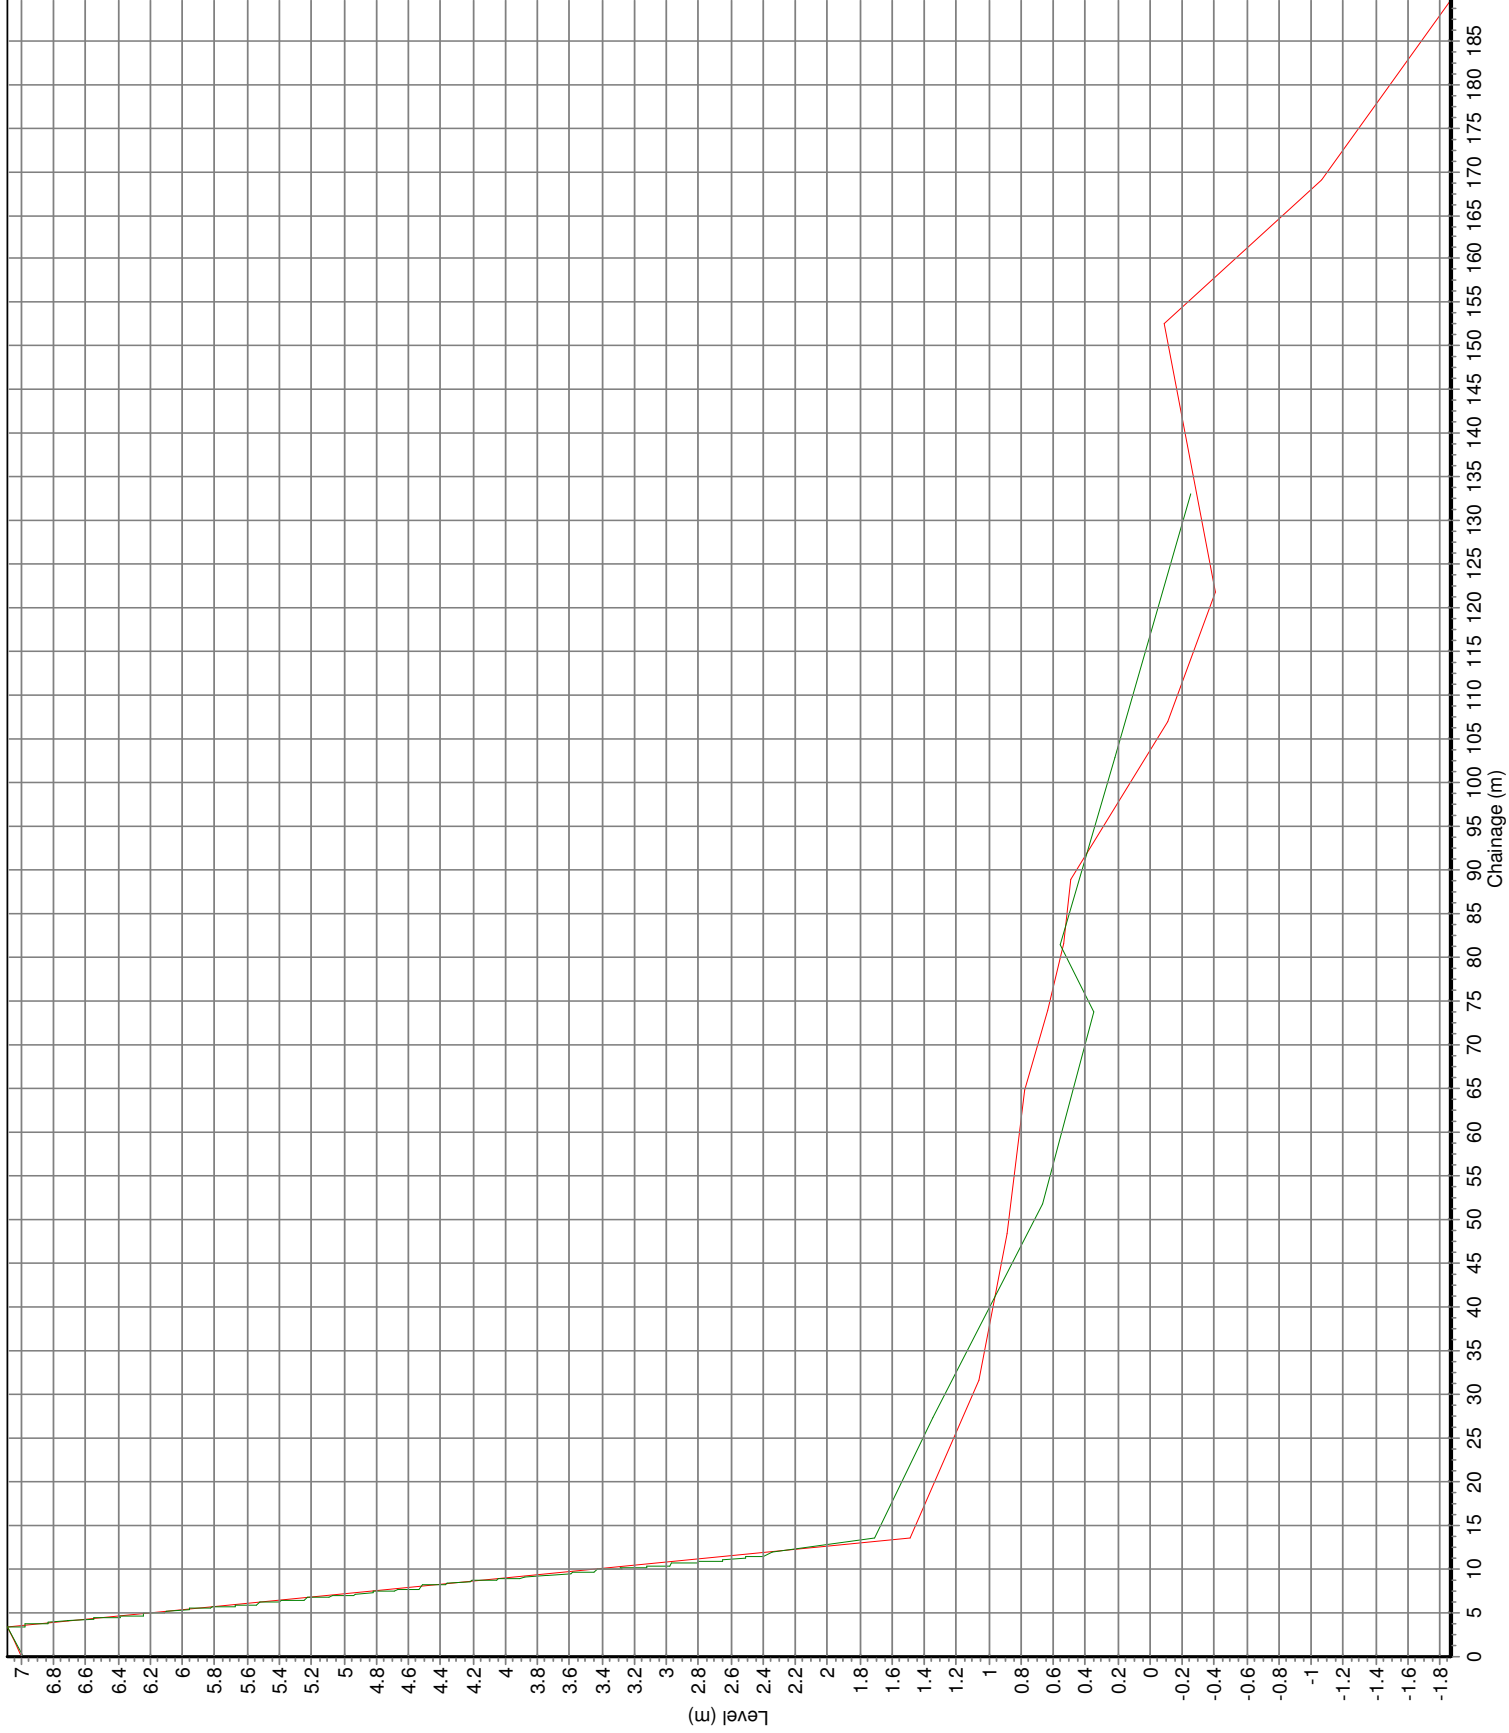
Beach Profiles: 1cRC5

Survey Date	Description of Changes Since Last Survey	Interpretation
03-2009	<p>Beach Profiles:</p> <p>Redcar Sands is covered by three beach profiles (RC5 to RC7; Appendix A), with RC7 being approximately on the boundary with the Marske Sands area.</p> <p>Beach levels at the toe of the concrete wall and revetment along RC5 recovered over a width of some 25m from the wall, with levels directly at the toe improving by 0.2m. This is likely to be due to redistribution of material from lower down the profile, around 40m to 80m chainage, to both the upper profile and the lower profile where levels also increased.</p> <p>Only very modest changes were recorded along RC6 and RC7, with some local redistribution of sediment across each profile resulting in areas of slight accretion and a smaller zone of slight lowering on each.</p>	<p>RC5 was previously identified as an area of concern due to low beach levels at the toe of the concrete crest wall fronting The Esplanade. Here, levels directly at the toe were improved slightly, but not significantly, due to redistribution of sediment from lower down the profile.</p> <p>Whilst the profiles showed only relatively modest change, more substantial changes occurred along beach sections in between the profiles. Some of the upper beach lowering along parts of The Esplanade and parts of The Stray is of particular concern.</p> <p>Overall, it appears that beach morphology along Redcar Sands is highly variable, with a combination of cross-shore and longshore redistributions occurring. It is envisaged that future surveys will show continued variability, but a longer term series of surveys should reveal any trends of erosion or accretion underlying the seasonal variability.</p>

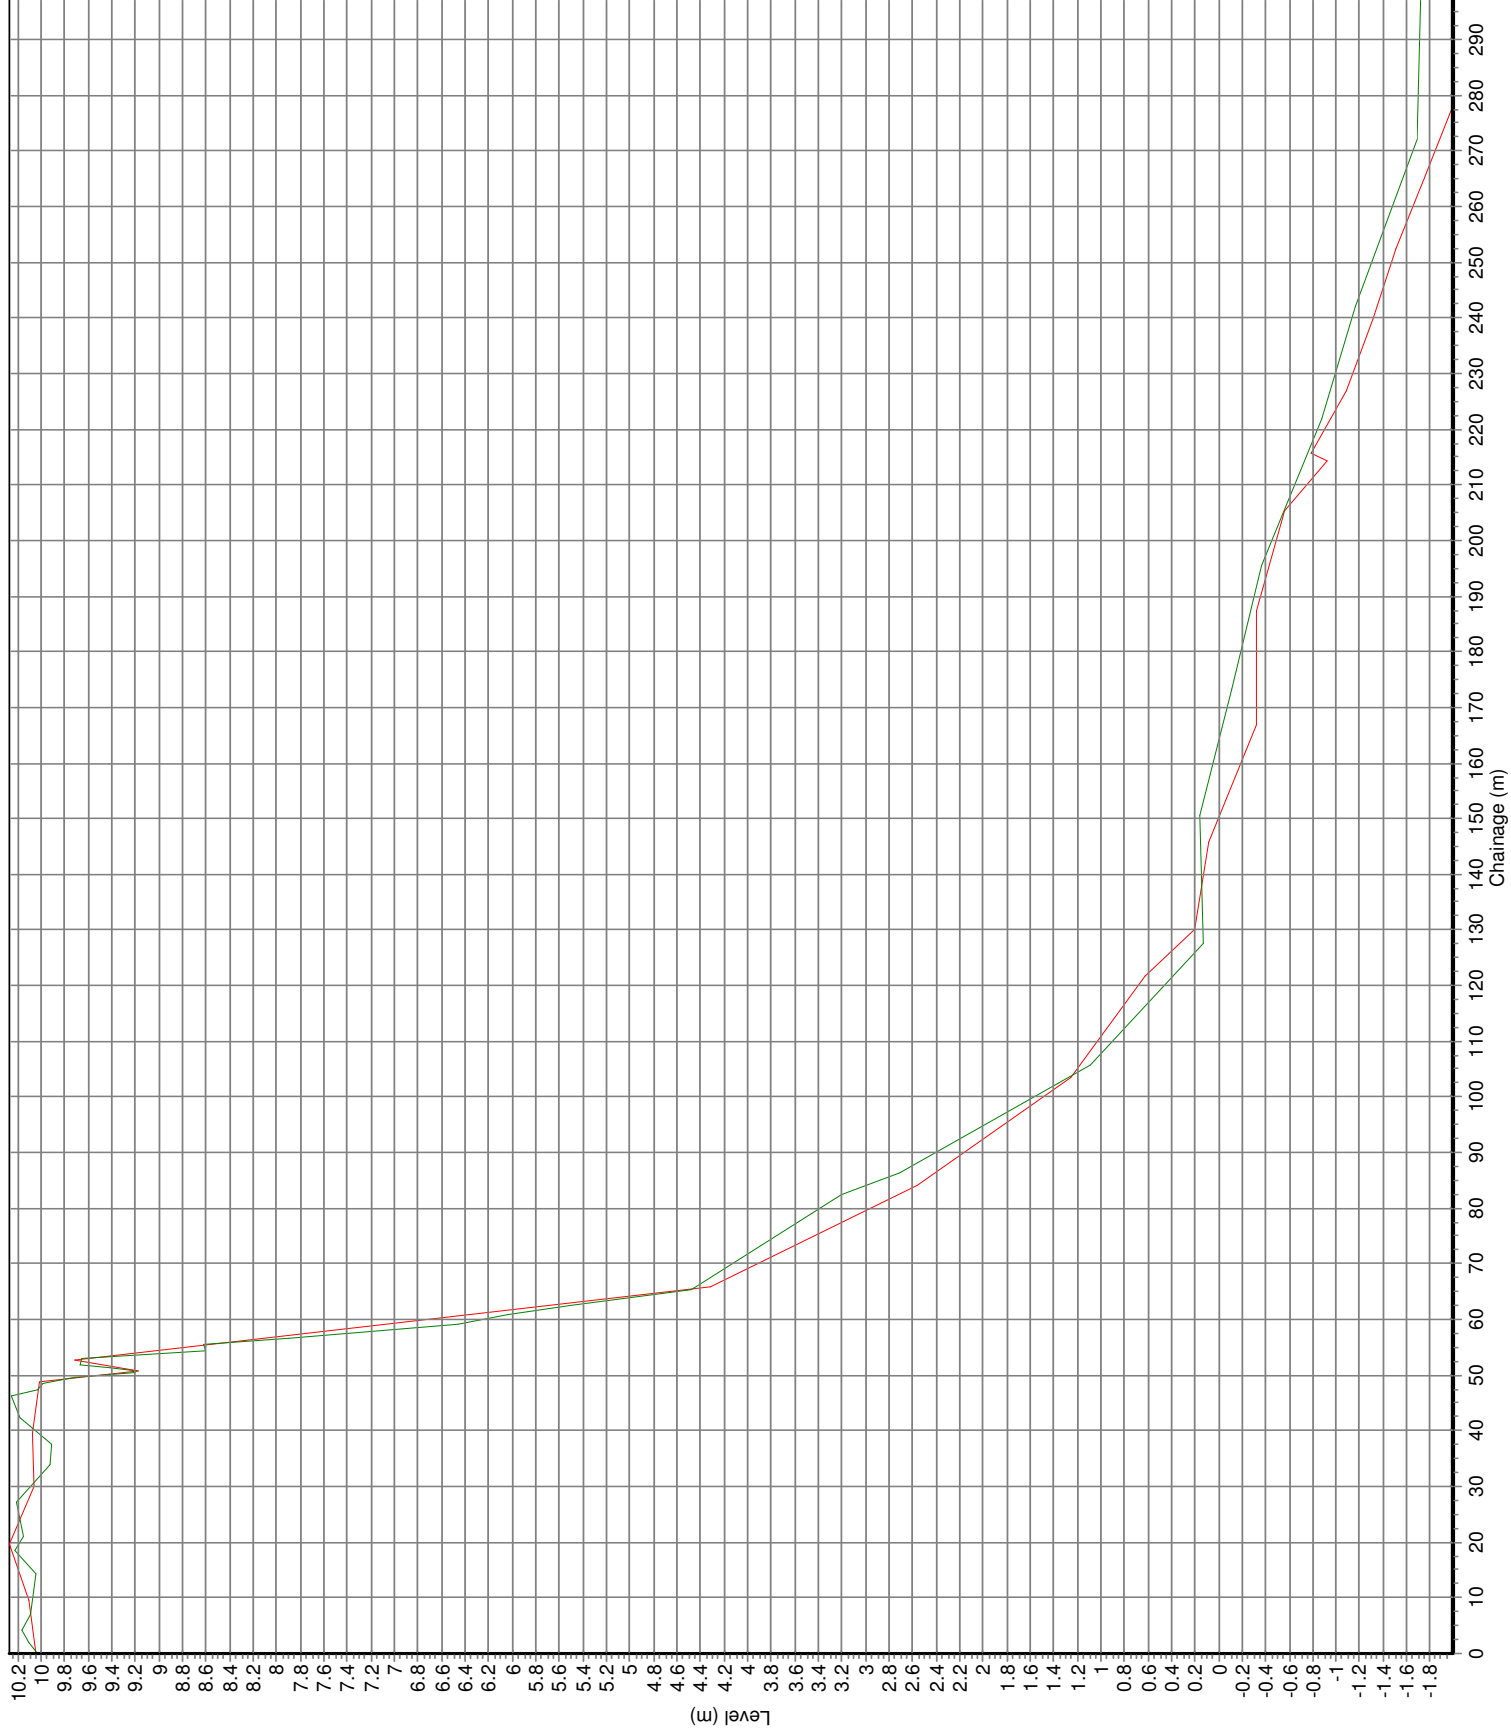
Beach Profiles: 1cRC7

Survey Date	Description of Changes Since Last Survey	Interpretation
03-2009	<p>Beach Profiles:</p> <p>Marske Sands is covered by two beach profiles (RC7 to RC8; Appendix A), with RC7 being approximately on the boundary with the Redcar Sands area.</p> <p>RC7 is located along The Stray and has been discussed in Section 2.2.</p> <p>RC8 experienced some minor redistribution of sediment from the toe of the dunes to form a slight berm at around MHWS level. Lower down the profile, minor lowering occurred. This was of modest values, but reached a maximum difference of around 0.3m locally.</p>	<p>Marske Sands represents a continuation of Redcar Sands and seemed to be experiencing similar redistribution of sediment, although the changes recorded along profile RC8 are within the anticipated bounds of natural variability and do not present a concern.</p>

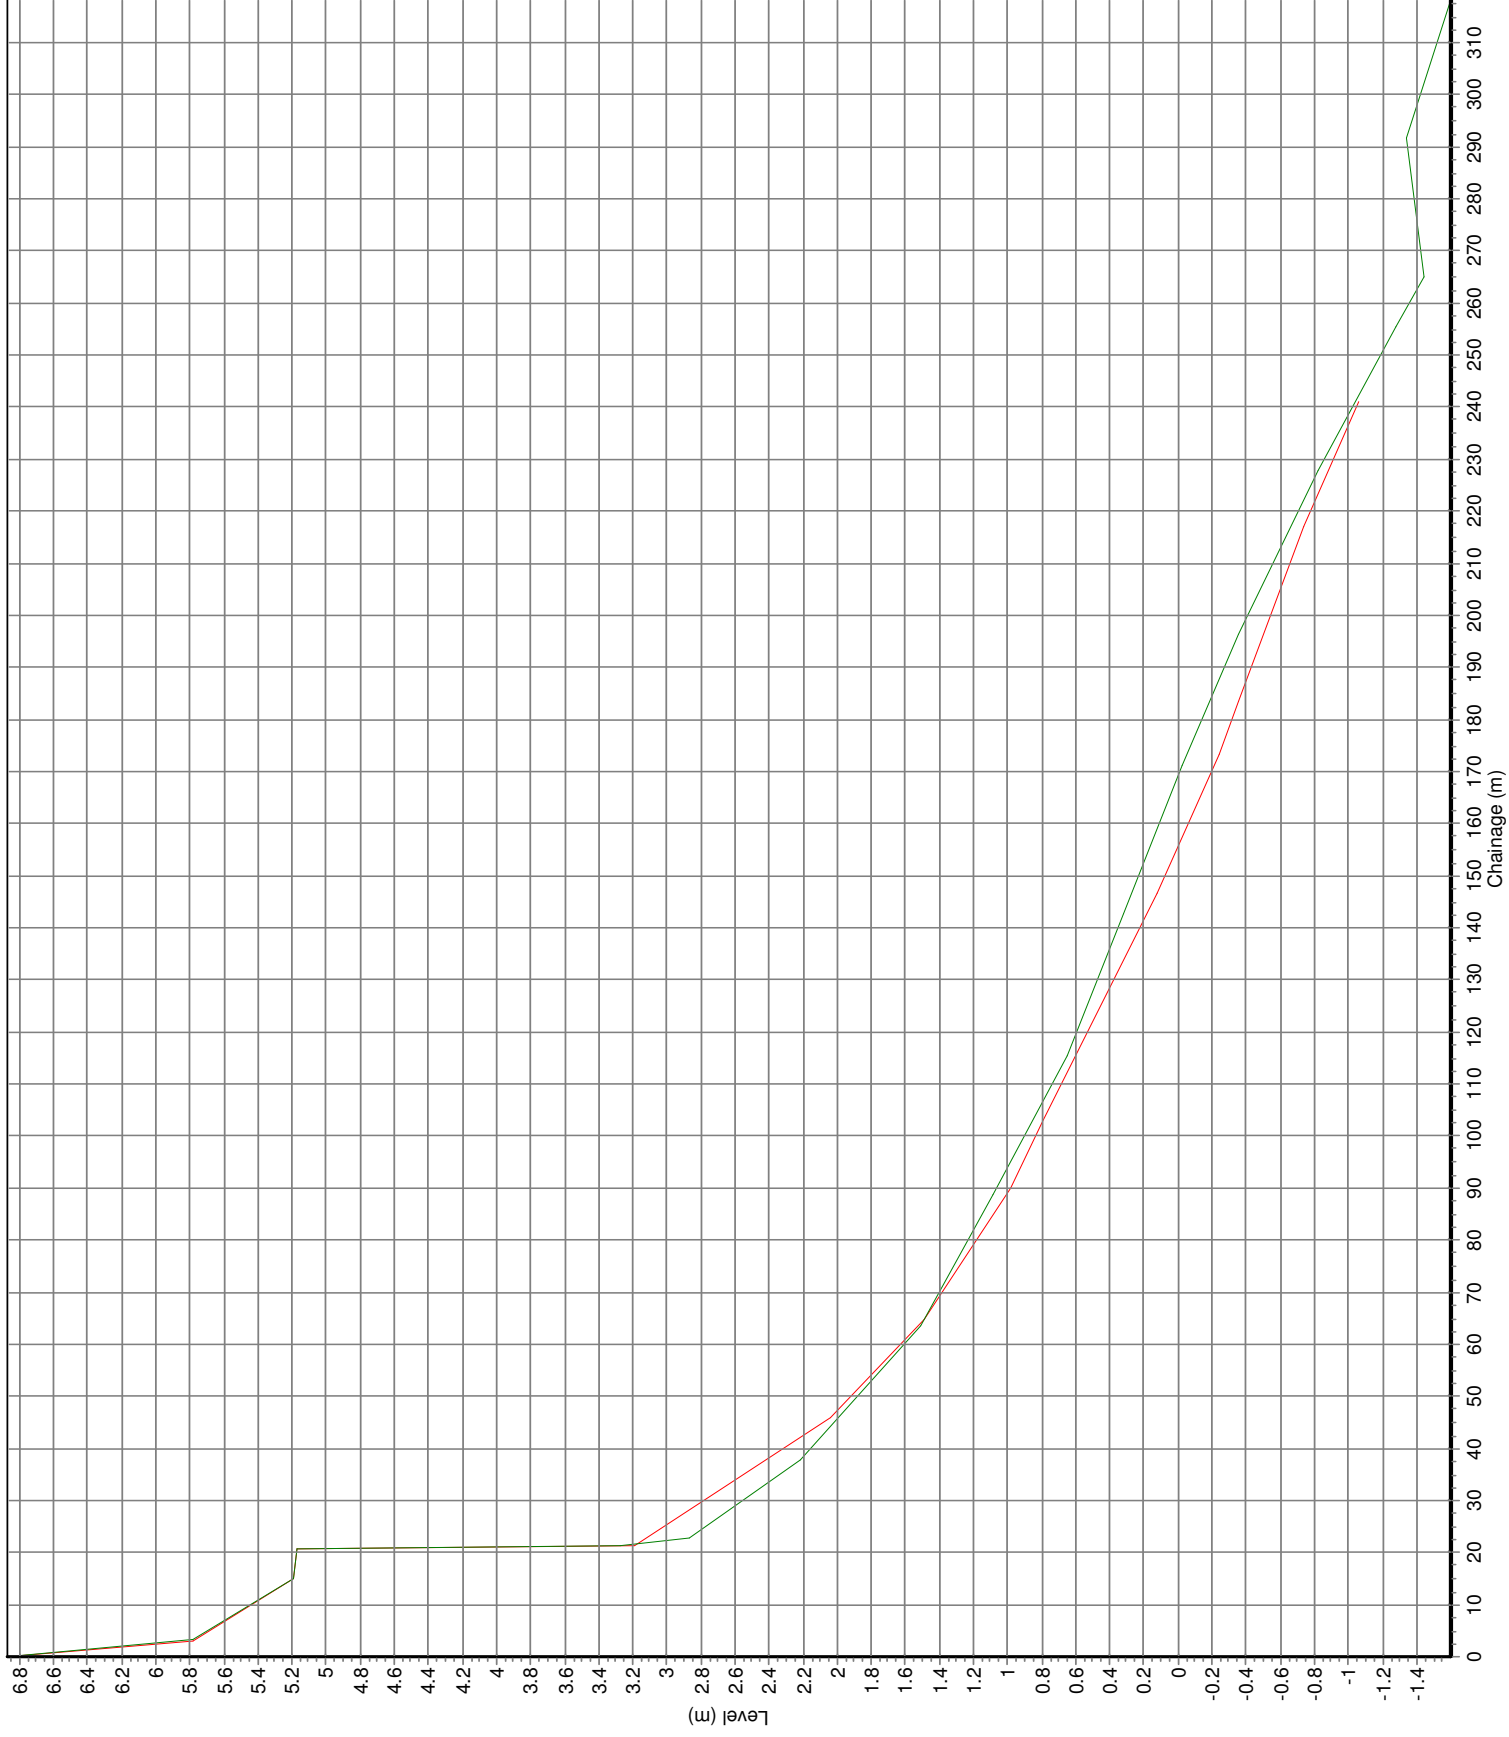
Beach Profiles: 1cRC9

Survey Date	Description of Changes Since Last Survey	Interpretation
03-2009	<p>Beach Profiles:</p> <p>Saltburn Sands is covered by one beach profile (RC9; Appendix A).</p> <p>Upper beach levels dropped in front of the sea wall, with a reduction of some 0.35m observed at the toe of the defence. Seaward of a chainage of 70m, however, the profile accreted down to low water level, with maximum difference between levels being around 0.2m.</p>	<p>Beach changes suggest a degree of flattening, with material eroded from the very upper beach and redistributed across the lower sections, particularly to the west of Skelton Beck. East of the beck, accretion occurred over the mid and lower profile, with less upper beach lowering. This is perhaps a consequence of the presence of Saltburn Scar, which traps some of the beach sediment moving along the coast.</p>
	<p>Topographic Survey:</p> <p>Saltburn Sands is covered by a 6-monthly topographic survey. Data have been used to create a DGM (Appendix B – Map 2a). This DGM has been compared against the previous (November 2008) survey in Appendix B – Map 2b.</p> <p>This DGM shows lowering along a narrow section of upper beach along much of the length between Hazel Grove Foot and Skelton Beck. This is particularly severe along a 100m stretch immediately east of Saltburn Pier. However, the lower beach has accreted over this length. East of Skelton Beck the upper beach erosion is less noticeable and the accretion has occurred over the mid and lower beach.</p>

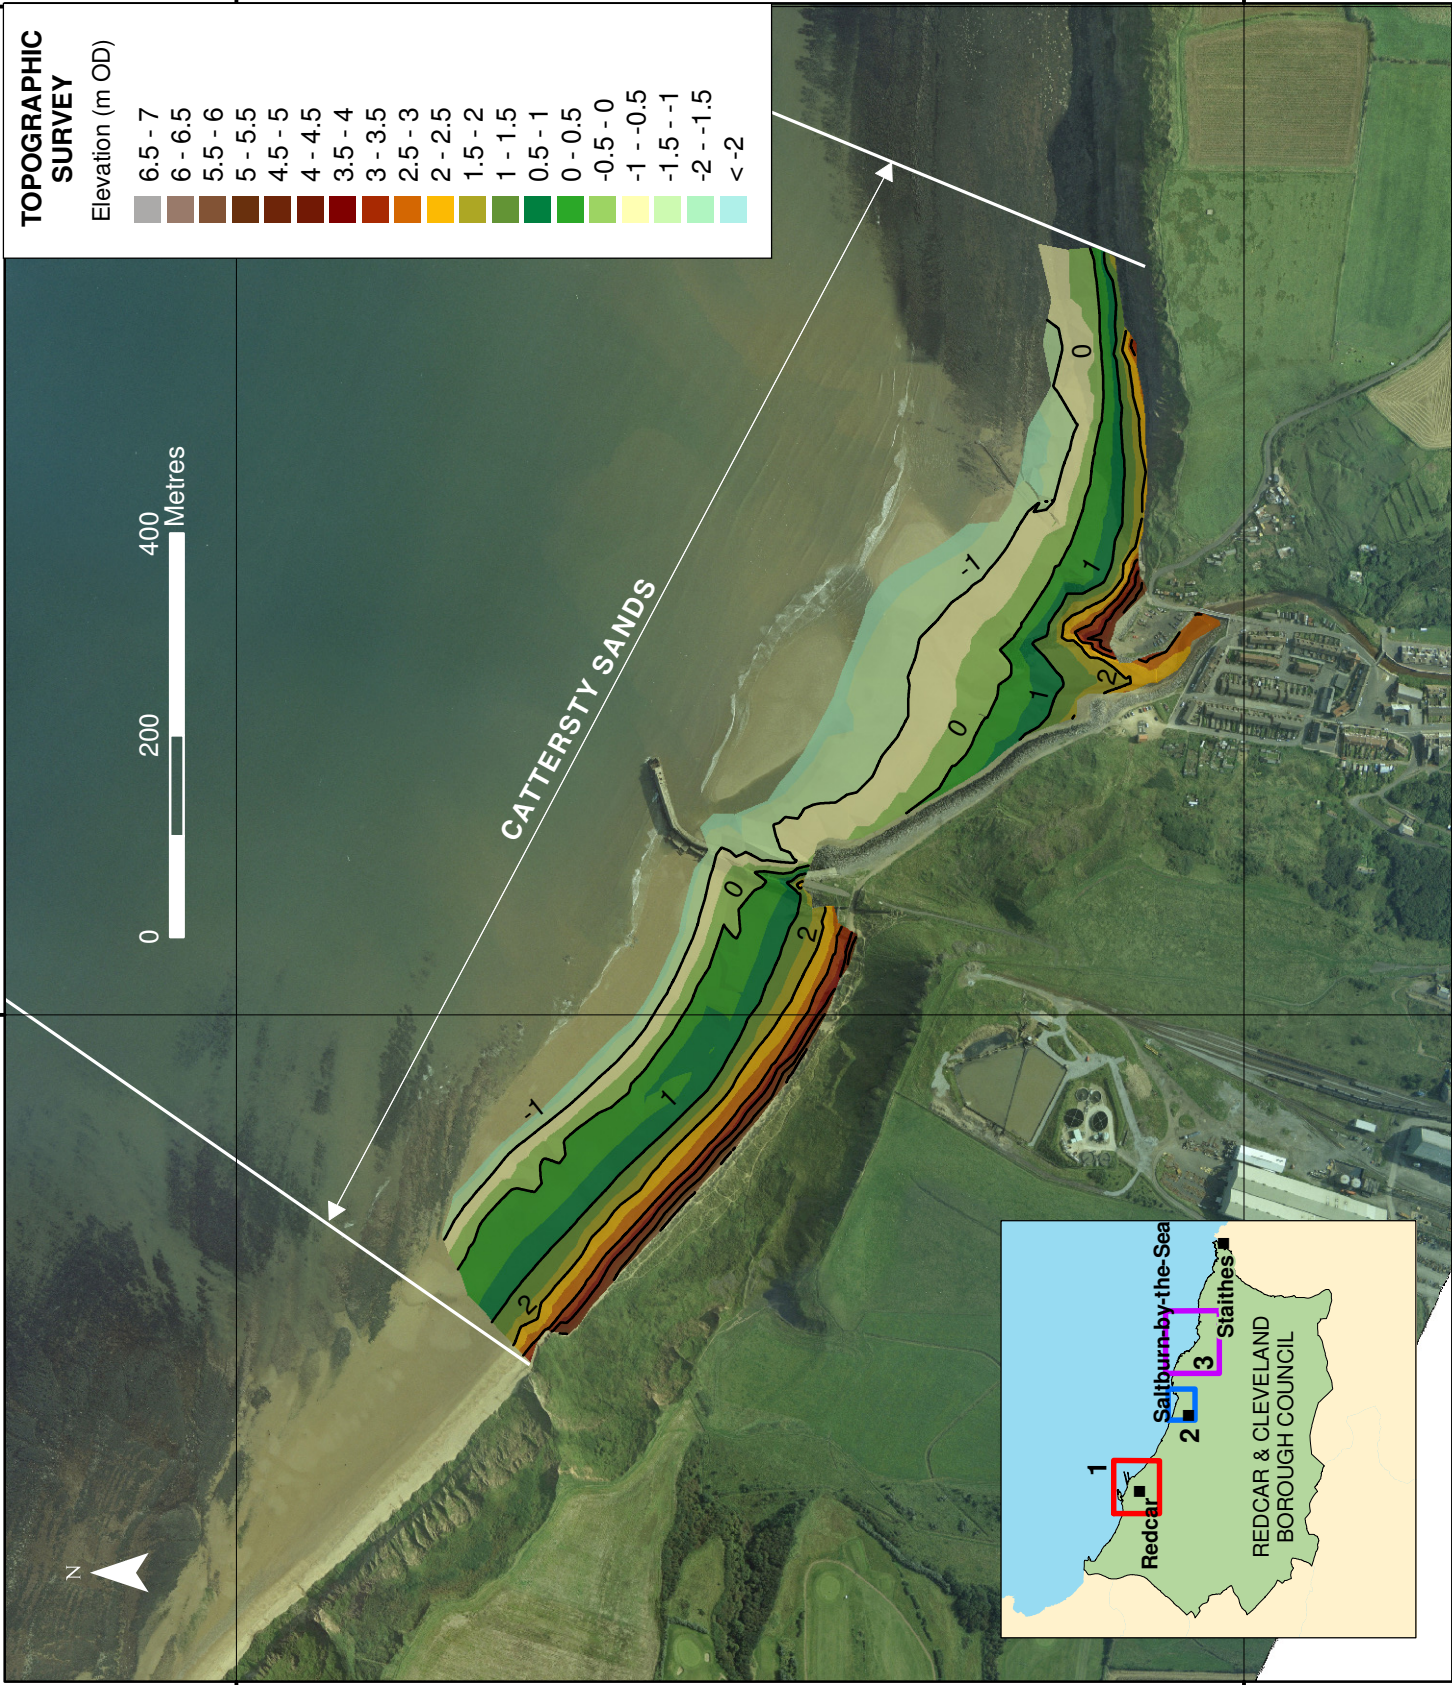
**Appendix B - Map 3b
 Redcar & Cleveland
 Borough Council Frontage**

Survey Date	Description of Changes Since Last Survey	Interpretation
03-2009	<p>Topographic Survey:</p> <p>Cattersty Sands is covered by a 6-monthly topographic survey. Data have been used to create a DGM (Appendix B – Map 3a). This DGM has been compared against the previous (November 2008) survey in Appendix B – Map 3b.</p> <p>This difference model plot highlights areas of accretion (gain) and erosion (loss), in 0.1 m elevation bands. Survey error is anticipated to be c. \pm 0.1m, so indicated changes of this magnitude may not be real but instead a product of survey error. The plot reveals different behaviours either side of the Jetty. Cattersty Sands to the west show a sequence of shore-parallel change and net stasis. At the head of the beach erosion occurs, followed c.100m seaward from the dune field by small discontinuous berm building. This is in turn followed by an erosional trough. Collectively this represents a net seaward transfer of beach materials over the winter period. To the east of the Jetty, a similar sequence is evident below Hummersea Cliff, with the most intense erosion adjacent to rock armour defences. The river outflowing onto the beach is probably responsible for the depositional zone moving through the central area. To the north-west an area of erosion has developed, and immediately adjacent to the Jetty is an area of accretion.</p>	<p>This frontage shows beach change influenced by both marine and fluvial processes. The shore-parallel troughs and berms are indicative of the transition from a swell (summer) to storm (winter) dominated beach profile. In contrast, fluvial impacts are orthogonal to the coastline, resulting in different patterns of beach/river mouth change.</p>

- Cattersty Sands (Skinningrove) shows beach change typical of seasonal marine processes, and also depicts the influence of the outflowing river. The patterns of beach change are therefore more complicated than would be anticipated by coastal processes alone.
