## **Cell 1 Regional Coastal Monitoring Programme Update Report 2: 'Partial Measures' Survey 2010**

Redcar & Cleveland Borough Council Final Report

**July 2010**

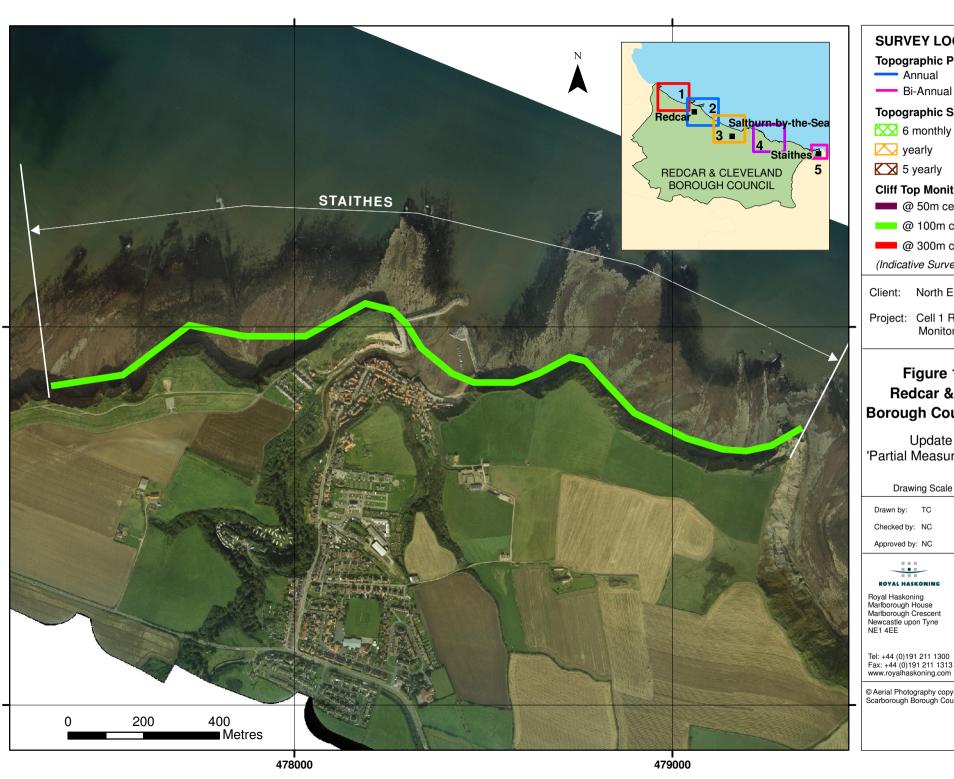
#### Figure 1 - Map 5 **Redcar & Cleveland Borough Council Frontage**

The location of these surveys is shown in Figure 1. They have also previously been provided on a digital file which can be opened in Google Earth showing the locations of the surveys.

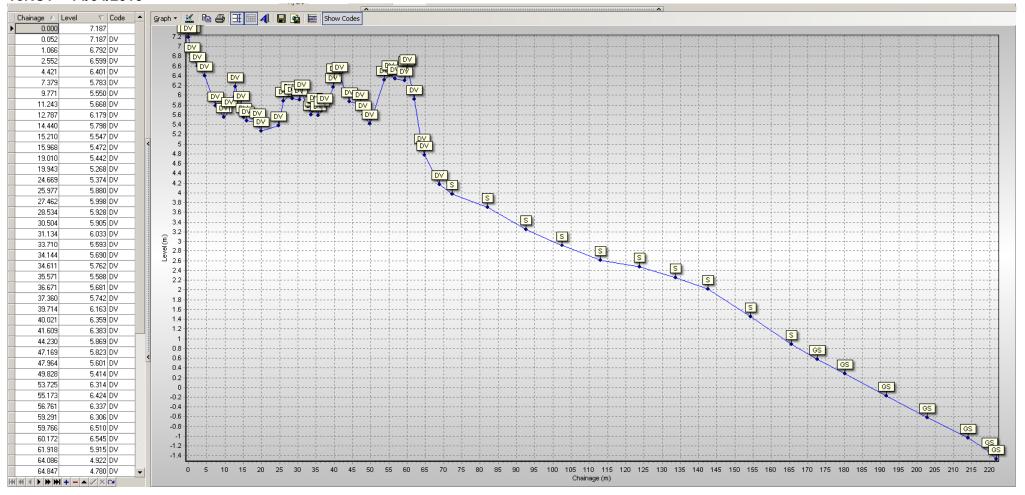
#### 1cRC1 - 14/04/2010

Survey Date	Description of Changes Since Last Survey	Interpretation
04-2010	Beach Profiles:  Coatham Sands is covered by four beach profiles during the Partial Measures survey (RC1 to RC4; Appendix A).  RC1 is located approximately 300m south of the South Gare Breakwater, immediately in the lee of the German Charlies. The profile showed some minor accretion at the crest of the dunes and stability to landward within the main body of dunes. Along the foreshore, the berm which was notable between MHWS and HAT in the September 2009 survey was flattened by April 2010, causing increases in foreshore levels at the toe of the dunes and along the lower foreshore.  Along RC2 beach levels were quite healthy, showing an accretion of sand along much of the profile since the September 2009 survey. In contrast, lowering occurred along almost the entire length of RC3, recording levels similar to those observed in November 2008 during the first survey. The present survey included the lowest recorded levels to date at the toe of the dunes, but no significant erosion of the dune face. Along RC4 accretion of typically 0.15m but locally up to 0.35m occurred.	At the northern end of Coatham Sands, profile RC1 is sheltered to an extent by the presence of the German Charlies slag banks. The April 2010 survey was the first survey along this profile in which a beach berm was absent, suggesting wave-driven flattening of the profile. It is anticipated that the beach will slowly return to its characteristic profile, exhibiting a berm in future surveys.  Further south the frontage is outwith the zone of protection of these features and there appears to have been some loss from RC3 and gain along both RC2 and RC4, perhaps indicating a longshore redistribution of sediment within the bay. It is interesting to note that the profile shape along RC2 to RC4 generally remains uniform, but the level increases or decreases relatively consistently across its length depending on the preceding wave and tidal conditions.

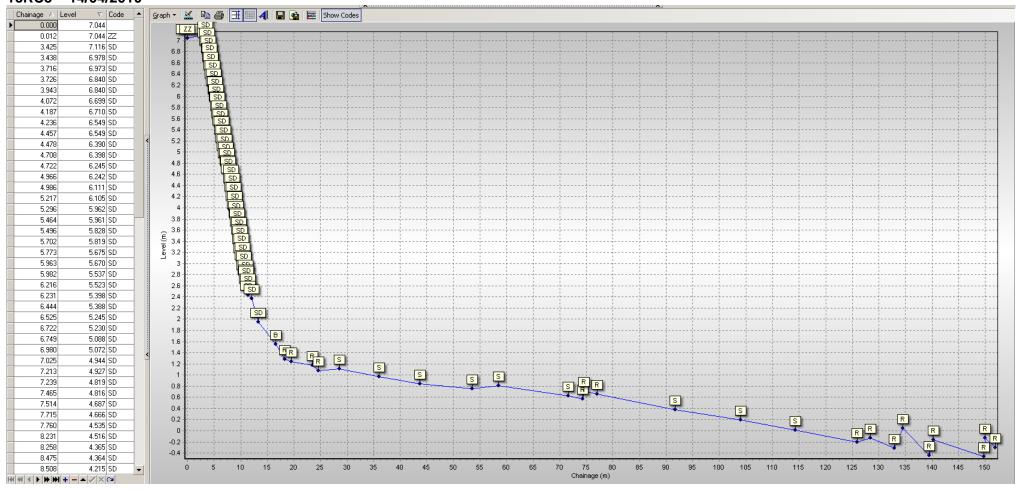
#### 1cRC5 - 14/04/2010

Survey Date	Description of Changes Since Last Survey	Interpretation
_	Beach Profiles:  Redcar Sands is covered by three beach profiles (RC5 to RC7; Appendix A), with RC7 being approximately on the boundary with the Marske Sands area.  Beach levels at the toe of the concrete wall and revetment along RC5 lowered by up to 0.45m between September 2009 and April 2010 to reach record low levels since surveys began in November 2008 in places. Further seaward along the profile, subtle increases and decreases in level occurred as a result of local redistribution of sediment.  Along RC6 a notable volume of material was 'scalloped' from the beach at around MHWN and deposited at the toe of the dunes in the form of a new foredune. This meant that the profile exhibited a very different shape in April 2010 than has characteristically been observed in previous surveys.  The high dune along RC7 exhibited little change between September 2009 and April 2010, although there was modest accretion along the mid foreshore.  Topographic Survey:  Redcar Sands is covered by a 6-monthly topographic survey. Data have been used to create a DGM (Appendix B – Map 1a). This DGM has been compared against the previous (September 2009) survey in Appendix B – Map 1b and the last Partial Measures survey (April 2009) in Appendix B – Map 1c.  The DGMs show that considerable redistribution of sediment has occurred across Redcar Sands between September 2009 and April 2010. There appears to have been a general removal of material from the upper and mid beach and its deposition on the lower beach in the lee of Coatham Rocks and Redcar Rocks. Further south the lowering was more consistent across the whole foreshore width, with some material accumulation at the toe of the dunes. Further south still, towards Marske Sands, some accretion on the lower foreshore also occurred. The DGMs also show that the upper beach levels in April 2010 were generally lower than those recorded in April of the previous year.	RC5 is located in the lee of Redcar Rocks and is at the southerly end of a trend shown in the DGM of upper beach lowering (still notably exhibited along RC5) and lower beach accretion (not significantly exhibited along RC5). This suggests that the beach levels at the toe of the defences fronting much of Redcar town lowered notably over the winter of 2009/2010.  South of RC5 towards Mackinlay Park, lowering continues to have been exhibited along much of the upper and all of the mid foreshore, but with a strip of material accumulation along the uppermost section of beach, as demonstrated by the new foredune development along RC6. In places the beach lowering continued all the way down the foreshore to low water, but on the north-easterly facing sections accretion along the lower foreshore occurred, suggesting some local redistribution along the Redcar Sands frontage.  By comparing the April 2010 survey against the Partial Measures survey from the previous year, it can be concluded that the winter of 2009/2010 had a particularly notable effect on lowering beach levels along the upper foreshore.

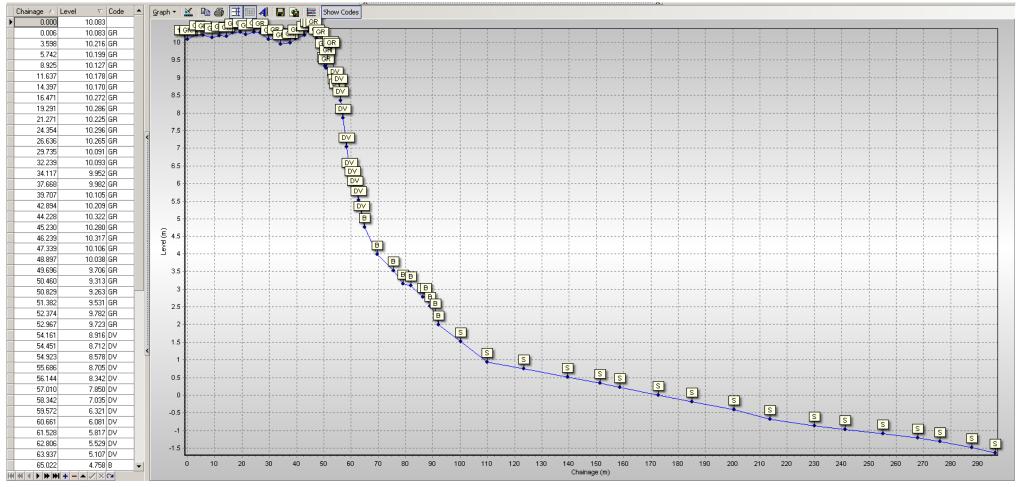
#### 1cRC7 - 14/04/2010

Survey Date	Description of Changes Since Last Survey	Interpretation
04-2010	Beach Profiles:  Marske Sands is covered by two beach profiles (RC7 to RC8; Appendix A), with RC7 being approximately on the boundary with the Redcar Sands area.  RC7 is located along The Stray and has been discussed in Section 2.2.  RC8 experienced some minor redistribution of sediment along the foreshore and general stability in the high backing dunes.	Marske Sands represents a continuation of Redcar Sands and seemed to be relatively stable, with changes confined to minor redistribution of sediments along the foreshore.

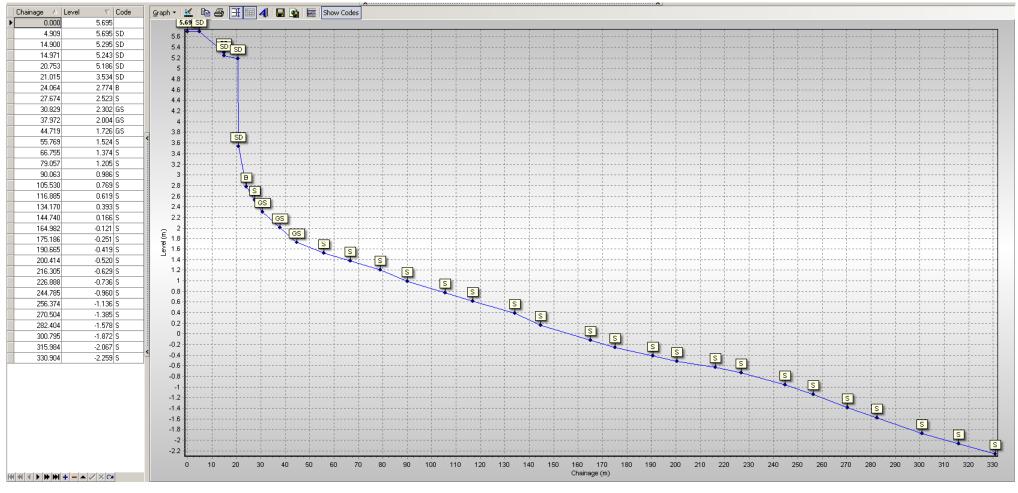
#### 1cRC9 - 14/04/2010

Survey Date	Description of Changes Since Last Survey	Interpretation
Date  Bea Salt Upp surv of th from fore  Top Salt (App in A The lowe whil Betw	Peach Profiles:  altburn Sands is covered by one beach profile (RC9; Appendix A).  pper beach levels dropped notably in front of the sea wall, to record new record low levels since urveying began in November 2008. There was a reduction in level of some 0.3m observed at the toe the defence. This lowering extended from the toe of the wall to a chainage of approximately 80m om the survey origin (i.e. a width of foreshore of approximately 60m. Seaward of this limit, the reshore became more stable.  Propagraphic Survey:  altburn Sands is covered by a 6-monthly topographic survey. Data have been used to create a DGM appendix B – Map 2a). This DGM has been compared against the previous (November 2008) survey. Appendix B – Map 2b and the last Partial Measures survey (April 2009) in Appendix B – Map 2c.  The DGMs show that since September 2009 the foreshore to the west of Skelton Beck exhibited general wering (as observed along profile RC9). There were further differences around the mouth of the beck, while to the east there was general modest accretion.  Between April 2009 and February 2010, most differences were observed along the outfall channel of kelton Beck. East of Skelton Beck the differences in beach levels were very modest increases by April	Beach changes along Saltburn Sands since September 2009 included relatively consistent lowering to the west of Skelton Beck, changes around the mouth of the beck seemingly caused by changes in its alignment across the foreshore, and modest accretion to the east. This suggests a degree of redistribution of sediment from west to east across Saltburn Sands.  Saltburn Sands is in a broadly similar condition in February 2010 to that recorded in April of the preceding year, with differences mostly focused in the vicinity of the outfall channel of Skelton Beck.

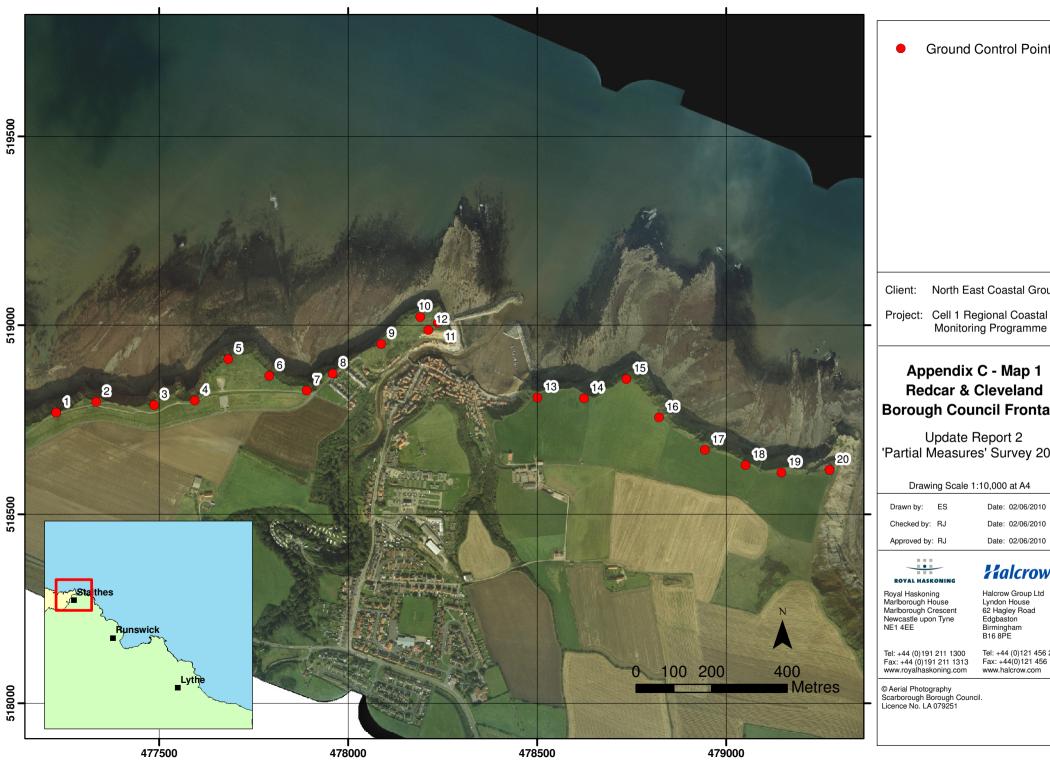
## Appendix C - Map 1 **Redcar & Cleveland Borough Council Frontage**

Twenty ground control points have been established at Staithes (Appendix C - Map 1). The maximum separation between any two points is nominally 100 m.

The cliff top surveys at Staithes are undertaken bi-annually. Measurements are taken from a fixed ground control point along a fixed bearing to the edge of the cliff top.

The cliff top surveys at Staithes are assumed to have a limit of accuracy of  $\pm$  0.1 m due to the techniques used. At a sizeable number of locations 'apparent' cliff advance is calculated, which is highly unlikely (except under a toppling mechanism of failure). It is more likely that this is due to a different point being identified as the edge of the cliff, especially with different seasonal vegetation covers. To improve the data quality, enhancing their long-term value, a visit to all measurement locations by a cliff geomorphologist would provide a useful means to evaluate this issue further.

It is understood that Redcar & Cleveland Borough Council is presently applying to the Environment Agency for funding to commission repeat terrestrial laser scan surveys of cliff faces and cliff tops at Cowbar. The increased accuracy and resolution of data from laser scanning would enable a very detailed appreciation of changing conditions, and thereby further inform management planning.
