Cell 1 Regional Coastal Monitoring Programme Update Report 3: 'Partial Measures' Survey 2011

Redcar & Cleveland Borough Council

August 2011

^(*) The present report is **Update Report 3** and provides an analysis of the 2011 Partial Measures survey for Redcar & Cleveland Borough Council's frontage. It is intended as a brief update of the key findings from this survey to maintain an understanding of ongoing changes.

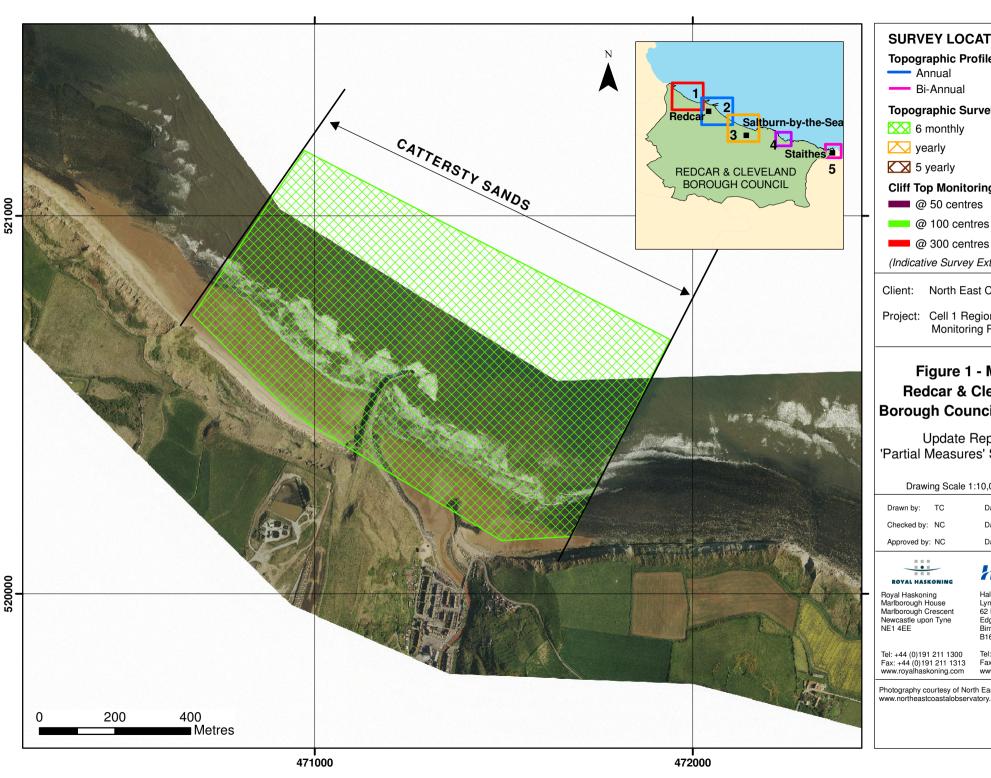
Figure 1 - Map 4 **Redcar & Cleveland Borough Council Frontage**

The location of these surveys is shown in Figure 1. They have also previously been provided on a digital file which can be opened in Google Earth showing the locations of the surveys.

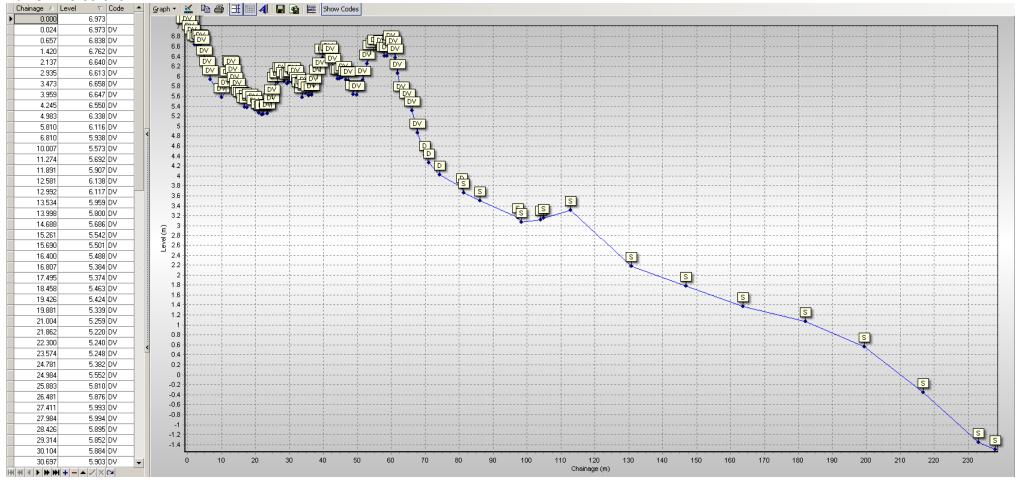
1cRC1 - 07/04/2011

Survey Date	Description of Changes Since Last Survey	Interpretation
04-2011	Beach Profiles:	
	Coatham Sands is covered by four beach profiles during the Partial Measures survey (RC1 to RC4; Appendix A).	
	RC1 is located approximately 300m south of the South Gare Breakwater, immediately in the lee of the German Charlies. The profile showed some continued minor accretion at the seaward face of the dunes and stability to landward within the main body of dunes. Along the foreshore, the berm which was last present in the September 2009 survey flattened between MHWS and HAT in the September 2009 survey but absent due to flattening in the April 2010 and November 2010 surveys had re-formed, peaking in crest level at around HAT. Considerable accretion occurred along the lower foreshore.	Along most of Coatham Sands, there was accretion along the lower foreshore. Dunes were stable or accreting and the only areas of beach lowering, typically at the toe of the dunes or sea defence, were

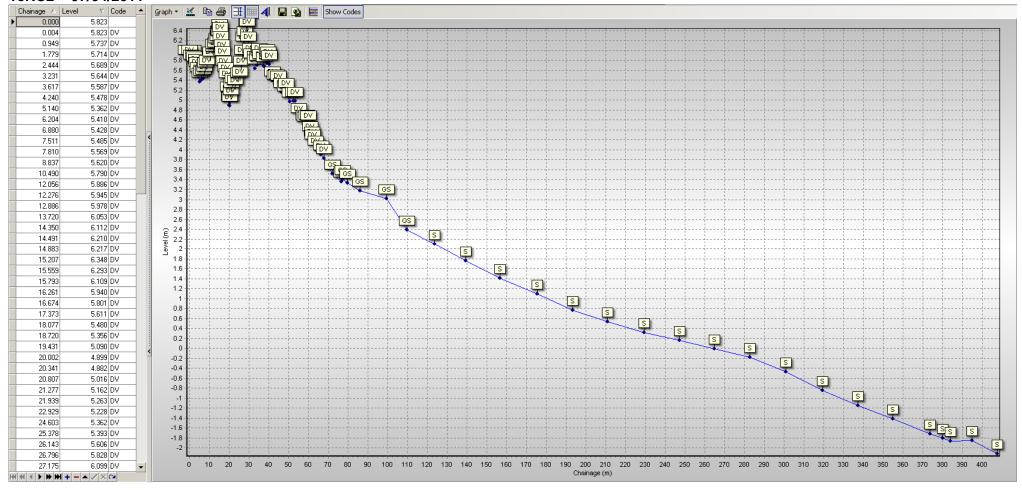
1cRC2 - 07/04/2011

Along RC2 dune levels remained healthy, showing a slight redistribution of sand to form a berm at the dune toe between MHWS and HAT. The mid section of the profile experienced some lowering, but lower beach levels were high.	very local and within the bounds of previous reco behaviour since surveys began in November 2008
	Profile RC3 showed accretion on the seaward face of the dunes, but relatively low foreshore levels , similar to those recorded in November 2010, along the entire profile.	
	Along RC4 there was some local lowering at the toe of the sea defence, but accretion since November 2010 along the rest of the profile, with levels along the lower foreshore particularly high.

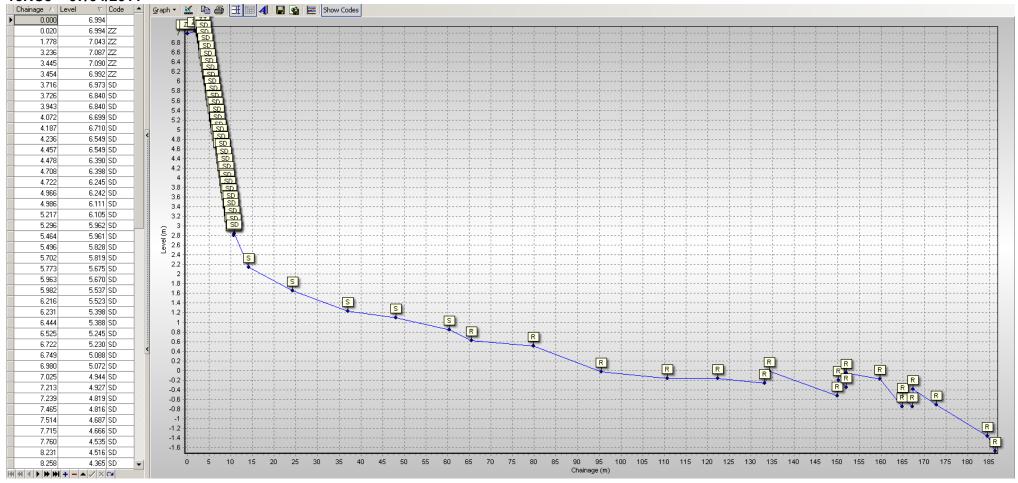
1cRC5 - 07/04/2011

Survey Date	Description of Changes Since Last Survey	Interpretation
	Beach Profiles:	
	Redcar Sands is covered by three beach profiles (RC5 to RC7; Appendix A), with RC7 being approximately on the boundary with the Marske Sands area.	
	Beach levels at the toe of the concrete wall and revetment along RC5 increased by up to 0.65m between November 2010 and April 2011 to reach record high levels since surveys began in November 2008. Further seaward along the profile, levels remained high until a chainage of 80m. After this point they dropped to low values to a chainage of 130m, where after rock remained exposed on the lower-most foreshore.	
	Along RC6 profile levels were almost identical to those recorded in November 2010 along the dunes, upper beach and lower beach, but increased by around 0.1m along the mid beach.	The profiles along Redcar Sands generally showed a
04-2011	The high dune along RC7 exhibited little change between November 2010 and April 2011, although there was accretion on the upper foreshore and erosion on the lower foreshore.	modest redistribution of sand since the last survey in November 2010. Levels at the toe of the defences along RC5 were particularly high, as also represented

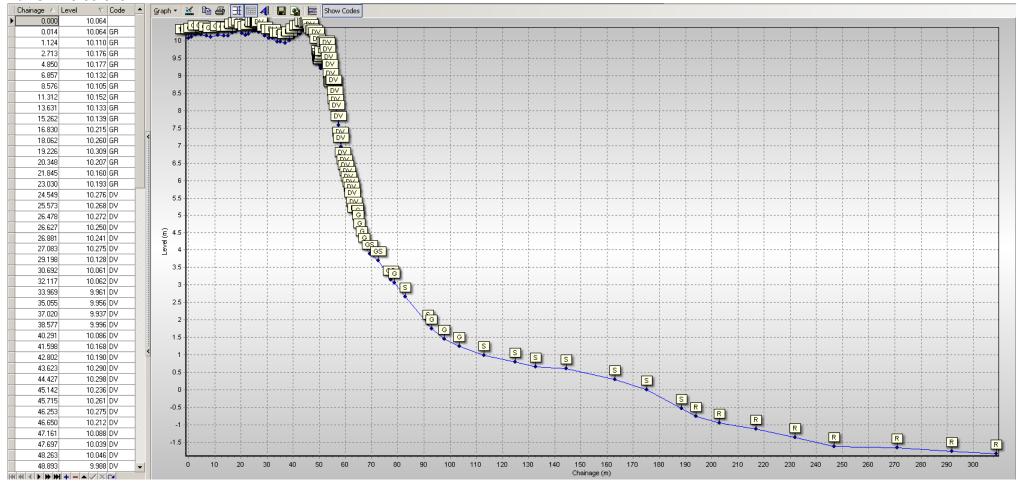
1cRC7 - 07/04/2011

Survey Date	Description of Changes Since Last Survey	Interpretation
	Beach Profiles:	
04-2011	Marske Sands is covered by two beach profiles during the Partial Measures survey (RC7 to RC8; Appendix A), with RC7 being approximately on the boundary with the Redcar Sands area.	The two profiles along Marske Sands remained remarkably stable between November 2010 and April
	RC7 is located along The Stray and has been discussed in Section 2.2.	2011.
	RC8 experienced little change since November 2010.

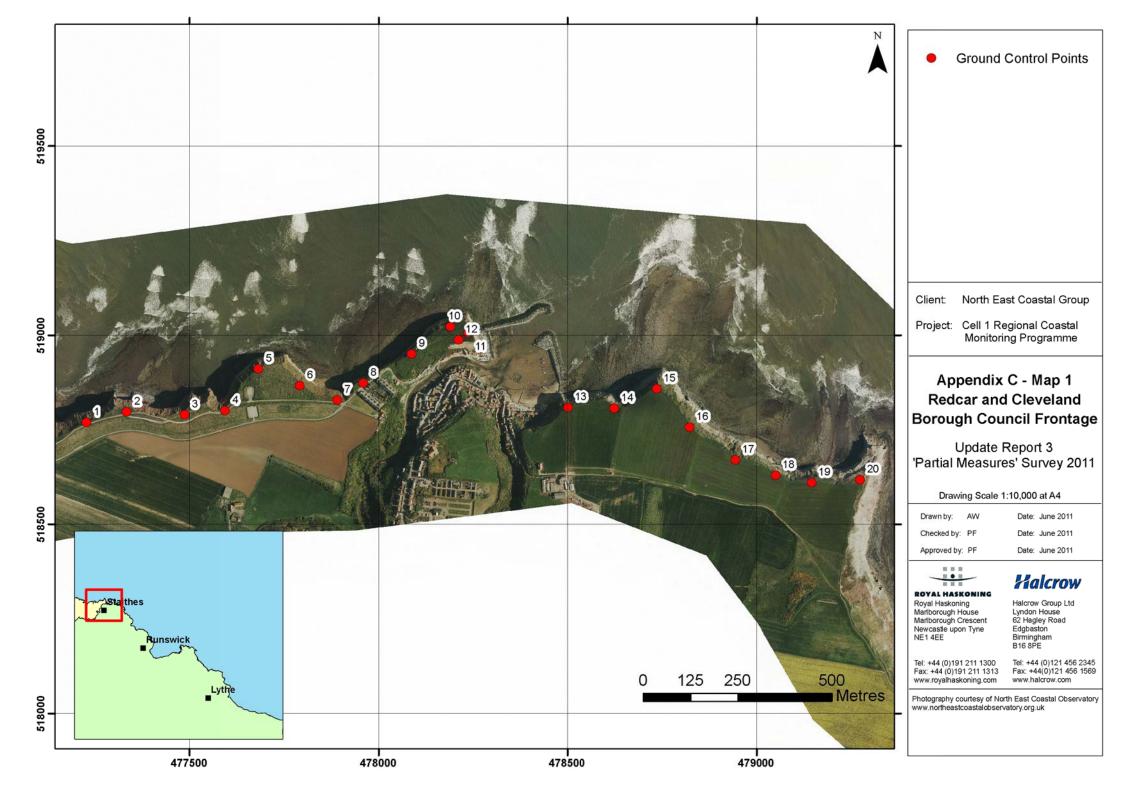
When survey accuracy is taken into consideration, eight of the twenty points have shown no change in cliff top position between the November 2008 and April 2011 surveys (i.e. the measured change in cliff position is less than the survey error). Only two locations (points 4 and 13) have shown recession of the cliff line, by 0.6 and 1.9m respectively, since the baseline survey (±0.1m due to survey accuracy). This equates to erosion rates of 0.2m/yr and 0.8m/yr respectively. At a large number of locations an apparent increase in distance to the cliff edge has occurred, highlighting the limits of accuracy of this cliff top monitoring technique.

Ten of the surveyed locations show an increase in distance to the cliff edge. It is possible that these data represent an extension of the cliff top due to a progressive toppling failure but this is not supported by field observations over this time. These data are therefore considered to be resulting from differing interpretation of the exact position of the cliff edge between surveys. This suggests that the Council's approach of using laser scanning to monitor cliff recession at the key points of concern is a more suitable approach.

Twenty ground control points have been established at Staithes (Appendix C - Map 1). The maximum separation between any two points is nominally 100m.

It is understood that Redcar & Cleveland Borough Council is undertaking terrestrial laser scan surveys of cliff faces and cliff tops at Cowbar. The increased accuracy and resolution of data from laser scanning would enable a very detailed appreciation of changing conditions, and thereby further inform management planning.
