**Cell 1 Regional Coastal Monitoring Programme
Update Report 4: 'Partial Measures' Survey 2012**

**Redcar and Cleveland Council
Final Report**

February 2013

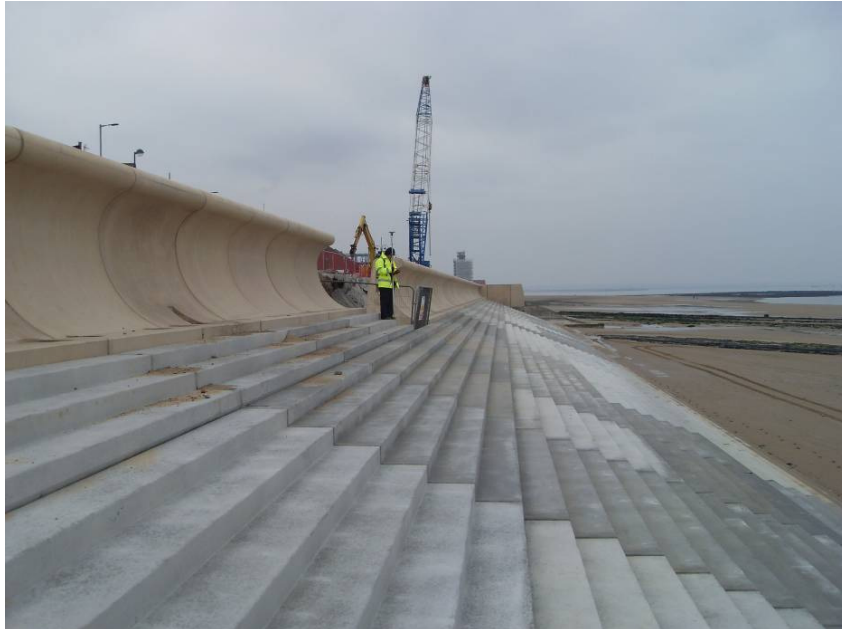
At Redcar the Sea defence construction works continue around the area of Redcar town and works continue in the area of the groyne.

Profile RC5 now has new sea wall defence, which has resulted in the change to the profile. Offshore, foundations for a wind farm are currently being installed.

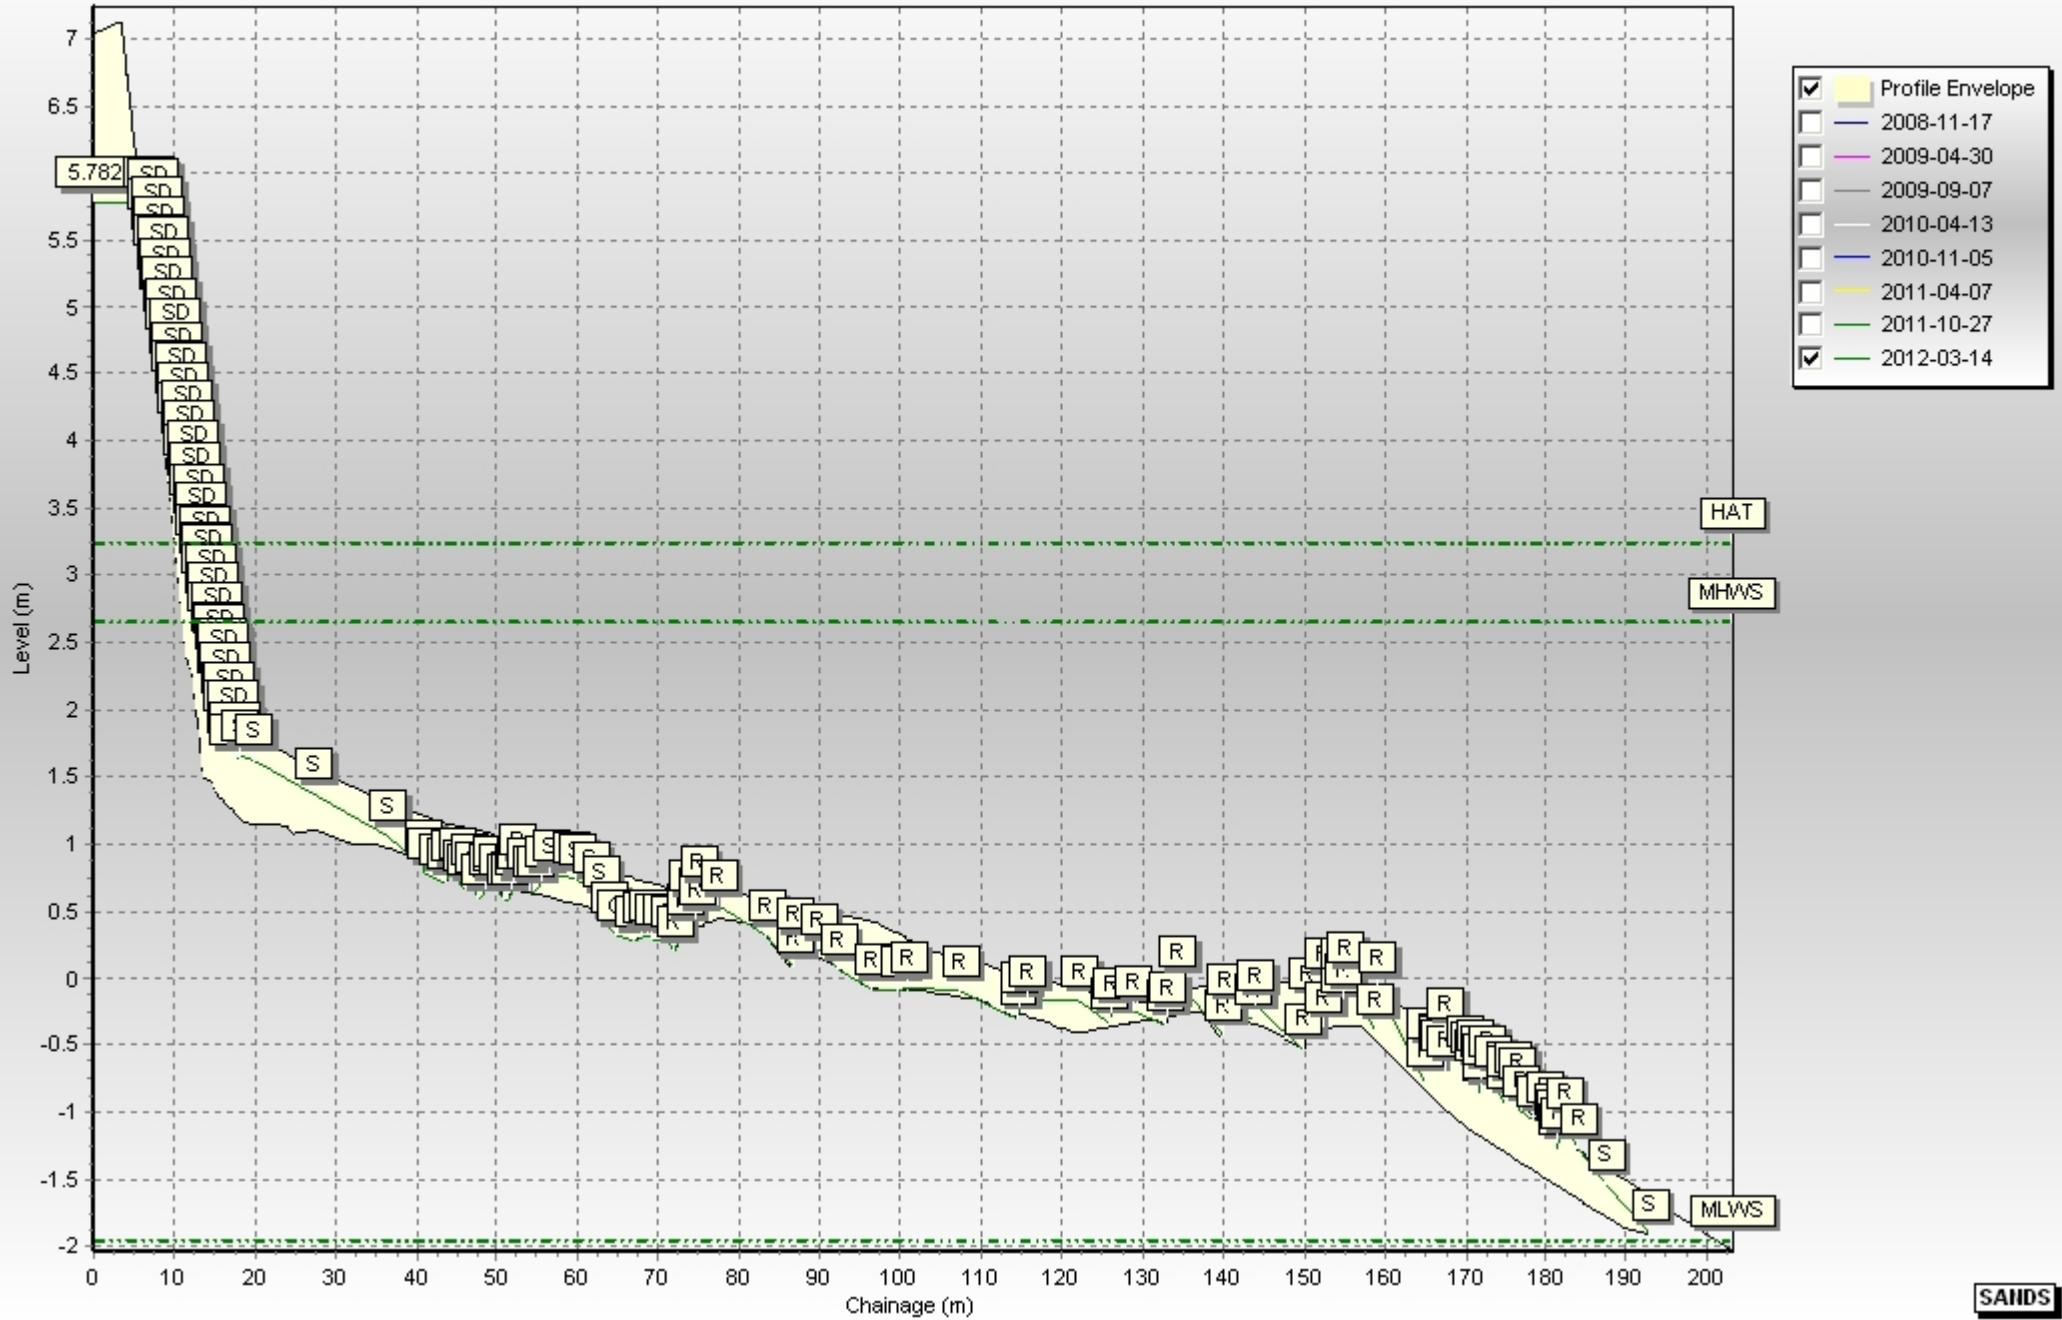
Beach Profiles: 1cRC5

Survey Date	Description of Changes Since Last Survey	Interpretation
14/03/12	<p>Beach Profiles:</p> <p>Redcar Sands is covered by three beach profiles (RC5 to RC7; Appendix A), with RC7 being approximately on the boundary with the Marske Sands area. They were last surveyed in October 2011.</p> <p>At profile RC5 the construction of a new sea defence continued, as a result the profiles have changed above HAT. Between 20 and 75m the beach has eroded by 0.3m. There are parts of the profile between 40 and 70m chainage which look uneven and it is unclear whether this is due to the nearby engineering works or the underlying rock platform being exposed. Between 90 and 115m chainage a berm visible in the last survey had been eroded. Beyond 115m chainage the profile has not changed between October 2011 and March 2012 because the rocks are exposed in both surveys.</p> <p>Along profile RC6 levels were almost identical to those recorded the last survey along the dunes, upper beach and lower beach, but increased by around 0.1m along the mid beach.</p> <p>At profile RC7 the data collected in October 2011 was corrupt and consequently the last survey was March 2011. When that survey is compared to the current profile they can be seen to be very similar above HAT. Between 75 (the HAT level) and 90m chainage there was erosion of the beach by around 0.2m. Between 90 and 180m chainage the beach has flattened since March 2011. From 180m to 270m chainage the beach has accreted by up to 0.5m. Below 270m chainage there was very little change from March 2011 to March 2012.</p>	<p>A new defence has been built at RC5 so the beach is likely to have been altered during the construction process. Future profile analysis should be cautious about interpretation of the 2011 and 2012 data and establish a new baseline following the completion of the works on construction of the defences. Both profiles RC9 and RC 7 show relative stability, with few changes in gradient or beach level.</p> <p>Longer term trends:</p> <p>With the exception of an accumulation of sand at the base of the seawall, the beach at RC5 was lowest beach level recorded. This is in contrast to RC6 and RC7, where the March 2012 profiles are among the highs recorded for the foreshore.</p>
