**Cell 1 Regional Coastal Monitoring Programme
Update Report 5: 'Partial Measures' Survey 2013**

**Redcar and Cleveland Council
Final Report**

June 2013

(*) The present report is **Update Report 5** and provides an analysis of the 2013 Partial Measures survey for Redcar and Cleveland Council's frontage.

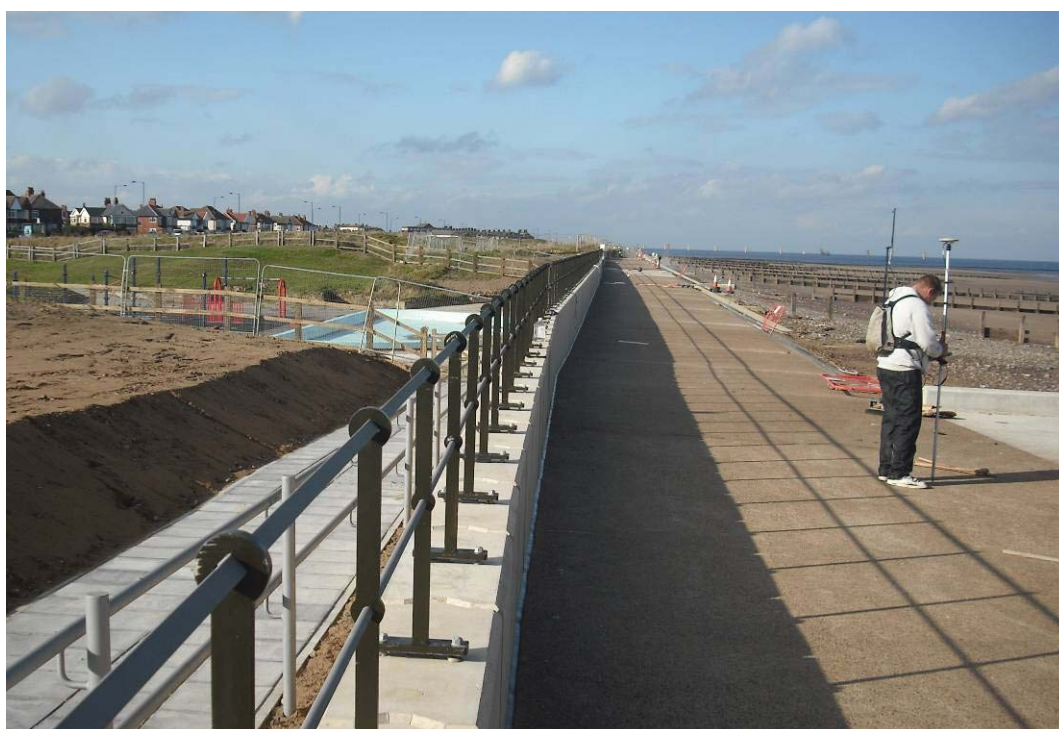
Profile RC6 now has new sea wall defence, which has resulted in the change to the profile. Offshore, foundations for a wind farm are currently being installed.

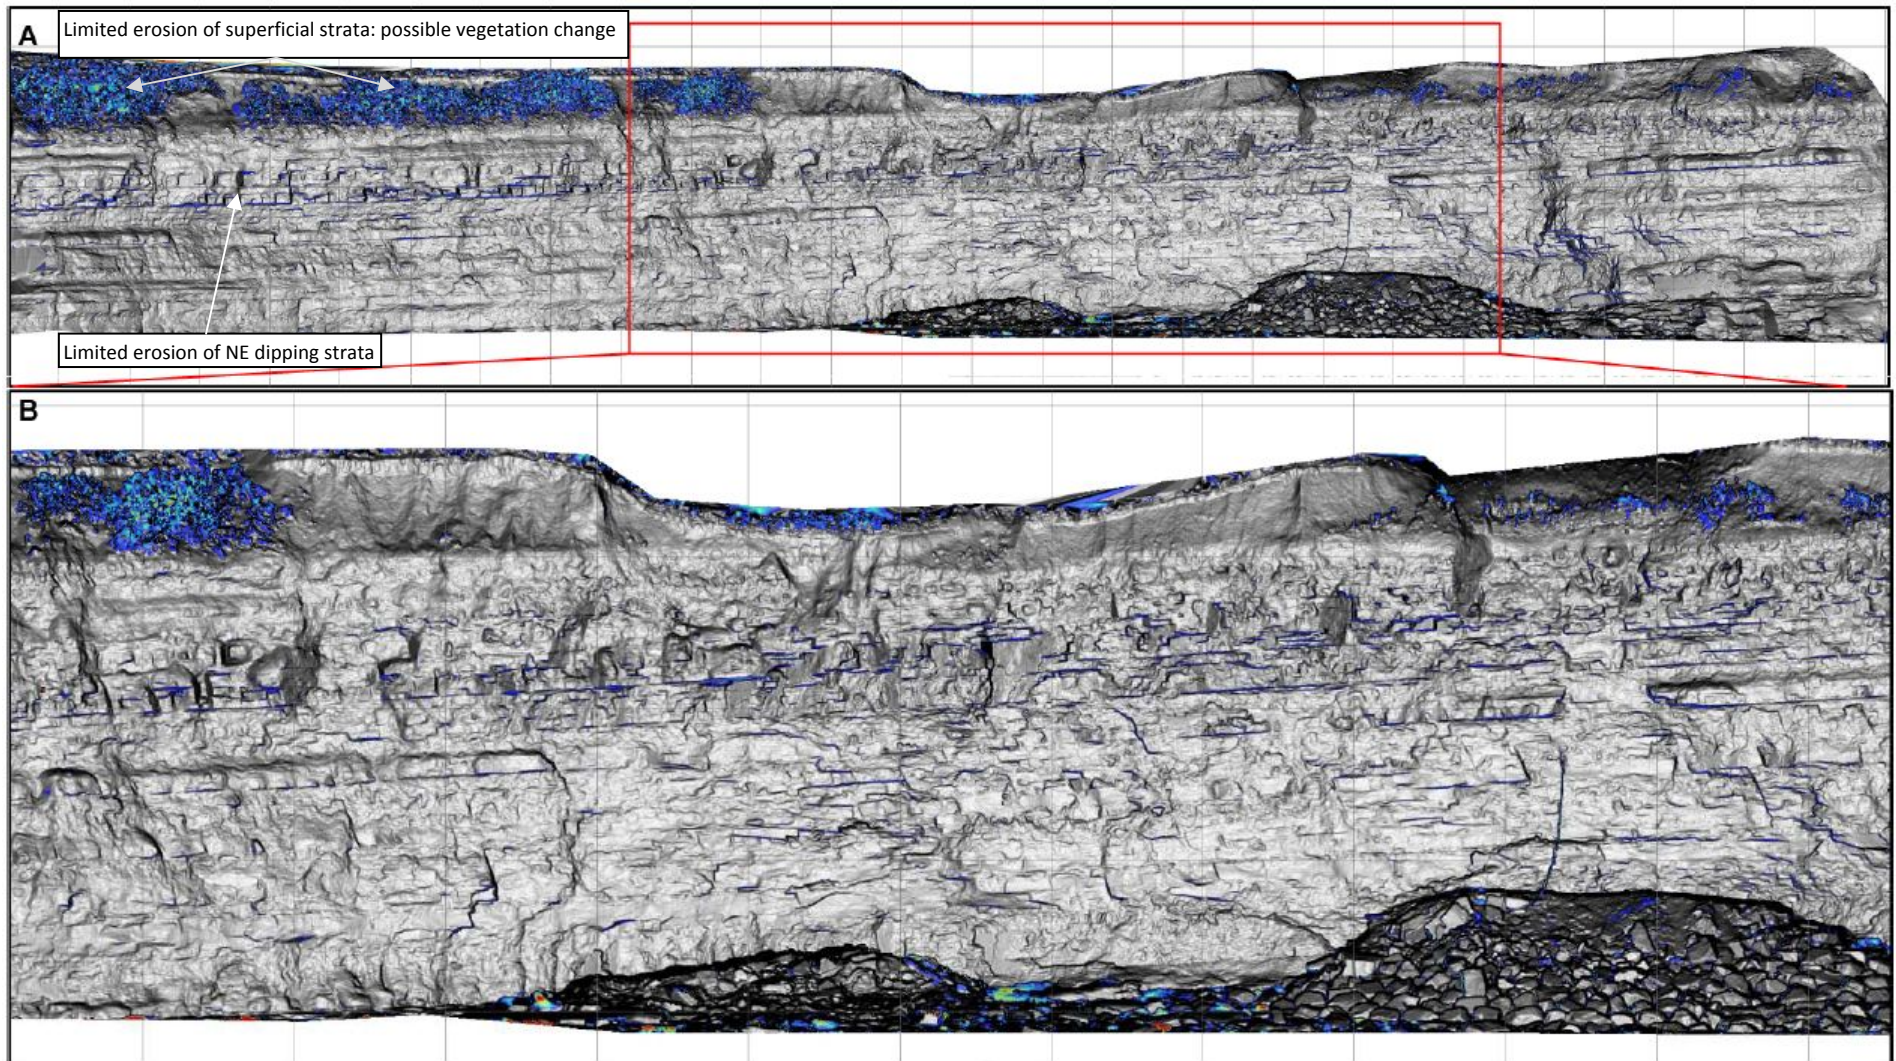
Figure D1: Cliff erosion 25 April 2013 to 23 May 2013. (A) Full cliff scan length section (B) close-up of area indicated by red box. Cold colours (blue) show erosion \Rightarrow 0.1m, and warm colours (red) show erosion up to 2.5m normal to the cliff face.

<p>April to June 2013</p>	<p>Durham University Laser Scanning:</p> <p>The Cowbar Nab cliff is subject to monthly high-resolution laser scanning surveys by Durham University that are used to precisely monitor the locations and rates of erosion. The baseline document was included in the previous full measures report. An update on erosion during April to June 2013 is provided here.</p> <p>Three surveys have been undertaken, allowing difference models to be calculated for two periods of Intervening time: 25 April 2013 to 23 May 2013, and 23 May 2013 to 13 June 2013. The results of the analysis are presented in Appendix D.</p>	<p>The data indicate limited erosion of the glacial sediments that cap the cliff and localised, small losses from a single bedrock layer of the cliff face. In all areas, total losses do not exceed c. 0.1m. Review of oblique photography from 2010 indicates the presence of vegetation on the glacial sediments where erosion is shown to have taken place and therefore the recoded change needs to be treated with caution.</p> <p>Two accumulations of material are visible at the toe of the cliff. The right feature is rock armour placed to protect the cliff from further erosion and the left feature is a deposit from a rockfall that predates the laser scanning monitoring. Limited erosion is indicated to be taking place on either of these cliff toe accumulations.</p> <p>Longer Term Trends Although the cliff has remained between April 2013 and May 2013 there is a chance that the cliff could collapse over the coming winter.</p>

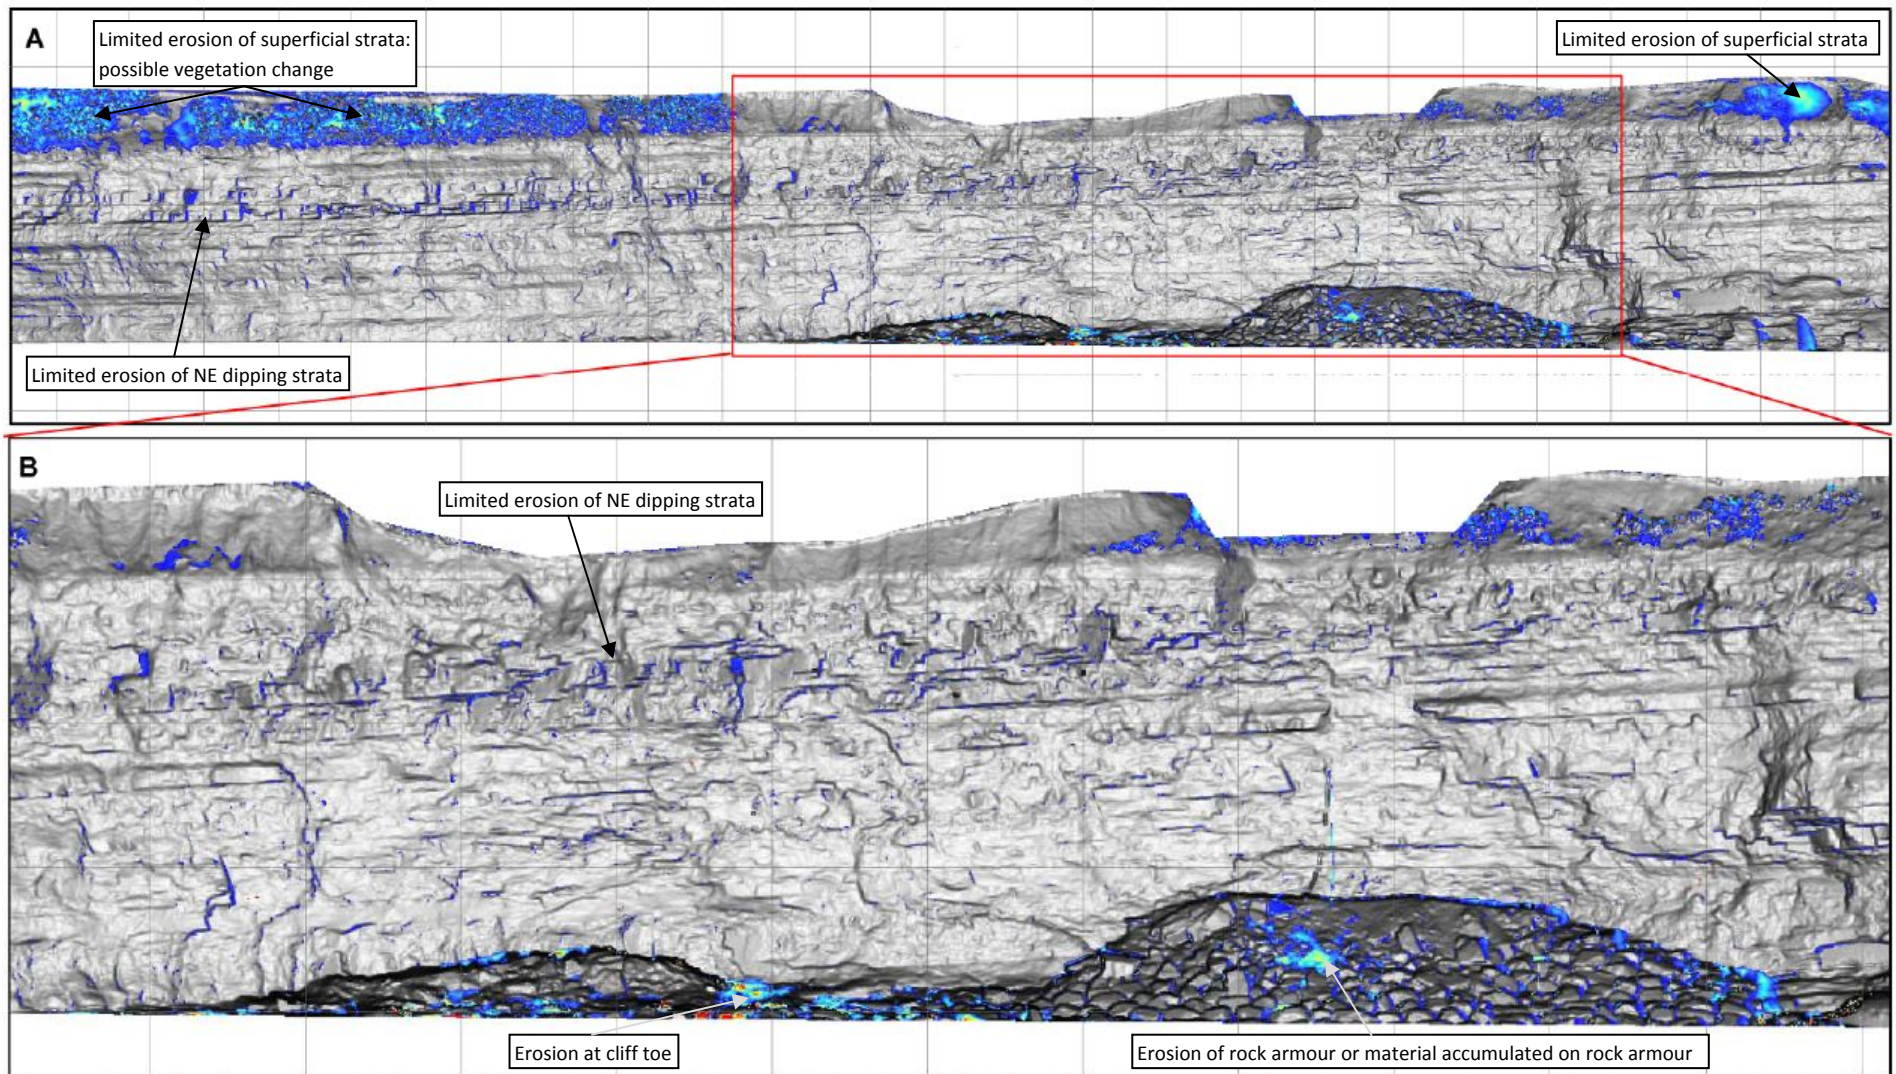
Figure D2: Cliff erosion 23 May 2013 to 13 June 2013. (A) Full cliff scan length section (B) close-up of area indicated by red box. Cold colours (blue) show erosion \Rightarrow 0.1m, and warm colours (red) show erosion up to 2.5m normal to the cliff face.
