**Cell 1 Regional Coastal Monitoring Programme
Update Report 10: 'Partial Measures' Survey 2018**

Redcar and Cleveland Council

June 2018

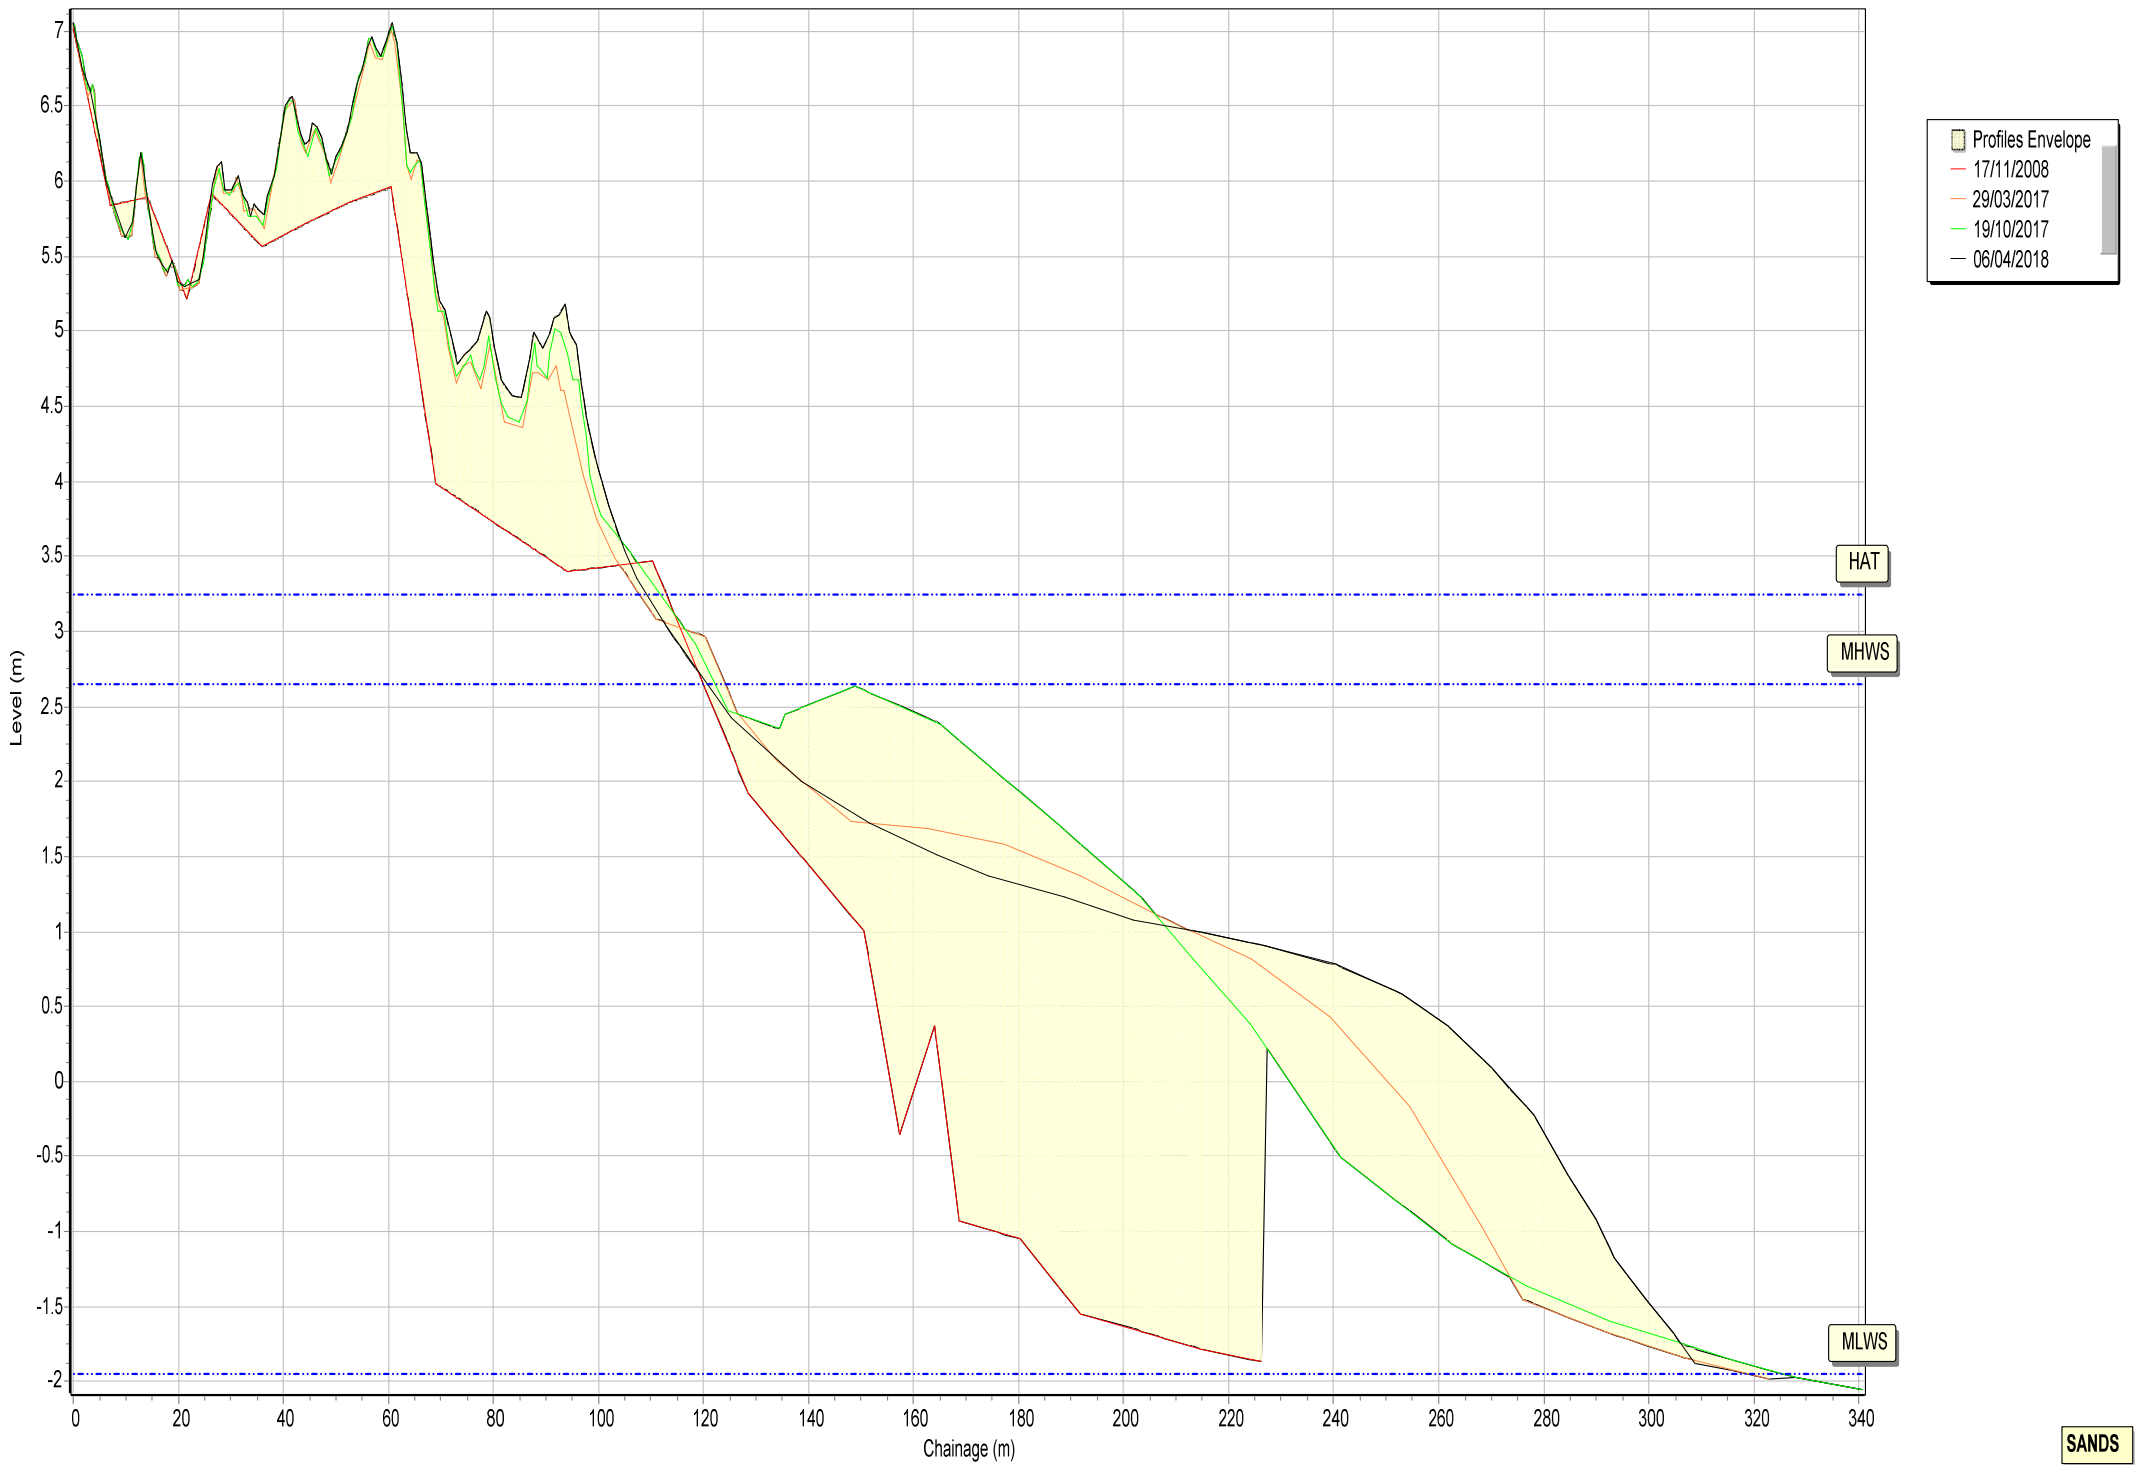
Beach Profiles: 1cRC1

Survey Date	Description of Changes Since Last Survey	Interpretation
6 th April 2018	<p>Beach Profiles:</p> <p>Coatham Sands is covered by four beach profiles during the Partial Measures survey (1cRC1 to 1cRC4; Appendix A) that were last surveyed in October 2017.</p> <p>Profile 1cRC1 is located 300m southeast of the South Gare Breakwater, in the lee of the German Charlies slag banks. The upper profile to 105m chainage is dominated by dunes that have remained stable since 2009. The highest dune (chainage 60m), closest to the beach, is unchanged since October 2013. The foredune between 70m and 105m chainage has increased in height by up to 0.3m, and is at its highest recorded level. Between 105m and 210m chainage the upper beach has eroded by up to 0.8m since October 2017, removing the berm previously surveyed. From 210m to the end of the profile at 310m chainage the lower beach level is at its highest recorded level, having accreted by up to 1.4m, steepening the lower beach and forming a more convex shape to the profile.</p> <p>At profile 1cRC2 the dunes have remained largely stable with accretion of up to 0.6m on the foredunes between chainage 30m and 100m since the previous survey. The beach profile is dominated by erosion of up to 0.8m, creating a smoother profile. Overall the beach is at a medium-low level compared to the range recorded from previous surveys, however the dunes are at their highest recorded levels.</p> <p>Profile 1cRC3 showed the main dune has remained stable since April 2014, with the foredune between chainage 16m and 51m showing accretion of up to 0.6m since the previous survey. The beach between 51m and 288m has dropped since October 2017 by up to 0.8m, with the toe of the beach seawards of chainage 288m showing very little change. A lower beach berm has formed between chainage 240m and the end of survey at chainage 330m. The dunes are at a high level compared to the range recorded from previous surveys, however the upper beach is at its lowest recorded level, and the lower beach at a more medium level.</p>	<p>Overall the beaches are healthy. The dune areas all show accretion on the foredunes over the winter of 2017/18, which conforms to a wider trend towards stability. The dunes are at their highest recorded levels for all profiles.</p> <p>All of the profiles show erosion as the dominant process on the beach since the previous survey. Profiles RC1 and RC4, however, do show accretion at the toe of the beach. The beach levels of the western profiles, RC1 and RC2, are within their previously recorded range, however the eastern profiles, RC3 and RC4, show their lowest recorded levels in the upper-mid beach.</p> <p>Longer term trends:</p> <p>All of the Redcar profiles show the dunes are stable or accreting on their seaward extent. The beaches to the west show a typical longer term trend of progressive accretion. The beaches in the centre and to the east have a more fluctuating long-term pattern.</p> <p>The erosion in the east of the bay with low beach levels is not consistent with previous observations of an eastwards net transfer of material at Coatham sands.</p>

- All of the beaches have been dominated by erosion over the winter of 2017/18 and it is likely that much of that can be attributed to the March 2018 severe storms. Anecdotal evidence suggests that beach levels in the Redcar area were particularly badly hit by the March 2018 storms, with the remains of a petrified forest which once stretched to Hartlepool being exposed, as reported in the local and national news.

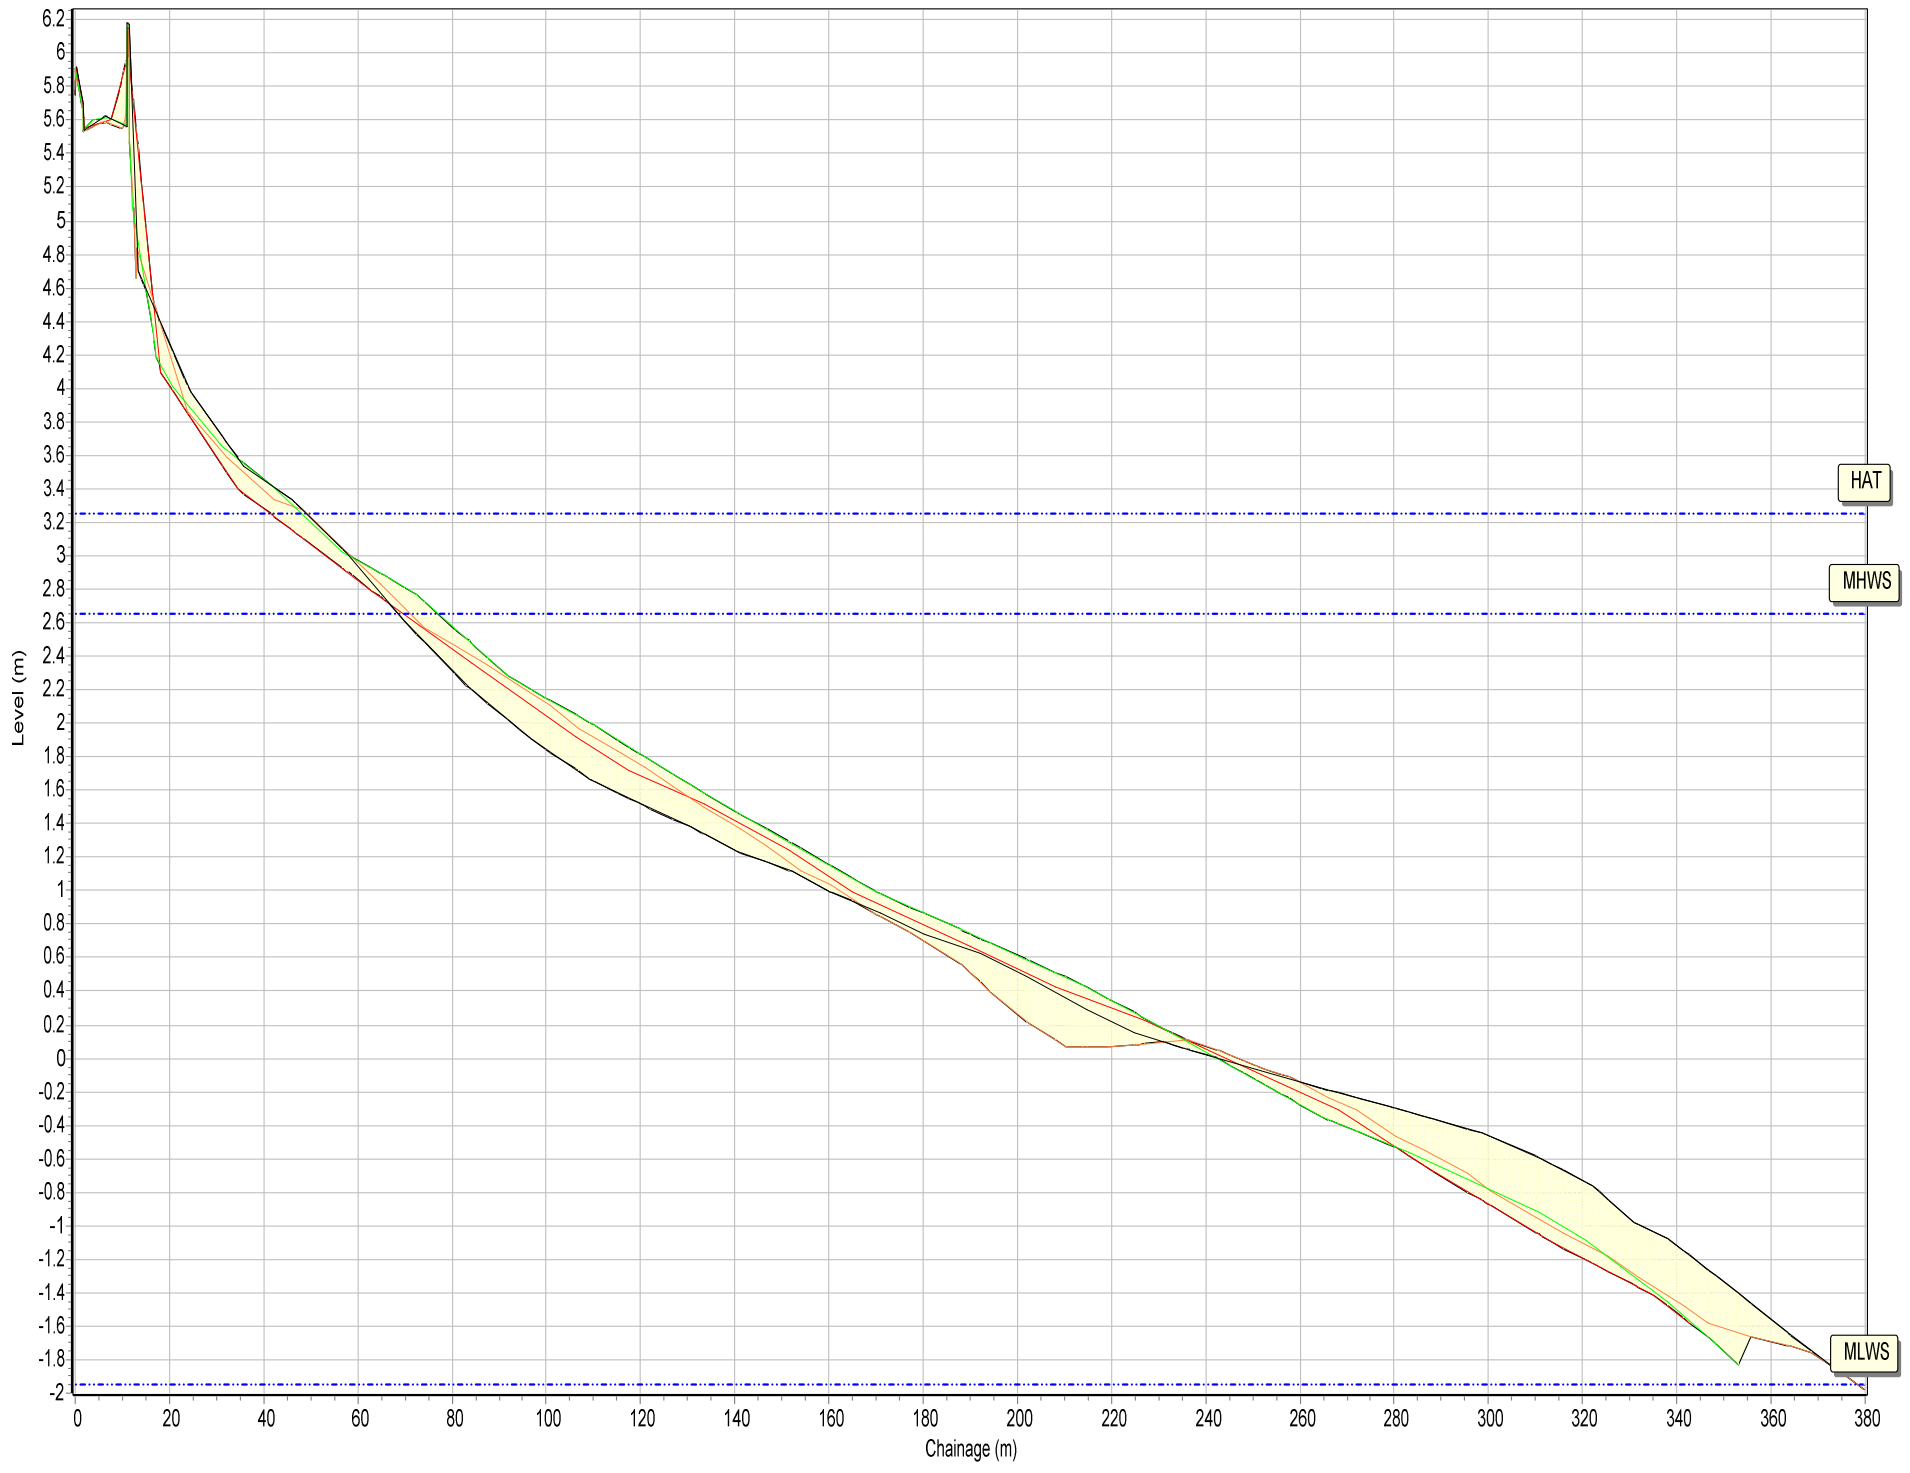
Beach Profiles: 1cRC4

Survey Date	Description of Changes Since Last Survey	Interpretation
	<p>Profile 1cRC4 is located at the beginning of the defended section at Coatham and Redcar. No change has occurred landward of the base of the seawall. The beach levels at the toe of the seawall have increased slightly by up to 0.2m. Between chainage 60m and 240m there has been erosion of up to 0.3m. Seawards of chainage 240m there has been accretion of up to 0.4m. Overall the profile is at a medium-low level compared to the range recorded from previous surveys, with the middle section at its lowest recorded levels (chainage 70m to 160m). However, the toe of the beach from chainage 290m is at its highest recorded level.</p>

- At Redcar all the profiles show erosion as the dominant process on the beach since the previous survey. However there has been some accretion at the toe of the beach at both ends of the bay. The dunes are stable or accreting on their seaward extent.

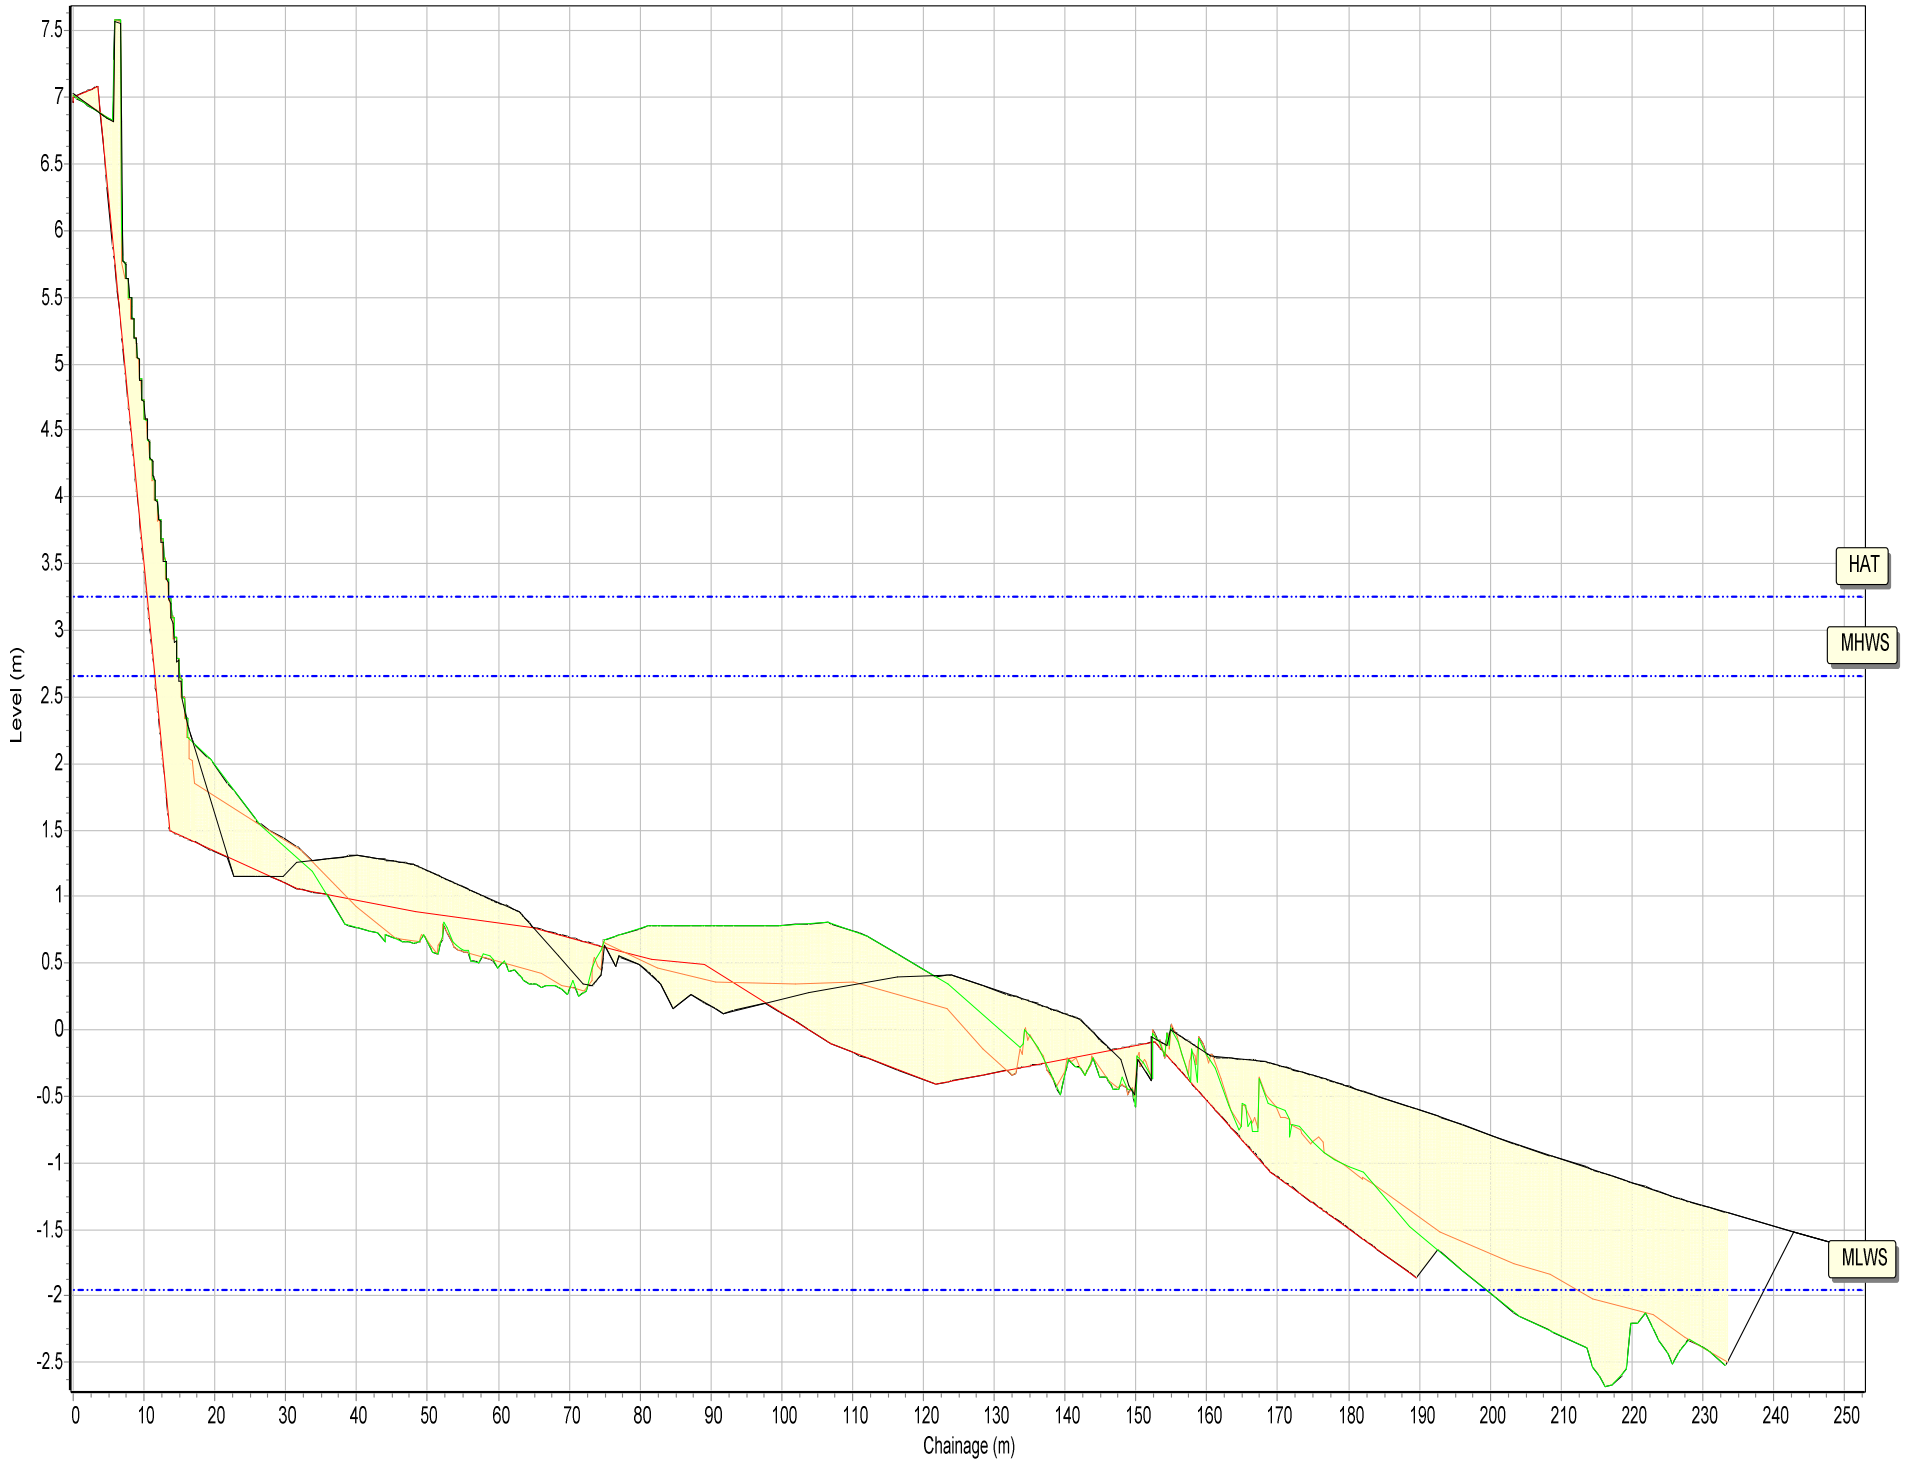
Beach Profiles: 1cRC5

Survey Date	Description of Changes Since Last Survey	Interpretation
6 th April 2018	<p>Beach Profiles:</p> <p>Redcar Sands is covered by three beach profiles (RC5 to RC7; Appendix A), with RC7 being approximately on the boundary with the Marske Sands area. They were last surveyed in October 2017.</p> <p>At profile 1cRC5 the sea defences constructed in 2012 remain unchanged as far as 20m chainage. There has been erosion at the toe of the sea defence of 0.6m. The upper beach berm previously recorded at chainage 90m has moved by around 50m up the beach, covering up previously exposed rock outcrops. A secondary berm has formed at chainage 120m. Seawards of the rock exposure at chainage 155m there has been significant accretion of up to 1.6m. Overall the upper beach is at a relatively medium level compared to the range recorded from previous surveys, with the lower beach seawards of the rock exposure at chainage 155m having its highest recorded levels.</p> <p>The profile at 1cRC6 has not changed landward of 55m chainage since the last survey due to the presence of the sea defence. There has been accretion at the toe of the sea defence of up to 0.6m. The rest of the beach profile from chainage 75m is dominated by erosion, with beach levels dropping by up to 0.8m. The profile has been smoothed out. The upper beach is at a high level compared to the range recorded from previous surveys, the mid beach between chainage 80m and 150m is at its lowest recorded level, and the lower beach is at a relatively medium level.</p> <p>Profile 1cRC7 is undefended. The dune face at 60m chainage remained stable since October 2014. Between chainage 70m and 90m there has been up to 0.4m of accretion. The rest of the profile shows erosion of up to 1.2m, removing the berms present on the previous survey at chainage 100m and 170m, and moving the toe of the beach landwards by around 80m. Overall the beach profile is at a relatively low-medium level compared to the range recorded from previous surveys.</p>	<p>All of the profiles, except RC5, show erosion but remain largely within the bounds of the previous profiles. Profile RC5 shows the movement of berms and accretion on the lower beach.</p> <p>Longer term trends:</p> <p>Profiles RC5 and RC7 show movement of beach berms, across the profile with some evidence for gradual accretion.</p>

- At Redcar Sands, all of the profiles, except RC5, show erosion but remain largely within the bounds of the previous profiles. Profile RC5 shows the movement of berms and accretion on the lower beach. The topographic change plots show that erosion has dominated since the previous survey, which supports the pattern seen in the beach profiles.

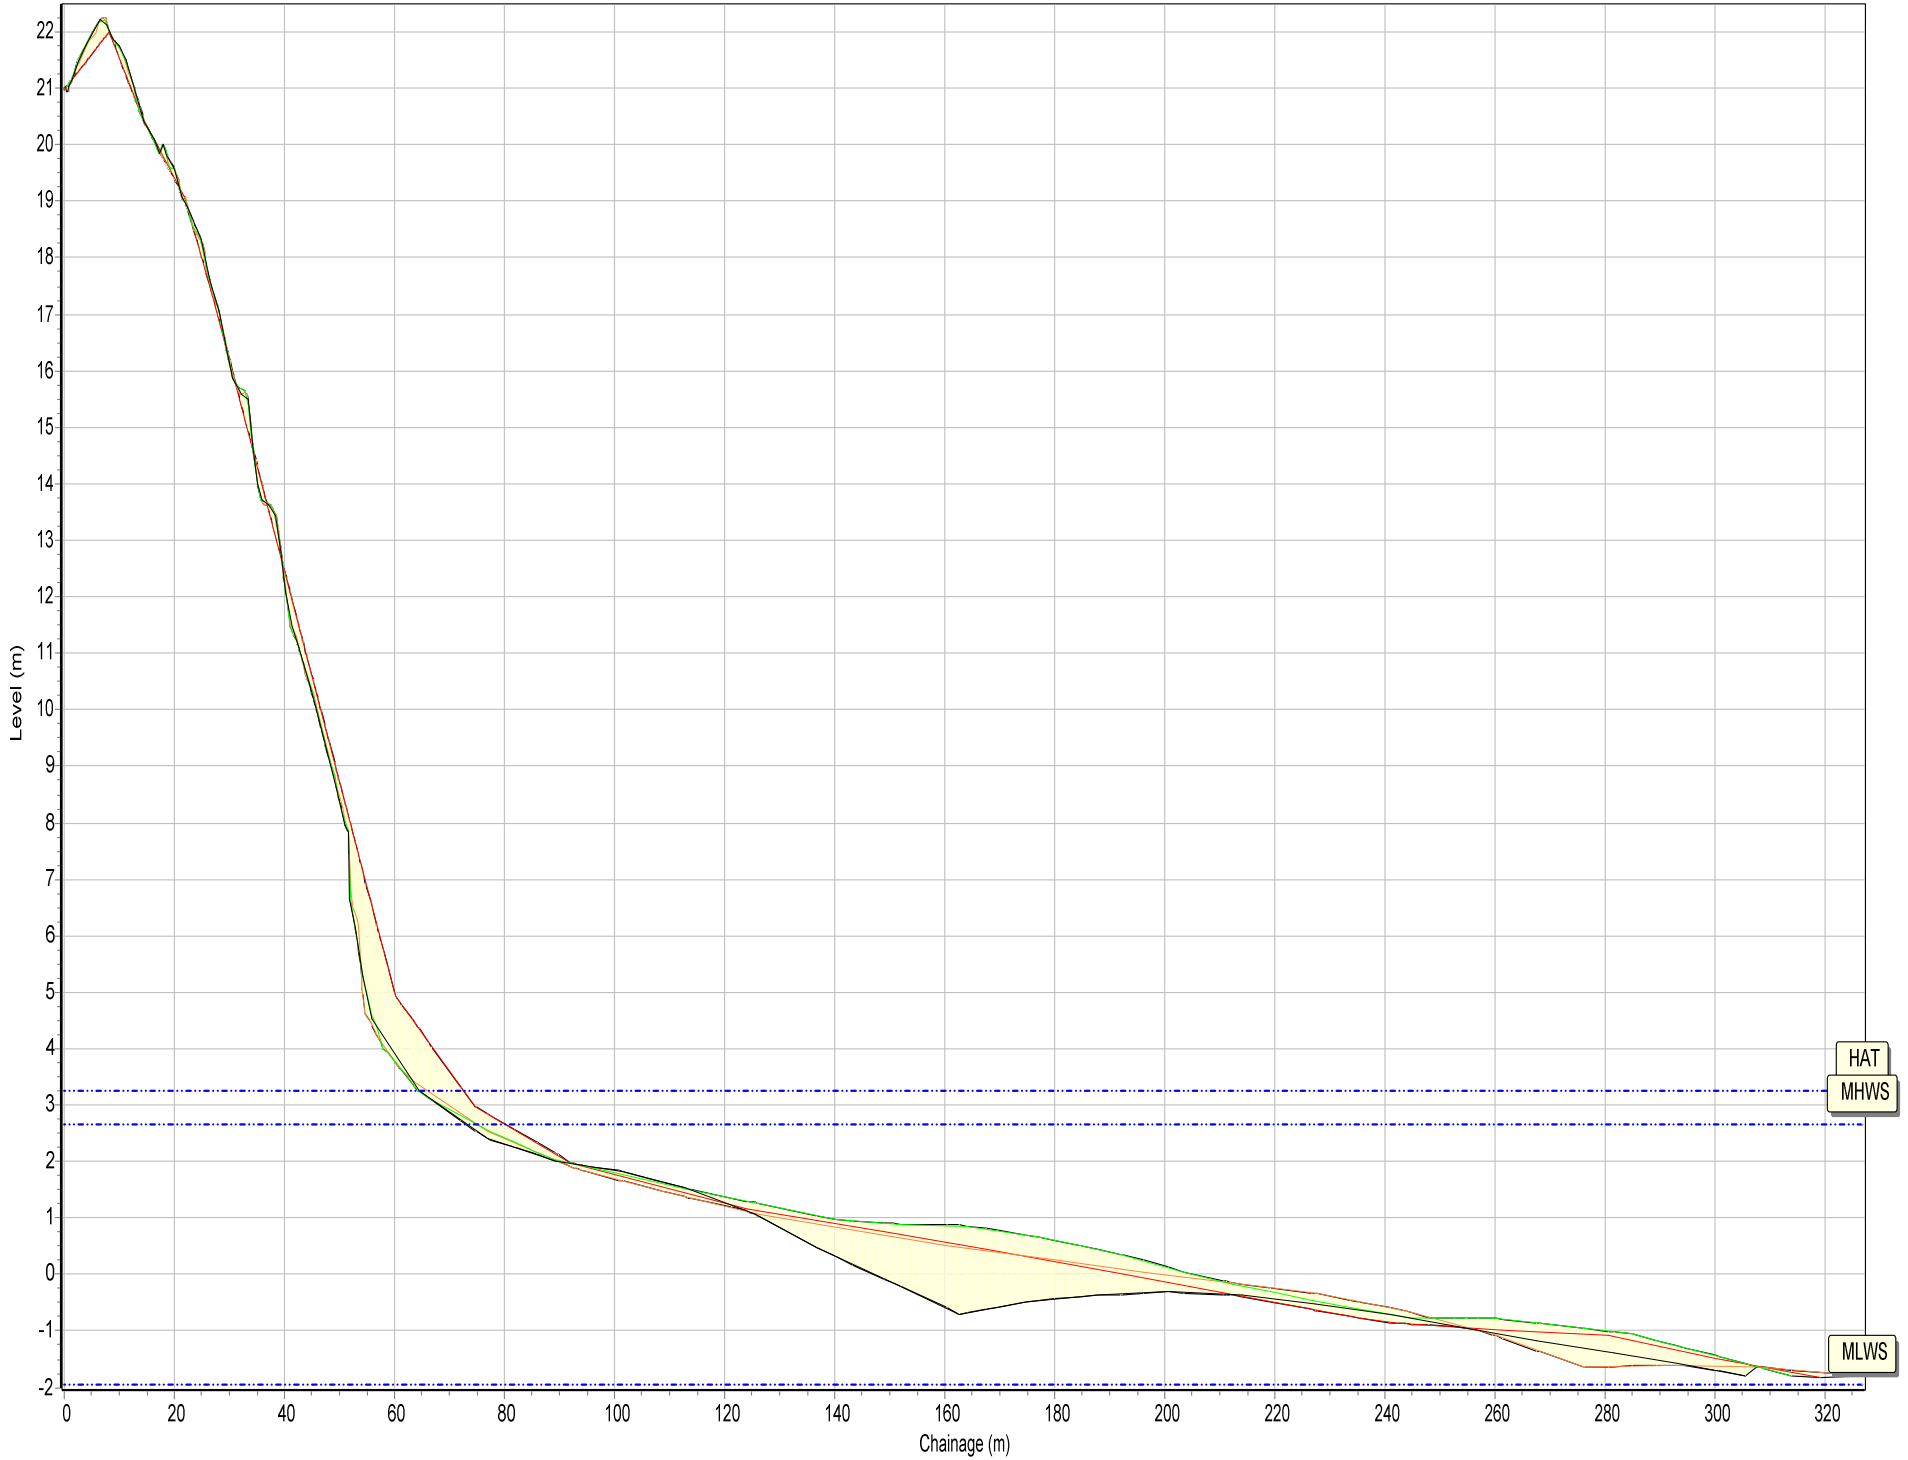
Beach Profiles: 1cRC8

Survey Date	Description of Changes Since Last Survey	Interpretation
6 th April 2018	<p>Beach Profiles:</p> <p>Marske Sands is covered by two beach profiles during the Partial Measures survey (RC7 to RC8; Appendix A). RC7 is on the boundary with the Redcar Sands area.</p> <p>Profile 1cRC7 is located along The Stray and has been discussed in Section 2.2.</p> <p>Profile 1cRC8 is largely unchanged as far as 110m chainage. Seawards of chainage 110m there has been erosion across the rest of the profile, of up to 1.5m, forming a depression at chainage 160m. Since April 2014 the dune face (chainage 55m) has remained stable, which contrasts with the winter of 2013/14 when 10m of recession was recorded. The profile is relatively low in the upper beach compared to the range recorded from previous surveys (chainage 55m to 180m), with the depression between chainage 135m and 185m showing the lowest recorded levels., the profile is at a more medium-high level on the lower beach.</p>	<p>The cliffed face of the dune remained stable at both RC7 and RC8 following the recession over the winter of 2013/14.</p> <p>RC8 shows erosion, with a depression forming in the mid beach.</p> <p>Longer term trends:</p> <p>The April 2014 profiles were amongst the lowest seen at 1cRC8, due to the December 2013 storm surge. The beach had recovered but the March 2018 storms have resulted in comparatively low levels again.</p>

- At Marske Sands, the cliffed face of the dune remained stable at both RC7 and 8 following the recession caused by the winter storms of 2013/14. RC8 shows erosion with a depression forming in the mid beach.

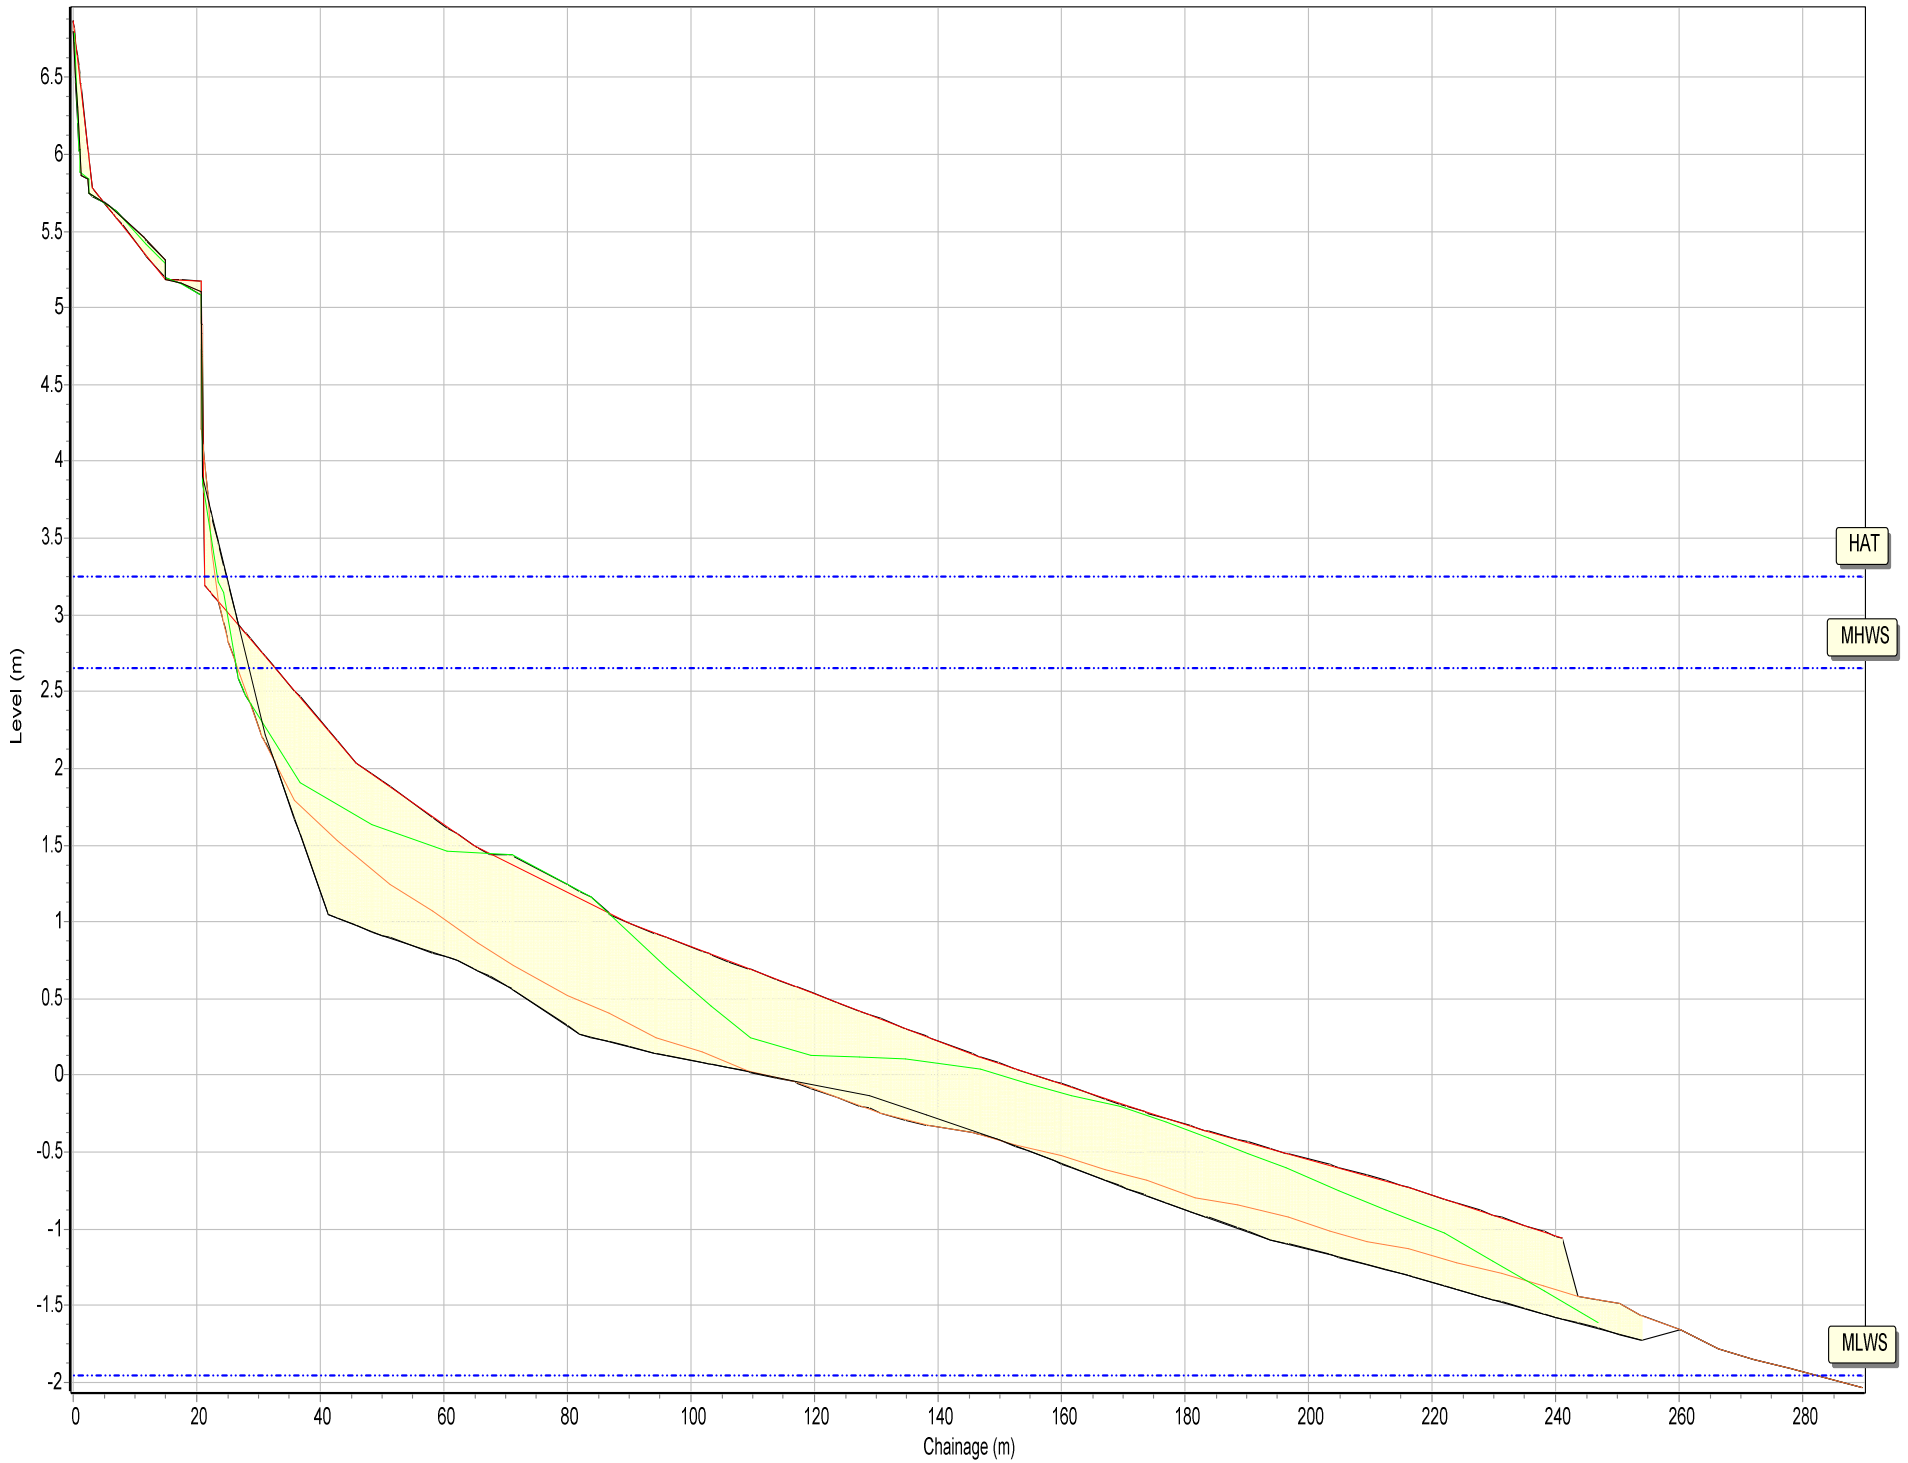
Beach Profiles: 1cRC9

Survey Date	Description of Changes Since Last Survey	Interpretation
6 th April 2018	<p>Beach Profiles:</p> <p>Saltburn Sands is covered by one beach profile (RC9; Appendix A).</p> <p>Overall Profile 1cRC 9 has experienced no change over the section covered by the sea defence as far as 20m chainage. There has been slight accretion at the toe of the seawall. Seawards of chainage 30m there has been erosion of up to 0.9m across the rest of the profile. The section of beach between chainage 35m and 180m is the lowest recorded compared to the previous surveys, the rest of the profile is at a relatively low level.</p>	<p>The drop in beach level at RC9 over the winter of 2017/18 was relatively high, which could potentially be due to the March 2018 storms. Overall, the beach level is low and has been eroding at a low rate since 2008.</p> <p>Longer term trends: The profile plots show net erosion, although there are periods of recovery. The profile for April 2018 is the lowest recorded in the upper and mid beach.</p>

- At Saltburn Sands, the profile plots show erosion has dominated. The profile for March 2018 is one of the lowest recorded.
- At Cattersty Sands, the plot for the bay shows erosion has dominated across the beach. The distribution of change is likely to be linked to the movement of material seaward during the winter.
