Cell 1 Regional Coastal Monitoring Programme Update Report 15: 'Partial Measures' Survey 2023

Redcar and Cleveland Council

June 2023

(*) The present report is Update Report 15 and provides an analysis of the 2023 Partial Measures survey for Redcar and Cleveland Council's frontage.

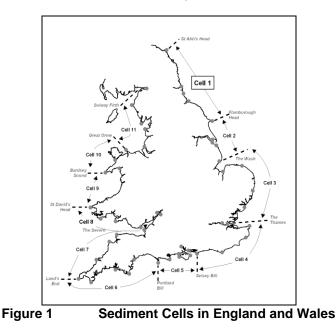
The Cell 1 Regional Coastal Monitoring Programme covers approximately 300km of the north east coastline, from the Scottish Border (just south of St. Abb's Head) to Flamborough Head in East Yorkshire. This coastline is often referred to as 'Coastal Sediment Cell 1' in England and Wales (Figure 1). Within this frontage the coastal landforms vary considerably, comprising low-lying tidal flats with fringing salt marshes, hard rock cliffs that are mantled with glacial sediment to varying thicknesses, softer rock cliffs and extensive landslide complexes.

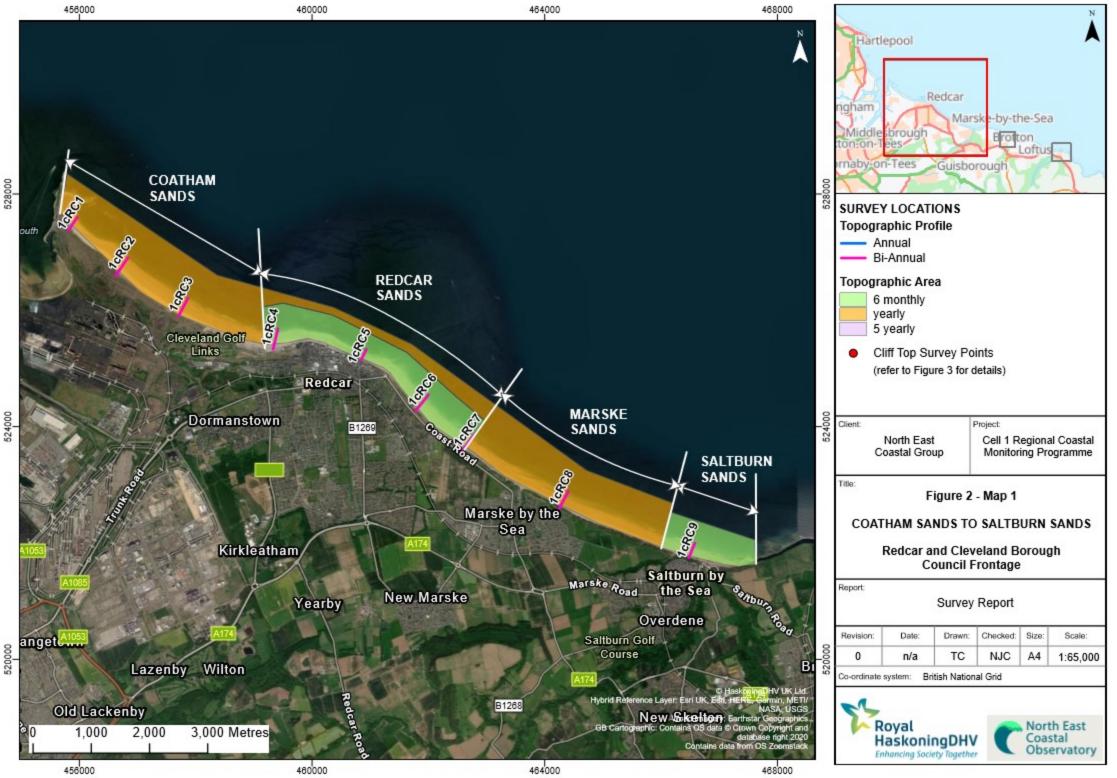
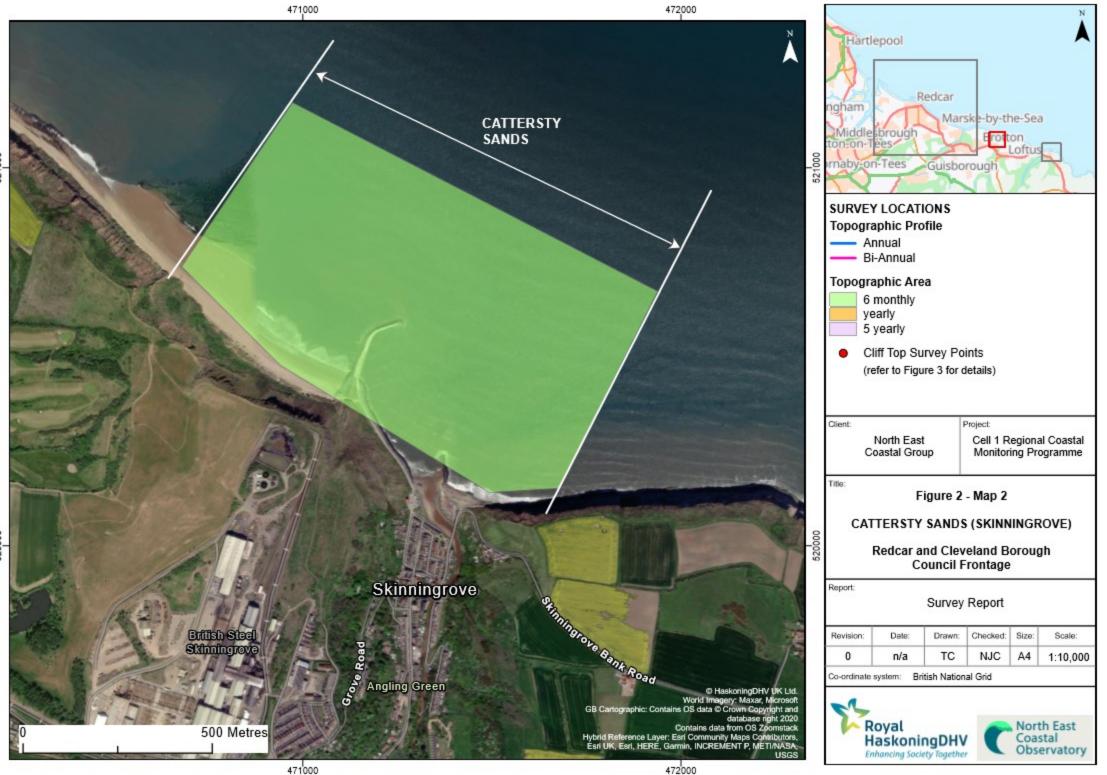
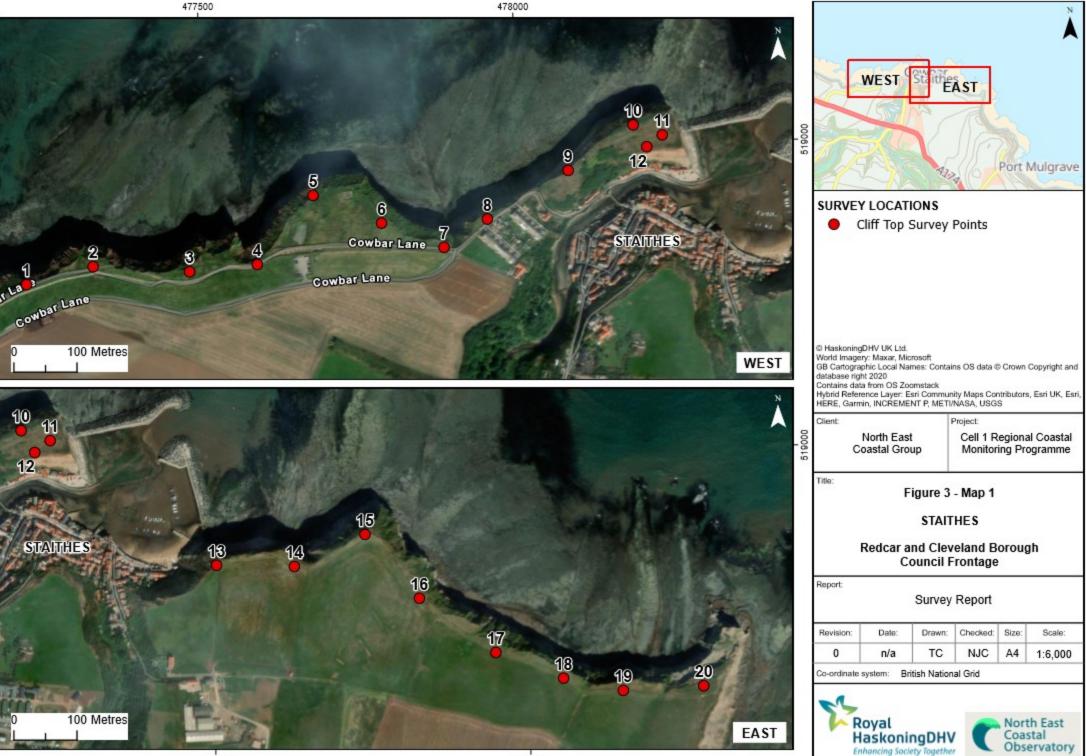
The location of these surveys is shown in Figure 2 and 3. The Partial Measures survey was undertaken along this frontage between 19th and 21st April at Redcar (Coatham Sands, Redcar Sands, Marske Sands and Saltburn Sands), 18th March at Skinningrove and 17th March at Staithes. During the surveys the weather was varied with varying sea states. Specific weather conditions are detailed in the survey reports.

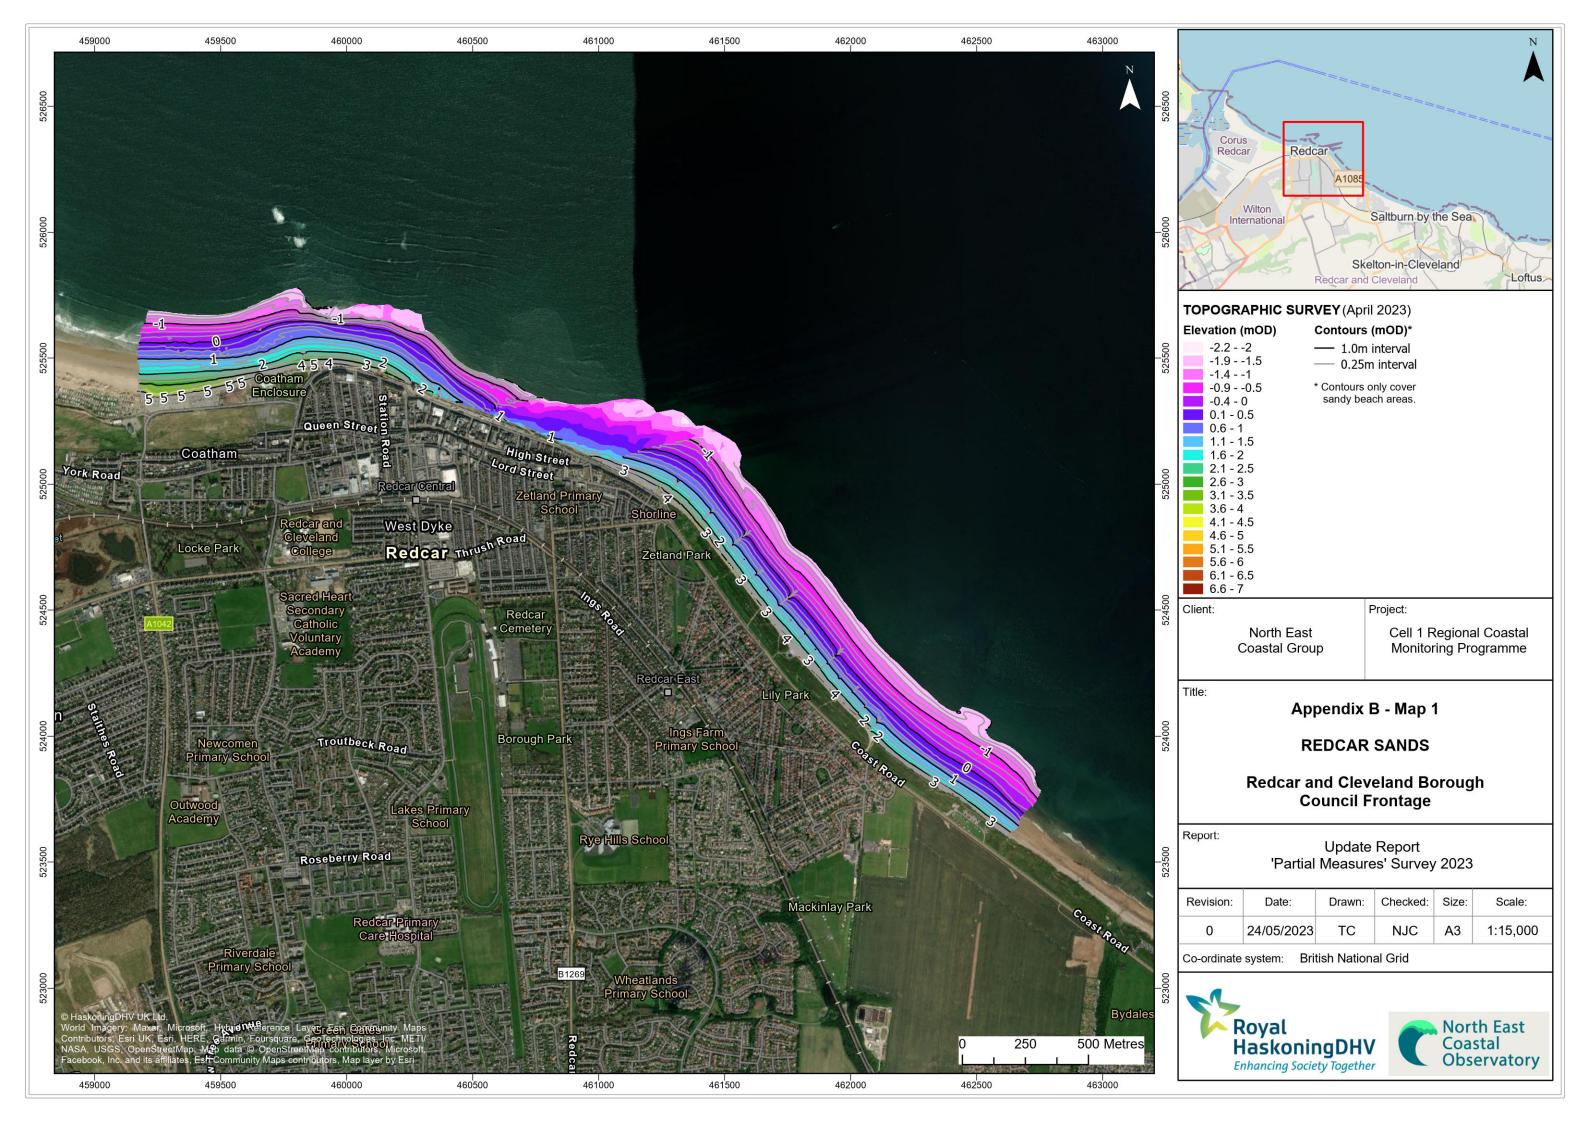
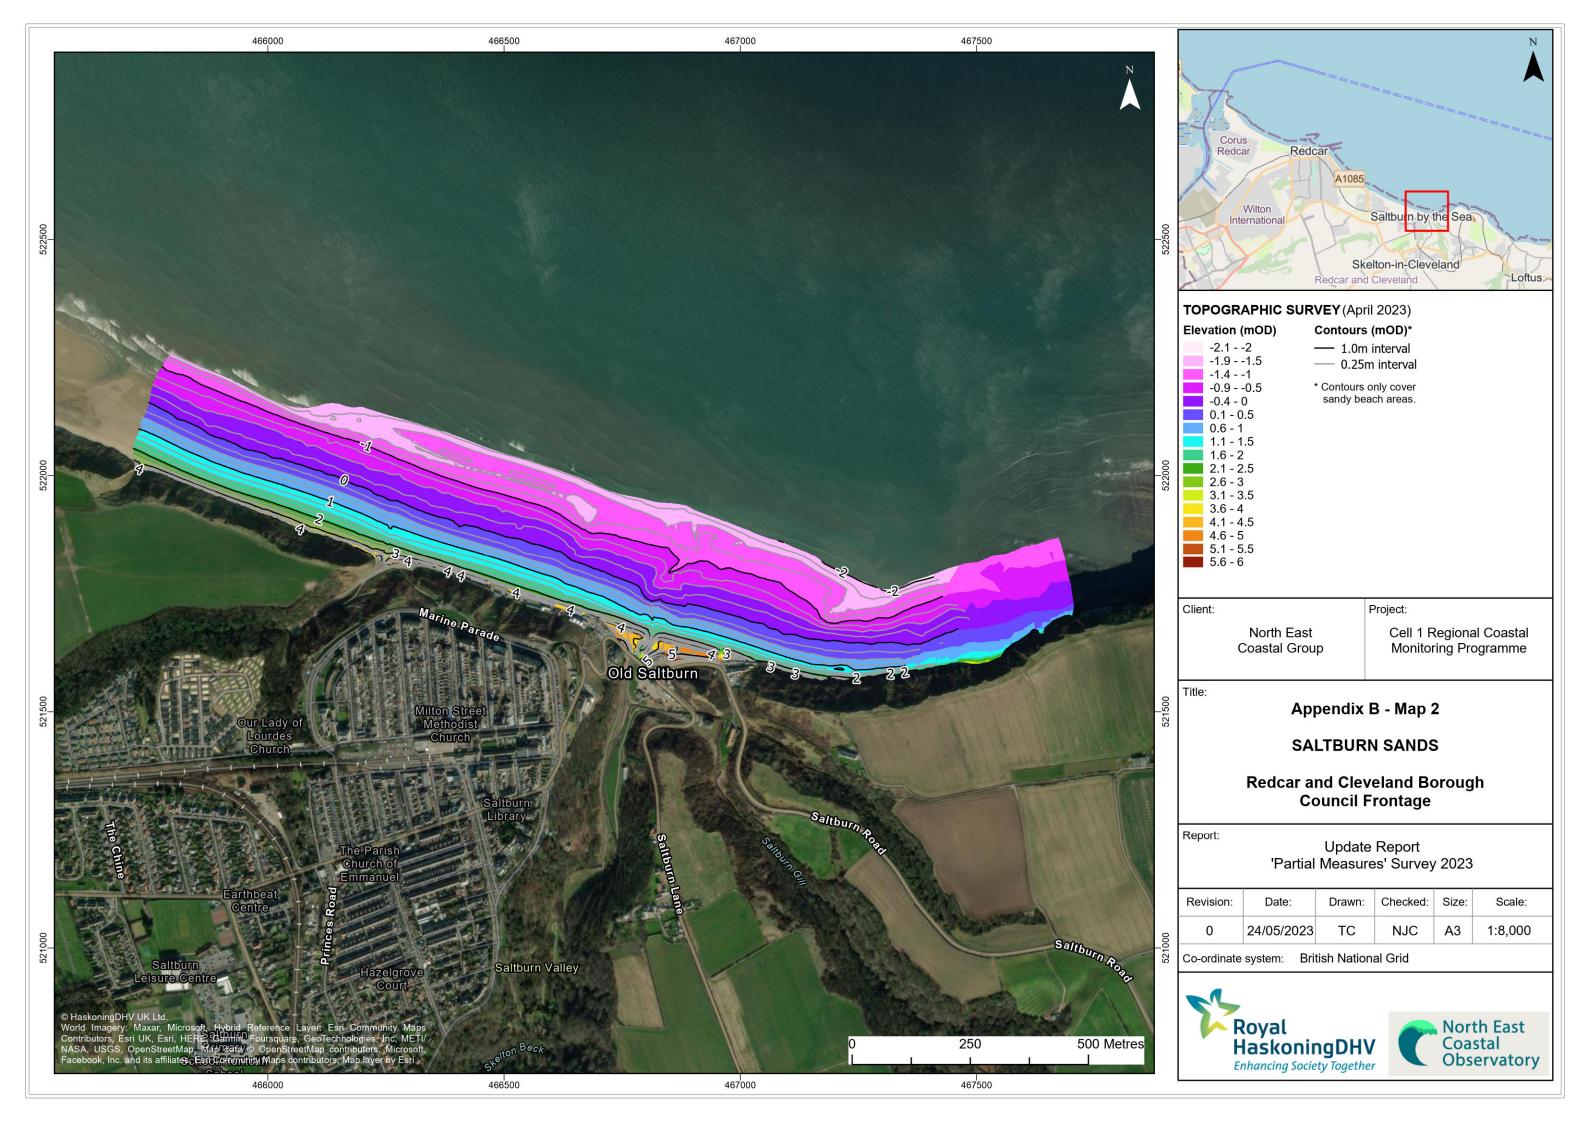
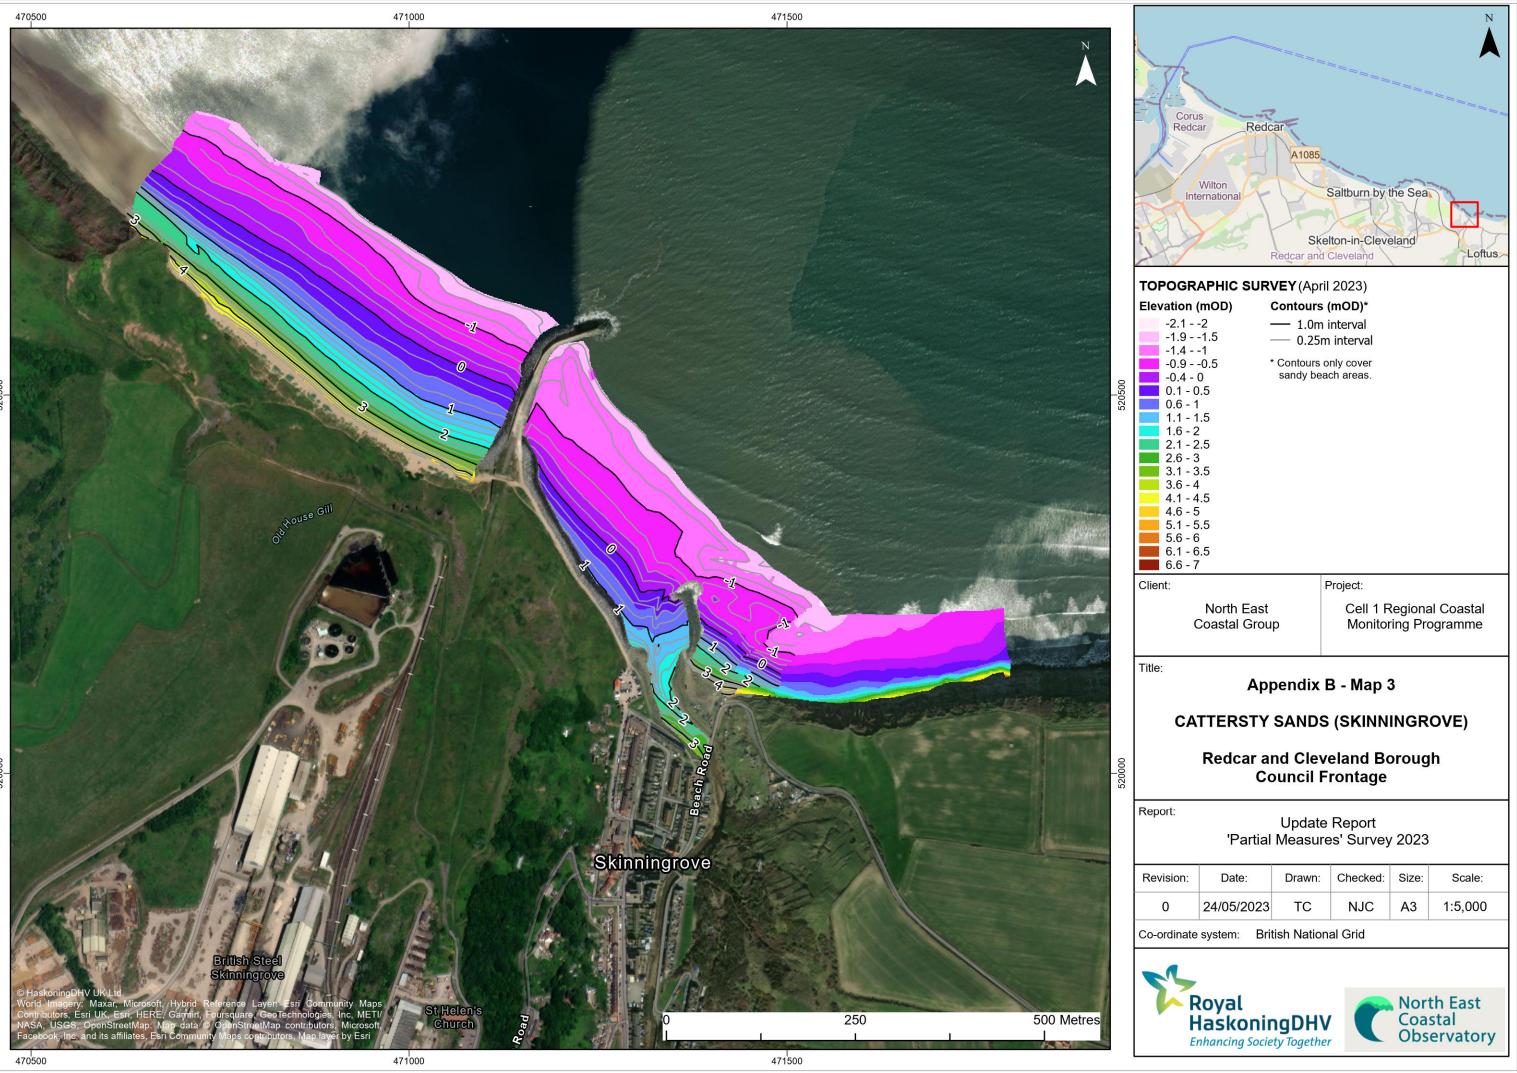
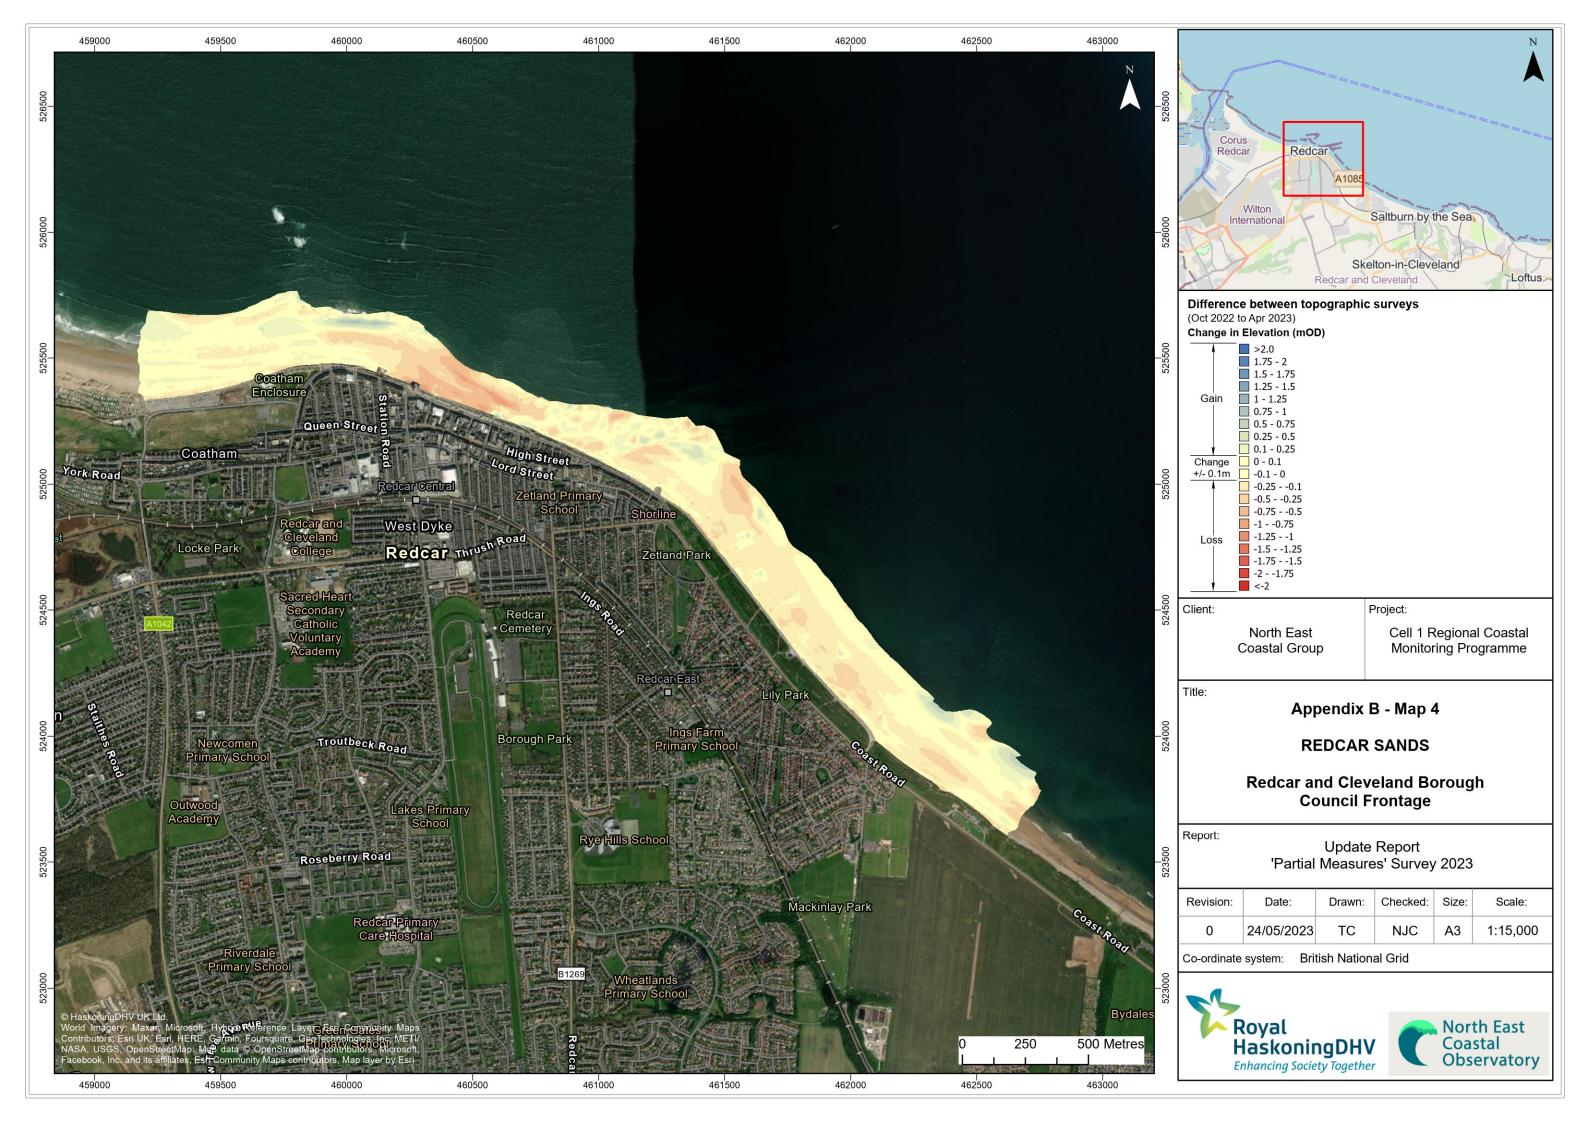
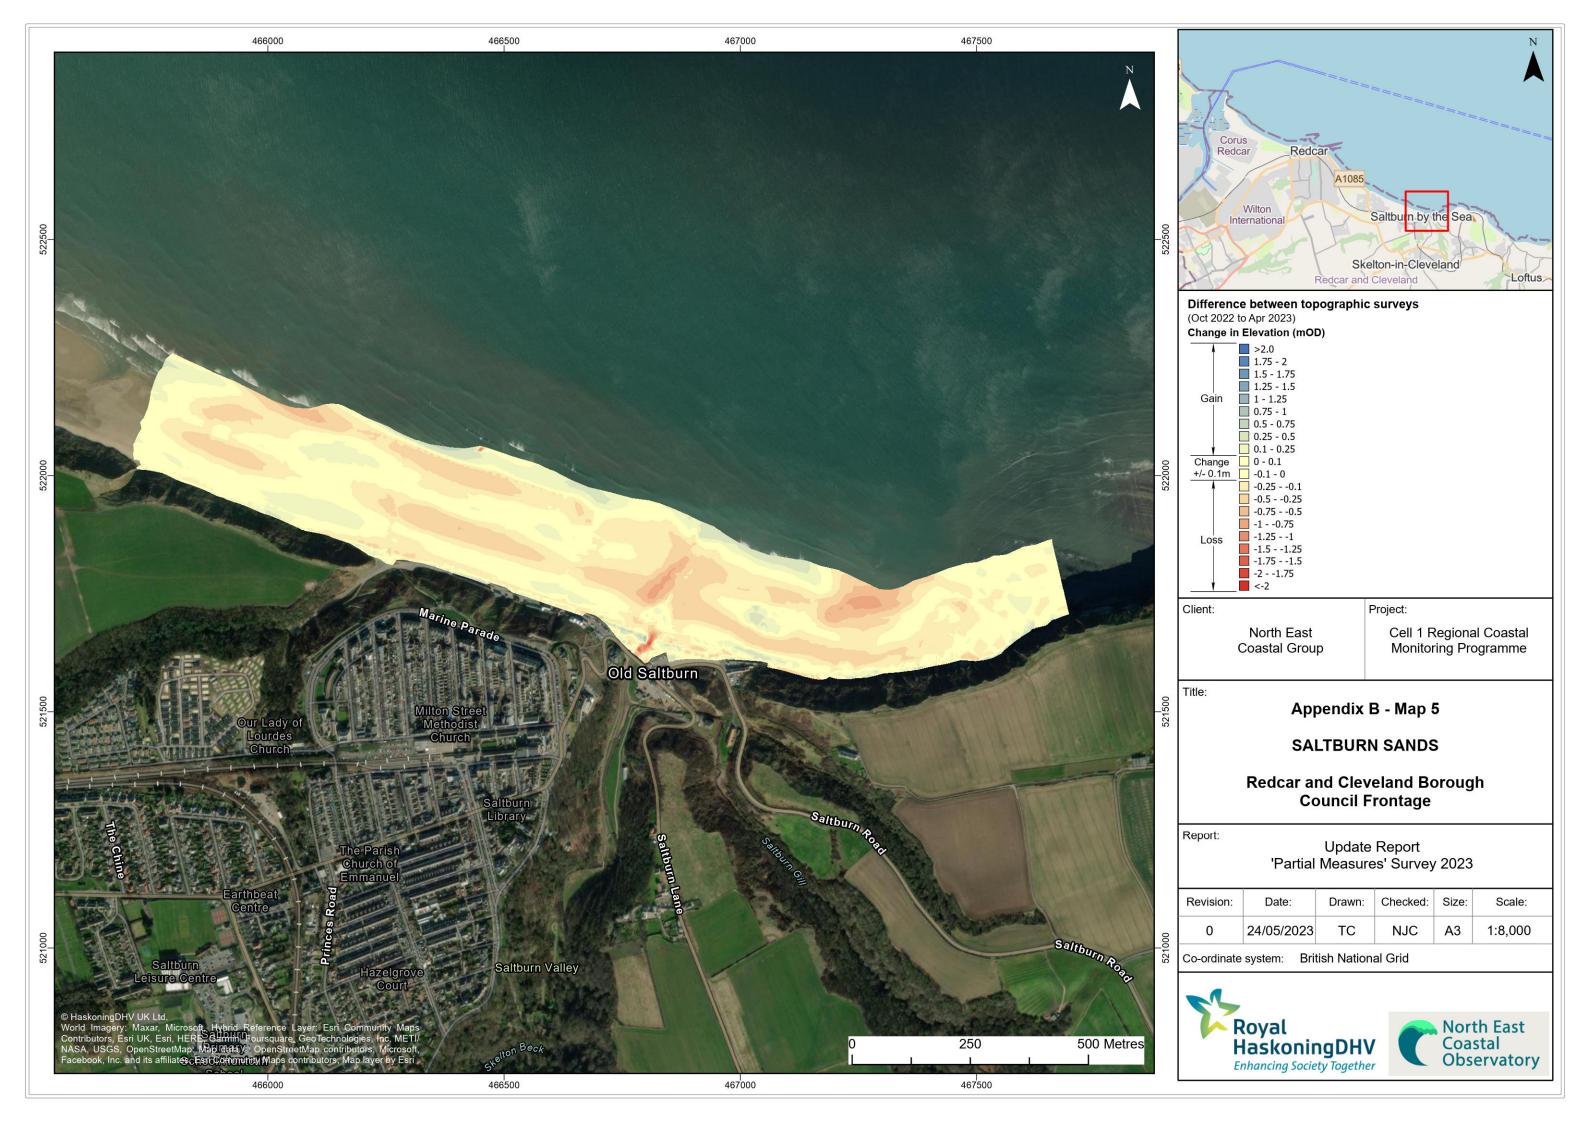
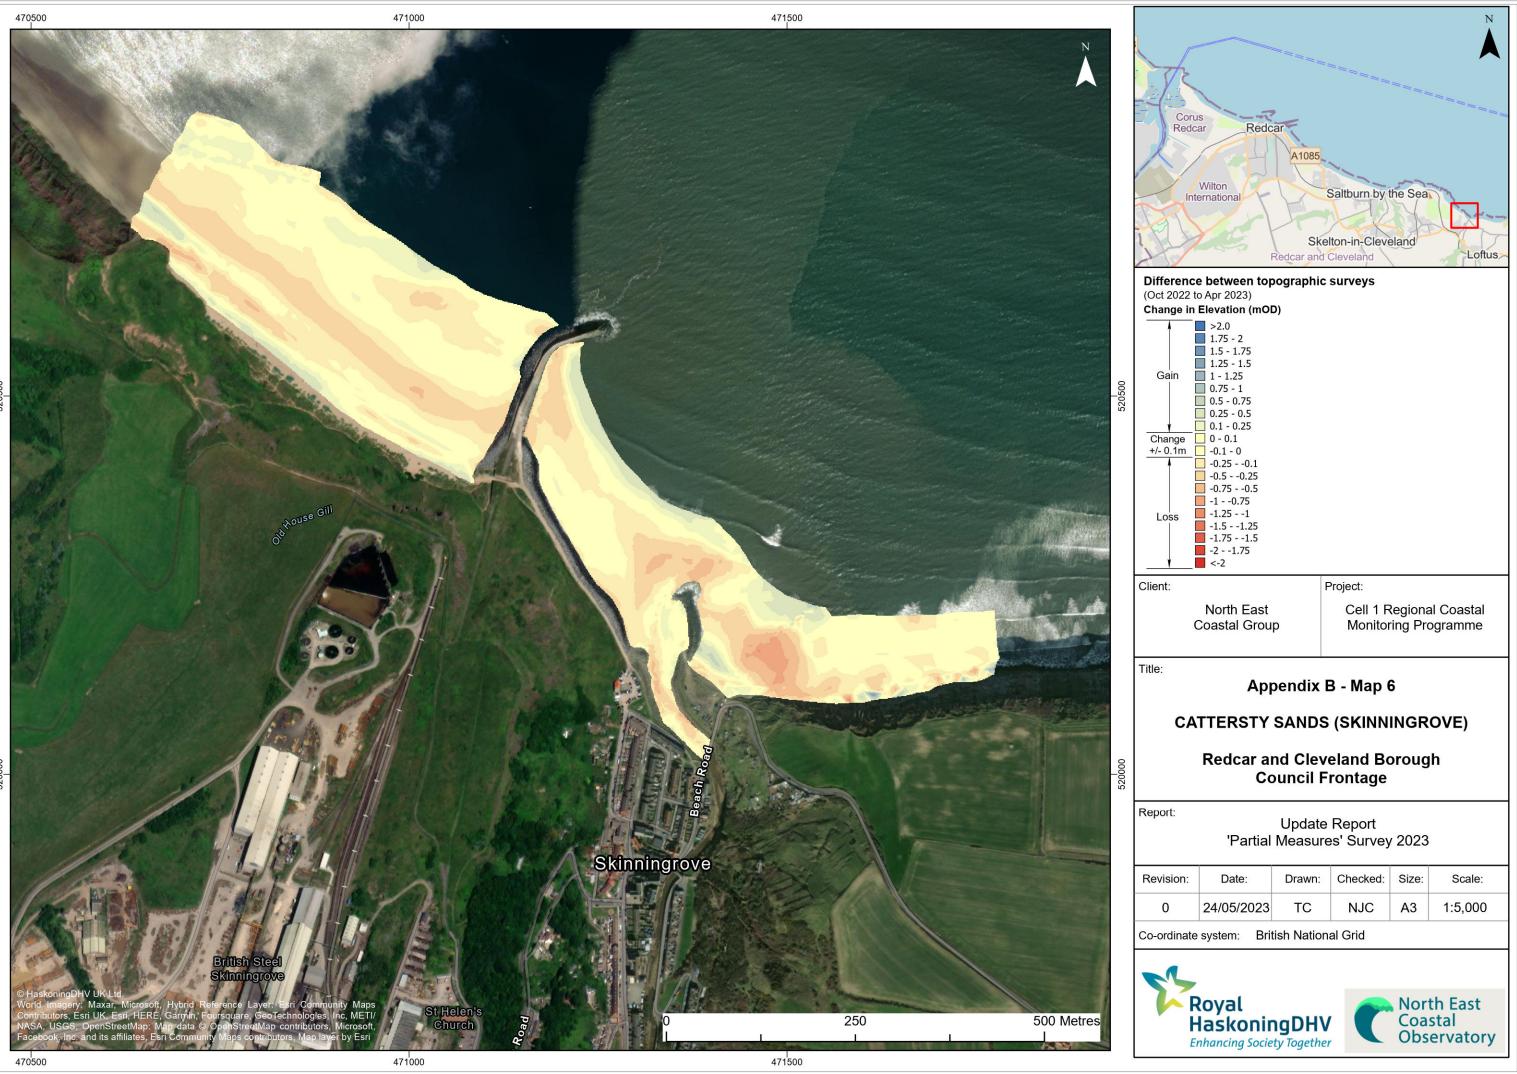
Topographic Survey

Topographic Survey: Redcar Sands is covered by a 6-monthly topographic survey. Data have been used to create a DGM (Appendix B – Map 1) using a GIS. The DGM shows that the beach topography is broadly parallel to the shore, although there is a slight embayment with a slightly steeper beach between the two headlands at Coatham Rocks and Redcar Rocks. The contours around Redcar Rocks are distorted due to the exposed rocky foreshore.	The topographic difference plots show low level erosion has been dominant across Redcar Sands over Winter 22/23. The most significant change has occurred to the beach fronting Coatham Rocks.

Survey Date	Description of Changes Since Last Survey	Interpretation
	The GIS has also been used to calculate the differences between the current topographic survey (April 2023) and the previous topographic survey (October 2022), as shown in Appendix B – Map 4, to identify areas of erosion and accretion.	
	The difference plot shows that over winter 22/23, the dominant process across Redcar Sands has been erosion, At the eastern extent, at the transition to Marske Sands, the beach is dominated by low level erosion of between 0.1m and 0.25m in level. At Redcar Rocks, the change is more varied with accretion and erosion evident, the pattern is typical of pockets of sediment moving across the rocky foreshore. The most significant erosion has occurred fronting Coatham Rocks, where erosion across the whole profile is up to 1m in level. To the west, the change again becomes less in magnitude with a balance of accretion and erosion evident.

Survey Date	Description of Changes Since Last Survey	Interpretation
18 th April 2023	 Topographic Survey: Cattersty Sands is covered by a 6-monthly topographic survey. Data has been used to create a DGM (Appendix B – Map 3). The beach is steeper to the west of the breakwater than the east, but in both areas the gradient is relatively smooth. East of the breakwater, the beach is punctuated by Kilton Beck and the harbour. Immediately east of the former fishtail groyne (which has since been modified to a rock breakwater arm), the stream has cut a channel, which is most deeply incised at its landward extent. The survey report notes that "strong onshore winds restricted the depth which was achievable on the day." The April 2023 DGM has been compared against the previous survey (October 2022) in Appendix B – Map 8. To the west of the breakwater, the upper beach has largely been dominated by erosion of up to - 0.5m in level. The lower beach has broadly remained stable with the majority of change limited to ±0.1m. Some low-level accretion if observed on the very lower reaches of the beach and at the toe of the cliffs. A similar pattern is observed to East of the breakwater with large swathes of erosion evident in the lee of the breakwater, across the middle beach and around the reconfigured rock armour roundhead. The most intense swathe of change has occurred landward of the rock armour outcrop, east of the beck, at a magnitude of up to 1m. The lower beach has been dominated by accretion of a low magnitude (+0.25m). The survey report notes that a disused pipeline was also exposed in this location which is usually covered by sand. The survey report also notes a noticeable rock fall to the east of Skinningrove. This roughly correlates with a patch of accretion observed at the toe of the cliff approximately 1m in magnitude. 	The data plot shows that Cattersty Sands has been dominated by erosion over winter 2022/2023. Some low-level accretion across the lower reaches of the beach indicates some level of drawdown of material typical of seasonal patterns. Longer term trends: At Cattersty Sands, the winter erosion dominates the overall behaviour of the beach but the calmer weather in the summer months should lead to some accretion. If the erosion of the upper beach continues it is likely to drive cliff failures which would add material to the upper beach for redistribution.
