Cell 1 Regional Coastal Monitoring Programme Update Report 16: 'Partial Measures' Survey 2024

Redcar and Cleveland Council

June 2024

(*) The present report is **Update Report 16** and provides an analysis of the 2024 Partial Measures survey for Redcar and Cleveland Council's frontage.

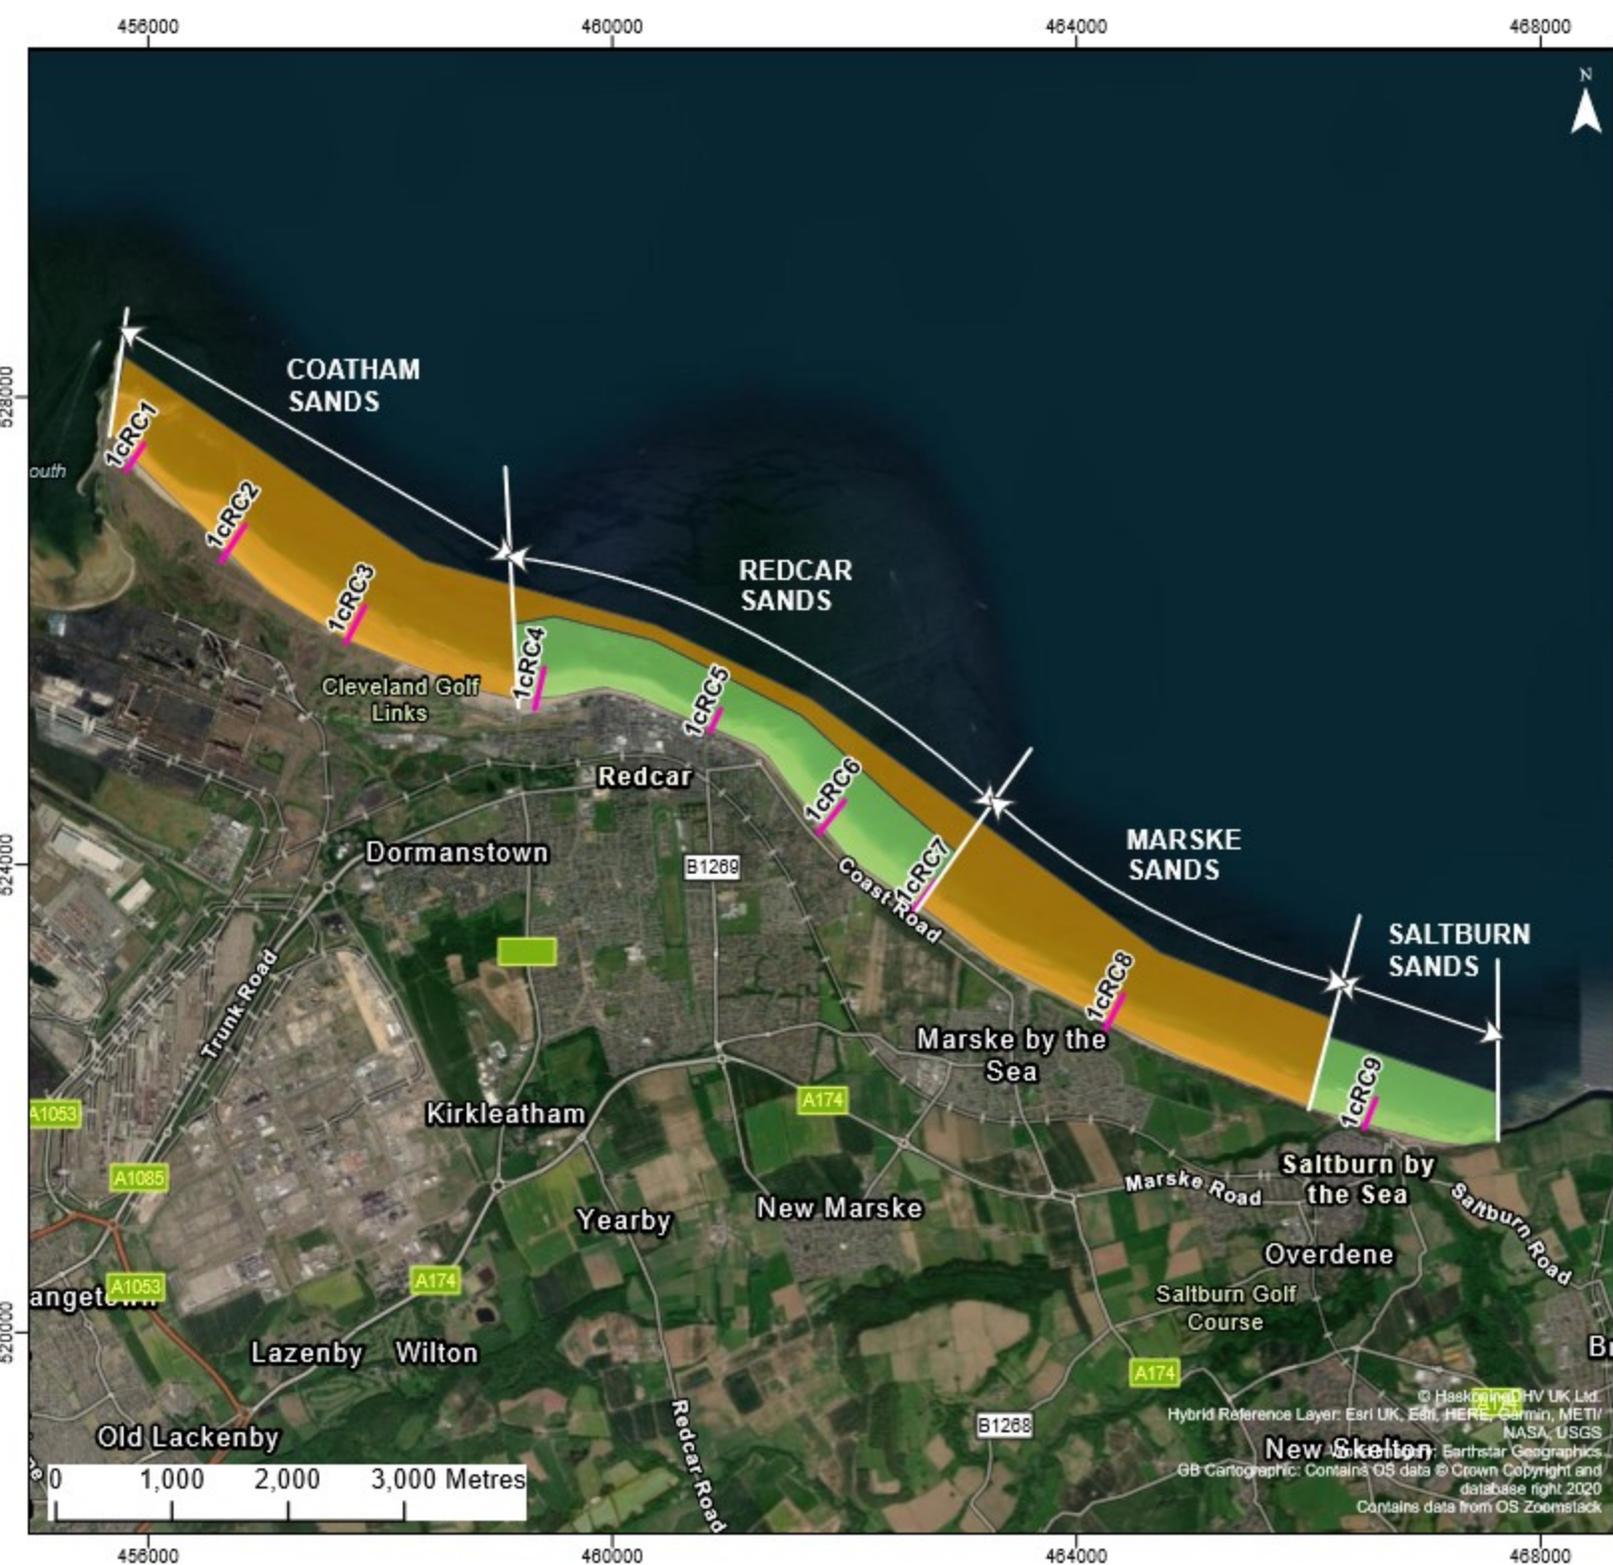
Title: **Figure 2 - Map 1**
COATHAM SANDS TO SALT BURN SANDS
Redcar and Cleveland Borough Council Frontage

The location of these surveys is shown in Figure 2 and 3. The Partial Measures surveys was undertaken on the following dates;

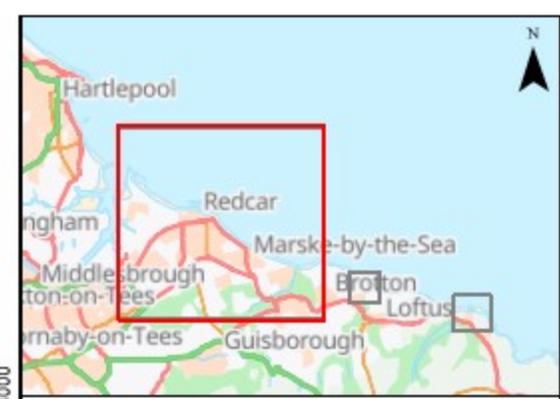
SURVEY LOCATIONS

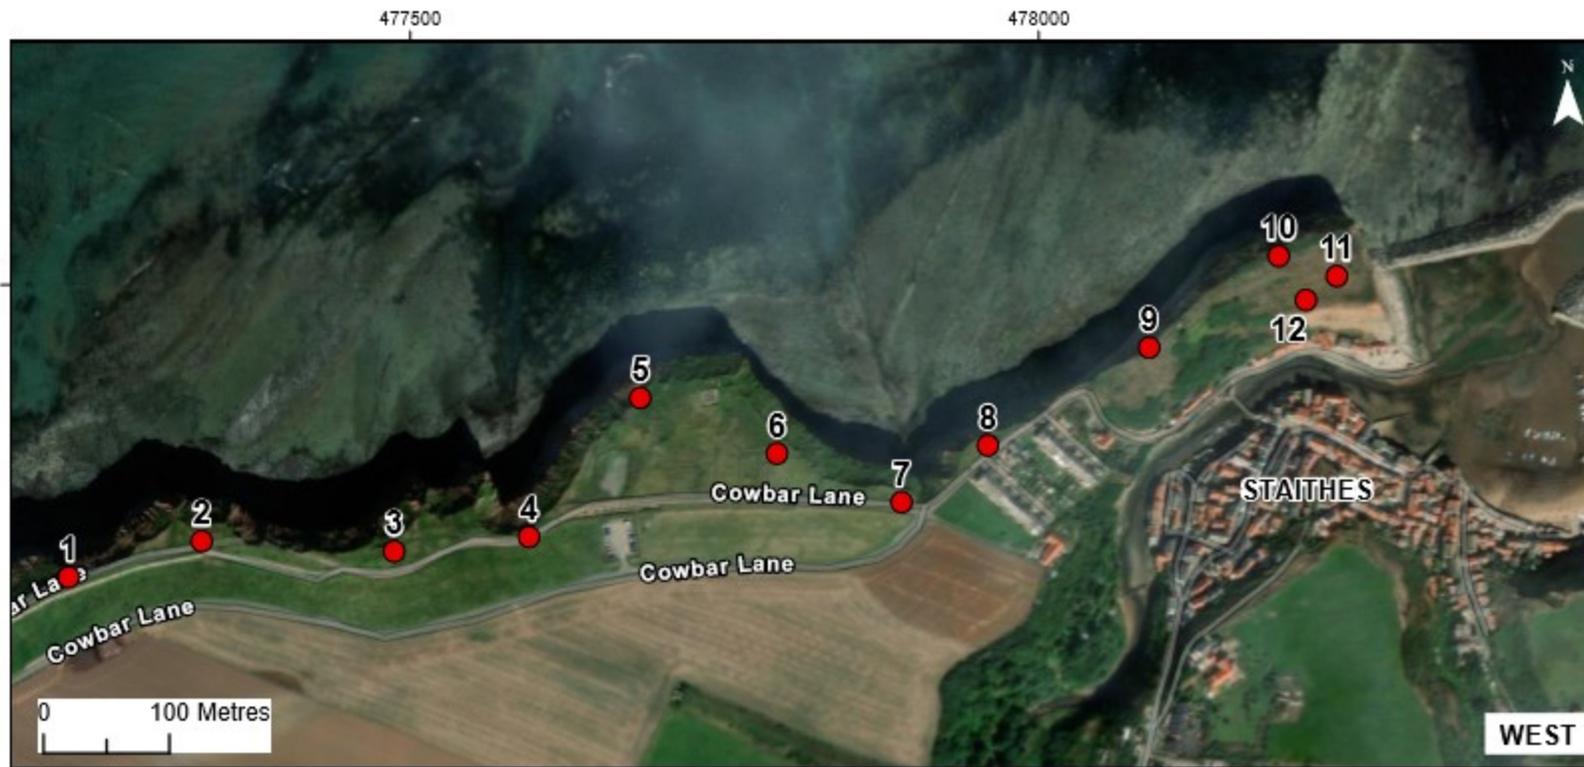
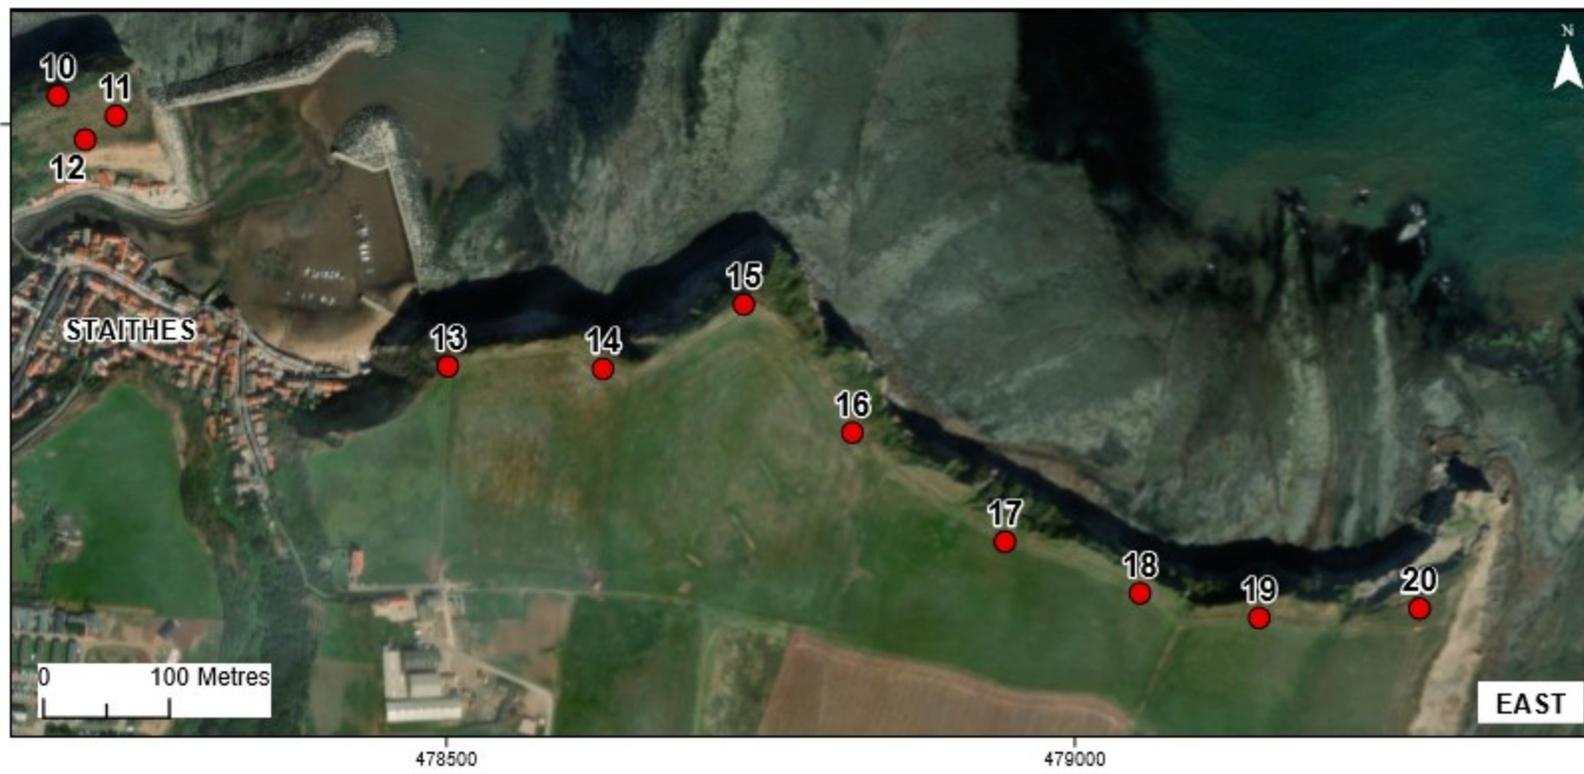
Title:
Figure 3 - Map 1
STAITHES
Redcar and Cleveland Borough Council Frontage

Twenty ground control points have been established at Staithes (Figure 3 – Map 1). The maximum separation between any two points varies along the coast, reflecting the degree of risk from the erosion. The cliff top surveys at Staithes are undertaken bi-annually. Measurements are taken from a fixed ground control point along a fixed bearing to the edge of the cliff top.

Survey Date	Description of Changes Since Last Survey	Interpretation
<p>6th March 2024</p>	<p>Cliff-top Survey:</p> <p>Twenty ground control points have been established at Staithes for the purposes of cliff top monitoring. The separation between any two points is a nominal 100m. The cliff top surveys at Staithes are undertaken bi-annually. Data collection involves a distance offset measurement from the ground control point to the cliff edge along a fixed bearing.</p> <p>Appendix C provides results from the March 2024 survey, showing the distance from the ground control point to the edge of the cliff top along the defined bearing and changes in position since the November 2008 baseline survey and the previous September 2023.</p> <p>The results show that zero of the 23 control points experienced erosion greater than the survey error ($\pm 0.2\text{m}$) since the previous survey. This indicates a period of stability along this frontage. It has also resulted in a decrease in the long term recession rates. The two points with the greatest rates are now Point 1 (with 0.48m/yr.) and Point 13 (with 0.20m/yr.).</p>	<p>The cliff top along the Staithes frontage have remained stable since the previous survey.</p> <p>Longer term trends: Only Point 1 (0.48m/yr.) and Point 13 (0.20m/yr.) have experienced long term recession rates greater than (or equal to) 0.2m/yr. Point 4 also previously had a recession greater than the margin of error however, a period of stability means it is now only averaging 0.15m/yr.</p>

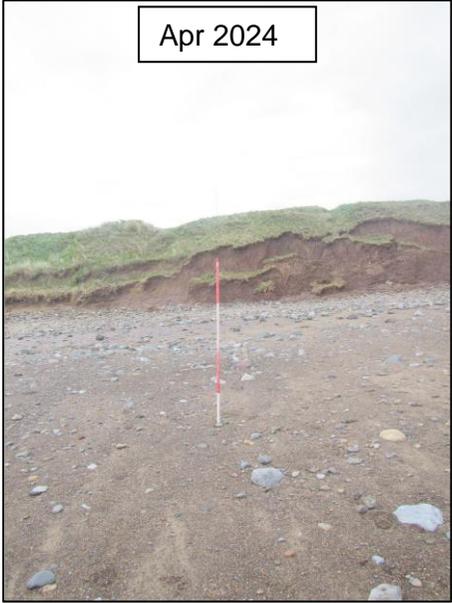
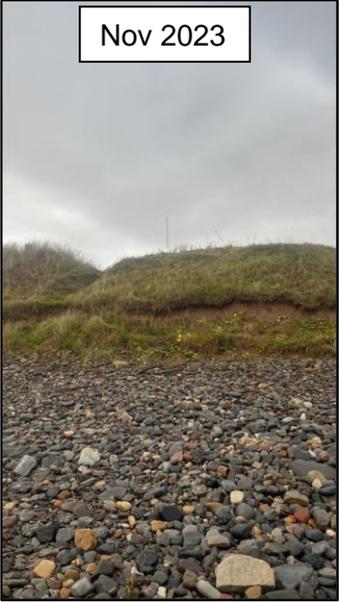
Survey Date	Description of Changes Since Last Survey	Interpretation
	<div style="display: flex; justify-content: space-around;"> <div style="text-align: center;"> <div data-bbox="488 272 667 328" style="border: 1px solid black; padding: 2px;">Apr 2024</div>

</div> <div style="text-align: center;"> <div data-bbox="887 272 1066 328" style="border: 1px solid black; padding: 2px;">Nov 2023</div>

</div> </div>	
	<p>Topographic Survey:</p> <p>Redcar Sands is covered by a 6-monthly topographic survey. Data have been used to create a DGM (Appendix B – Map 1) using a GIS. The DGM shows that the beach topography is broadly parallel to the shore other than between Coatham Rocks and Redcar Rocks where the lack of sediment is reflected with distorted contours. The GIS has also been used to calculate the differences between the current topographic survey (April 2024) and the previous topographic survey (November 2023), as shown in Appendix B – Map 4, to identify areas of erosion and accretion.</p> <p>The difference plot shows that the change around Redcar since the previous survey is varied. To the west, at the interface with Coatham Sands, the profile has been dominated by low level erosion (-0.5m). The pattern of change at Coatham and Redcar Rocks reflects the exposed rocky foreshore with patches of both accretion and erosion observed. From Redcar Rocks south, the dominant process of change appears to have been accretion, albeit again at a low magnitude (+0.5m) and not exclusive.</p>

Survey Date	Description of Changes Since Last Survey	Interpretation
<p>24th – 26th April 2024</p>	<p>Beach Profiles:</p> <p>Redcar Sands is covered by three beach profiles (1cRC5 to 1cRC7; Appendix A), with 1cRC7 being approximately on the boundary with the Marske Sands area. They were last surveyed in November 2023.</p> <p>At profile 1cRC5 the sea defences constructed in 2012 remain unchanged. At the toe of the stepped revetment, beach levels have locally accreted by 0.9m in level concealing the lower section of the structure. This accretion has created a steep upper beach, with the profile tapering to no change by chainage 28m. This is followed by a short length of erosion, it is likely it is this same material that has been driven against the seawall. Seawards of chainage 60m there has been no change with the rocky foreshore still exposed. Due to the lack of sediment present, the profile remains at a very low level when compared to the range of the previous surveys.</p> <p>Profile 1cRC6 is defended up until chainage 52m and has remained unchanged over this length. At the toe of the sloping concrete apron, beach levels have accreted, continuing across the upper beach, tapering to no change by chainage 73m. This accretion is limited to +0.3m in level, the material appears to be larger cobbly material likely driven up during storms. A short length of minor erosion (-0.15m) is then again proceeded by accretion which has occurred between chainage 94m and 218m (limited to +0.3m) and again seawards of change 231m. The accretion across the lower beach is up to +0.7m in magnitude. Overall, the beach is at a medium level when compared to the range of the previous surveys.</p> <p>Profile 1cRC7 is undefended. At the toe of the cliff, beach levels have dropped by up to 1.4m in level. It is clear this drop in level has accelerated the erosion of the toe of the cliff. This initial erosion tapers to no change by chainage 71m. A short length of minor accretion (+0.15m) is then followed by widescale erosion, peaking in magnitude at chainage 221m with -0.5m. Accretion is observed at the very lower reaches of the profile, seawards of chainage 270m. This widescale erosion has resulted in the profile being at the lowest level on record for approximately 100m over the upper central sections.</p>	<p>Change across Redcar Sands is varied. It is thought this varied change can partially be explained due to the timing of the Full Measures Survey which was undertaken in November, later in the year than usual. This meant that Full Measure Survey was after some of the more severe winter storms that significantly eroded the frontage (particularly Storm Babet).</p> <p>As a result, rather than erosion dominating the partial measures report, as is the seasonal pattern, the 2024 partial measures survey has possibly recorded some post storm recovery, particularly at The Stray. This said, levels have not returned to those pre-storm, and further erosion in some areas (notably 1cRC7) reflects further storms later in season.</p>

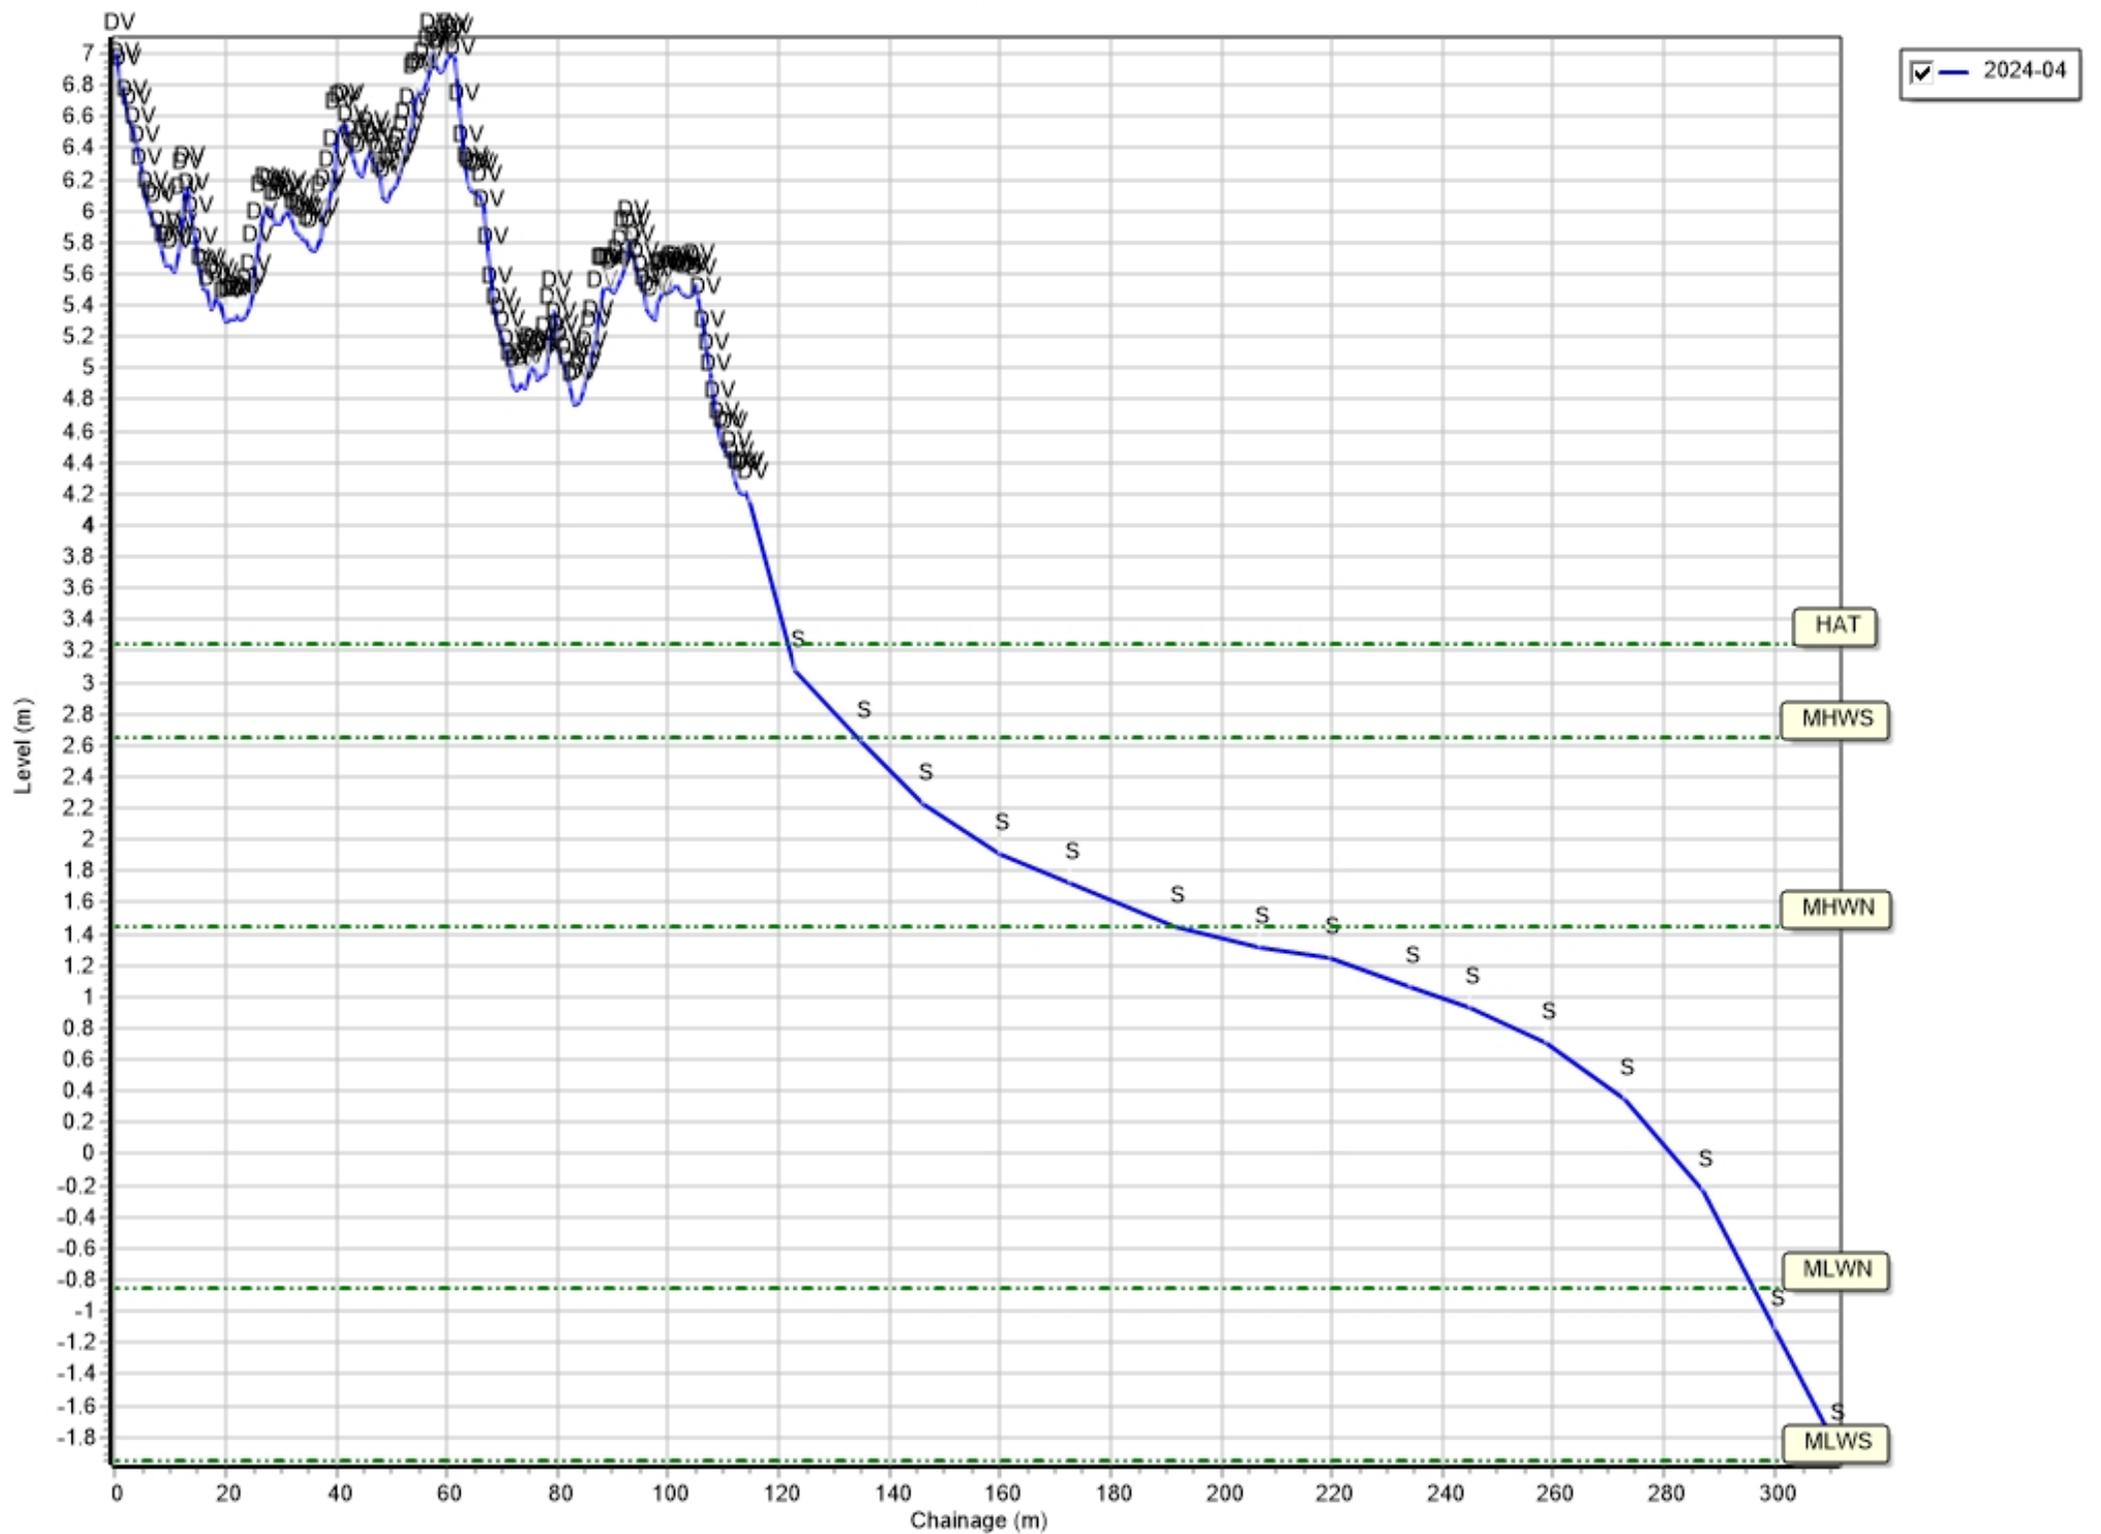
Profiles: 1cRC1

Survey Date	Description of Changes Since Last Survey	Interpretation
<p>24th – 26th April 2024</p>	<p>Beach Profiles:</p> <p>Coatham Sands is covered by four beach profiles during the Partial Measures survey (1cRC1 to 1cRC4; Appendix A) that were last surveyed in November 2023.</p> <p>Profile 1cRC1 is located 300m southeast of the South Gare Breakwater, in the lee of the German Charlies slag banks. The upper profile to chainage 107m is covered by dunes, over which change is limited to ± 0.1m. From the toe of the foredune, to chainage 210m, the upper beach has dropped in level by up to 0.5m. Seawards of chainage 210m, to the end of the profile at chainage 310m, the lower beach has accreted by a similar magnitude. Compared to the range of the previous surveys the upper beach is at a medium level, where as accretion on the lower beach has resulted in the profile, between chainage 225m and 306m, being at the highest level on record. The dunes remain at a high level.</p> <p>At profile 1cRC2, change across the dune system up until the foredune is limited to low level accretion up to 0.15m in level. At the foredune, at chainage 97m, erosion has steepened the seaward face creating a 1.3m high cliff. This erosion reduces in magnitude to 0.2m in level by chainage 100m before gradually tapering to no change by chainage 170m. Seawards of chainage 170m, the beach has accreted, initially limited to +0.2m but increasing to 0.4m between 270m and 340m. The profile remains within the range envelope of the previous surveys. The dunes remain at a high level.</p> <p>At Profile 1cRC3, the largest change over the dune system has occurred on the seaward face of the foredune where accretion of up to +0.5m is observed. The rest of the dune system has remained stable. At the toe of the foredune, to chainage 190m, the upper beach has dropped in level by up to 0.2m. Seawards of chainage 190m the beach has accreted in level, initially limited to +0.1m up to chainage 268m, before increasing to +0.4m at chainage 320m. The profile is generally at medium level, with the lower beach at a high level and even the highest on record between 302m and 346m as a result of the accretion.</p>	<p>The profiles, particularly the three northern profiles, show a clear pattern of drawdown of material from the upper beach to the lower beach, a typical seasonal response. While the upper beach remains at medium level the accretion on the lower beach has resulted in sections being at highest level on record (compared to the range of previous surveys), indicating the strength of storms over winter 2023 / 2024.</p> <p>Other than moderate cliffing of the foredune in profile 1cRC2, the dunes appear to have been resilient to the storms with the surveyors' photos even suggesting embryonic dune growth across some of the foredune.</p> <p>Longer term trends:</p> <p>All beach profiles at Coatham show the dunes are stable or accreting on their seaward extent. The beaches to the west show a typical longer-term trend of progressive accretion. The beaches in the centre and to the east have a more fluctuating long-term pattern.</p>

- At Coatham Sands, the profiles, particularly the three northern profiles, show a clear pattern of drawdown of material from the upper beach to the lower beach, a typical seasonal response. While the upper beach remains at medium level the accretion on the lower beach has resulted in sections being at highest level on record (compared to the range of previous surveys), indicating the strength of storms over winter 2023/24. Other than moderate cliffing of the foredune in profile **1cRC2**, the dunes appear to have been resilient to the storms with the surveyors' photos even suggesting embryonic dune growth across some of the foredune.

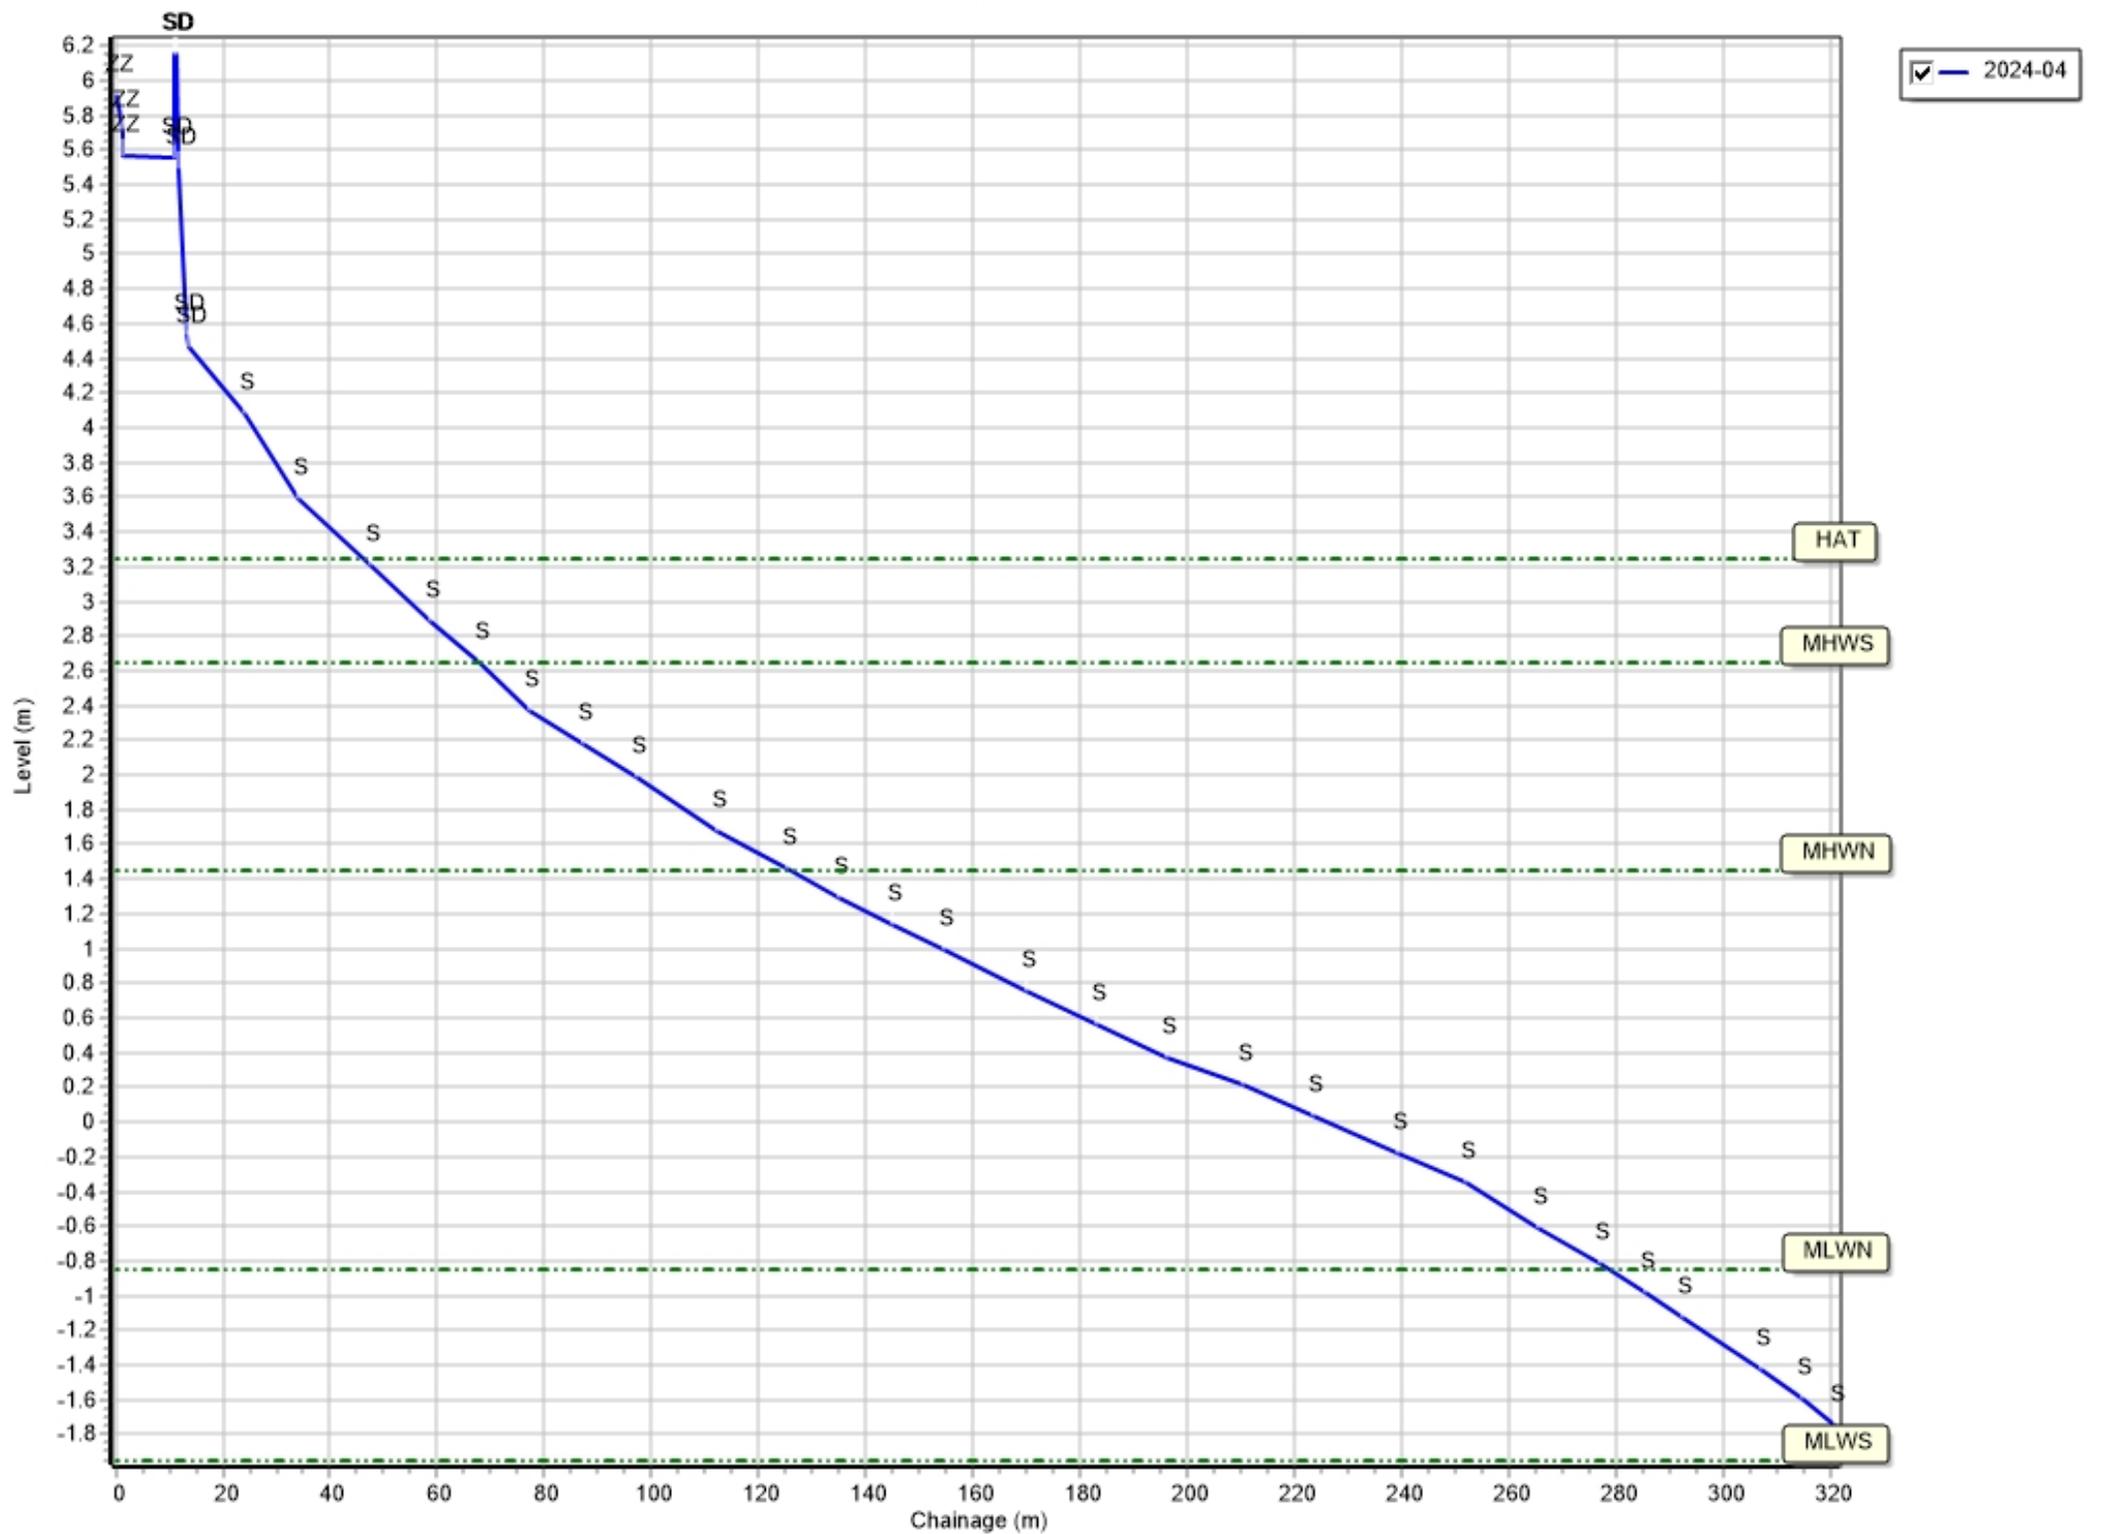
Profiles: 1cRC4

Survey Date	Description of Changes Since Last Survey	Interpretation
	<p>Profile 1cRC4 is located at the beginning of the defended section at Coatham and Redcar. Beach levels at the toe of the wall have dropped in level by 0.5m, exposing a greater length of the sloping apron. Bar a small section of accretion on the upper beach, erosion dominates the rest of the profile. This erosion is modest (-0.2m) for the majority of the profile but does increase (-0.5m) on the lower beach between chainage 260m and 320m. The profile is at a very low when compared to the range of the previous surveys, with not insignificant lengths at the lowest level on record.</p>

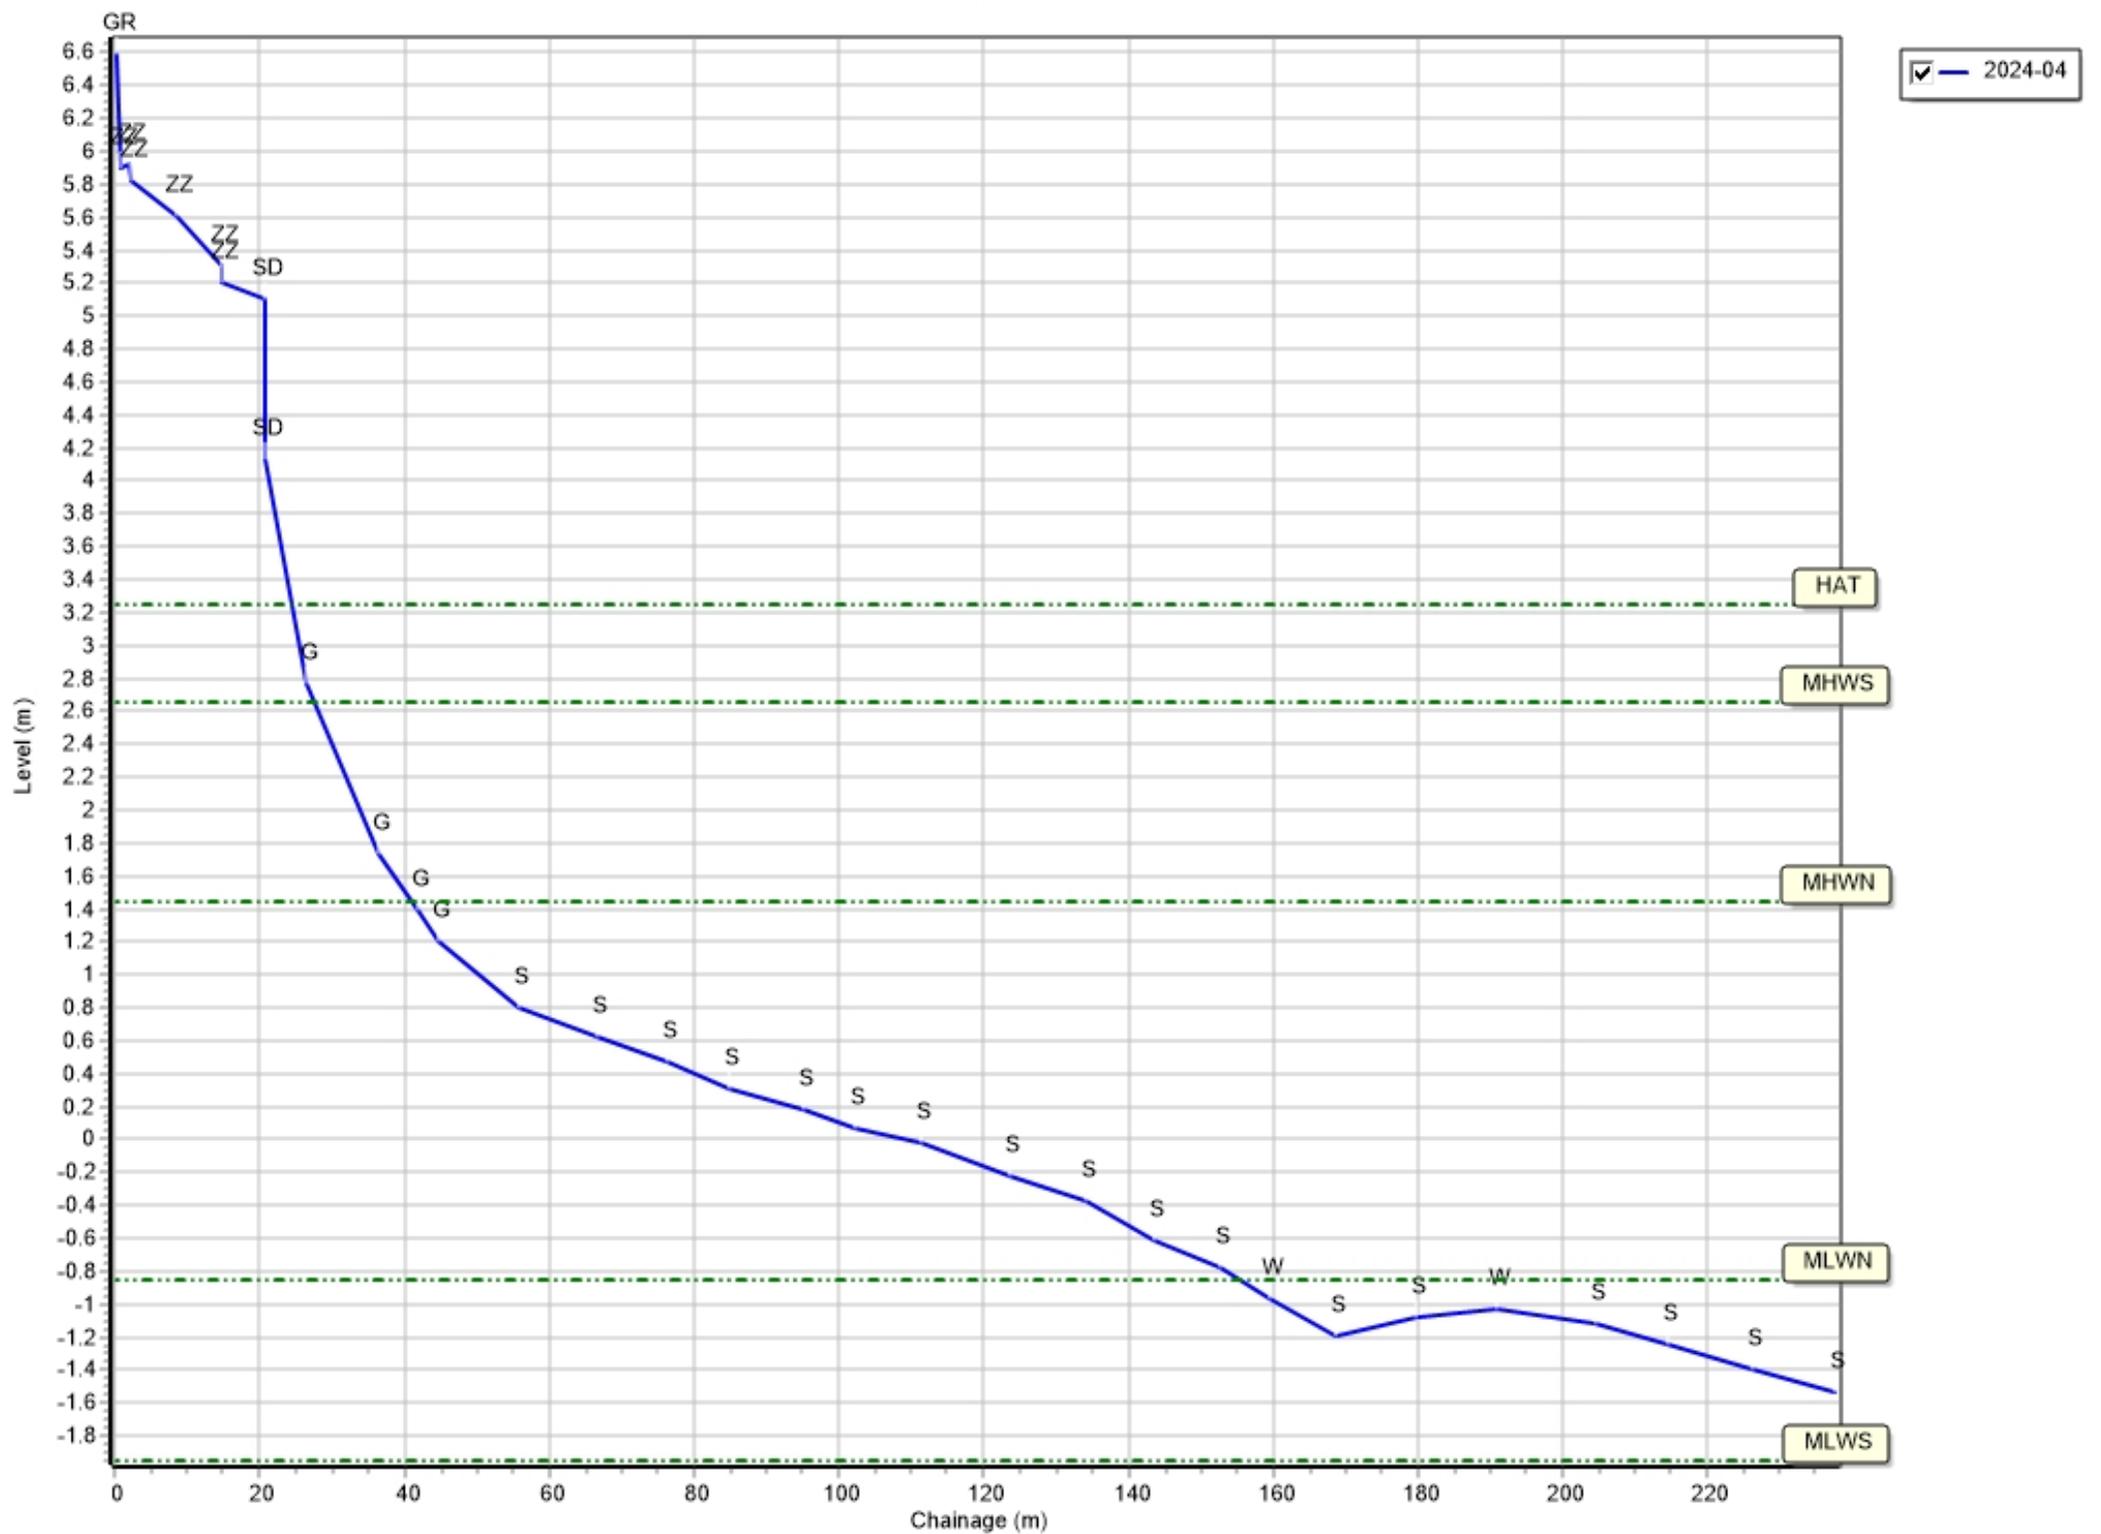
Profiles: 1cRC9

Survey Date	Description of Changes Since Last Survey	Interpretation
24 th – 26 th April 2024	<p>Beach Profiles:</p> <p>Saltburn Sands is covered by one beach profile (1cRC9; Appendix A).</p> <p>Profile 1cRC9 is covered by a sea defence as far as chainage 20m and has experienced no change over this defended length. The toe of defence is fronted by a cobble berm that has accreted in level by 0.4m at the toe of the wall. Accretion continues across the upper beach tapering to no change by chainage 38m. Seawards of chainage 38m, the beach has been dominated by erosion, lowering in level by up to 0.6m in level. Consequently, at the toe of the seawall beach levels are at the highest on record where across the centre and lower beach there are at the lowest level on record.</p>	<p>The storm driven shingle berm against the seawall has further accreted. It is thought this, combined with a drop in level of the rest of beach, will only exacerbate overtopping concerns associated with waves 'ramping' up the berm.</p> <p>It is understood the council has attempted to redistribute the berm in the past. A beach management plan is ongoing, amongst other things, address concerns here.</p>

- At Saltburn Sands, the storm driven shingle berm against the seawall has further accreted. It is thought this, combined with a drop in level of the rest of beach, will only exacerbate overtopping concerns associated with waves 'ramping' up the berm. It is understood the council has attempted to redistribute the berm in the past. A beach management plan is ongoing to, amongst other things, address concerns here.
