Cell 1 Regional Coastal Monitoring Programme Update Report 16: 'Partial Measures' Survey 2024

Redcar and Cleveland Council

June 2024

(*) The present report is **Update Report 16** and provides an analysis of the 2024 Partial Measures survey for Redcar and Cleveland Council's frontage.

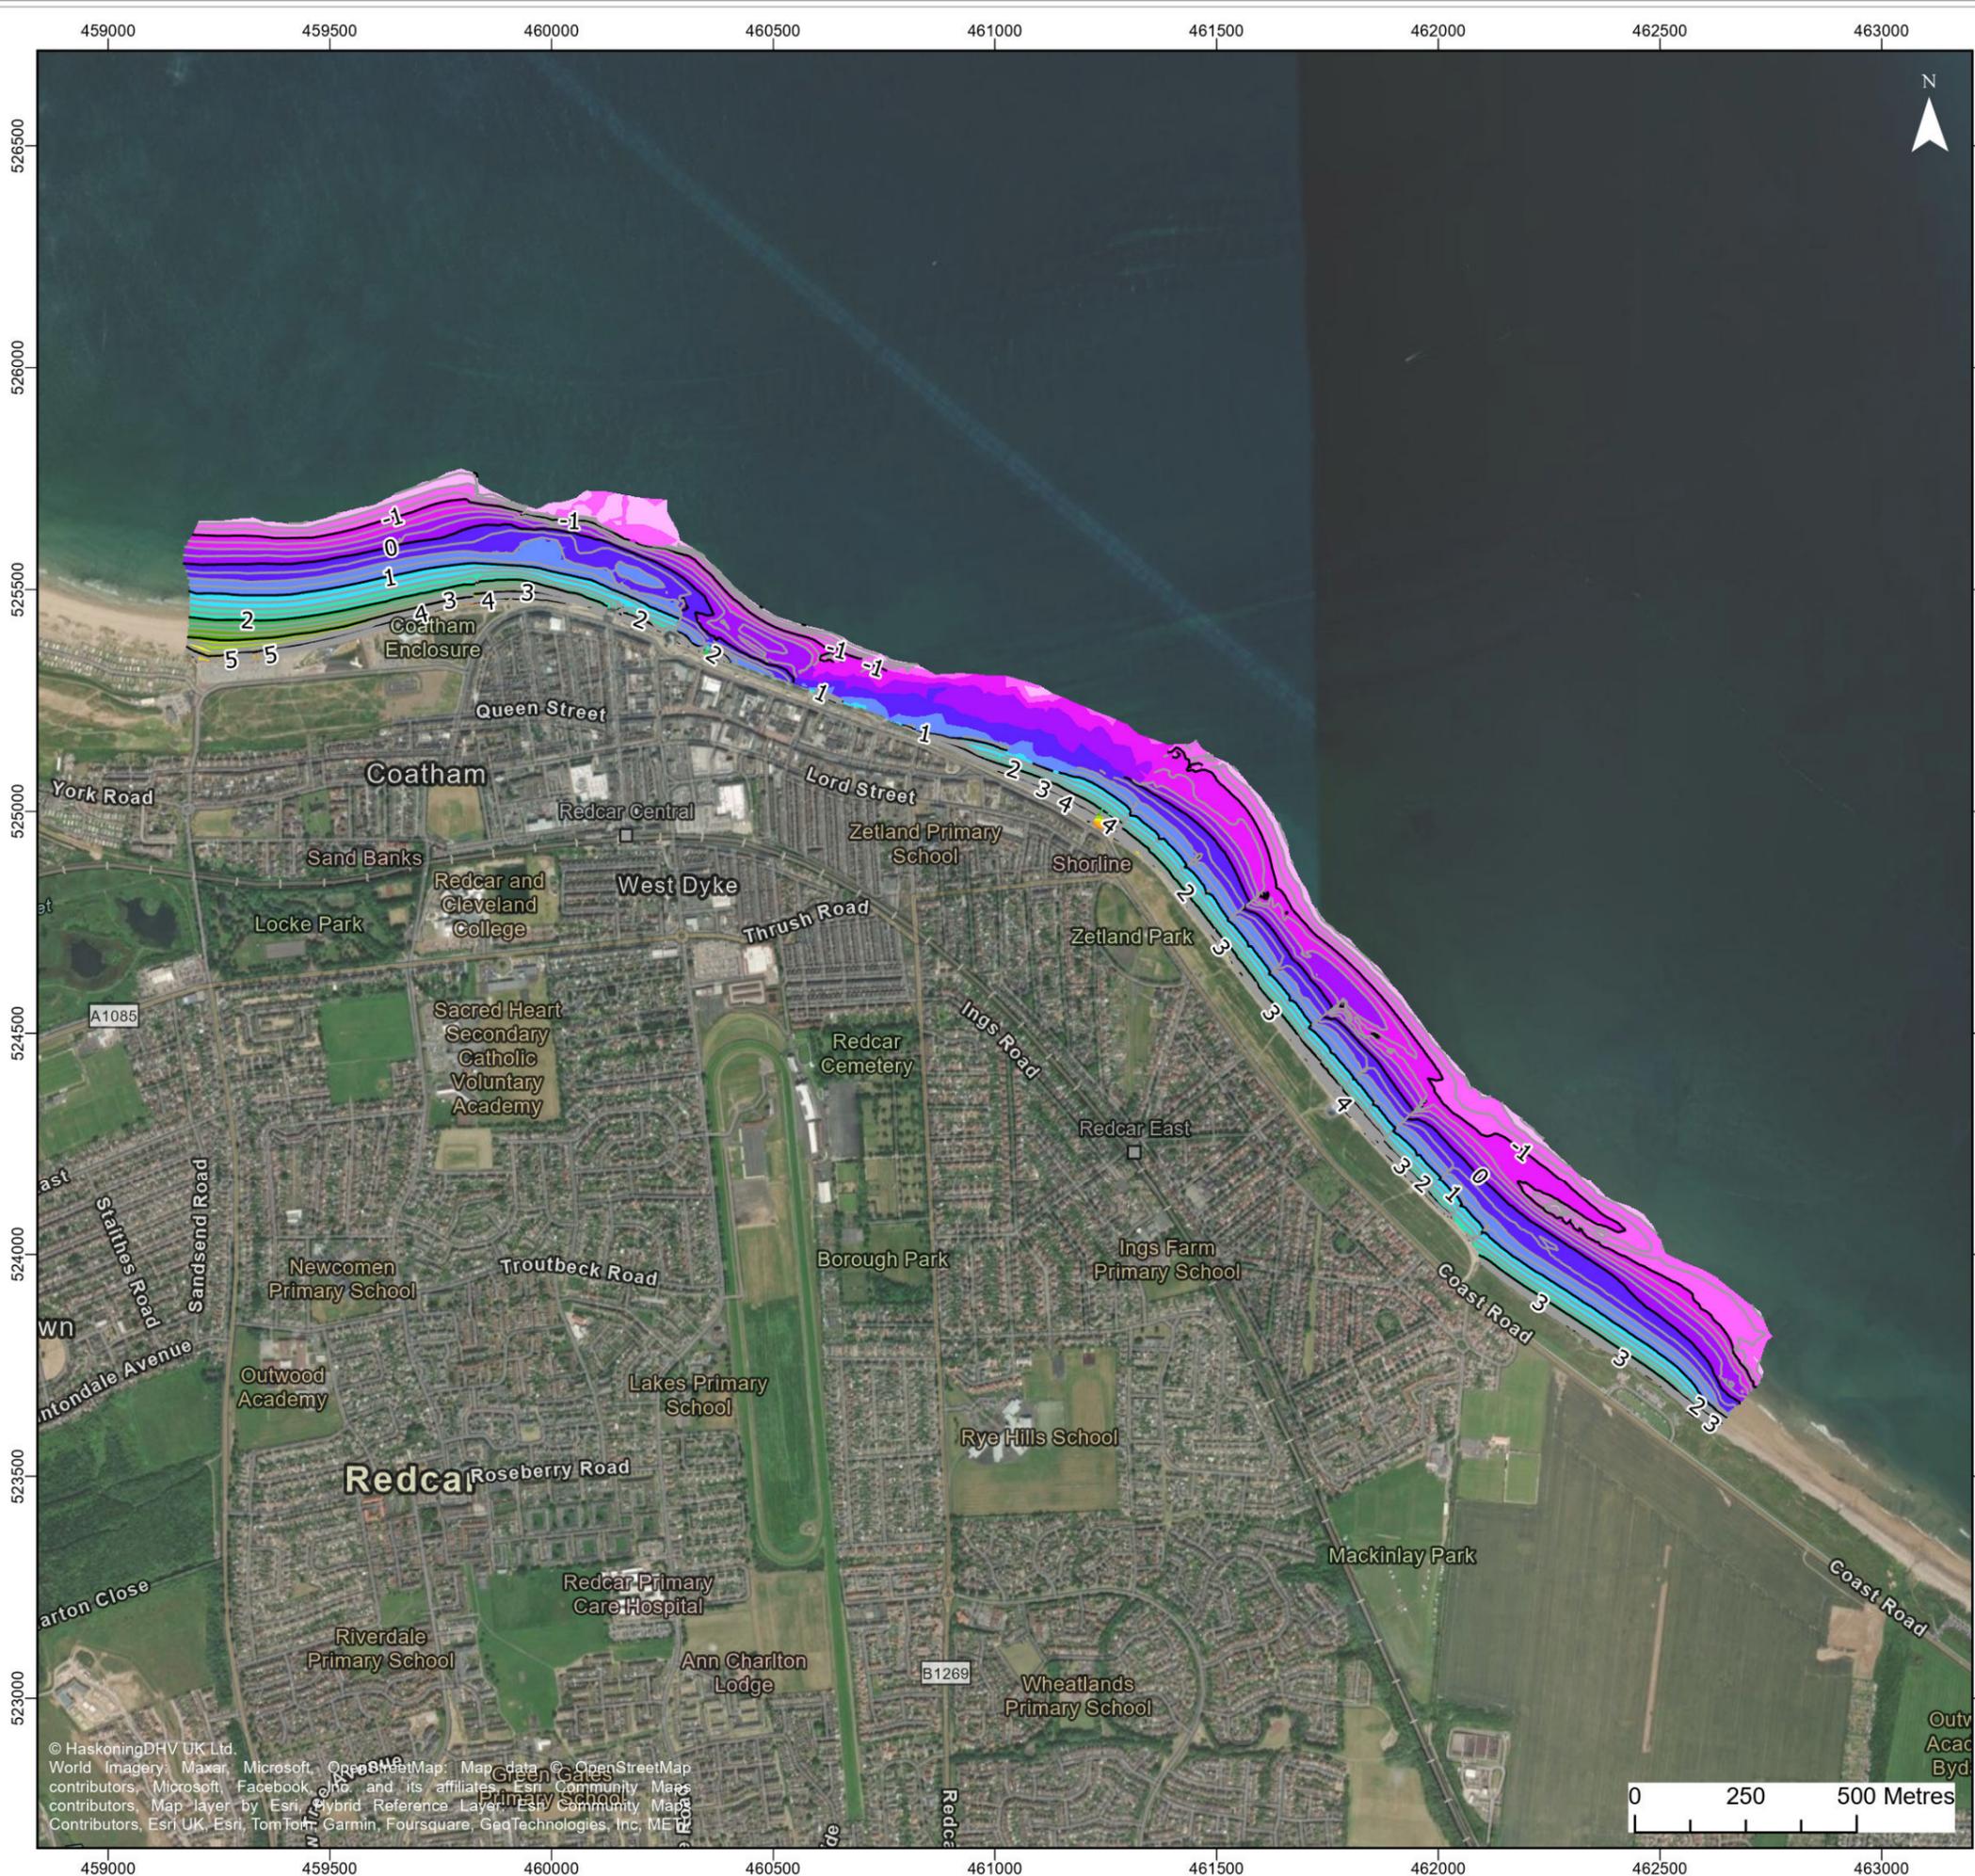
Appendix B - Map 1

</div> </div>	
	<p>Topographic Survey:</p> <p>Redcar Sands is covered by a 6-monthly topographic survey. Data have been used to create a DGM (Appendix B – Map 1) using a GIS. The DGM shows that the beach topography is broadly parallel to the shore other than between Coatham Rocks and Redcar Rocks where the lack of sediment is reflected with distorted contours. The GIS has also been used to calculate the differences between the current topographic survey (April 2024) and the previous topographic survey (November 2023), as shown in Appendix B – Map 4, to identify areas of erosion and accretion.</p> <p>The difference plot shows that the change around Redcar since the previous survey is varied. To the west, at the interface with Coatham Sands, the profile has been dominated by low level erosion (-0.5m). The pattern of change at Coatham and Redcar Rocks reflects the exposed rocky foreshore with patches of both accretion and erosion observed. From Redcar Rocks south, the dominant process of change appears to have been accretion, albeit again at a low magnitude (+0.5m) and not exclusive.</p>

- Change across Redcar Sands is varied. It is thought this varied change can partially be explained due to the timing of the Full Measures Survey, which was undertaken in November 2023, later in the year than usual. This meant that Full Measure Survey was after some of the more severe winter storms that significantly eroded the frontage (particularly Storm Babet). As a result, rather than erosion dominating the partial measures report, as is the seasonal pattern, the 2024 partial measures has recorded some post storm recovery, particularly around The Stray. This said, levels have not returned to those pre-storm, and further erosion in some areas (notably 1cRC7) reflects further storms later in the season.

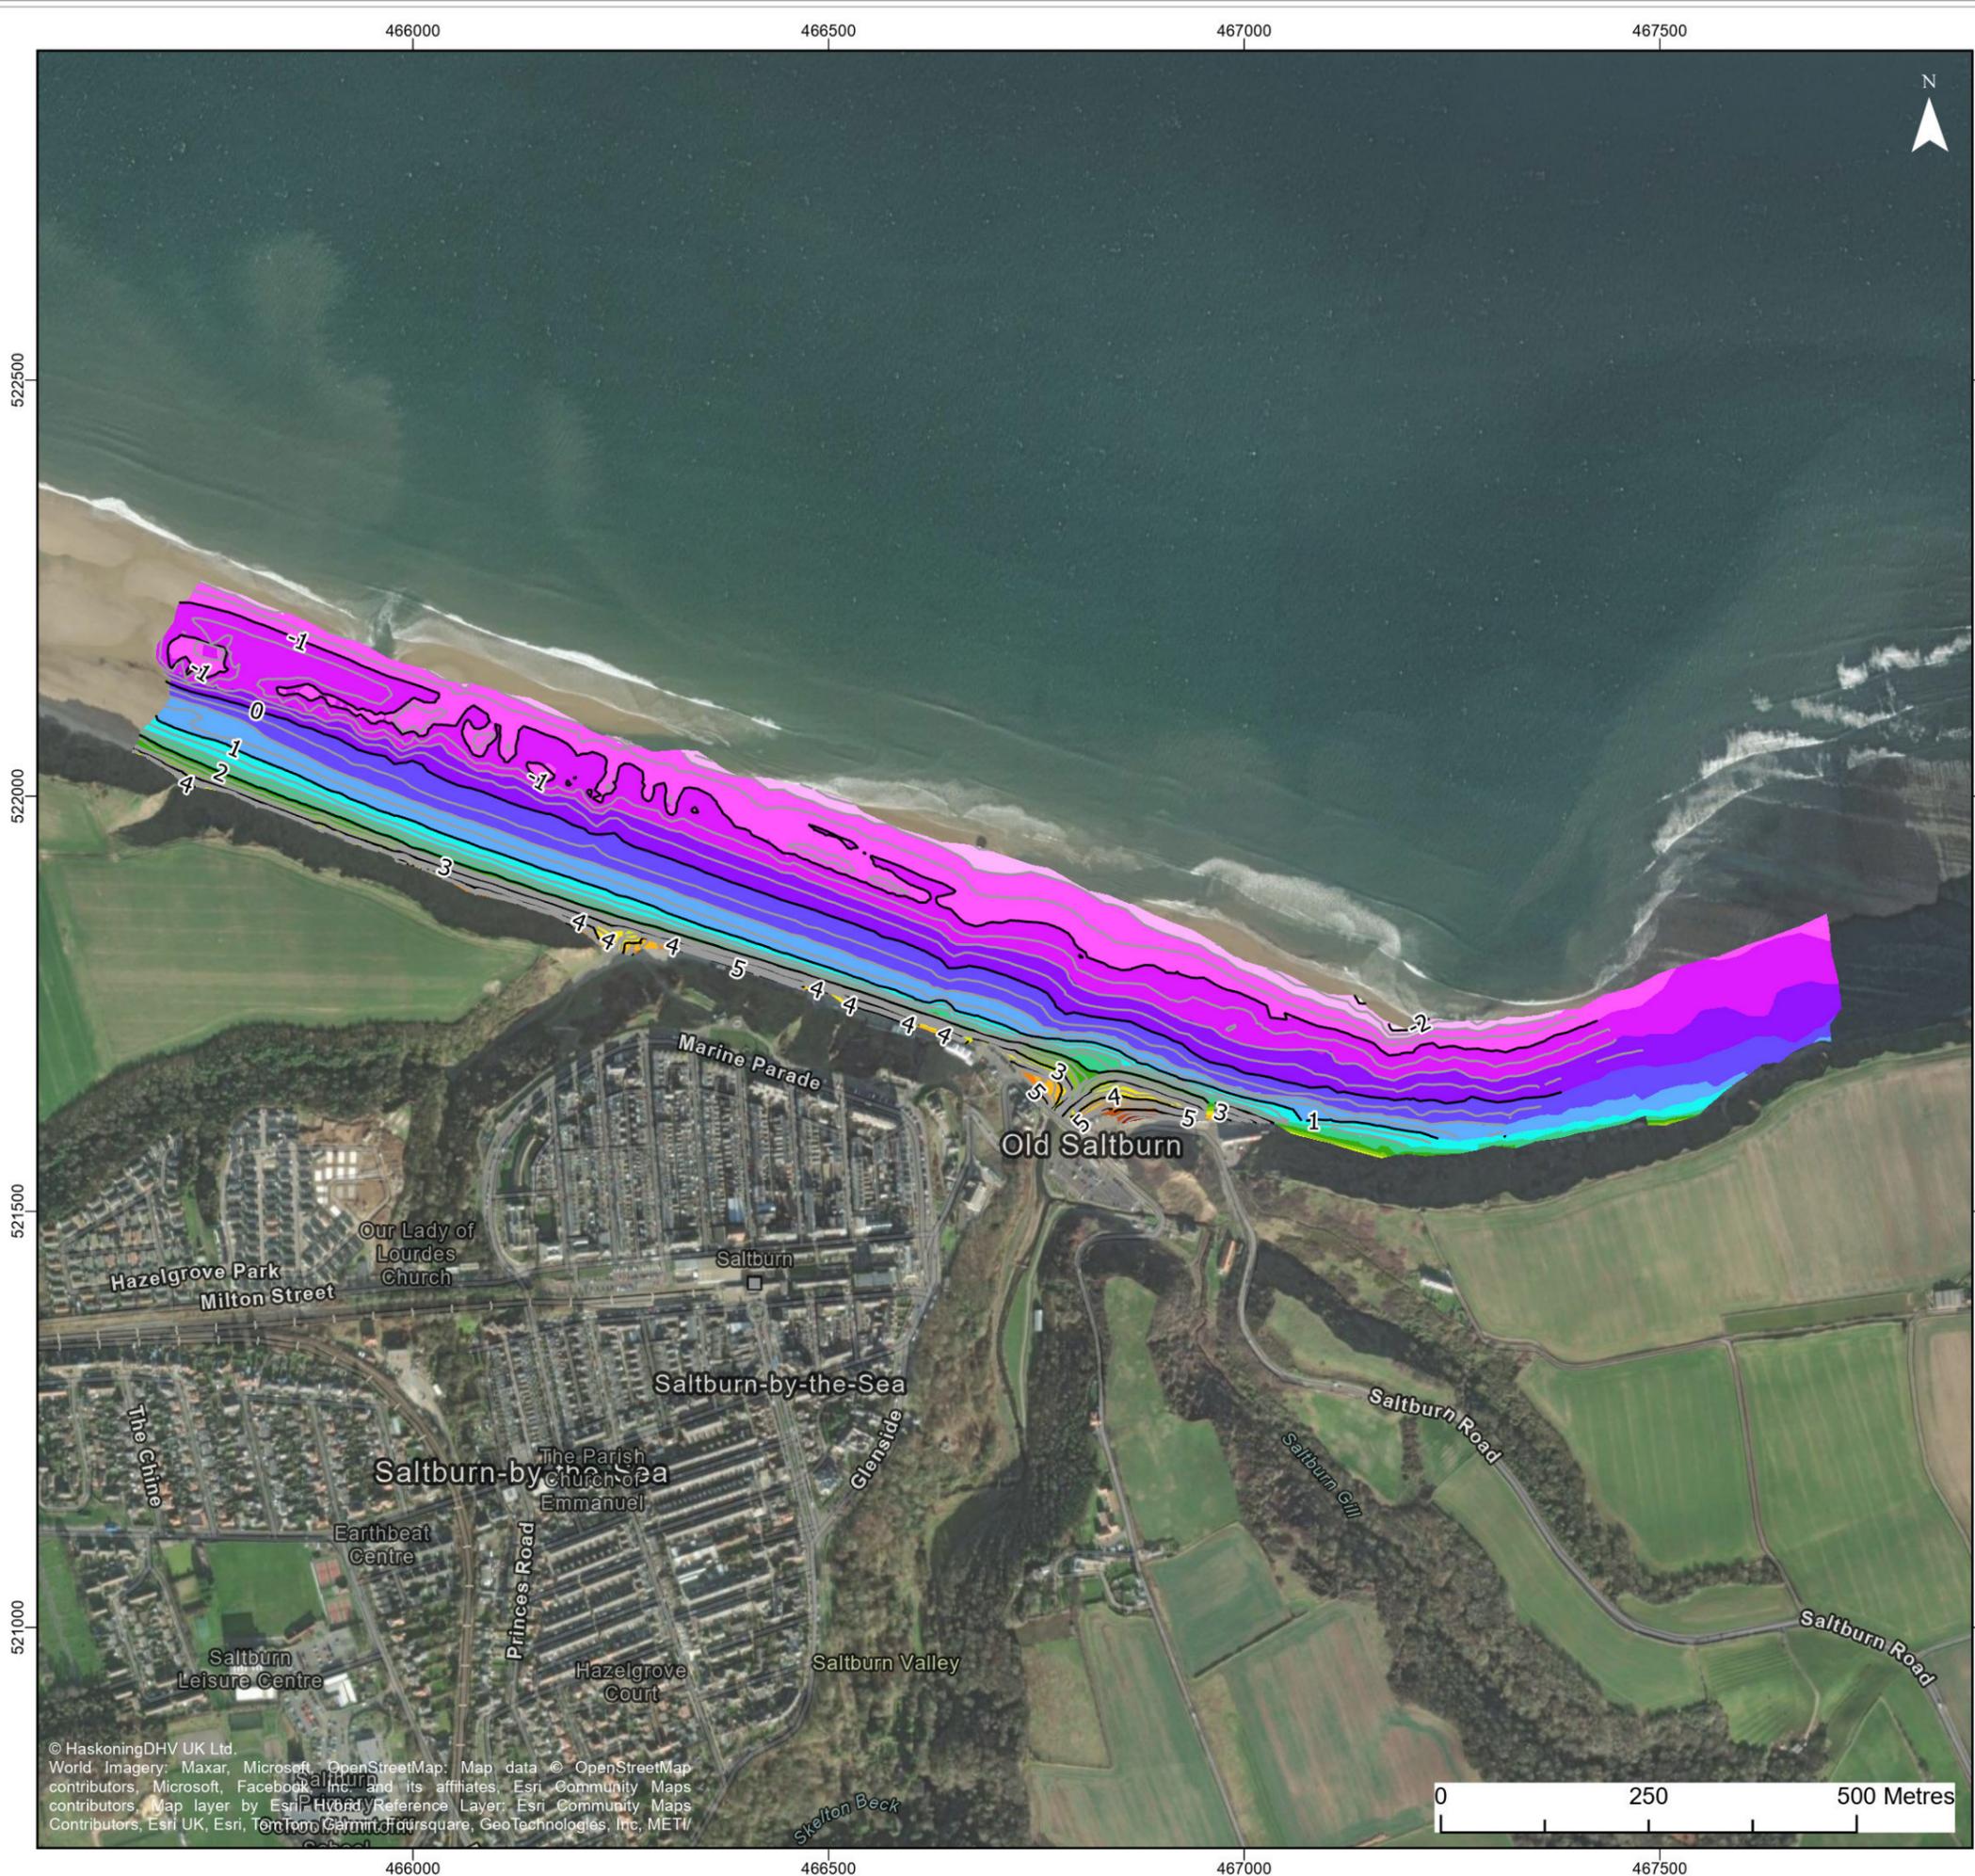
Title:
Appendix B - Map 2
SALTBURN SANDS
Redcar and Cleveland Borough Council Frontage

<p>Topographic Survey:</p> <p>Saltburn Sands is covered by a 6-monthly topographic survey. The data has been used to create a DGM (Appendix B – Map 2). The DGM highlights the beach topography consists of shore parallel contours that begin to become distorted on the lower beach suggesting a plateau. The contours are also distorted at the interface with Skelton Beck.</p> <p>The DGM has been compared against the previous survey (November 2023) in Appendix B – Map 5 to observe patterns of erosion and accretion. The difference plot shows that over winter 2023 / 2024, Saltburn Sands has been dominated by erosion (up to -0.75m) across the vast majority of the beach. A very narrow band of accretion is observed up against the seawall and again at the mouth of the Skelton Beck.</p>

- At Saltburn Sands, the storm driven shingle berm against the seawall has further accreted. It is thought this, combined with a drop in level of the rest of beach, will only exacerbate overtopping concerns associated with waves 'ramping' up the berm. It is understood the council has attempted to redistribute the berm in the past. A beach management plan is ongoing to, amongst other things, address concerns here.

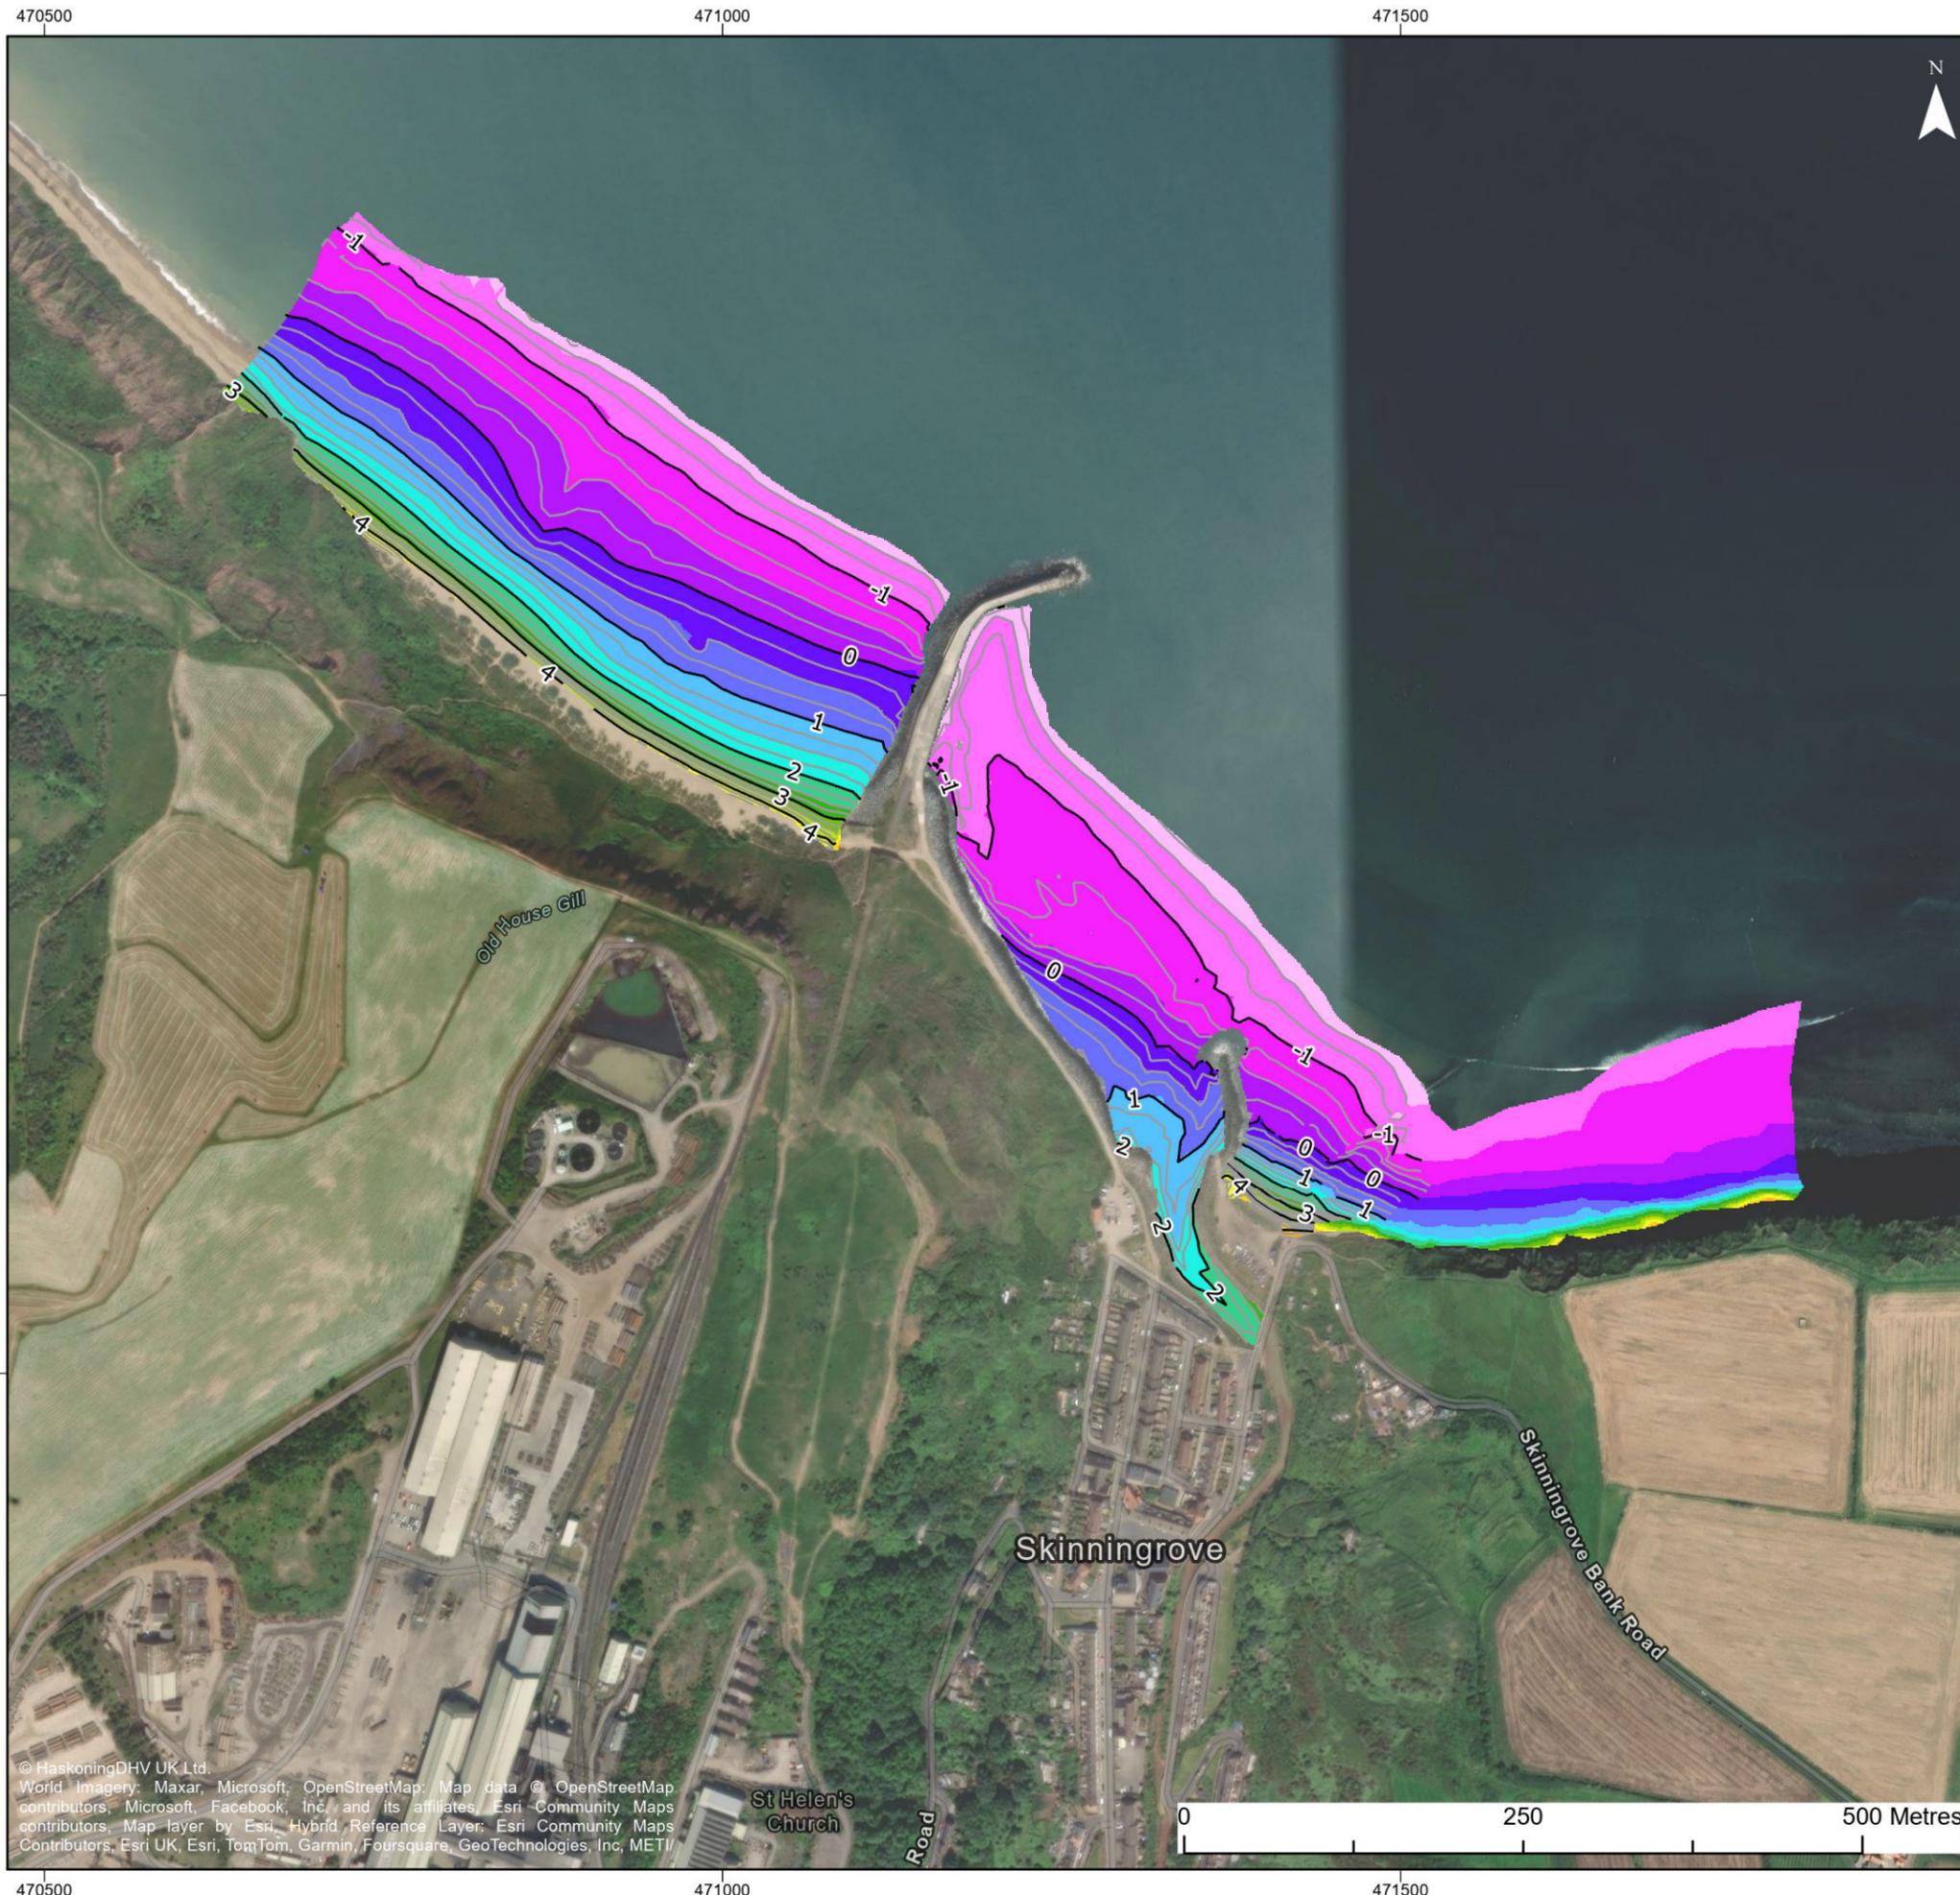
Appendix B - Map 3

Survey Date	Description of Changes Since Last Survey	Interpretation
<p>27th March 2024</p>	<p>Topographic Survey:</p> <p>Cattersty Sands is covered by a 6-monthly topographic survey. Data has been used to create a DGM (Appendix B – Map 3). The beach is steeper to the west of the breakwater than the east, but in both areas the gradient is relatively smooth. East of the breakwater, the beach is punctuated by Kilton Beck and the harbour. Immediately east of the former fishtail groyne (which has since been modified to a rock breakwater arm), the stream has cut a channel, which is most deeply incised at its landward extent.</p> <p>The March 2024 DGM has been compared against the previous survey (November 2023) in Appendix B – Map 8. To the west of the breakwater a significant, shoreline parallel band of erosion is observed at the toe of the cliffs and across the upper beach. This erosion is up to -2m in level and was reported by the surveyor to be ‘noticeable around the pillbox’. Two swathes of much lower magnitude accretion across the lower beach suggests that at least some of the material has been drawn down onto the lower beach (rather than transported offshore),</p> <p>The frontage east of the breakwater has also been dominated by erosion, albeit at much lower magnitude. Erosion is observed in the lee of the breakwater up against the structure and to the east of the modified fish tail groyne. The erosion on the east side of the breakwater is limited to -1.0m. Very minor accretion is observed in the mouth of the beck.</p>	<p>As is the seasonal pattern, Cattersty Sands has been dominated by erosion over the winter. The most notable change has occurred to the west of the breakwater, where the upper beach has experienced a significantly drop in level.</p> <p>Whilst this does raise some concerns regarding the exposure of the cliffs to increased erosion, it is expected that this will only be temporary, and that the area will recover in the coming months.</p> <p>This area was subject to notable accretion over the previous summer and so, to an extent, may be balancing itself out.</p> <p>Longer term trends:</p> <p>At Cattersty Sands, the winter erosion dominates the overall behaviour of the beach but the calmer weather in the summer months should lead to some accretion. If the erosion of the upper beach continues it is likely to drive cliff failures which would add material to the upper beach for redistribution.</p>

- As is the seasonal pattern, Cattersty Sands has been dominated by erosion over the winter of 2023/24. The most notable change has occurred to the west of the breakwater, where the upper beach has experienced a significant drop in level. Whilst this does raise some concerns regarding the exposure of the cliffs to increased erosion, it is expected that this will only be temporary and that the area will recover in the coming months. This area was subject to notable accretion over the previous summer and so, to an extent, may be balancing itself out.

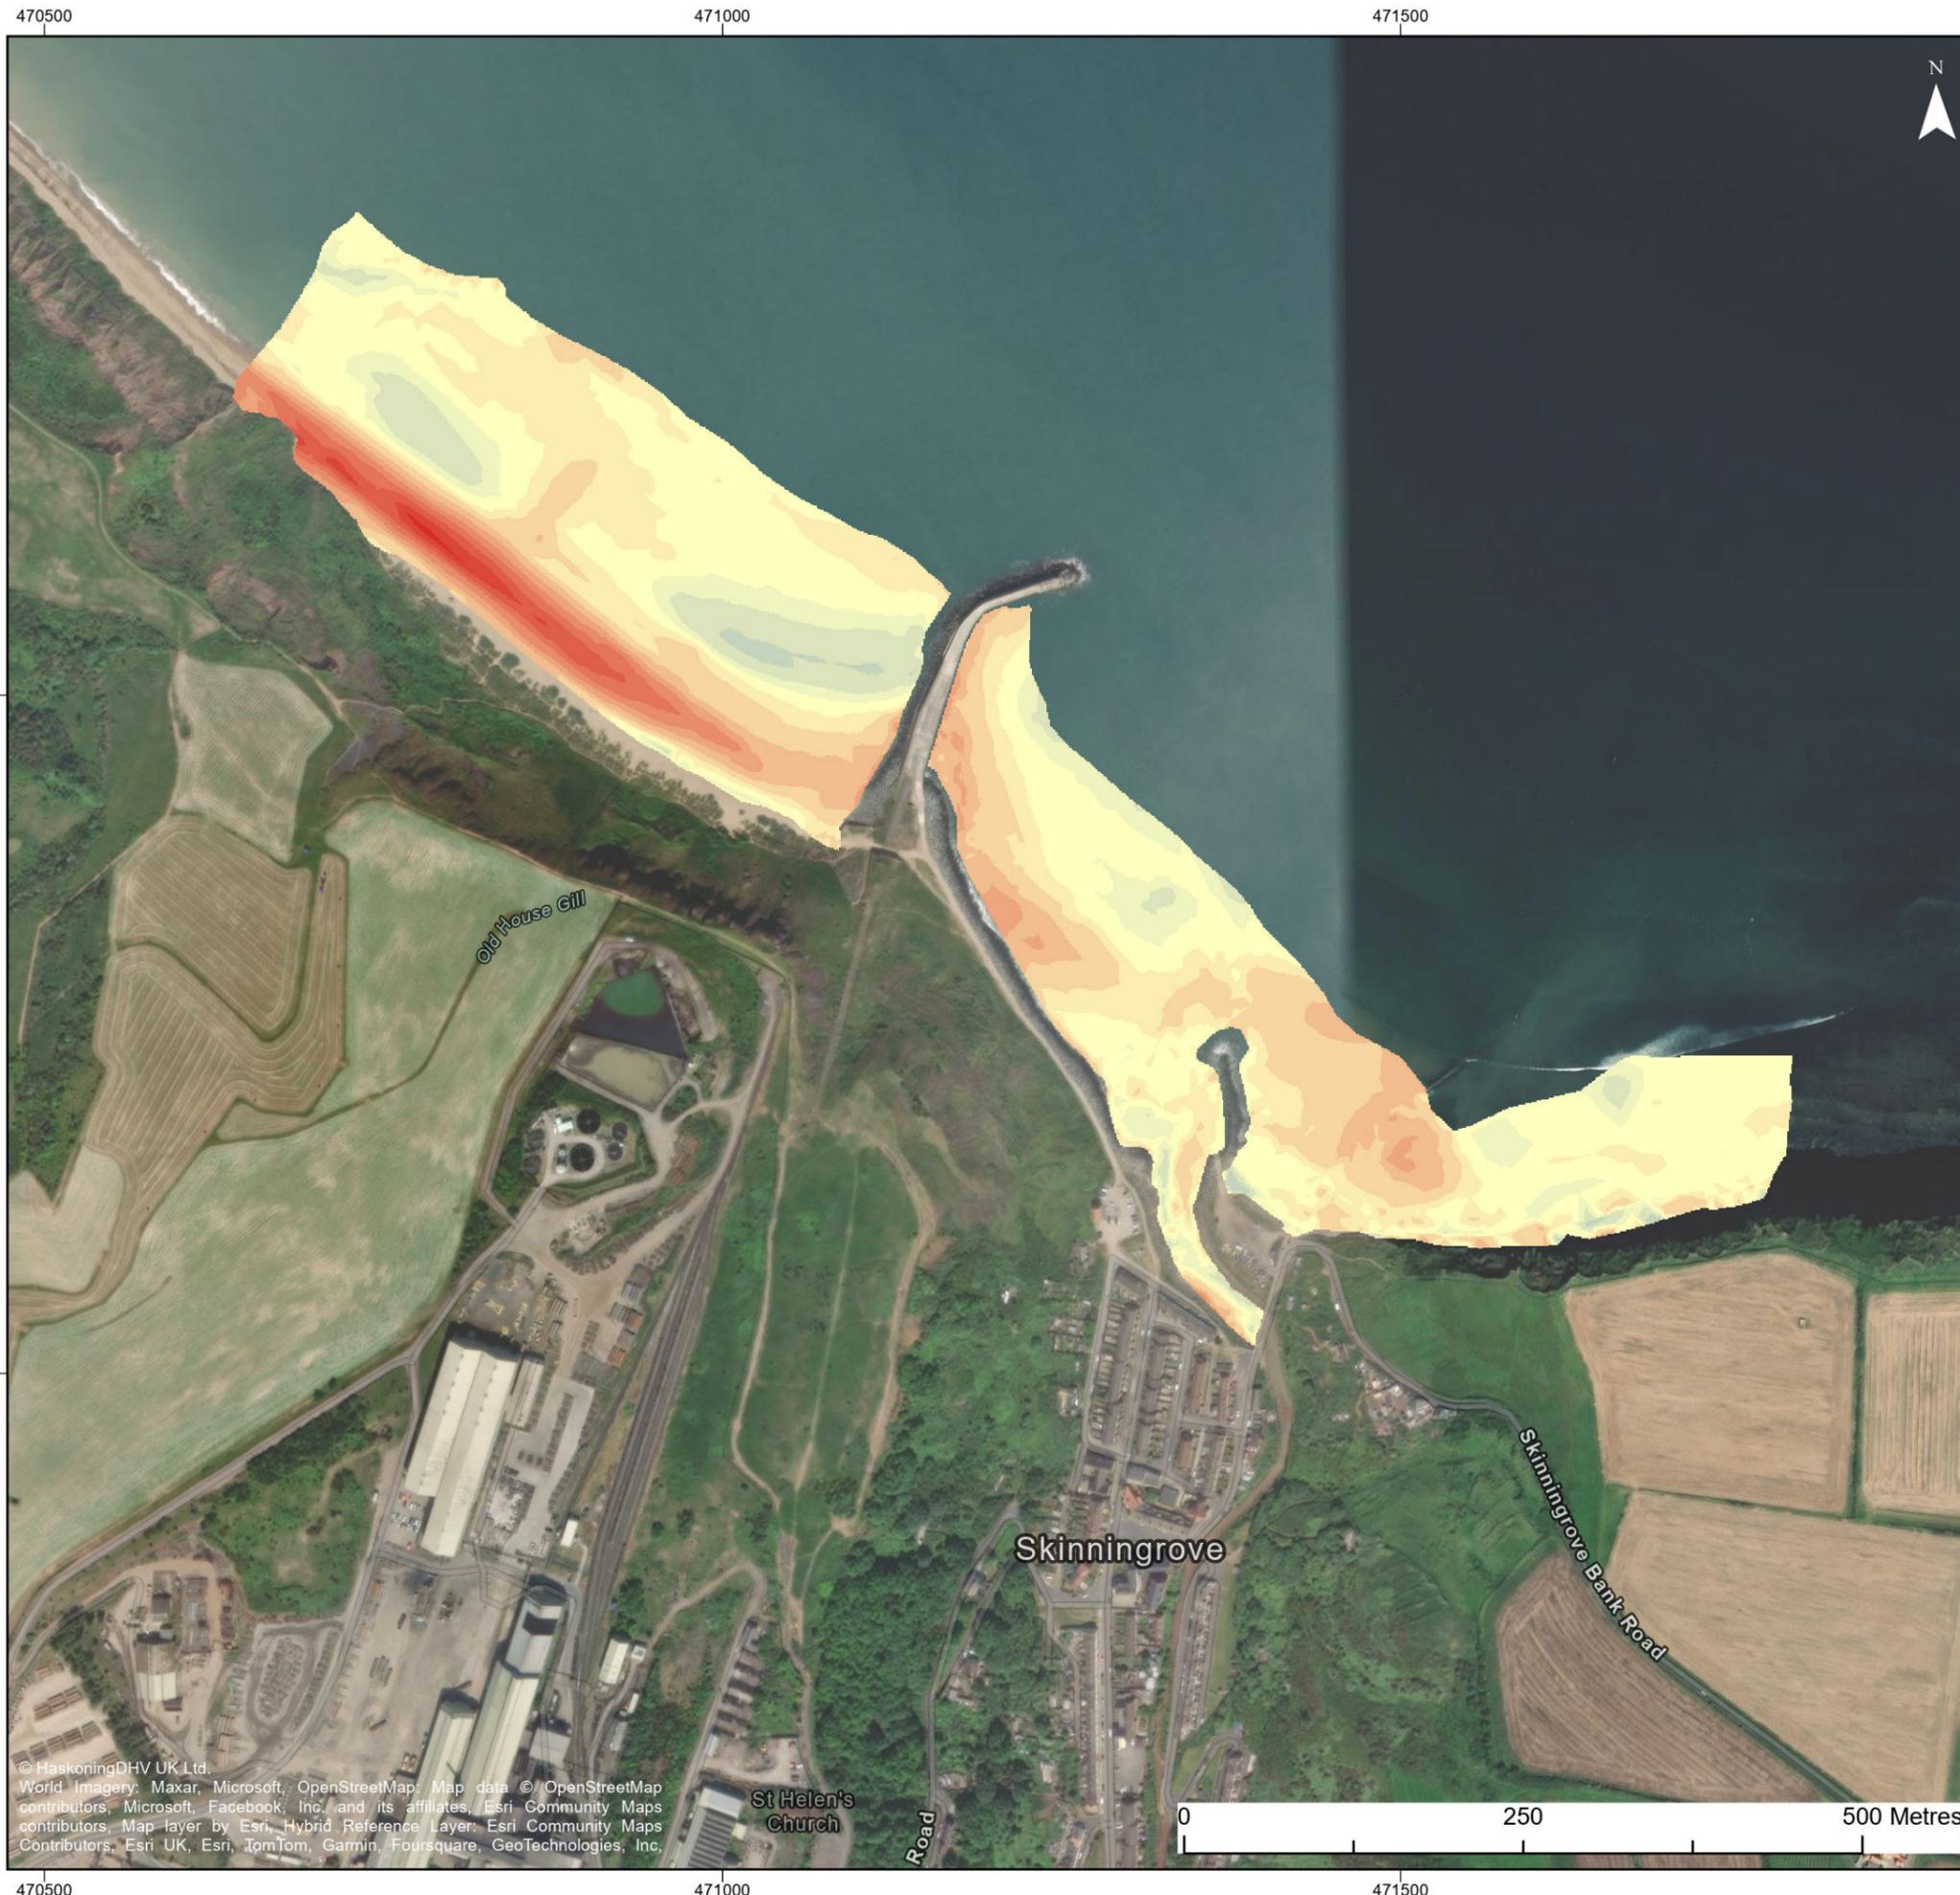
Appendix B - Map 6

Difference between topographic surveys
(Nov 2023 to Apr 2024)
