Cell 1 Regional Coastal Monitoring Programme Update Report 16: 'Partial Measures' Survey 2024

North Yorkshire Council

June 2024

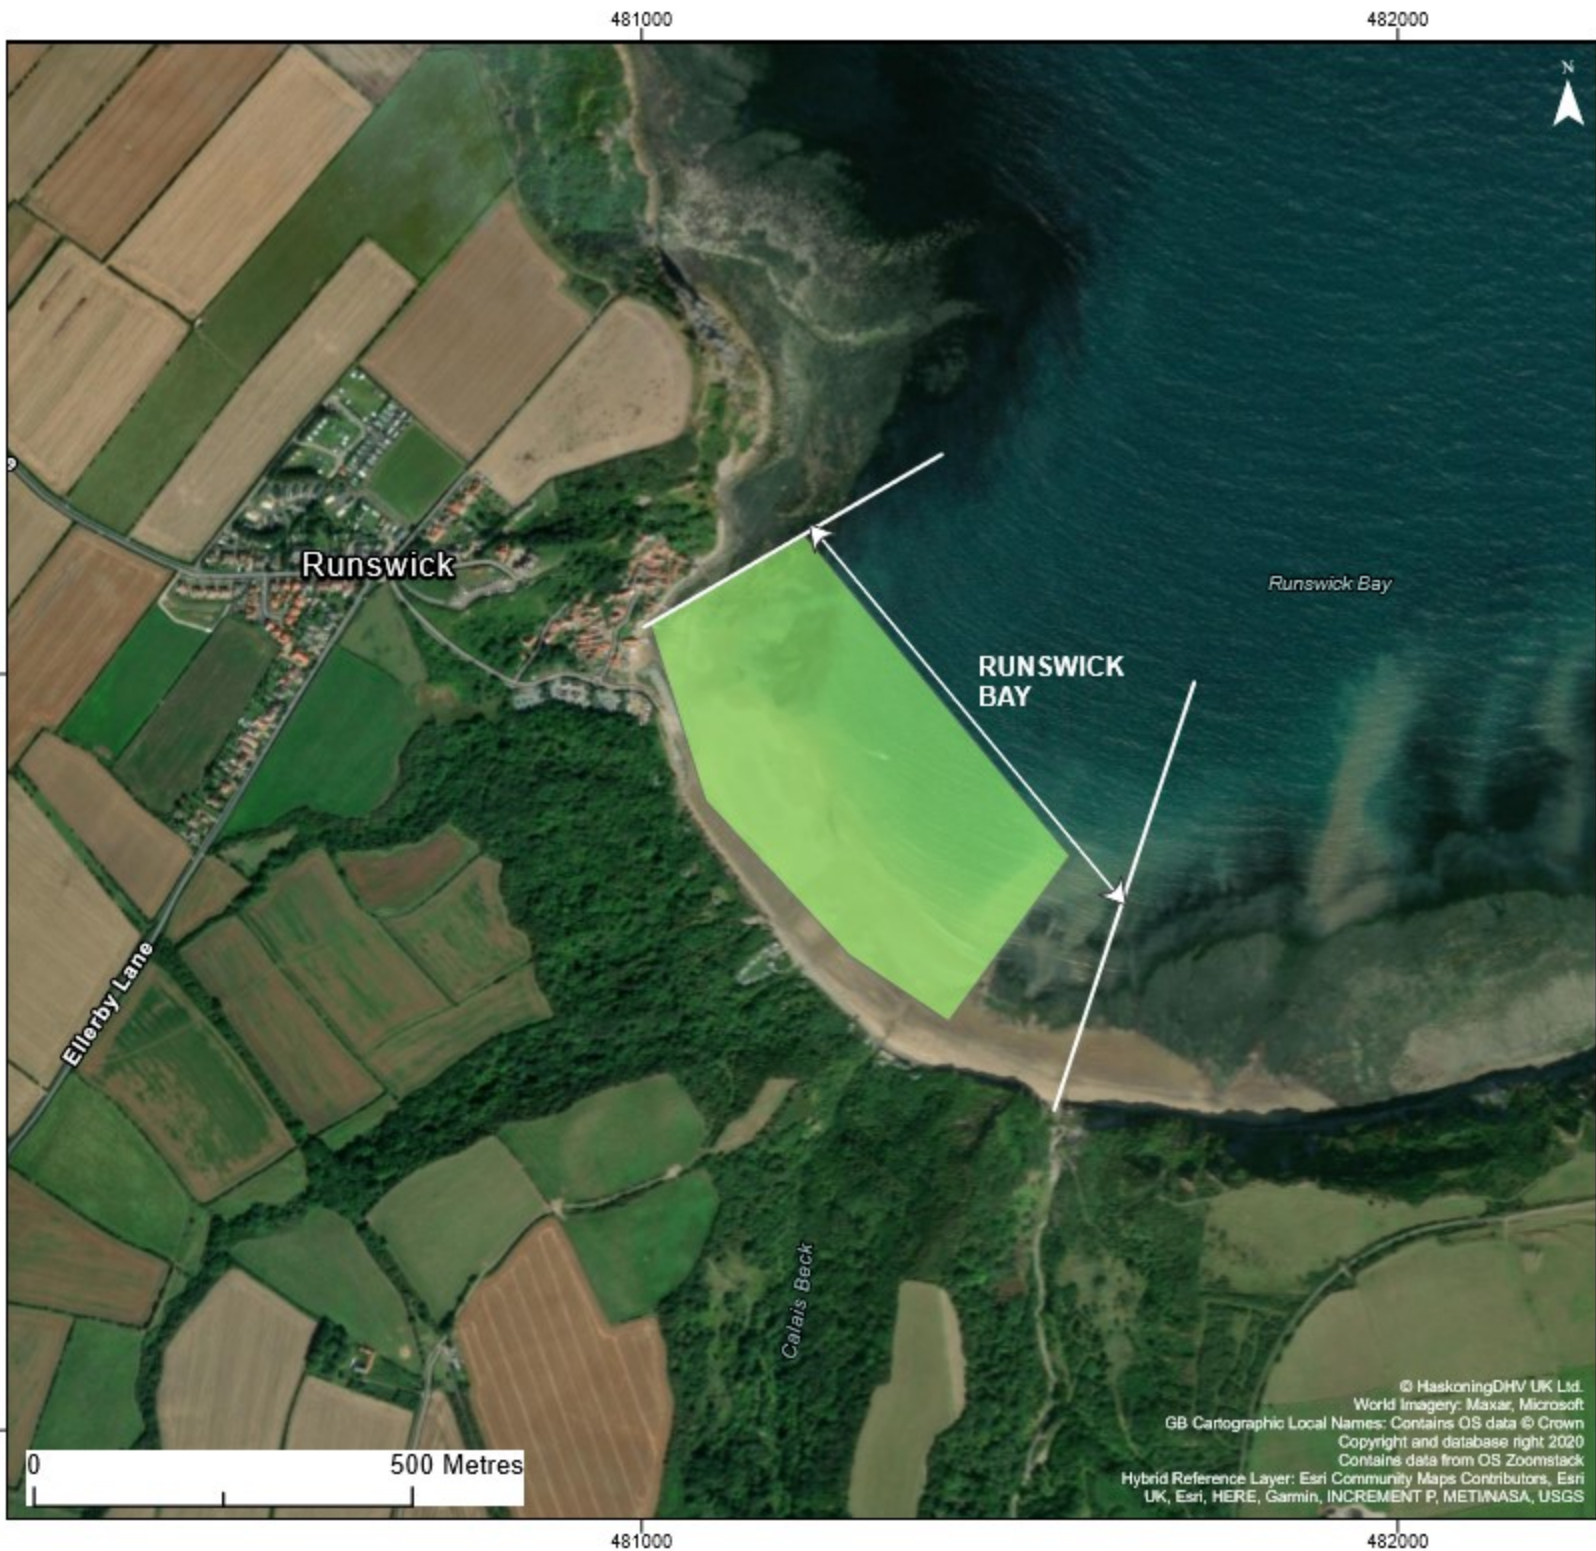
Title: **Figure 2 - Map 1**
RUNSWICK BAY
Scarborough Borough Council Frontage

The location of these surveys is shown in Figure 2. The Partial Measures survey was undertaken along this frontage between 27th Feb and 11th April 2024, more specifically:

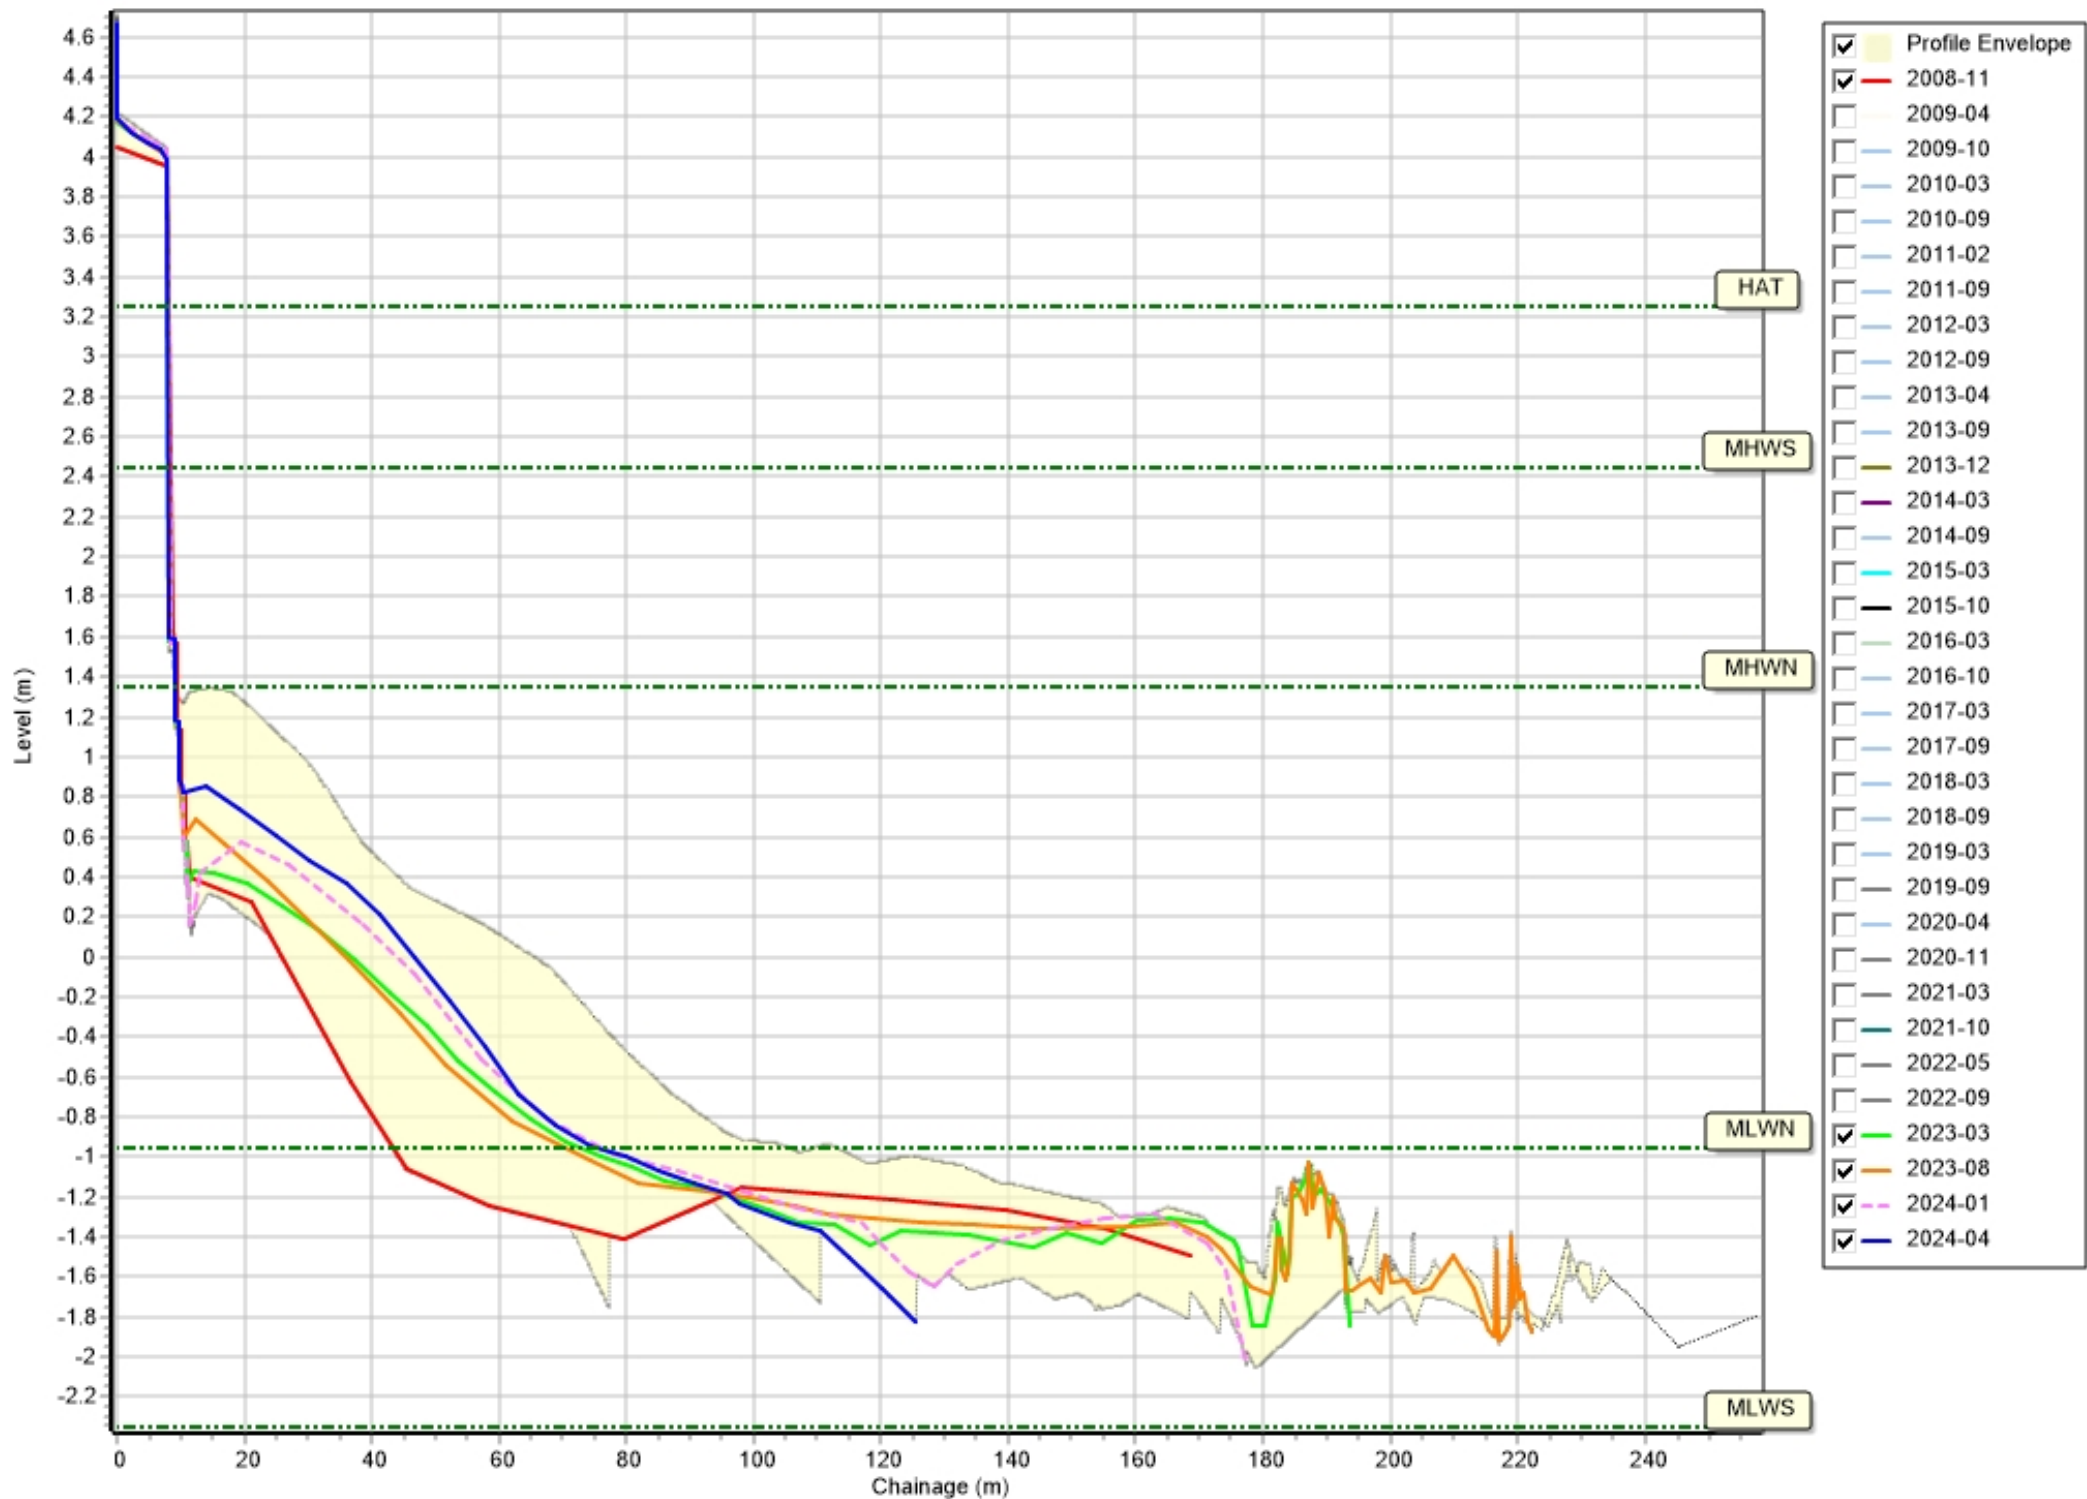
Profiles: 1dSBN2

- Scarborough North Bay experienced a net erosion over Winter 2023 / 2024 with material being draw down the profiles, particularly in the south (as was recorded in the January 2024 post storm survey). Since this post storm survey however, it appears there has some signs of recovery with accretion occurring, particularly on the upper and middle sections of the profiles. Although levels have not fully recovered to those observed pre-storms it is an encouraging start.

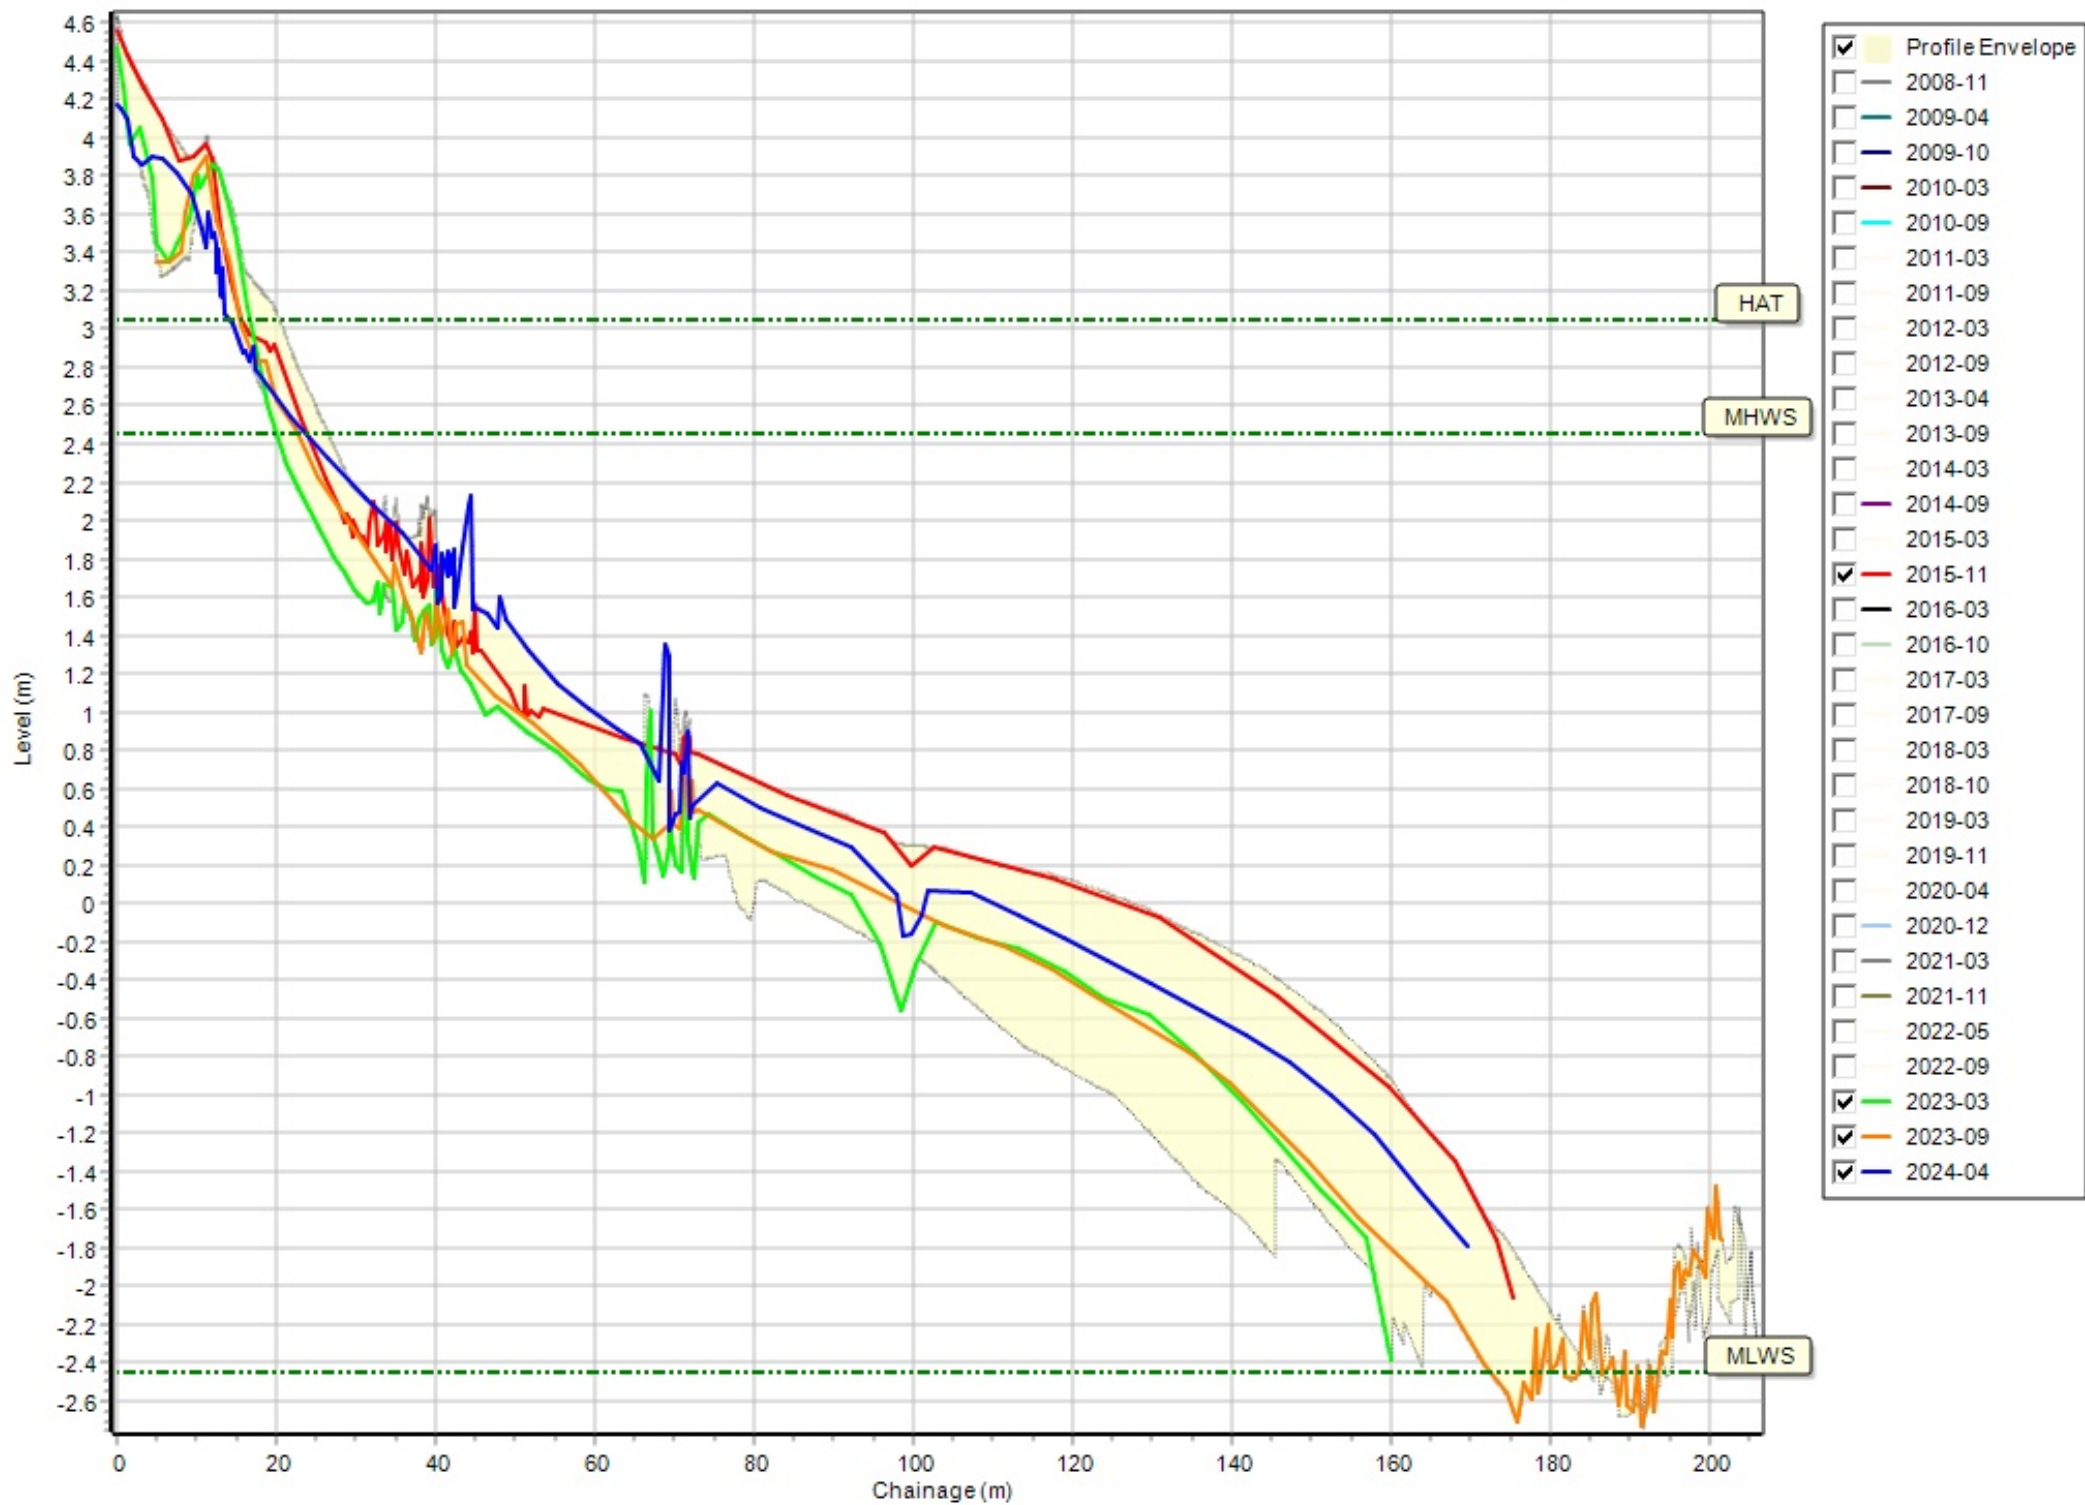
Profiles: 1dCY1

- At Cayton Bay, the winter storms have resulted in the erosion of material from the upper beach with the partial redistribution to the lower beach. This drop in beach levels coincides with the apparent increase in erosion activity in the cliff face, including a mud slide at profile 1dCY2 that has temporarily advanced the 'toe' of the cliff seawards 2m. The decimation of the cobble berm in profile 1dCY1A and the dismantling of the WW2 pillbox in profile 1dCY3, both not observed before, highlight the severity of the storms over Winter 2023/2024.

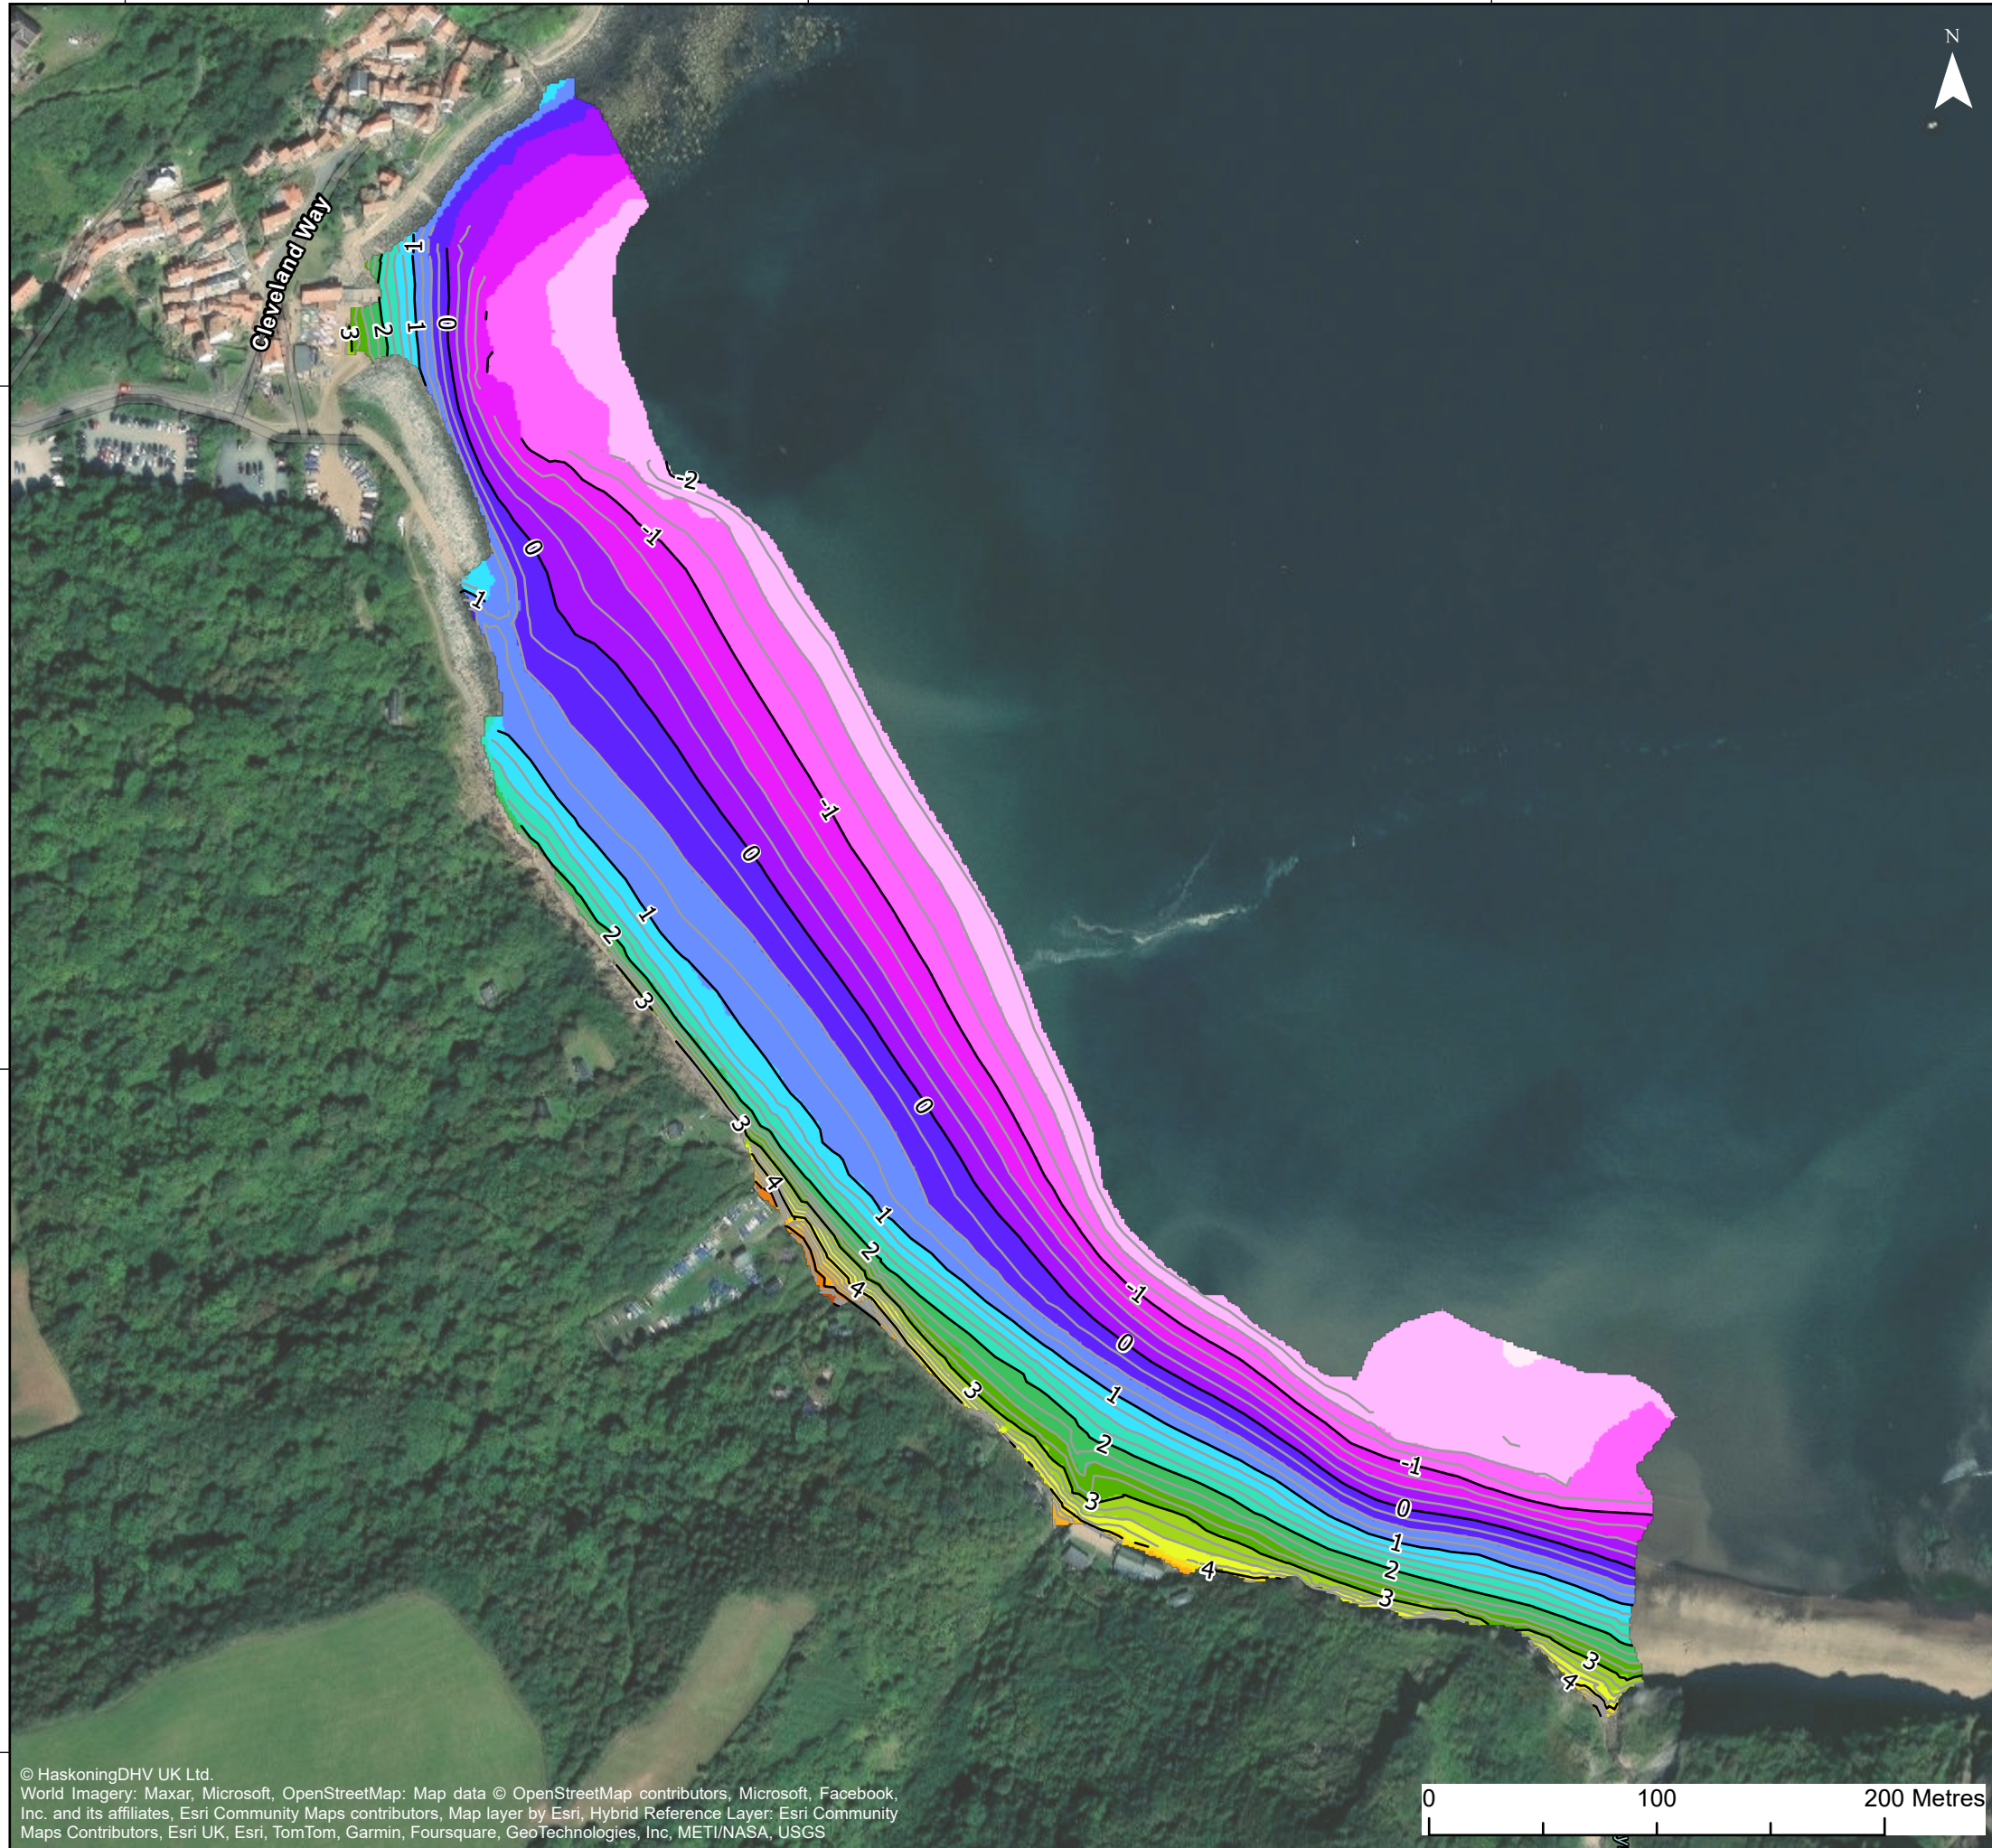
TOPOGRAPHIC SURVEY (February 2024)

- At Runswick Bay, as in previous years, the bay appears to have experienced seasonal fluctuation with a drawdown of material from the upper beach to the lower beach, typical of winter conditions. The magnitude of change is modest and not a cause for concern.

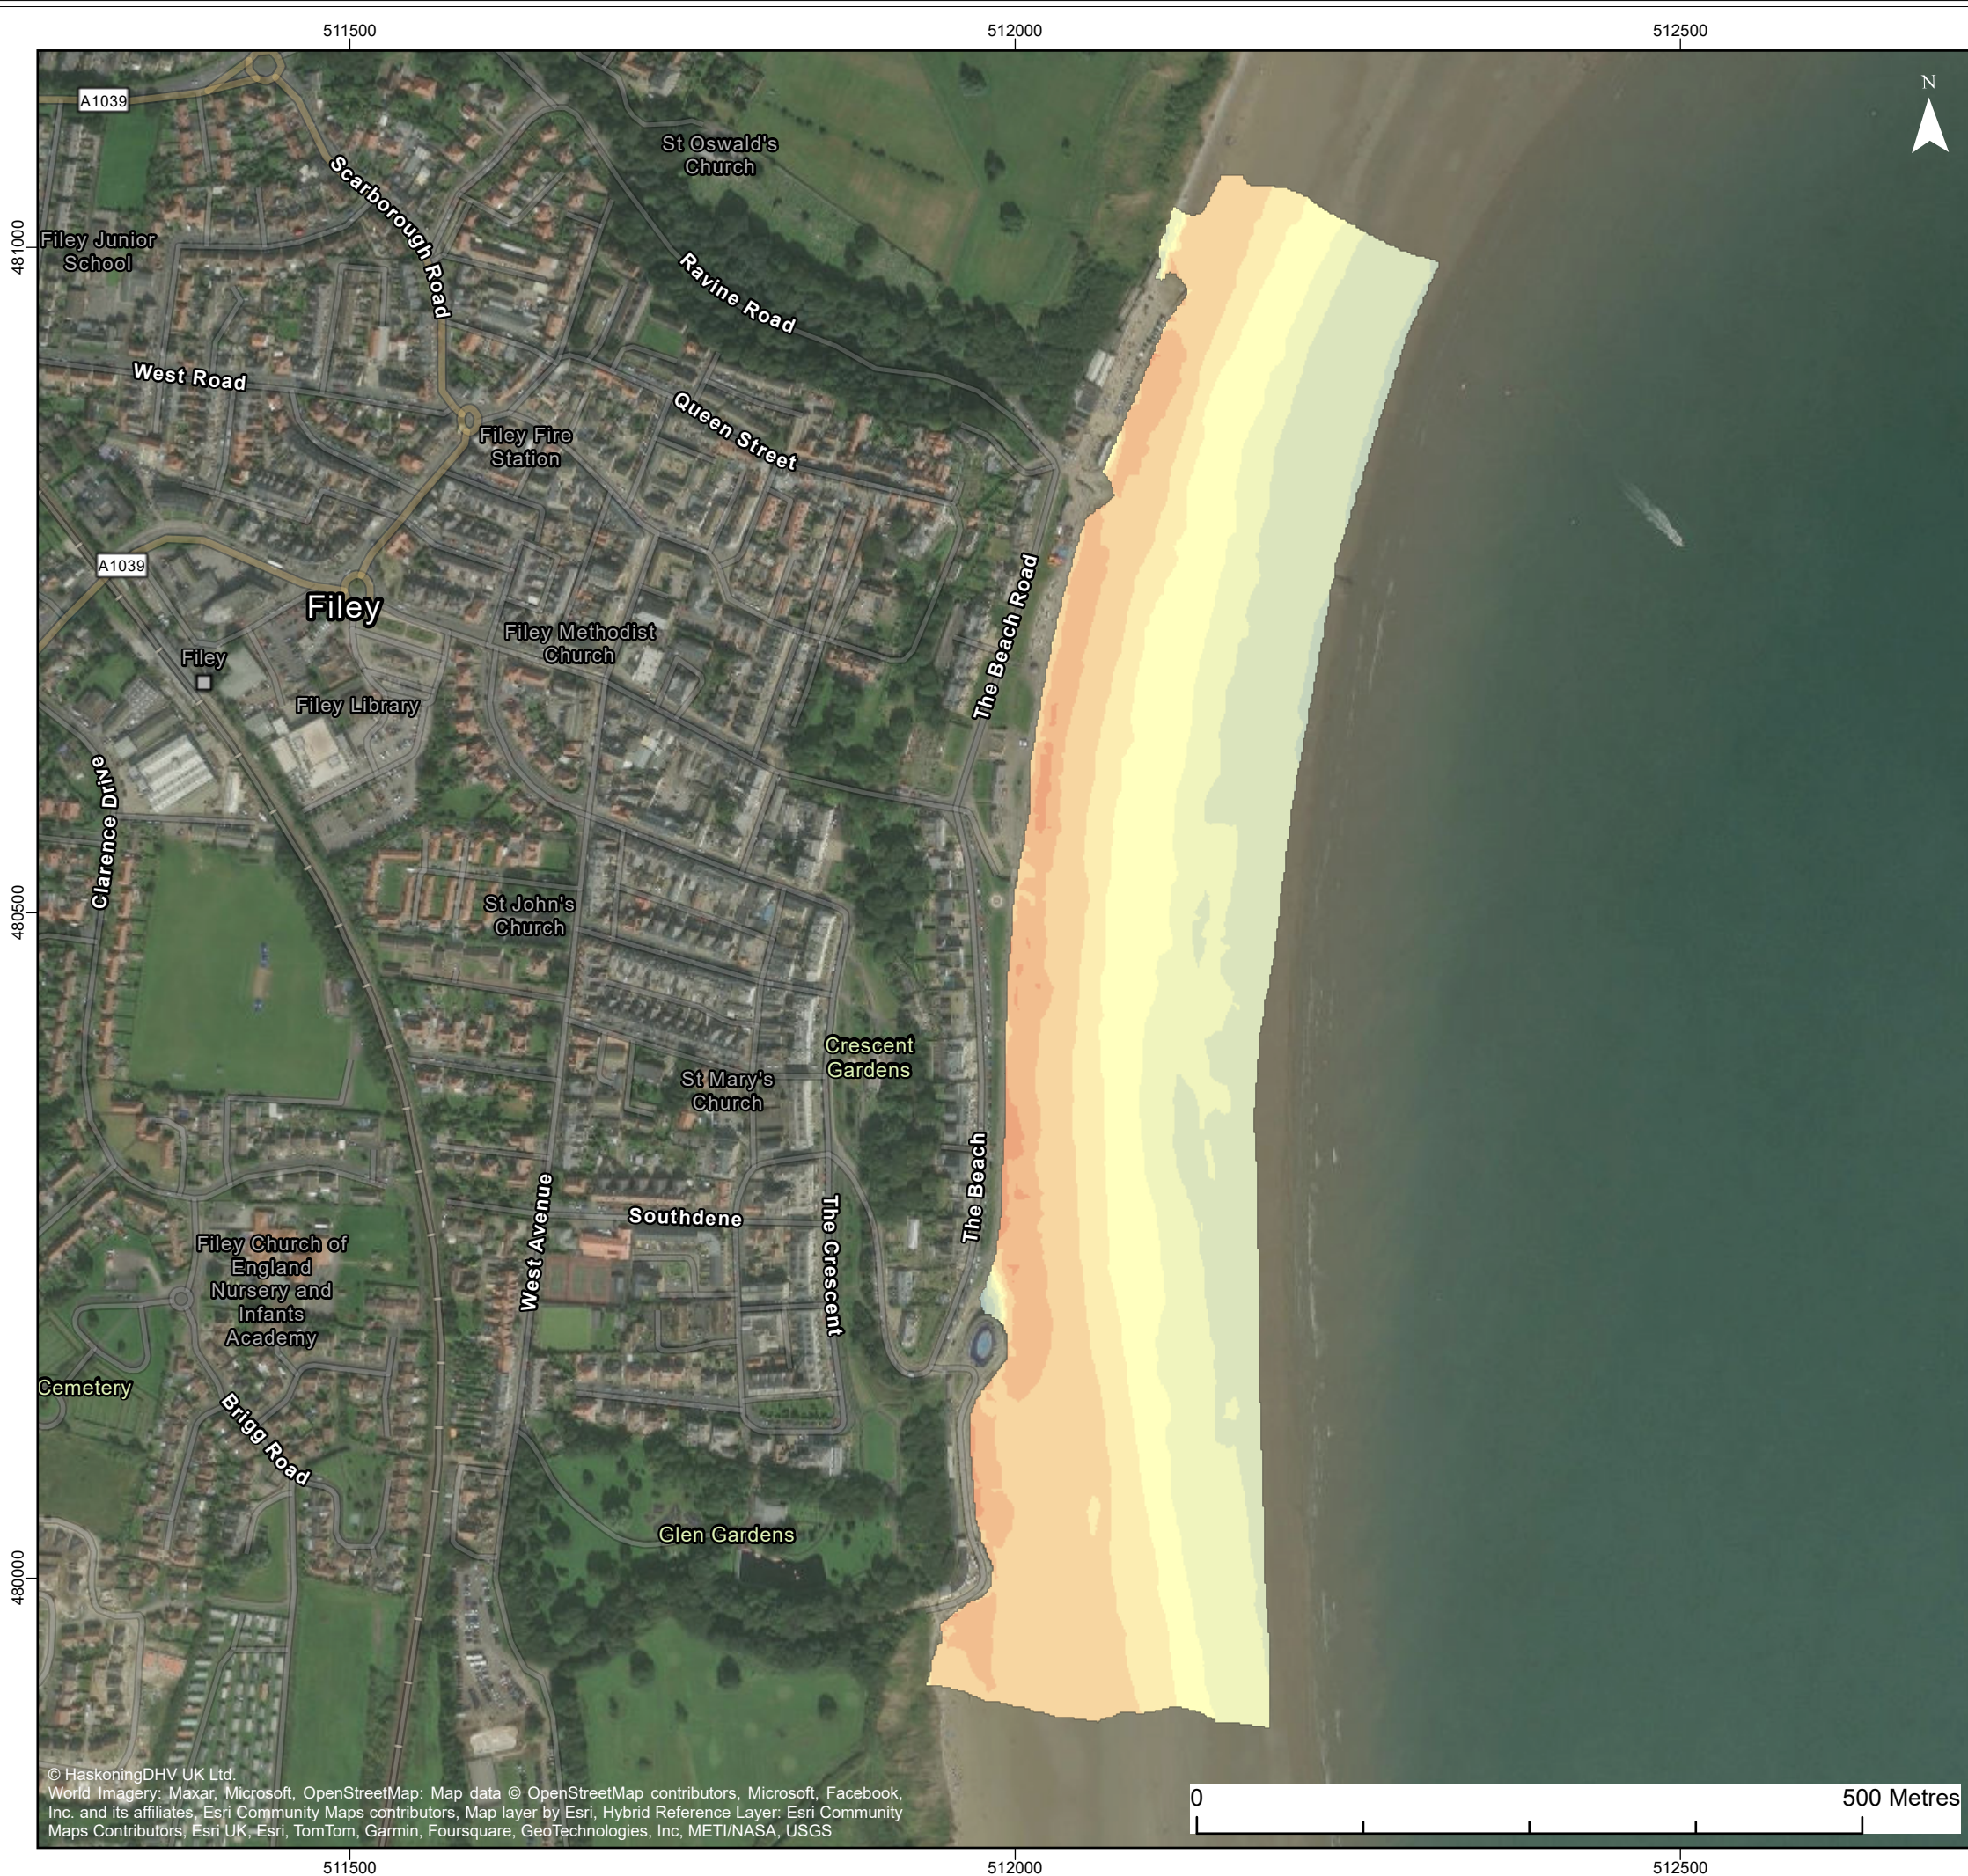
Title:
Appendix B - Map 6
FILEY
North Yorkshire Council

- At Filey Bay, erosion has dominated the beach, particularly across the upper and central sections. All of the profiles are at a very low level on the upper beach (compared to the range of the previous surveys) with several actually at the lowest on record. The profiles also generally show accretion on the lower beach indicating a drawdown of material, a typical response to winter conditions. The low beach levels provide some cause for concern, particularly along the undefended sections, where an increase in rate of erosion would be expected until the beach levels recover.
