Appendix C

Cliff Top Survey

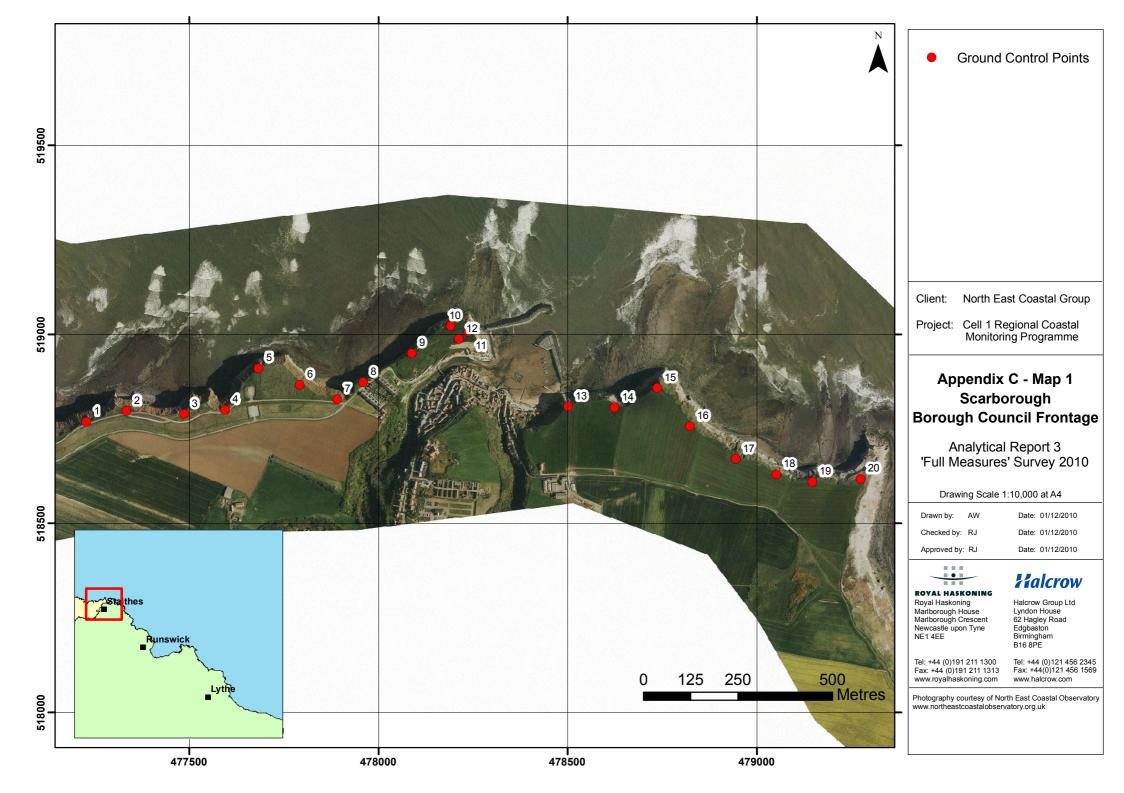
Twenty ground control points have been established at Staithes (Appendix C- Map 1). The maximum separation between any two points is nominally 100 m.

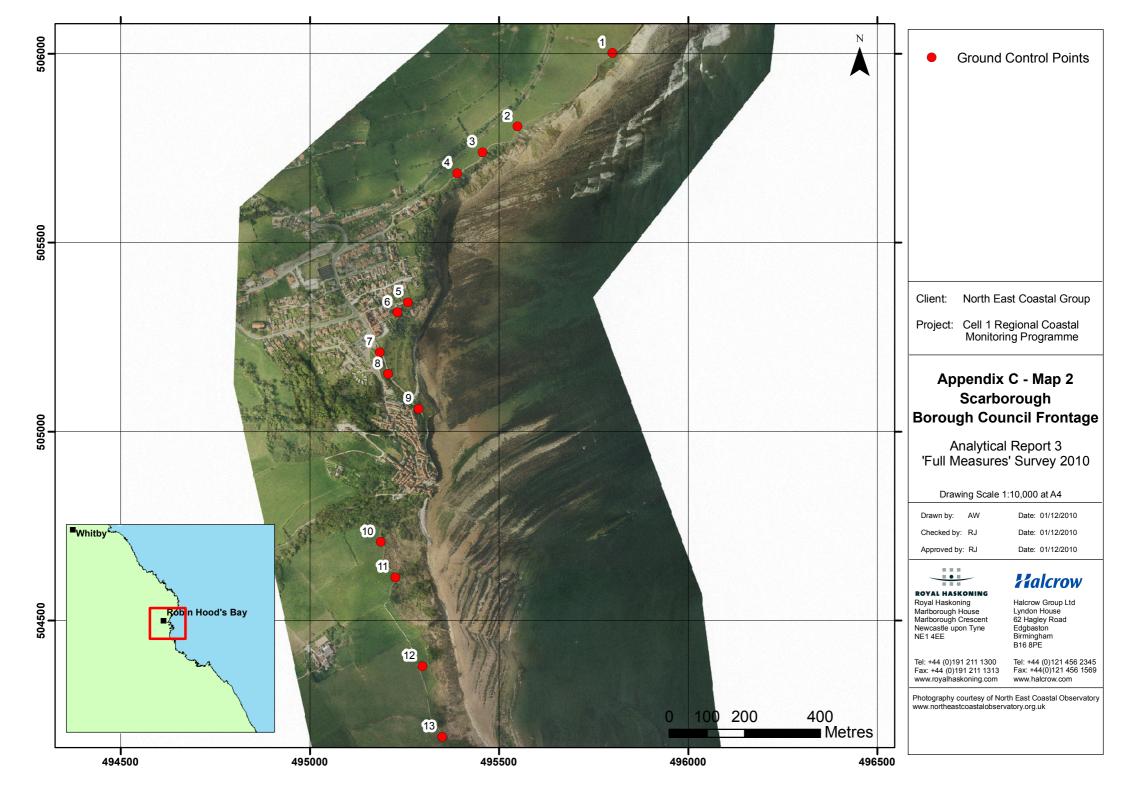
Thirteen ground control points have been established at Robin Hood's Bay (Appendix C- Map 2). The maximum separation between any two points is nominally 100 m.

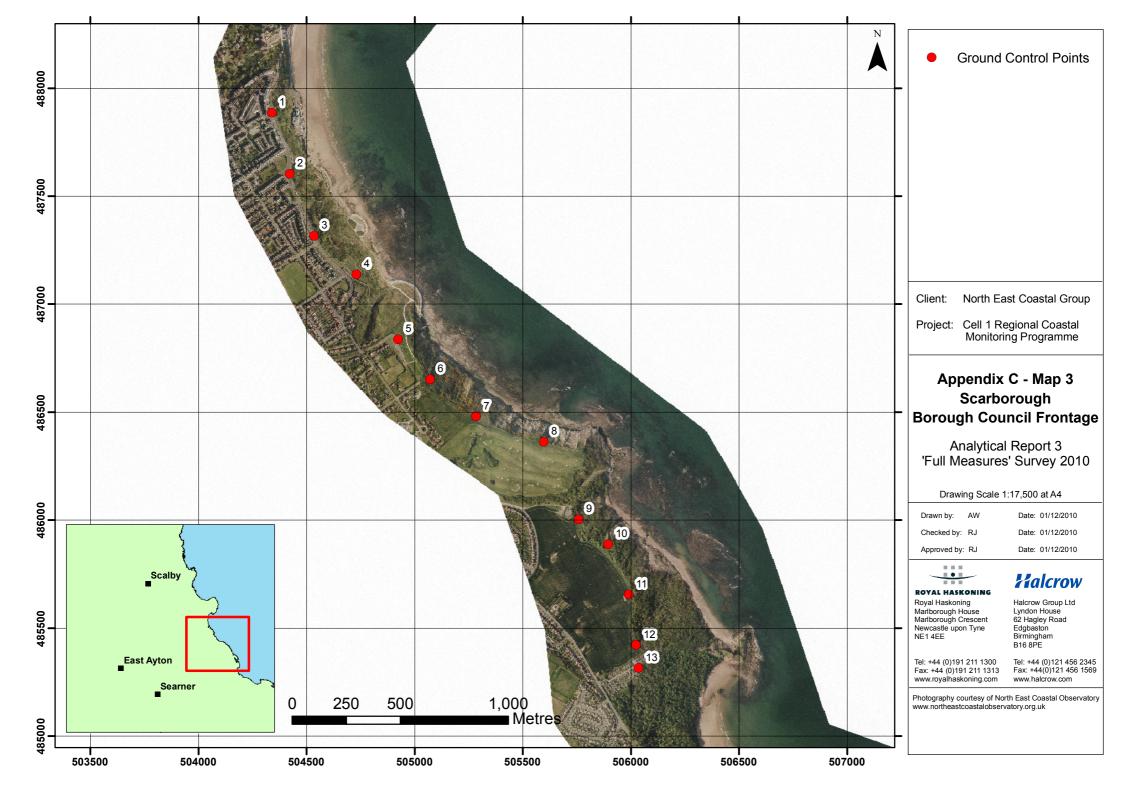
Thirteen ground control points have been established at Scarborough South Bay (Appendix C- Map 3). The maximum separation between any two points is nominally 300 m.

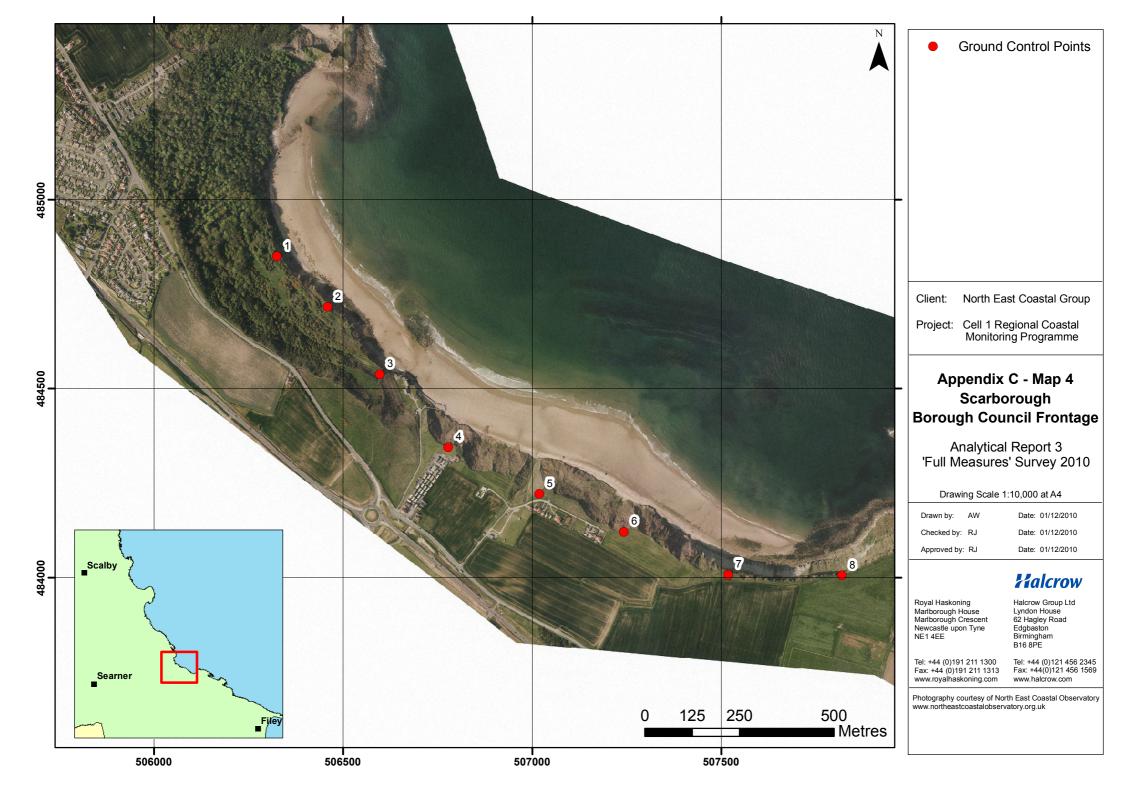
Eight ground control points have been established within Cayton Bay (Appendix C- Map 4). The maximum separation between any two points is nominally 300m.

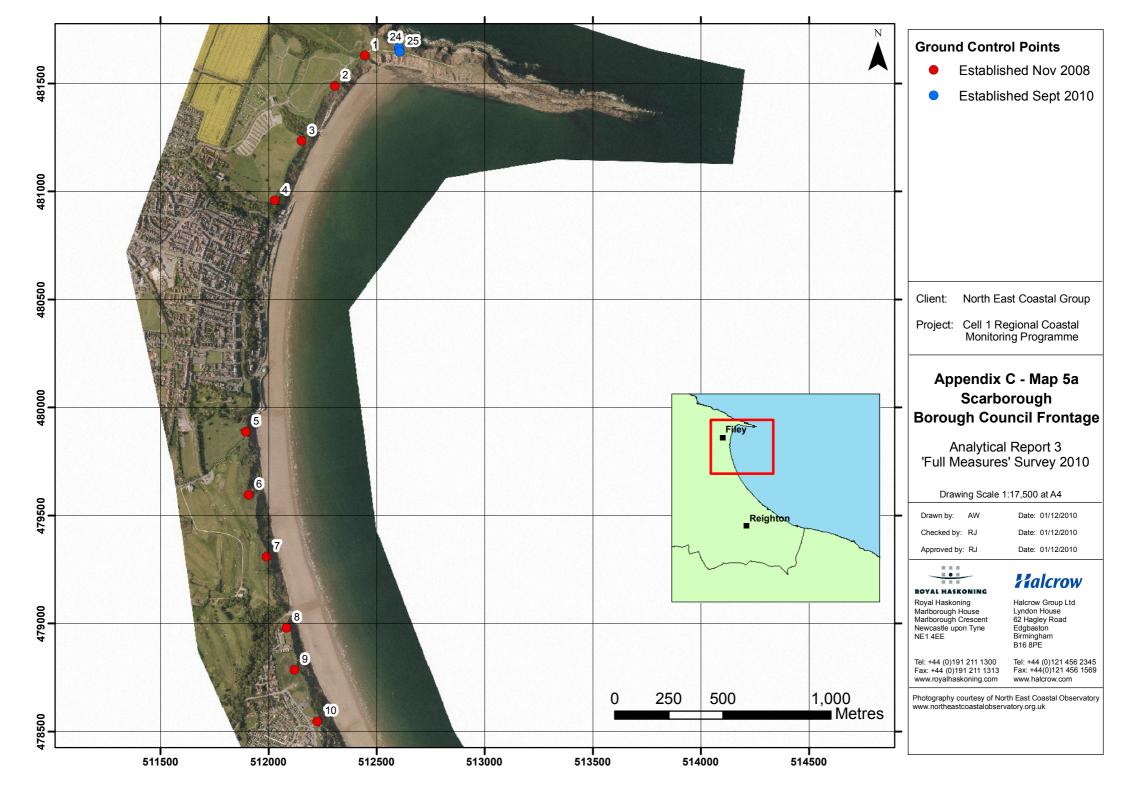
Twenty-three ground control points have been established within Filey Bay (Appendix C- Map 5). The maximum separation between any two points is nominally 300 m.
