**Cell 1 Regional Coastal Monitoring Programme  
Analytical Report 2: 'Full Measures' Survey 2009**

**Scarborough Borough Council  
Final Report**

**March 2010**

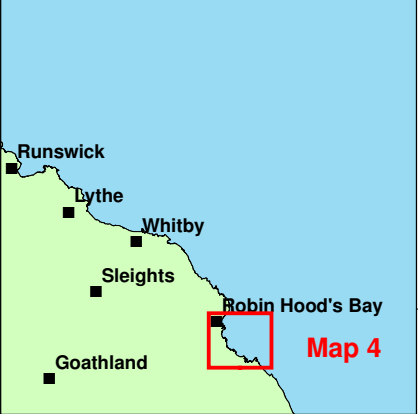
**SURVEY LOCATIONS**

**Topographic Profiles**

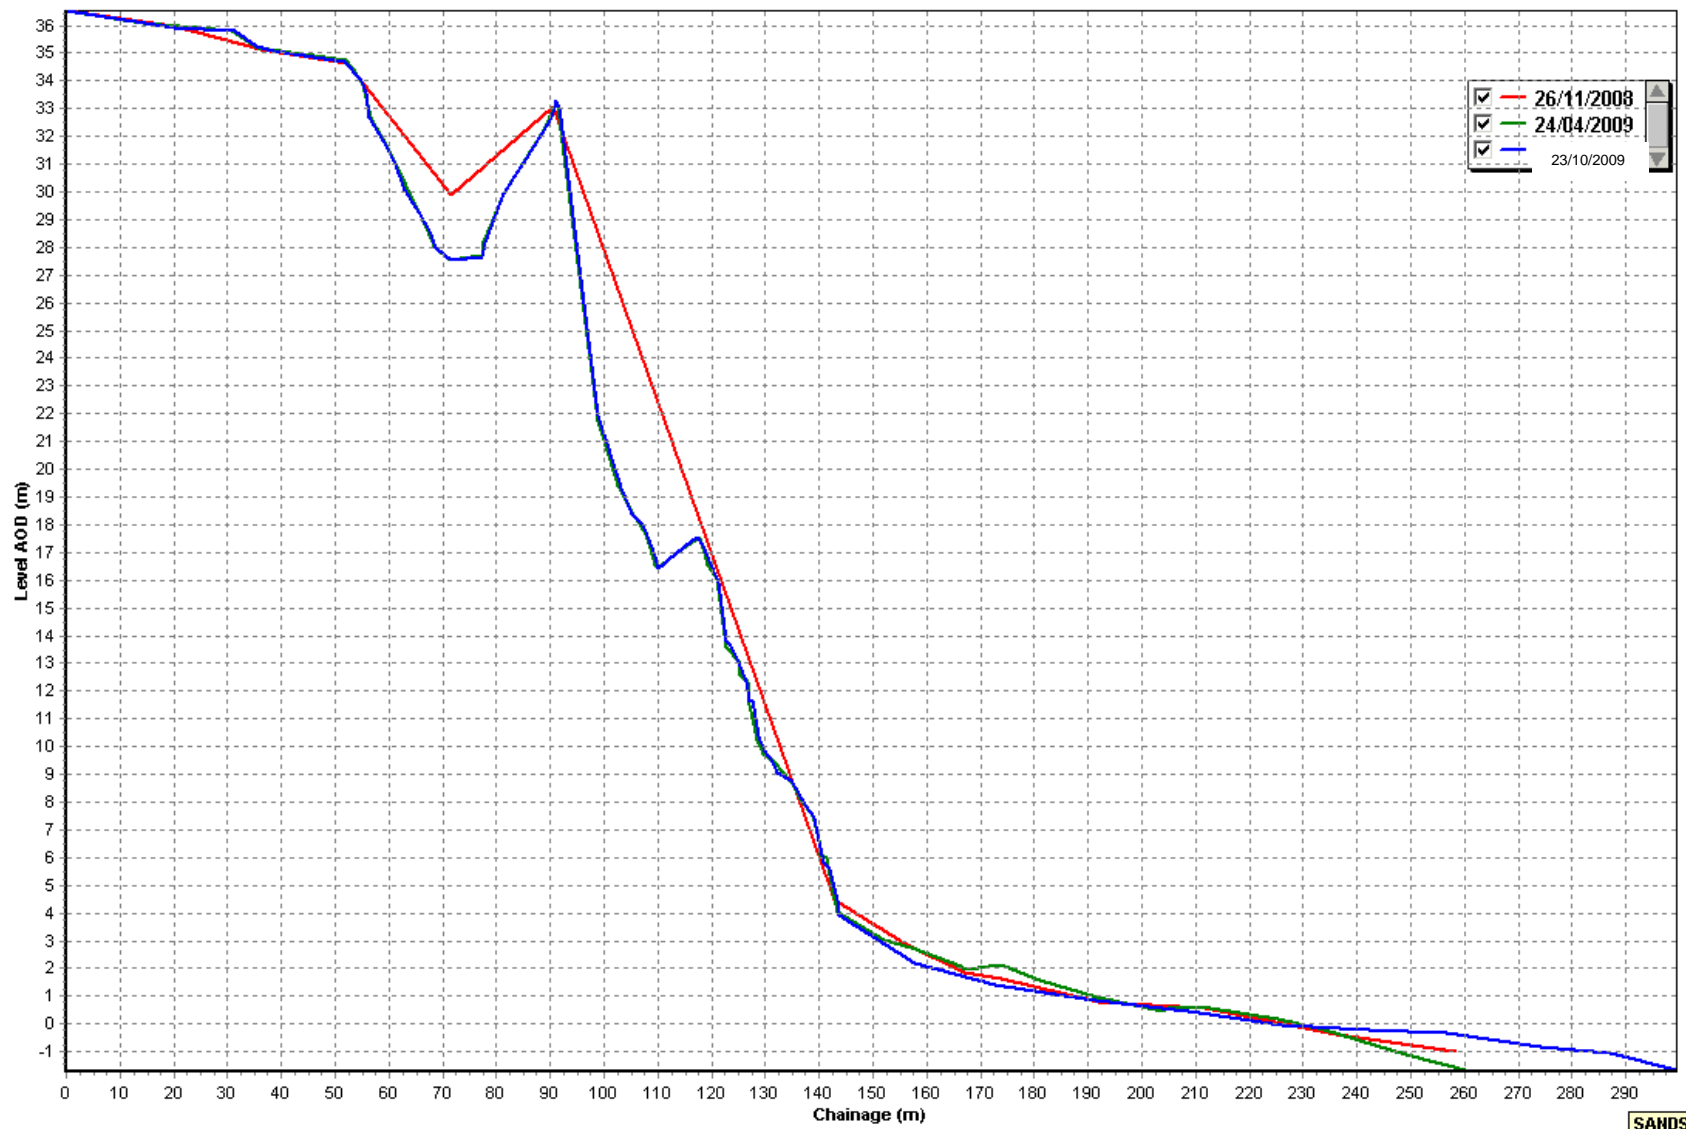
Beach Profiles: 1dWB2

# Beach Profile

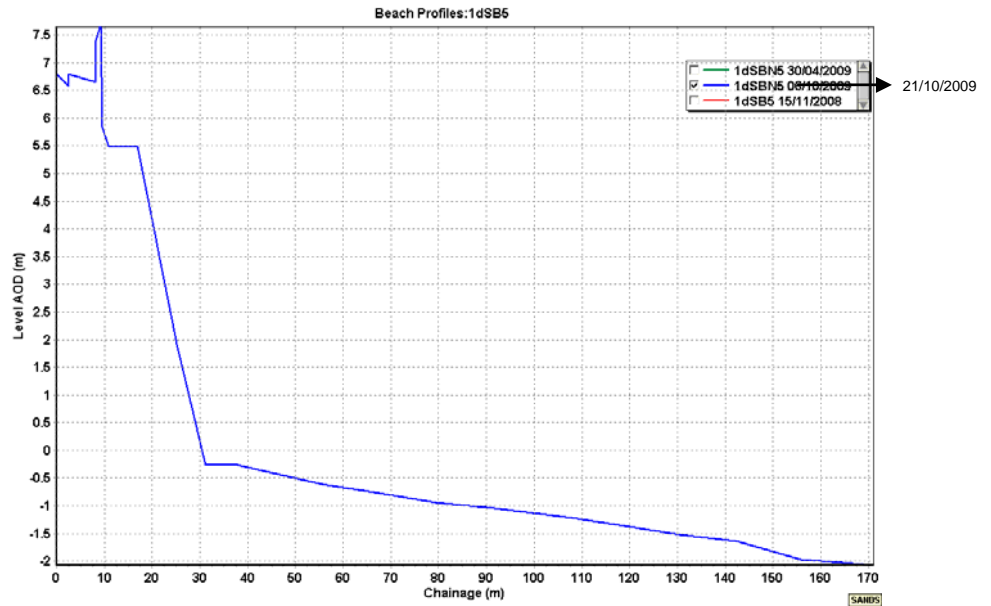
### Beach Profiles:1dSB5

Chainage (from base station)	Level AOD (m)
0	6.793
0.001	6.793
2.504	6.58
2.576	6.796
8.228	6.646
8.231	6.652
8.235	7.361
8.283	7.397
8.986	7.645
9.164	7.645
9.489	5.833
10.856	5.495
14.148	5.474
16.925	5.496
25.081	1.919
31.109	-0.257
37.935	-0.263
55.596	-0.612
66.561	-0.755
79.434	-0.944
91.616	-1.037
107.868	-1.217
118.982	-1.367
130.45	-1.522
142.235	-1.635
155.821	-1.967
171.058	-2.069

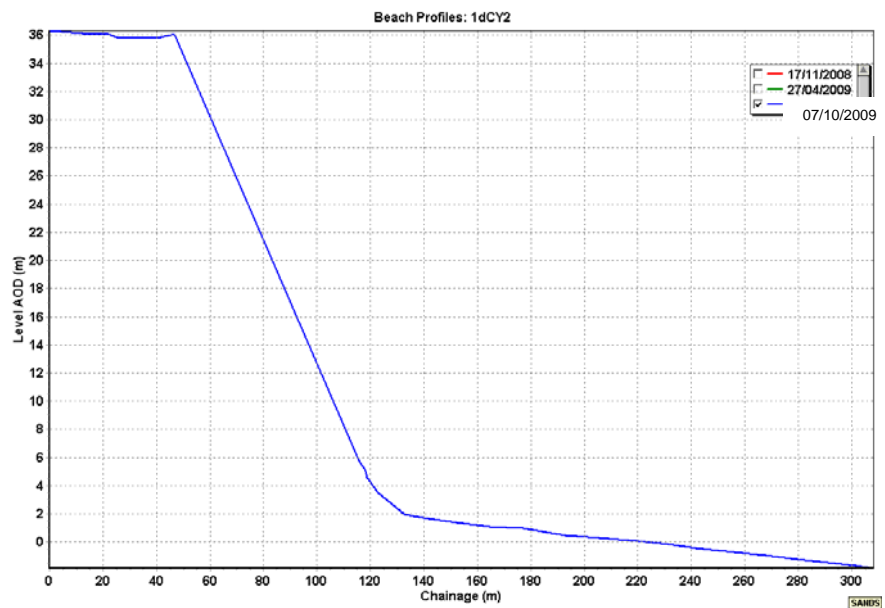
### Beach Profiles: 1dCY2

Chainage (from base station)	Level AOD (m)
0	36.301
0.016	36.301
16.431	36.079
20.926	36.146
26.112	35.797
40.508	35.809
46.652	36.068
115.809	5.774
118.026	5.097
118.909	4.574
119.91	4.282
122.668	3.519
132.871	1.924
139.713	1.738
152.3	1.389
164.557	1.085
177.007	0.963
193.025	0.5
205.487	0.319
220.175	0.049
231.28	-0.141
241.624	-0.421
253.024	-0.661
267.651	-0.953
279.603	-1.221
291.148	-1.486
301.434	-1.704
308.146	-1.856

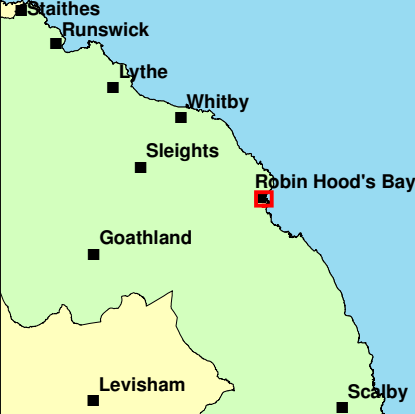
Elevation (m OD)

— Topographic Contours at 1 metre interval

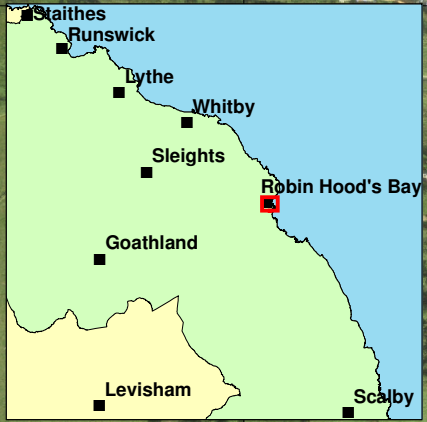
**Appendix B - Map 6**  
**Scarborough**  
**Borough Council Frontage**

**DIFFERENCE BETWEEN TOPOGRAPHIC SURVEYS**  
**April 2009 and Sept 2009**  
**Change in elevation (m OD)**

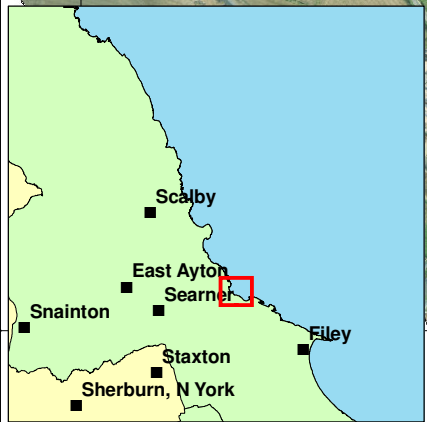
**Appendix B - Map 12**  
**Scarborough**  
**Borough Council Frontage**

**DIFFERENCE BETWEEN TOPOGRAPHIC SURVEYS**  
 Nov 2008 and Oct 2009  
 Change in elevation (m OD)

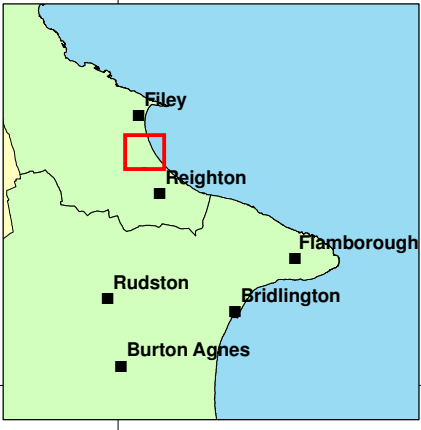
**Appendix B - Map 14b  
Scarborough  
Borough Council Frontage**

**DIFFERENCE BETWEEN TOPOGRAPHIC SURVEYS**

Nov 2008 and Oct 2009  
Change in elevation (m OD)

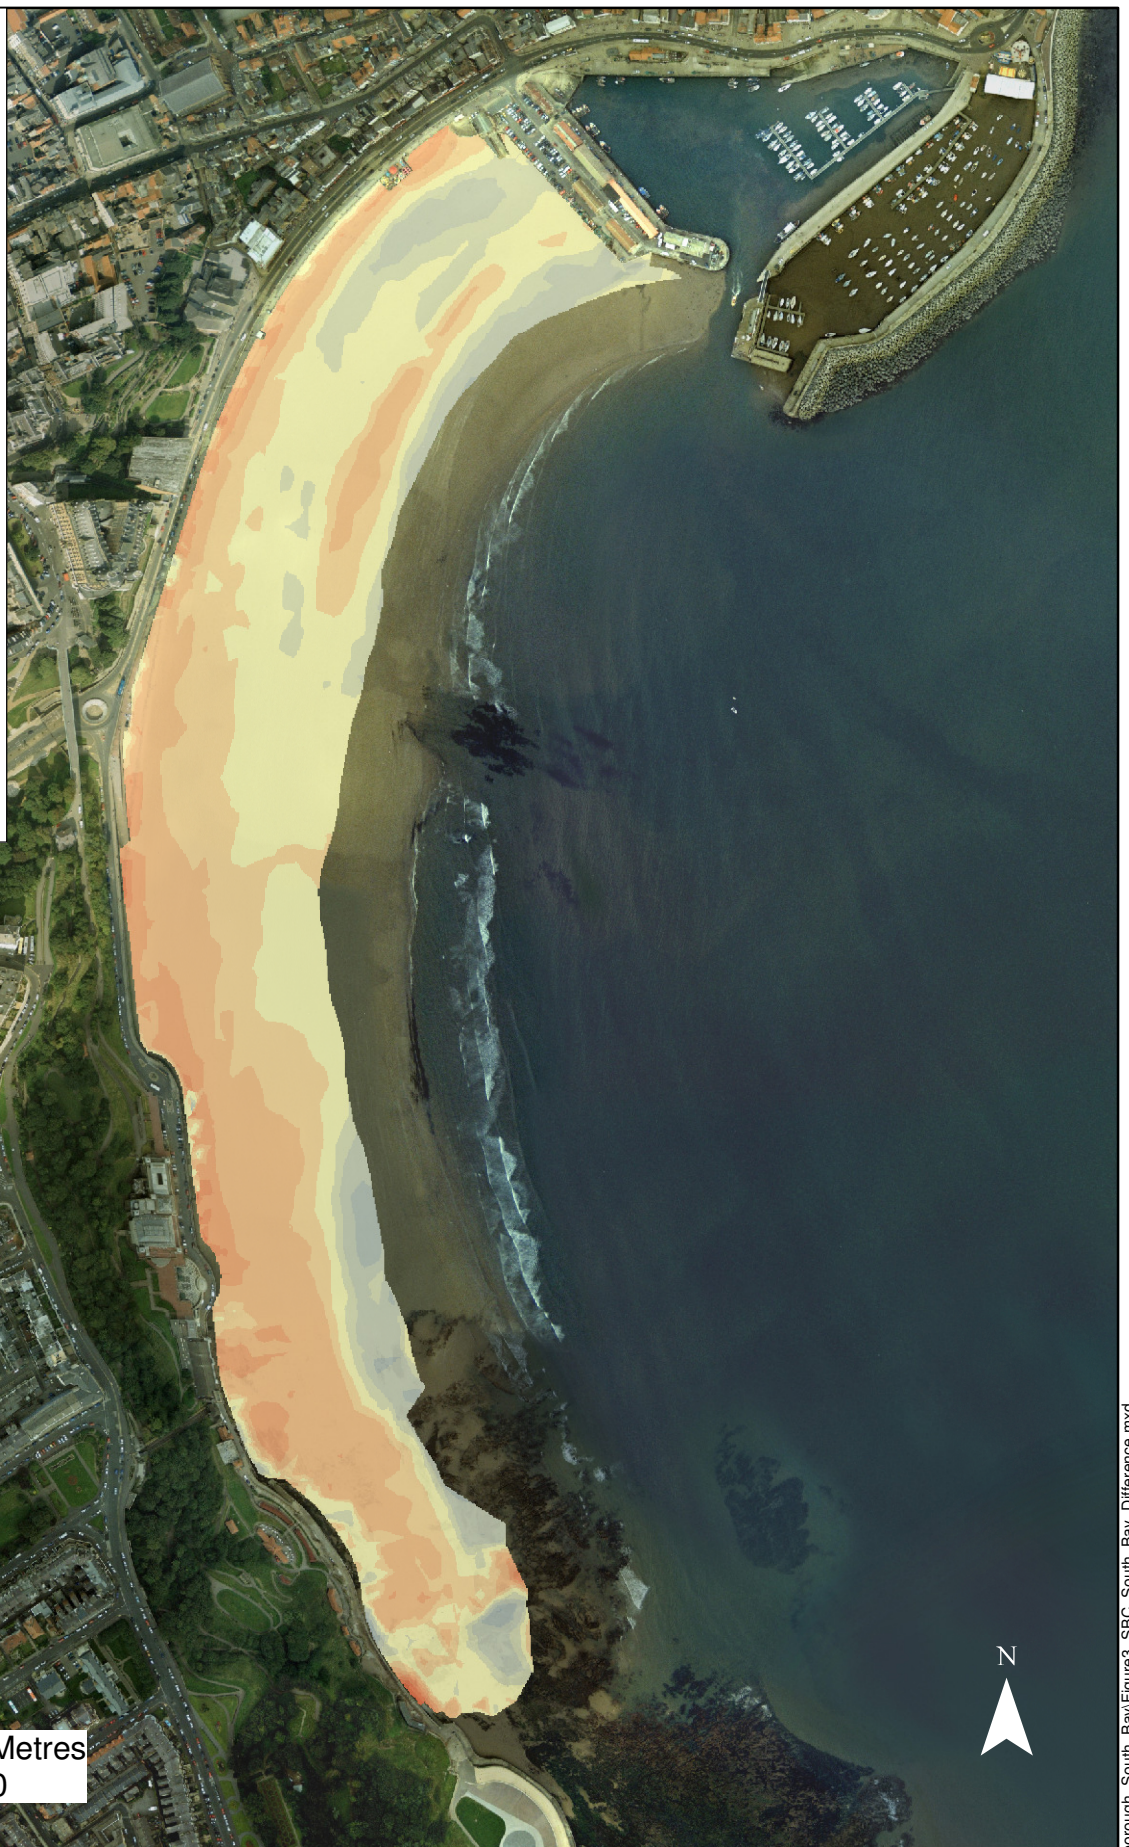
Oct 2009 and Jan 2010

Change in Elevation (m OD)

- Net Gain
- Unchanged
- Net Loss = 34,000 m<sup>3</sup>
