Cell 1 Regional Coastal Monitoring Programme Analytical Report 5 Full Measures Survey 2012

**Scarborough Council
Final Report**

March 2013

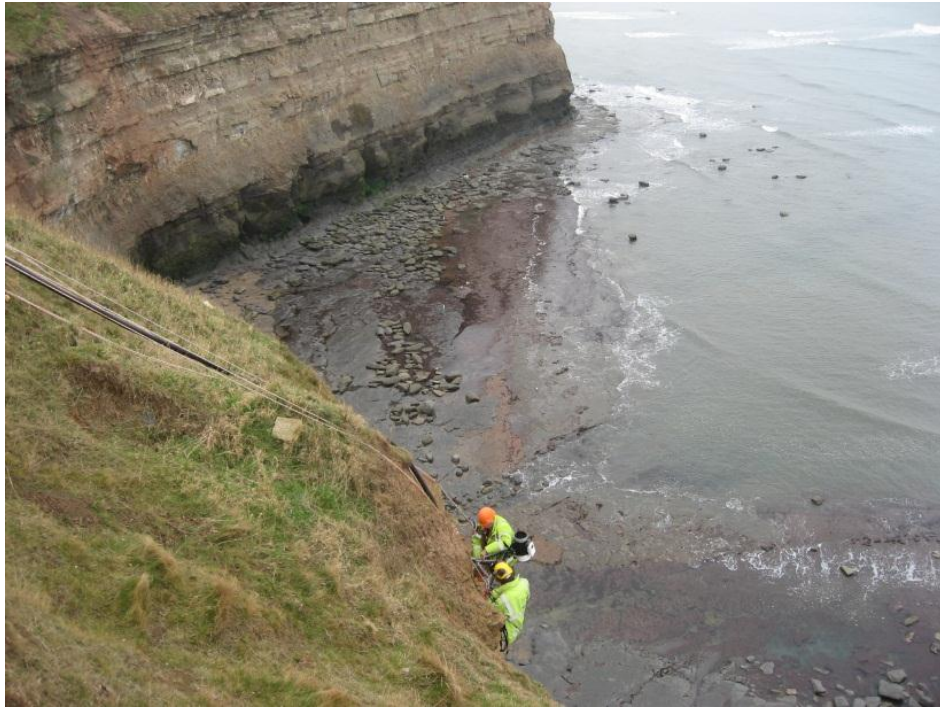
Figure 6 Installation of the cliff face instrumentation, including weather station, laser radar and camera.

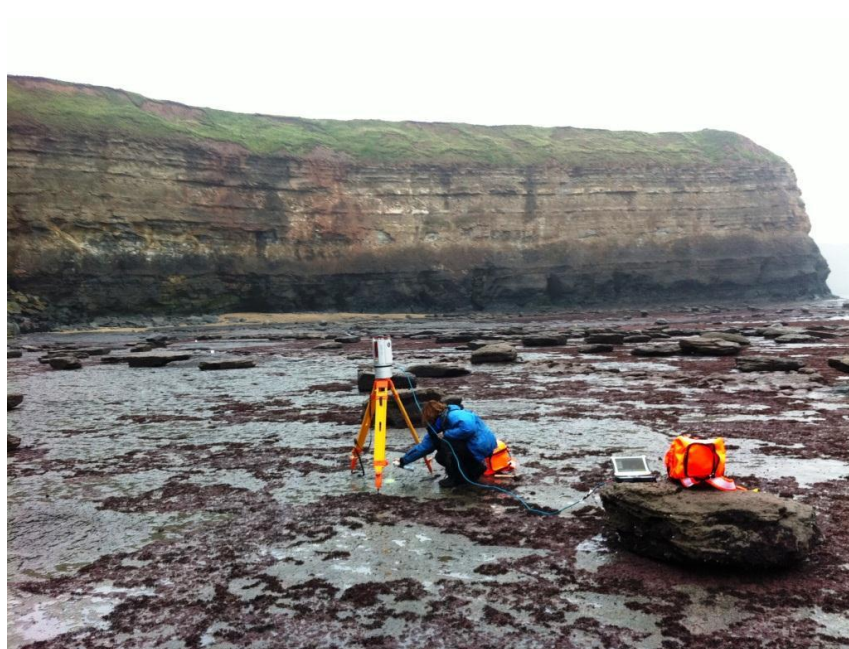
Figure 8 Reigl VZ-1000 at QP1 on the foreshore below Cowbar Nab.

Two survey benchmarks have been established on the foreshore marked with standard survey nails, over which the TLS system is repositioned each month. In the first months survey the 3D position of the survey points was located using a Leica GPS System 1200, to within ± 0.005 m (Figure 7 & 8). The coordinates of the control points are as follows:

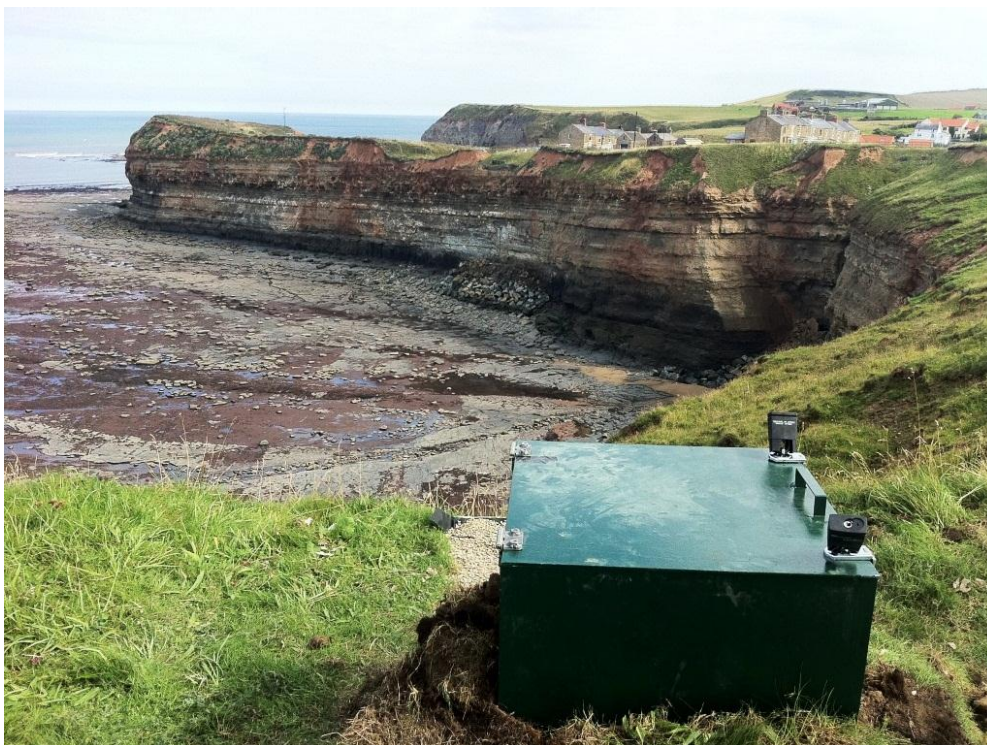
Figure 11 Foreground: Permanent laser scanner installation, showing the view of Cowbar from the scanner housing in the background.

The scanner is housed in a custom built steel box, mounted on a stable 0.5 m deep concrete foundation (Figures 11, 12, 13 & 14). The box contains deep cycle batteries to provide power back-up, a control PC with GPRS modem, and a series of relays which open and close the box window, and trigger the scanner. A motor driven window mechanism opens each night providing a secure installation for the scanner. Power is provided by a solar array located adjacent to the scanner on a pre-existing concrete slab.

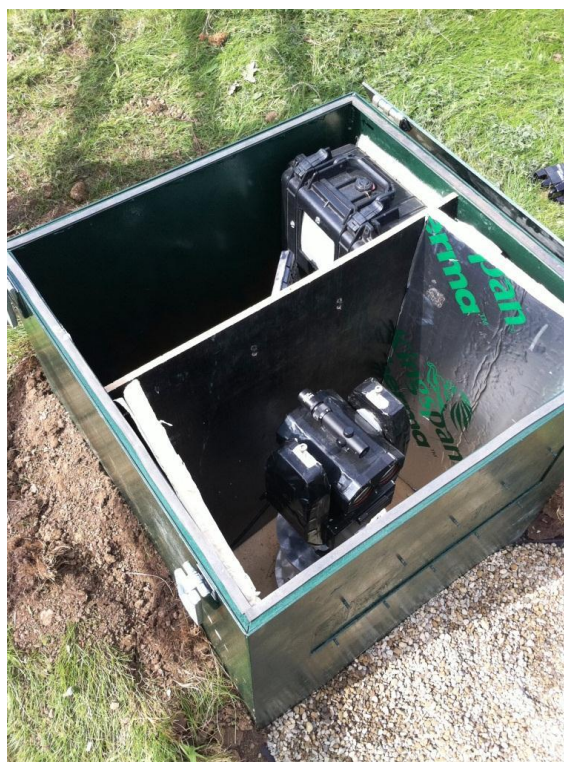
Figure 12 View inside the permanent scanner installation, showing the scanner nearest to the window mechanism, and the controls PC at the rear of the box

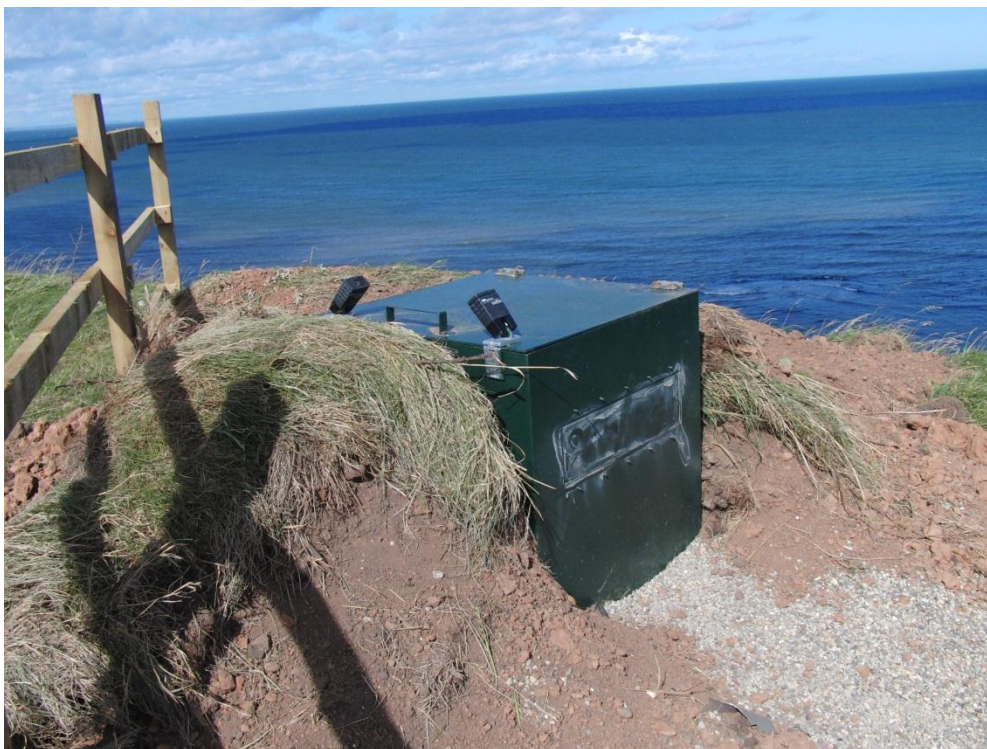
Figure 13 View of the automatic window (closed) on the scanner housing.

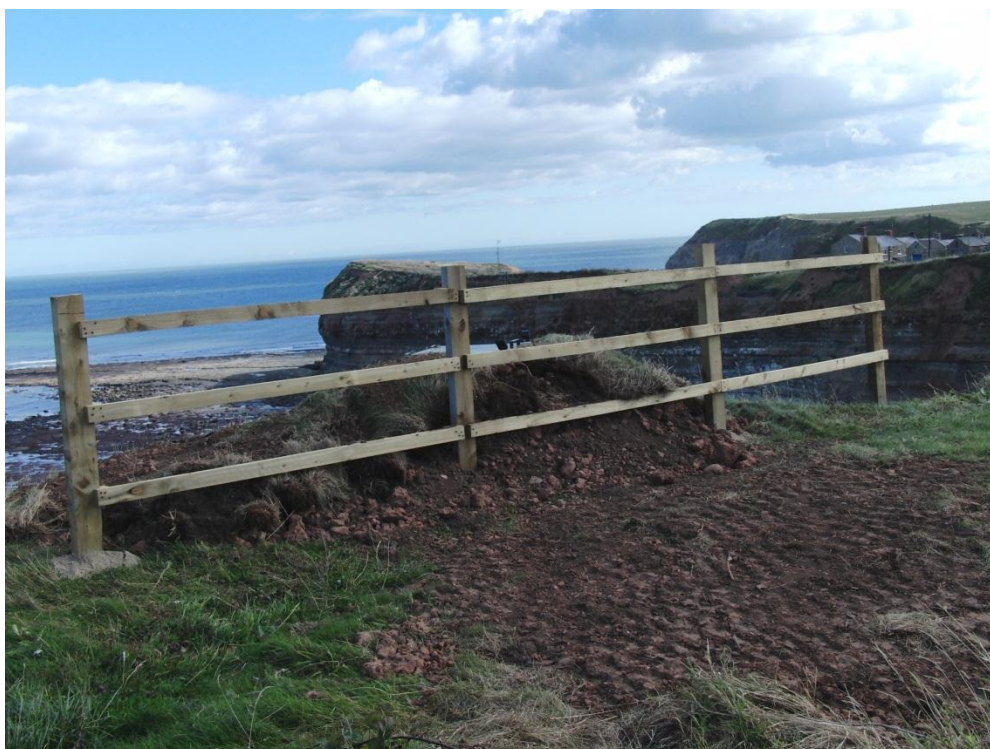
Figure 14 Fencing erected around the scanner housing
