Cell 1 Regional Coastal Monitoring Programme Update Report 1: 'Partial Measures' Survey 2009

Scarborough Borough Council Final Report

June 2009

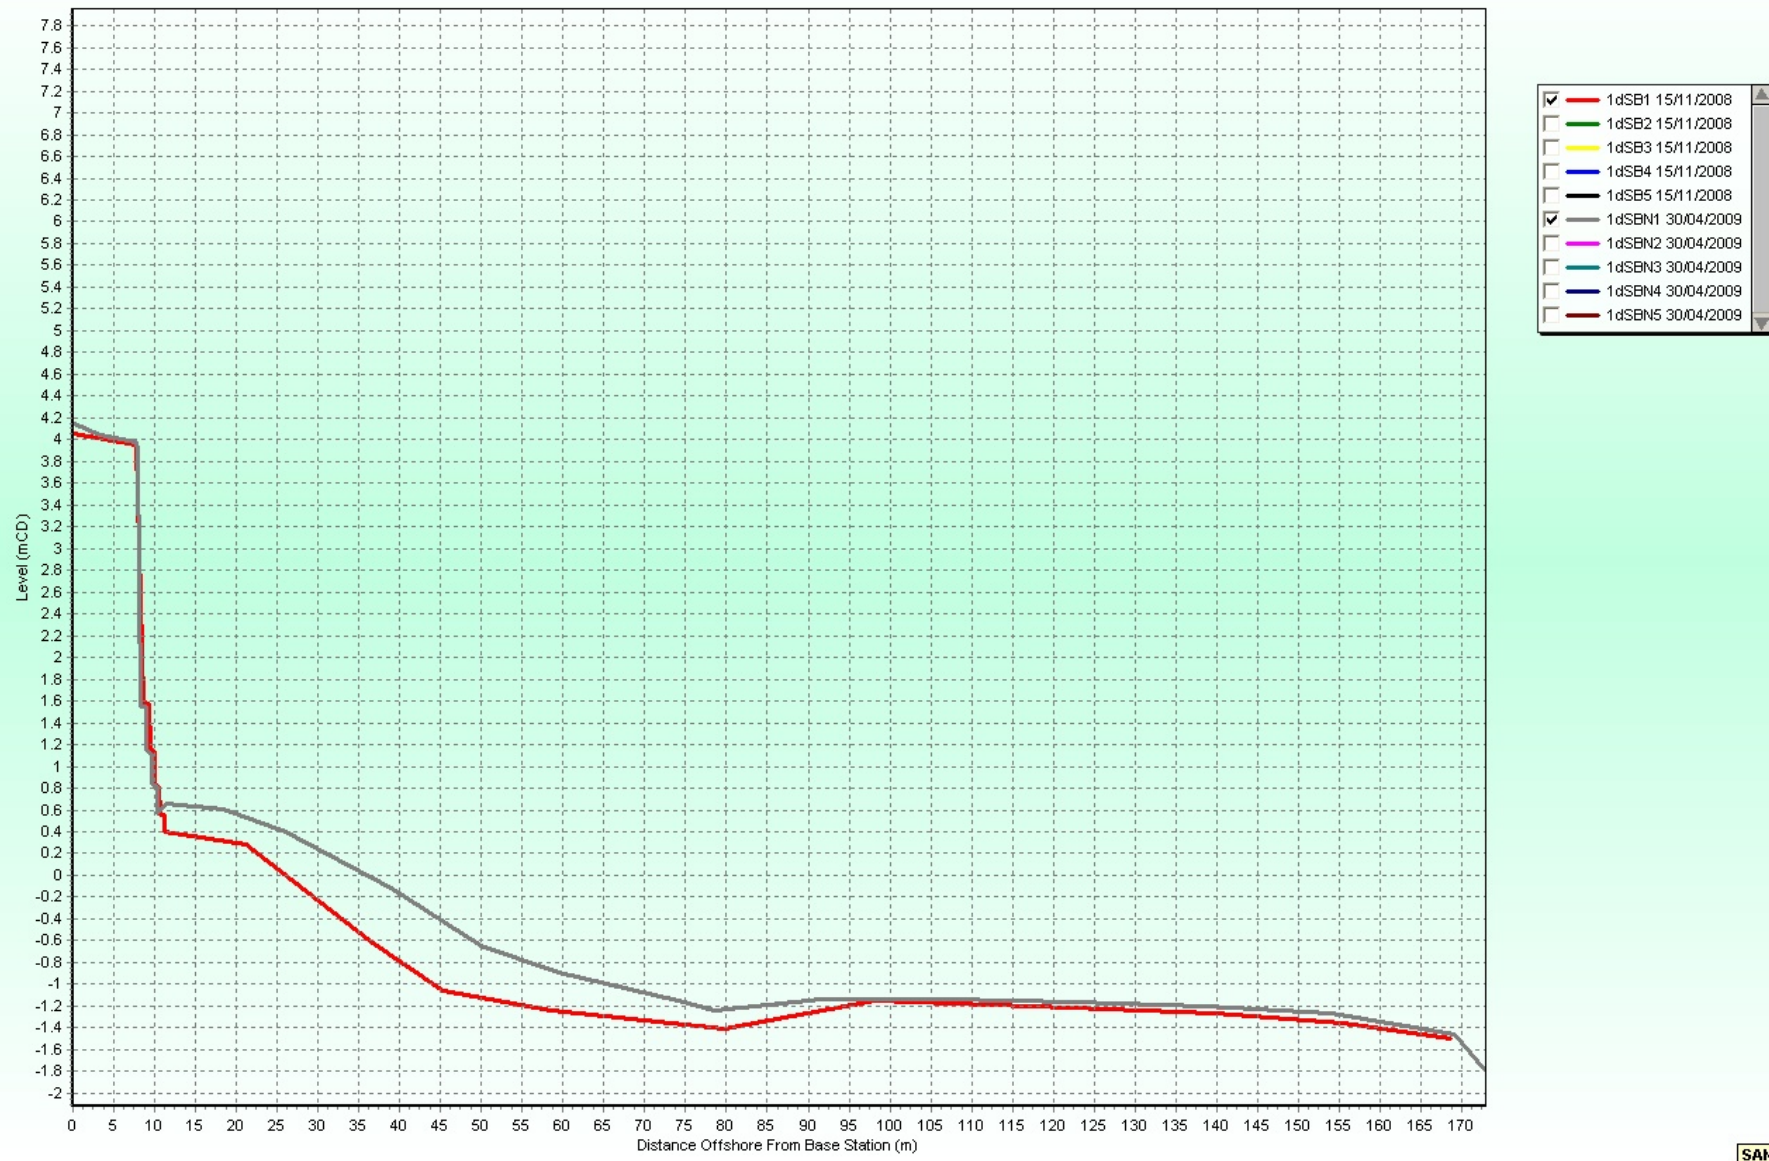
Beach Profile

Bearing 78

Chainage	Level
0	
0.02	4.156
3.74	4.075
7.3	3.943
7.4	3.862
7.47	2.936
7.67	2.952
15.36	2.19
24.66	1.66
37.6	0.987
52.67	0.426
67.75	-0.174
83.07	-0.982
83.92	-1.102
98	-1.833
100.52	-1.807
100.68	-1.534
101.85	-1.146
104.64	-1.11
107.84	-1.441
108.15	-1.543
112.1	-1.821
117.04	-2.02
117.29	-1.1
122.42	-1.258

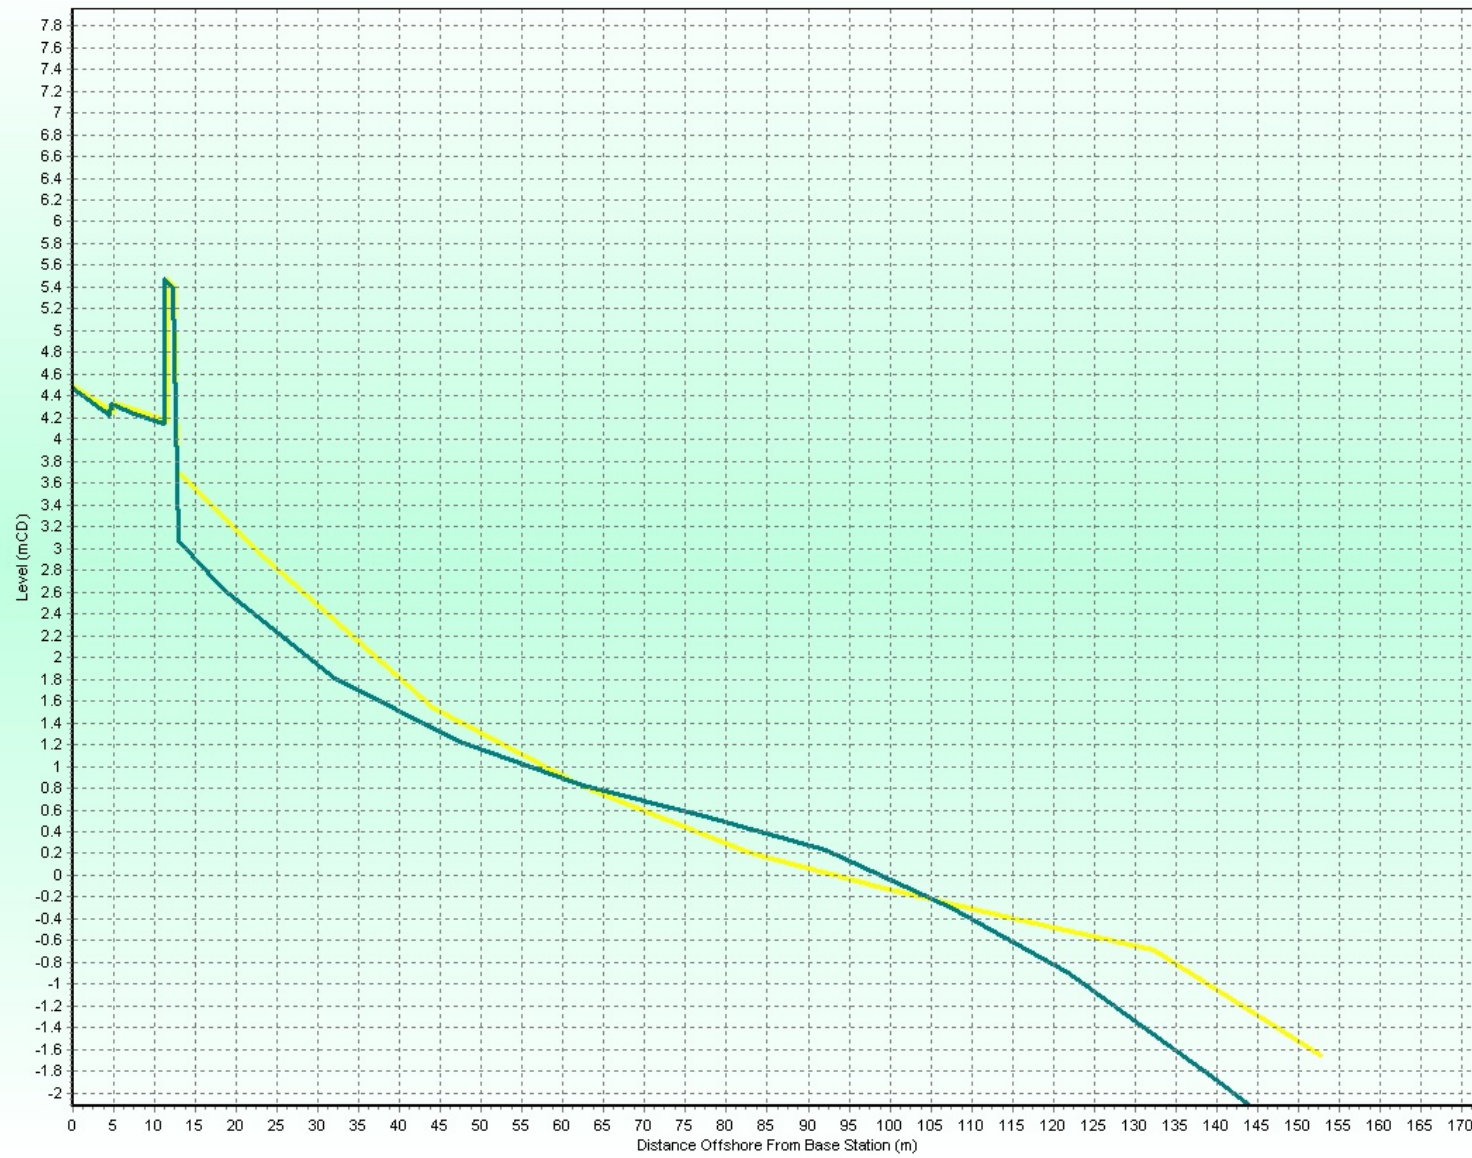
Beach Profile

Northing 489397.699 Bearing 38

Chainage	Level
0	
0.01	7.781
3.74	7.638
3.79	7.717
5.61	7.784
5.69	7.945
5.91	7.94
6.03	7.239
6.11	7.246
6.22	7.072
11.02	6.929
16.16	6.776
16.47	6.757
16.48	5.781
16.68	5.78
16.68	5.45
16.93	5.45
16.93	5.12
17.18	5.12
17.18	4.79
17.43	4.79
17.43	4.46
17.68	4.46
17.68	4.13
17.93	4.13
17.93	3.8
18.18	3.8
18.18	3.57
21.23	3.57
21.23	3.24
21.48	3.24
21.48	2.91
21.73	2.91
21.73	2.58
21.98	2.58
21.98	2.25
22.23	2.25
22.23	1.92
22.48	1.92
22.48	1.59
22.73	1.59
22.73	1.26
23	1.26
23.01	0.873
25.84	-0.148
26.93	-0.011
32.06	-0.289
35.36	-0.64
35.61	0.188
37.12	0.062
37.19	-0.615
38.47	-0.723
39.11	0.009
39.86	-0.453
41.65	-0.285
48.85	-0.294
48.96	-0.153
50.7	-0.069
51.21	-0.246
65.08	-0.22
79.87	-0.44
94.7	-0.691
110.85	-1.091
123.81	-1.422
139.38	-1.24
154.35	-1.528
