**Cell 1 Regional Coastal Monitoring Programme
Update Report 2: 'Partial Measures' Survey 2010**

**Scarborough Borough Council
Final Report**

July 2010

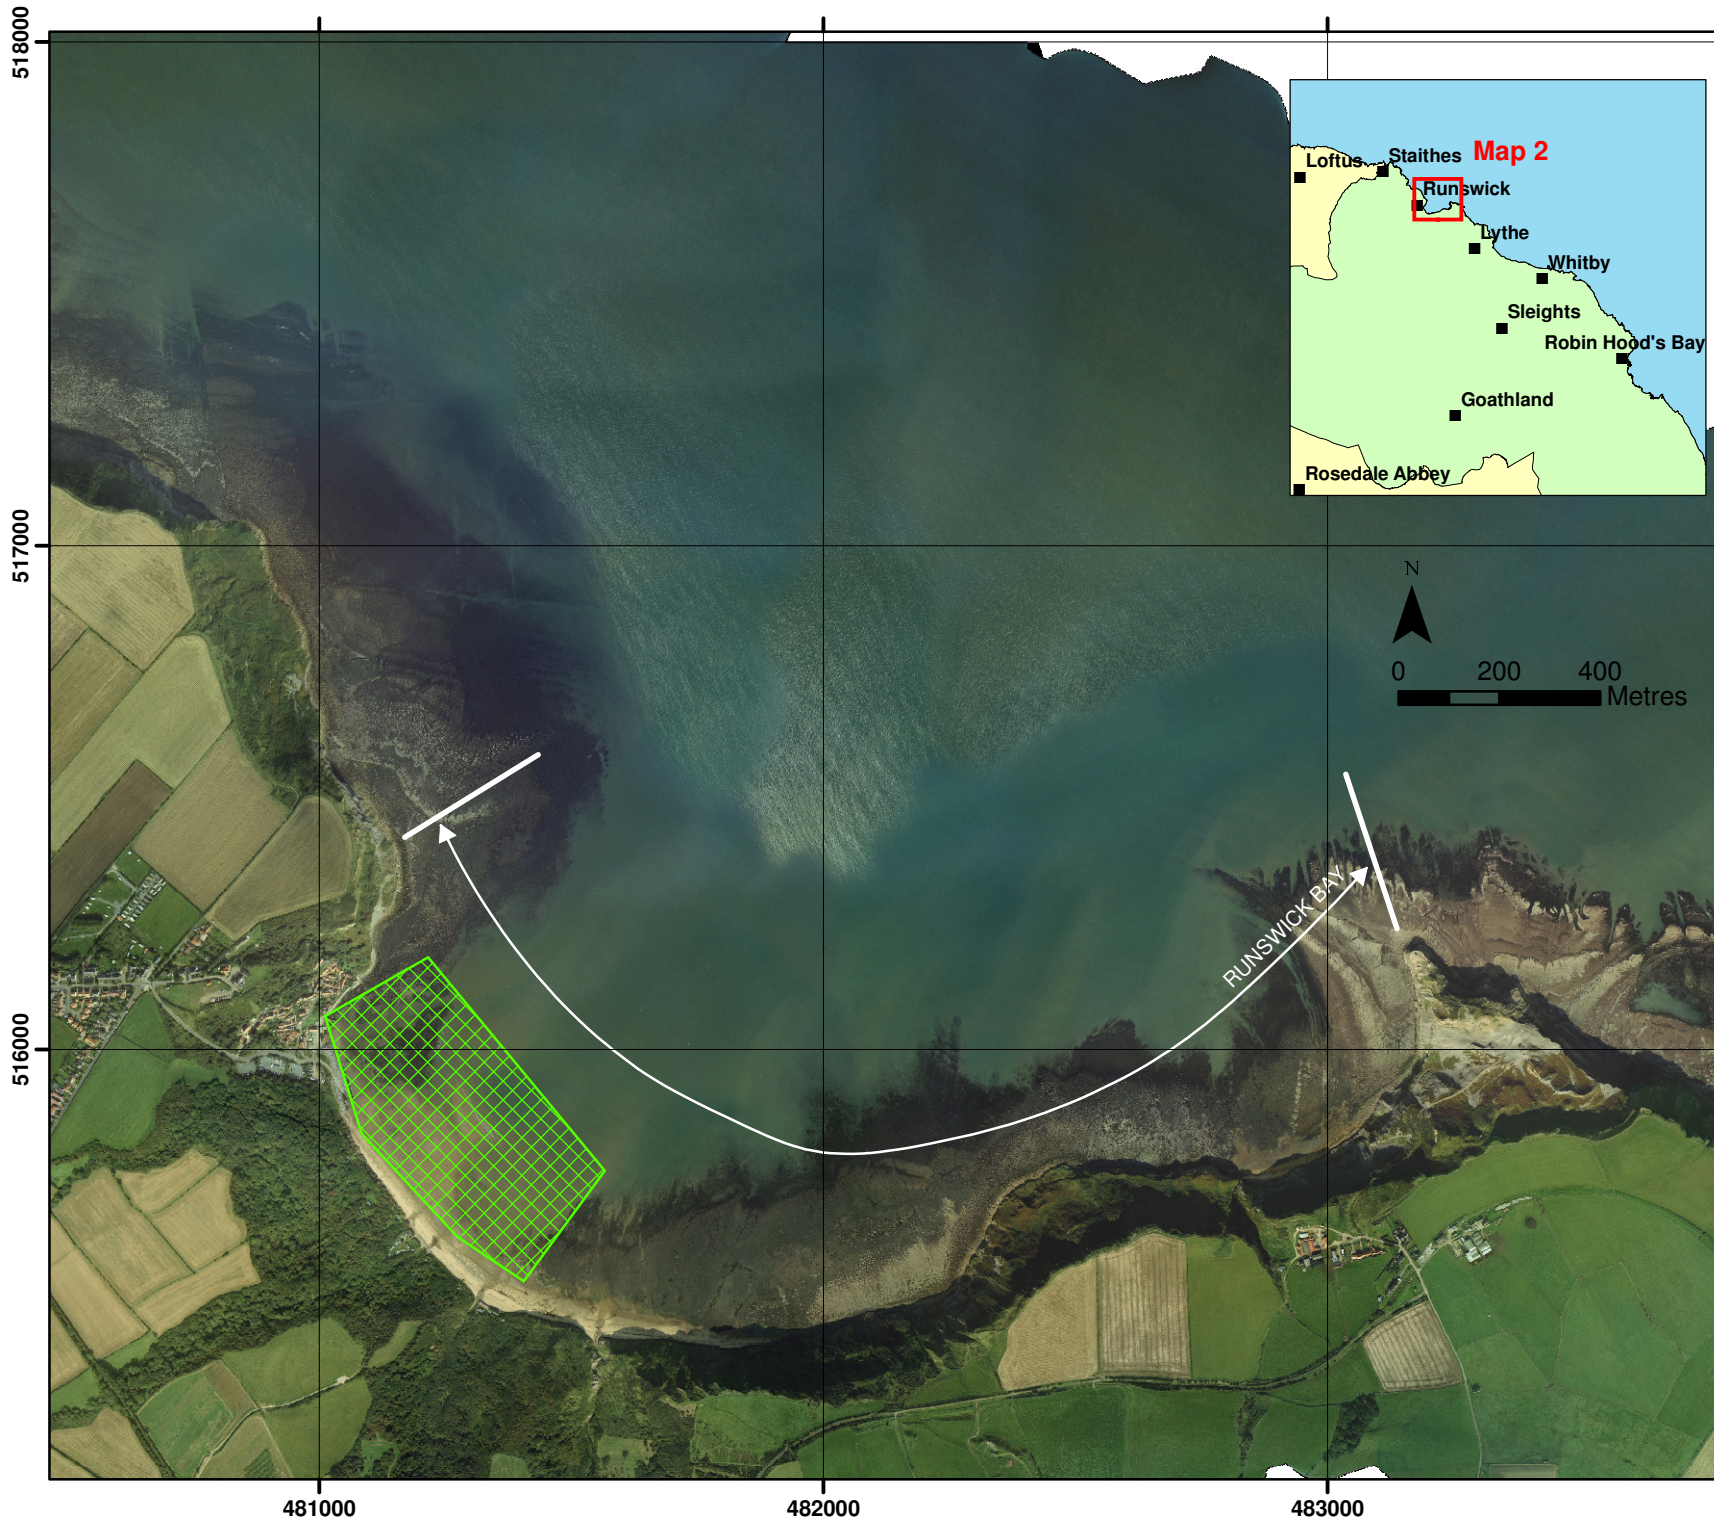
**Figure 1 - Map 2
 Scarborough
 Borough Council Frontage**

- SURVEY LOCATIONS**
- Topographic Profiles**
- Annual
 - Bi-Annual
- Topographic Surveys**
- 6 monthly
 - yearly
 - 5 yearly
- Cliff Top Monitoring Pegs**
- @ 50 centres
 - @ 100 centres
 - @ 300 centres
- (Indicative Survey Extents shown)*
