Cell 1 Regional Coastal Monitoring Programme Update Report 4: 'Partial Measures' Survey 2012

Scarborough Council Final Report

February 2013

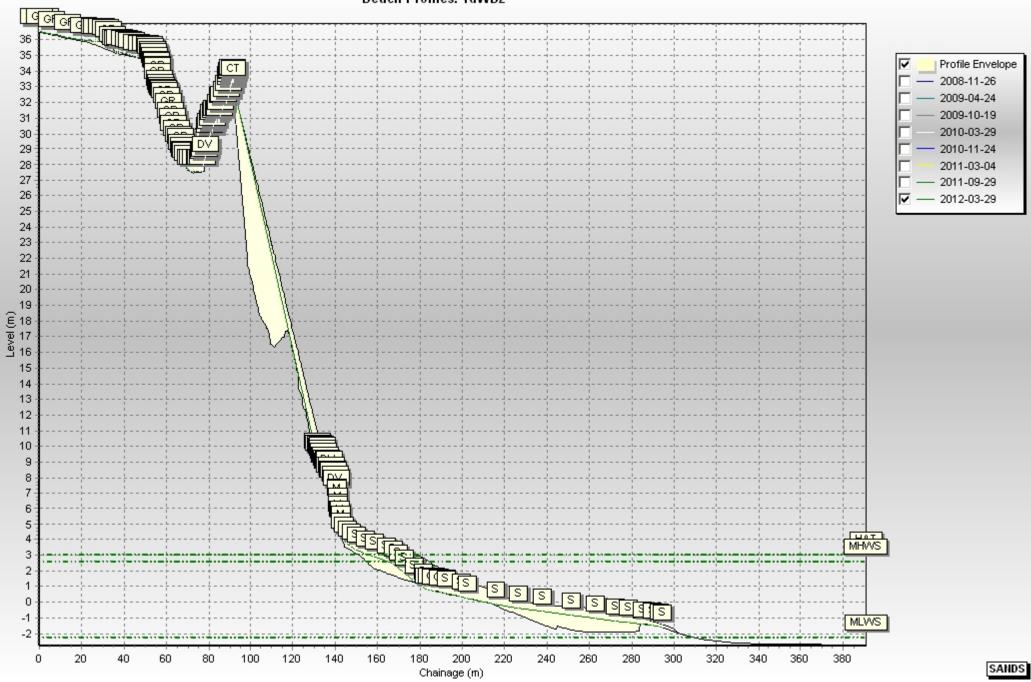
Beach Profiles: 1dWB2

At Whitby the middle of section WB2 was not accessible due to soft mud and a deep fissure.

Survey Date	Description of Changes Since Last Survey	Interpretation
29 th March 2012	 Beach Profiles: The Sandsend, Upgang and Whitby frontage is covered by three beach profile lines for the Partial Measures survey (Appendix A). The profiles were last surveyed in September 2011. Profile 1dWB1 is located around 400m south of Sandsend village. Over the winter the beach has become much steeper, with a net transfer of sediment towards the back of the beach. Profile 1dWB2 is located in the centre of Upgang beach. The part of the profile above 4m OD has changed very little. Around the level of HAT the level of the beach has eroded by 0.5m. The berm which had been present in the last survey has been eroded by March 2012. There is now a steep mid-beach at this location, although the middle of this profile was not accessible due to soft mud and a deep fissure. The rest of the beach has eroded by around 0.25m. Profile 1dWB3 is located on Whitby Sands and showed no significant changes above MHWS. The beach has steepened between since the last survey. The beach at the toe of the defence appears to have accreted by 0.5m over the winter. However, the remainder of the beach has eroded by up to 0.25m in two places as the summer berms have been eroded from the profile. 	All three of the beaches have steepened, to a varying degree, over the winter months. This is likely to be due to the erosion of the foreshore, which, when coupled with strong long period swell waves that act to throw material up the beach during storms, leads to deposition at the back of the beach. Longer term trends: At WB1 the beach has steepened but the March 2012 profile is closer to the norm for this frontage. Only the 2011 profiles show a flat beach, the rest since 2008 are steep. There is no evidence of progressive erosion of the beach. When compared to the past profiles both WB2 and WB3 show the beach level in March 2012 was close to the centre of the spread of previous results.

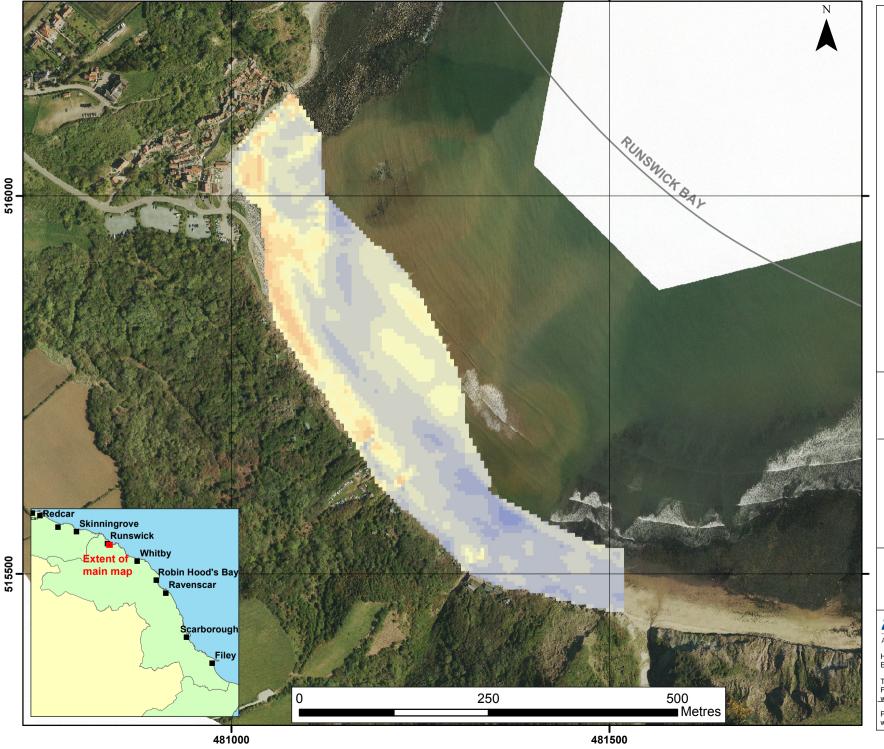
Appendix B - Map 1b **Topographic Difference** Runswick Scarborough **Borough Council**

Survey Date	Description of Changes Since Last Survey	Interpretation
23 rd March 2012	Topographic Survey: Data from the most recent topographic survey (partial measures, spring 2012) have been used to create a digital ground model (DGM) (Appendix B – Map 1a) using a Geographical Information System (GIS). A difference plot has also been produced using the DGM (Appendix B – Map 1b) produced from the last produced topographic survey (full measures, winter 2011) and the present survey, to identify areas of net erosion and accretion. Appendix B - Map 1b shows two predominant areas of erosion and accretion in Runswick Bay. Close to the shore and in the north of the bay there has been erosion. Overall around 0.25m in level has been lost from the beach but there has been erosion of up to 1m in some places. Lower down the beach and in the southern half of the bay there has been deposition between Autumn 2011 and Spring 2012. Most of the beach had accreted by over 0.5m and the largest gains were around 1m in the south of the bay. There was very little change in the centre of the bay, where a rocky shore platform is present.	The majority of the bay has accreted over the winter with the erosion being limited to the shoreline in the north of the Bay Longer term trends: The trend of accretion in the south of the bay continued. There was also a repeat of the erosion observed in the previous year in front of the rock armour defence in the north of the bay.

- At Runswick Bay the topographic survey shows that the bay has accreted overall over the winter with the erosion being concentrated in close to the shore in the north of the Bay. As a result there are no causes for concern.

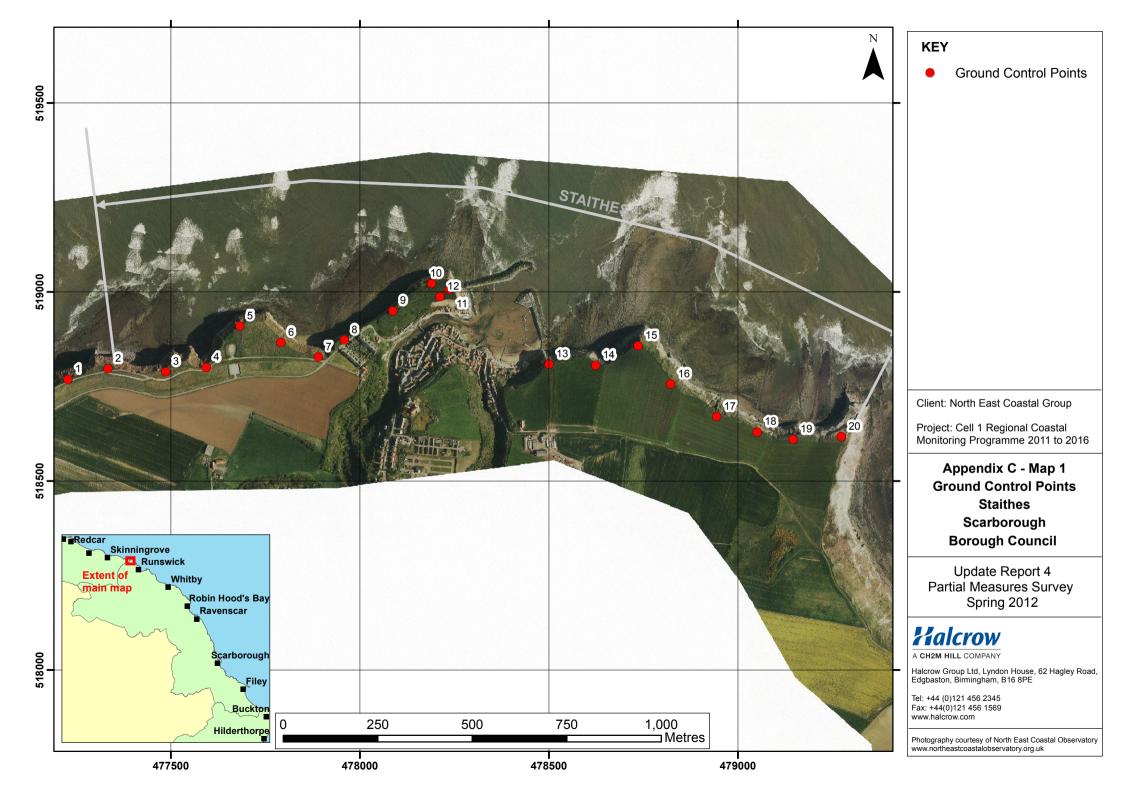
Twenty ground control points have been established at Staithes (Figure C1). The maximum separation between any two points is nominally 100m.

The cliff top surveys at Staithes are undertaken bi-annually. Measurements are taken from a fixed ground control point along a fixed bearing to the edge of the cliff top.

Survey Date	Description of Changes Since Last Survey	Interpretation
March 2012	 Cliff-top Survey: Twenty ground control points have been established at Staithes for the purposes of cliff top monitoring. The separation between any two points is a nominal 100 m. The cliff top surveys at Staithes are undertaken bi-annually. Data collection involves a distance offset measurement from the ground control point to the cliff edge along a fixed bearing. Appendix C provides results from the March 2012 survey, showing the distance from the ground control point to the edge of the cliff top along the defined bearing and changes in position since the November 2008 baseline survey and the previous September 2010 survey. The results provided in Appendix C show that 18 of the 20 control points showed change of ±0.1m, which is within the likely error of measurement. The four remaining control points all show advance of the cliff line, which suggests errors in identification of the cliff edge has occurred. The long-term data, covering the period 2008 to present, are also hard to interpret. Most monitoring points show rates of change within the range of expected error, some show advance of the cliff of up to 0.4m/yr, which is presumably an error in the identification of the cliff edge, and others show a small erosion rate. Point 13 shows the highest rate of erosion of 0.7m/yr. The widespread occurrence of erroneous data make any meaningful interpretation of these data difficult. 	The recorded change between October 2011 and March 2012 are very small. Longer term trends: Table C1 in Appendix C presents the erosion rate calculated from the data collected from 2008. The table shows that only three of the 20 control points indicate cliff erosion. Nine of the 20 control points have a rate of change close to zero. The remaining eight control points show growth, which is thought to relate to error in the definition of the cliff top.

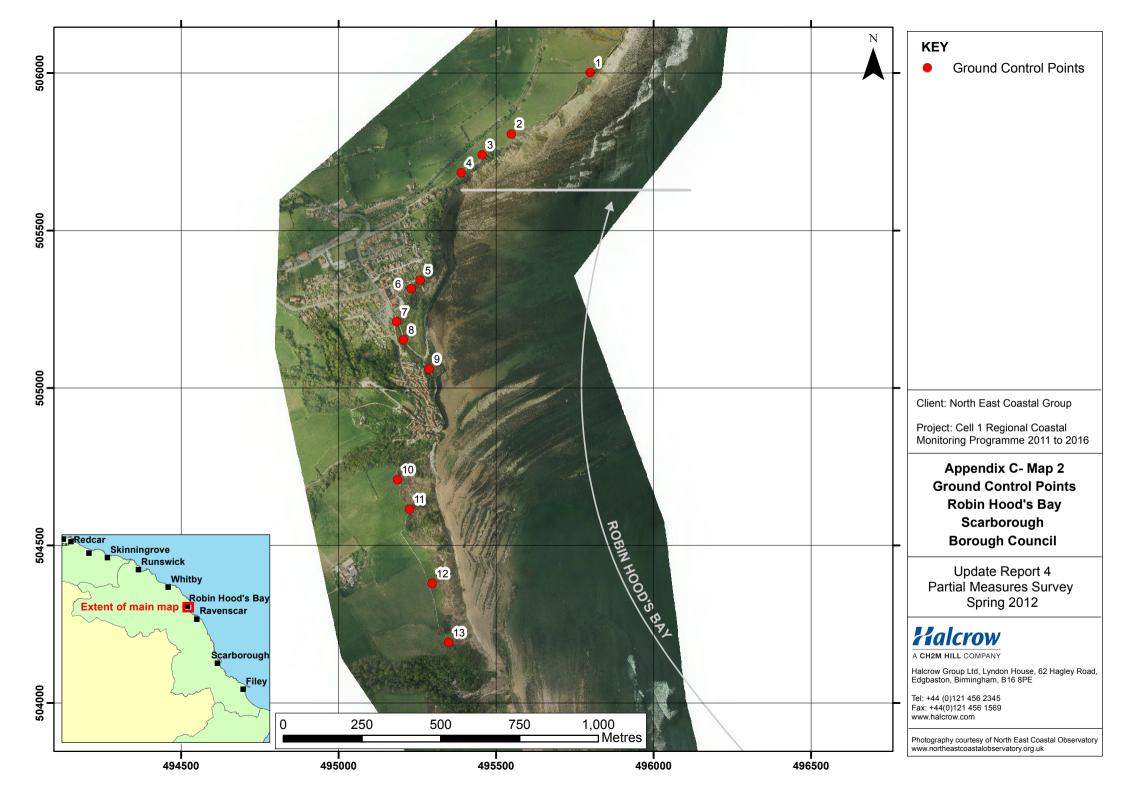
Thirteen ground control points have been established at Robin Hoods Bay (Figure C2). The maximum separation between any two points varies along the coast, reflecting the degree of risk from the erosion. The cliff top surveys at Robin Hoods Bay are undertaken bi-annually. Measurements are taken from a fixed ground control point along a fixed bearing to the edge of the cliff top.

March 2012	 Cliff-top Survey: Thirteen ground control points have been established at Robin Hood's Bay (since 3rd March 2010) to monitor the cliff top The separation between any two points is around 200m. The cliff top surveys at Robin Hood's Bay are undertaken bi-annually. Data collection involves a distance offset measurement from the ground control point to the cliff edge along a fixed bearing. Appendix C provides results from the March 2012 survey, showing the distance from the ground control point to the edge of the cliff top along the defined bearing (Appendix C- Map 2) and changes in position since the last survey in September 2011 and the baseline survey in March 2010. Taking into account the survey accuracy of +/-0.1m, seven of the thirteen markers show no change in cliff top position since the last survey in September 2011. Of the other six markers, three show cliff recession. Markers 5 and 10 show recession of 1.1m while one shows less significant recession of 0.2m (Marker 1). The remaining three markers show cliff top advance (Markers 4, 8 and 11), which is assumed to be error in recognition of the clifftop. 	There appears to have been two significant changes in cliff position, with Markers 5 and 10 both showing recession of 1.1m over the winter of 2011/12. Longer term trends: The erosion rates calculated from the observed changes since March 2010 show a low erosion rate for most of the cliff points. Two of the markers have significant recession rates; markers 1 and 5 have rates of 1.6m/yr and 0.7m/yr respectively. The data has not been collected over a long time span and as a result there is not a high confidence in the recession rates. More data collected over future years will help to clarify cliff behaviour at Robin Hoods Bay.

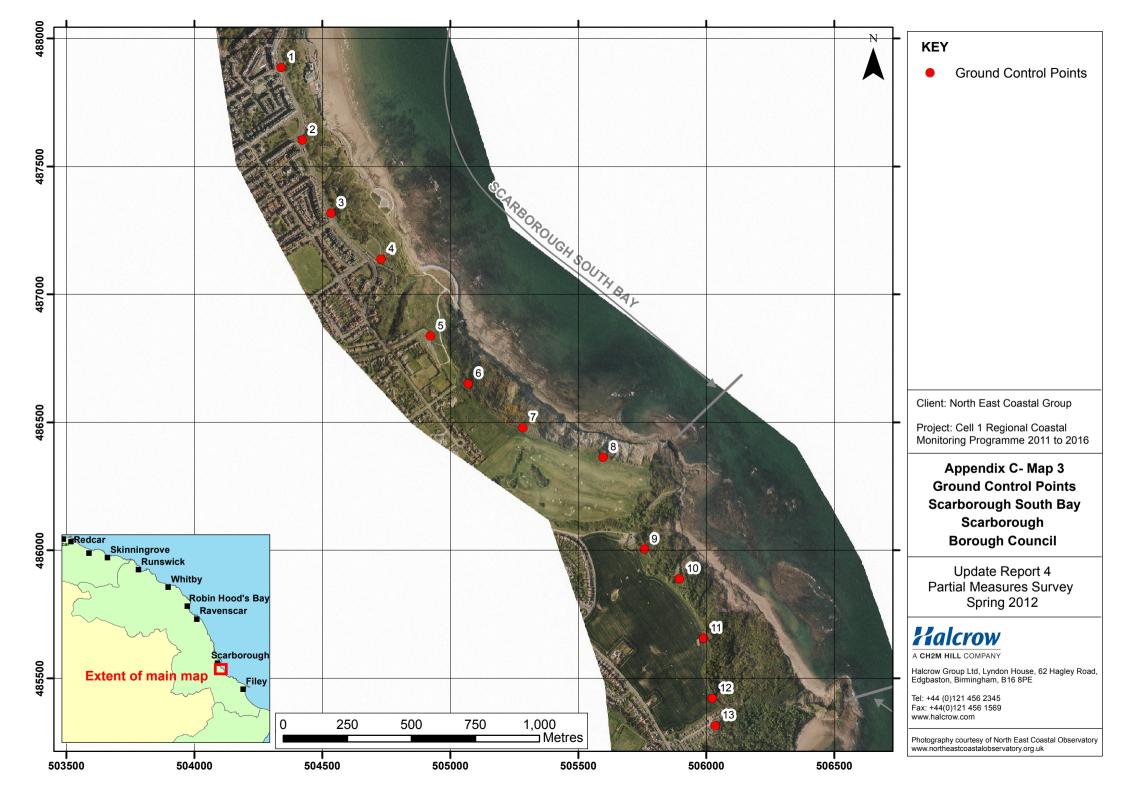
Thirteen ground control points have been established at Scarborough South Bay (Figure C3). The maximum separation between any two points varies along the coast, reflecting the degree of risk from the erosion. The cliff top surveys at Scarborough South Bay are undertaken bi-annually. Measurements are taken from a fixed ground control point along a fixed bearing to the edge of the cliff top.

March 2012	Cliff-top Survey: Thirteen ground cliff top monitoring control points have been established at Scarborough South Bay and	The recession rates show that there has been little recession along this frontage. Nine of the thirteen survey points have a recession rate of around
	in Cornelian Bay and Knipe Point at Cayton Bay. The separation between points is around 300m. The cliff top surveys at Scarborough South Bay are undertaken bi-annually. Data collection involves a distance offset measurement from the ground control point to the cliff edge along a fixed bearing.	± 0.1 m/yr. The four markers with significant recession rates of between 0.1m/year and 0.2m/year are Markers 3.6.11 and 12.
	Appendix C provides results from the March 2010 baseline survey through to the most recent March 2012 survey, showing the distance from the ground control point to the edge of the cliff top along the	Longer term trends: Eight of the thirteen points have a recession rate of 0m. Three have a rate of 0.1m and

Survey Date	Description of Changes Since Last Survey	Interpretation
	defined bearing (Appendix C- Map 3). The recoded changes between February 2011 and March 2012 show that of the 13 survey points, seven show no change in cliff top position outside of the +/-0.1m error bands. Five of the points show advance of the cliff, which is likely to be a result of errors in the method. The remaining point is the only marker where significant erosion (0.3m) was recorded.	two have a rate of 0.2m. The cliff recession data has been collected over a short time span, as a result there is a low confidence in the rates which have been calculated. The rate of recession on this coast will be clarified with a longer duration of data collection. There are concerns about the accuracy of the method, the appearance of positive recession readings shows that there are large errors in the data set. The errors will become less significant in a longer-term dataset.

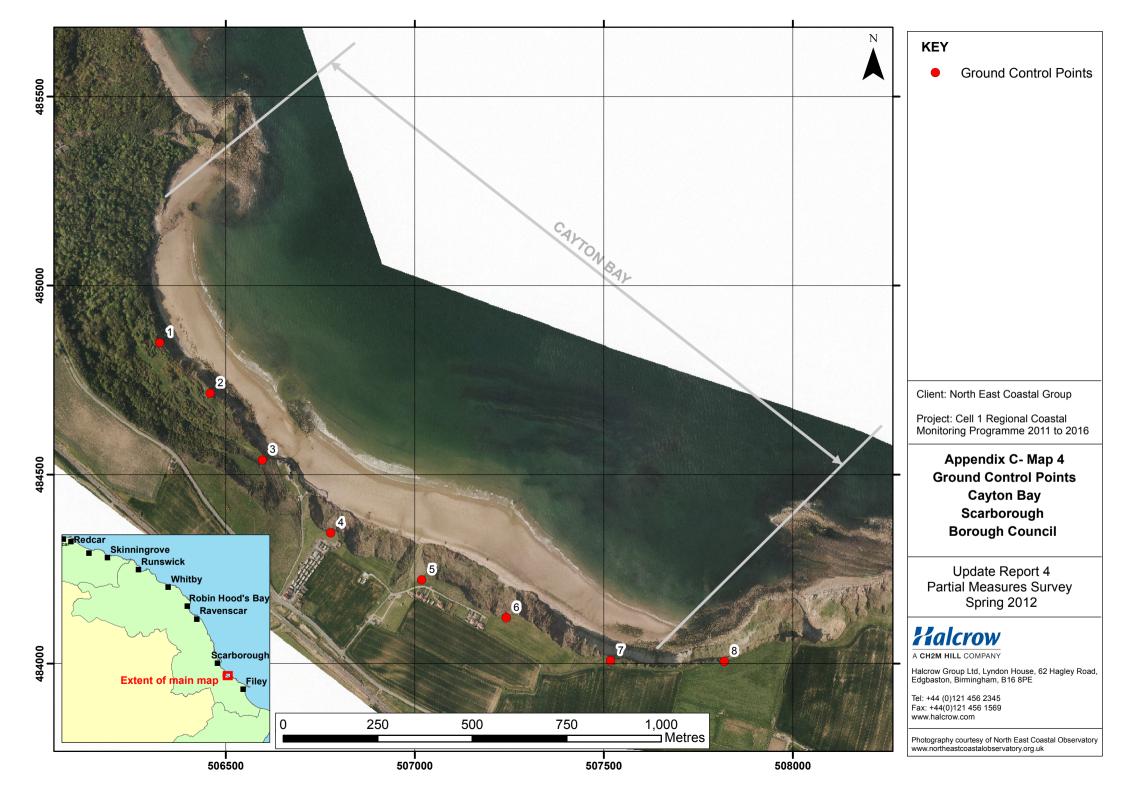
Eight ground control points have been established at Cayton Bay (Figure C4). The maximum separation between any two points varies along the coast, reflecting the degree of risk from the erosion.

The cliff top surveys at Cayton Bay are undertaken bi-annually. Measurements are taken from a fixed ground control point along a fixed bearing to the edge of the cliff top.

Survey Date	Description of Changes Since Last Survey	Interpretation
	point to the edge of the cliff top along the defined bearing and changes in position since the November 2008 baseline survey and the previous September 2011 survey. Considering the survey accuracy of +/-0.1m, two of the eight marker points shows no change between the baseline survey and the most recent March 2012 survey. Four marker points have exhibited an advance in cliff top position by between 0.3m and 1.3m and two points have shown a recession of the cliff top by 0.5m and 5m.	0.2m/yr and 1.5m/yr respectively. The results from Markers 1 and 2 show a lot of variation along 300m of coast, which is likely to be due to the short time span that data is collected over. If data continues to be collected for a much longer time it is likely the recession rates will be more similar throughout the bay and that there will be more confidence in the calculated rate if it is based on a longer data set.

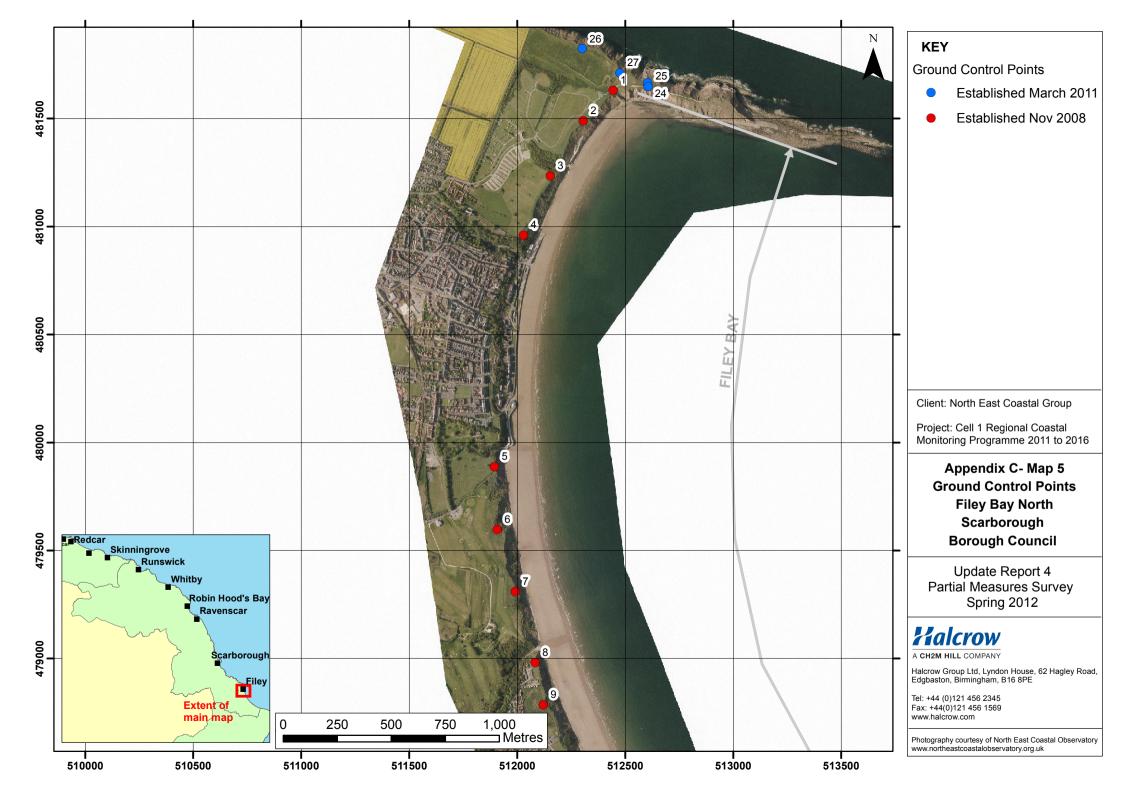
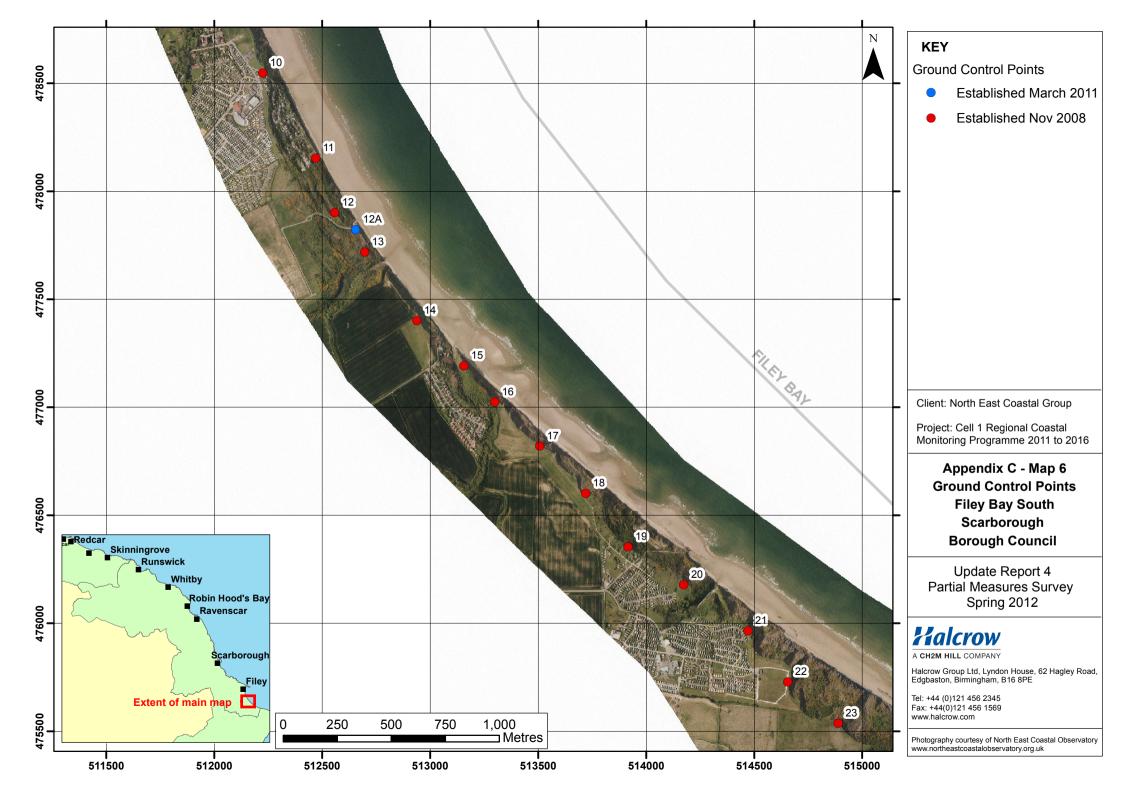
Twenty-three ground control points have been established in Filey Bay (Figure C5 and C6). The maximum separation between any two points varies along the coast, reflecting the degree of risk from the erosion.

The cliff top surveys at Filey Bay are undertaken bi-annually. Measurements are taken from a fixed ground control point along a fixed bearing to the edge of the cliff top.

March 2012	 Cliff-top Survey: Twenty-three ground control points were established within Filey Bay for the purposes of cliff top monitoring in November 2008. Additional points were added in September 2010 and March 2011 (as shown in Appendix C – Maps 5a and 5b) taking the total number of ground control points within Filey Bay to twenty-eight. The maximum separation between any two points is nominally 300m. The cliff top surveys at Filey Bay are undertaken bi-annually. Data collection involves a distance offset measurement from the ground control point to the cliff edge along a fixed bearing. Appendix C provides results from the March 2012 survey showing the distance from the ground control point to the edge of the cliff top along the defined bearing and changes in position since the November 2008 baseline survey and the previous September 2010 survey. Between the last survey in September 2011 and the current survey twenty of the twenty-eight ground control markers in Filey Bay showed recession within the ±0.1m of error in the method. Two of the points showed advance of the cliff, which suggests there are errors in the data set. The remaining six markers showed recession of between 0.2m/yr and 0.6m/yr over the winter of 2011/12. 	Over the winter of 2011/12 the marker points show stability overall, with the majority of change observed in the centre of the bay. Longer term trends: The average annual recorded rate of change tends to be low for the majority of the frontage. Markers 5, 7 and 14 have recession rates of 1.7m, 0.5m and 0.2m respectively. The recession rates will become clearer as the more data is collected on the erosion rates.
