Cell 1 Regional Coastal Monitoring Programme Update Report 9: 'Partial Measures' Survey 2017

**Scarborough Borough Council
July 2017**

(*) The present report is **Update Report 9** and provides an analysis of the 2017 Partial Measures survey for Scarborough Council's frontage.

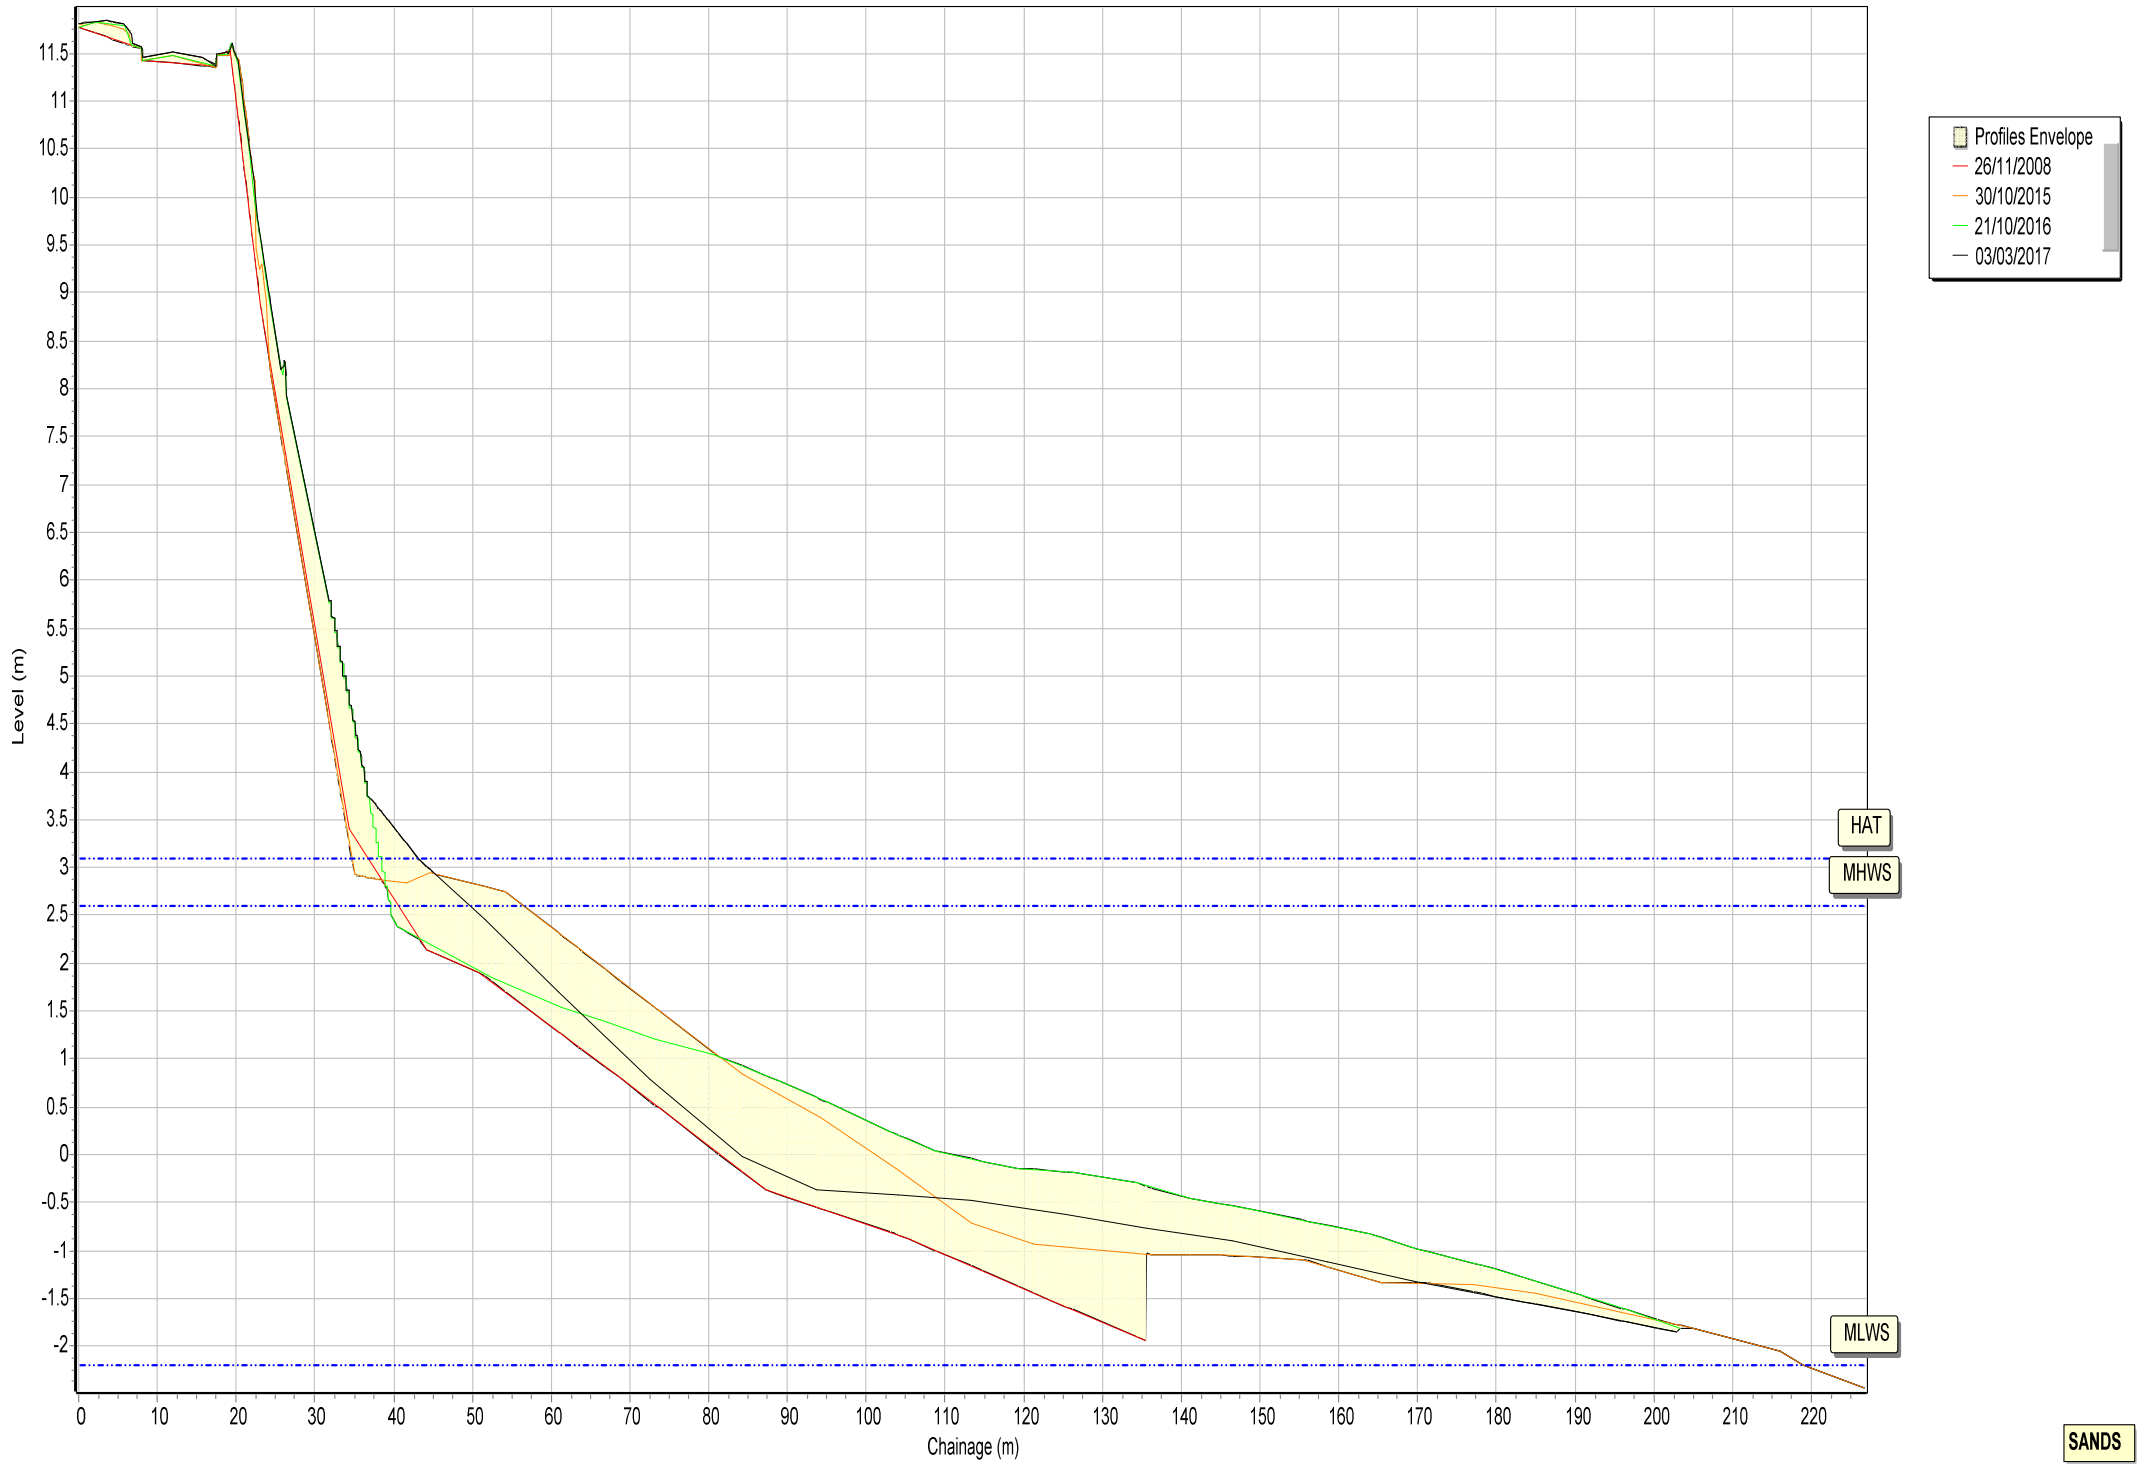
Beach Profiles: 1dWB1

Survey Date	Description of Changes Since Last Survey	Interpretation
3 rd March 2017	<p>Beach Profiles:</p> <p>The Sandsend, Upgang and Whitby frontage is covered by three beach profile lines for the Partial Measures survey (Appendix A). The profiles were surveyed in October 2016 (2016 Full Measures) and in March 2017.</p> <p>Profile 1dWB1 is located around 400m south of Sandsend village. There has been accretion of up to 1.0m at the toe of the new coastal defence, covering several of the lower steps, up to chainage 65m. Seawards of chainage 65m there has been erosion of up to 1.0m, but more typically 0.4m. Overall the profile is at a medium level compared to the range recorded from previous surveys.</p> <p>Profile 1dWB2 is located in the centre of Upgang beach. The profile remained stable to the face of the cliff at 145m chainage. From 145m to 175m chainage there is has been a drop in the beach of up to 0.5m since the previous survey. Between chainage 175m and 220m there has been accretion of up to 0.7m, creating a berm at chainage 185m. Seawards of chainage 220m there has been erosion of up to 1.0m. The upper beach is at a relatively low level compared to the range recorded from previous surveys, whilst the rest of the beach is at a more medium level.</p> <p>Profile 1dWB3 is located on Whitby Sands and showed erosion of up to 1.0m, but more typically 0.3m, across the whole beach profile. Overall the beach is at a medium level compared to the range recorded from previous surveys.</p>	<p>All of the profiles are in the middle of the range of previous profiles, which shows that this frontage is dominated by seasonal fluctuation of the beach levels.</p> <p>Longer term trends:</p> <p>The beach profiles appear to be reasonably stable showing only seasonal fluctuations. The long term difference plot for Autumn 2008 to Autumn 2016 show accretion in the eastern and western ends of the bay and erosion in the centre.</p>

- At Sandsend, Upgang and Whitby, the profiles show seasonal fluctuation. There has been significant accretion at the toe of the new defence at Sandsend. At profile B2, where the frontage is undefended there was the formation of a beach berm through the winter.

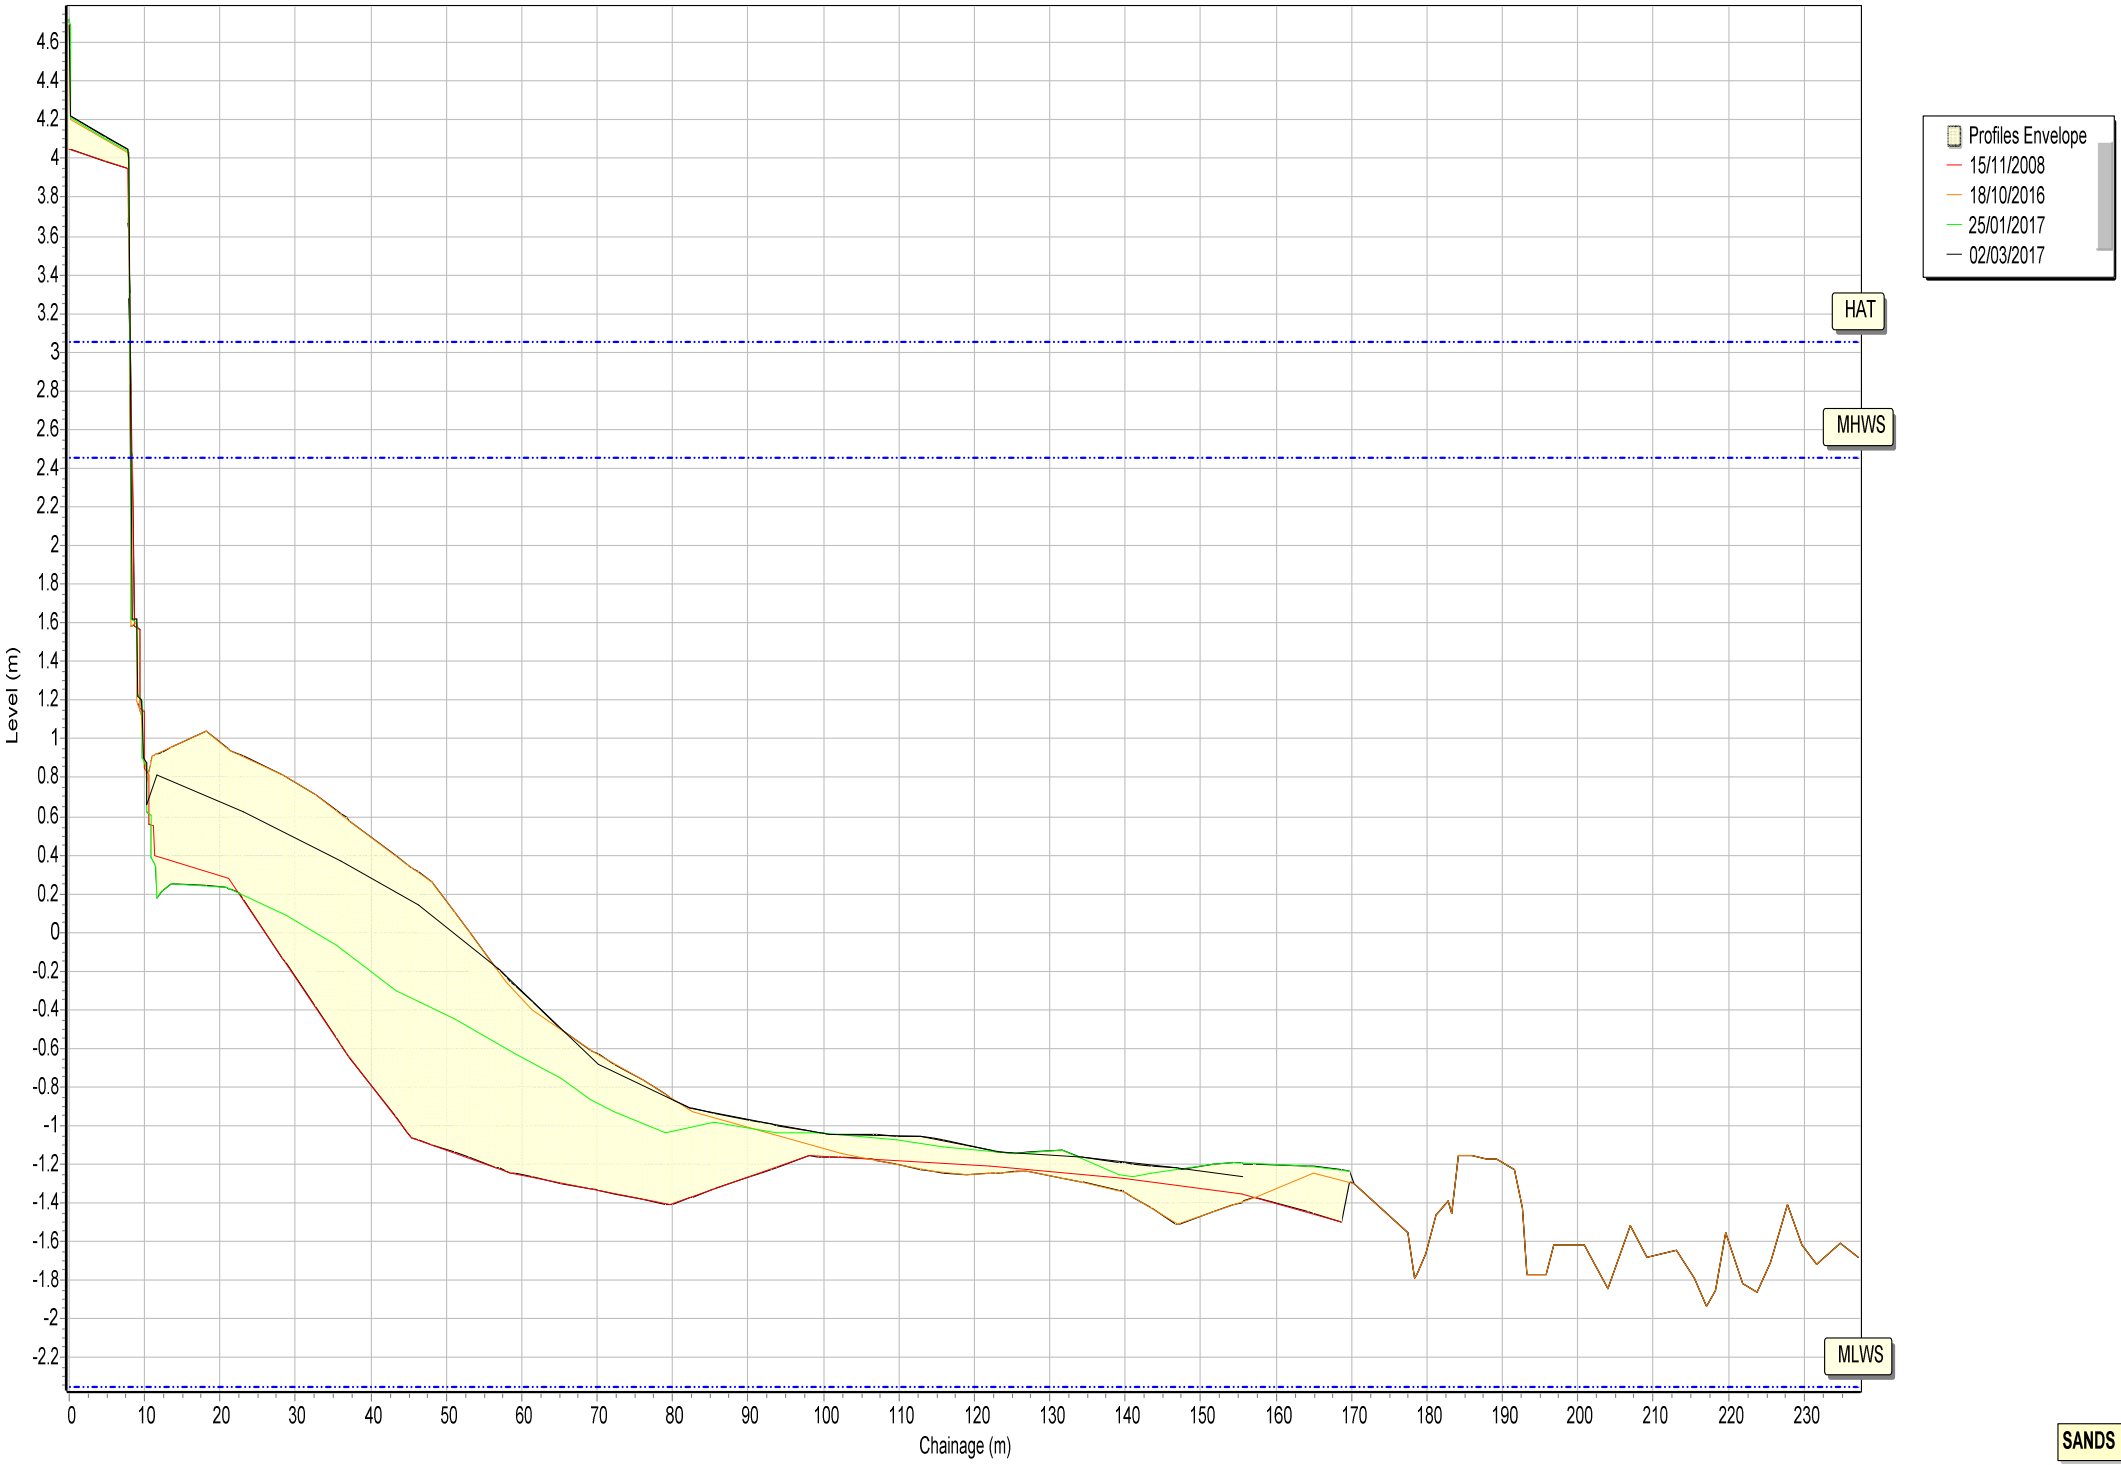
Beach Profiles: 1dSBN1

Survey Date	Description of Changes Since Last Survey	Interpretation
2 nd March 2017	<p>Beach Profiles:</p> <p>Scarborough North Bay is covered by five beach profile lines for the Partial Measures survey (Appendix A) that are monitored biannually. The previous Full Measures survey was undertaken in October 2016, with an additional post-storm survey undertaken in January 2017.</p> <p>Profile 1dSBN1 is located around 200m south of the Sea Life Centre. The beach level in front of the seawall to chainage 80m dropped by up to 0.8m following the January storm surge event, though had recovered by 0.5m by the March survey. From chainage 80m seawards the beach level increased slightly by up to 0.2m in the January post-storm survey, retaining this level in the March survey. The upper beach is at a medium level compared to the range recorded from previous surveys, whilst the lower beach is at a relatively high level.</p> <p>Profile 1dSBN2 is located close to the former chair lift. The January post-storm survey shows a drop of 0.8m at the toe of the seawall, with the formation of a berm 0.5m above the October 2016 beach level at chainage 40m, and erosion seawards of chainage 60m by up to 1.0m. The March survey shows the levels at the toe of the seawall dropped a further 0.4m, with the removal of the berm (0.9m lowering) creating a flatter mid beach. Seawards of chainage 60m the beach levels have recovered by 0.5m. The upper beach is at a relatively low level compared to the range recorded from previous surveys, with a high middle beach, and medium lower beach.</p> <p>Profile 1dSBN3 is located near Royal Albert Drive. The January post-storm survey shows accretion across the whole profile compared to the October 2016 profile, with 0.4m accretion at the toe of the seawall, little change between chainage 30m and 70m, and up to 0.5m accretion seawards of chainage 70m. The March 2017 profile shows erosion of up to 0.4m across the whole profile when compared to the January post-storm survey. When compared to the October 2016 profile however, the most recent survey shows erosion of up to 0.2m on the upper beach up to chainage 75m, and then accretion of up to 0.3m to chainage 130m, with erosion of up to 0.3m at the toe of the beach. The upper beach is at a medium-low level compared to the range recorded from previous surveys, but a medium-high level over the lower beach.</p> <p>Profile 1dSBN4 is located at the northern end of Clarence Gardens. The January post-storm survey</p>	<p>The January post-storm survey generally shows a pattern of erosion at either end of the bay but accretion in the centre, as well as the drawdown of material across the individual profiles.</p> <p>The March 2017 profiles show a general pattern of little change in the south of the bay, erosion in the centre, and accretion in the north of the bay.</p> <p>Longer term trends: The beach is within the mid-range of profiles with changes typical of seasonal drawdown and recovery, with the exception of 1dSBN4 which has the lowest levels recorded for the mid beach area. Levels indicate recovery since the severe storms of December 2013.</p>

- At Scarborough North Bay, the January post-storm survey generally shows a pattern of erosion at either end of the bay but accretion in the centre, as well as the drawdown of material across the individual profiles. The March 2017 profiles show a general pattern of little change in the south of the bay, erosion in the centre, and accretion in the north of the bay. The March 2017 profiles are within the range of the previous recording of beach levels, with the exception of the middle section of profile SBN4 which shows its lowest recorded levels, so the observed changes are likely to be due to the drawdown of beach material.

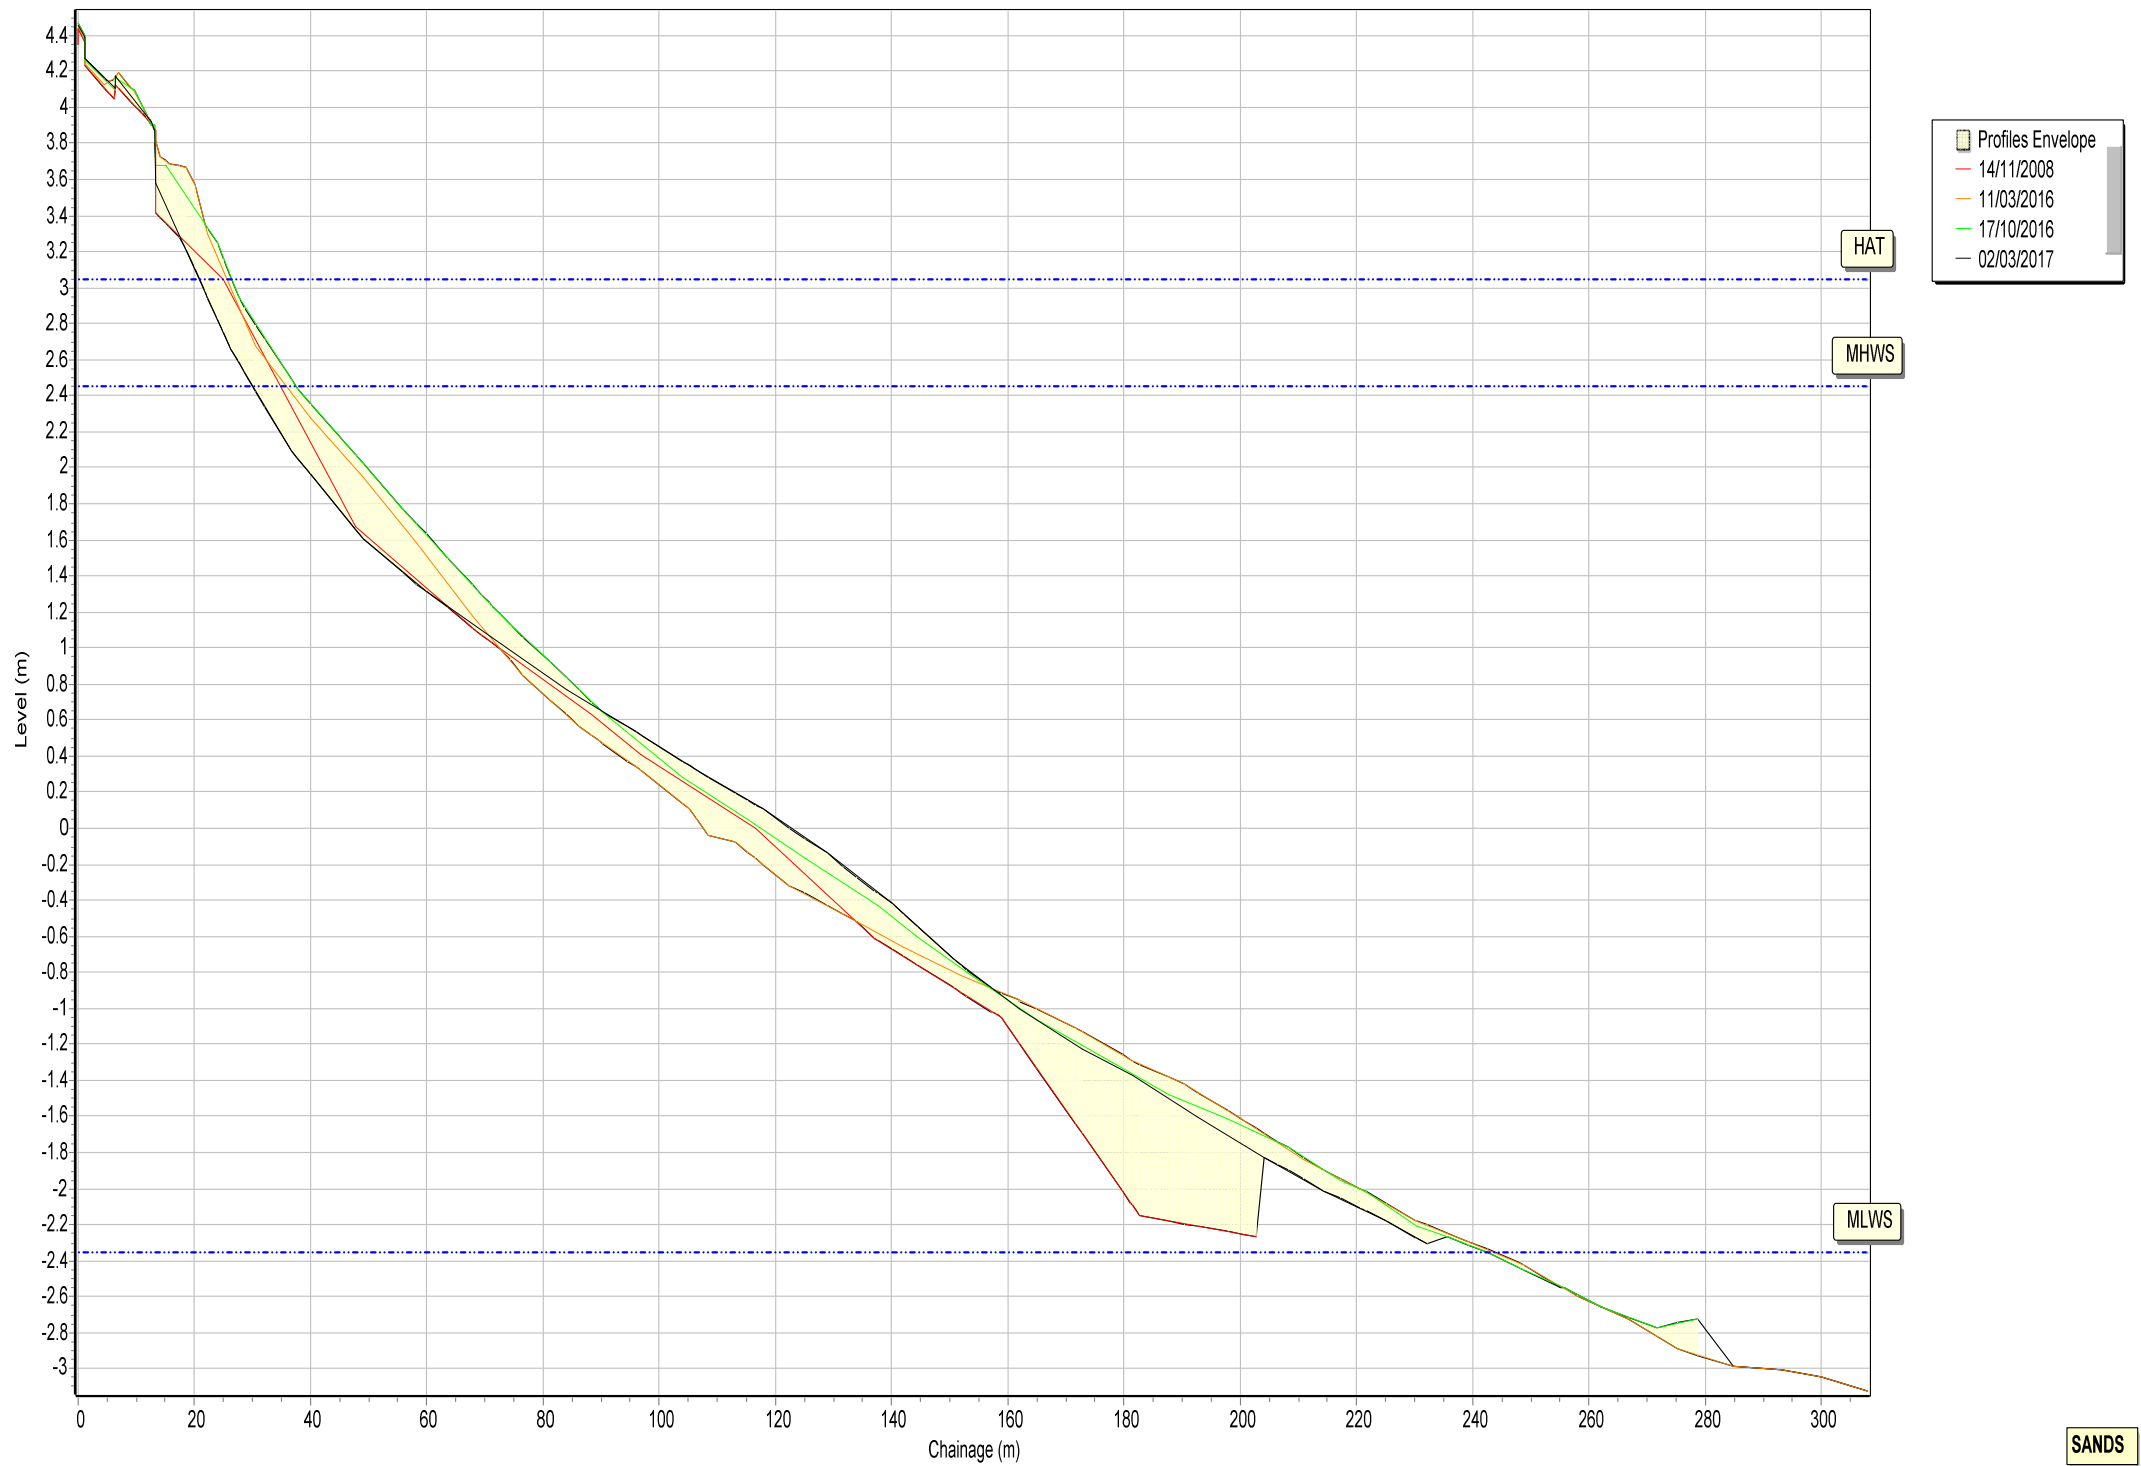
Beach Profiles: 1dSBS1

Survey Date	Description of Changes Since Last Survey	Interpretation
2 nd March 2017	<p>Beach Profiles:</p> <p>Scarborough South Bay is covered by four beach profile lines for the Partial Measures survey (Appendix A). The profiles were surveyed during the Full Measures survey of October 2016.</p> <p>Profile 1dSBS1 is located around 250m south of the West Pier. The profile is unchanged to the upper edge of the sea defences at 15m chainage. Between the sea wall and chainage 90m there has been erosion of up to 0.4m. Seawards of chainage 90m the changes in beach level have been minimal, ± 0.1m. Overall the profile is at a medium-high level compared to the range recorded from previous surveys.</p> <p>Profile 1dSBS2 is located on the shore fronting St Nicolas Cliff. Between the sea wall and chainage 80m there has been erosion of up to 0.4m. Between chainage 80m and 120m there has been very little change. Seawards of chainage 120m there has been accretion of up to 0.3m. The profile is low at the base of the sea wall, but at a medium-high level across the rest of the profile compared to the range recorded from previous surveys.</p> <p>Profile 1dSBS3 is located 250m north of the Scarborough Spa complex. From the sea wall at 10m to 170m chainage the beach level has dropped by up to 0.3m. Seawards of chainage 170m there has been accretion of 0.2m. The profile is relatively low at the base of the sea wall rising to relatively high at the toe of the beach, compared to the range recorded from previous surveys.</p> <p>Profile 1dSBS4 is located on the beach in front of the Scarborough Spa Complex. There has been slight erosion across the profile of <0.2m. The upper beach is at a relatively low-medium level, whilst the lower beach is relatively high compared to the range recorded from previous surveys.</p>	<p>All of the profiles show erosion of 0.2-0.4m, particularly across the upper beach. The lower beach in profiles SBS2 and SBS3 show slight accretion on the lower beach.</p> <p>Longer term trends: The observed changes in the profiles in South Bay are consistent with the seasonal fluctuations of sediment with a bay system.</p>

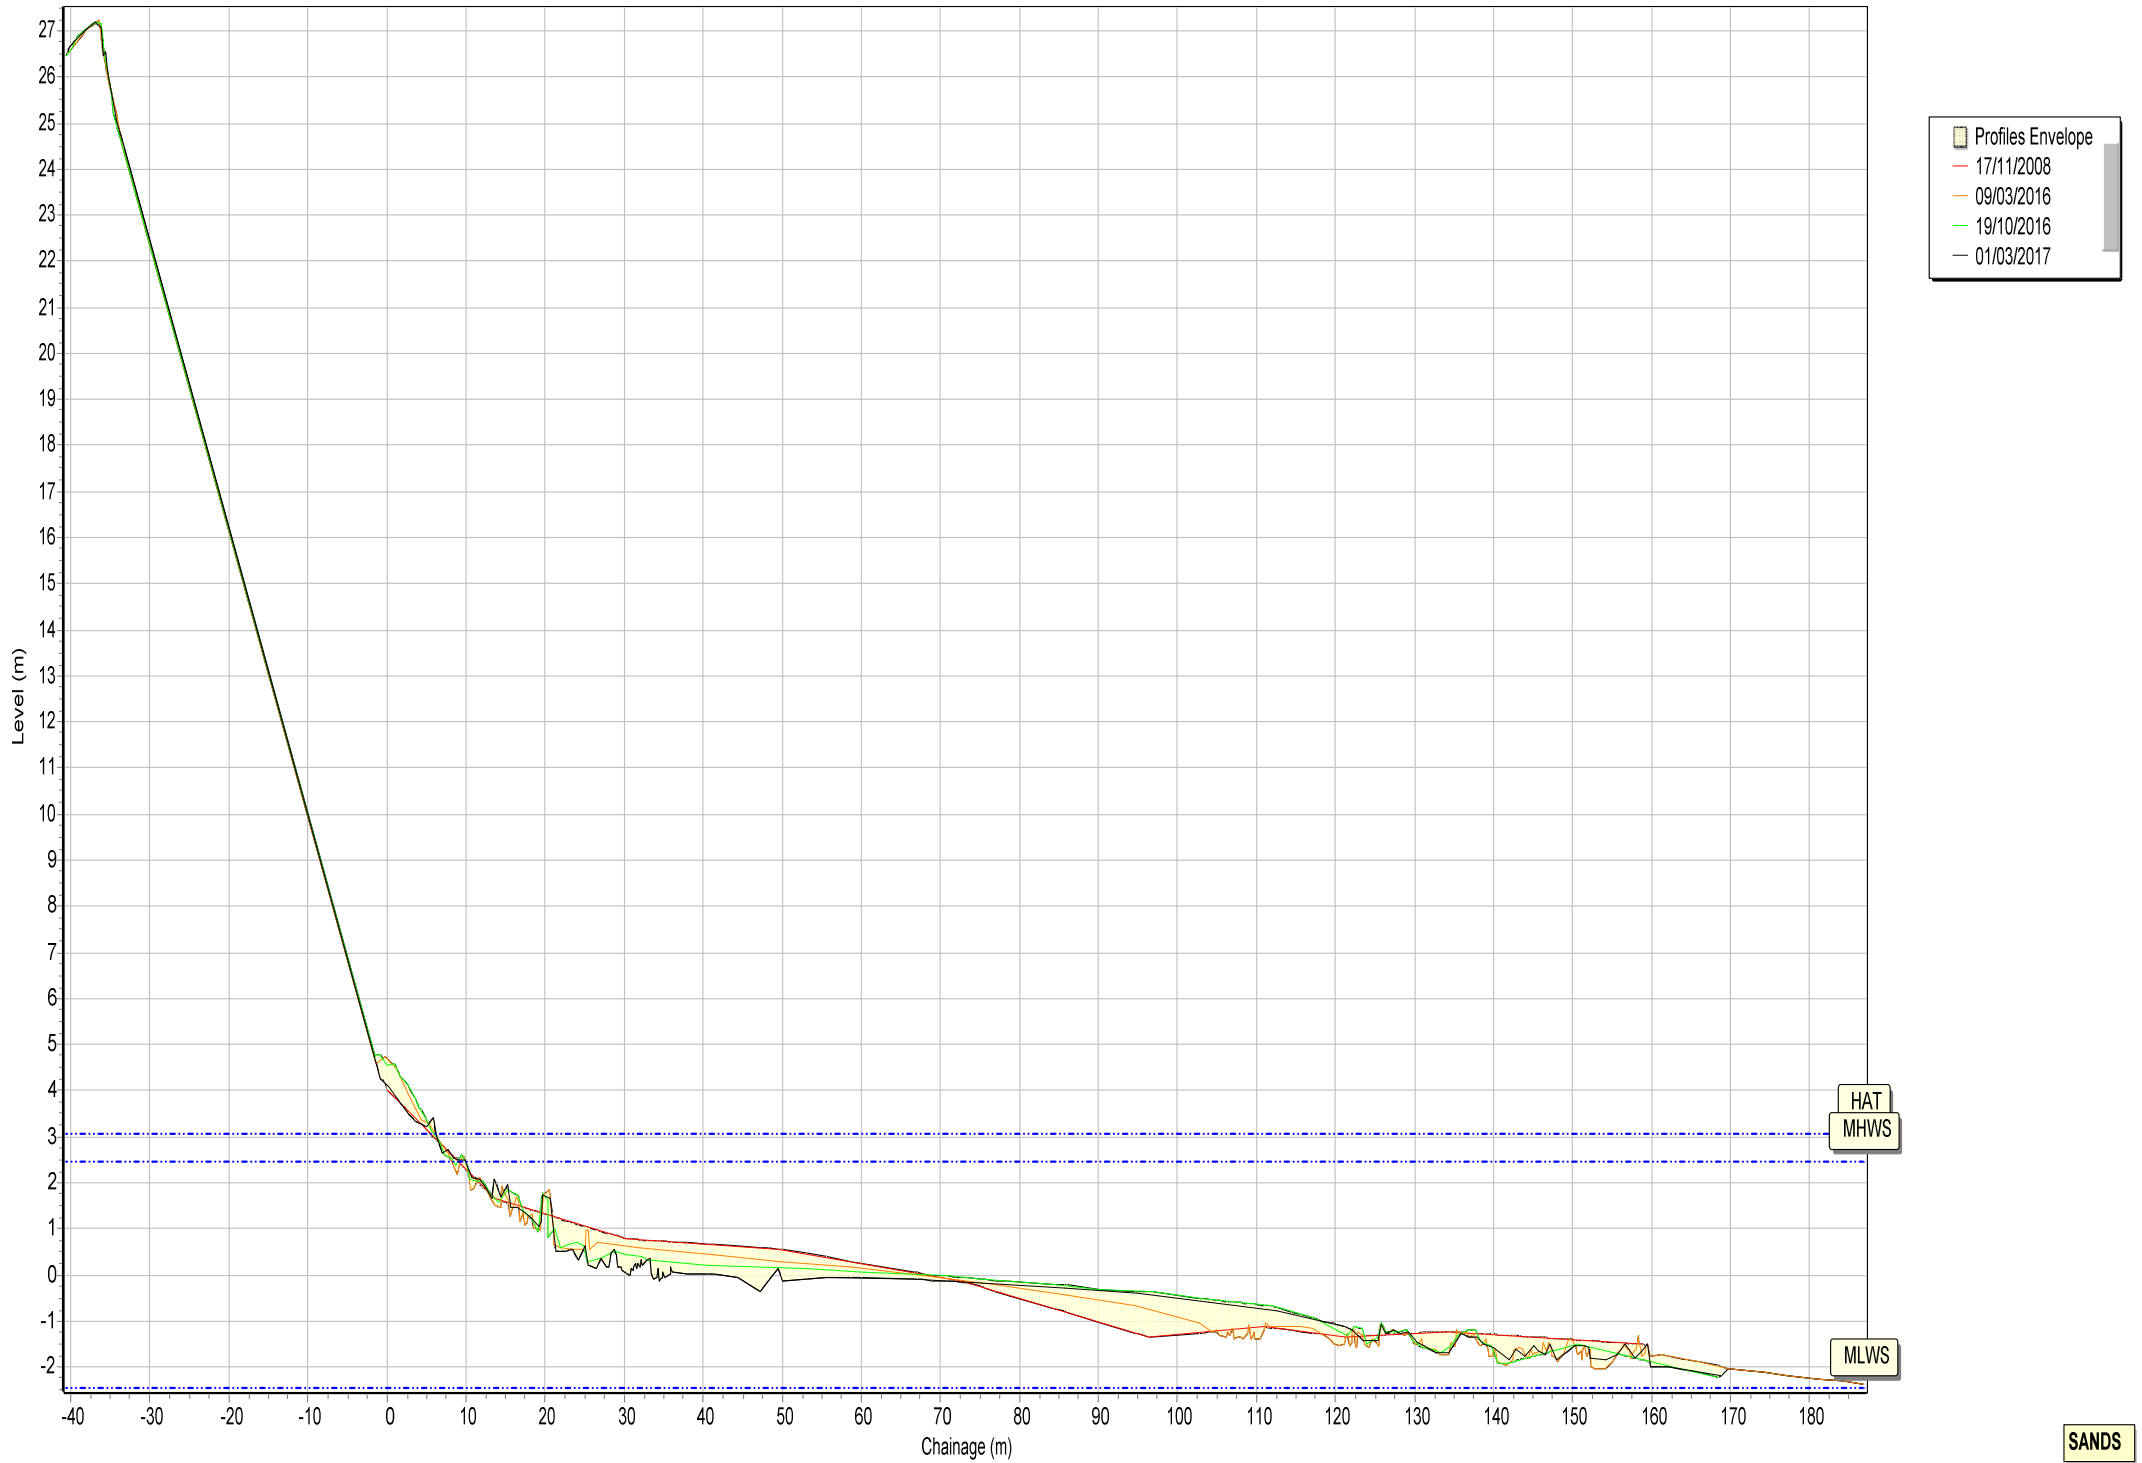
Beach Profiles: 1dCY1

Survey Date	Description of Changes Since Last Survey	Interpretation
1 st March 2017	<p>Beach Profiles:</p> <p>Cayton Bay is covered by three beach profile lines for the Partial Measures survey (Appendix A). The previous survey was undertaken in October 2016.</p> <p>Profile 1dCY1A is located on the beach below Knipe Point at the north of the bay, and was added to the programme in November 2015. There has been very little change along the profile until chainage 90m. Seawards of chainage 90m the beach level has dropped by 0.4m. Overall the profile is at a medium level compared to the range recorded from previous surveys.</p> <p>Profile 1dCY1 is located on the beach in front of Tenants' Cliff in the north of the Bay. The surveyors report states that 'the top of section 1 could not be measured due to dense vegetation'. The profile to 20m chainage is similar to the November 2015 record. At around 20m chainage rocks are exposed on the upper beach, to chainage 35m. From 25m to 80m chainage the beach has remained stable, dropping by a maximum of 0.2m. Seawards of chainage 80m very little change has occurred. From 125m to the end of the survey at 140m chainage the rocks on the lower beach are exposed. The profile is at a medium-high level in the middle, but low where the rocks are exposed on the upper and lower beach.</p> <p>Profile 1dCY2 is close to the former pumping station in the middle of Cayton Bay. The cliffed part of the profile has not changed a great deal. From the toe of the cliff at 120m chainage to the end of the profile at chainage 325m there has been erosion of up to 0.4m, though changes at the toe are minimal. Overall the profile is at a relatively medium level compared to the range recorded from previous surveys, except for the toe which is relatively high.</p> <p>Profile 1dCY3 is located around 600m southeast of the pumping station. The cliffed part of the profile has not changed a great deal. From the toe of the cliff at 120m chainage to chainage 240m there has been erosion of up to 0.5m removing the upper beach berm. The lower beach seawards of chainage 240m has accreted by 0.2m. The upper beach is at a relatively low level compared to the range recorded from previous surveys, the middle beach is at a medium-low level and the lower beach is at a relatively high level.</p>	<p>Each of the beach profiles saw a drop in beach level, of up to 0.5m.</p> <p>Longer term trends:</p> <p>The beach close to the toe of the cliff was comparatively low in March 2017, which means that the destabilisation of the cliff continues. Additional cliff failures will feed additional material onto the beach and driver erosion of the cliff top.</p>

- the top of profile 1dCY1 cannot be measured due to dense vegetation;
- The middle of profile 1dCY2 could not be measured due to the ground make-up, soft mud flows, and unstable grass;
- The middle of profile 1dCY3 could not be measured due to the ground make-up, soft mud flows, unstable grass, and landslips;
- Profile 1dCY3 was measured to cliff edge on top and as close to the cliff face at the bottom as possible.

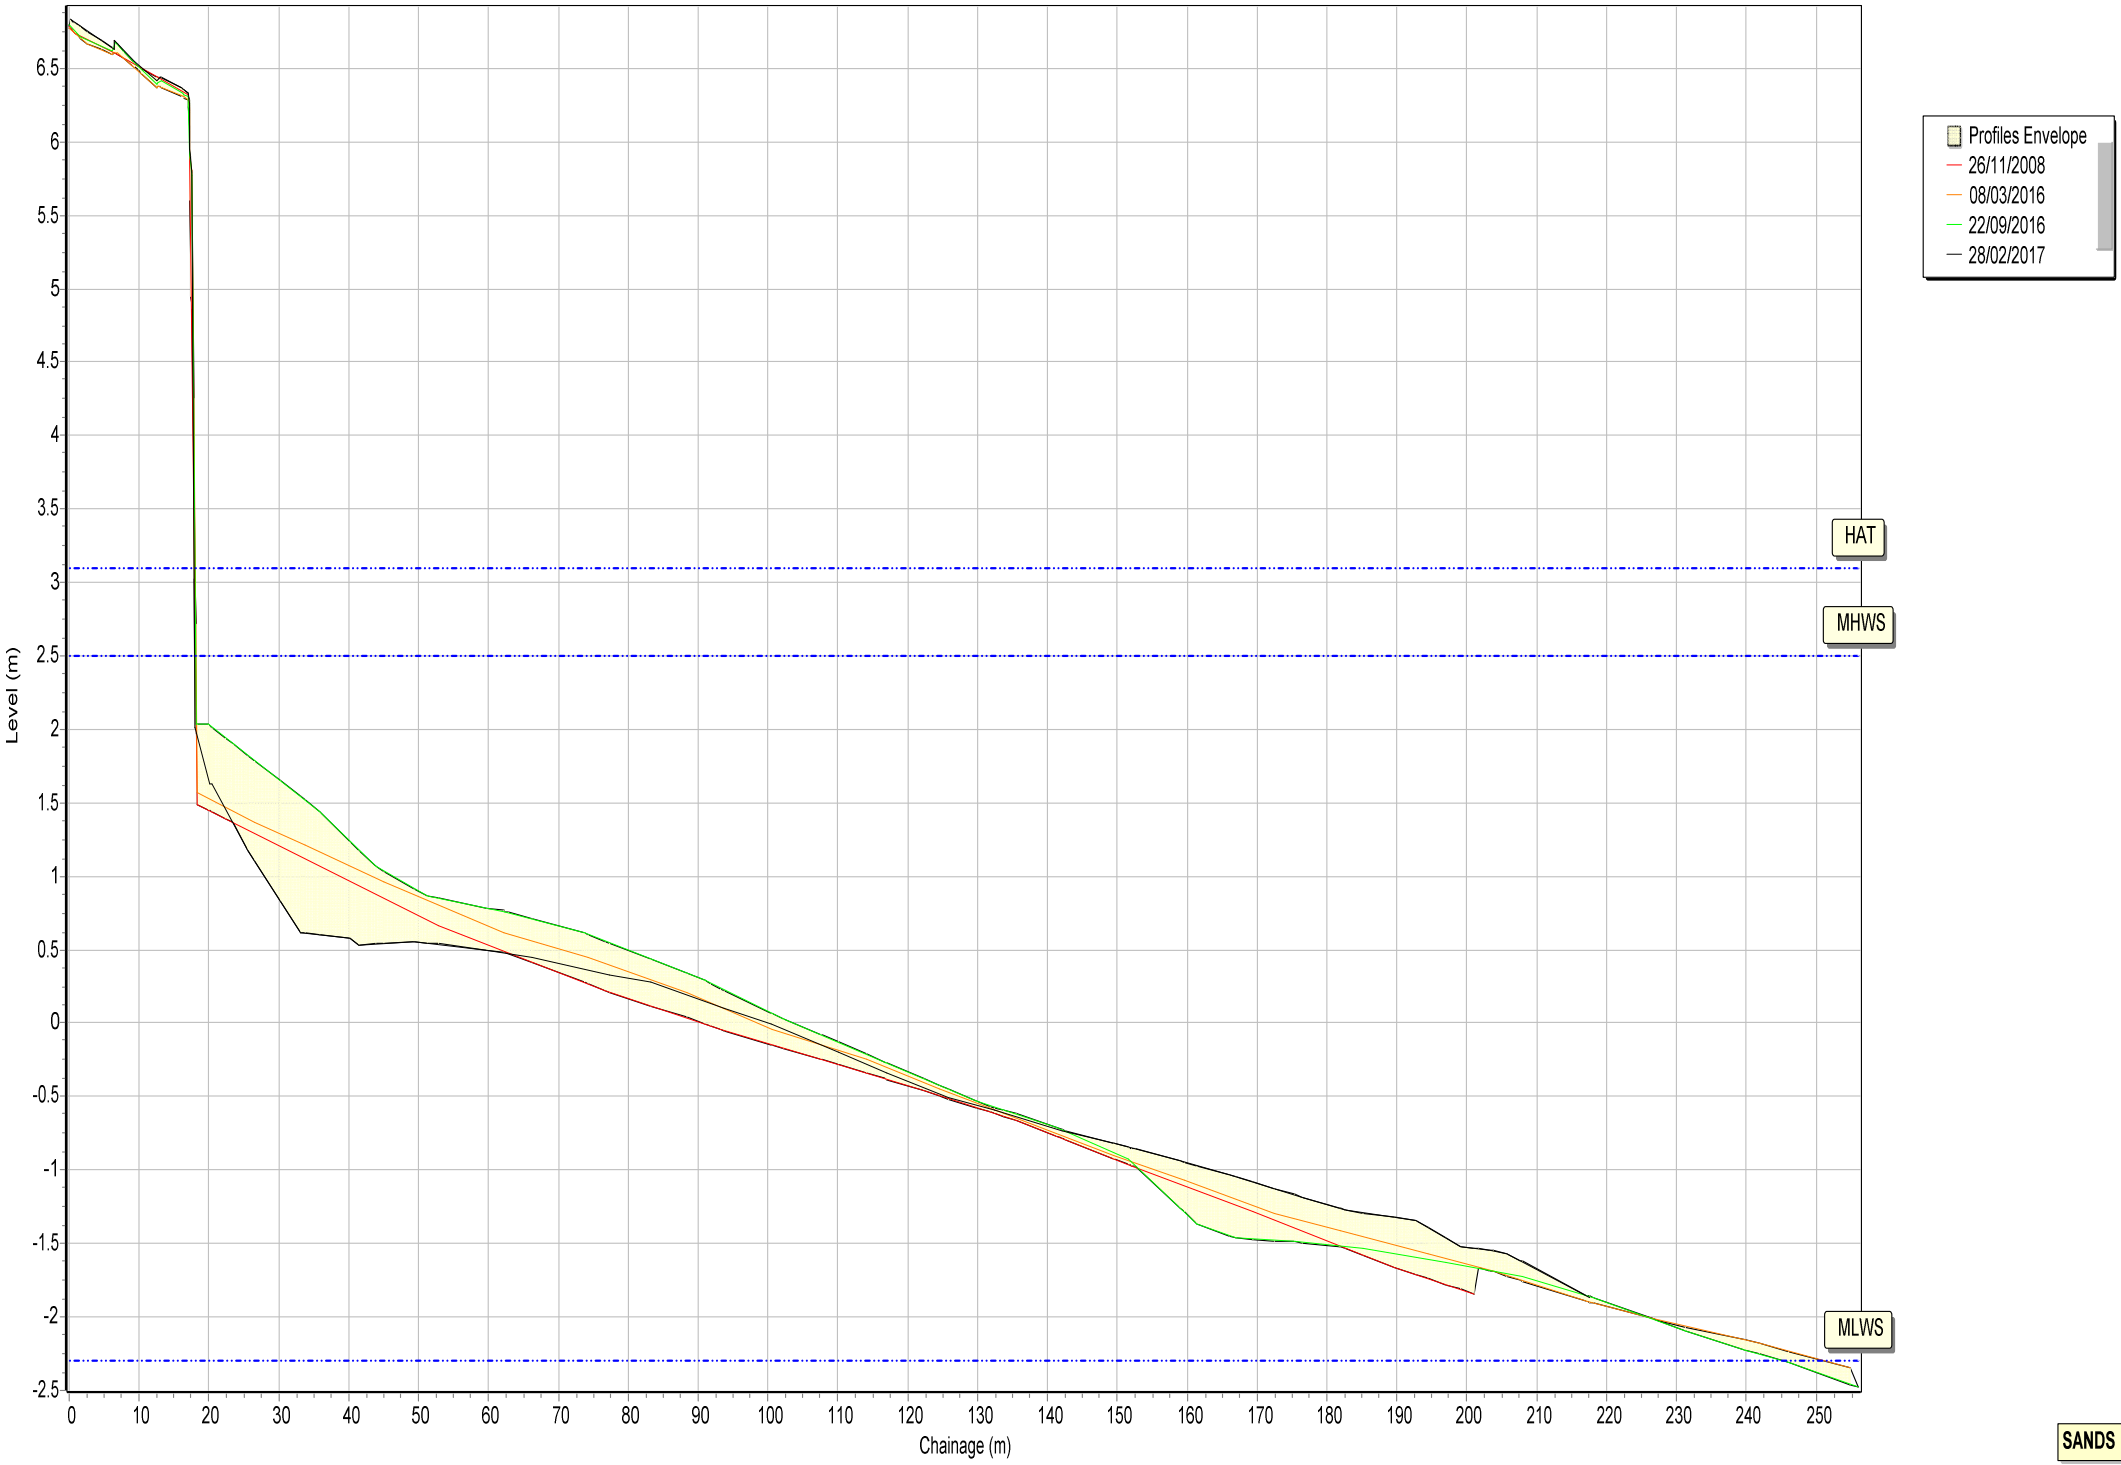
Beach Profiles: 1dFB1

Survey Date	Description of Changes Since Last Survey	Interpretation
28 th February 2017	<p>Beach Profiles:</p> <p>Filey Bay is covered by five beach profile lines for the Partial Measures survey (Appendix A). The previous programmed survey (Full Measures 2016) was undertaken in September 2016.</p> <p>Profile 1dFB1 is located in front of Filey town in the north of the bay. There has been erosion of up to 1m at the base of the sea wall, with erosion of up to 0.4m up to chainage 120m. There has been little change between chainage 120m and 150m. Seawards of chainage 150m there has been accretion of up to 0.4m. The upper beach is at a relatively low level compared to the range recorded from previous surveys, and a high level over the rest of the profile (chainage 140m to 200m is at its highest recorded level).</p> <p>Profile 1dFB2 is located north of Primrose Valley Holiday Village. The surveyor noted it was not possible to measure the beginning of the profile due to vegetation. There has been erosion of up to 0.4m across the whole profile over the winter of 2016/17. Overall the profile is at a medium-high level relative to the range recorded from previous surveys.</p> <p>Profile 1dFB3 is located in front of Flat Cliffs hamlet. There has been erosion of 0.4m between chainage 40m and 200m. Between chainage 200m and 260m there has been accretion of 0.3m. Between chainage 260m and 300m there has been erosion of 0.2m. The most seaward end of the survey appears to show accretion. Overall the profile is at a medium-high level relative to the range recorded from previous surveys.</p> <p>Profile 1dFB4 is located near Humanby Gap. There has been variable erosion of 0.1m to 1.3m between chainages 30m and 240m. This has created a stepped profile with berms at chainage 60m, 140m, and 240m. Seawards of chainage 240m there has been accretion of up to 0.8m at the toe of the beach. Overall the profile is at a medium-high level compared to the range recorded from previous surveys, with the toe of the beach being at its highest recorded level.</p> <p>Profile 1dFB5 is located close to Reighton Gap. The surveyor noted that the middle of profile 1dFB5 was unable to be measured from 65m to c. 204m chainage due to vegetation. There has been variable erosion across the whole beach profile of up to 0.7m, smoothing out the profile. Overall the profile is at a</p>	<p>All of the profiles show erosion over the winter of 2016/17, though all remain within the range recorded from the previous surveys.</p> <p>Longer term trends:</p> <p>The apparent stability of the beach is more likely to be due to the recovery of the beach following the winter storms, it is likely that the beach level was much lower in the mid-winter but that was not recorded.</p>
