Cell 1 Regional Coastal Monitoring Programme Update Report 9: 'Partial Measures' Survey 2017

**Scarborough Borough Council
July 2017**

(*) The present report is **Update Report 9** and provides an analysis of the 2017 Partial Measures survey for Scarborough Council's frontage.

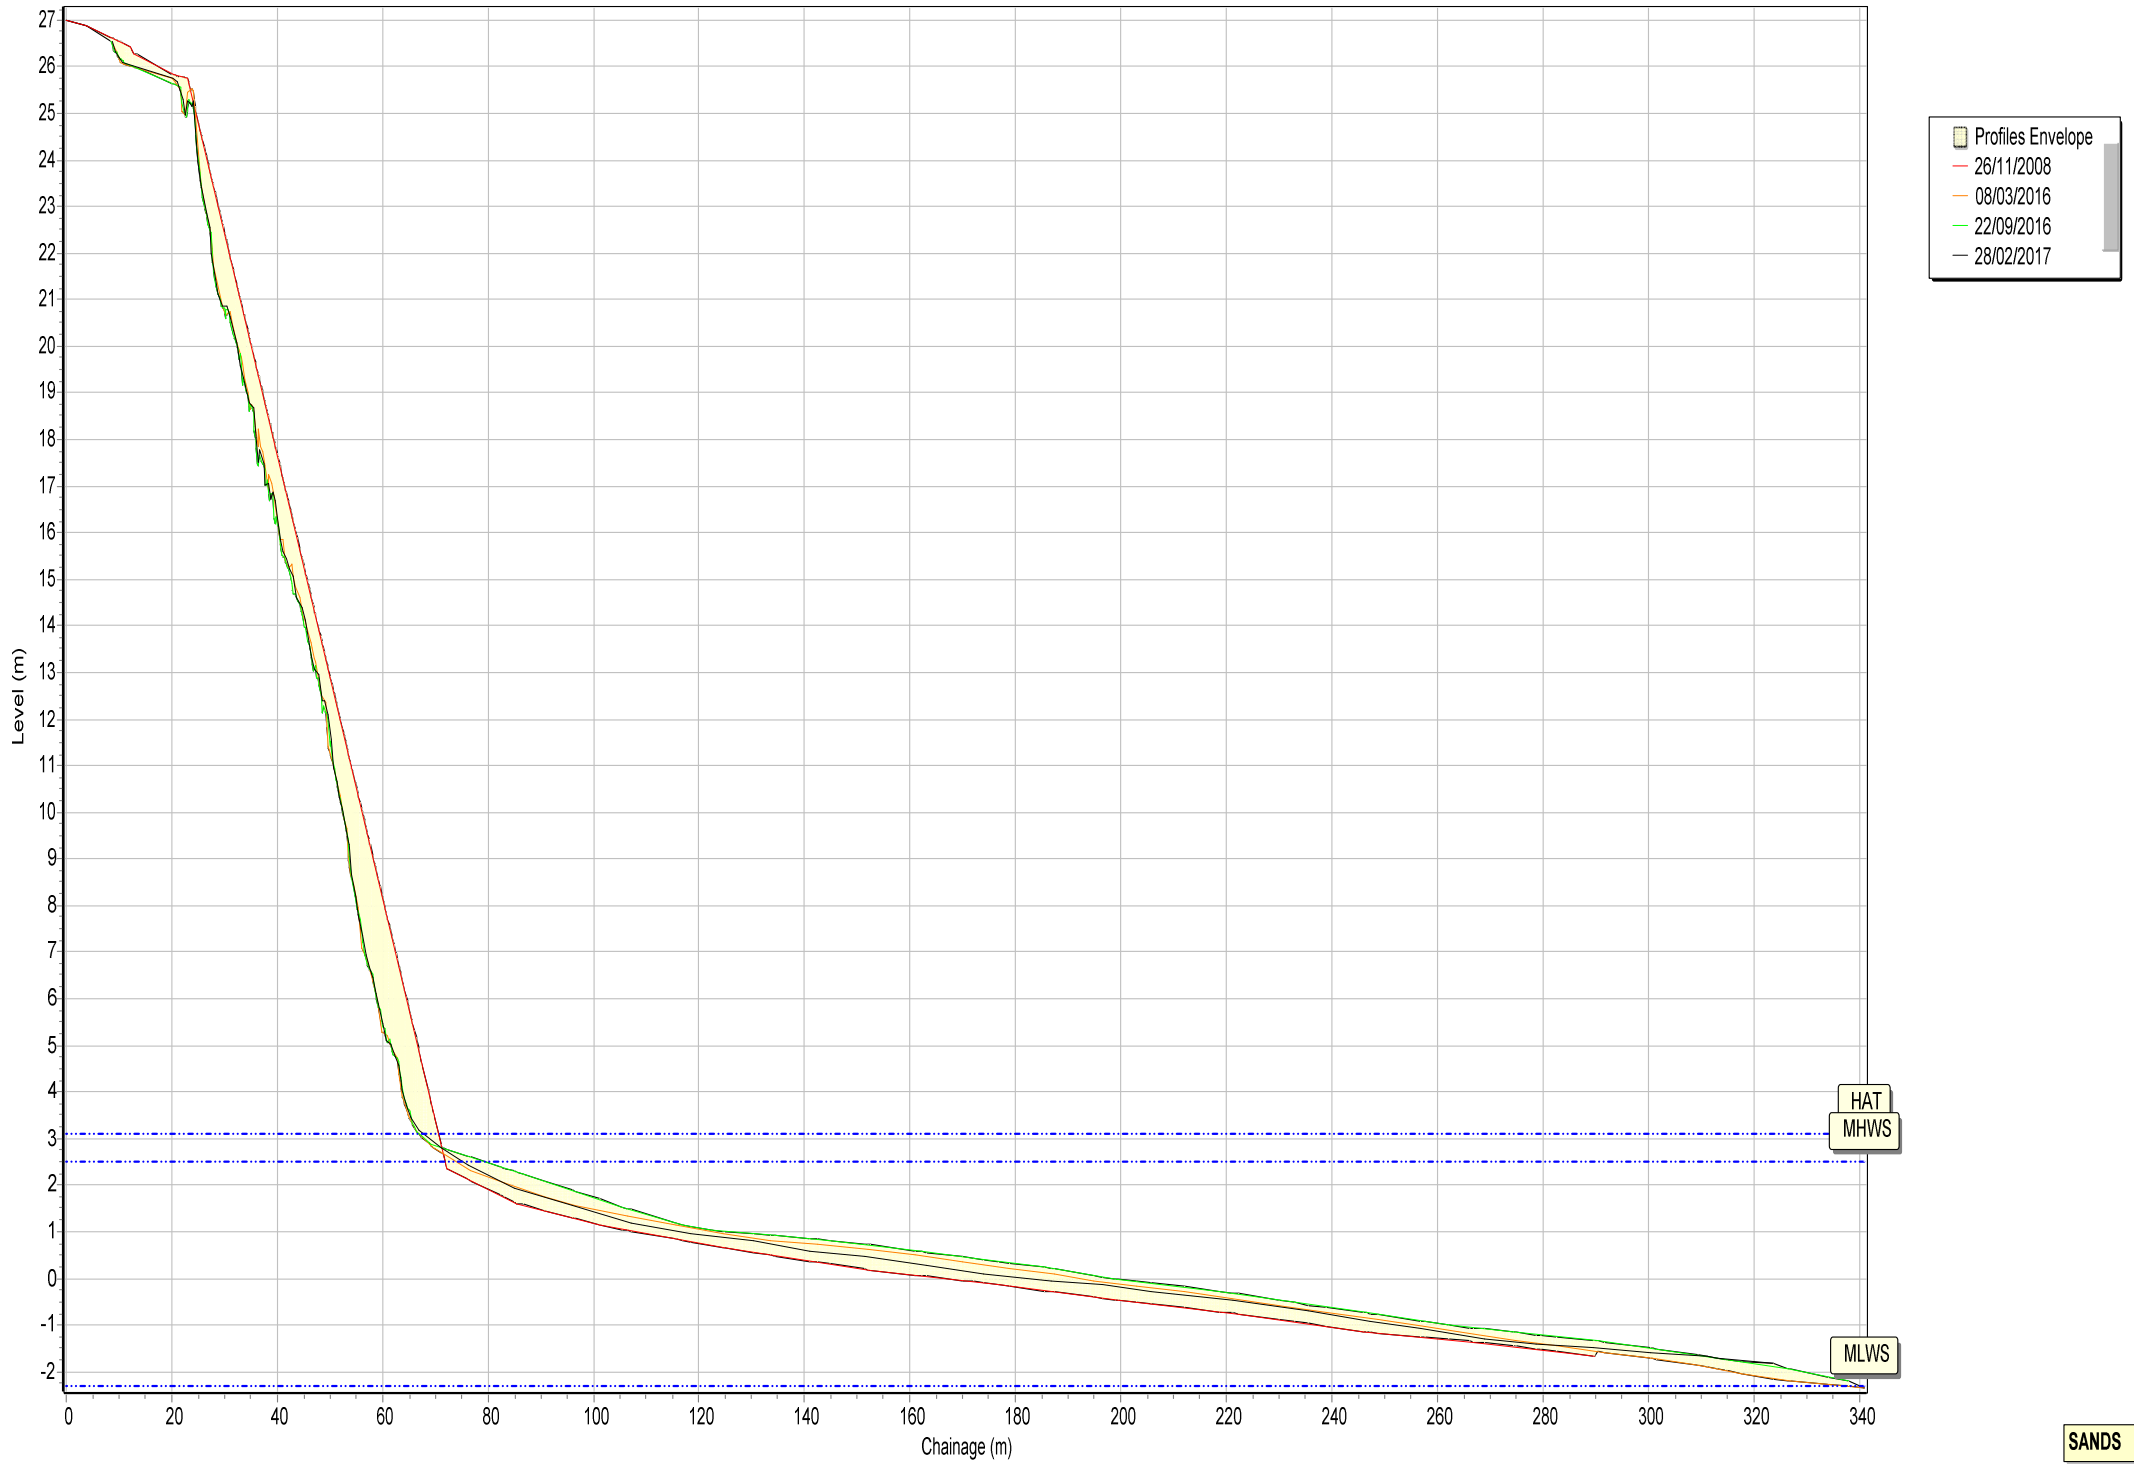
Beach Profiles: 1dFB2

Survey Date	Description of Changes Since Last Survey	Interpretation
28 th February 2017	<p>Beach Profiles:</p> <p>Filey Bay is covered by five beach profile lines for the Partial Measures survey (Appendix A). The previous programmed survey (Full Measures 2016) was undertaken in September 2016.</p> <p>Profile 1dFB1 is located in front of Filey town in the north of the bay. There has been erosion of up to 1m at the base of the sea wall, with erosion of up to 0.4m up to chainage 120m. There has been little change between chainage 120m and 150m. Seawards of chainage 150m there has been accretion of up to 0.4m. The upper beach is at a relatively low level compared to the range recorded from previous surveys, and a high level over the rest of the profile (chainage 140m to 200m is at its highest recorded level).</p> <p>Profile 1dFB2 is located north of Primrose Valley Holiday Village. The surveyor noted it was not possible to measure the beginning of the profile due to vegetation. There has been erosion of up to 0.4m across the whole profile over the winter of 2016/17. Overall the profile is at a medium-high level relative to the range recorded from previous surveys.</p> <p>Profile 1dFB3 is located in front of Flat Cliffs hamlet. There has been erosion of 0.4m between chainage 40m and 200m. Between chainage 200m and 260m there has been accretion of 0.3m. Between chainage 260m and 300m there has been erosion of 0.2m. The most seaward end of the survey appears to show accretion. Overall the profile is at a medium-high level relative to the range recorded from previous surveys.</p> <p>Profile 1dFB4 is located near Humanby Gap. There has been variable erosion of 0.1m to 1.3m between chainages 30m and 240m. This has created a stepped profile with berms at chainage 60m, 140m, and 240m. Seawards of chainage 240m there has been accretion of up to 0.8m at the toe of the beach. Overall the profile is at a medium-high level compared to the range recorded from previous surveys, with the toe of the beach being at its highest recorded level.</p> <p>Profile 1dFB5 is located close to Reighton Gap. The surveyor noted that the middle of profile 1dFB5 was unable to be measured from 65m to c. 204m chainage due to vegetation. There has been variable erosion across the whole beach profile of up to 0.7m, smoothing out the profile. Overall the profile is at a</p>	<p>All of the profiles show erosion over the winter of 2016/17, though all remain within the range recorded from the previous surveys.</p> <p>Longer term trends:</p> <p>The apparent stability of the beach is more likely to be due to the recovery of the beach following the winter storms, it is likely that the beach level was much lower in the mid-winter but that was not recorded.</p>

- The surveyor was unable to measure the start of section 1dFB2 due to vegetation.
- The middle of profile 5 was unable to be measured from chainage 65m to c. 204m, due to undergrowth and bushes.
