**Cell One Coastal Monitoring (2008-11)  
Aerial Photographic Survey 2010: Areas of Change**

**Final Report**

**August 2010**

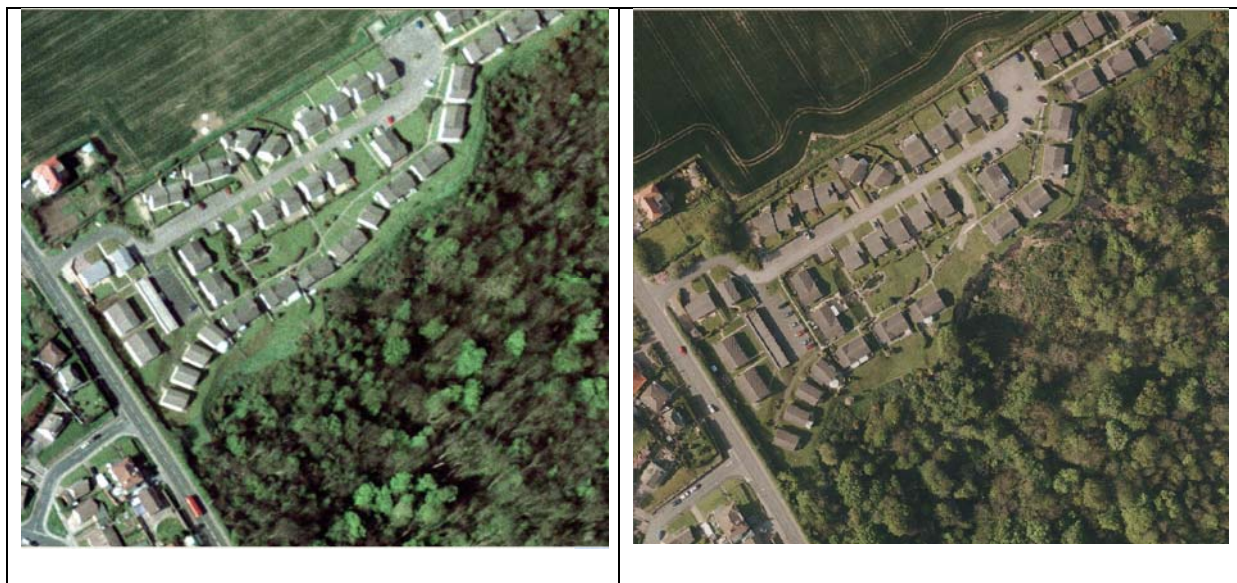
*Figure 1. Qualitative comparison of vertical imagery from 1999 and 2010, highlighting landslide reactivation at Cayton Bay.*

The newly-acquired 2010 aerial photography was compared with previous surveys from 1999, 2003 and 2008. An example of change between 1999 and 2010 at Cayton Bay is shown in Figure 1, which shows reactivation of the Cayton Bay landslide, headscarp recession and destruction of a number of properties. Areas of change were validated against data collected during past Cell 1 cliff and asset inspection surveys, to identify areas of change requiring further detailed investigation.

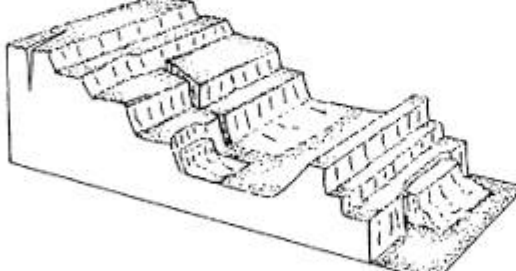
Figure 3. The key cliff behaviour unit (CBU) types

<p>Deep-seated landslide with failure at more than one level</p>

<p>Seepage erosion cliff alternating sand and clay</p>
Relict cliffs

Cliff behaviour units (CBU) provide a framework for understanding and management of cliff recession developed by Lee and Clark (2002) for Defra. A CBU spans the nearshore to the cliff top and is coupled to adjacent units with coastal sediment cells. CBUs are cascading sediment supply systems, with input from the cliff top, through put via the cliff face and output via the cliff toe. The classification scheme for CBUs recognises the variation in throughput and storage of sediment within the cliff system (Figure 3):

- **Simple cliffs** (topples and falls) comprise a single sequence of sediment inputs and outputs with limited intervening storage. Rates of cliff recession and sediment supply to the beach are therefore considered to be constant through time. Examples include the Silurian shale cliffs of St Abbs Head, the Jurassic cliffs of Bempton and pasts of Flamborough Head.

- **Simple landslides** (rotational landslides or mudslides) comprise a single sequence of sediment inputs and outputs with variable amounts of intervening storage within the failed mass. Rates of cliff recession and sediment supply to the beach are therefore considered to be episodic through time. Examples include the till cliffs of Sandsend and Hunmanby Gap

- **Composite systems** comprise a partly coupled sequence of different simple cliff sub-systems whereby the output from the upper system may fail directly to foreshore and not form an input to the lower cliff system. Examples are where near-vertical limestone simple cliffs are overlain by glacial sediment which fails through simple landslides. Failure of the till capping can be independent of recession of the underlying cliff and therefore these systems have annual and episodic components. Examples are common where a thick layer of glacial sediment overlies a simple cliff such as at Flamborough Head

- **Complex cliffs** comprise a series of interlinked sub-systems each with unique inputs and outputs. Complex cliffs are rare on the NE coast.
- **Dormant cliffs** (dormant, reactivated or slop-over-wall) comprise sequences of pre-existing landslide sequences which are currently stabilised by engineering, but which may be reactivated by climate change or failure of coastal defences. Dormant cliffs are also formed where fronting beaches or dunes have developed to protect the cliff. This process can be natural, such as at Bamburgh, where the once coastal castle is now fronted by an extensive beach and dune system, or in response to human activity, such as a Blast Beach, Horden, where colliery spoil deposits have afforded cliff protection.

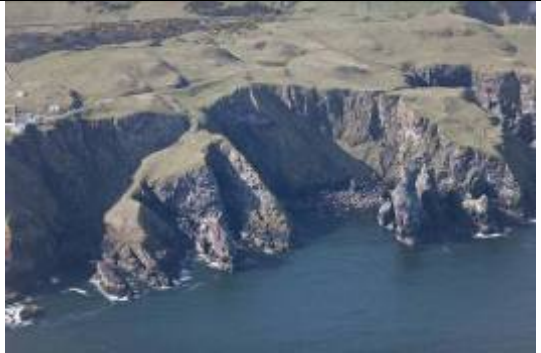
Cliff Type	Periodicity of major recession events (years)	Response to increased toe erosion	Response to elevated groundwater	Northeast coast examples	Picture
1. Simple cliff	1 - 10 <sup>1</sup>	very rapid	moderate	St Abbs Head

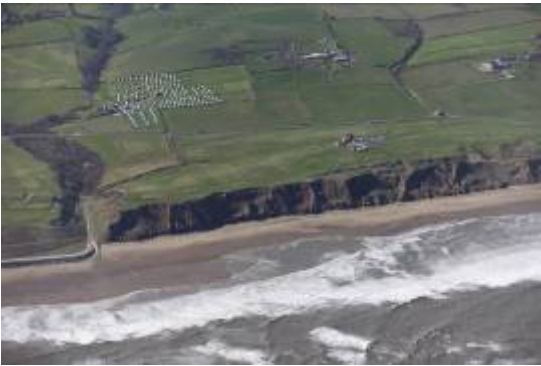
2. Simple landslide	10 <sup>1</sup> - 10 <sup>2</sup>	rapid	rapid	Sandsend, Whitby; Hunmanby Gap, Filey Bay

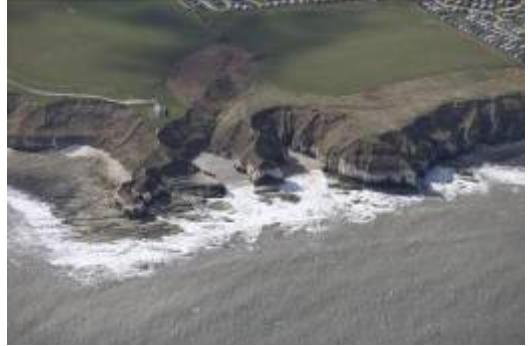
Cliff Type	Periodicity of major recession events (years)	Response to increased toe erosion	Response to elevated groundwater	Northeast coast examples	Picture
3. Composite	$10^2 - 10^3$	slow/moderate	moderate	Flamborough Head; Bempton Cliffs

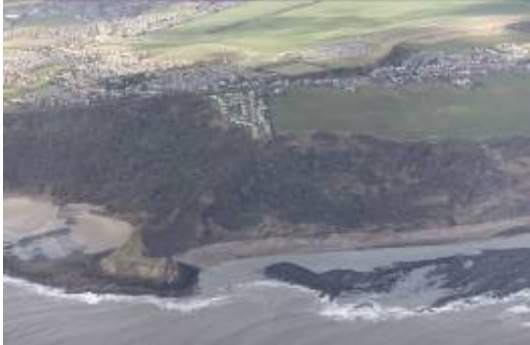
4. Complex	$10^2 - 10^3$	moderate	moderate to rapid	Cayton Bay and Tennants' Cliff; Flat Cliff, Filey

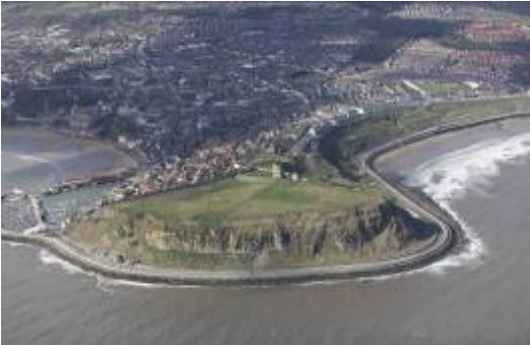
5. Dormant	Variable	moderate to rapid	moderate to rapid	Scarborough South and North Bays; Blast Beach, Horden

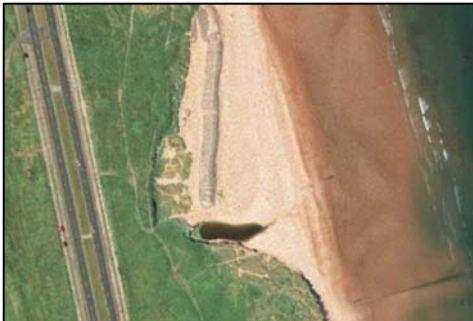
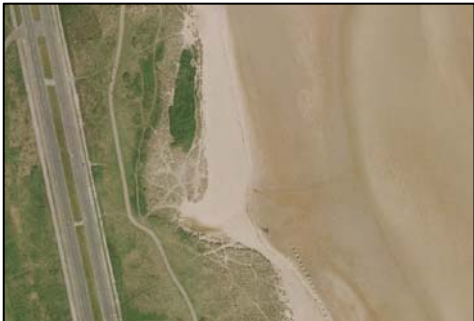
Table 3. Example of change near Blyth Cemetery

<b>Location</b>	Near Blyth Cemetery (PU23.3)	
<b>Observed changes</b>	Area of sand dunes within small embayment have advanced seaward	
<b>1999</b>	<b>2010</b>

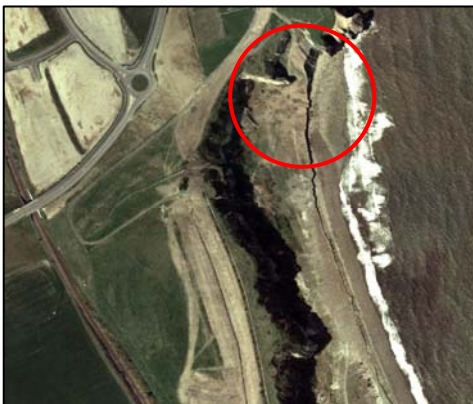
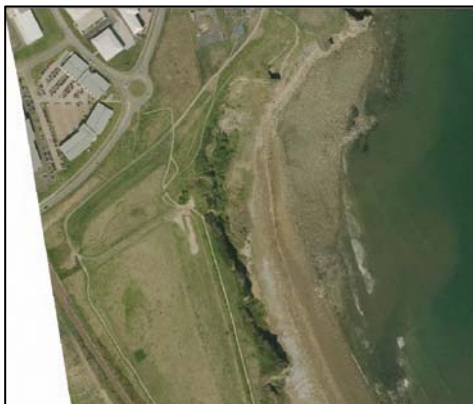
Table 4. Example of change at Dawdon Blast Beach

<b>Location</b>	Dawdon Blast Beach (PU9.7)	
<b>Observed changes</b>	Erosion of colliery spoil from beach, particularly notable at the northern end of the beach	
<b>1999</b>	<b>2010</b>

Dawdon Blast Beach (PU9.7): This beach was used for coal waste tipping before the closure of the colliery in 1991. Since this time, erosion of the colliery spoil from the surface of the beach and redistribution in the coastal system by marine action has led to significant changes in beach geomorphology. The spoil has been eroded landward and the thickness of material reduced, particularly at the north end of the beach. This is clearly evident in the comparison of imagery from 1999 and 2010, as shown in Table 4.

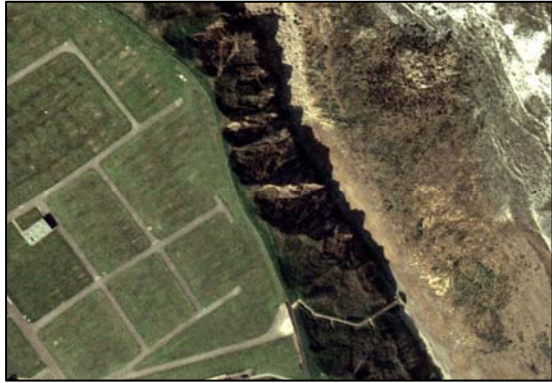
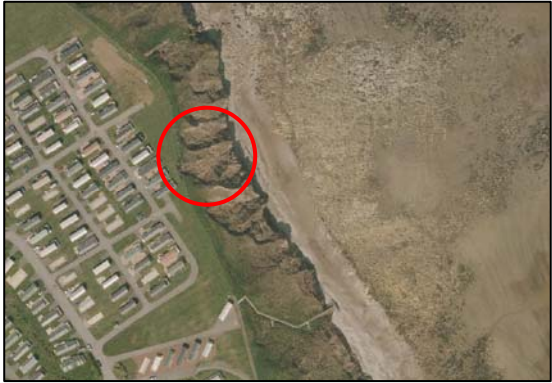
Table 5. Example of change at Crimdon Park Caravan Site

<b>Location</b>	Crimdon Park Caravan Site	
<b>Observed changes</b>	Headscarp recession due to mudsliding which is beginning to impinge on the Caravan Park	
<b>1999</b>

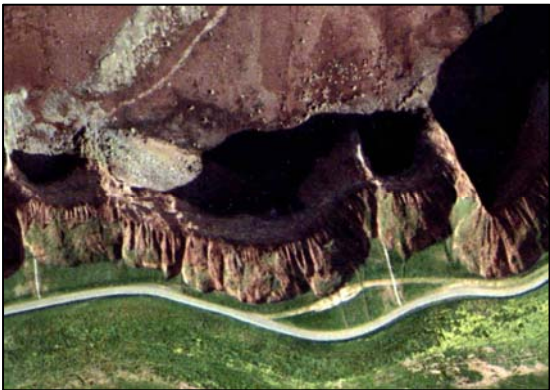
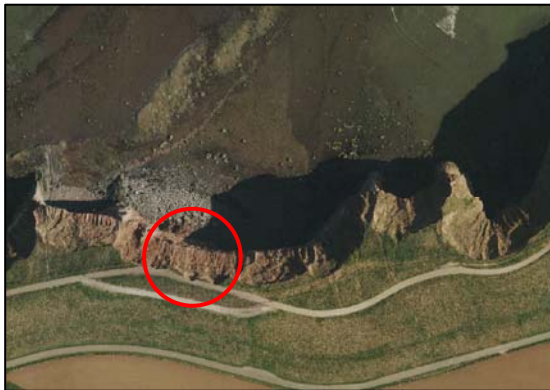
Table 6. Example of change between Redhouse Nab and Cowbar Nab

<b>Location</b>	Between Redhouse Nab and Cowbar Nab, near Staithes (PU18.1)
<b>Observed changes</b>	Mudsliding in upper till layer of the cliffs has caused significant headscarp recession and loss of the old Cowbar Lane
<b>1999</b>	<b>2010</b>

Redhouse Nab to Cowbar Nab, Staithes (E59/4 to E59/1, PU18.1): Since 1999 there has been continued erosion of the soft till capping of the cliffs. The mudslide headscarps have retrogressed significantly since 2003, so that by 2010 the road along the cliff top is being lost and has consequently been redirected inland. At the western corner of Cowbar Nab, erosion is beginning to threaten the road access to properties on the Nab itself. This ongoing activity was also noted during the 2008 and 2010 coastal cliff walkover inspections. This example is shown in Table 6. This area is being monitored.

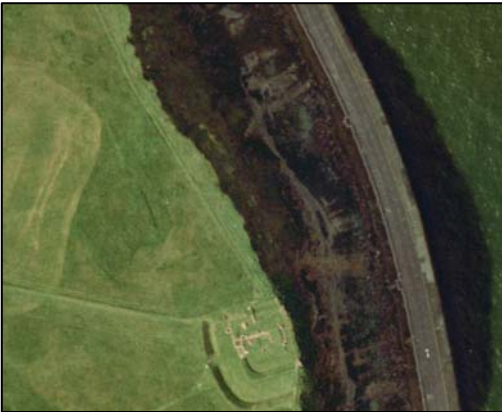
Table 7. Example of change at Castle Cliff, Scarborough

<b>Location</b>	Castle Cliff, Scarborough (PU27.2)	
<b>Observed changes</b>	Localised rockfall activity has occurred since 2003.	
<b>1999</b>

can be seen in the 2010 image. This activity was noted during the 2008 and 2009 coastal cliff walkover inspections (Table 8).

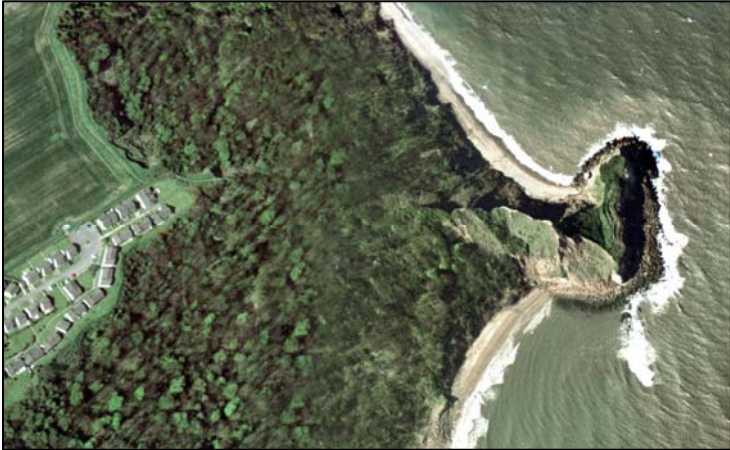
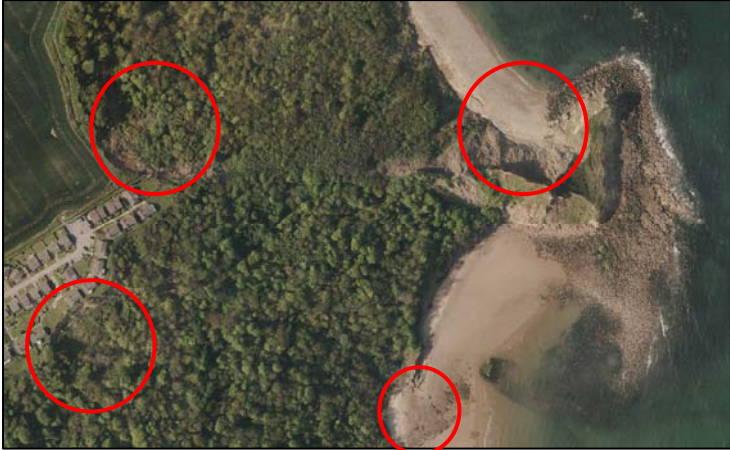
Table 8. Example of change at Cornelian Bay south and Knipe Point

<b>Location</b>	Cornelian Bay south and Knipe Point headland (PU29.1 and 29.2)
<b>Observed changes</b>	Headscarp recession and erosion at the southern end of Cornelian Bay and the Knipe Point headland. Landslide reactivation on the south side of Knipe Point with associated loss of property and beach uplift at the unit toe.
<p data-bbox="188 488 256 517"><b>1999</b></p>

Cornelian Bay South (Mu23/I, PU29.1): Between 1999 and 2010 there has been extensive recession of the headscarp of Cornelian Bay near the Knipe Point development. This was observed during the 2009 coastal cliff walkover survey. Furthermore there has been ongoing erosion of the headland at Knipe Point itself.

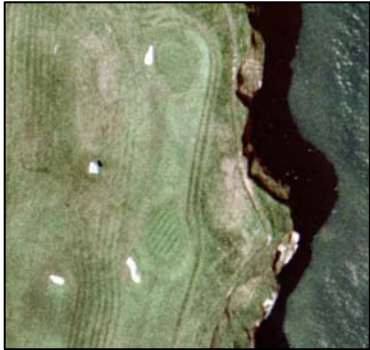
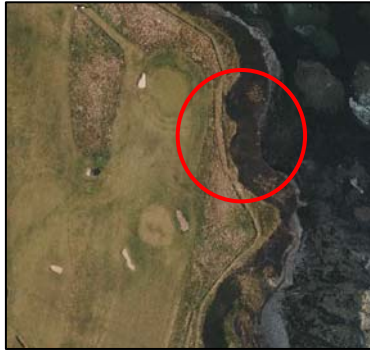
Table 8. Example of change at Stottle Bank Nook

<b>Location</b>	Stottle Bank Nook (PU33.2)	
<b>Observed changes</b>	Mudsliding and consequent headscarp recession has made redirection of the cliff top footpath necessary	
<b>1999</b>

Stottle Bank Nook (golf course) (E111/14, PU33.2): The 1999 and 2010 imagery indicates that headscarp recession through mudslide activity has occurred at this locality and is currently impacting on the route of the cliff top footpath.
