Cell 1 Regional Coastal Monitoring Programme Aerial Photography and LiDAR Surveys 2017

February 2018

Scarborough Borough Council

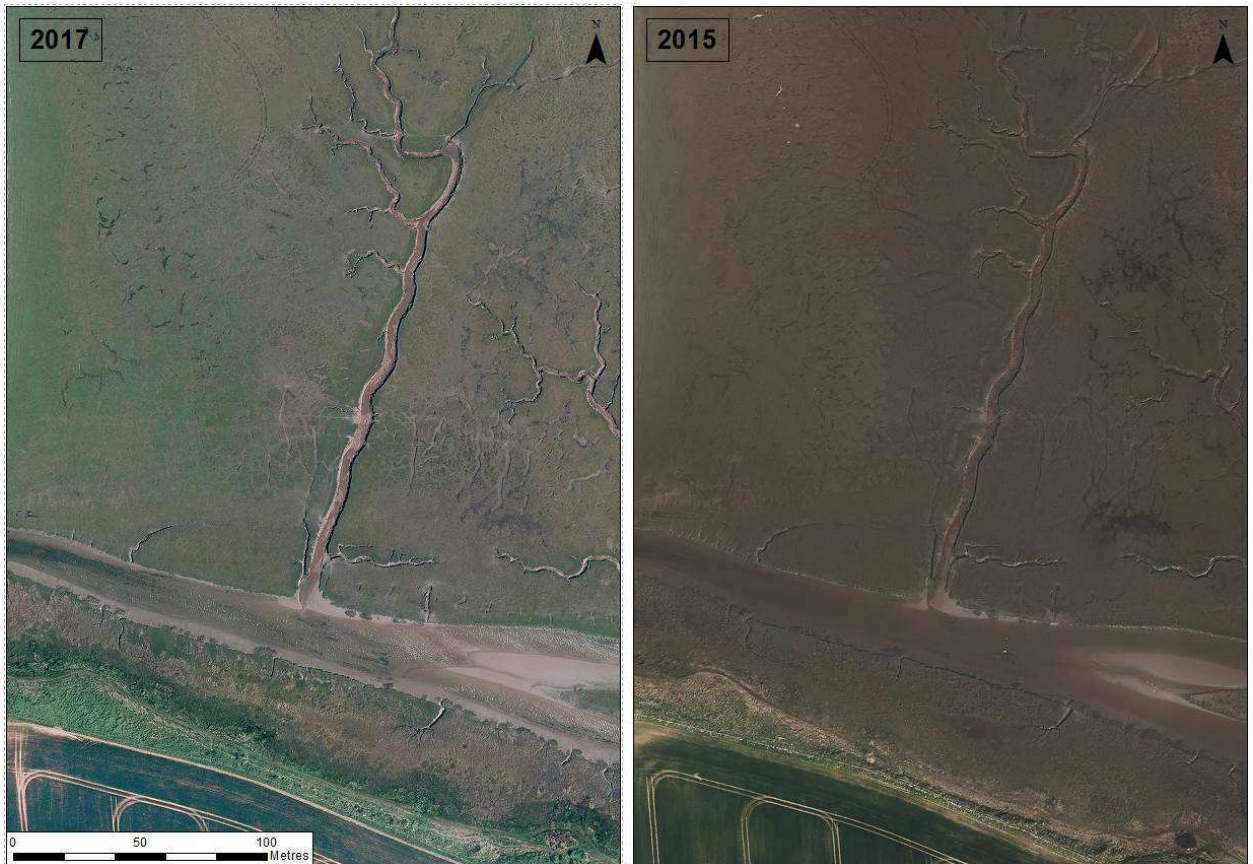
In general, the quality of the aerial imagery appears better than that recorded in 2015, as shown in Figures 1-1 and 1-2.

Figure 1-2 – Comparison of image quality at a saltmarsh creek from 2017 (left) and 2015 (right)

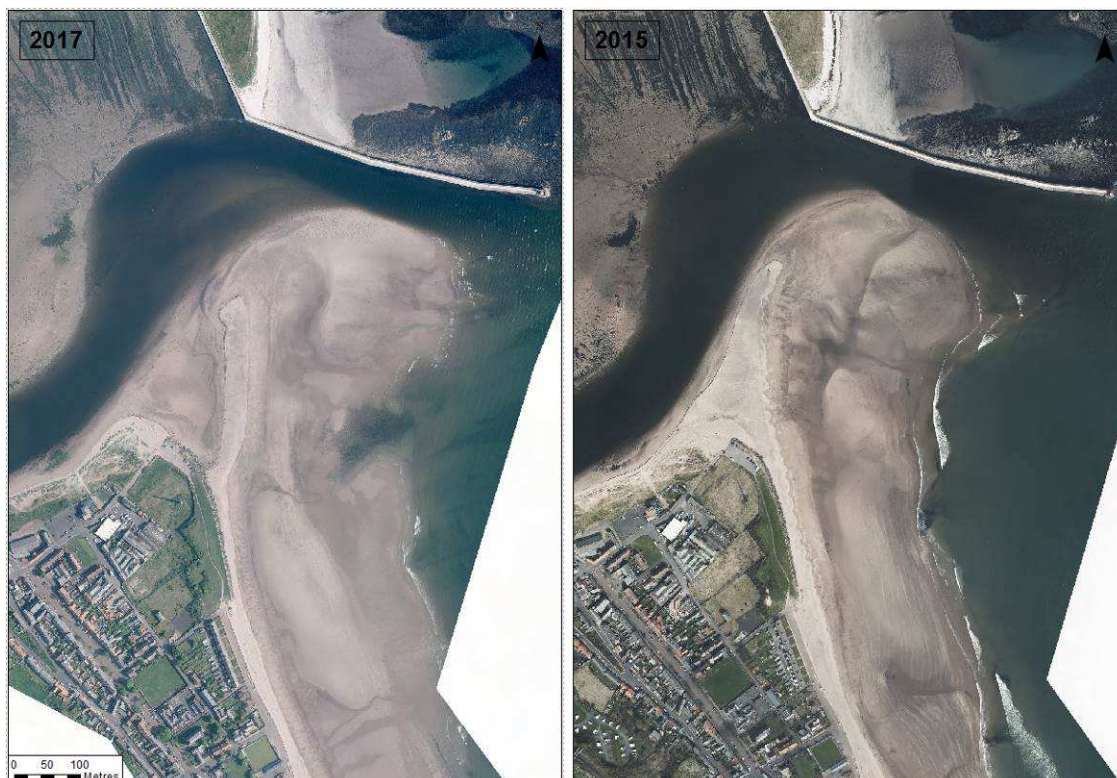
- **Marshall Meadows Bay**, Berwick-upon-Tweed (PU1.1): An area of cliff which appeared bare of vegetation in 2015, indicating either a small slippage or provision of a local access ramp to the beach, appears to have become partially remediated by 2017.
- **Sharppers' Head**, Berwick-upon-Tweed (PU1.2): The coastal slopes fronting the caravan park just to the west of the headland have suffered small slippages in a number of locations, although this is not affecting the siting of the caravans on the cliff top at present.
- **Sandstell Point**, Berwick-upon-Tweed (PU2.4): The sand spit at the mouth of the Tweed estuary has long been known to be dynamic in form and position, and changes continue between 2015 and 2017. The crest of the spit appears more seaward and the channel at the mouth of the estuary, between the end of the spit and the Berwick Breakwater, appears narrower (Figure 2-1).

Figure 2-1 – Changes at Sandstell Spit 2017 (left) and 2015 (right)

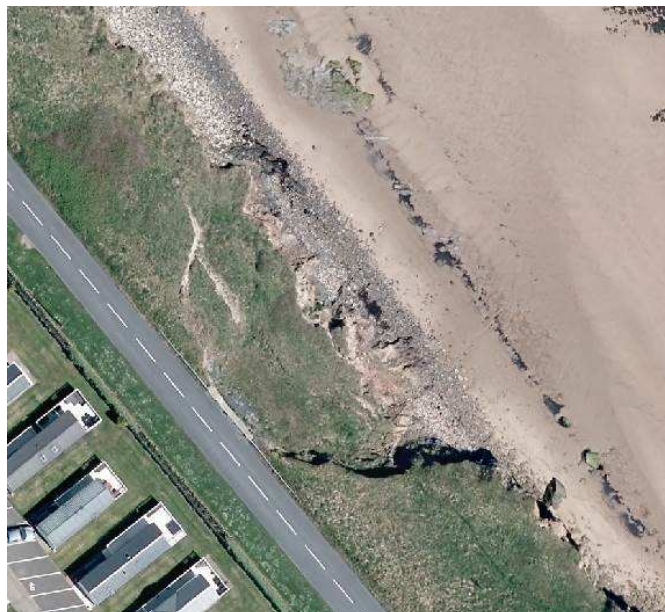
- **Cresswell** (PU17.5): The landslip in the cliffs just to the north of Cresswell that occurred prior to the 2015 survey has not worsened to 2017, but remains impacting the carriageway.

Figure 2-3 – Landslip at Cresswell impacting the road carriageway in 2017

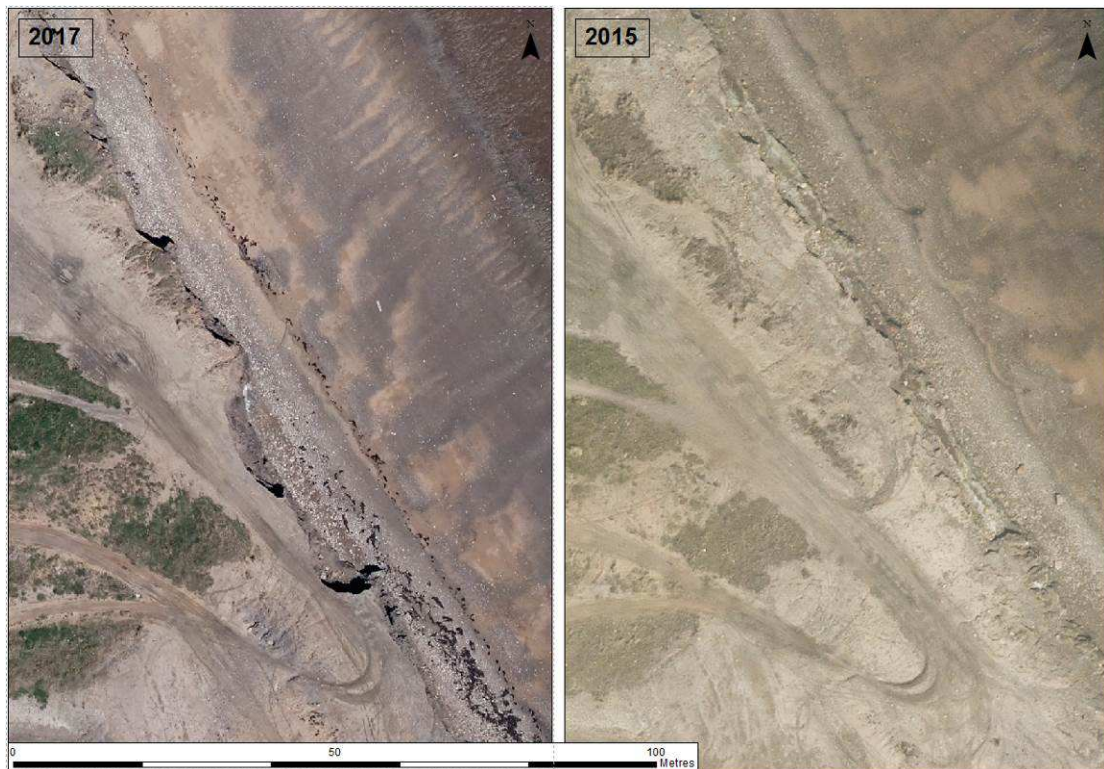
- **Snab Rocks (PU18.2):** The private defences at the property immediately south of Snab Rocks, which were extended a few years ago (and visible in the 2015 aerial photography), now have a property being constructed behind the extended length.
- **Lynemouth (PU19.1):** Some of the colliery spoil beach to the south of the Power Station has become quite noticeably eroded.

Figure 2-4 – Erosion of colliery spoil south of Lynemouth

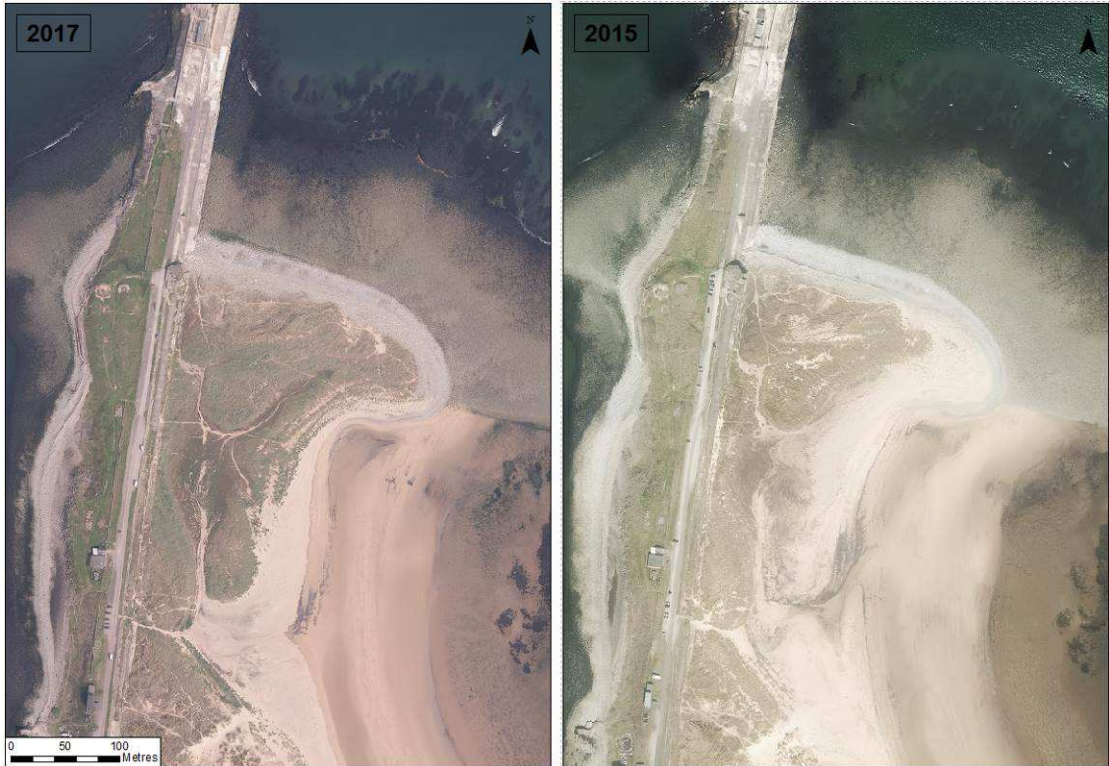
Figure 2-5 – Vegetation growth on dunes in the lee of South Gare Breakwater

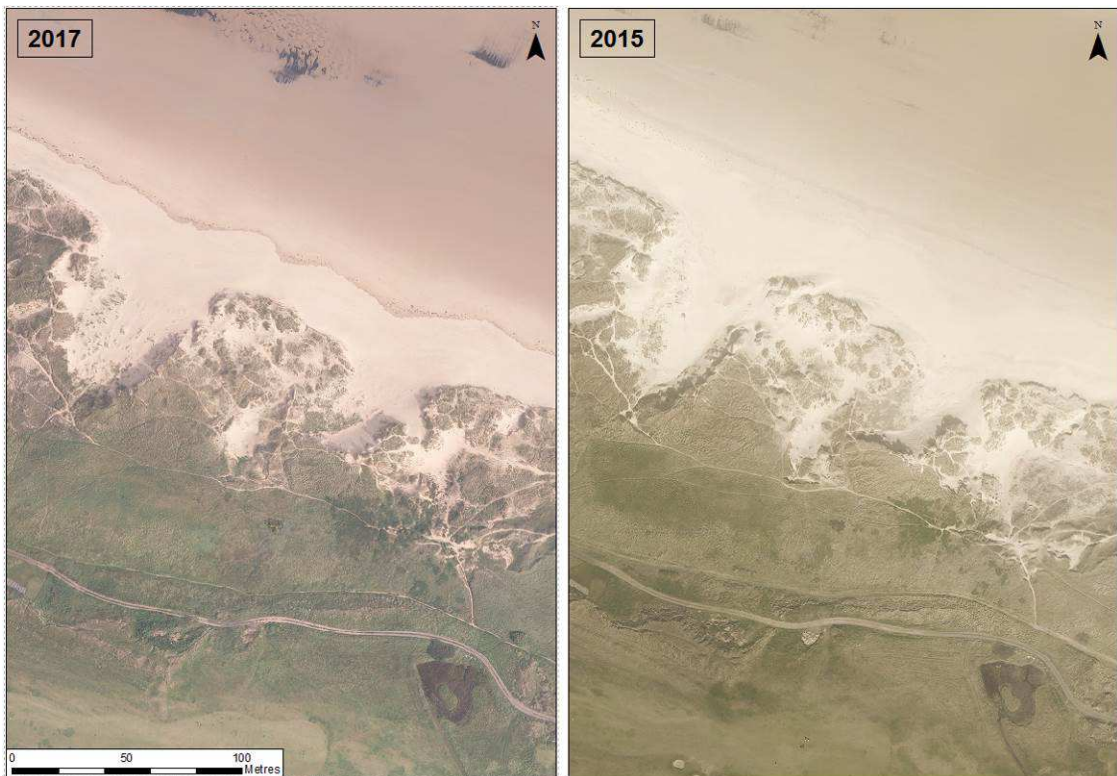
Figure 2-8 – Damage to dunes along Coatham Sands pre-dates January 2017 storms

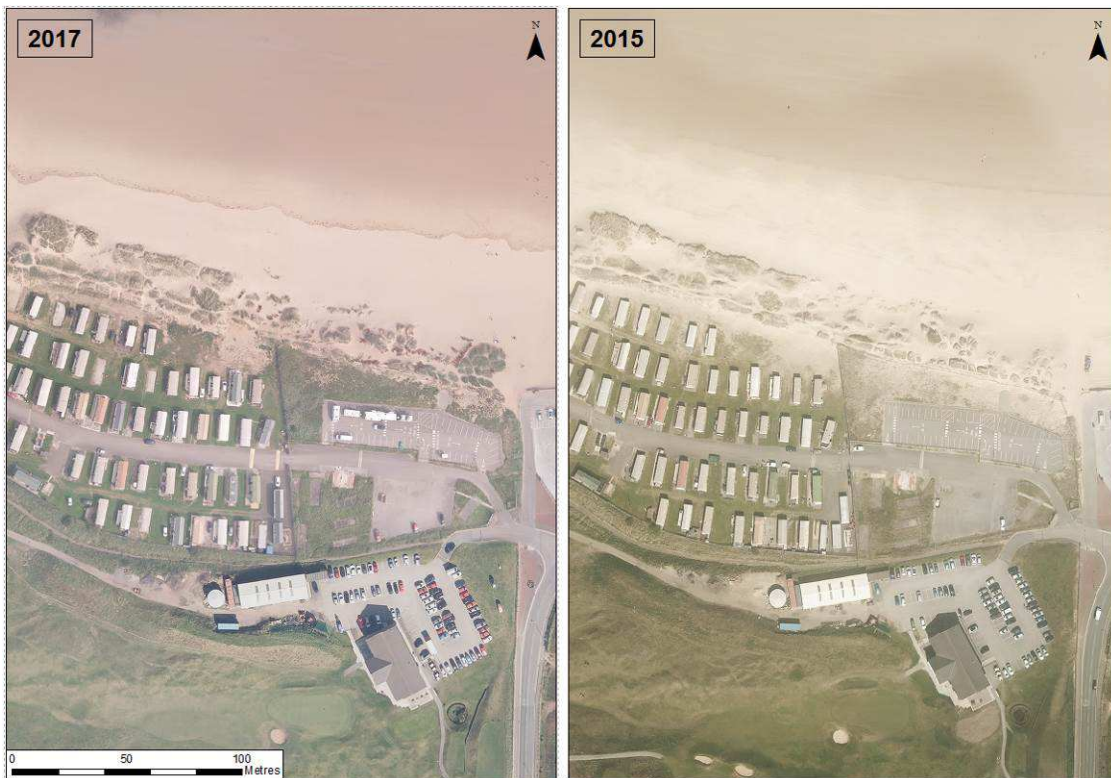
Figure 2-10 – Dune condition fronting eastern section of caravan park along Majuba section of Coatham Sands pre-dates January 2017 storms

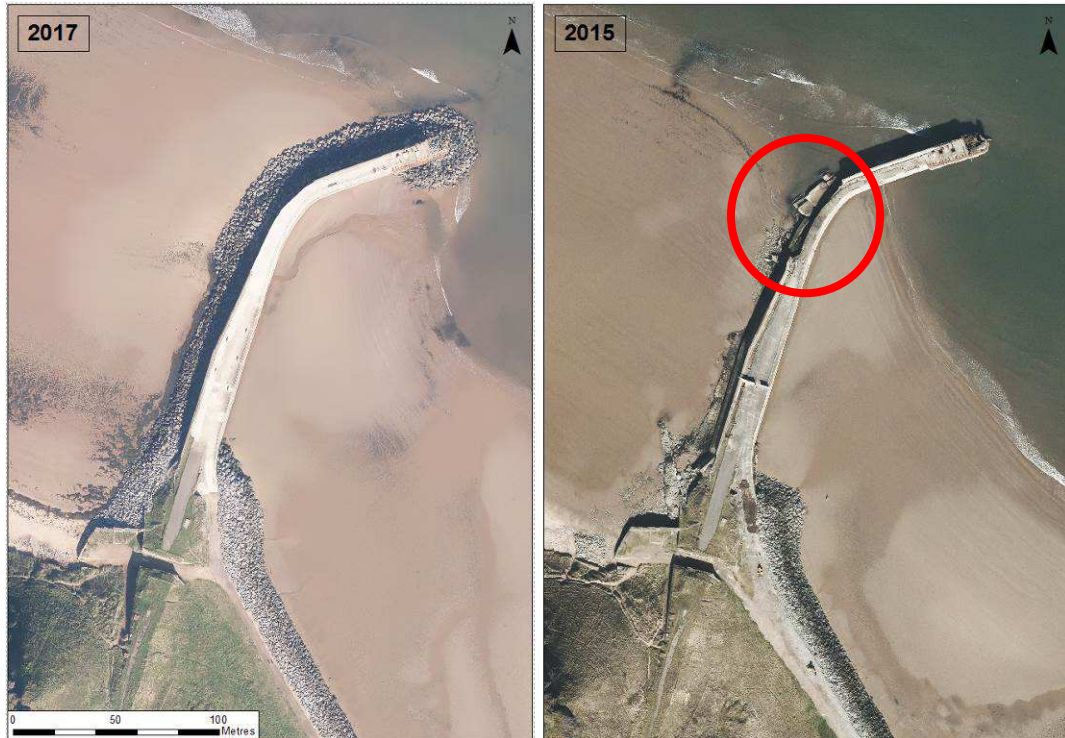
- **Skinningrove (MA17):** The coast protection scheme at Skinningrove involved the placement of rock armourstone along the seaward face and roundhead of the Jetty, along with refurbishment works to the Jetty itself. The repair of one failed section of the Jetty is visible in Figure 2-11. Some minor modifications were also made to the existing rock armour on the leeward side of the breakwater at its root.

Figure 2-11 – Rock armourstone and concrete repairs at Skinningrove Jetty

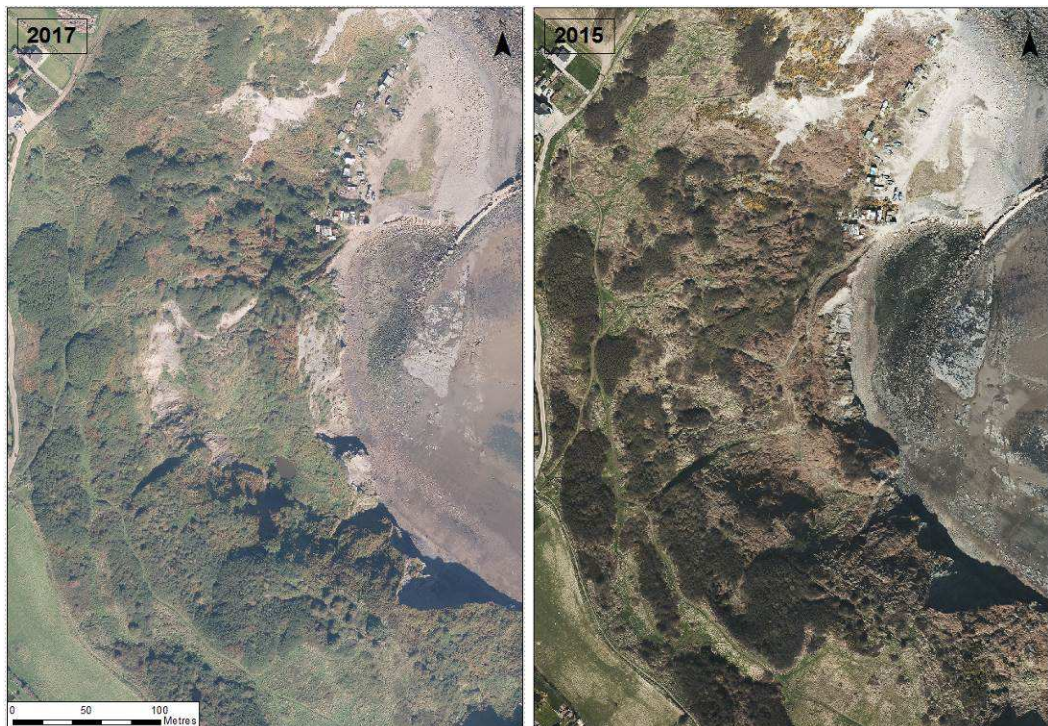
Figure 2-14 – Large landslip within Port Mulgrave

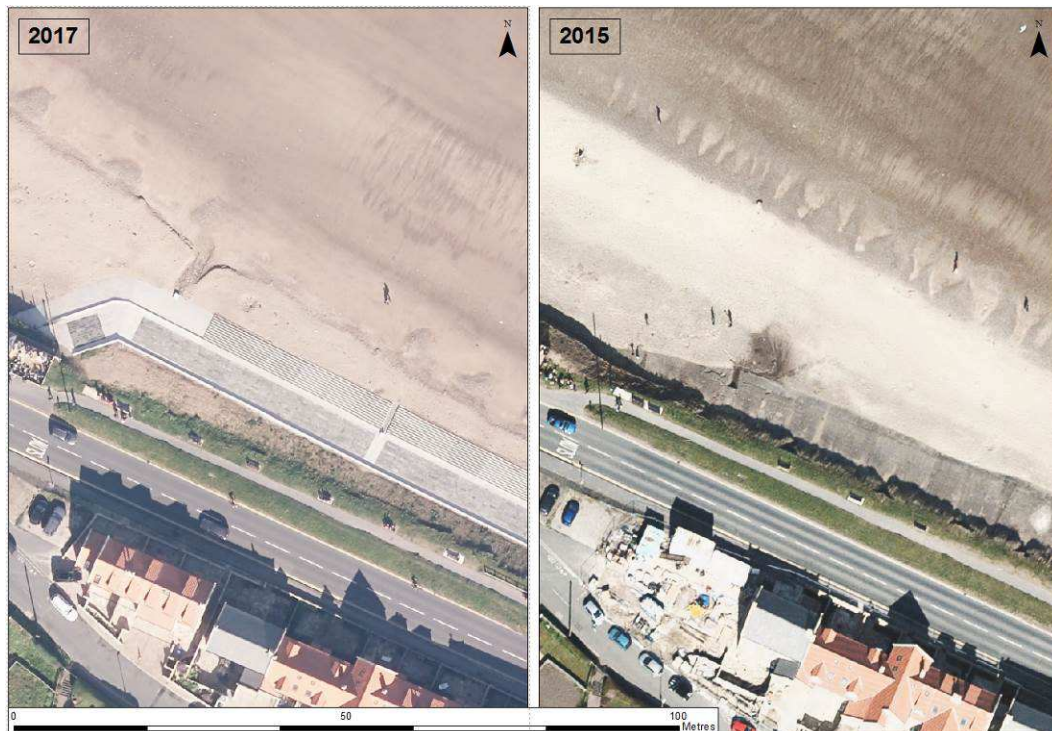
- **Sandsend (MA22):** Along Sandsend Road a coast protection scheme was introduced in 2016, involving the construction of a stepped concrete revetment with upper Dycel concrete units (Figure 2-16), re-grading and drainage of the coastal slopes landward of the road (Figure 2-17), and infilling of the ravine at Rathwaite Gill (Figure 2-18), with an extended outfall structure.

Figure 2-16 – Concrete revetment constructed at Sandsend Road

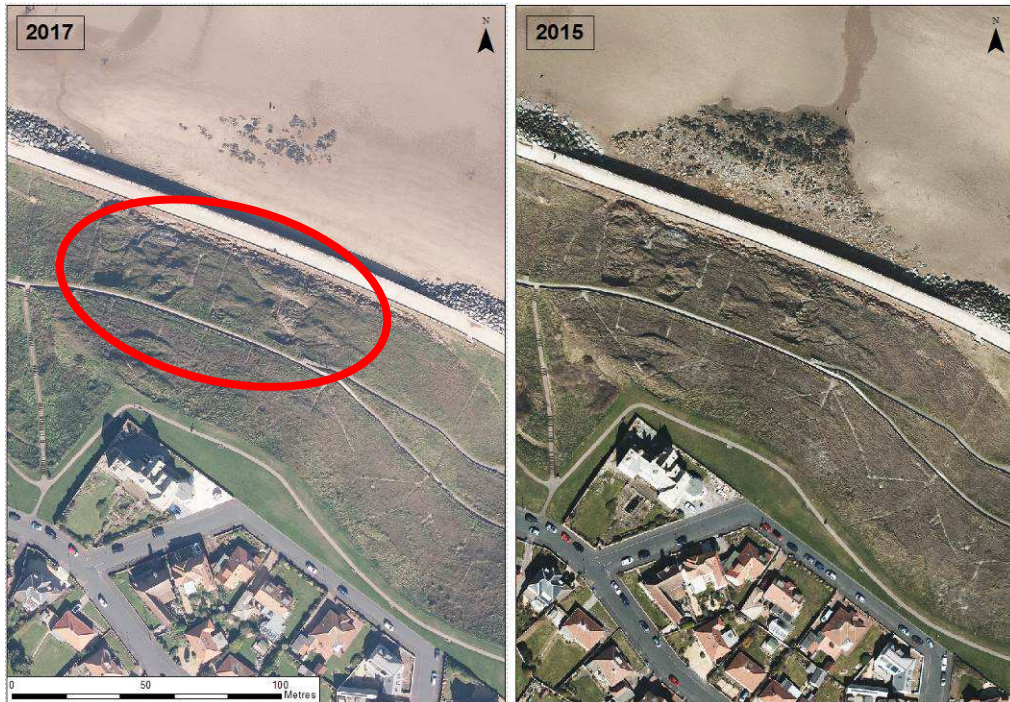
- **Whitby West Cliff (MA23):** A series of shallow slips remain evident near the base of the cliffs, in the area where there is a gap in the rock revetment which fronts the seawall. However, these have not worsened between 2015 and 2017 (Figure 2-19).

Figure 2-19 – Shallow slippages at the toe of Whitby West Cliff

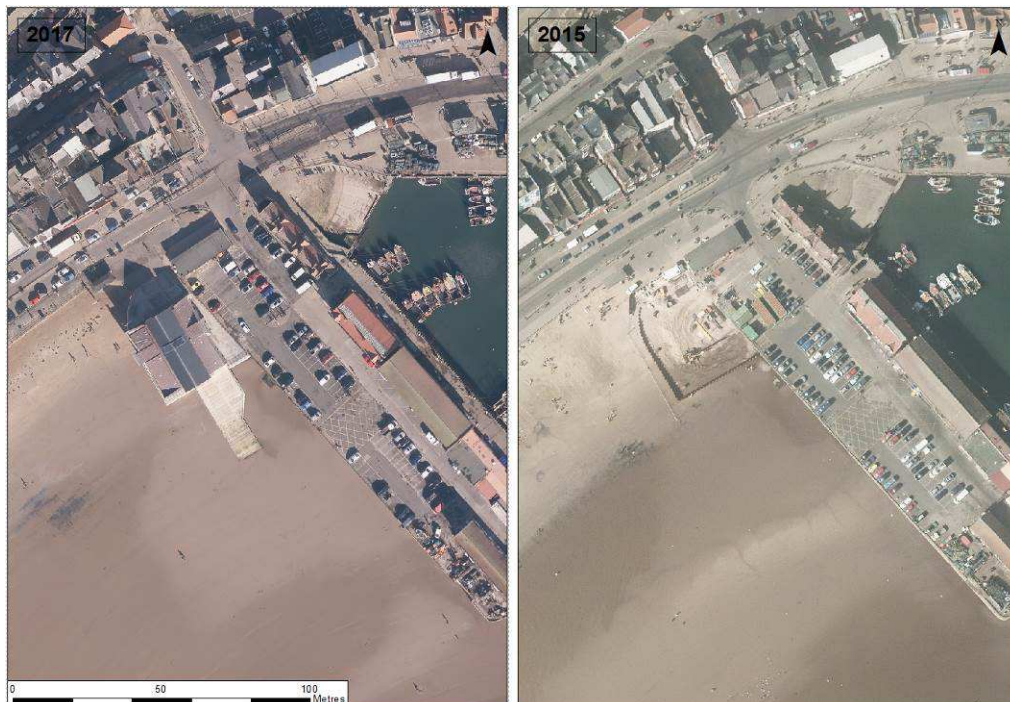
- **Scarborough South Bay (MA28):** Construction of new lifeboat station had been commenced at the time of the 2015 survey and was completed before the 2017 survey (Figure 2-20).

Figure 2-20 – RNLi Lifeboat Station at Scarborough South Bay

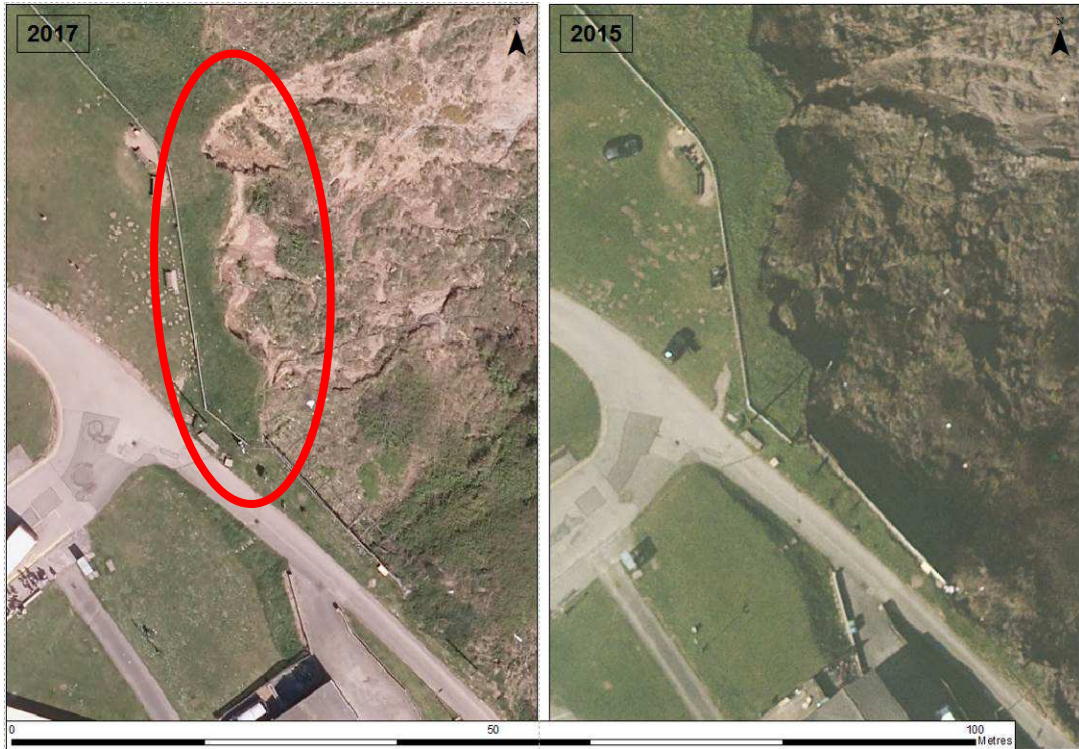
- **Filey Bay (MA32):** A small number of isolated sections of Filey Bay, south of the town, appear to remain active, with occasional shallow slips in the cliffs. However, the most notable past slippages (medium scale and larger) do not appear to have worsened since the 2015 survey. At Flat Cliffs, however, there are measureable changes in cliff top position to the north of the access road into the hamlet from the Primrose Valley Holiday Park (Figure 2-22). This area is soon to benefit from urgent works to reduce the risk of future failures.

Figure 2-22 – Erosion at Flat Cliffs access road

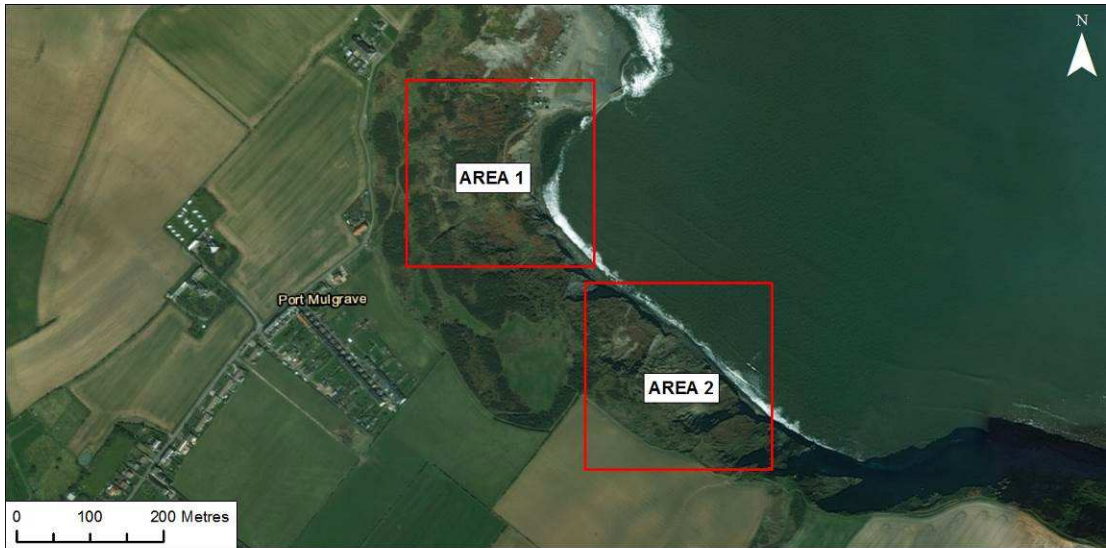
Figure 3-1 shows the changes in the two areas of landslip at Port Mulgrave between 2015 and 2017.

Figure 3-1 – Analysis of Changes at Port Mulgrave
