**Cell 1 Regional Coastal Monitoring Programme
Aerial Photography and LiDAR Surveys 2019-20**

North East Coastal Observatory

The present report covers the **Aerial Photography and LiDAR Surveys 2019-20** and provides details of these surveys and a comparison with past aerial surveys.

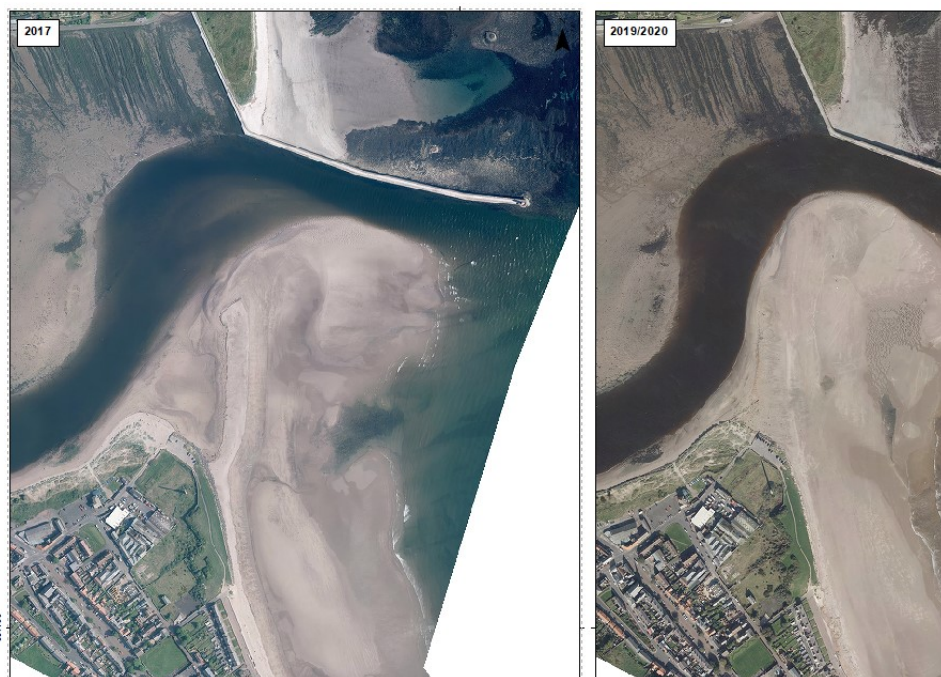
- **Sandstell Point**, Berwick-upon-Tweed (PU2.4): The sand spit at the mouth of the Tweed estuary has long been known to be dynamic, and changes continue between 2017 and 2019-20. In the recent survey, the spit appears more like its alignment in 2015, with a build-up of sediment constraining the river channel towards the Berwick Breakwater near the structure's landward end (Figure 2-1).

Figure 2-1 – Changes at Sandstell Spit 2017 (left) and 2019-20 (right)

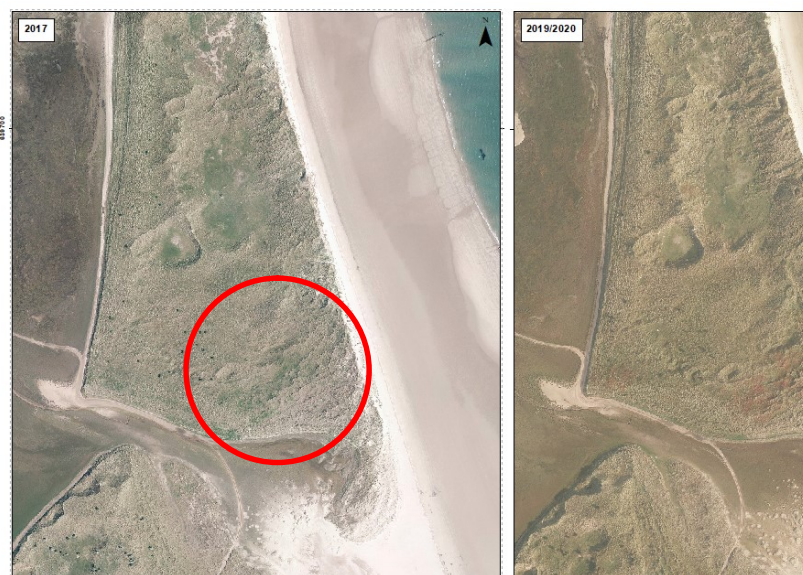
- **Ross Back Sands** (PU4.4): There is a continued (progradation) growth of sand to the seaward face of the dunes along Ross Back Sands, including to the Old Law dune ridge that extends from the western end of the beach. There is also pronounced growth of a sand spit at the southern end (seaward face) of Old Law Dunes, extending into Wide Open (Figure 2-2).

Figure 2-2 – Changes at Old Law Dunes (Ross Back Sands) 2017 (left) and 2019-20 (right)

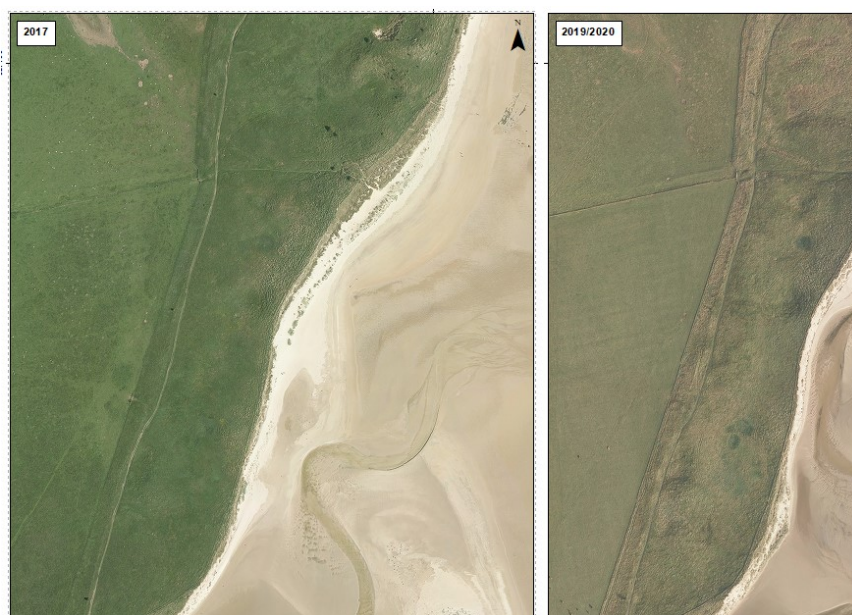
- **Annstead (PU7.1 & PU7.2):** There has been sand accumulation and embryo dune growth along much of the Annstead Links since 2017.
- **Beadnell North (PU8.1):** The failing Reno mattresses used to form a revetment where the road is less than 10 m from the coastal margin remain clearly visible in the 2017 aerial photography.
- **Beadnell Bay (PU8.4):** There appears to have been accretion of the dune front throughout much of the northern part of the bay, until approaching the channel of Brunton Burn. This adopts a more northerly alignment across the foreshore than was observed in 2017 and as a consequence some of the previous dune growth has been washed away, whilst the spit to the south of the channel has grown.

Figure 2-4 – Channel changes at Beadnell Bay, 2017 (left) and 2019-20 (right)

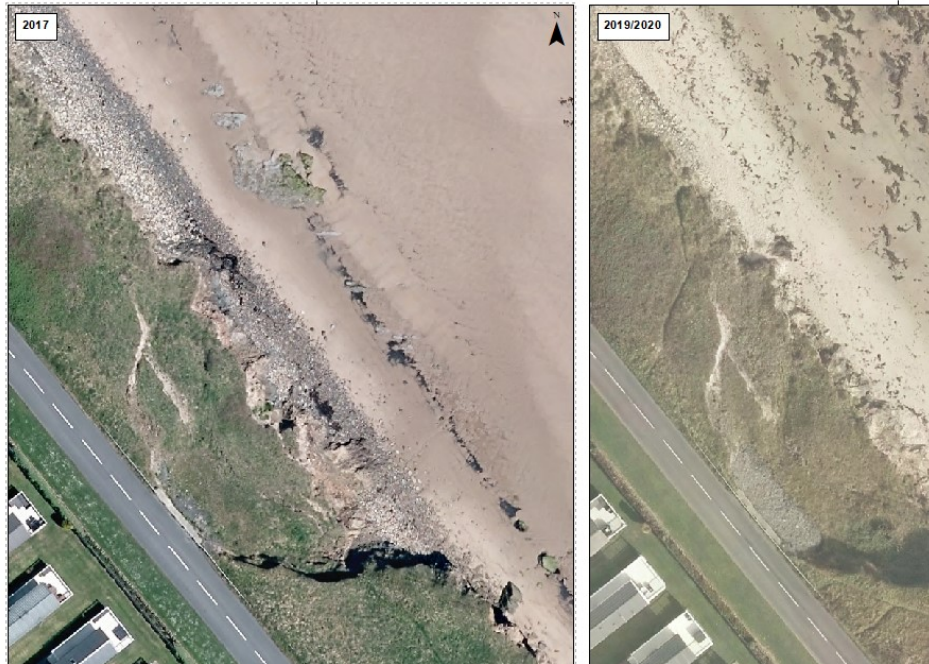
- **Cresswell** (PU17.5): The landslip in the cliffs just to the north of Cresswell that occurred prior to the 2015 survey had not worsened to 2017 or 2019-20, but remains impacting the carriageway.

Figure 2-6 – Landslip at Cresswell, 2017 (left) and 2019-20 (right)

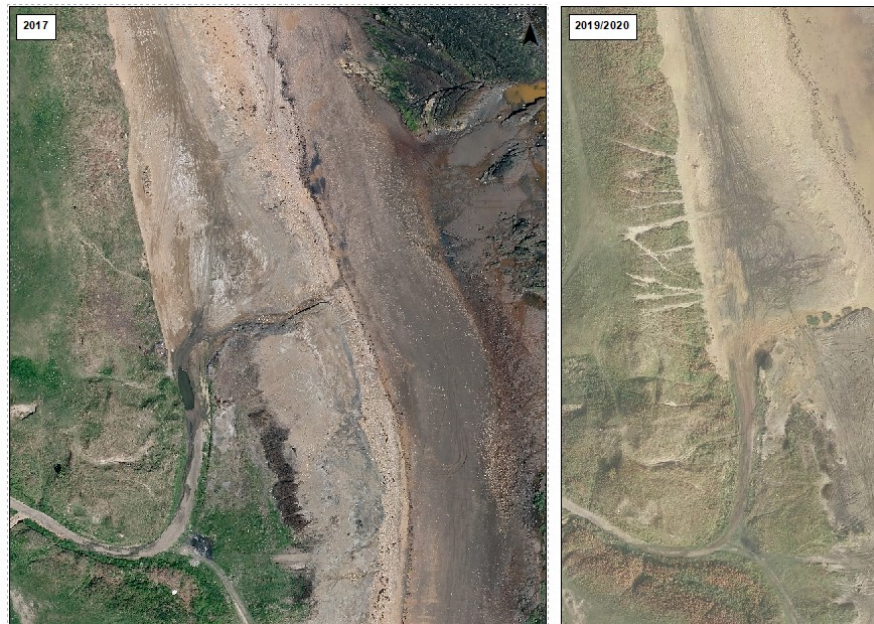
- **Lynemouth** (PU19.1 & PU19.3): In Lynemouth Bay there has been continued erosion of the colliery spoil beach where it is present in the north of the bay (i.e. around the Headagee rock outcrops) and erosion of the colliery spoil cliffs elsewhere, where not protected by fronting spoil beach.

Figure 2-7 – Erosion of colliery spoil beach in Lynemouth Bay, 2017 (left) and 2019-20 (right)

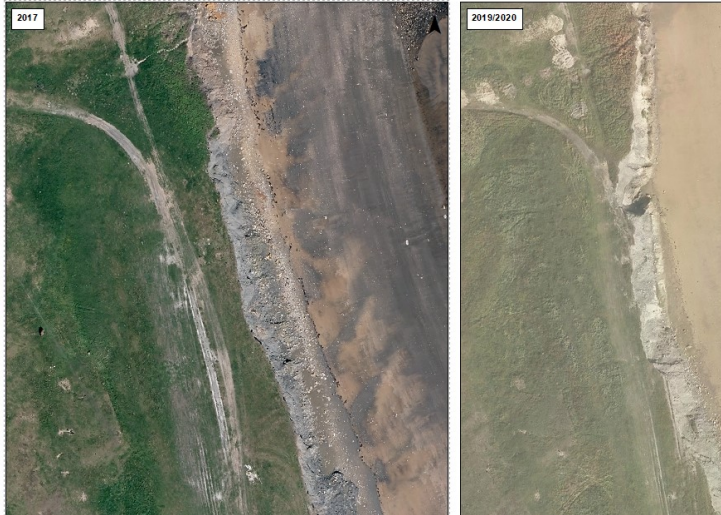
Figure 2-8 – Erosion of colliery spoil cliffs in Lynemouth Bay, 2017 (left) and 2019-20 (right)

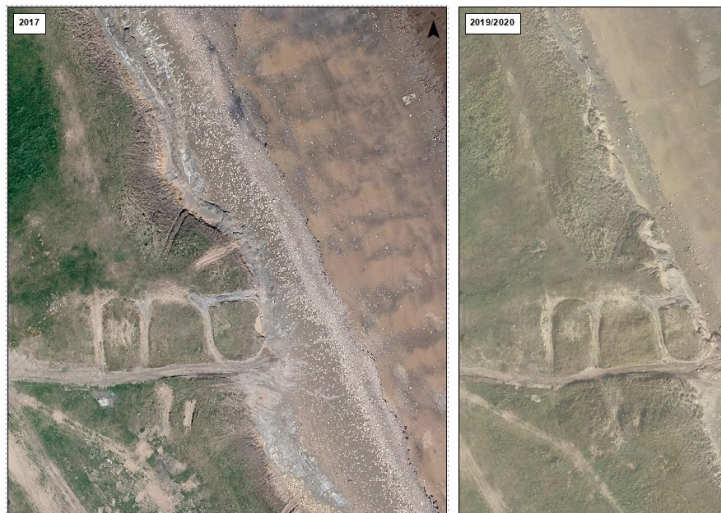
Figure 2-9 – Erosion of colliery spoil cliffs in Lynemouth Bay, 2017 (left) and 2019-20 (right)

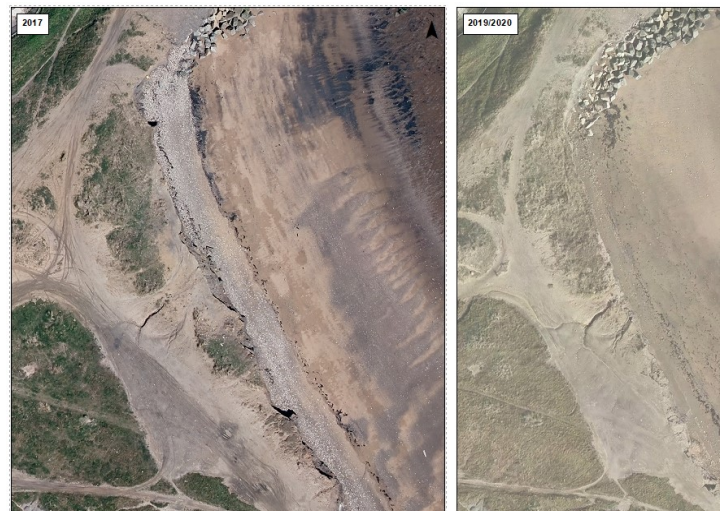
Figure 2-10 – Erosion of colliery spoil cliffs south of Lynemouth Power Station revetment, 2017 (left) and 2019-20 (right)

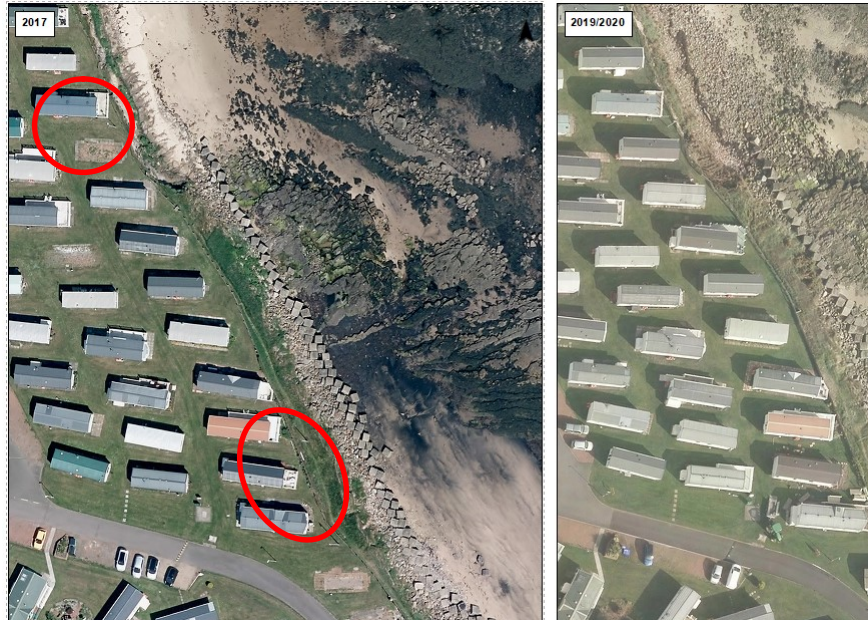
- **Newbiggin Moor (PU20.1):** Three of the caravans at the caravan park which were closest to the edge of the cliff top were removed between 2015 and 2017, but have since been replaced by the time of the 2019-20 survey. Elsewhere along this frontage, erosion has cut the cliff top right back to the footpath on the northern face of Newbiggin Point.

Figure 2-11 – Caravans previously removed from eroding cliff edge before 2017 now replaced, 2017 (left) and 2019-20 (right)

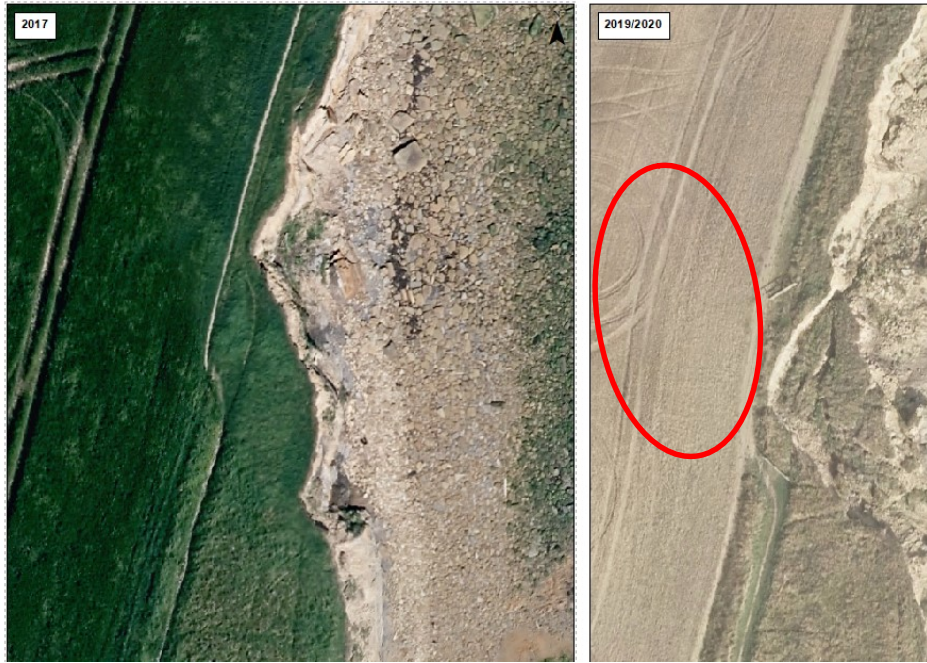
Figure 2-12 – Cliff collapse at Hawks Cliff, 2017 (left) and 2019-20 (right)

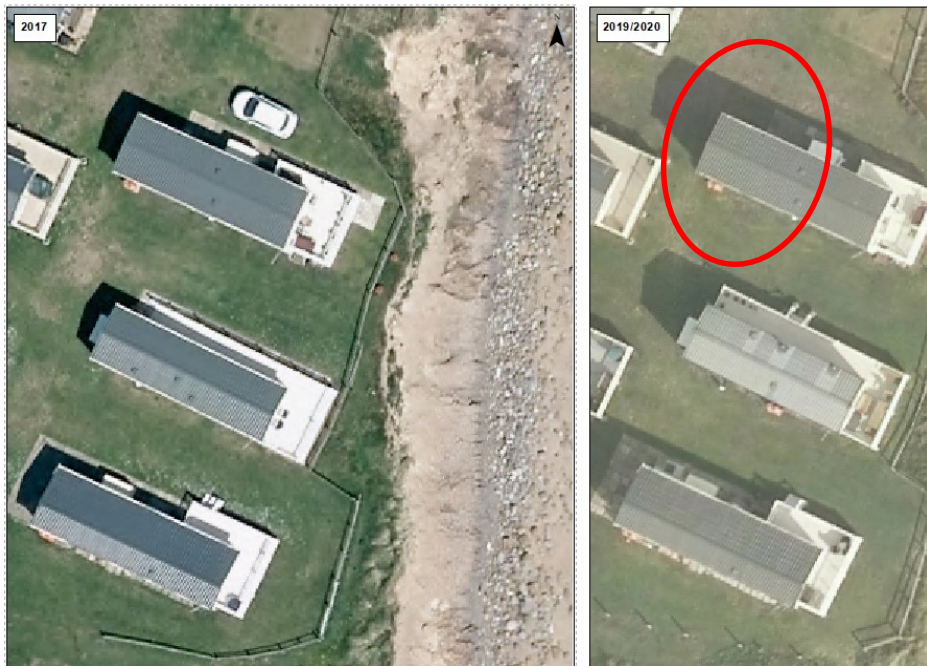
Figure 2-13 – Cliff erosion at Sandy Bay Caravan park, 2017 (left) and 2019-20 (right)

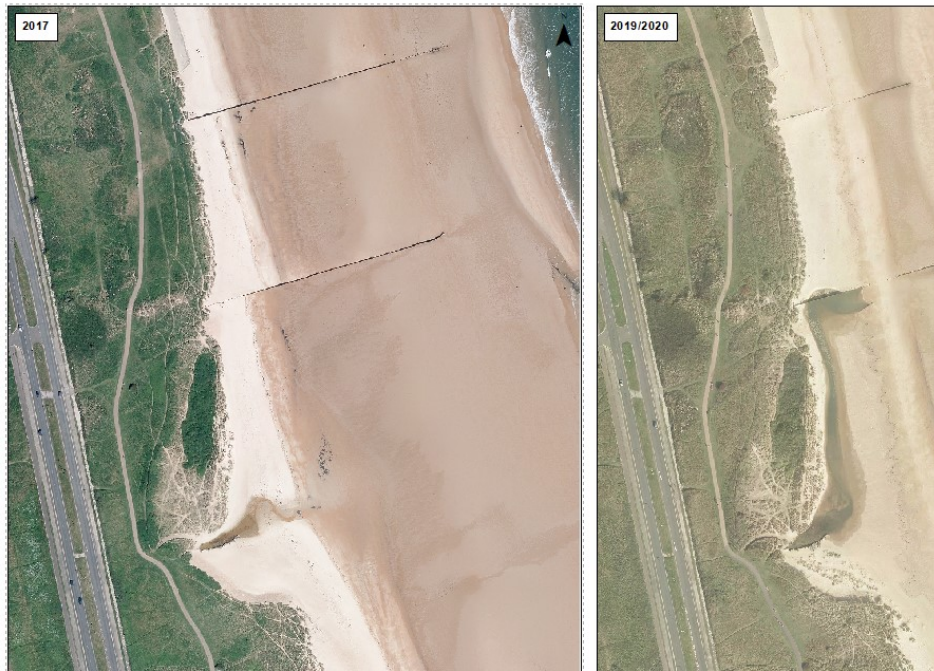
- **Cambois (PU21.5):** Some of the rock armour at the toe of the slipway has been repositioned to prevent outflanking at its northern end. There has been notable erosion in some places along the North Blyth dunes, especially in the vicinity of The Rockers.
- **Meggies Burn (PU23.2):** The channel of the burn had adopted a southerly alignment across the foreshore in 2015, prompting erosion counter-measures to the toe of the dunes to the south. However, by the time of the 2017 survey, the burn was flowing more directly easterly to discharge at sea. In the 2019-20 survey, it can be seen that the burn is aligned northerly along the dunes, causing their erosion and resulting in undermining of the timber groyne present on the foreshore. This has caused adverse amenity and safety issues.

Figure 2-14 – Channel changes at Meggies Burn, 2017 (left) and 2019-20 (right)

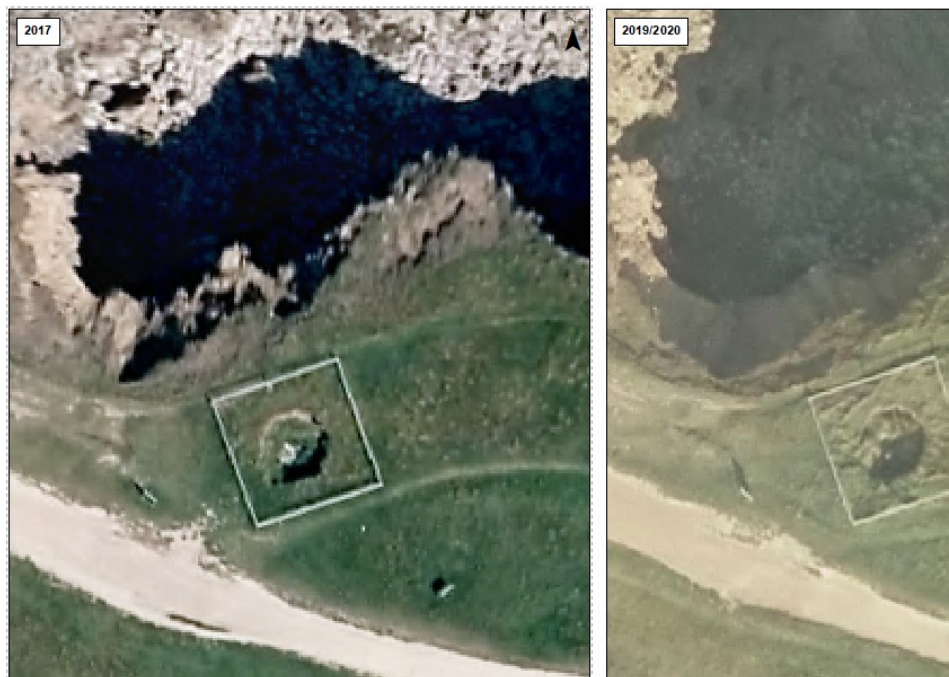
- **Man Haven (MA04):** A sink hole that had opened in the cliff top and which was partially infilled and fenced-off for reasons of public safety between 2015 and 2017 has not increased in size to 2019-20.

Figure 2-16 – Sink hole at Man Haven, 2017 (left) and 2019-20 (right)

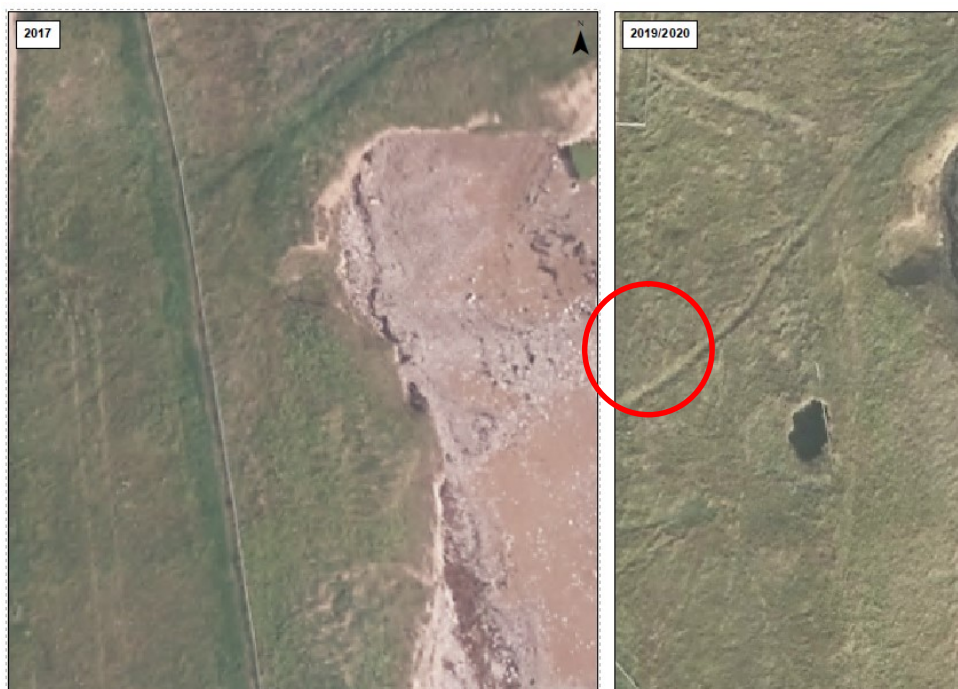
- **Old Harbour Quarry (MA05):** A new sink hole has opened up between 2017 and 2019-20 along the north part of Whitburn Coastal Park. The existing sink hole at Whitburn Coastal Park (Old Harbour Quarry) has further increased in size between 2015 and 2017, now measuring 23 m across at its widest point.

Figure 2-18 – New sink hole at Whitburn Coastal Park, 2017 (left) and 2019-20 (right)

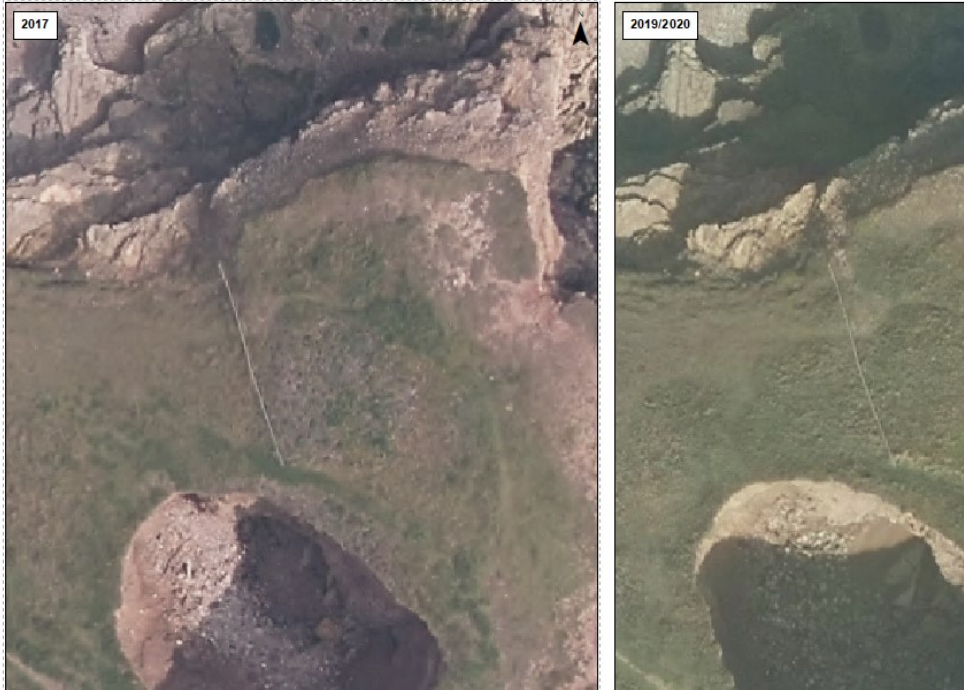
Figure 2-19 – Increase in size of existing sink hole at Whitburn Coastal Park (Old Harbour Quarry), 2017 (left) and 2019-20 (right)

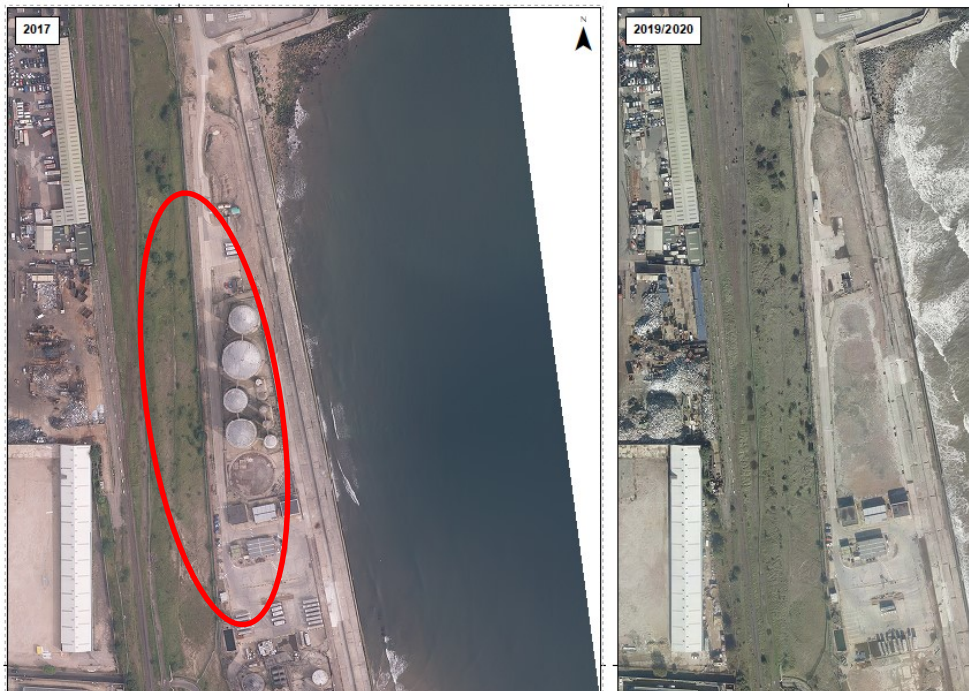
- **Roker Pier (MA07):** Construction works that were reported to have been underway at the time of the 2017 aerial survey on the Roker Pier were completed by the 2019-20 survey.
- **Hendon (MA08):** Some of the utility facilities behind the southern end of the Hendon seawall had been demolished by the 2019-20 surveys.

Figure 2-19 – Land use changes at Hendon Seawall, 2017 (left) and 2019-20 (right)

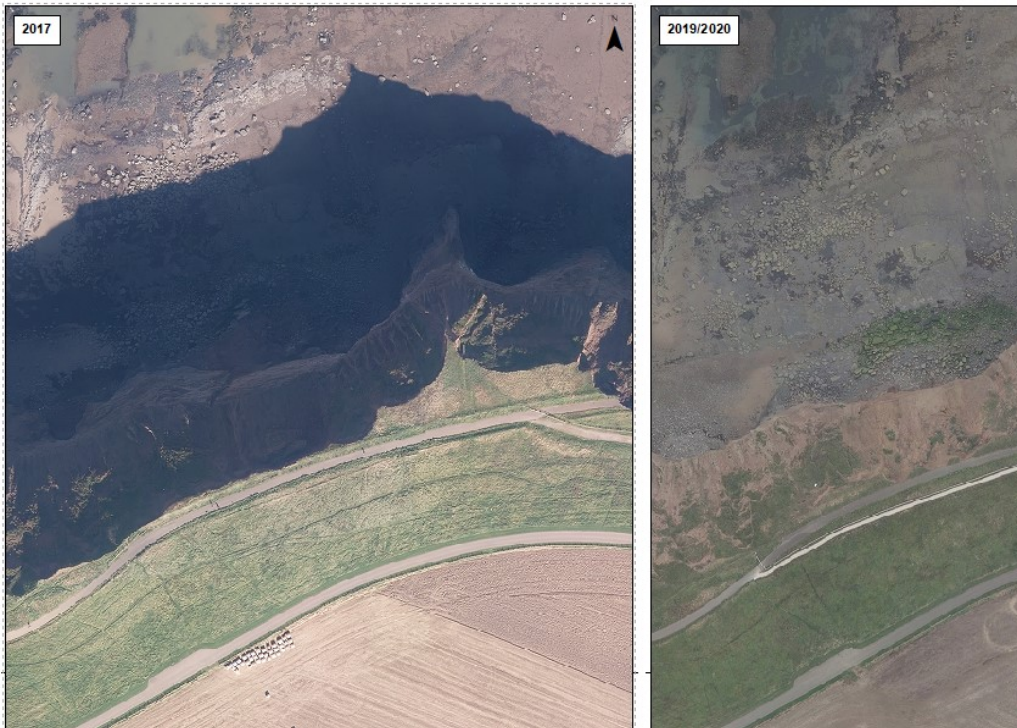
- **Cowbar (MA19):** A further section of the public footpath approaching Cowbar has been relocated inland.

Figure 2-21 – Footpath realignment at Cowbar Lane, 2017 (left) and 2019-20 (right)

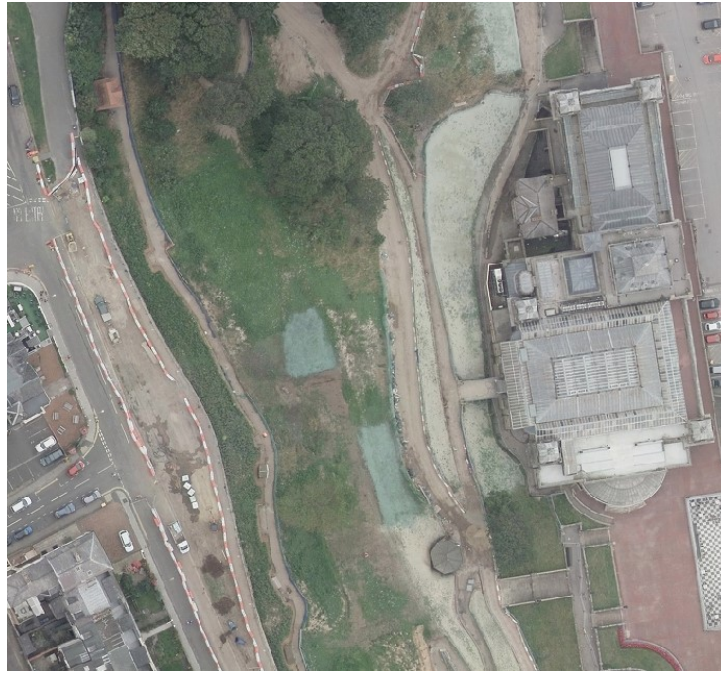
Figure 2-24 – Stabilisation works to cliffs behind Scarborough Spa during 2019-20 survey

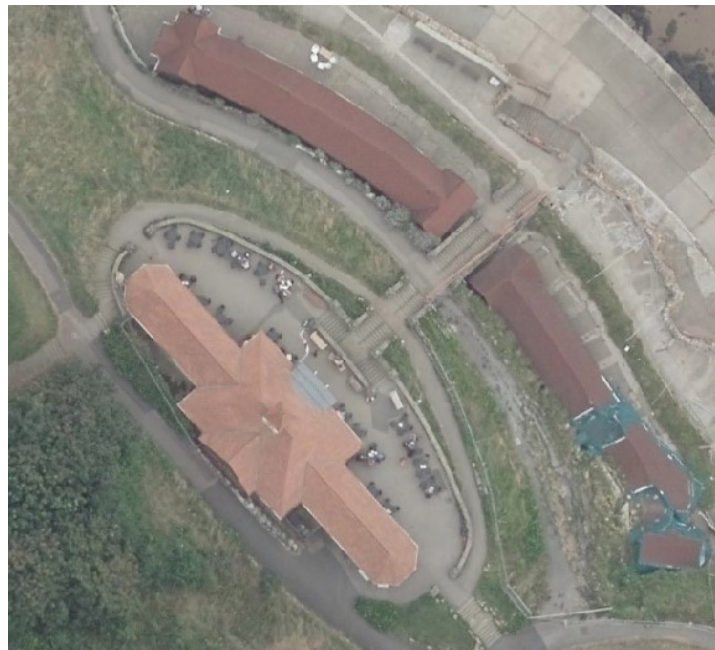
Figure 2-24 – Damaged beach huts by Clock Tower Café captured during the 2019-20 survey

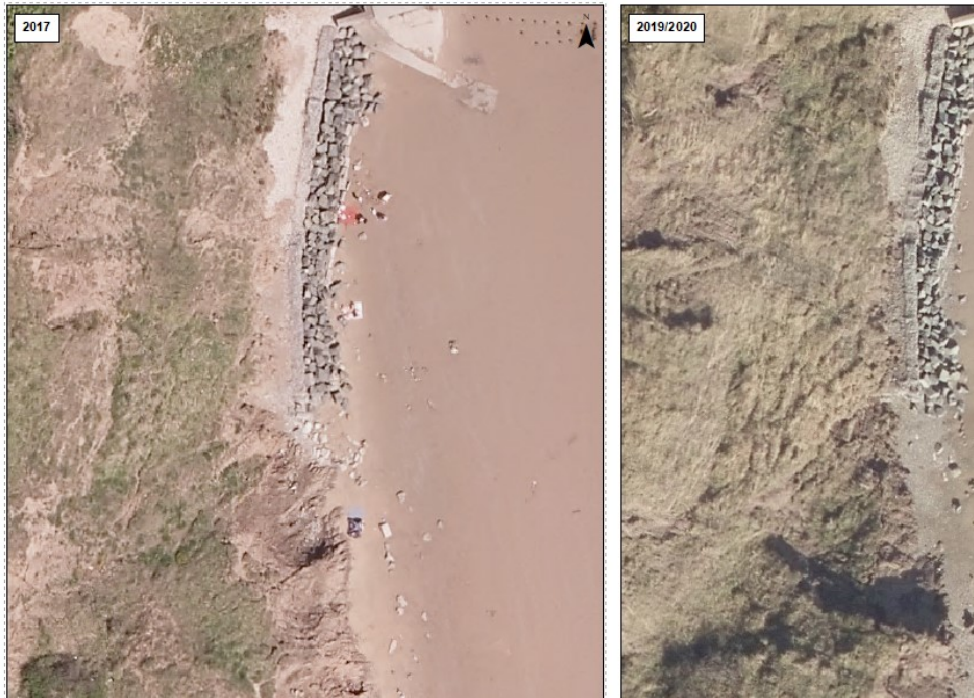
- **Cornelian Bay and Cayton Bay (MA29):** Whilst these areas are known to be potentially active, there is no significant apparent movement between the 2017 and 2019-20 surveys.
- **Filey Brigg (MA30) and north of Filey Town (MA31):** The apparently active or unstable sections of cliff do not appear to have altered since the 2017 survey. Remnants of past slippages and past rock falls remain evident in the slope face or cliff toe. The only exception is immediately south of Filey Town, where the seawall ends. At this location the outflanking of the rock armour placed at the end of the seawall continues.

Figure 2-25 – Outflanking at end of Filey Seawall

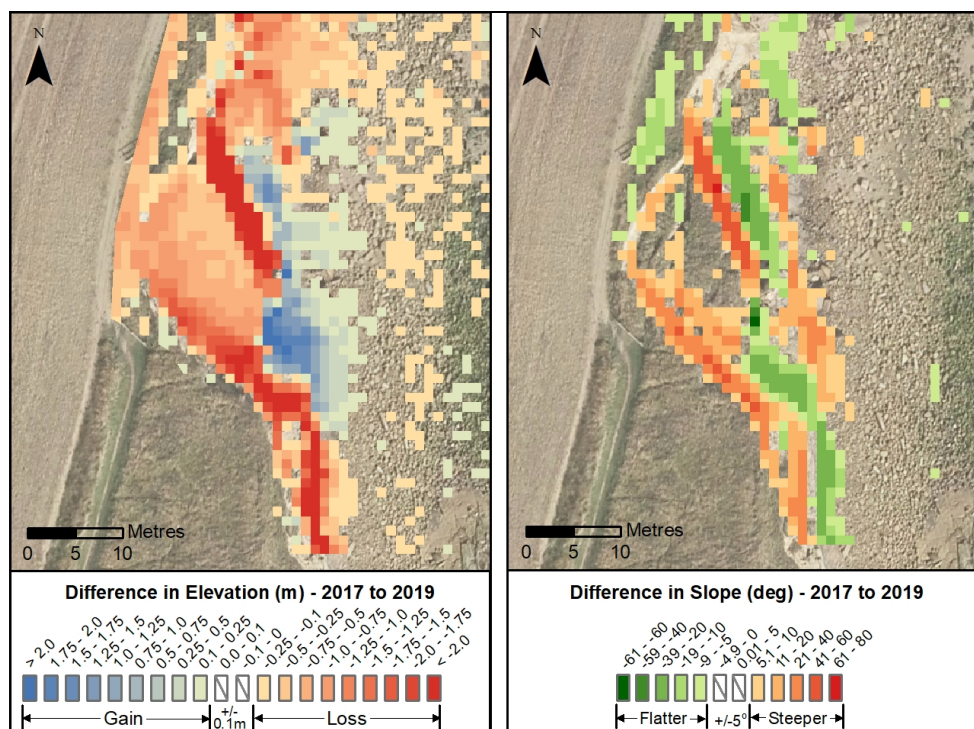
GIS analysis of the difference between 2017 and 2019 in topographic elevation and surface slope (Figure 3-2). This shows how material lost from the cliff crest and cliff face has been deposited at the toe as talus debris. It is envisaged that the talus will be slowly eroded away over time and future surveys should capture the morphological effects of such processes.

Figure 3-2 Difference in elevation (left plot) and surface slope (right plot) at Hawks Cliff, 2017 – 2019

- **Hawks Cliff** - Pre-existing rock falls at two distinct areas have become exacerbated through a larger-scale cliff failure in the area in between. Material lost from the cliff crest and cliff face has been deposited at the toe as talus debris. It is envisaged that this will slowly be eroded away over time and future surveys should capture the morphological effects of such processes. The cliff top path has been relocated inland away from the affected section of cliff top.

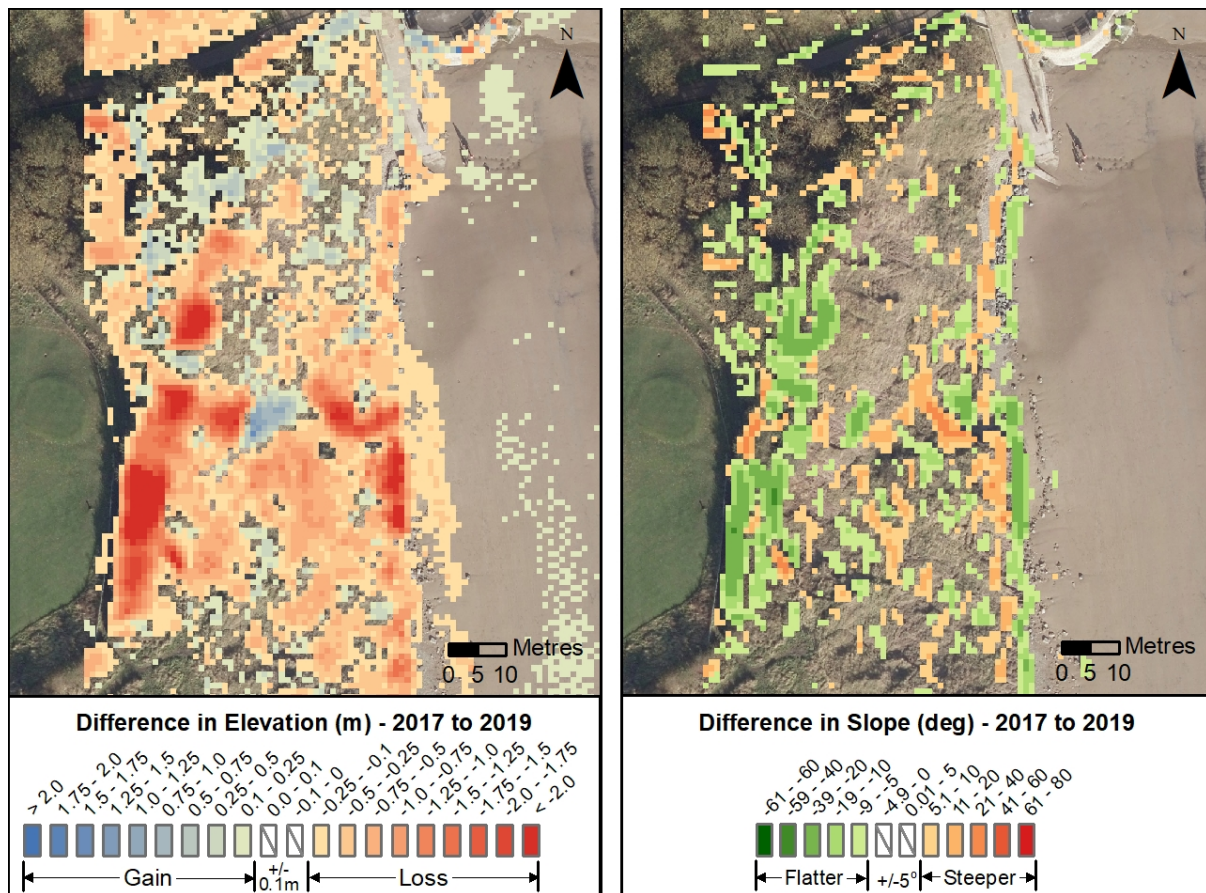
Figure 3-7 Difference in elevation (left plot) and surface slope (right plot) at the southern end of Filey seawall, 2017 – 2019

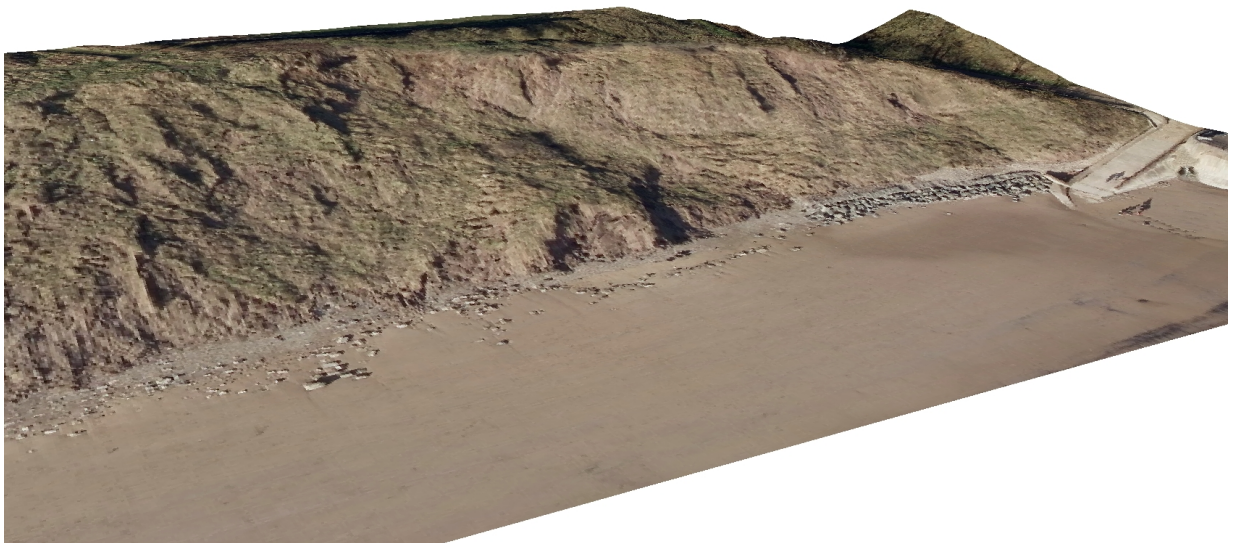
Figure 3-7 (overleaf) shows aerial photography imagery draped over a LiDAR-based DGM from 2017 (top plot) and 2019 (bottom plot). There is not a significant amount of visual difference between the successive surveys, indicating that the issue is not a hugely worsening one, but GIS analysis of the difference between 2017 and 2019 in topographic elevation and surface slope (Figure 3-8) does confirm some activity occurred over this timescale in the headscarp and at the toe of the coastal slopes south of the rock armour. It is intended that a scheme is developed to better protect the southern end of the seawall against outflanking due to this ongoing process.

Figure 3-8 - Aerial photography over a LiDAR DGM showing coastal slopes at the southern end of Filey seawall from 2017 (top plot) and 2019 (bottom plot)

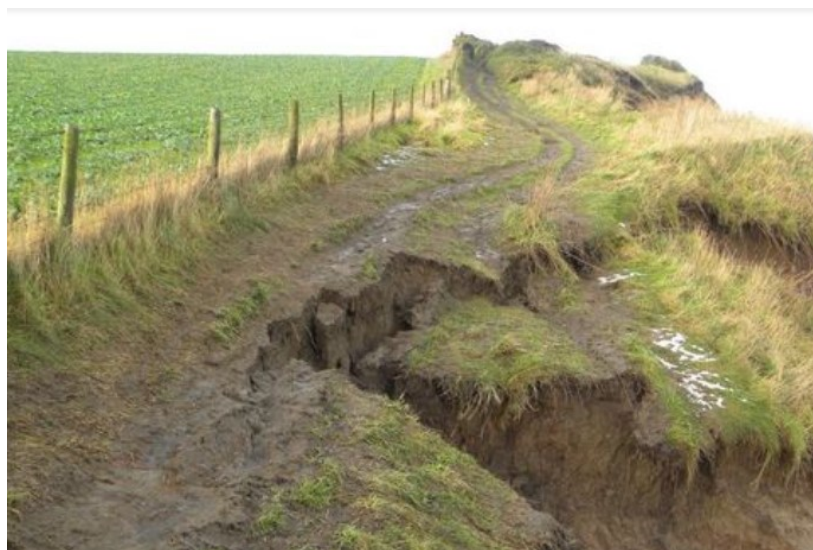
- **Marsden Bay** (rock fall) - In late January 2021, following a period of heavy rainfall and freezing temperatures. The collapse was captured in a video clip by a member of the public and posted on social media.
- **Huntcliff**, near Saltburn (landslip, shown below) – In late January 2021, following a period of heavy rainfall and freezing temperatures. Redcar & Cleveland Council closed a section of the Cleveland Way cliff top footpath while the site was being inspected.

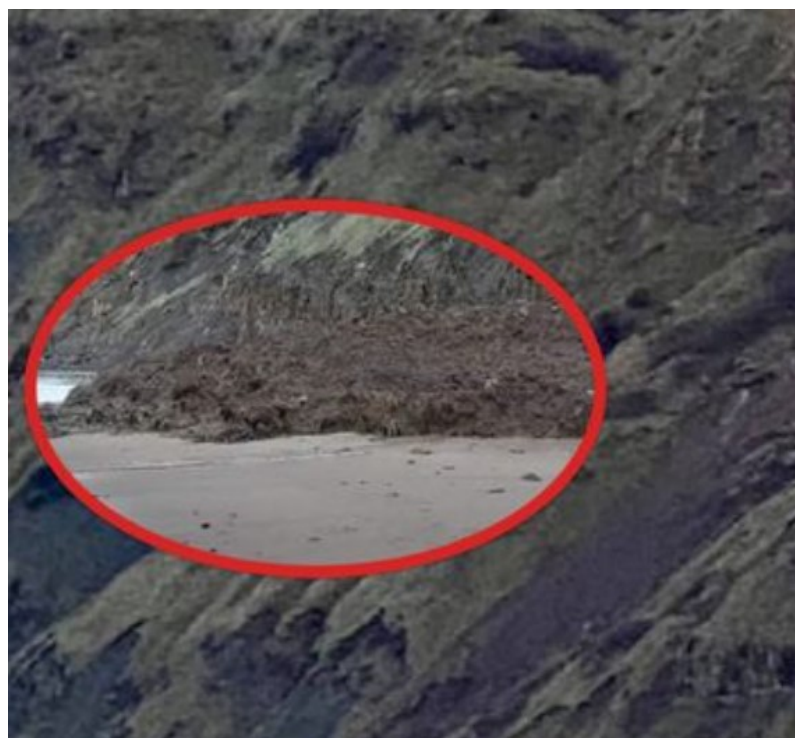
- **Runswick Bay** (landslip, shown below) - In late January 2021, following a period of heavy rainfall and freezing temperatures. The HM Coastguard estimated 200 tonnes of cliff material fell onto the beach.
