Cell 1 Regional Coastal Monitoring Programme

**Analysis of 1940s and 2015 Aerial Photography &
Detailed Assessment of Filey Bay to Cayton Bay**

Final Report

March 2016

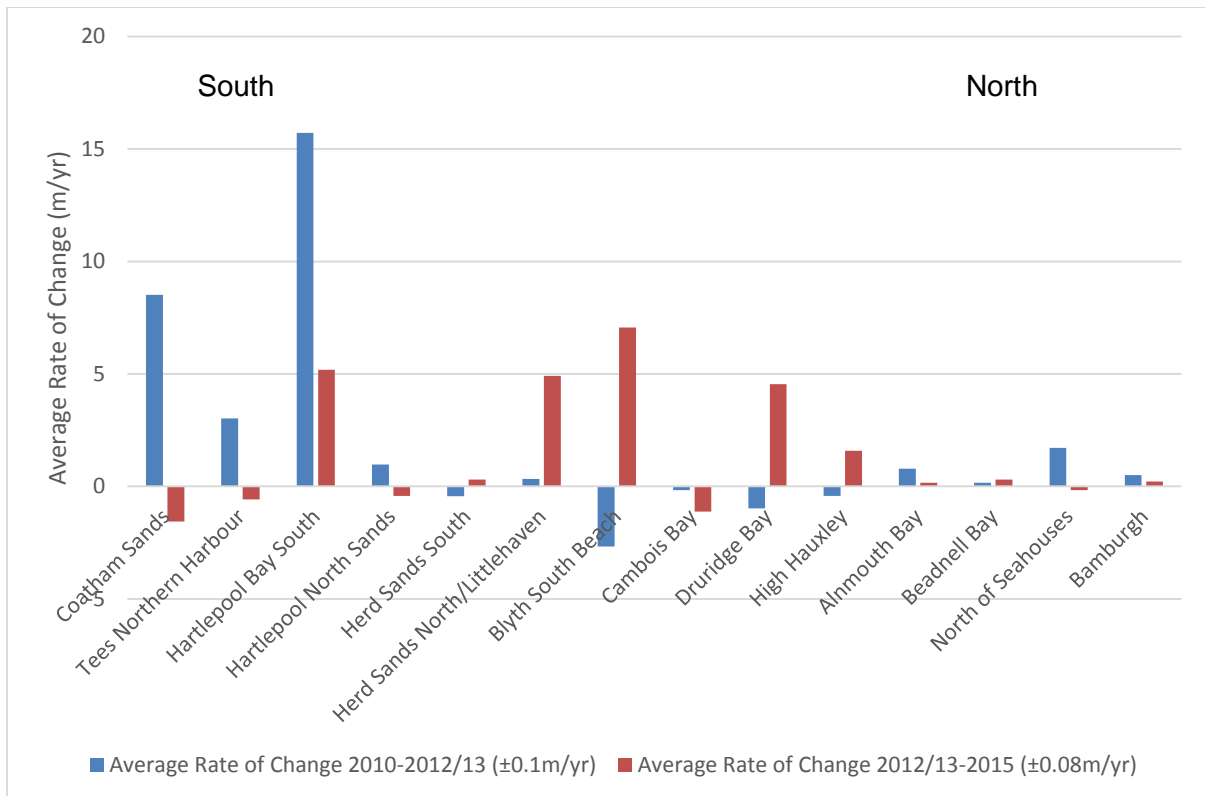
Figure 4.3: Patterns in change in dunes between 2010 and 2015 and impacts of the December 2013 surge.

The northeast coast was affected by a storm surge on 5/6 December 2013 and stormy conditions continued through January 2014 (Halcrow, 2013b). Beach profiles and topographic surveys of the coast undertaken since the surge have documented the widespread impacts, including erosion and subsequent recovery of beaches and dunes, but the aerial survey records have not hitherto been used. The period between the 2010 and 2012/3 photography shows the rate of the change prior to the storm, while the period between the 2012/3 and 2015 aerial surveys covers the period following the storm and includes both erosional and recovery phases. The data show widespread high rates of accretion before the storm surge and erosion or lower rates of accretion since, south of the River Tees. Walk-over visual inspections following the storm surge reflect these observations (Halcrow, 2013b). In contrast, dunes north of the River Tees display widespread erosion prior to the surge and high rates of accretion subsequently. Dunes north of Alnmouth Bay show behaviour over the two time periods are similar overall, and the dunes have recovered quickly. These data indicate the very dynamic nature of dunes and their ability to rapidly respond to storm events.

High average rates of advance between 2012/3 and 2015 have occurred in dune unit 6 at Herd Sands Littlehaven, dune unit 7 at Blyth South Beach and dune unit 9 at Druridge Bay. These are due to localised changes in the dune front, with more vegetation being established in 2015. The most dynamic area assessed is transect 10 at Coatham Sands on the south side of the southern harbour breakwater at the mouth of the Tees, however since the most recent time period the dune front has stabilised.

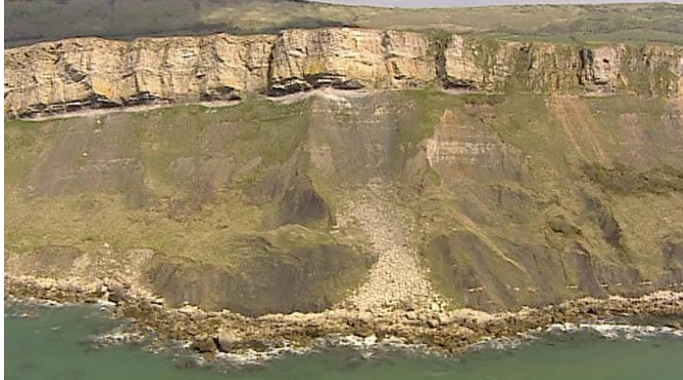
Composite Cliff -
Note different geological
formations with differing
properties forming
different slope
morphology in upper and
lower cliff

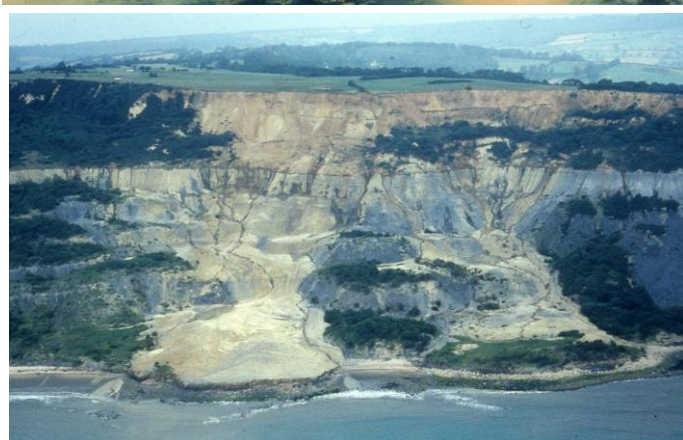
Complex Cliff –
Multiple geological
formations and failure
mechanisms
