Feasibility survey for the installation of artificial rock pools at Staithes, North Yorkshire

DATE: April 2020
VERSION: Final v1.0
BUG REFERENCE: BUG2857
PROJECT MANAGER: Dr Andrew Harrison
REPORT AUTHOR(s): Dr Alice Hall, Dr Susan Hull, Dr Roger Herbert

Client:
Scarborough Borough Council
Town Hall
St Nicholas Street
Scarborough
YO11 2HG

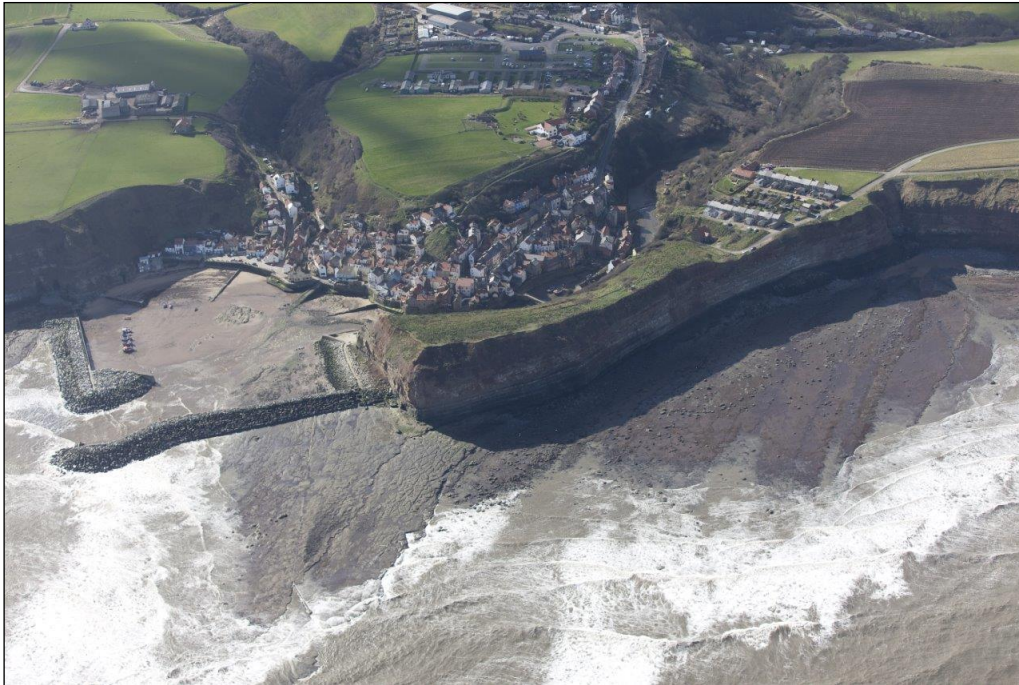
The foreshore at Staithes comprises an exposed shoreline with large mudstone bedrock platforms (Figure 2.1). It has an easterly prevailing wind direction and the tidal range is 5.6 m during spring tides and 4.2 m during neap tides. The harbour walls were reconstructed and reinforced with granite rock armour in 2002, with the granite being sourced from Norway.

Figure 2.1. Location of Staithes harbour and Staithes village - east harbour arm is on the left of the images and west harbour arm is on the right of the image (Source: North East Coastal Observatory).

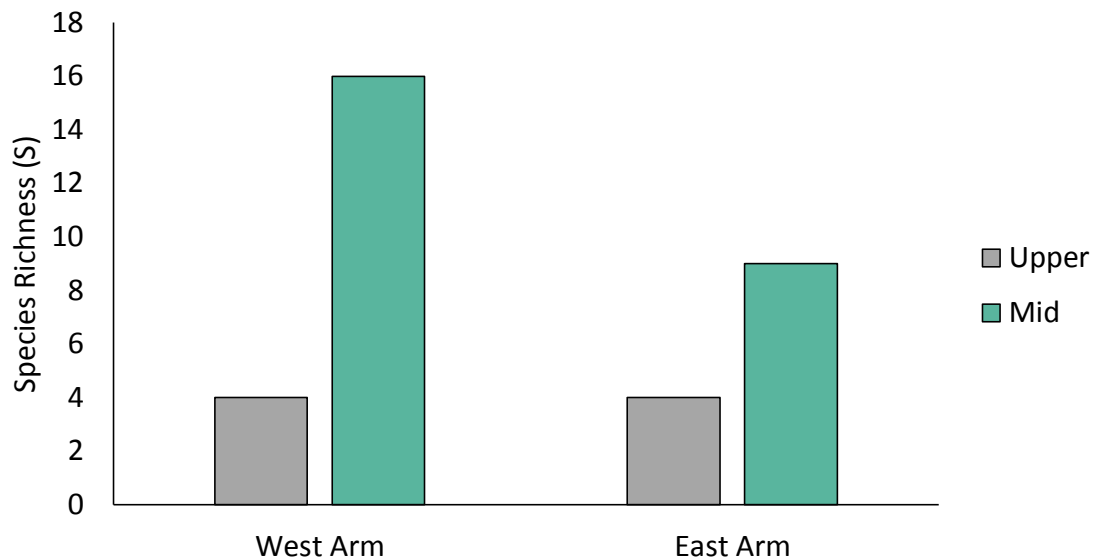
Overall the west arm of the harbour supported a higher number of species compared to the east arm of the harbour. In addition, the Mid shore sections of the rock armour arms supported the greatest number of species on both sides of the harbour (Figure 3.2). Four of the species recorded on the granite boulders were only found in areas of water retention, including the pink encrusting *Lithothamnion* sp. and the *Corallina officinalis*. The granite rock faces were dominated by the barnacle *Semibalanus balanoides* and the limpet *Patella vulgata*. In areas such as crevices the intertidal snail *Littorina littorea* were also superabundant.

Figure 3.2. Species richness of the Upper & Mid shore heights on both the East and West harbour arms.

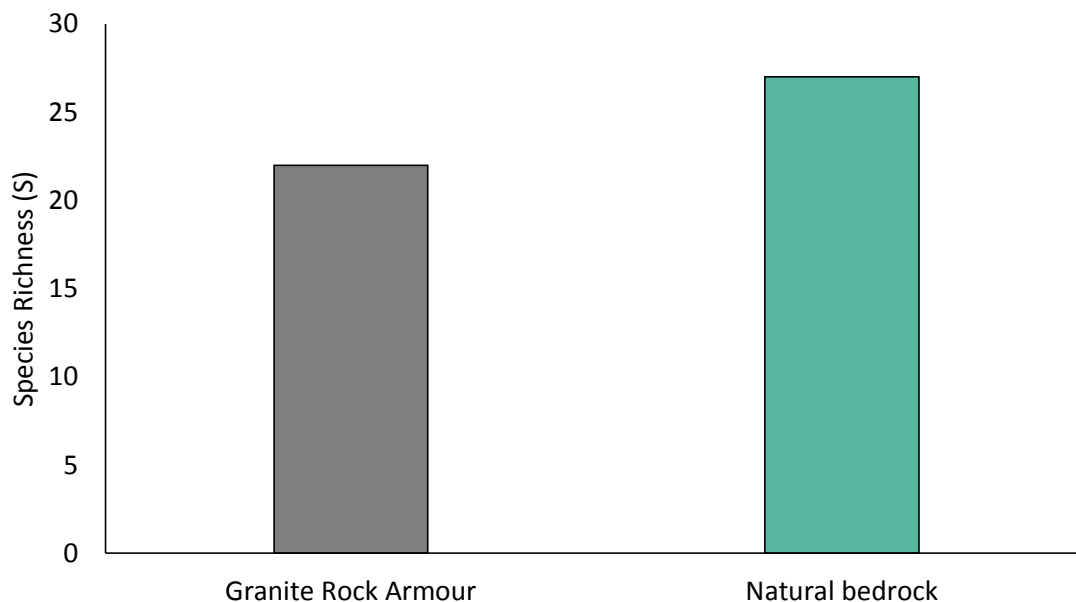
A total of 22 species were recorded on the granite rock armour compared to 28 recorded on the natural bedrock (Figure 3.3, Table 3.1, Appendix A). A total of nine species were present on the natural bedrock, but were absent on the rock armour; five algal species (*Dumontia contorta*, *Fucus serratus*, *Fucus vesiculosus*, *Osmundea osmundea*, *Rhodochorton purpureum*), one worm species (*Spirobranchus triqueter*), two lichens (*Verrucaria maura* and *V. mucosa*) and one mollusc species (*Littorina obtusata*). Three species were recorded on the concrete overlapping onto the granite rock armour and were not found on the natural bedrock – the breadcrumb sponge (*Halichondria panacea*), the Ross worm (*Sabellaria spinulosa*) and the alga (*Lomentaria articulata*) (Figure 3.4).

Figure 3.3. Species richness of the granite rock armour compared to natural bedrock at Staithe in Match 2020.

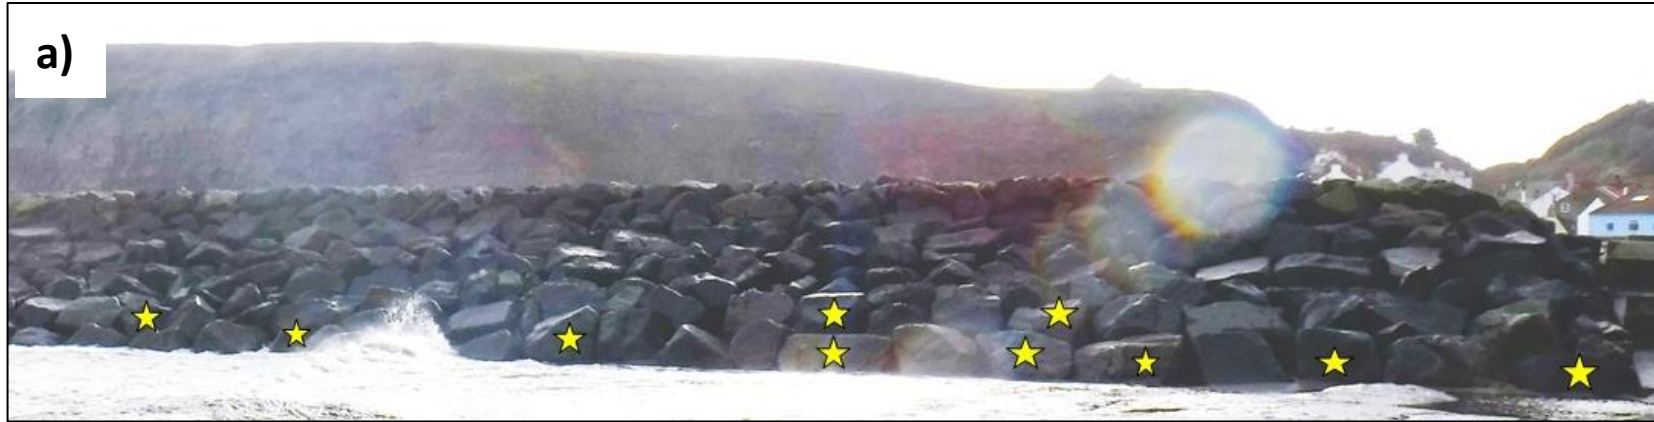
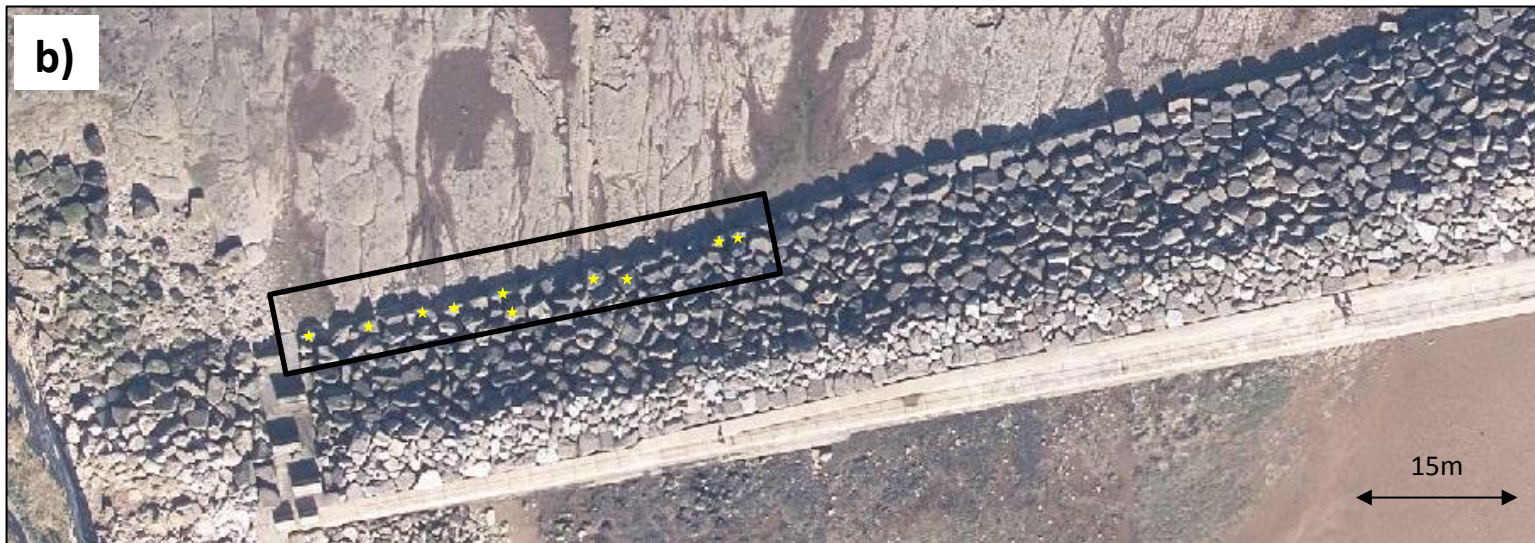
On the west harbour arm, 10 boulders on the lower layer were identified within the first 50 m which would be suitable for artificial rock pools (Figure 3.6a). These boulders were large enough in size and were orientated to retain water if a rock pool were created. These would all be accessible on a neap low tide; additional rock may be suitable on a lower spring tide, however the time available for working in that area may be limited.

Figure 3.6. Suitable boulders for artificial rock pool creation on west arm of harbour indicated with yellow star, a) site photo b) North East Coastal Observatory aerial image. Black box donates where site image was taken.

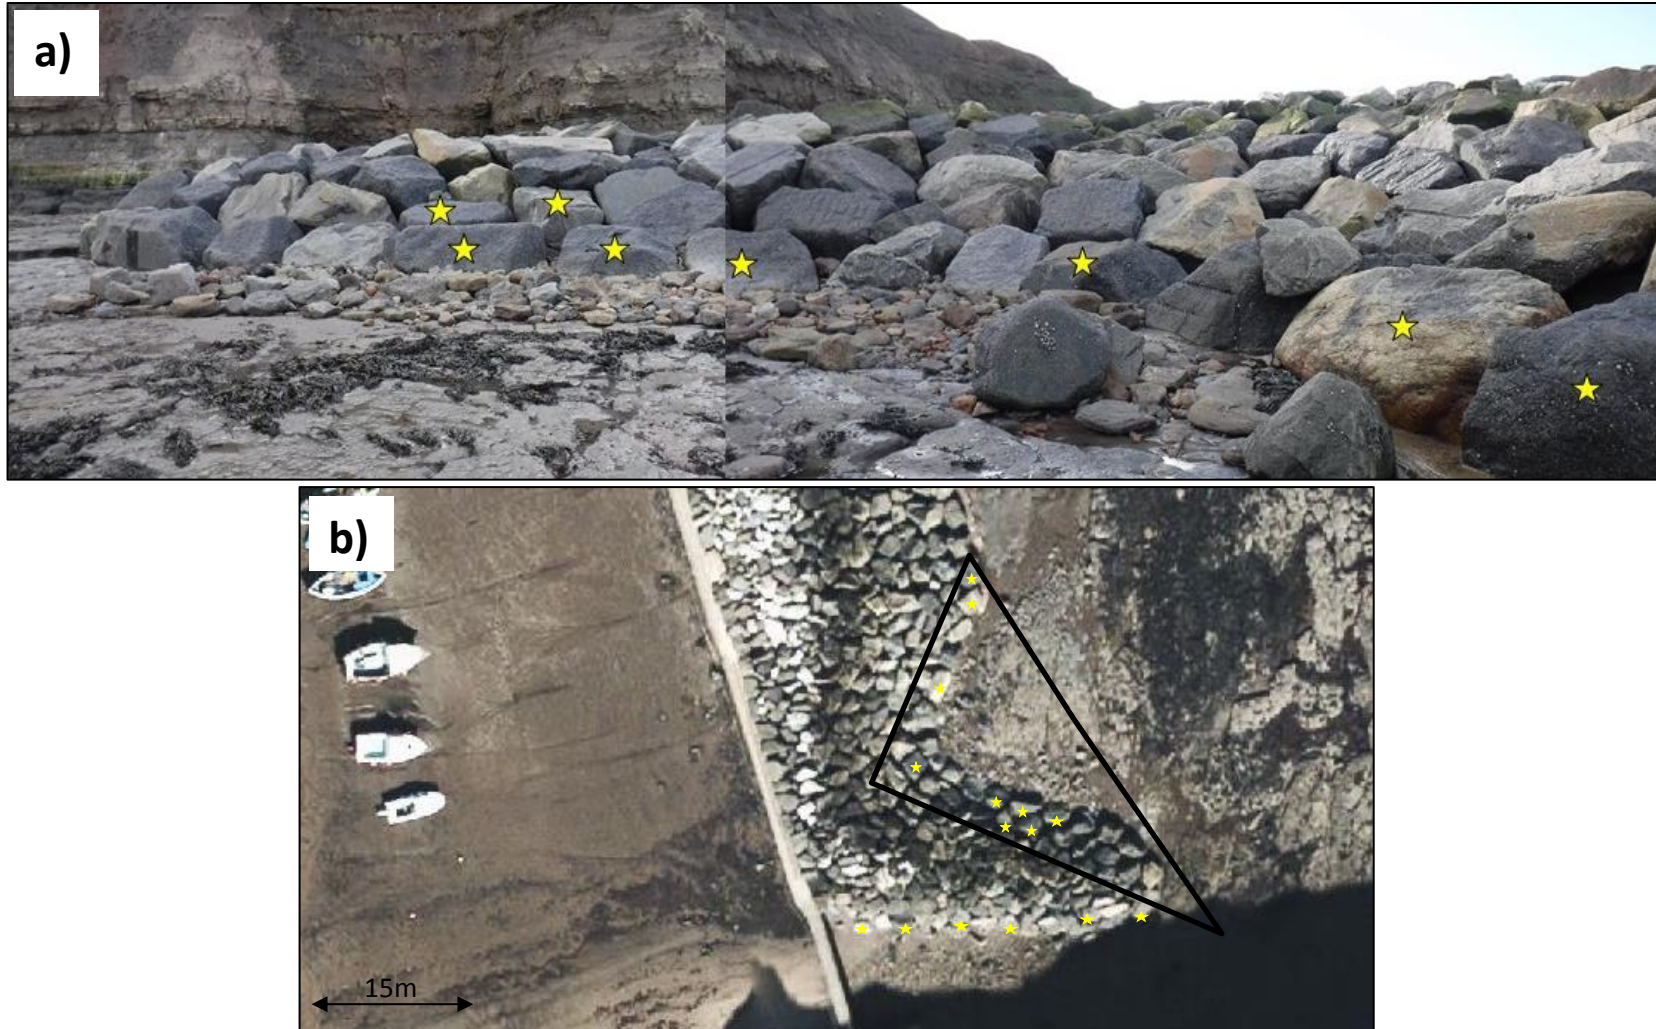
On the east harbour arm only 30 m was accessible on a neap tide due to a deep channel at the base of the rock armour. Eight boulders were identified on the seaward side of the arm which would be accessible and safe to install artificial rock pools (Figure 3.7a).

It would also be possible to install artificial rock pools on the cliff facing side of the rock armour toe (Figure 3.7b). Care would need to be taken not to damage any of the existing rock pools which have formed naturally on the granite boulders.

Figure 3.7 Suitable boulders for artificial rock pool creation on east arm of harbour indicated with yellow star, a) site photo b) North East Coastal Observatory aerial image. Black triangle donates where site image was taken.
