Managing Ecological, Community and Bathing Water Quality Aspects in Construction: Runswick Bay Coastal Protection Scheme, UK

The Runswick Bay Coastal Protection Scheme comprised repairs and installation of concrete toe protection to the existing seawall and the placement of approximately 9,500 tonnes of imported rock armour to form a new revetment totaling 250m length. The historic concrete seawall had reached the end of its serviceable life with a predicted failure within the next ten years. The newly constructed scheme offers an enhanced standard of protection to 96 residential and 17 non-residential properties including 6 listed buildings and infrastructure such as access roads and utilities, from coastal erosion for the next 100 years. Tourism, the foremost revenue stream of the community has also been safeguarded by the works. The effects of sea level rise and increased storminess predicted as a result of climate change have been factored into the design.

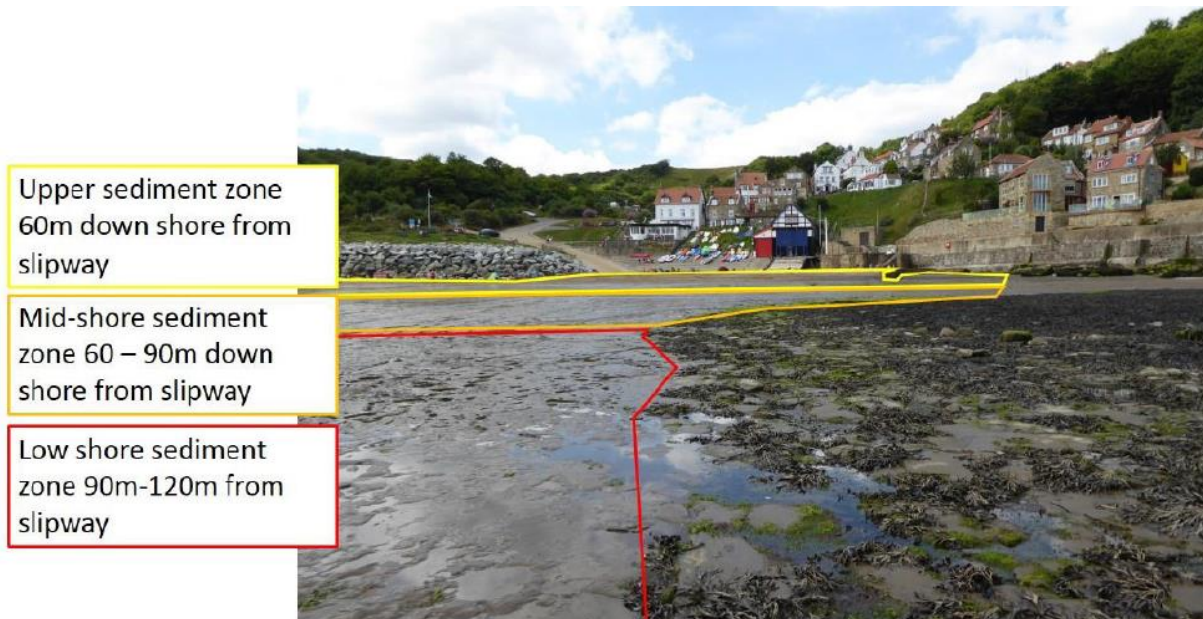
Figure 2: Habitat zones, Runswick Bay (University of Hull, 2014).

Runswick Bay became a Marine Conservation Zone (MCZ) in January 2016. Runswick Bay was designated an MCZ for its low energy, moderate energy and high energy intertidal rock with the conservation objectives to "maintain in favourable condition" (Defra 2016), these ecological enhancement measures were taken to prevent damage to the site. The site may also be described by the zones illustrated in Figure 2, although only a relatively small part of the site is classified intertidal sediment.

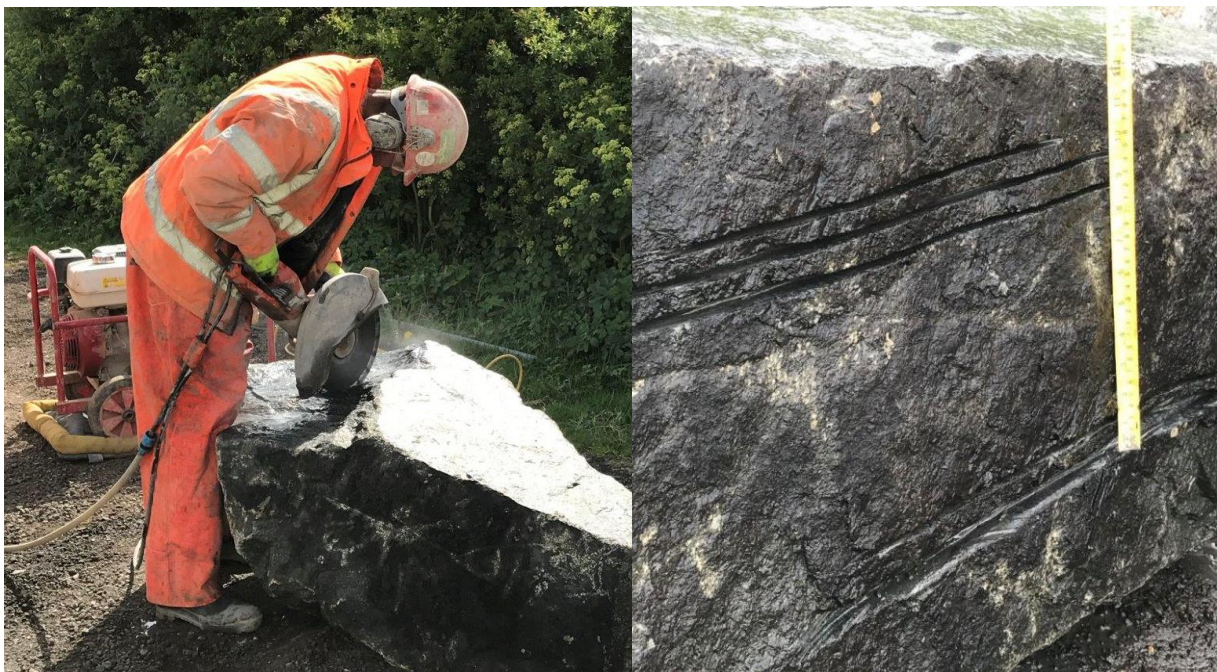
Figure 4: Creation of the distressed features on the granite rock armour.

During the scoping phase the MCZ did not include the intertidal zone, which meant that the preferred option did not directly affect the MCZ. However, at designation the final alignment of the MCZ was located against the toe of the existing seawall meaning the rock fillet was situated within the MCZ. The 250m long rock armour fillet is approximately 2.5 metres high and rises approximately two thirds up the height of the sea wall. The rock armour was placed with a slope of 1 in 3 towards the beach, creating an overall width at the base of approximately 8 metres. The fillet comprised 2 layers of 6-10 tonne rocks with a median diameter of 1.5 metres. The fillet causes the loss of 10-13m of intertidal habitat along the length of the existing wall, representing approximately 2600m² in total. It was assessed that the intertidal habitats would also be affected during the construction as a result of the installation of the rock armour fillet. It was also noted that disturbance would be created as a consequence of the delivery of the rock by boat, workforce movements across the intertidal zone, temporary storage of the rock on the intertidal area and movement of the rock into place by machinery. During the EIA, discussions with Natural England were undertaken to develop measures to mitigate for the permanent habitat loss and the temporary disturbance as a consequence of rock movements and installation. This included 'distressing' boulders and placement of seed boulders to encourage colonisation by marine invertebrates. The distressing of the imported granite armour stones new granite boulders included the cutting/drilling of rock pool features and thin horizontal grooves (approx. 60cm long x 1cm deep) and thicker, coarser grooves (approx. 60cm long x 2cm wide) cut into the rock using an angle grinder, Figure 4.

Trials had demonstrated that it was particularly important to have a rough surface to allow colonisation by intertidal organisms. Scratch grooves provide a vital refuge for marine organisms from environmental conditions and predation (Hall *et al* 2018). Over 130 groove sections have been cut into the armour stones. The project team worked with Bournemouth University and University of Hull to determine the success of the ecological designs. Monitoring was undertaken to provide a baseline and control areas were established for comparison (Hall, Hull and Herbert 2019).

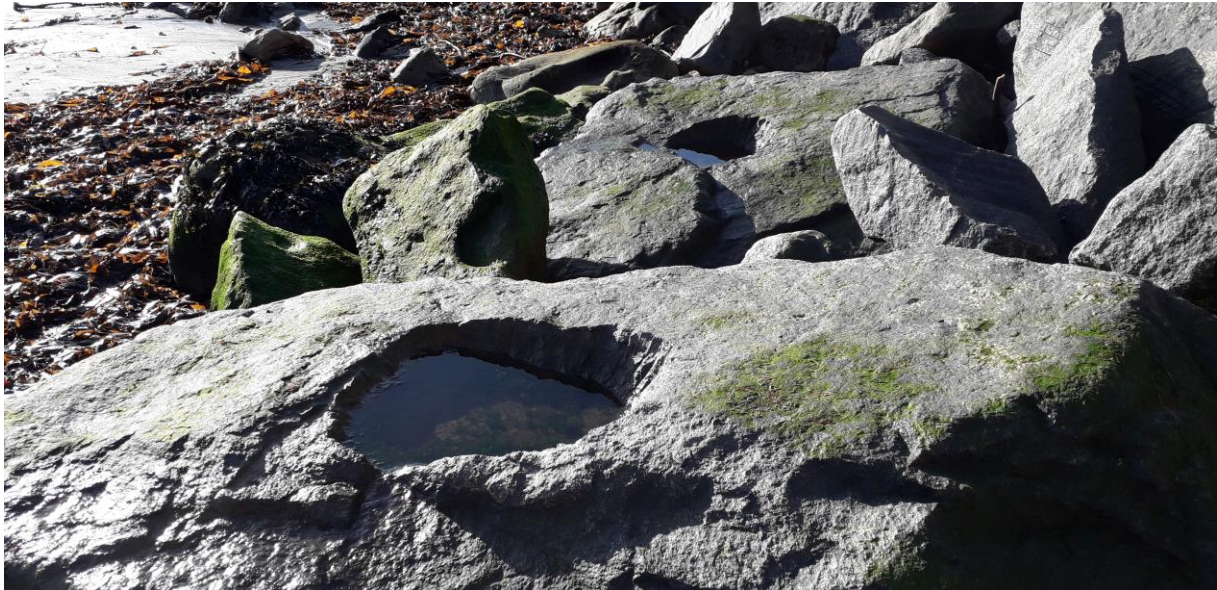
Figure 5: Artificial rock pools cut into the granite rock armour boulders.

Seventy artificial rock pools were installed using an innovative method utilising a circular saw and breaker. The circular saw was used to make two sets of parallel cuts which were perpendicular to each other to form a cross shape. A breaker was then used to break up the cuts and form pools of approximately 300 mm diameter and 150 mm depth with a rough surface. Rock pool diameter ranged between 36 cm and 56 cm and water depth ranged from 5 cm to 19 cm. The rock pools were created largely *in situ*. An additional 20+ pools were generated through the considerate placing/orientation of armour stones. Of the 70 artificial rock pools, 26 were located within the splash zone, three at the splash/upper height (MHWN), 38 at the upper tidal height (MHW) and one at the extreme upper tidal height (MHWS).

The positioning of the rock pools adds to the intrinsic value of the depressions. The water retention and increased habitat heterogeneity created by artificial rock pools on the granite boulders has provided habitat for intertidal organisms to survive on the rock armour. Without these features these organisms would be absent, or the diversity of species is likely to be more restricted. The granite boulders are slow to weather and are smooth, therefore they do not provide conditions that promote rapid colonisation.

Monitoring has shown that all 70 artificial rock pools retained water effectively at low tide and provided areas of increased surface texture, cracks and crevices which is more characteristic of natural shores (Hall, Hull and Herbert 2019). Water retention is a vital feature on a natural rocky shore; it creates protection from desiccation and predation during periods of low water (Firth *et al.*, 2013; White *et al.*, 2014).

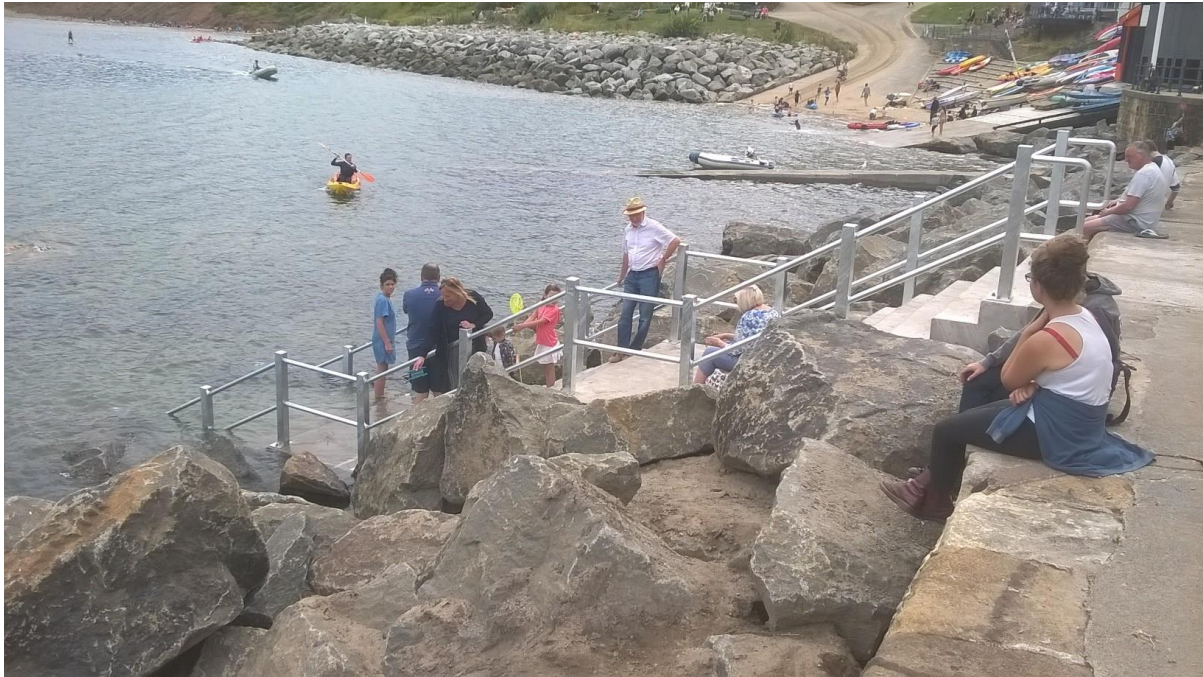
Figure 6: New steps and community ‘crabbing’. Runswick Bay summer 2018.

New steps were installed to provide improved access to the beach and is now proving a well-liked place to go crabbing. The natural rock pools are a popular feature at the Bay and enjoyed by the local community, especially during holiday periods. These features were protected during construction, some of the new manmade rock pools were installed close to the original pools and at the base of the stairs. A formal opening of the new defences was completed on 21st January 2019.
