# Runswick Bay artificial rock pool monitoring: 2018 results

**DATE:** February 2019  
**VERSION:** Final v1.0  
**BUG REFERENCE:** BUG2810  
**PROJECT MANAGER:** Dr Andrew Harrison  
**REPORT AUTHOR(s):** Dr Alice Hall, Dr Susan Hull, Dr Roger Herbert

Client:  
**Scarborough Borough Council**  
Town Hall  
St Nicholas Street  
Scarborough  
YO11 2HG

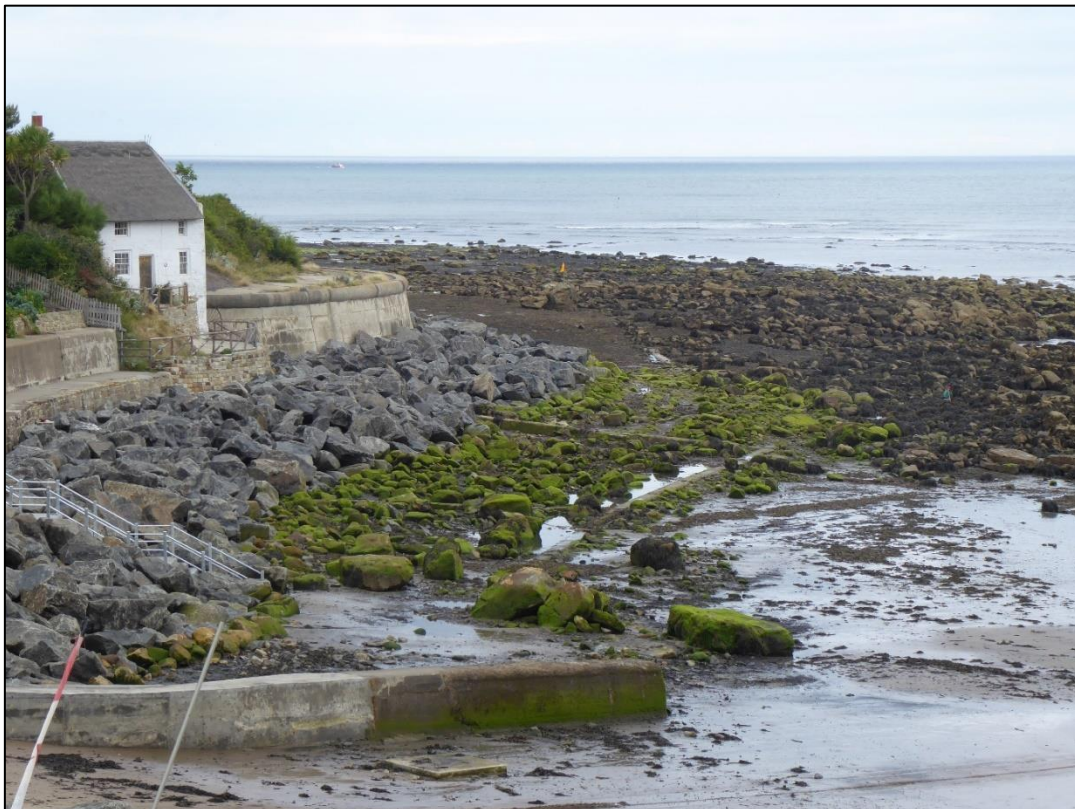
Runswick Bay is a moderately exposed sandy shore with large shale bedrock platforms. It has an easterly prevailing wind direction and the tidal range is 5.6 m during spring tides and 4.2 m during neap tides. The new rock armour was placed on top of the shale bedrock at the foot of the seawall (Figure 2.1). Existing boulders were moved during construction and replaced in front of the granite rock armour to test if “seeding” would increase colonisation rates.

**Figure 2.1. Location of new granite rock armour at the foot of the seawall, note the green (colonised) natural boulders which have been placed in front of the granite rock (August 2018).**

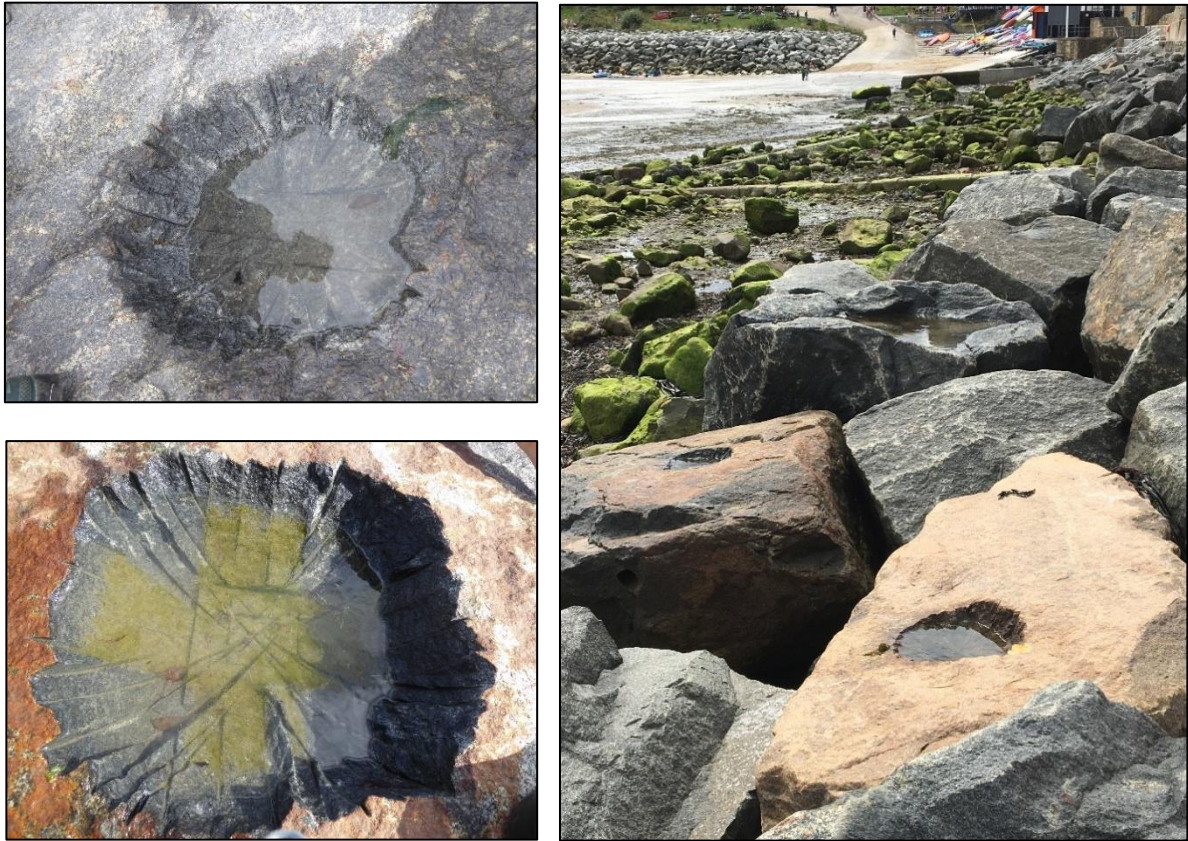
The 70 artificial rock pools were installed using a circular saw and breaker. The circular saw was used to make two sets of parallel cuts which were perpendicular to each other to form a cross shape. A breaker was then used to break up the cuts and form pools of approximately 300 mm diameter and 150 mm depth (Figure 2.2).

**Figure 2.2. Examples of saw cut artificial rock pools roughly 300 mm diameter x 150 mm deep.**

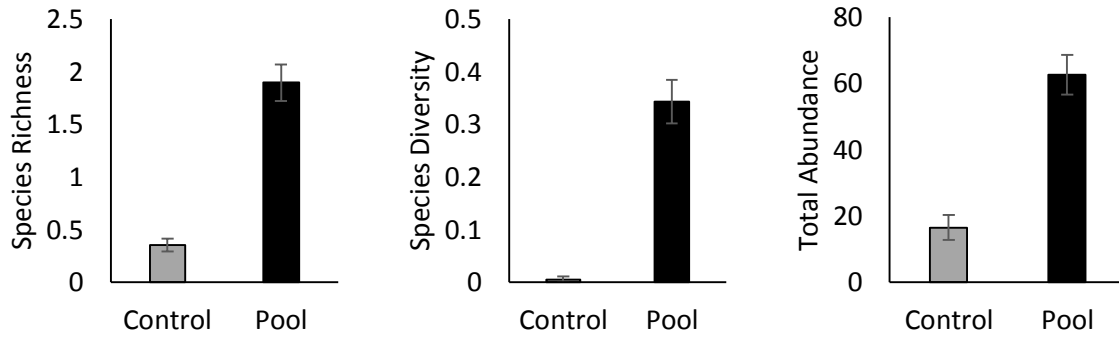
**Figure 3.3.** Mean species richness, species diversity (Shannon Wiener) and total abundance of flora and fauna found in the controls and rock pools after 3 months (+/- SE).

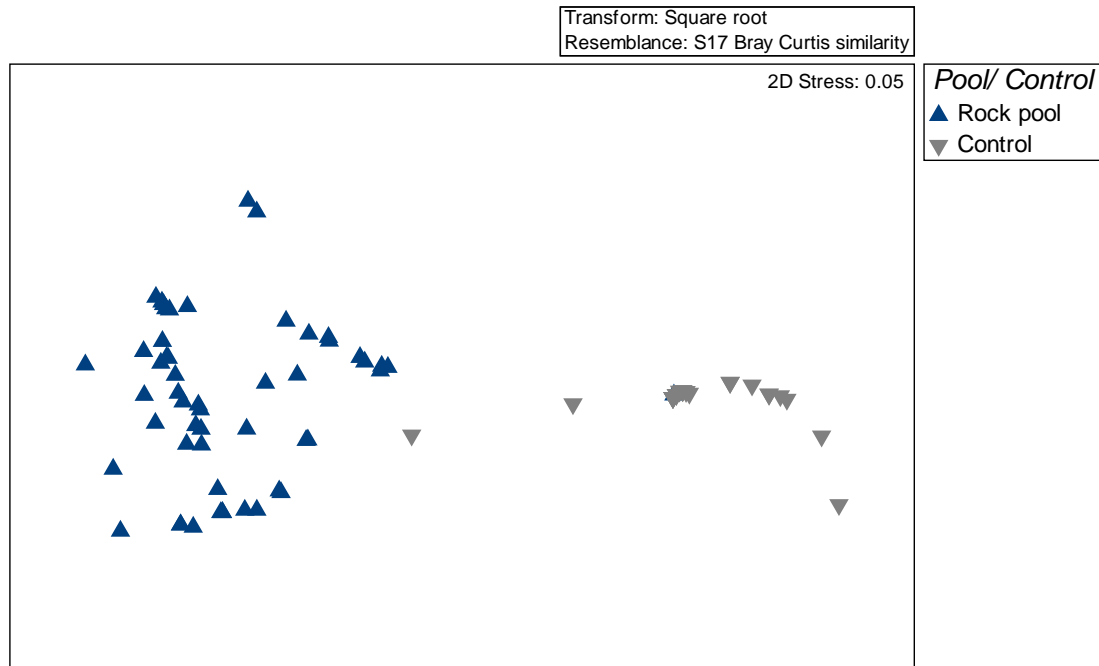
The multidimensional scaling plot (MDS) in Figure 3.4 illustrates the distinct separation in communities between artificial rock pools and the control rock face. Each individual triangular symbol represents a sample rock pool, the closer together the points the more similar the communities are. The similarity percentage analysis (SIMPER) found that 99.44 % of the overall 99.48 % dissimilarity between communities found in pools and controls was attributed to seven taxa; Brown filamentous algae, *Ulva* sp., unidentified green algae, green filamentous algae, *Carcinus maenas*, Amphipoda and *Liophrys pholis*. Table 3.2 illustrates the species abundance in the artificial rock pools compared to the control rock face.

**Figure 3.4. Multidimensional scaling plot of the samples in the rock pools and control areas on the rock armour (August 2018)**

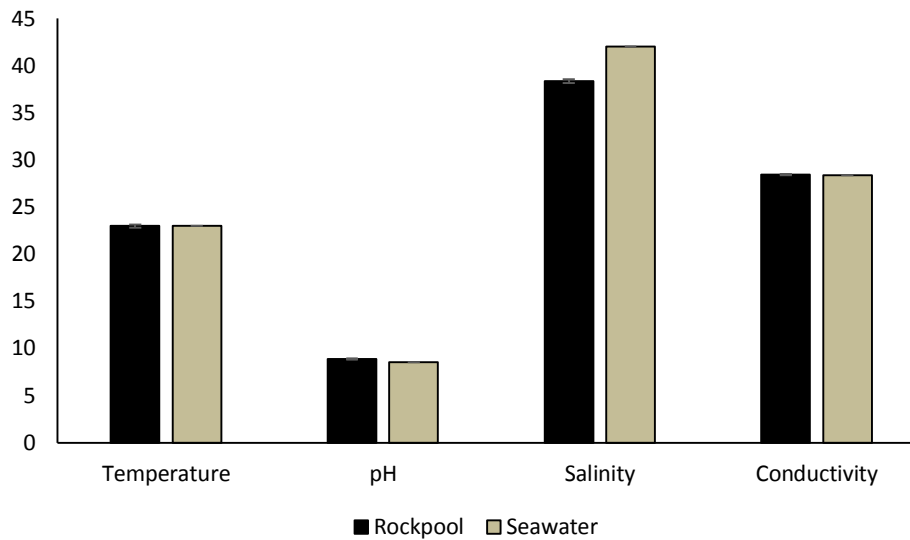
There were no significant differences in temperature, pH and conductivity between the artificial rock pools and the seawater. There was a significant difference in salinity between groups, with the rock pools having a slightly lower salinity compared to the seawater (Figure 3.5).

**Figure 3.5. Comparison of water temperature, pH, salinity and conductivity between artificial rock pools and seawater (+/- S.E).**
