Cell 1 Coatham Dunes Report 2018

March 2018

Cell 1 Regional Coastal Monitoring Programme Coatham Dunes Report 2018

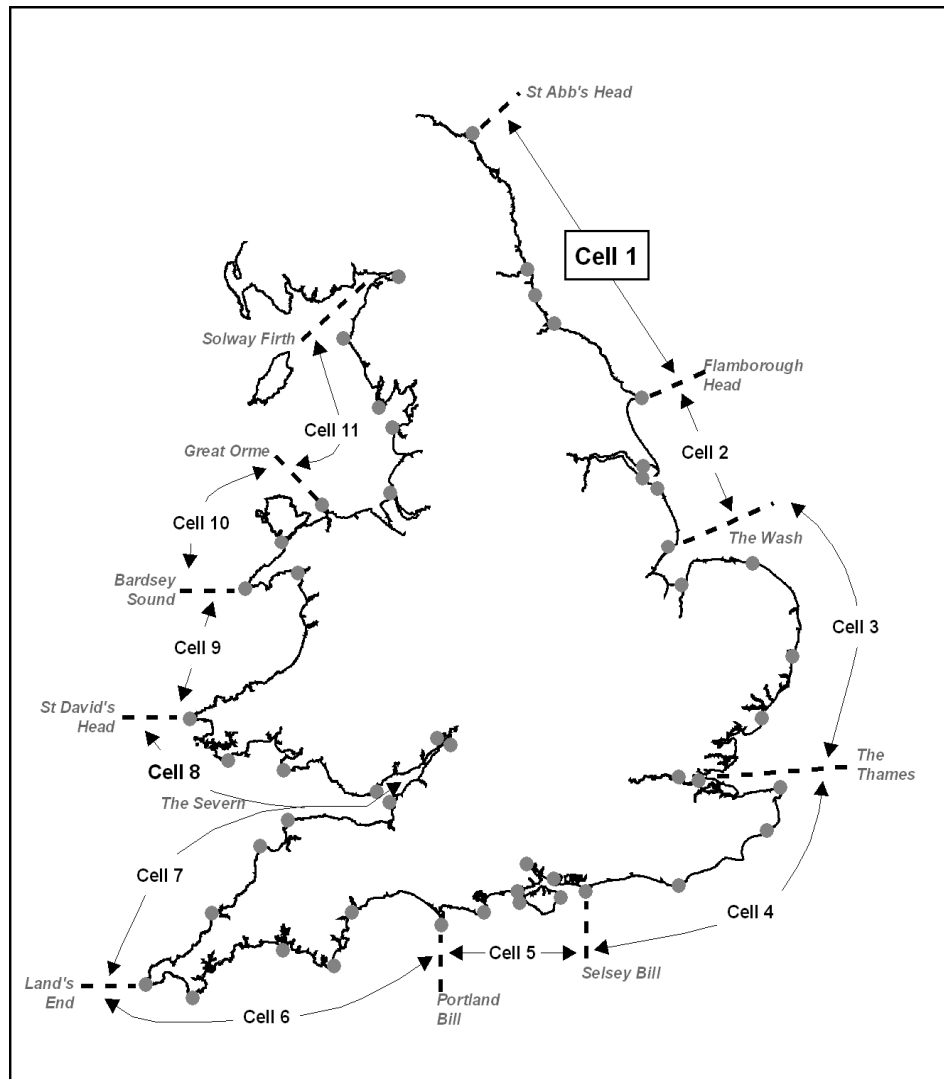
Figure 0-1 - Sediment Cells in England and Wales

The Cell 1 Regional Coastal Monitoring Programme covers approximately 300km of the northeast coastline, from the Scottish Border (just south of St. Abb's Head) to Flamborough Head in East Yorkshire. This coastline is often referred to as 'Coastal Sediment Cell 1' in England and Wales (Figure 0-1). Within this frontage the coastal landforms vary considerably, comprising low-lying tidal flats with fringing salt marshes, hard rock cliffs that are mantled with glacial till to varying thicknesses, softer rock cliffs, and extensive landslide complexes.

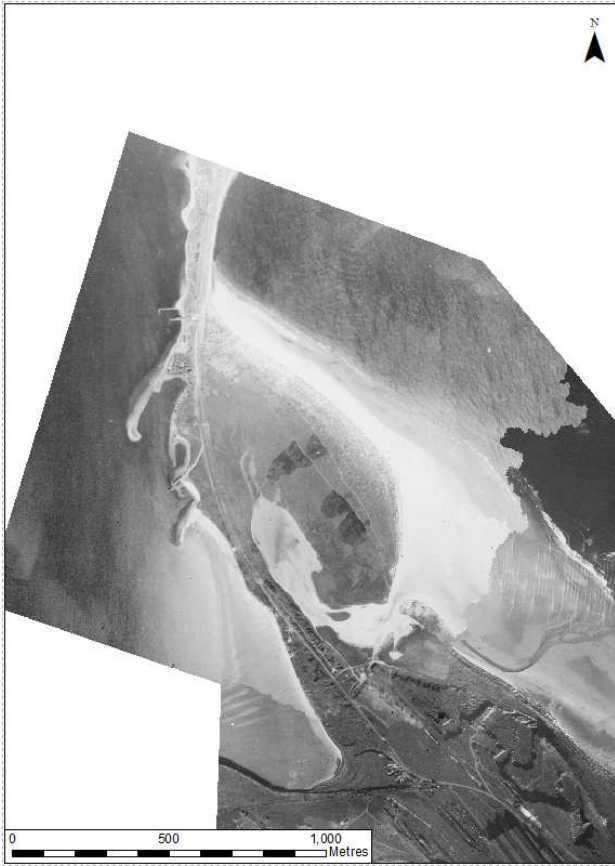
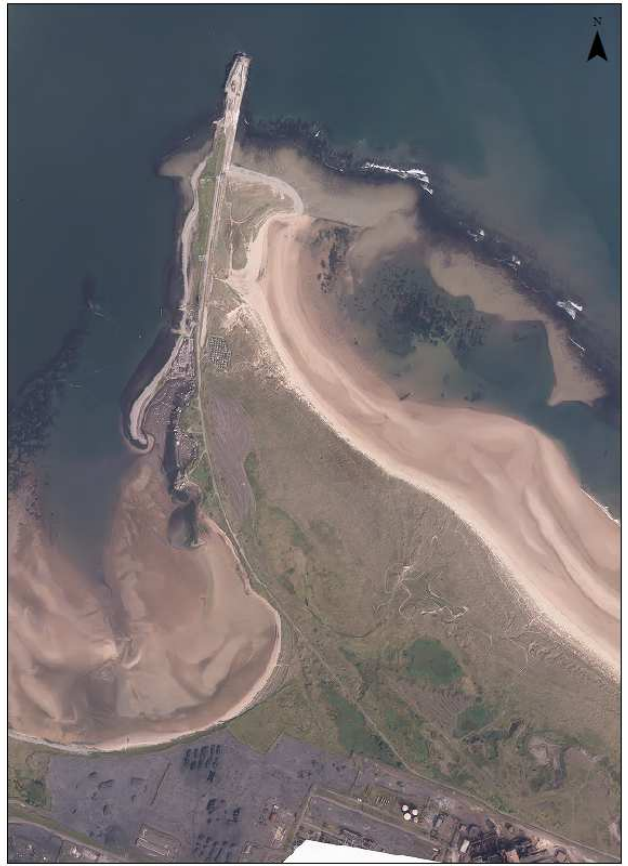
Figure 1 – South Gare, 1940 (left) and 2017 (right)

In the 1940 aerial imagery, the dunes adjacent to South Gare had not built out along the seaward edge of the spit in the manner that is observed in the present day, but instead occupied a bulbous shape, with a distinct ingress of sea water into a saline lagoon, with only a thin azimuth of land between the lagoon and the Bran Sands area of the River Tees estuary (Figure 1).

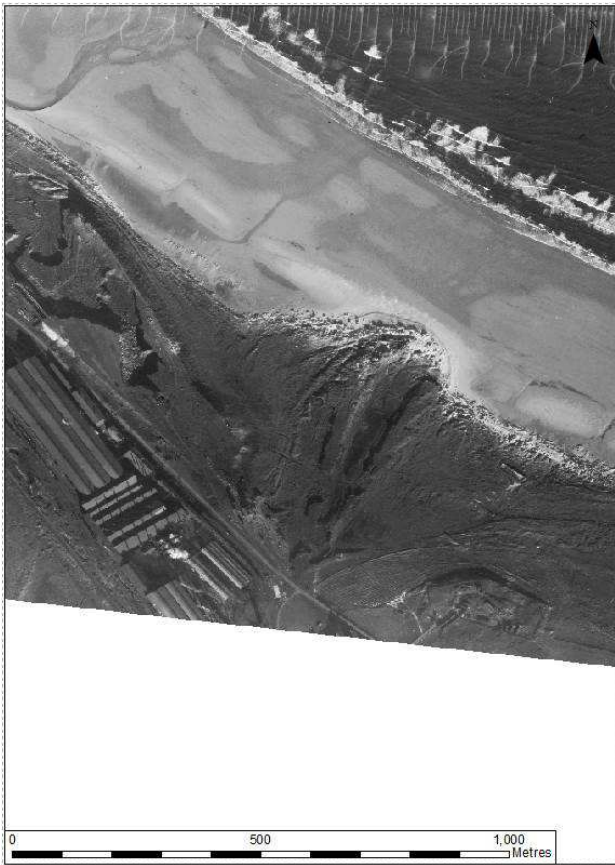
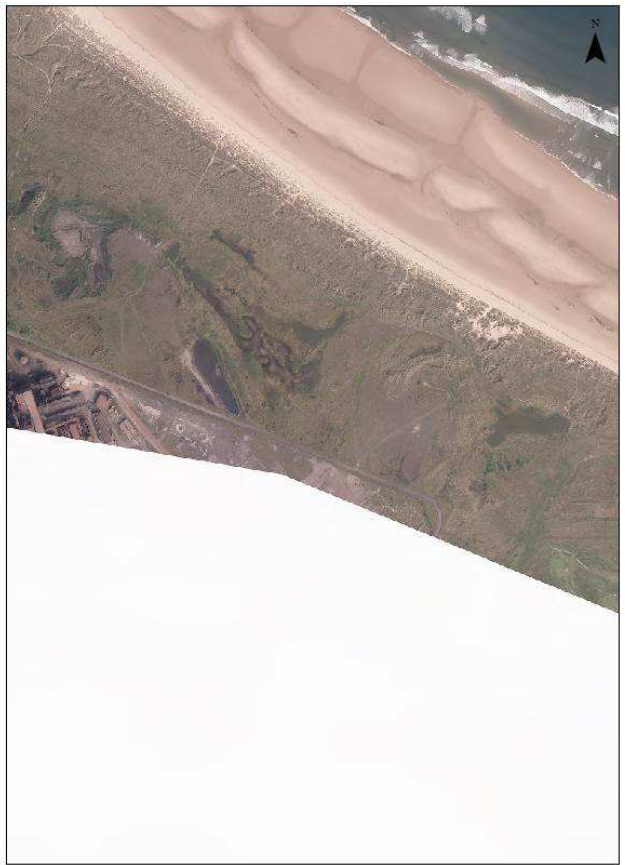
Figure 2 – Warrenby Slag Works, 1940 (left) and 2017 (right)

The Warrenby Slag Works are present in the 1940 imagery and slag deposits appear to push the shoreline seaward in locations immediately adjacent to the works, although the coastline here was still somewhat landward of its present day position in 1940 (Figure 2).

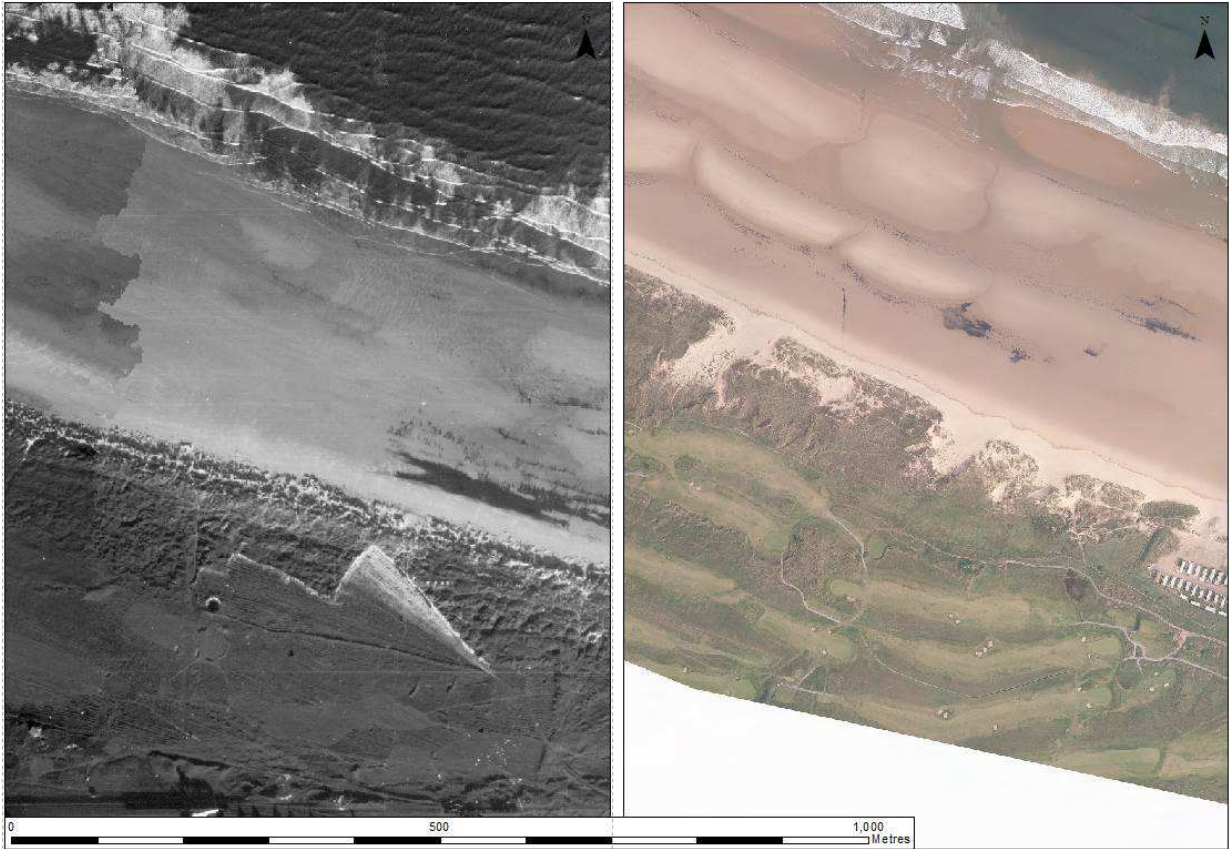
Figure 3 – Majuba Area (west), 1940 (left) and 2017 (right)

In the Majuba area, the present day caravan park had not been constructed in 1940 and whilst a seawall appeared to be present from the Redcar frontage towards the area of the present day Majuba car park, the car park itself was also not constructed at this time (Figures 3 & 4). It is notable that the dunes at this location were experiencing some vegetation loss and encroachment by the sea in the 1940s, even before the caravan park was built on this area.

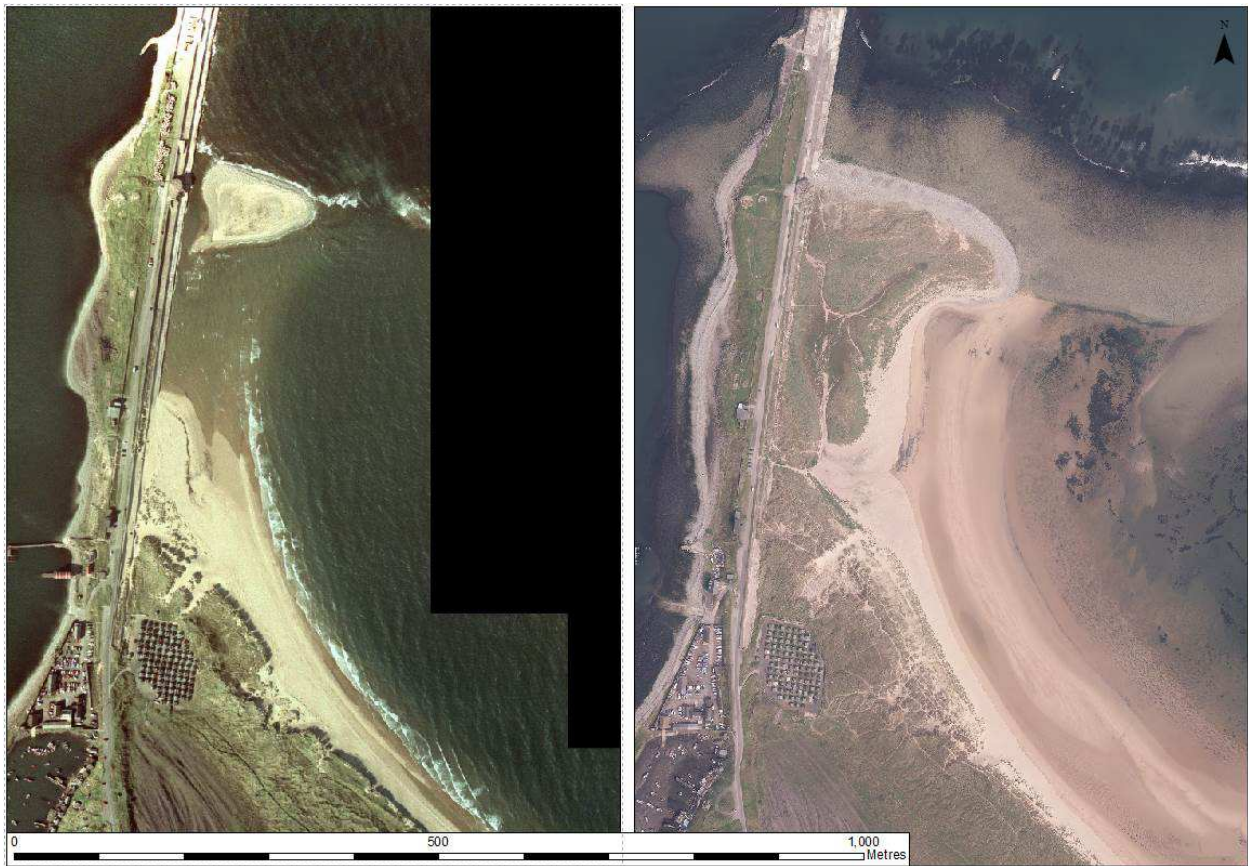
Figure 5 – South Gare, 1999 (left) and 2017 (right)

By the time of the next available aerial photography from the Cell 1 Regional Coastal Monitoring Programme in 1999, the shore adjacent to the South Gare was undergoing change (Figure 5). It appears that sand or slag may have been artificially deposited to the east of the South Gare at this time, although the present day alignment had not yet been fully attained.

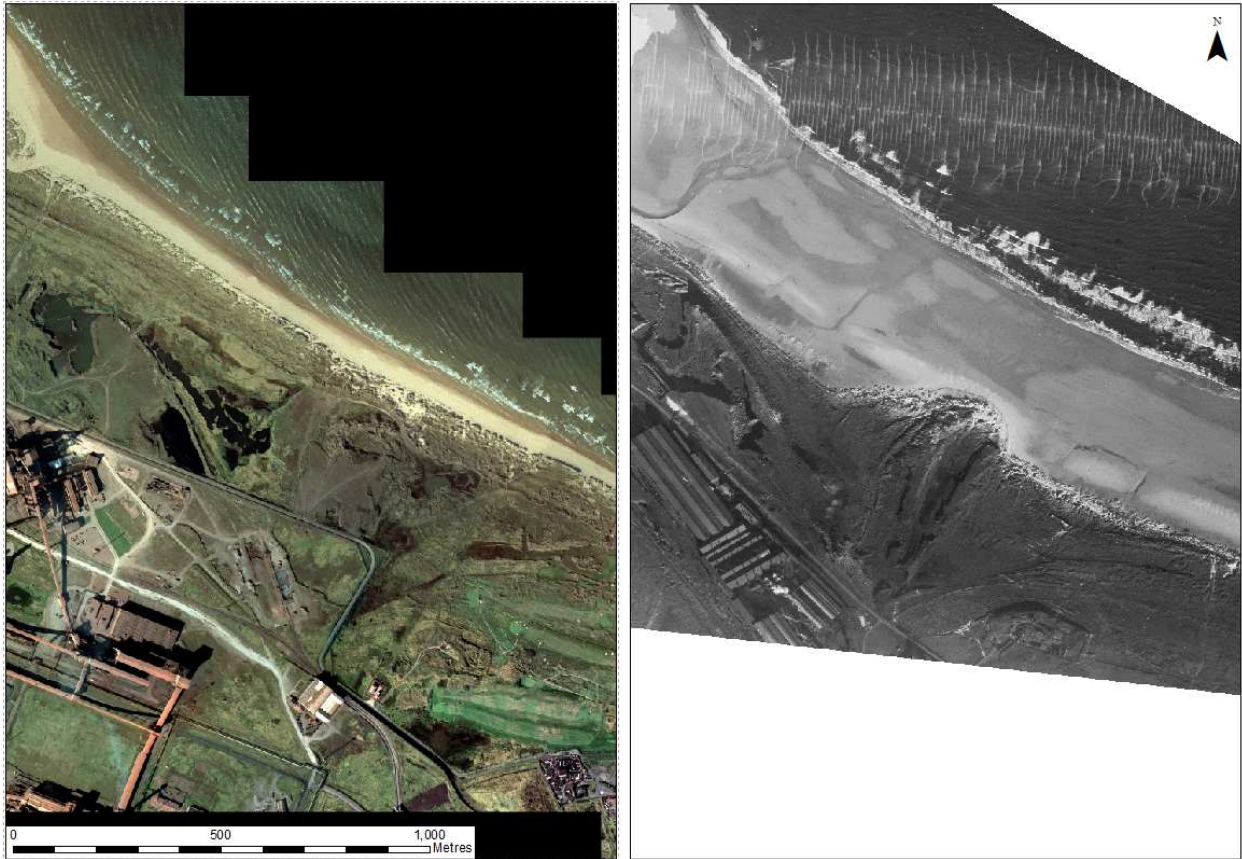
Figure 6 – Warrenby Slag Works, 1999 (left) and 1940 (right)

There had been continued progradation of the shore in the centre of the frontage, in the vicinity of the Warrenby Slag Works and the frontage by 1999 was appearing much more like a 'natural' dune system, with vegetated sand at the seaward limit, as opposed to a probable sand/slag mix present at the shore face in 1940 (Figure 6).

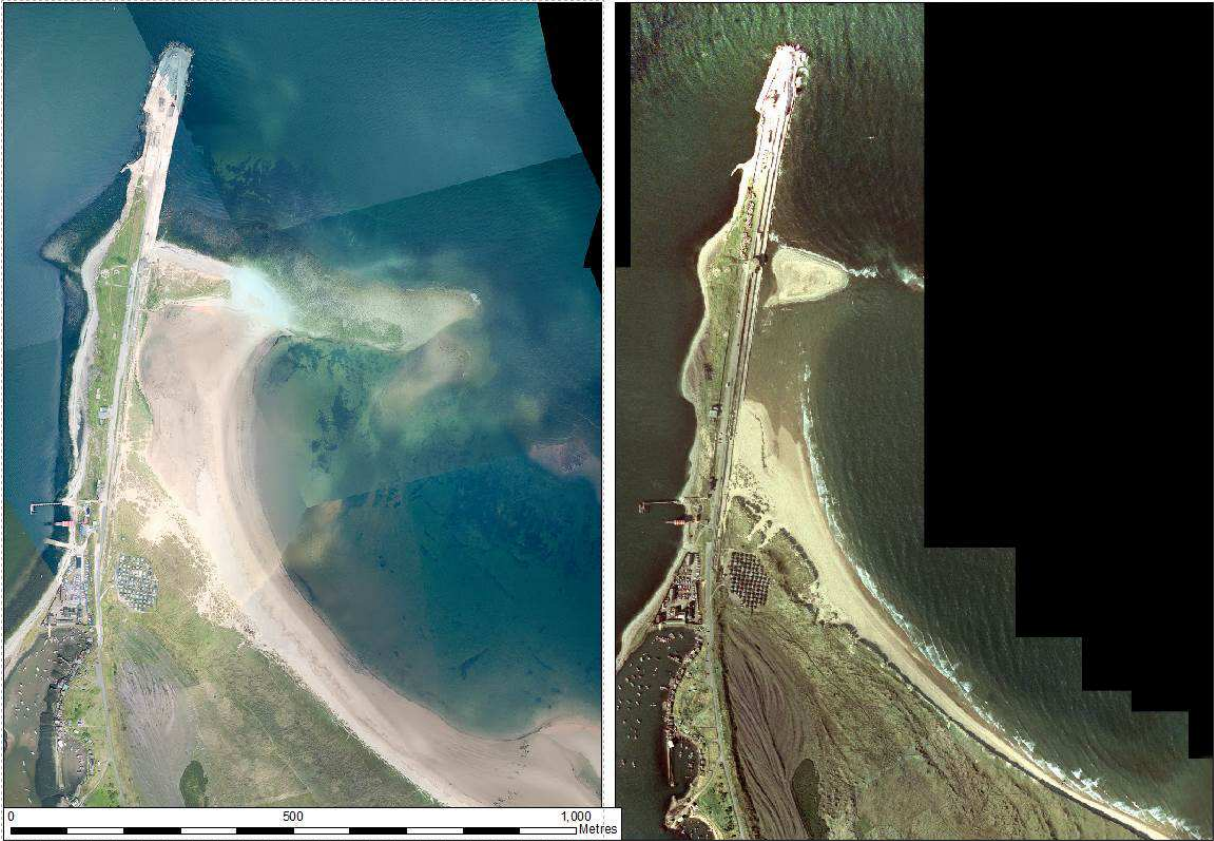
Figure 7 – South Gare, 2009 (left) and 1999 (right)

By 2009, the shore adjacent to South Gare had continued to experience change, again likely in the form of sand/slag deposition and, due to the presence of the German Charlies in the nearshore, natural sand deposition in the now-sheltered areas. This resulted in quite a growth in the shore adjacent to the South Gare and stability in the dunes at the western end of the frontage (Figure 7).

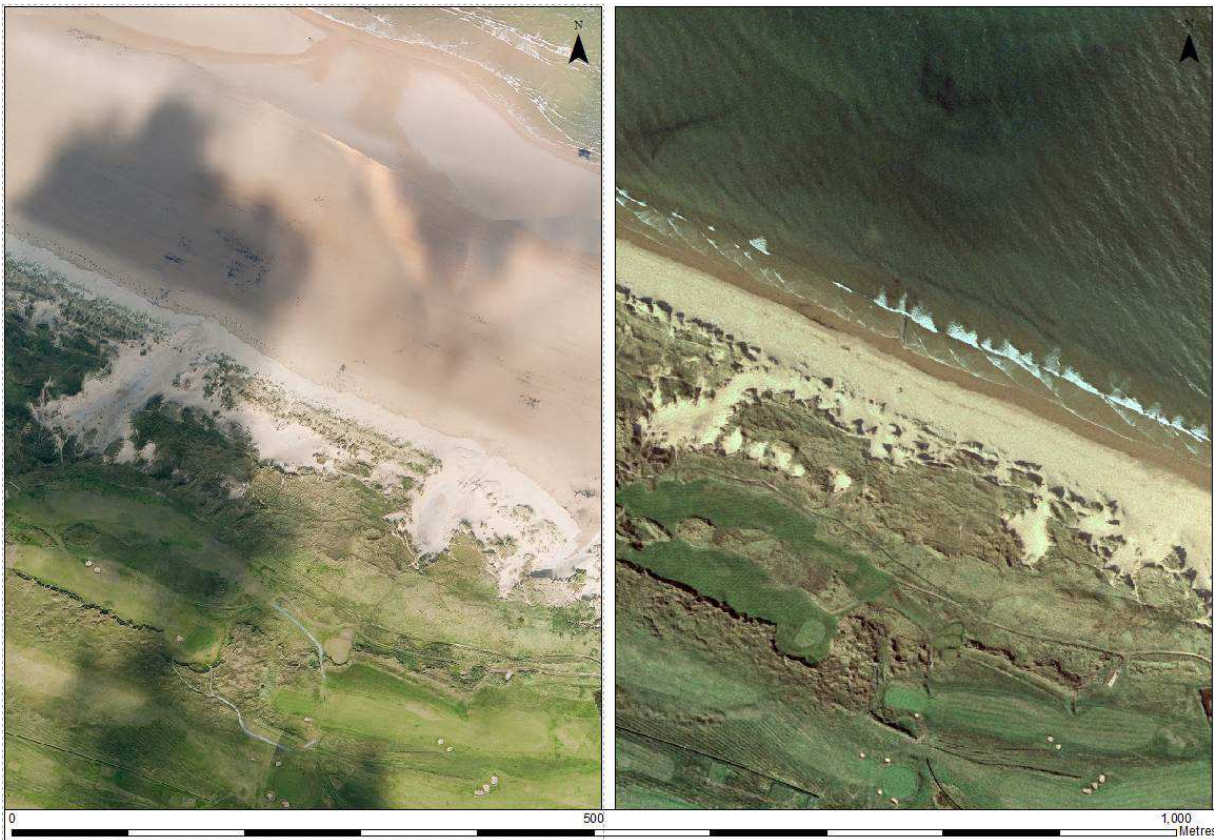
Elsewhere along the frontage there was little change from 1999 to 2009, other than some exacerbation of areas of blow outs or bare dune vegetation to the immediate west of the caravan park in the Majuba area (Figure 8).

Figure 8 – Worsening of blow outs along eastern Coatham Sands, 2009 (left) and 1999 (right)

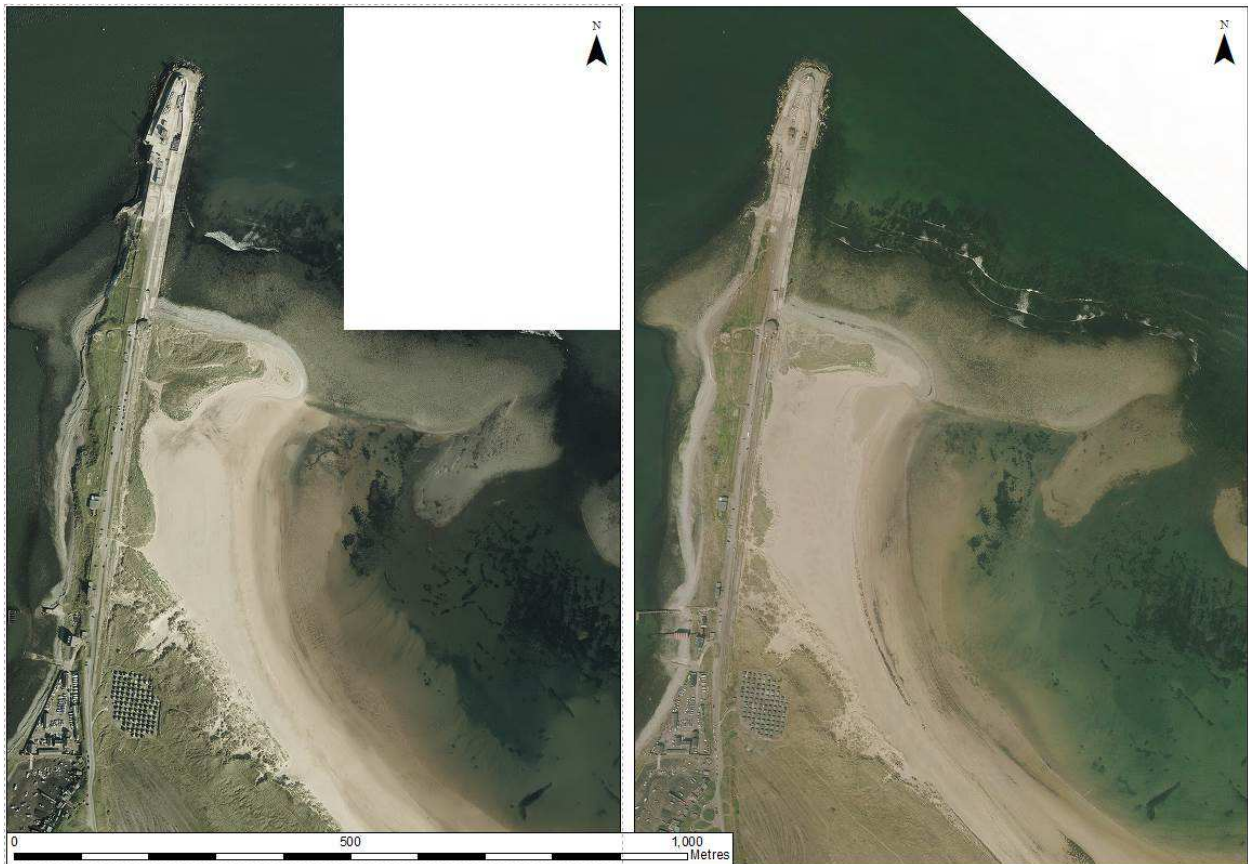
Figure 9 – South Gare, 2012 (left) and 2010 (right)

The shore adjacent to South Gare appeared to contain greater quantities of material (sand/slag) and was more widely vegetated in 2012 than in 2010 (Figure 9).

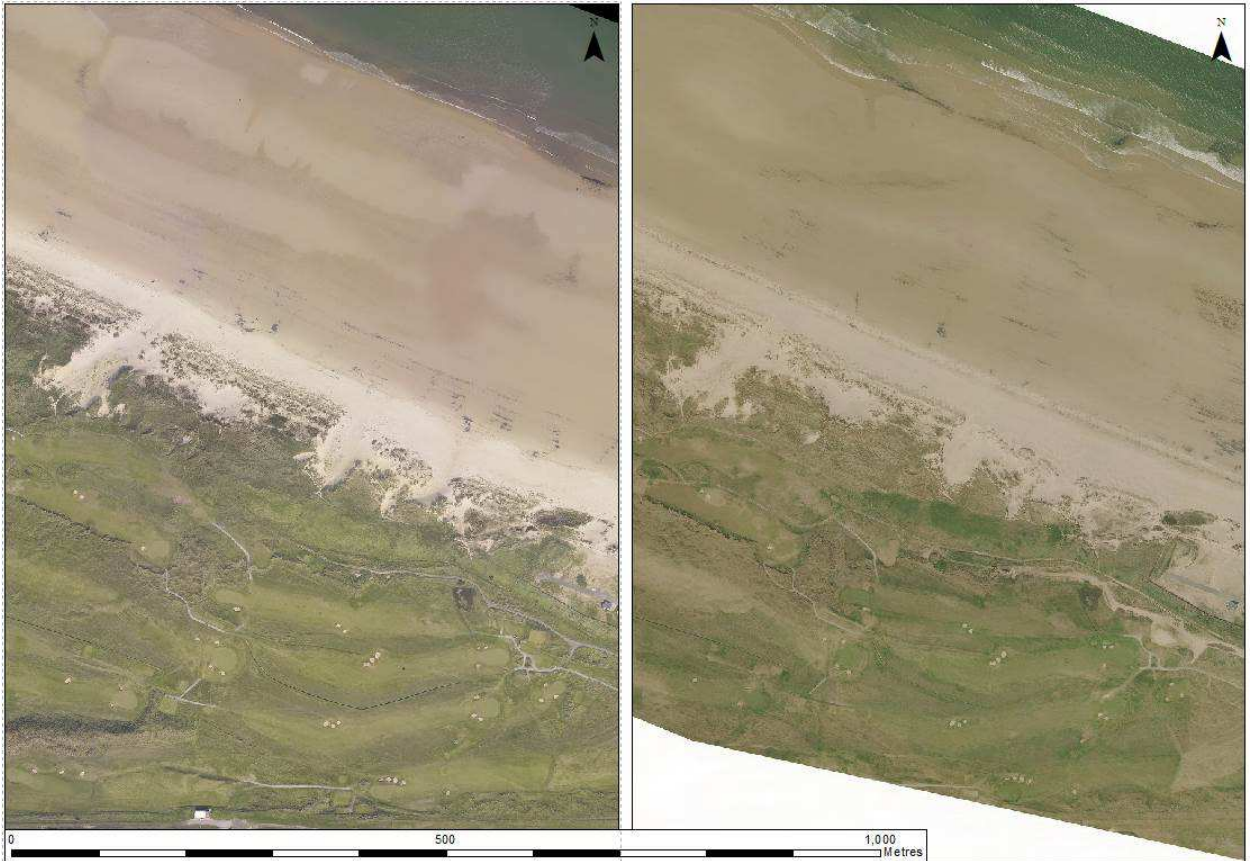
Figure 10 – Majuba Area (west), 2012 (left) and 2010 (right)

At the Majuba area (Figures 10 & 11), part of the dunes adjacent to the caravan park were covered with hard-top and being used for car parking and portacabins in 2012. Presumably this was the Contractor's compund for the duration of construction of the Redcar Sea Defence Scheme. It is also noticeable that the seaward row of caravans seen in the 2010 imagery had been removed by 2012, indicating a risk from erosion or sea flooding at that time.

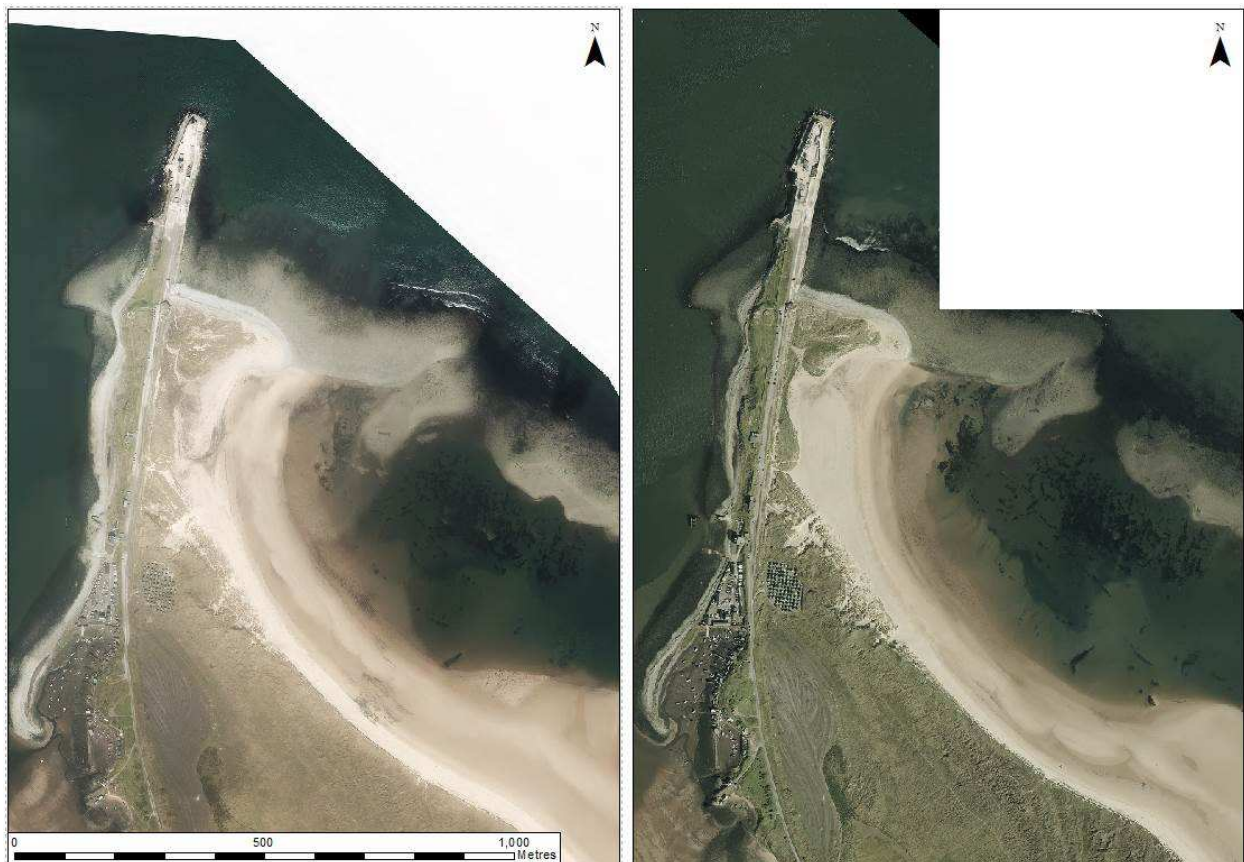
Figure 12 – South Gare, 2015 (left) and 2012 (right)

The shore adjacent to South Gare showed some further growth between 2012 and 2015 (Figure 12), but elsewhere along the Coataham Sands frontage there was no significant difference in the shore between the 2012 and 2015 imagery, indicating that if the December 2013 storm did cause localised damage, there had been natural recovery by 2015.

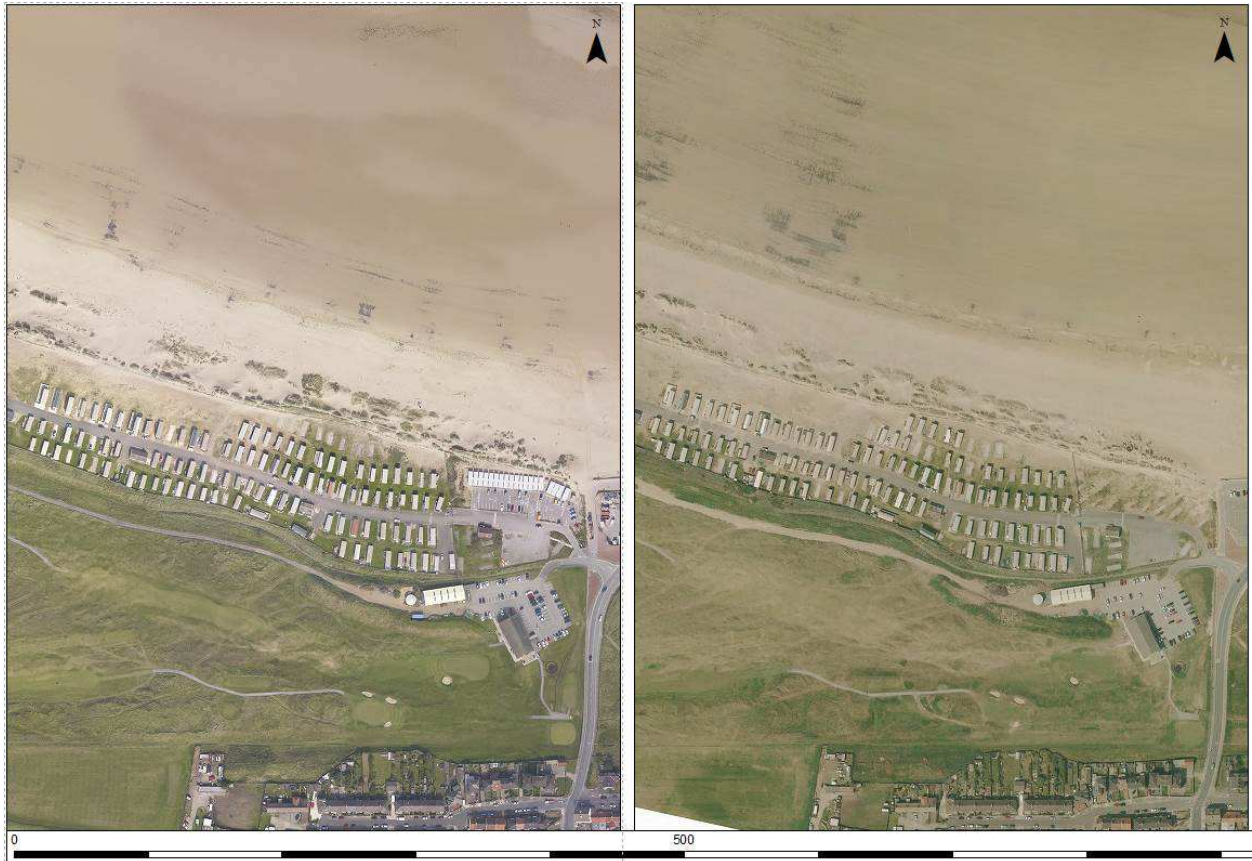
Figure 13 – Majuba Area, 2015 (left) and 2012 (right)

Following completion of the Redcar Sea Defence Scheme, the Contractor's portacabins at the caravan park in the Majuba area had been removed by 2015, but the hard-top remained intact. The most seaward row of caravans seen in the 2015 imagery had been restored since being (temporarily) removed before the 2012 imagery (Figure 13).

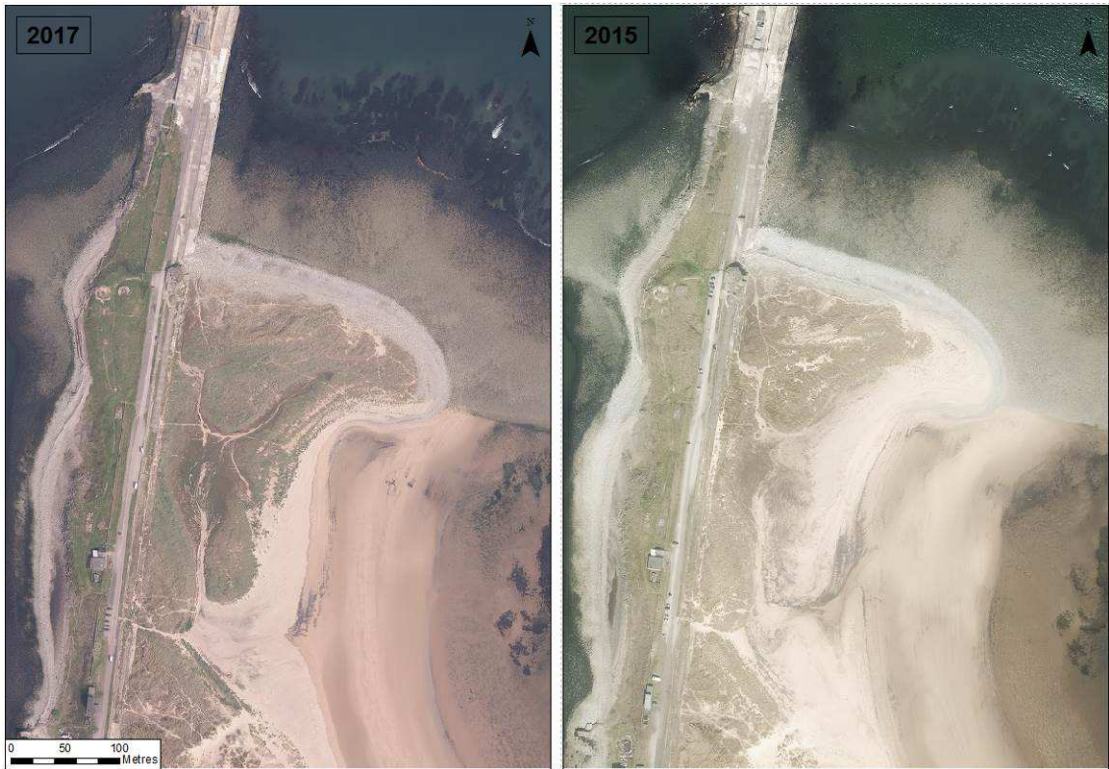
In the immediate lee of the South Gare breakwater, the trend continued to be one of accretion in the shelter of the structure, with a notable increase in the extent of dune vegetation (Figure 14). Some areas of ‘scalped’ dune evident in the 2017 aerial photography was also present in the photography that was collected in 2015 and appears not to have worsened. Arguably in some areas (e.g. Figure 15) it may have marginally recovered, although remaining heavily scalped.

Figure 14 – Vegetation growth on dunes in the lee of South Gare Breakwater between 2017 (left) and 2015 (right)

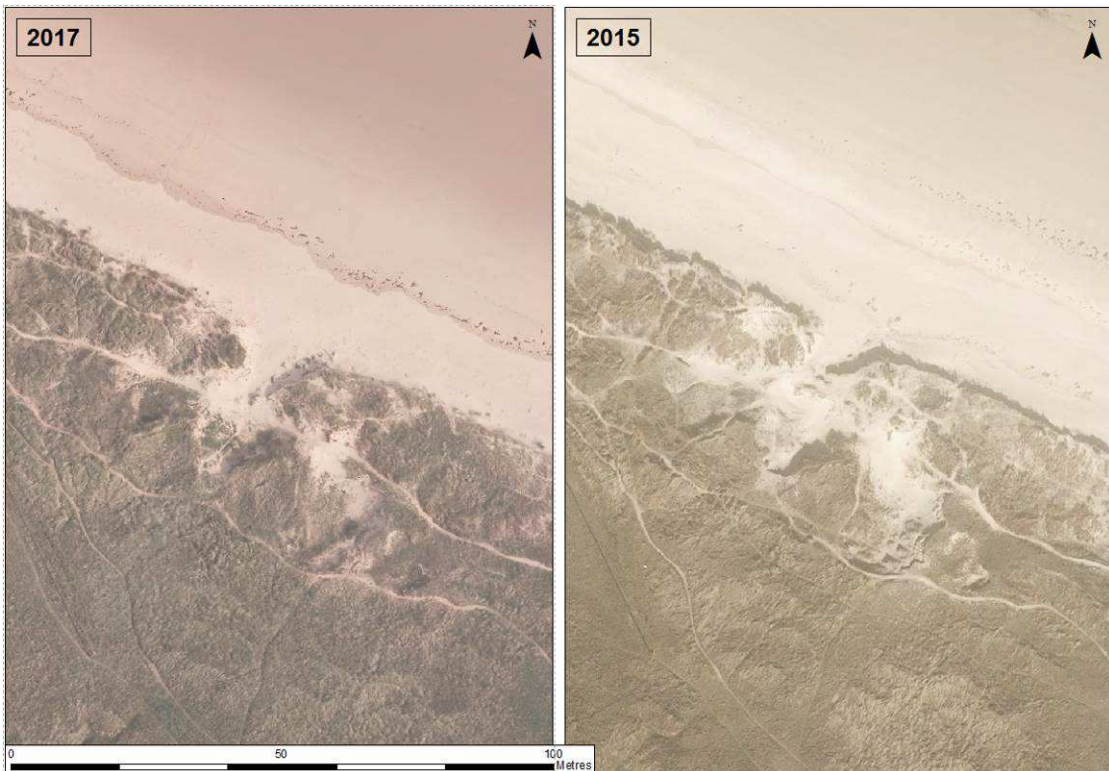
Figure 15 – ‘Scalloping’ of dunes along Coatham Sands in 2017 (left) and 2015 (right)

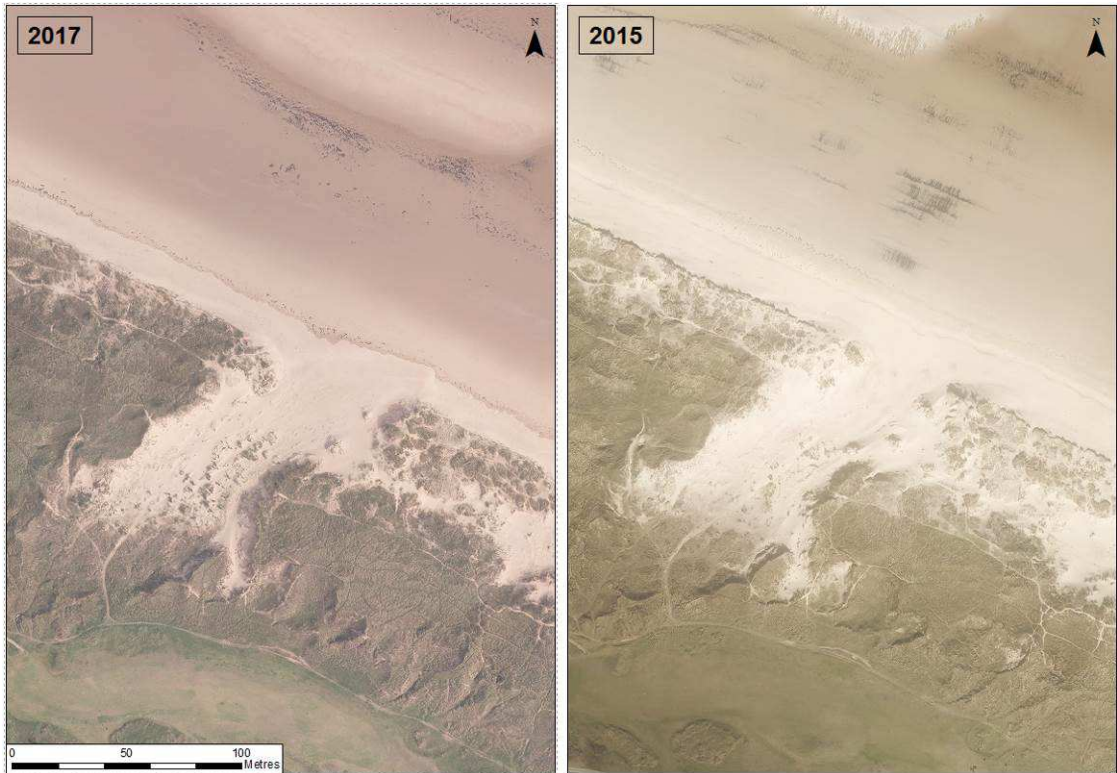
Some areas that were anecdotally described as ‘breaching’ or ‘severely eroding’ during the January 2017 storms, were clearly in such a state before the 2015 photography was collected and thus the damage to these dunes cannot be ascribed to the January 2017 storms alone (Figures 16 to 2-10).

Figure 16 – Damage to dunes along Coatham Sands in 2017 (left) and 2015 (right)

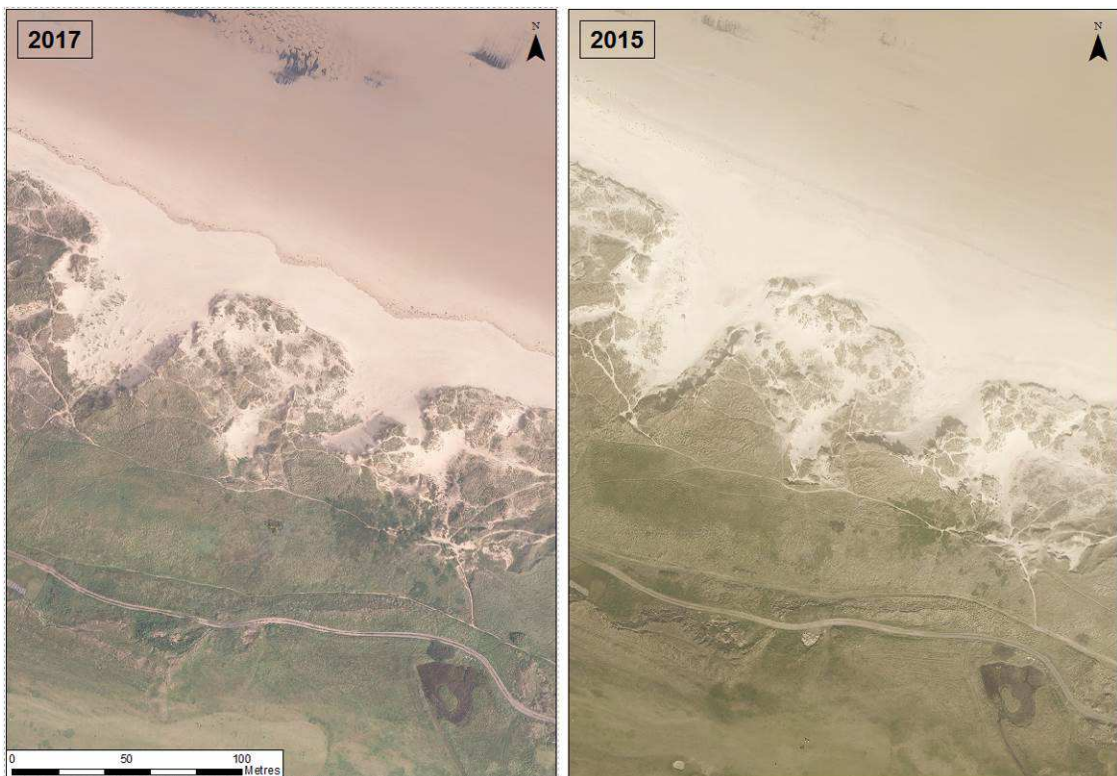
Figure 17 – Damage to dunes along Coatham Sands in 2017 (left) and 2015 (right)

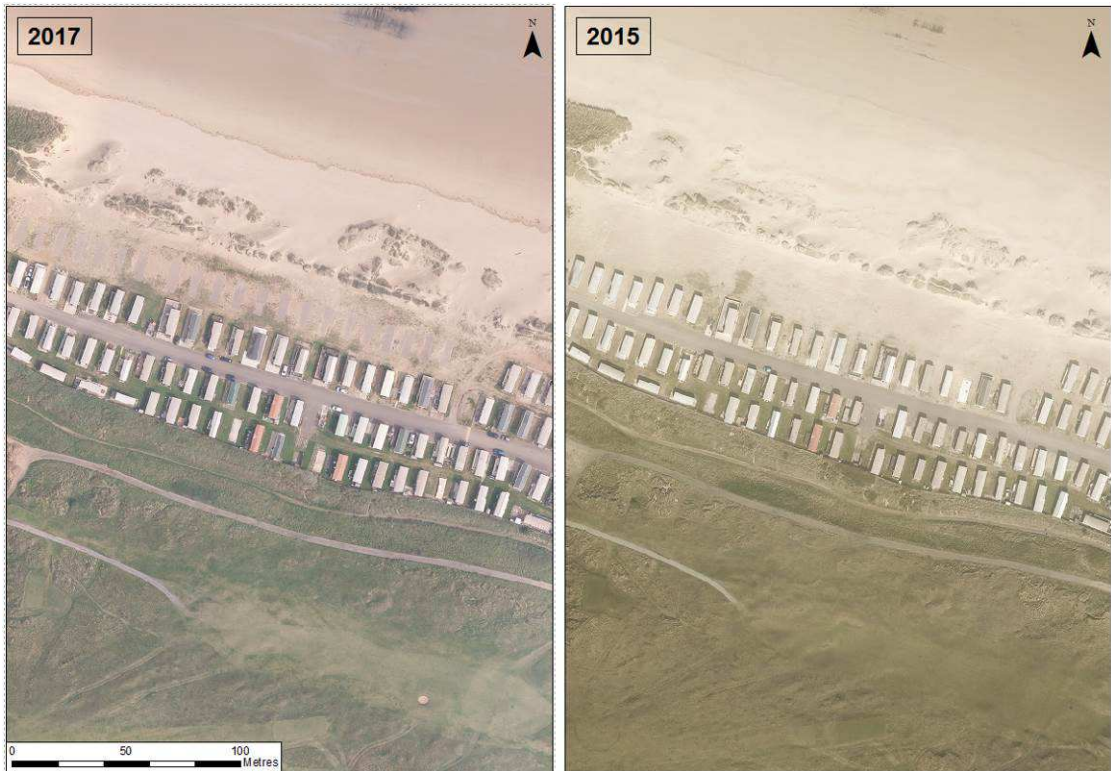
Figure 18 – Dune condition fronting western section of caravan park along Majuba Area in 2017 (left) and 2015 (right)

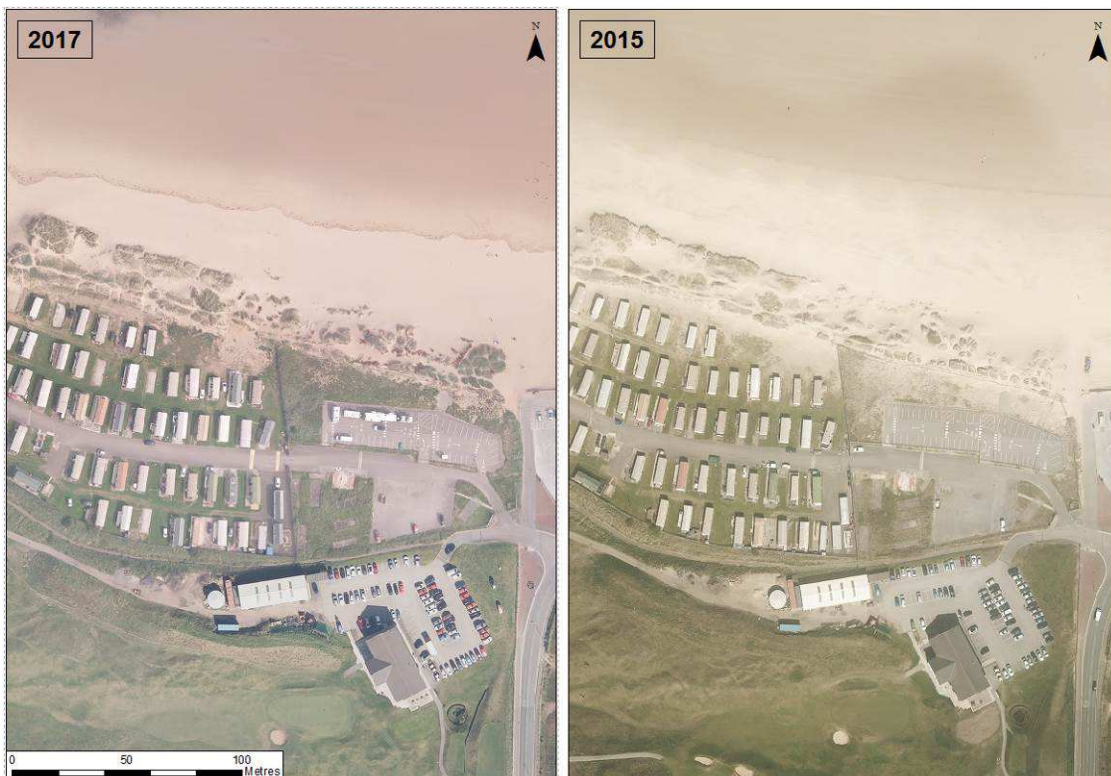
Figure 19 – Dune condition fronting eastern section of caravan park along Majuba Area in 2017 (left) and 2015 (right)

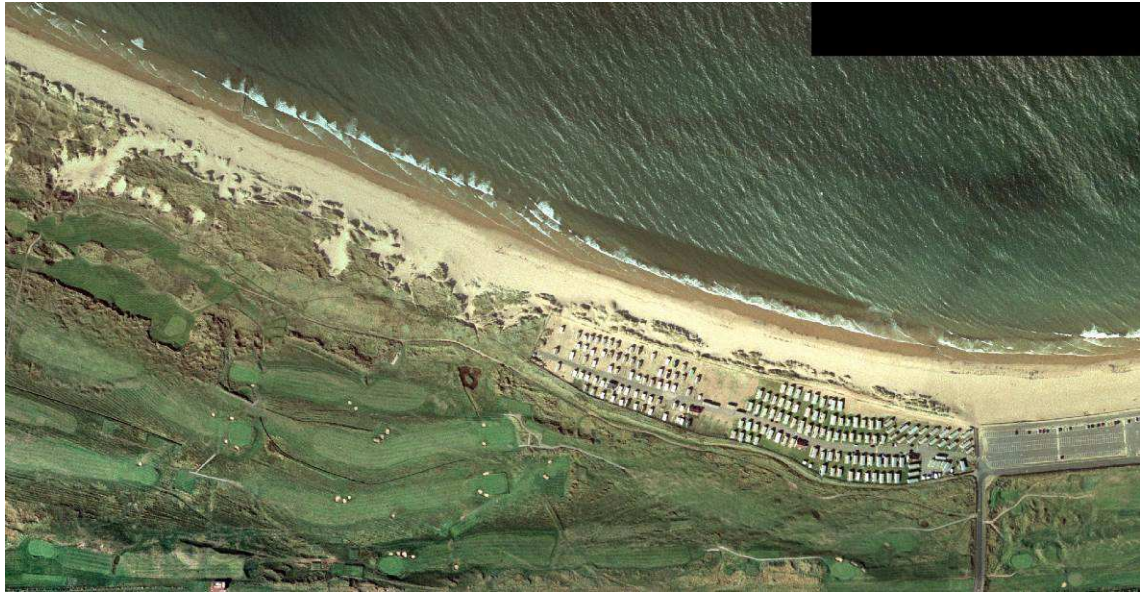
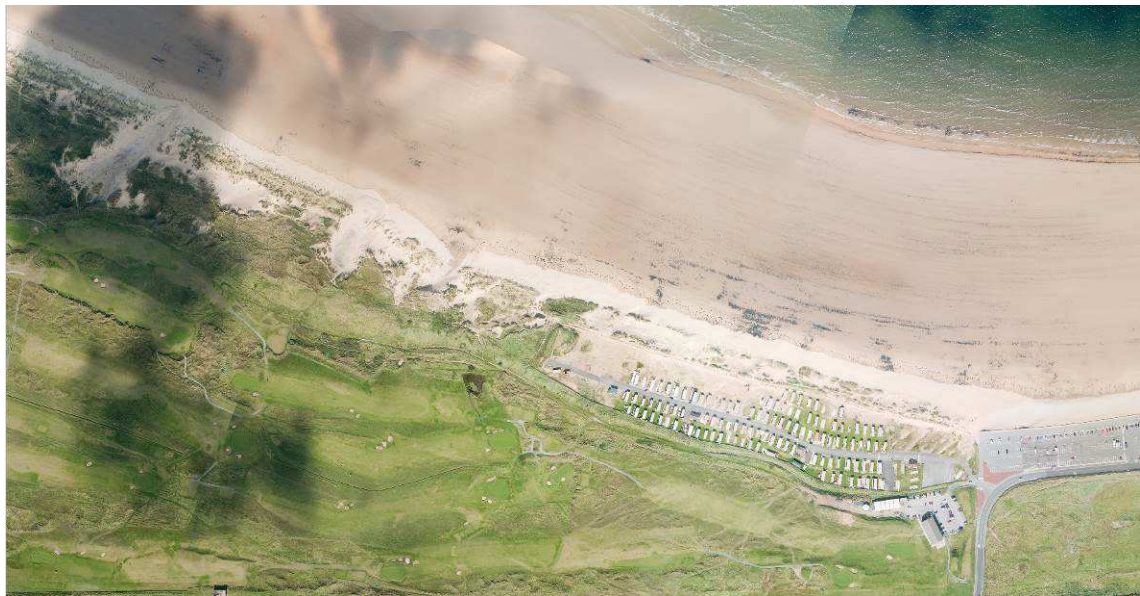
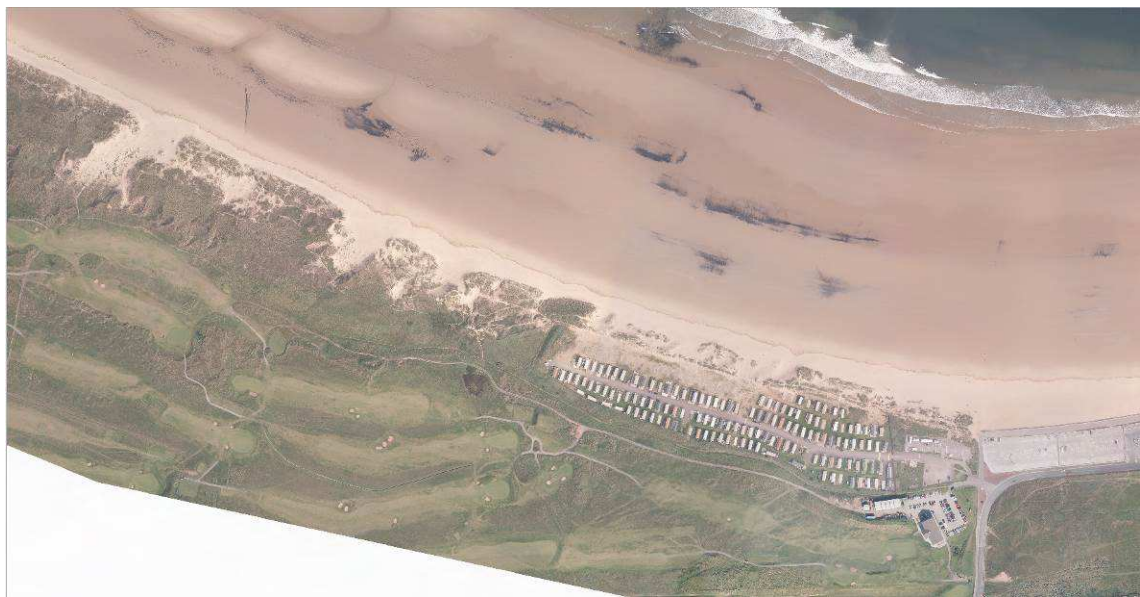
Figure 20 - Majuba Area, 1999 (top), 2009 (middle) and 2017 (bottom)

- The Majuba area, where it is understood there is an historic landfill at the core of the dunes with a covering of wind-blown sand, does appear to have lost vegetation (marginally) between 1999 and 2009 (Figure 20), perhaps due to local blow outs or storm erosion. However, the broad configuration of the dunes here has been roughly in its present condition consistently, with only minor changes, for some considerable time as shown by the similarities between the 2009 and 2017 photography (Figure 20). From previous field visits it is known that the historic waste material has become exposed on the seaward face where the covering of blown sand is absent, but this is not visible from the aerial photography.
